# THE EXPLOSION OF THE DISPLAY FIREWORKS ASSEMBLY PLANT "MS VUURWERK" ON FEBRUARY 14, CULEMBORG, THE NETHERLANDS

25th DoD Explosives Safety Seminar  
18-20 August 1992, Anaheim, California

W.P.M. Mercx and H.H. Kodde

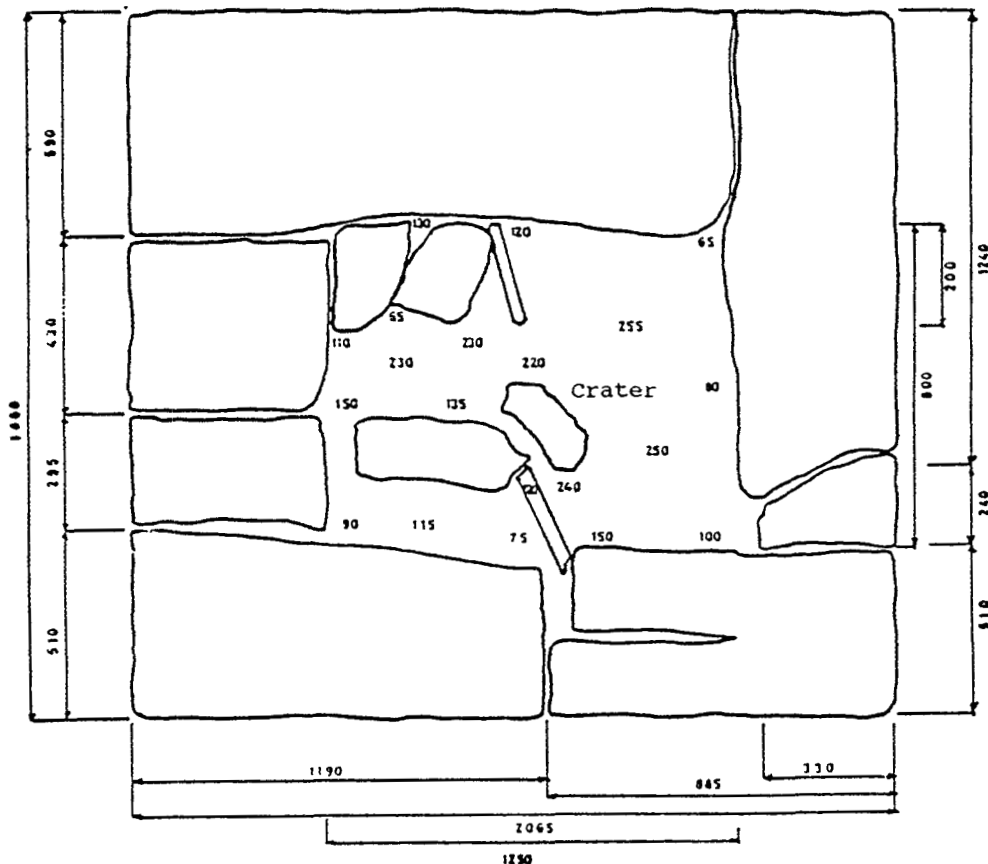
It appeared that the new building was completely vanished and that only a large crater was left. The crater dimensions were 10 by 5 meters with a depth of more than two meters (see Figure 5).

Figure 5 Overview of the crater

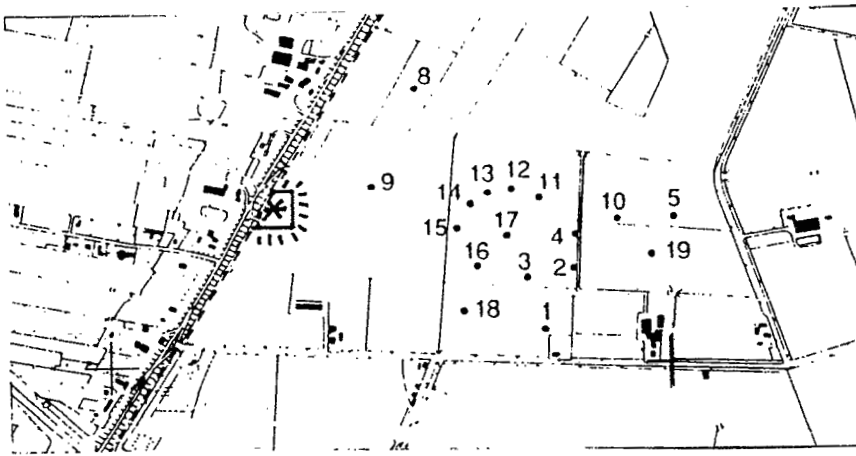
Beside damage caused by the blast there was considerable damage caused by flying debris. The largest range over which debris was thrown was found on the eastern side. The storage rooms were situated on the eastern side of the assembling hall. Up to 650 m east of the plant large pieces of concrete weighting 10 to 20 kg and parts of steel girders (length approx. 4m) were found.

Table 1 gives an overview of the large steel girders that were found and Figure 6 gives the location of these pieces of steel. All IPE's box girders and steel strips were parts of the steel truss of the exploded building.

Figure 6 Location of the large steel girder parts

It is recommended to make an evaluation of the damage caused by the explosion in relation of the criteria of the quantity distances as recommended by the AC/258 storage group. This should be done especially for the fragment and debris criterion for HD 1.1 as large pieces of steel girders were thrown far beyond the 400 m circle.

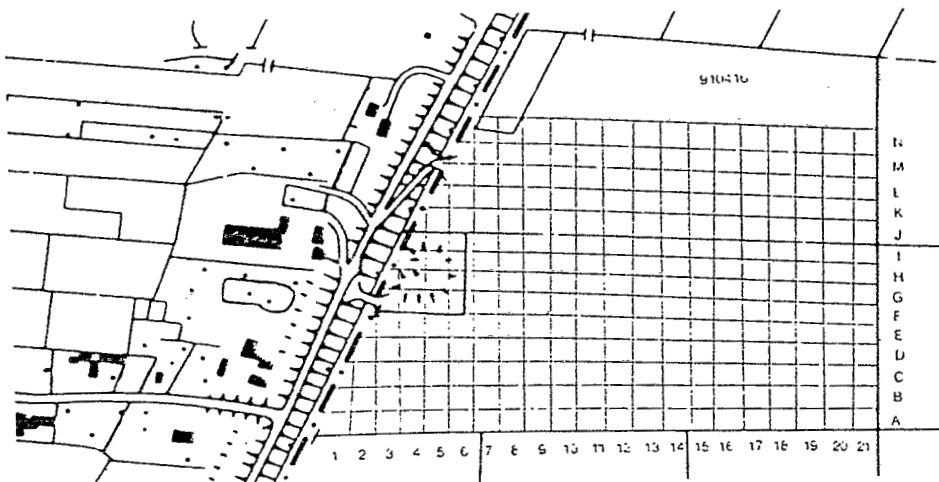
Figure 7 Sections for fragment and debris recovery

Each section was searched by a team of police and army men and every piece of debris weighting over 0.5 kg was gathered. Table 2 gives the total weight of the debris found in each section.

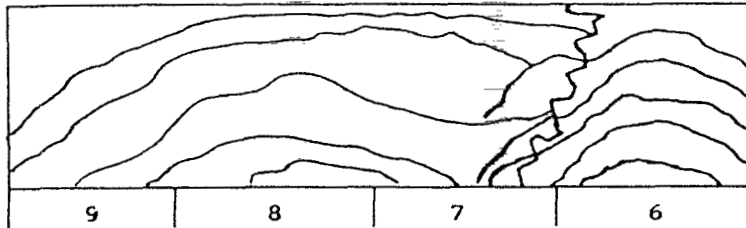
A second fact to support the theory of an initial explosion . immediately followed by a second one, is the crack pattern in the concrete floor plates in front of the storage rooms (see Figure 8).

Figure 8 Cracks in concrete floor in front of the storage rooms

This pattern showed two circular crack zones, one in front of storage room 6 and one in front of the storage rooms 7, 8 and 9 and a large cross crack perpendicular to the storage rooms. The circular cracks in front of storage room 6 were not interrupted by the cross crack while the circular cracks in front of 7, 8 and 9 were. This indicates that the cracks in front of rooms 7, 8 and 9 were created after the formation of the cracks in front of room 6.
