**WATERTOWN ARSENAL
LABORATORY**

NO. WAL 710/347

Metallurgical Examination of Two T23 Cast Turrets

Produced by the Continental Foundry and Machine Company

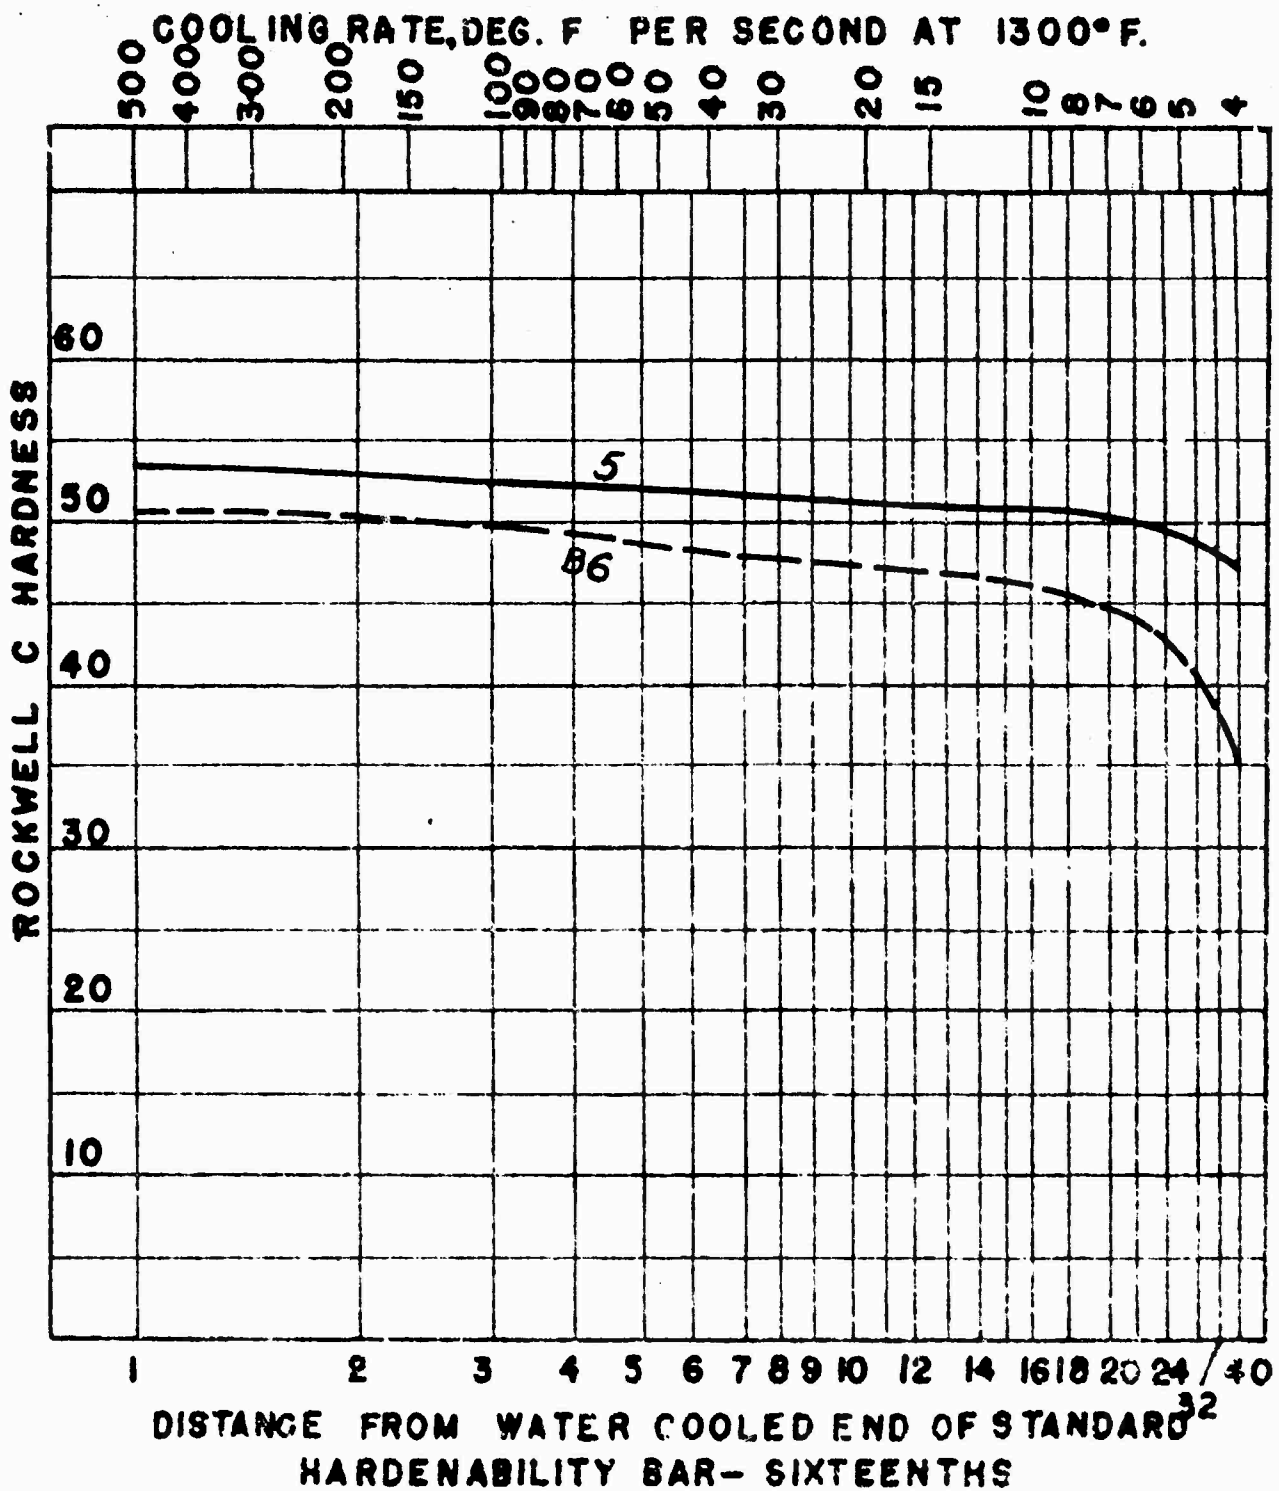
FIGURE 1.

f. Hardenability determination. Standard Jominy hardenability bars were end-quenched after austenitization at 1575°F. for 3 hours. The resultant hardness curves are plotted in Figure 1. The hardenability of both heats is considered adequate to fully quench out the heaviest section occurring in the T-23 turret. Water quenching for a sufficient length of time to bring the temperature of the casting below 300-400°F., air cooling, then tempering to attain the desired hardness, followed by a water quench to reduce the temperature below 400°F. should develop the optimum properties without difficulty.
