TITLE: Minutes of the Explosives Safety Seminar (22nd) Held in Anaheim,
California on 26-28 August 1986. Volume 1.

Technical Investigation of 11 January 1985
PERSHING II Motor Fire

James A. Knaur
US Army Missile Command
Redstone Arsenal, Alabama

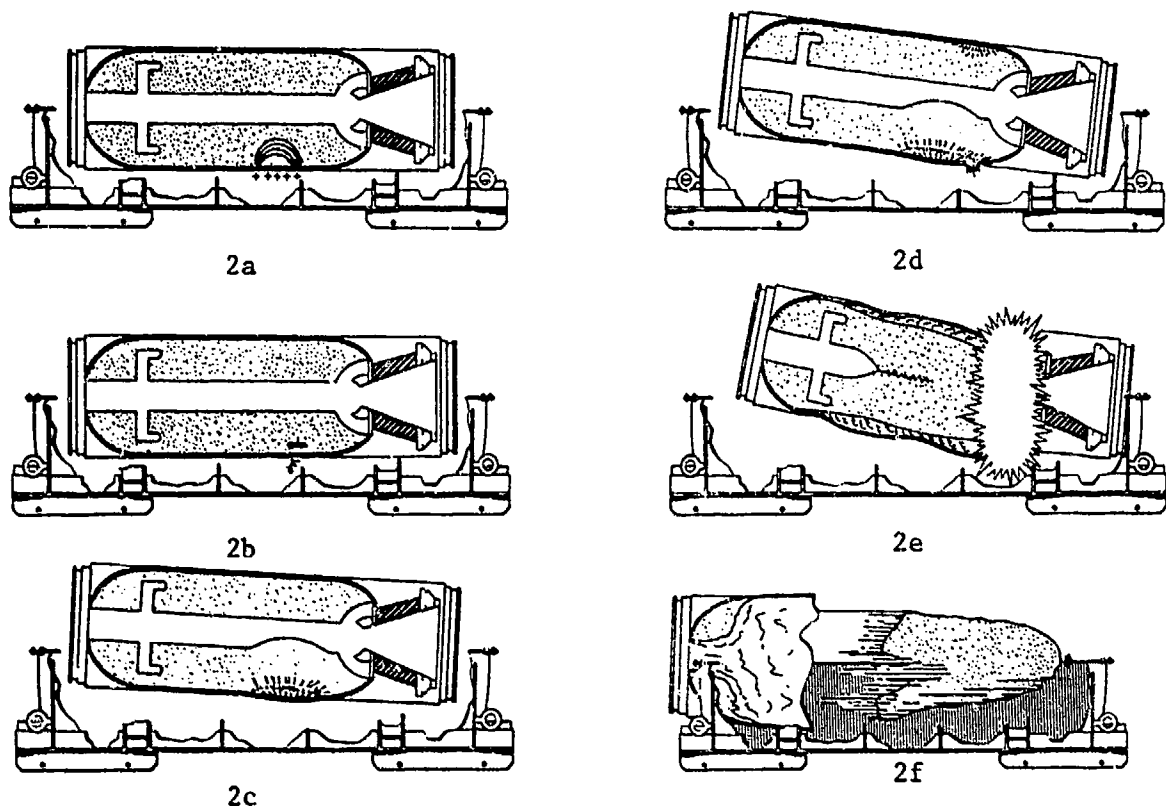
As the rocket motor was being lifted from the container, the separation of the Kevlar rocket motor case from the silicone rubber pads resulted in the creation of a static electric charge by a triboelectric process (see figure 1a). The charge was localized on the motor surface in the area above the pads and on the pads. In tests on tactical, full scale motors being separated from a shipping container cradle it has been found that the high charge density areas (hot spots) tended to be localized to the region between 130° and 160° from the top of the motor. Further, due to the fit of a specific motor into a specific container, these hot spots tended to be repeatedly created in certain areas. The density of the electrostatic charge has been shown to increase as

The epicenter of the event was located between 130° and 150° of rotation, and approximately 94 inches aft of the forward surface of the propellant grain. The flame stabilized in a gas pocket between the bond-line and the grain, and the aft section of the grain started to implode. See figure 2c. The flame spread forward and aft at a higher rate than the circumferential rate. The stiffness of the propellant grain and the case restricted gas expansion and created a high temperature region which supported further burning and pressure increase. The mechanical stress on the grain from the high pressure packet caused a sudden, partial collapse of the center bore of the grain in the region of the gas pocket. But, the rapid decrease in pressure due to the sudden increase in volume was insufficient to extinguish the fire. Collapse of the grain center bore progressed fore and aft, reaching the aft end first, such that it blocked gas flow through the nozzle. This resulted in an increased pressure buildup and ignition of an increasing surface of propellant. Soon the pressure was above the limits of the strength of the case (see figures 2d and 2e) and the aft end of the propulsion section was expelled aft. At nearly the same time, the expanding gas pocket had reached and broken into the forward cavity. Again, the decrease in pressure was insufficient to extinguish the fire. The pressure built rapidly within the forward cavity since the bore was completely collapsed causing about 4000 pounds (1800 kg) of propellant to be expelled approximately 50 meters aft of the incident site where it burned. See figure 2f. The reactive force simultaneously moved the head end of the motor and container forward, approximately one meter, to rest against the truck used in the assembly.

Figure 2a-f. Sequence of events as PII first stage motor was being removed from its shipping container which led to the motor fire and damage. Figure 2a shows a positively charged patch on the outer surface of the composite PII motor case created by the silicone foam rubber cradle pads of the container. An external arc discharge resulting in the internal arc is shown in 2b. Figures 2c and 2d show the progressive expansion of the localized high pressure area causing case failure which resulted in the collapse of the grain, shown in 2e, and the separation of the nozzle/aft skirt section. Figure 2f shows the result of the high pressure pocket formed in the "P-groove" area in the front of the propellant grain.
