**AEROPLANE AND ARMAMENT
EXPERIMENTAL ESTABLISHMENT**

WYVERN S. MK. 4 VW. 684
(PYTHON 3)

PRELIMINARY DIRECTIONAL HANDLING ASSESSMENT

AEROPLANE AND ARMAMENT EXPERIMENTAL ESTABLISHMENT
BOSCOMBE DOWNWyvern S. Mk.4 VW. 884
(Python 3)Preliminary directional handling assessment

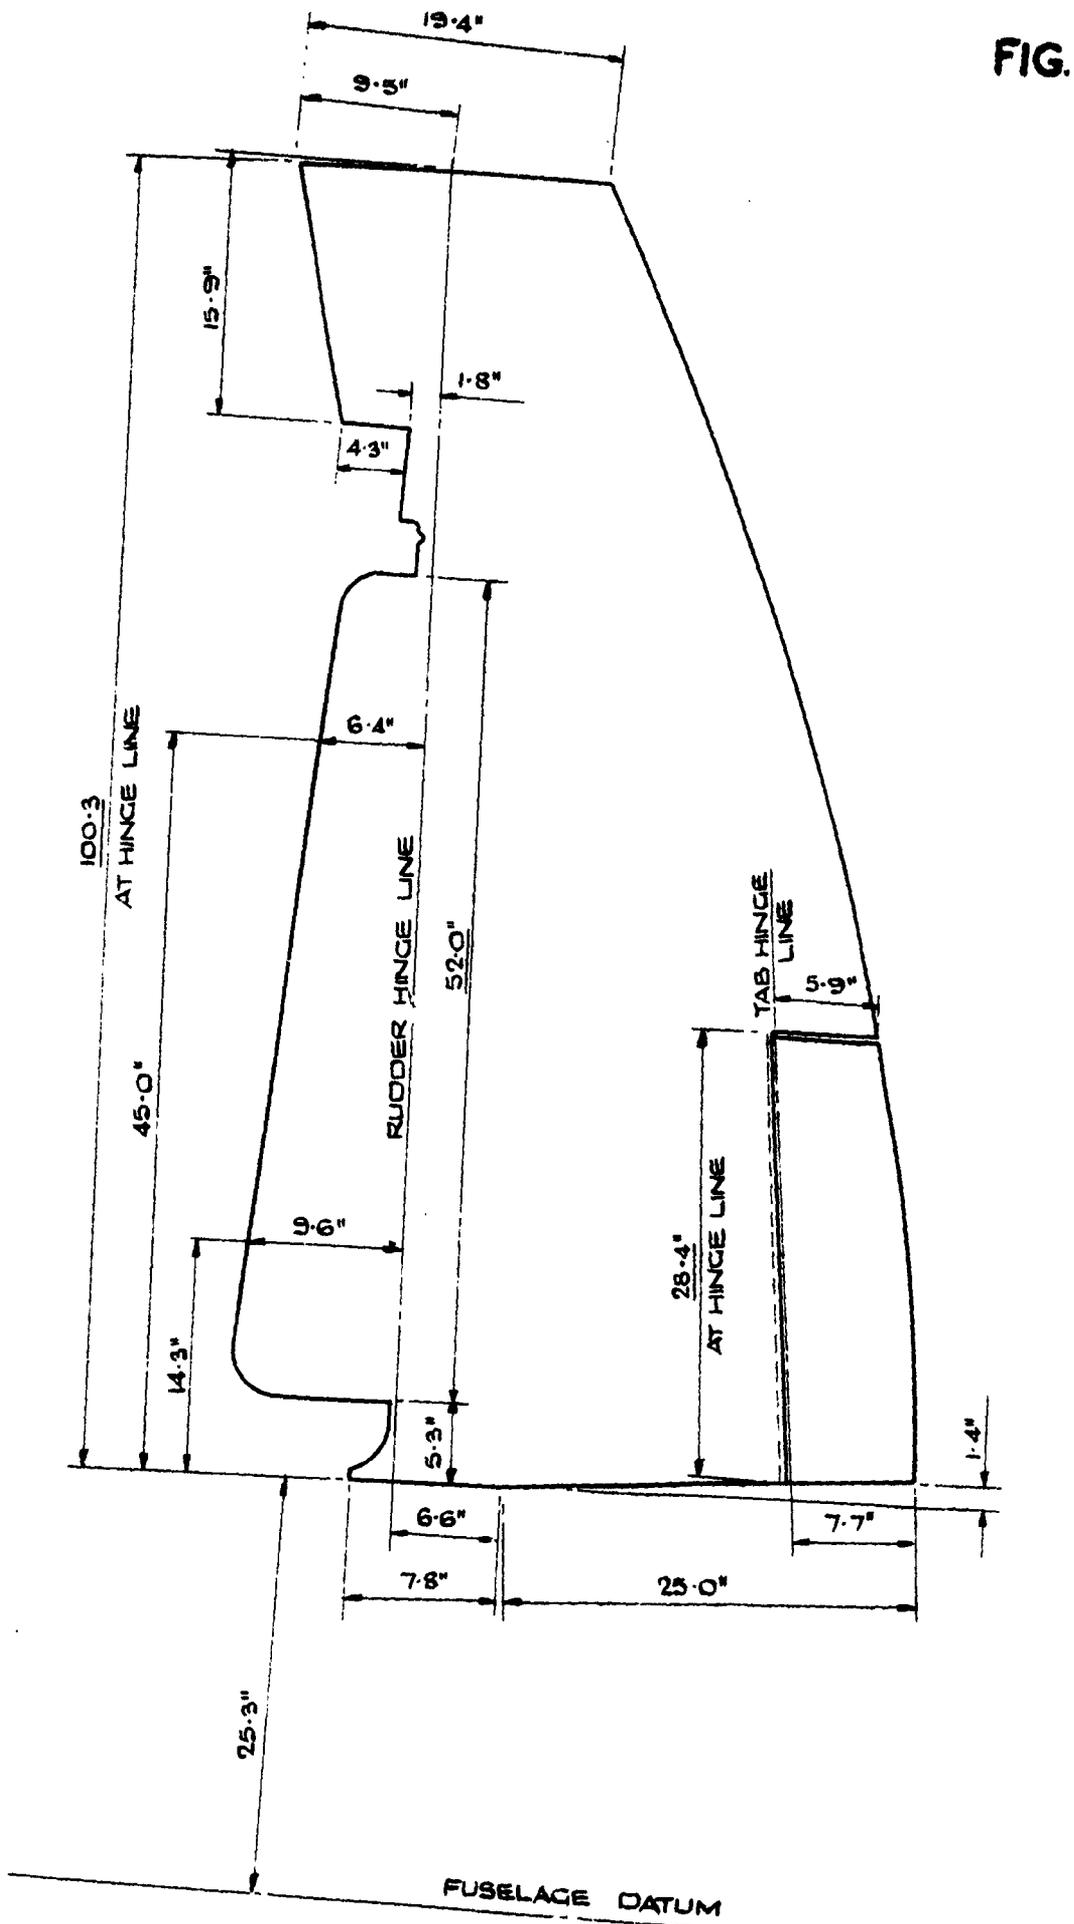
FIG. 3.

2.5 Rudder and fin details. A diagram of the rudder as originally fitted to VW. 884 is given in Fig.3.

The leading edge of the rudder above the top hinge was extended forward to form a 'horn balance'. The rest of the rudder leading edge, between the top and bottom hinges, was shrouded by rearward extensions of the fin skinning. The gap between the fin and the rudder nose was fully sealed by rubberised fabric.

The rudder tab could be adjusted on the ground to give, in addition to its normal trim function zero balance or 0.312:1 balance. The latter setting was used for the first series of tests.

Gross fin and rudder area	50.2 sq.ft.
Gross rudder area	17.1 sq.ft.
Rudder area aft of hinge line	13.3 sq.ft.
Horn balance area above top hinge and forward of hinge line	0.97 sq.ft.
Tab area	1.59 sq.ft.
Rudder travel	15° each way.
