A SAMPLE TEST EXPOSURE
TO EXAMINE CORROSION
AND FOULING OF EQUIPMENT
INSTALLED IN THE DEEP OCEAN

U.S. NAVAL
UNDERWATER ORDNANCE STATION
NEWPORT, RHODE ISLAND

TECHNICAL MEMORANDUM

November 1962

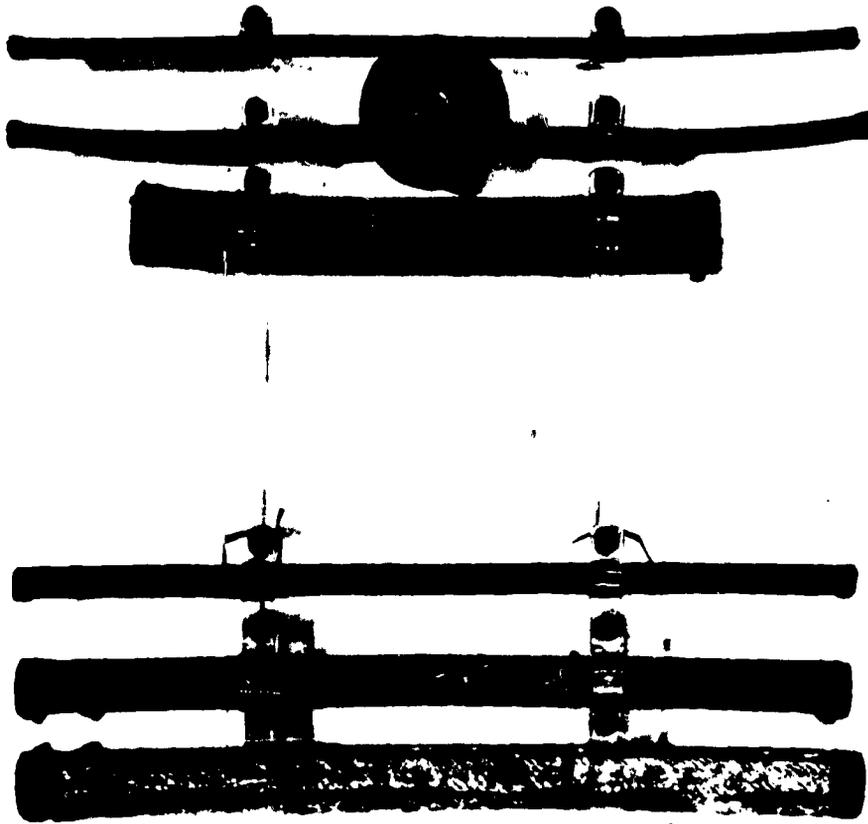
Figure 1

Cables and Polyurethane Rubber Samples
After Exposure

None of the plastic jackets of the conductor cable samples were cracked.

The polyurethane pedestal hydrophone mount sample appeared to have undergone no change. Size, weight, and hardness measurements showed no differences between the initial measurements before exposure.

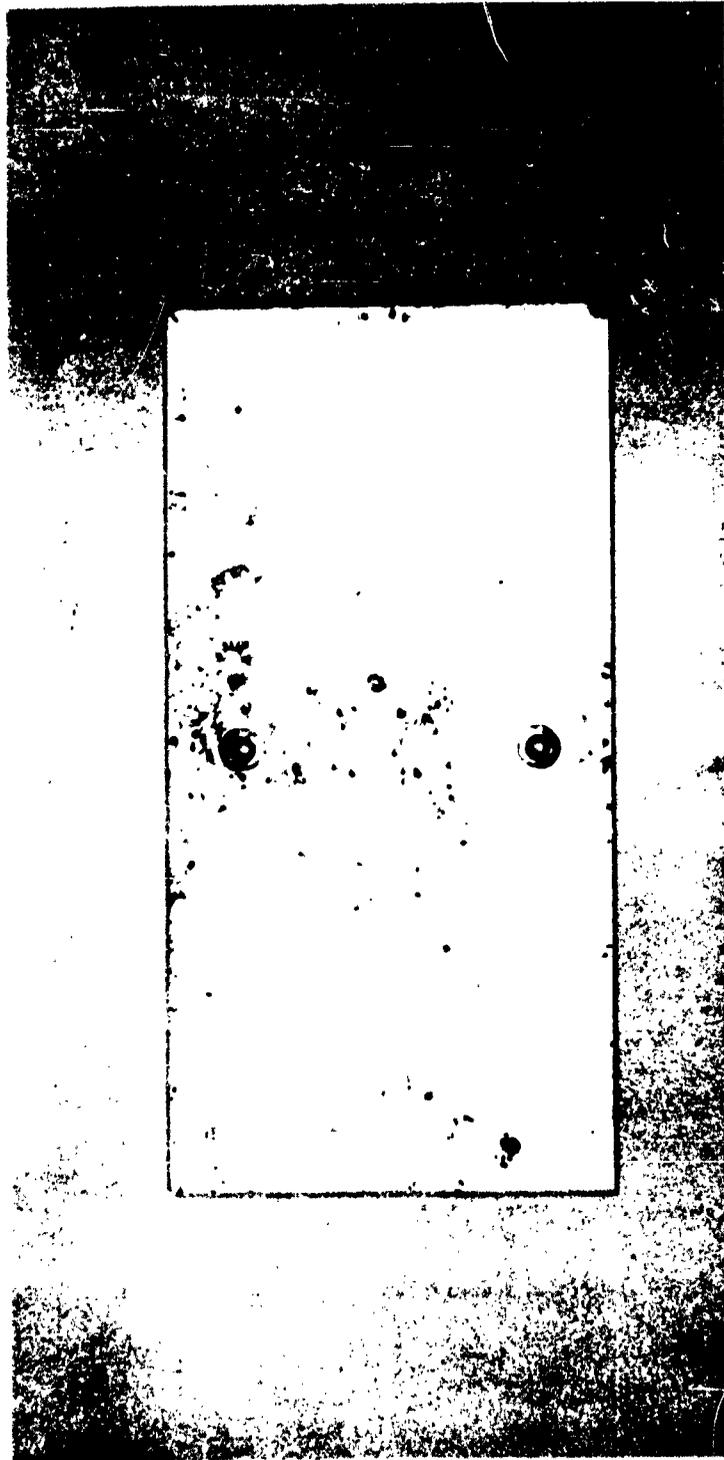
Figure 6

The coating system on the low carbon steel panel, representative of the coatings used in the Rigid Base Line Array, while generally intact, gave some small evidence of deterioration (see figure 6). Small blisters were apparent in localized areas, and the paint had become somewhat brittle and friable at the blistered areas. Extensive corrosion had not proceeded.

Coated Steel Sample Panel
After Retrieval

1. To avoid corrosion, all metal structures designed for installation in deep water be coated or covered with pliable plastic material in order to take advantage of possible pressure sealing effects.
