NEW YORK NAVAL SHIPYARD
NAVAL BASE, BROOKLYN 1, NEW YORK

975:CL:hW
Lab. Project 5319-39
Final Report

Subj: Atmospheric Contamination from Selenium Rectifiers SF-013-12-09

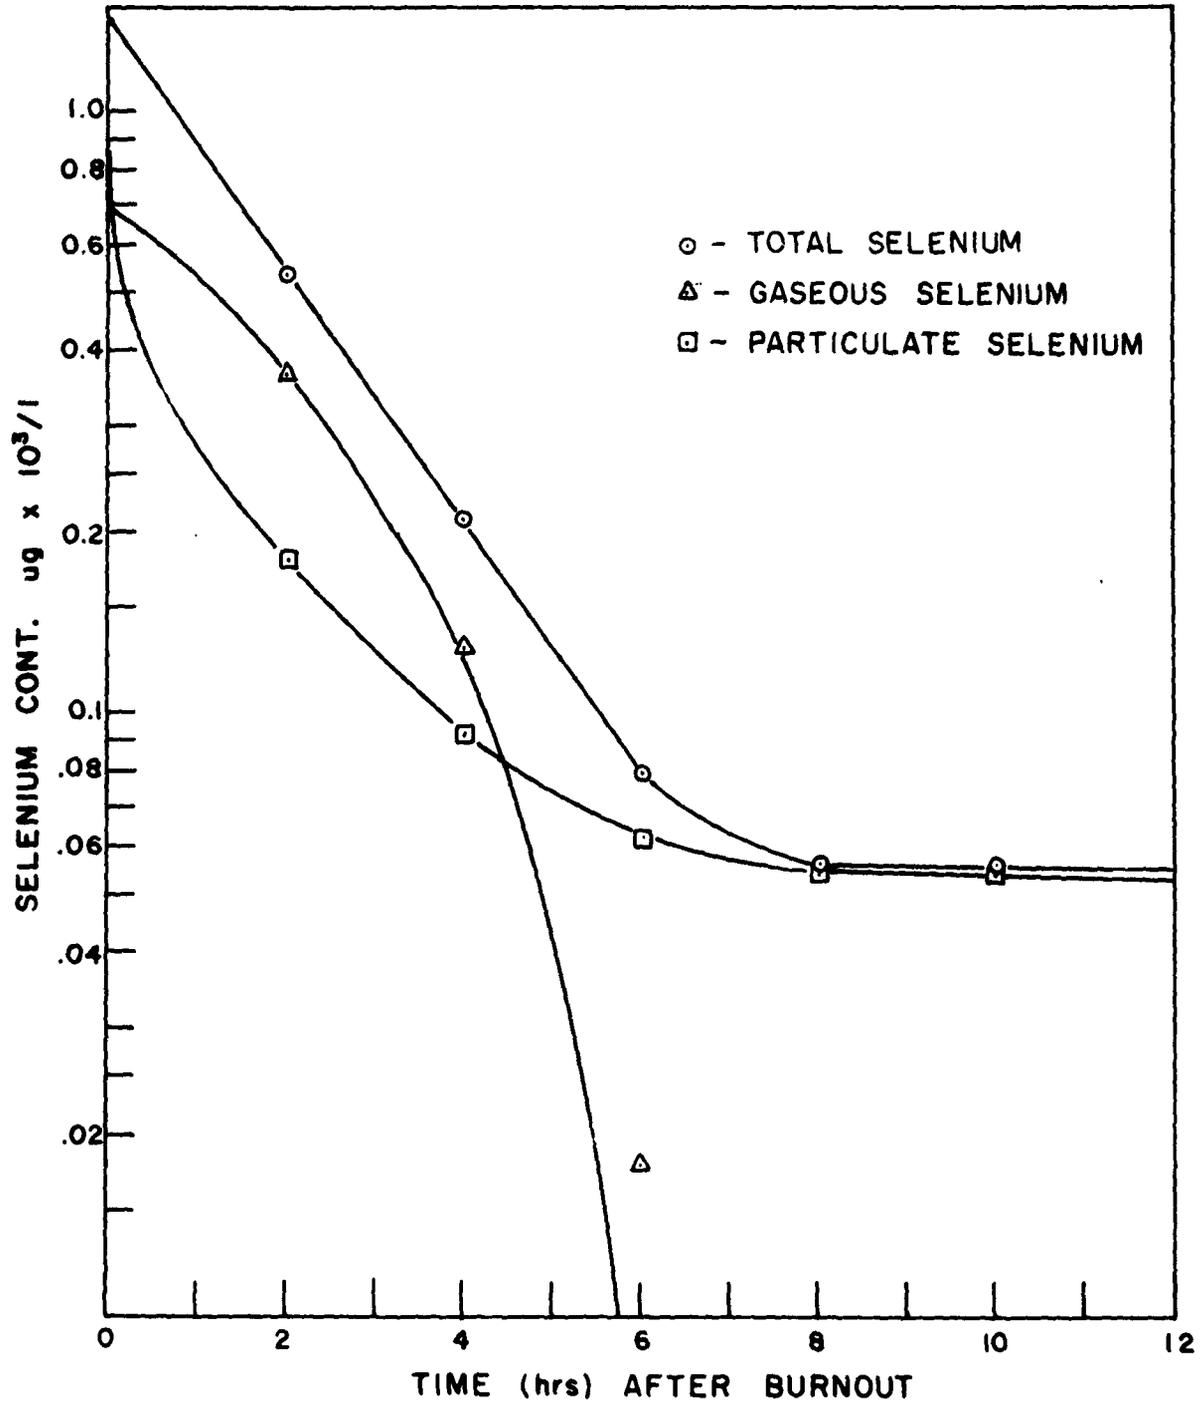
ENCLOSURE 2. PLOTS OF SELENIUM CONTAMINATION IN ATMOSPHERE VS. TIME AFTER RECTIFIER BURNOUT

4. The concentrations of selenium gaseous and particulate contamination produced on burnout of the 6"x4" twelve plate rectifier at the severe electrical loading level of 960 volts A.C. and 30 amperes D.C. are shown in enclosure (1). On burnout, the combined particulate and vapor selenium concentrations, averaged for the first two hours of monitoring, was 0.54×10^{-3} $\mu\text{g/liter}$. As illustrated in enclosure (2) the gaseous selenium curve shows a rapid exponential drop to background level in approximately four hours. The particulate selenium content descends to a constant level after 8 hours of atmospheric monitoring. The residual value of 0.054×10^{-3} $\mu\text{g/liter}$ of selenium is higher than background and may be due to circulation of selenium dust that deposited on various surfaces in the room on burnout of the rectifier. Analysis of adhesive paper, $6\frac{1}{2} \times 6\frac{1}{2}$ inches which represents particulate fallout placed 2 in. and 24 in. from the rectifier gave values of 0.90×10^{-3} and 0.35×10^{-3} $\mu\text{g/sq. in.}$ respectively for a 20 hour period. A photo of the rectifier after burnout is shown in enclosure (3).

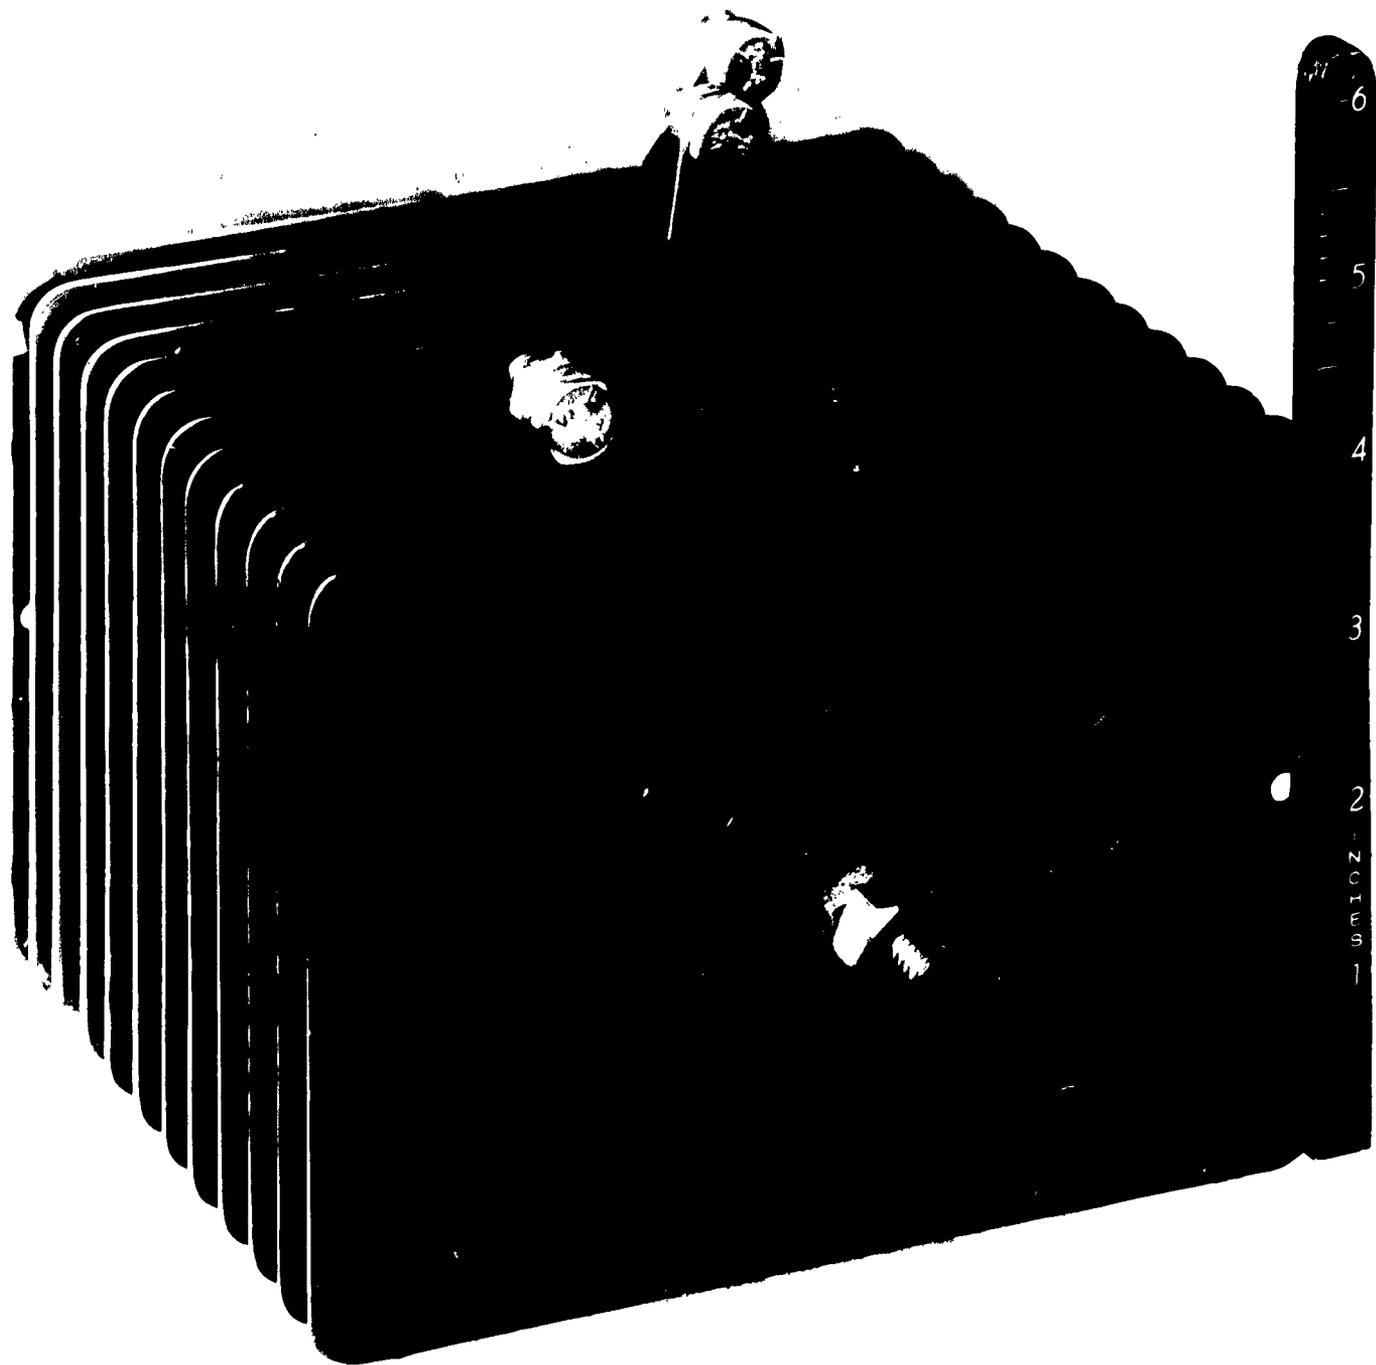
PHOTO L-19459

Selenium Rectifier After Burnout

In the event of rectifier burnout, it is recommended that routine hygienic measures in the contaminated area be observed for the protection of those personnel engaged in the handling and repair of failed equipment.
