# Development and Proof Services

SECOND MEMORANDUM REPORT

Frontispiece: Tank, 90-mm Gun, M48A2.

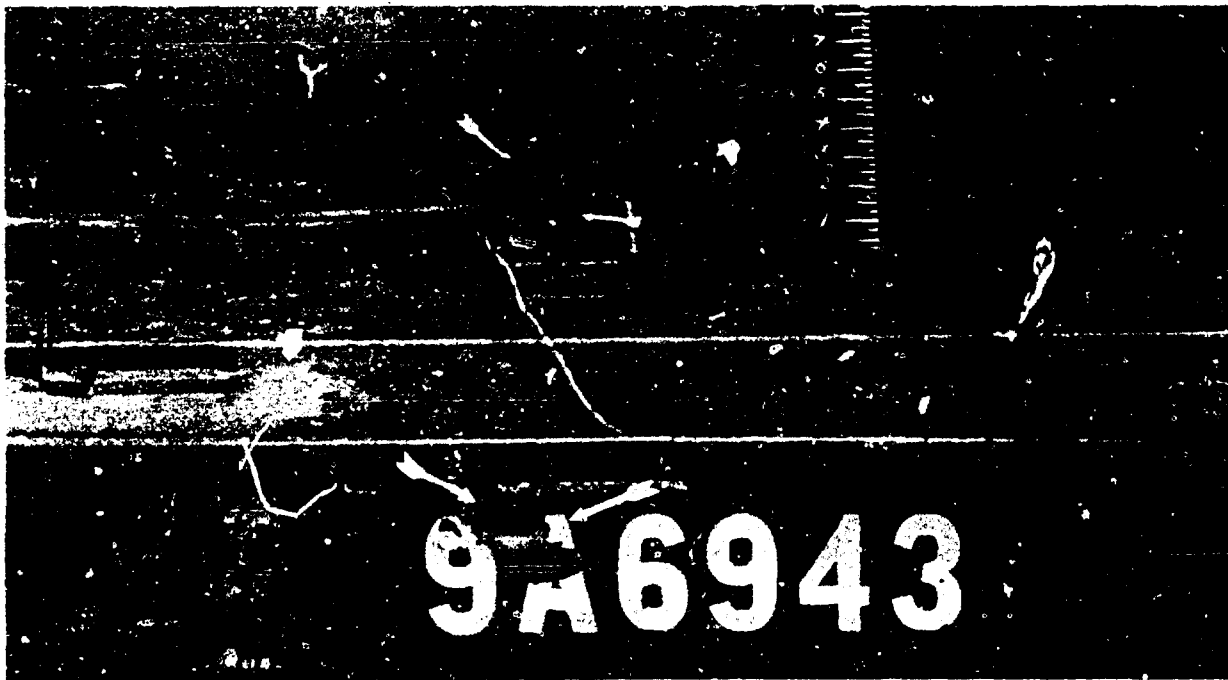
- 3.2.1.2 90° Flank Attack. One round of 20-mm, AP, M95 was fired in a direct flank attack through a fender box, impacting 1 inch below the opening between the turret and hull. This projectile scooped upward into the base of the turret, closing the 1/2-inch opening and locking the turret in the traverse operation. Fifteen minutes of labor with a cutting torch was required to free the turret (Figure 2).
- a.

Figure 2 - B29723: Turret Locked in Traverse by 20-mm, AP, M95 Projectile Penetrating Fender Box and Impacting into Turret and Hull Opening.

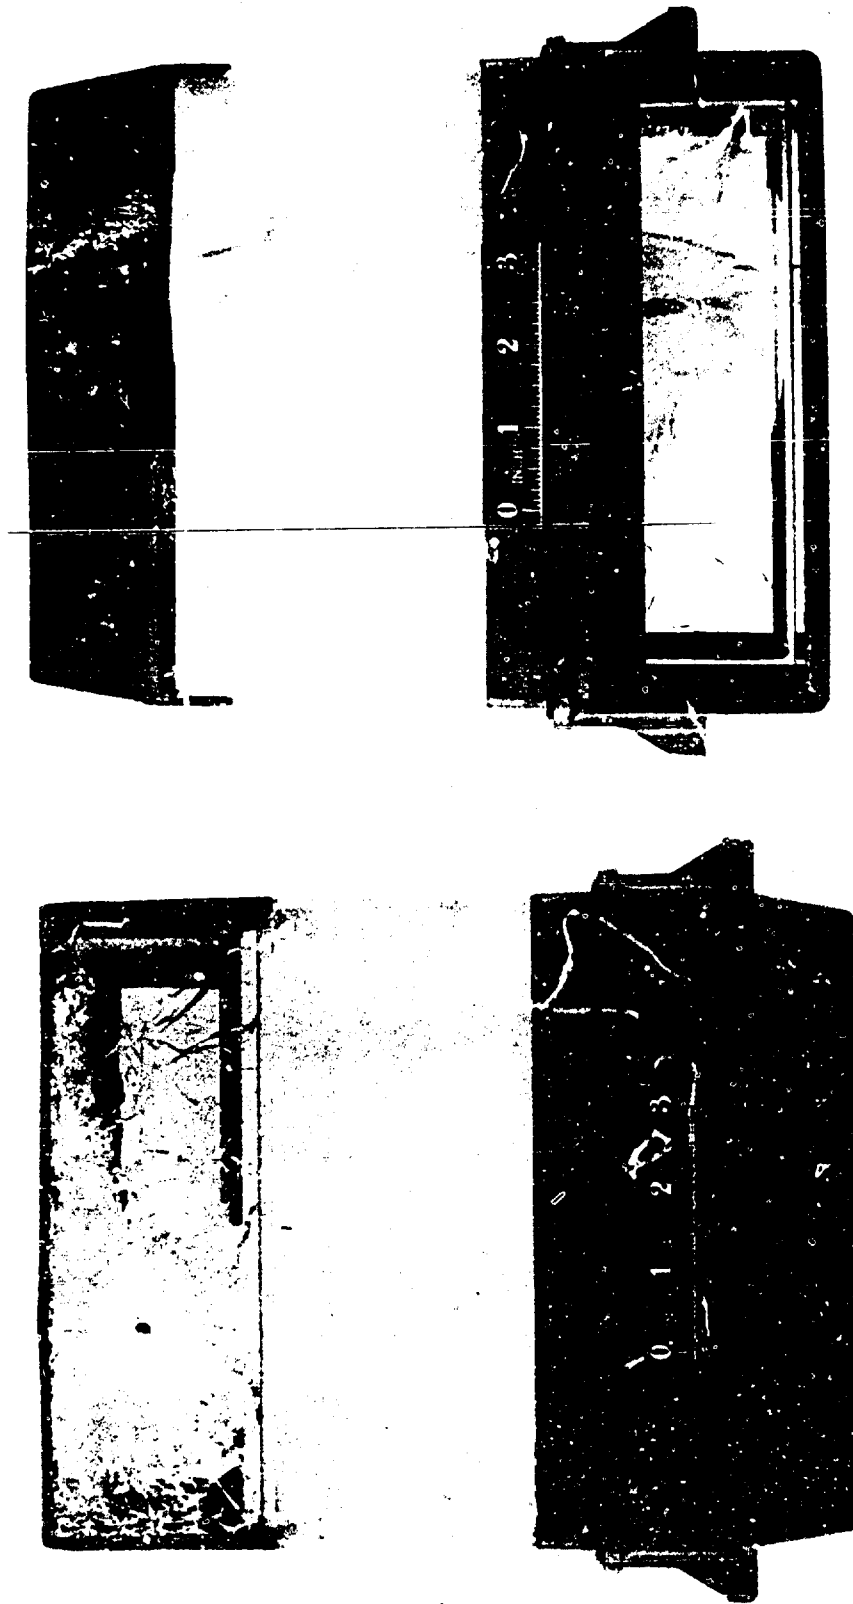
The two periscopes attacked with the caliber .30, AP, M2 projectiles suffered 50% and 85% destruction of visibility, respectively. No glass fragments were displaced from either eye prism and each periscope could have been readily replaced by the driver from within the vehicle without outside assistance (Figure 4).

Figure 4 - 59T2090 (Left) and 59T2091: Front Surface (Left) and Rear Surface Views of One M36 Driver's Periscope Impacted with One Round Caliber .30, AP, M2 Projectile.

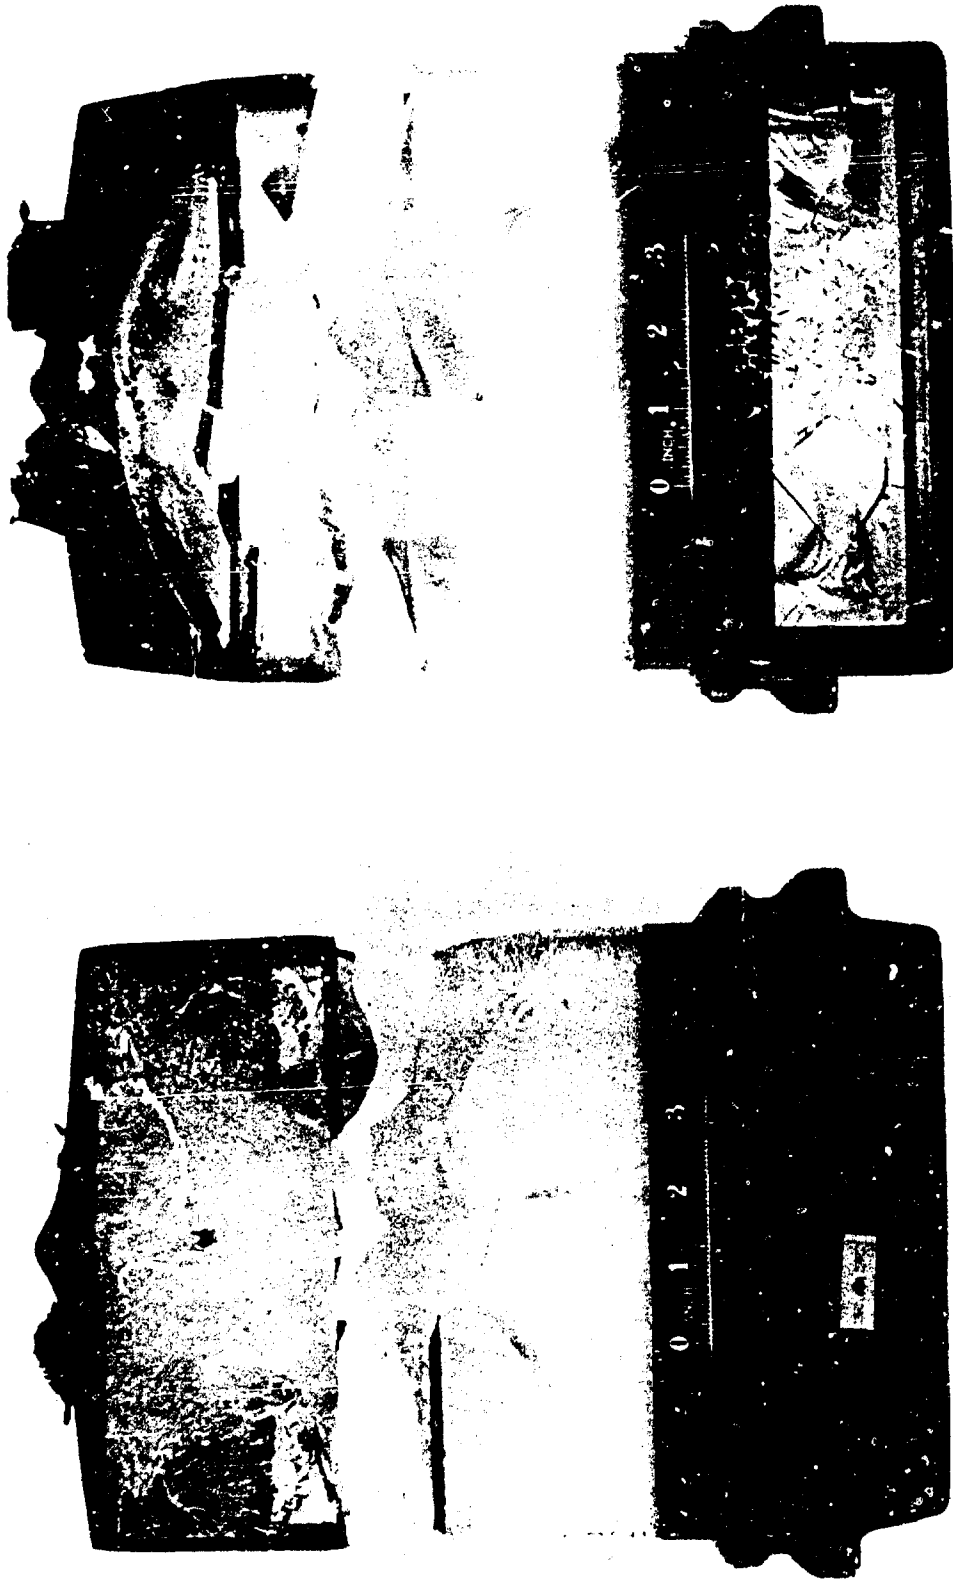
Three of the periscopes impacted with the caliber .50, AP, M2 projectiles sustained 100% destruction of visibility. In each of these three instances the plastic body of the periscope was sheared and the top prism completely displaced from its normal position (Figure 5). In all three of these cases the driver would have been able to effect a rapid, unassisted change from within the vehicle under fire. The fourth periscope in this group suffered 75% destruction of visibility and no shearing of the plastic body occurred. Although this item suffered the least damage of the four periscopes attacked with the caliber .50 projectiles it was this last unit which would have caused the tank crew the most trouble in making a replacement under fire. A 2- by 2-5/8 inch opening on the rear of the metal top prism frame petalled out over the limits of the periscope slot and would not permit the periscope to be withdrawn into the driver's compartment for replacement without assistance from someone on the exterior of the vehicle (Figure 6). The eye prisms of the four periscopes were badly cracked but no glass fragments were displaced to injure the driver's eyes, although some glass dust was observed to filter down into the driver's compartment as a result of the projectile impacts in the upper prism.

Figure 5 - 59T2092 (Left) and 59T2093: Front Surface (Left) and Rear Surface Views Showing Fracturing of Plastic Body of M36 Driver's Periscope When Attacked with a Caliber .50, AP, M2 Projectile.

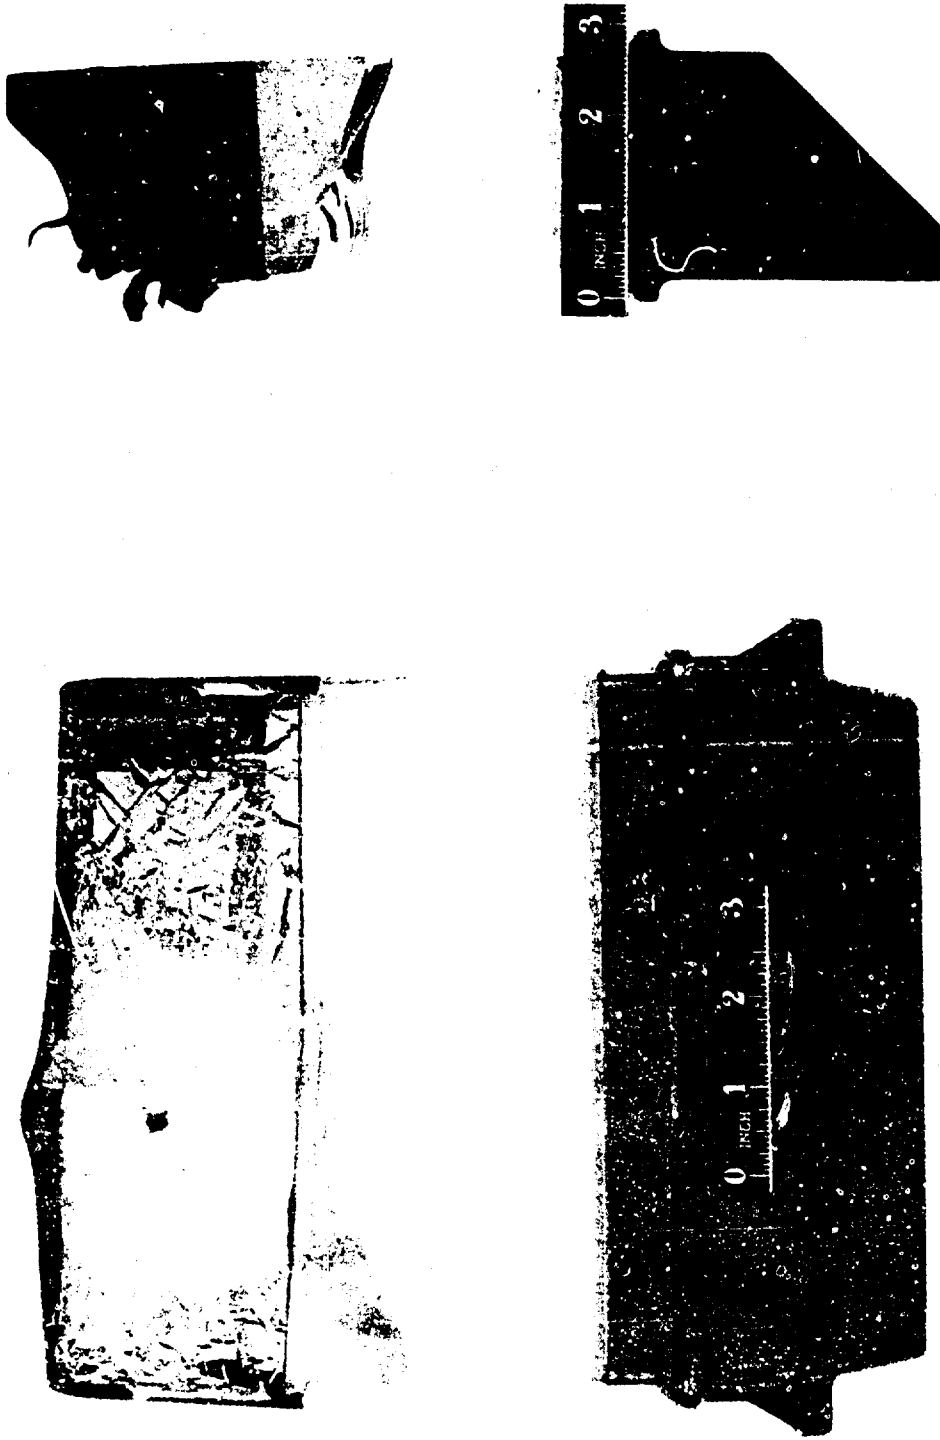
Figure 6 - 59T2096 (Left) and 59T2097: Front Surface (Left) and Side Surface Views Showing Petalling of Objective Prism Metal Case Caused by One Impact of a Caliber .50, AP, M2, Projectile.

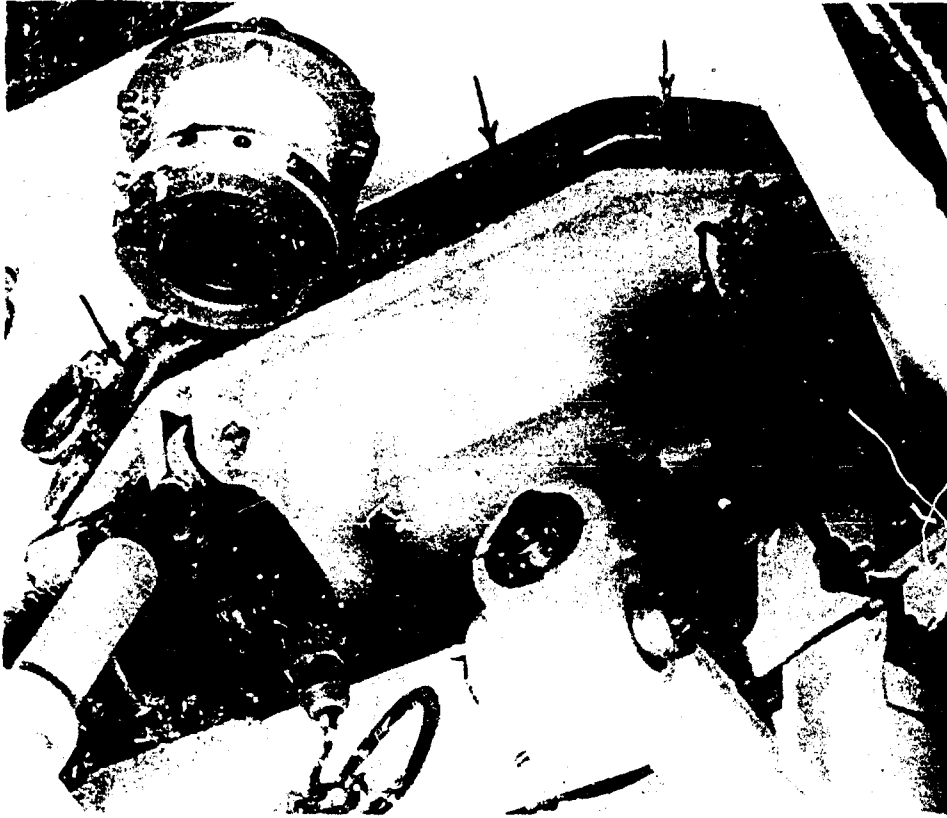
Figure 12: Black Arrows Indicate Splash Guard Installed at Top of MG Cradle and Top of Cupola.

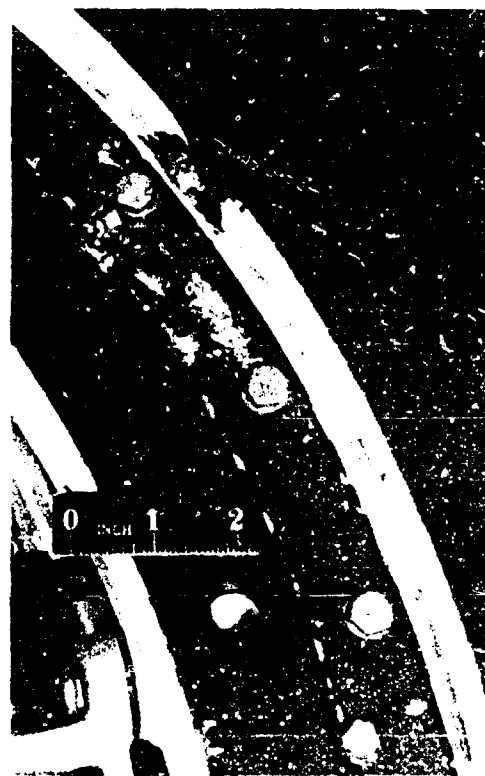
Figure 15 - B32061: Damage to Cupola Mounting Ring and Bearings Caused by One Round of Caliber .50, AP, 1Q Ammunition.
