OPERATION CASTLE

Project 6.2a

**BLAST AND THERMAL EFFECTS ON
B-36 AIRCRAFT IN FLIGHT**

REPORT TO THE TEST DIRECTOR

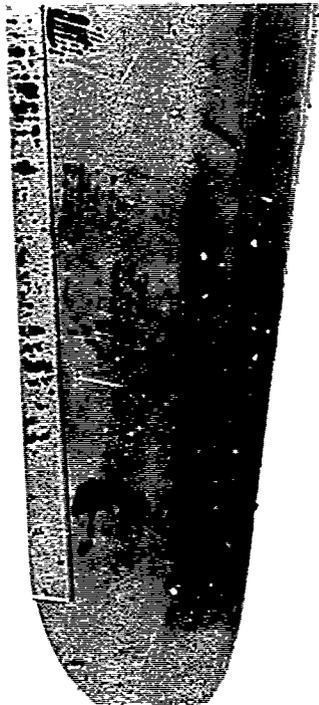
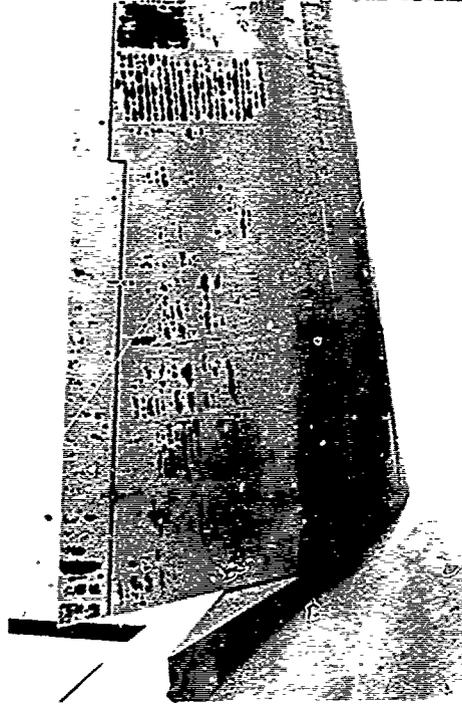
Fig. 4.18 Left and Right Elevators After Shot 5

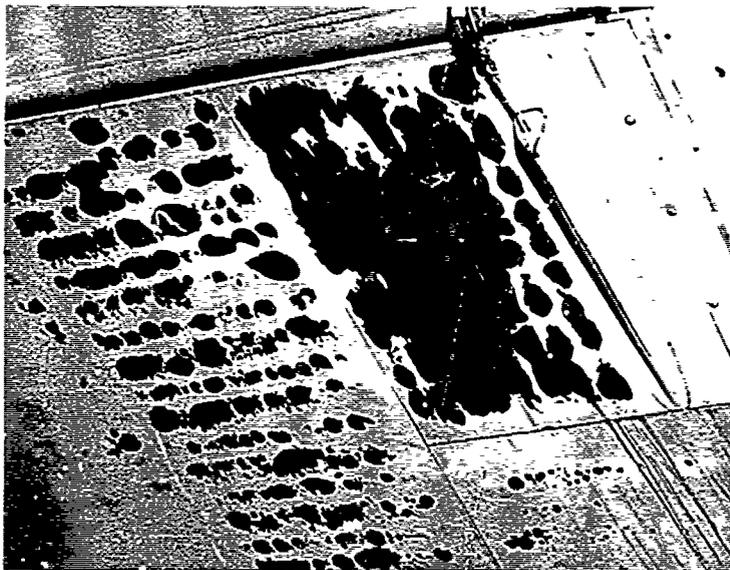
Fig. 4.20 Permanently Buckled Skin Of Ho Panel Section On Right Elevator After Shot 5
