4
EXPLOSION OF A
TITANIUM FURNACE AT THE
JESSOP-SAVILLE WORKS, SHEFFIELD

R.A.E. Report No. PBW.2

EXPLOSION OF A TITANIUM FURNACE
AT THE JESSOP-SAVILLE WORKS, SHEFFIELD

An investigation into the explosion of a titanium arc-furnace is briefly described, and photographs of the more important pieces of wreckage are given.

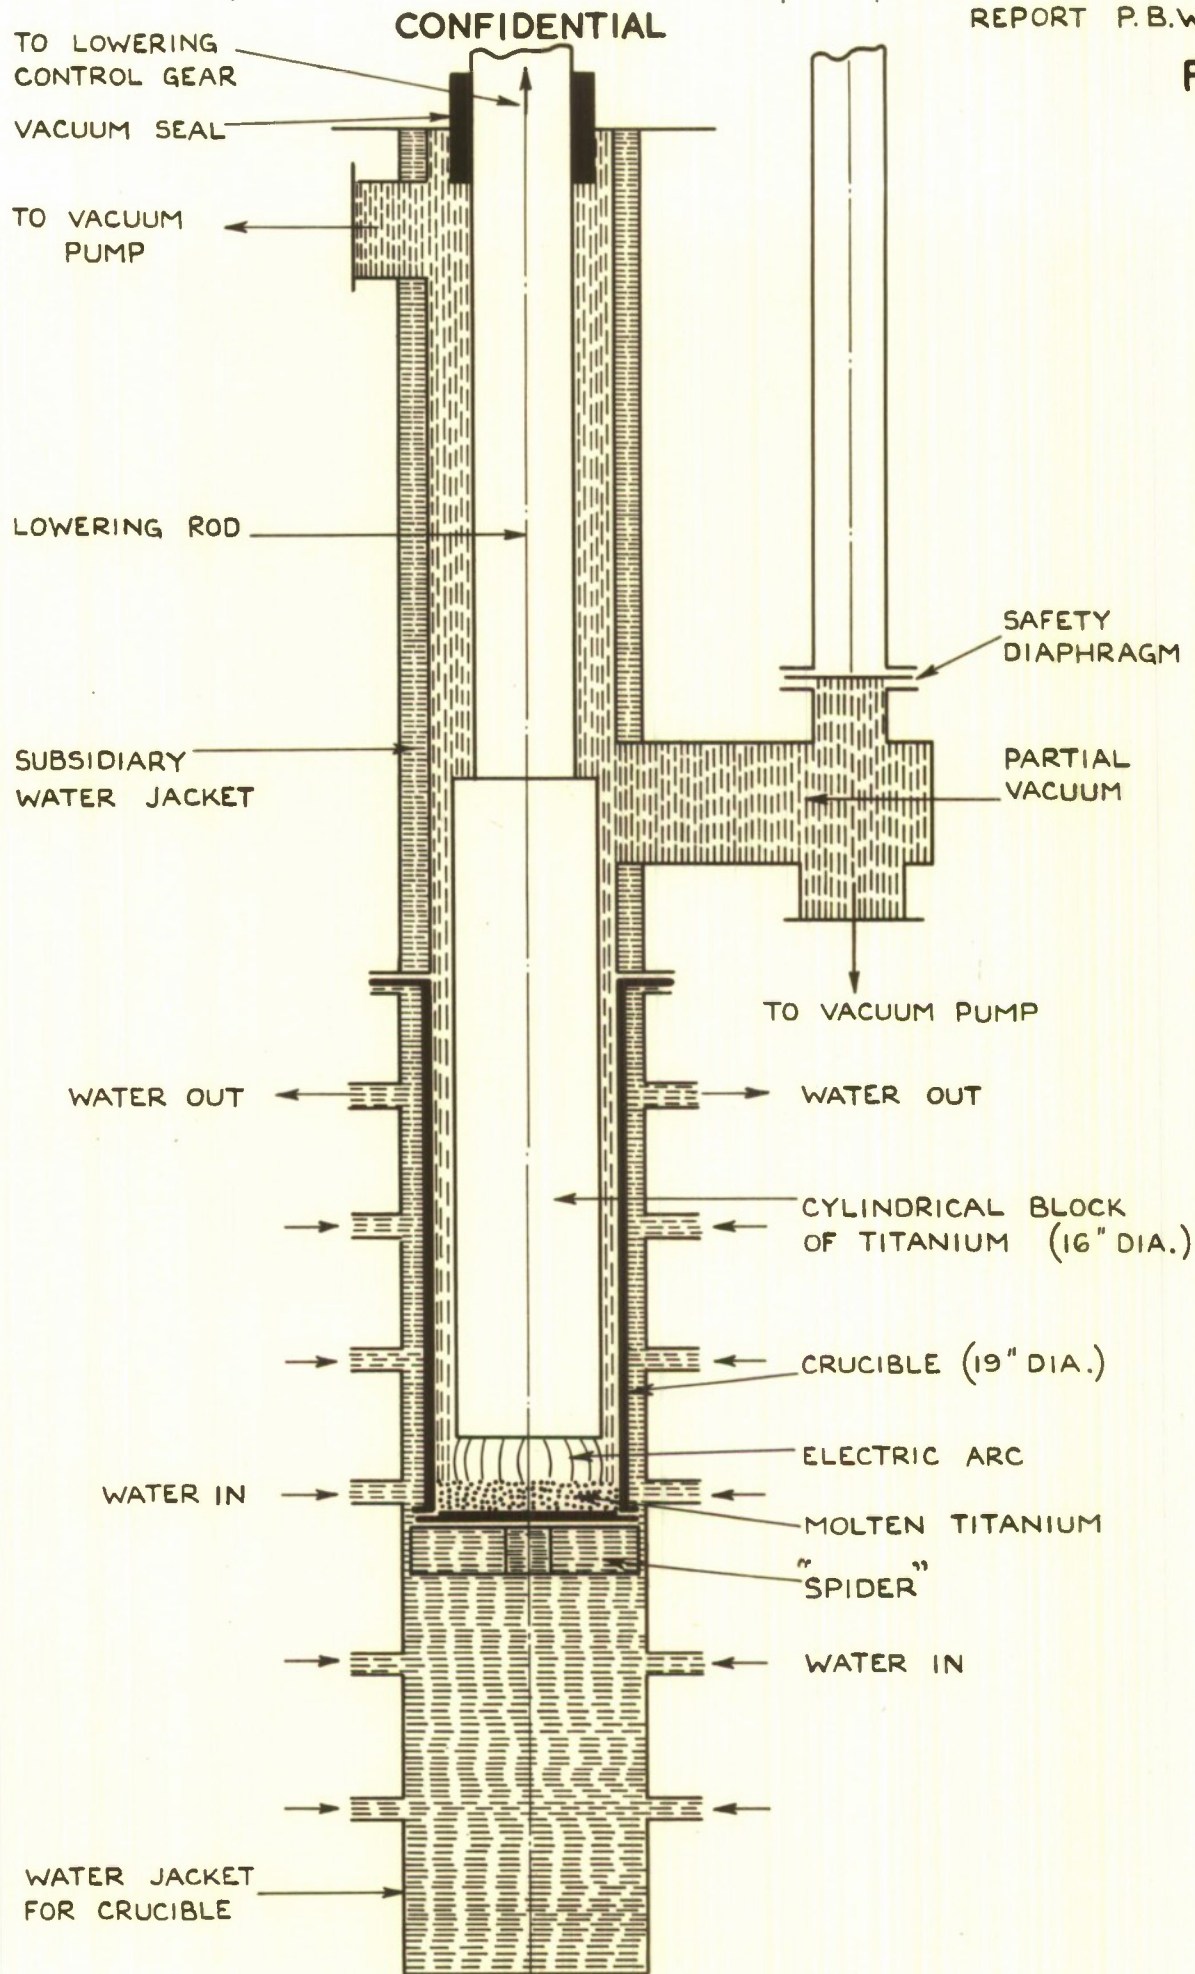
The furnace, which had seen many years service, operated on the principle of the electric arc at about 400 kilowatts of power. In this design, a cylindrical block of titanium, weighing initially about a ton, drips molten metal along a downward moving arc into a copper crucible. This crucible is cooled on the outside by a steady circulation of water enclosed in a steel jacket. The system is illustrated diagrammatically in Fig.1.

FIG.1. DIAGRAM OF TITANIUM MELTING FURNACE.

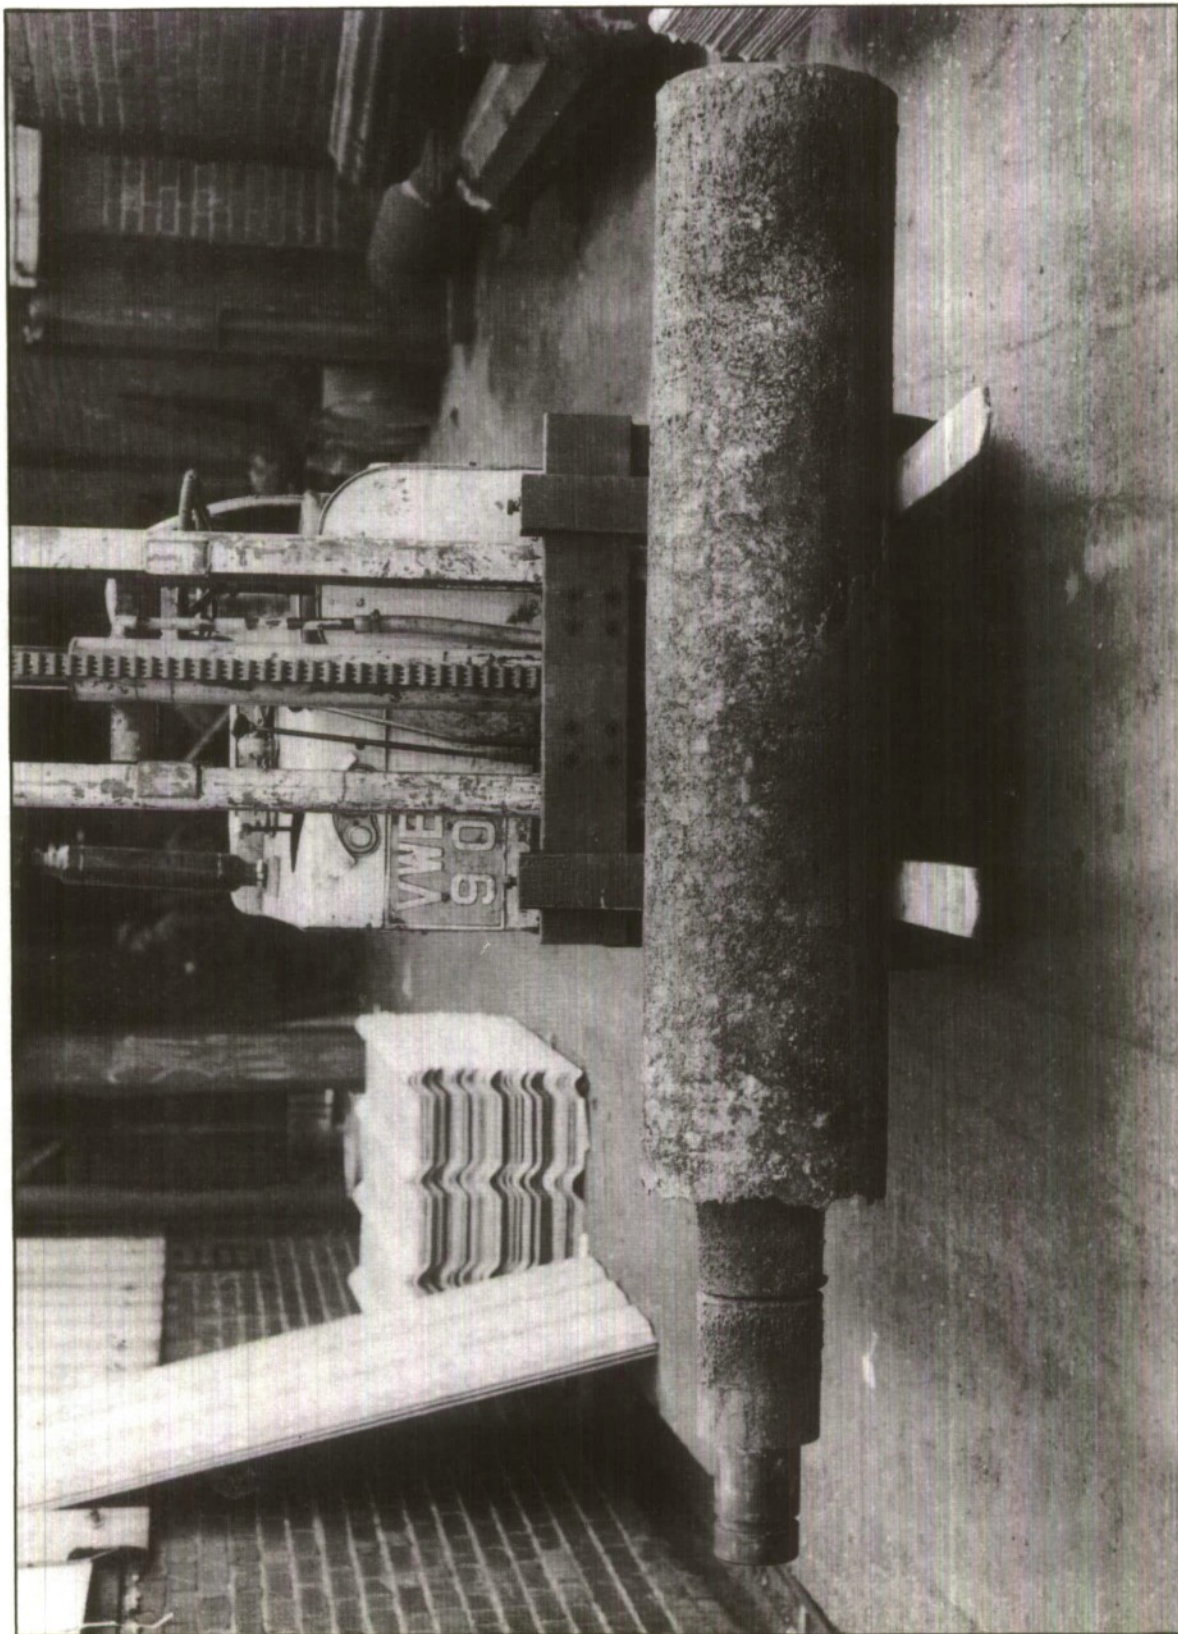
The explosion occurred shortly after the "melt" had been started, and there would have been about 100 lb of titanium in the bottom of the crucible. About three tons of control gear together with the block of titanium (Fig.2) were projected upwards through several feet. Hundreds of square feet of glass and panelling were removed from the roof and walls of the building. The water jacket, made of quarter inch steel, was blown apart (Fig.3).

FIG.2. TITANIUM BILLET WITH ITS ELECTRICAL COUPLING

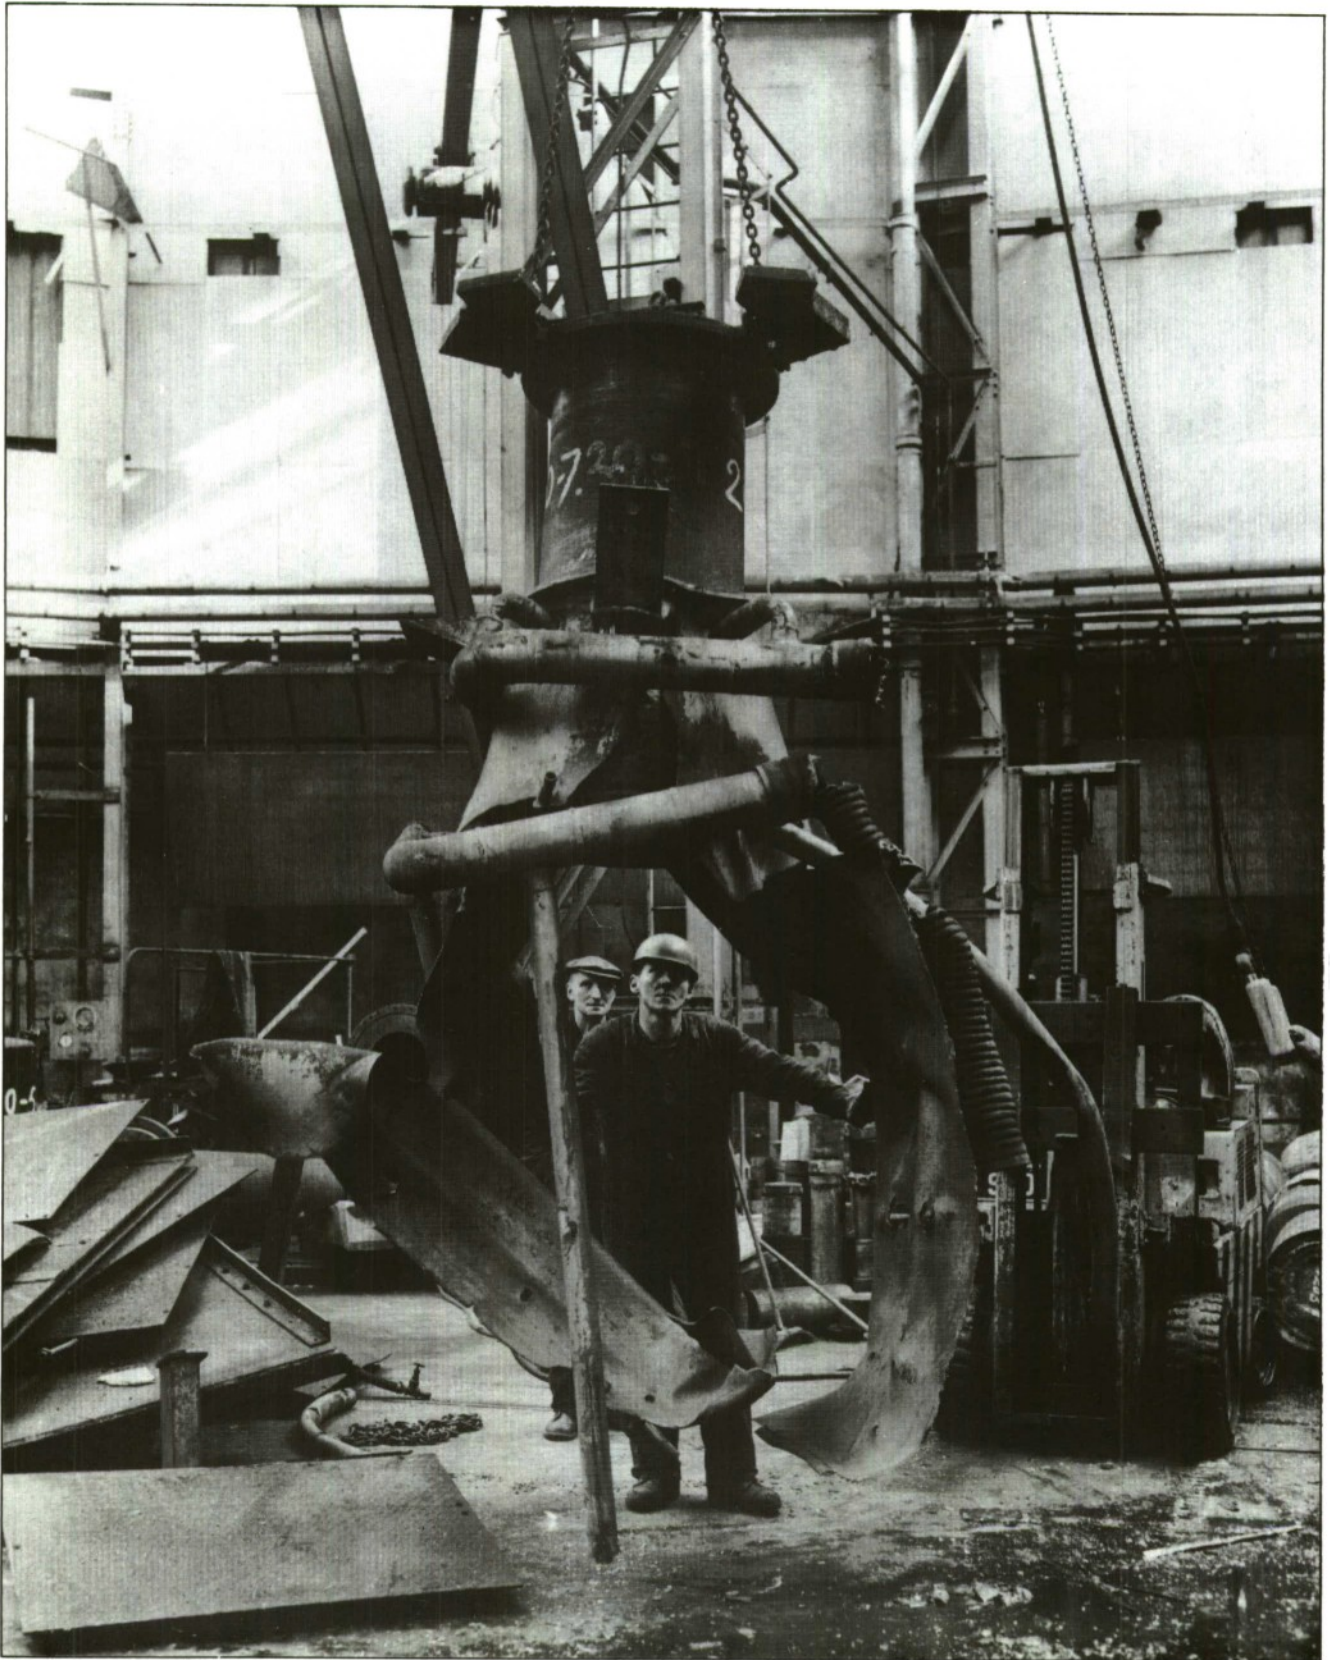
FIG.3. THE EXPLODED WATER JACKET

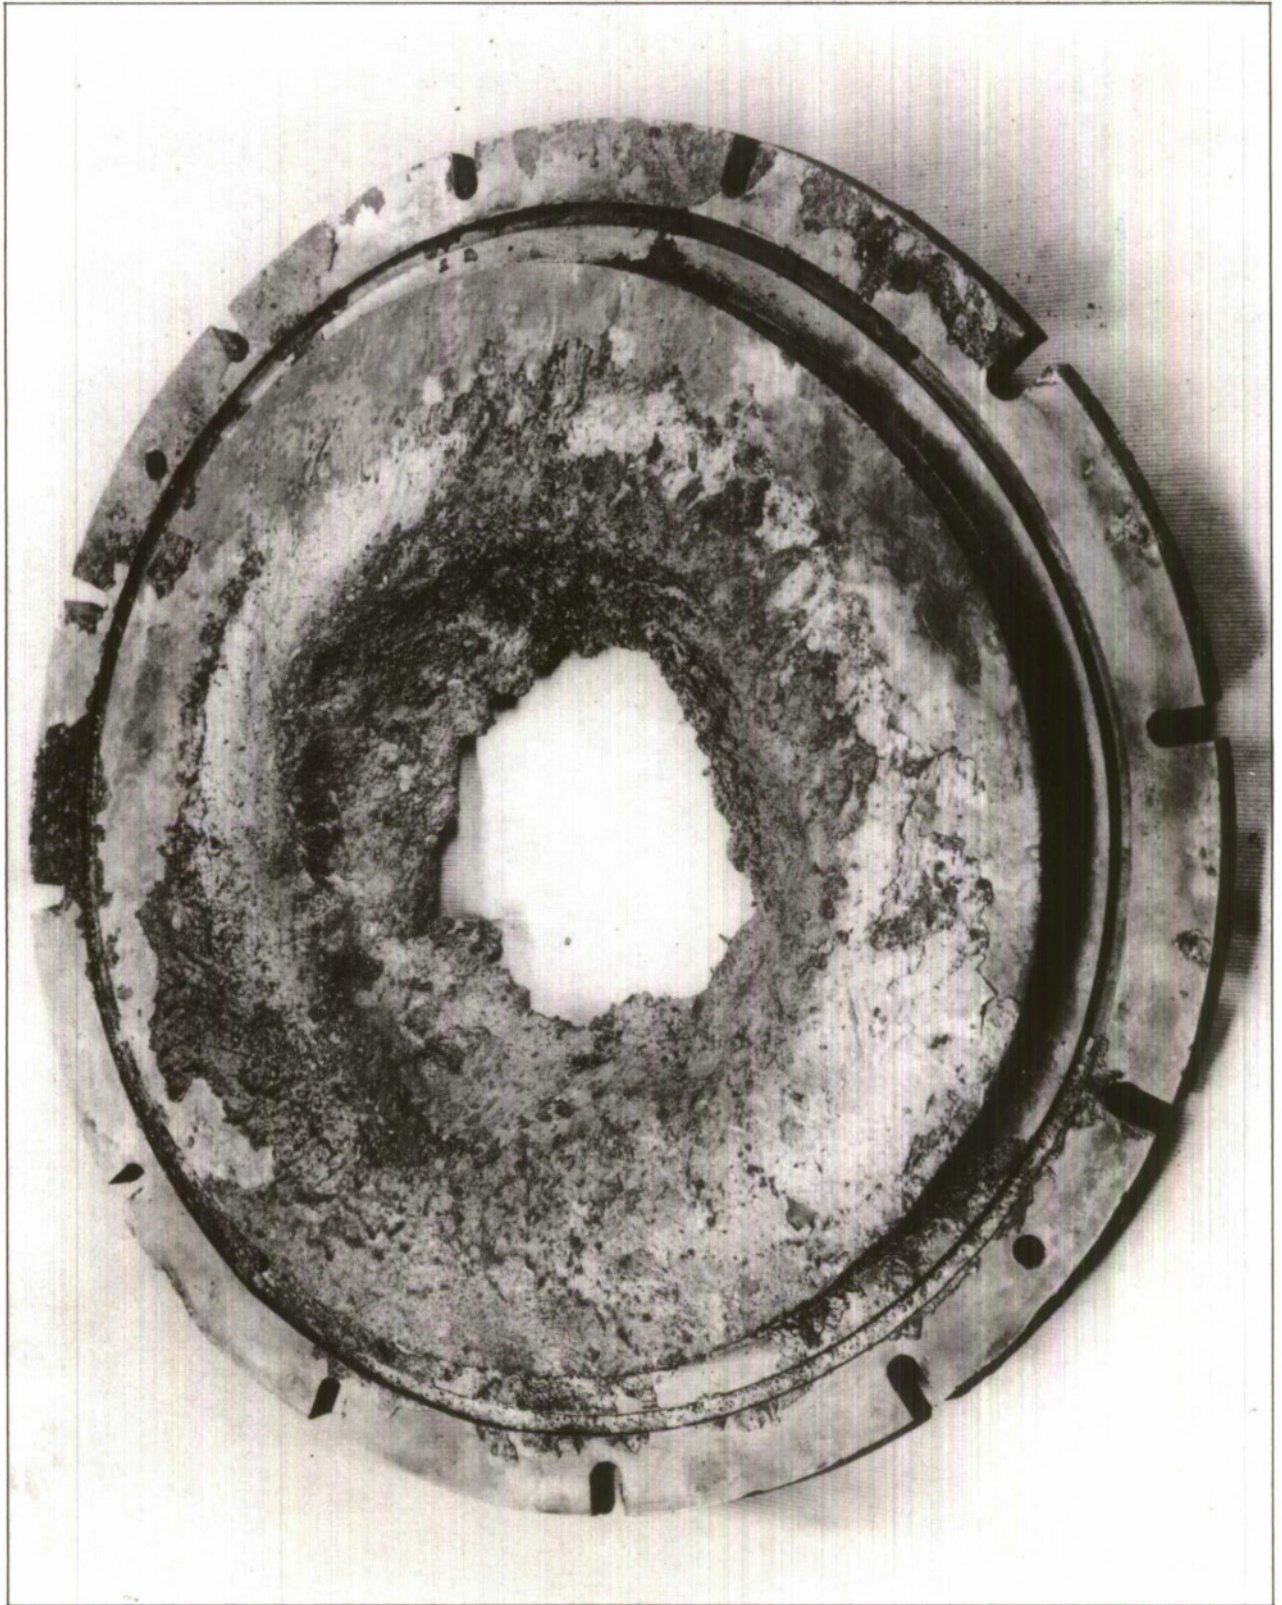
Despite the evidence of violence, injuries to personnel were minor, and caused mainly by falling debris and flying dust. After a preliminary examination, the complete wreckage was sent to Farnborough for investigation. A most significant item in the wreckage was the bottom of the crucible. This was made of copper two inches thick, and had clearly been melted right through (Fig.4).

The primary cause of the explosion is considered to be defective circulation of cooling-water immediately underneath the bottom of the copper crucible. It is probable that a bubble of steam or air collected there and allowed the copper to reach an excessively high temperature.

It is believed that the electric arc, in the early stages of melting, pushed aside the molten titanium and penetrated the copper base. The evidence of such penetration (Fig.4) is regarded as conclusive.

FIG.4. DETACHABLE BOTTOM OF CRUCIBLE

- (a) The water circulation must clearly cover all parts of the outside of the crucible, with water specially directed to the centre of the base.
- (b) Failure or impairment of the supply of cooling water should automatically switch-off the electric current.
- (c) Special care should be taken in design, manufacture and assembly of the joints in the crucible.
- (d) The crucible should be provided with a substantial escape route for hydrogen and steam, with a valve that opens at a small excess pressure and closes again before air can enter the crucible.
- (e) If practicable, opening of the release valve or abnormal rise in internal pressure should automatically switch-off the current. In any event a warning signal should be given to the operator.

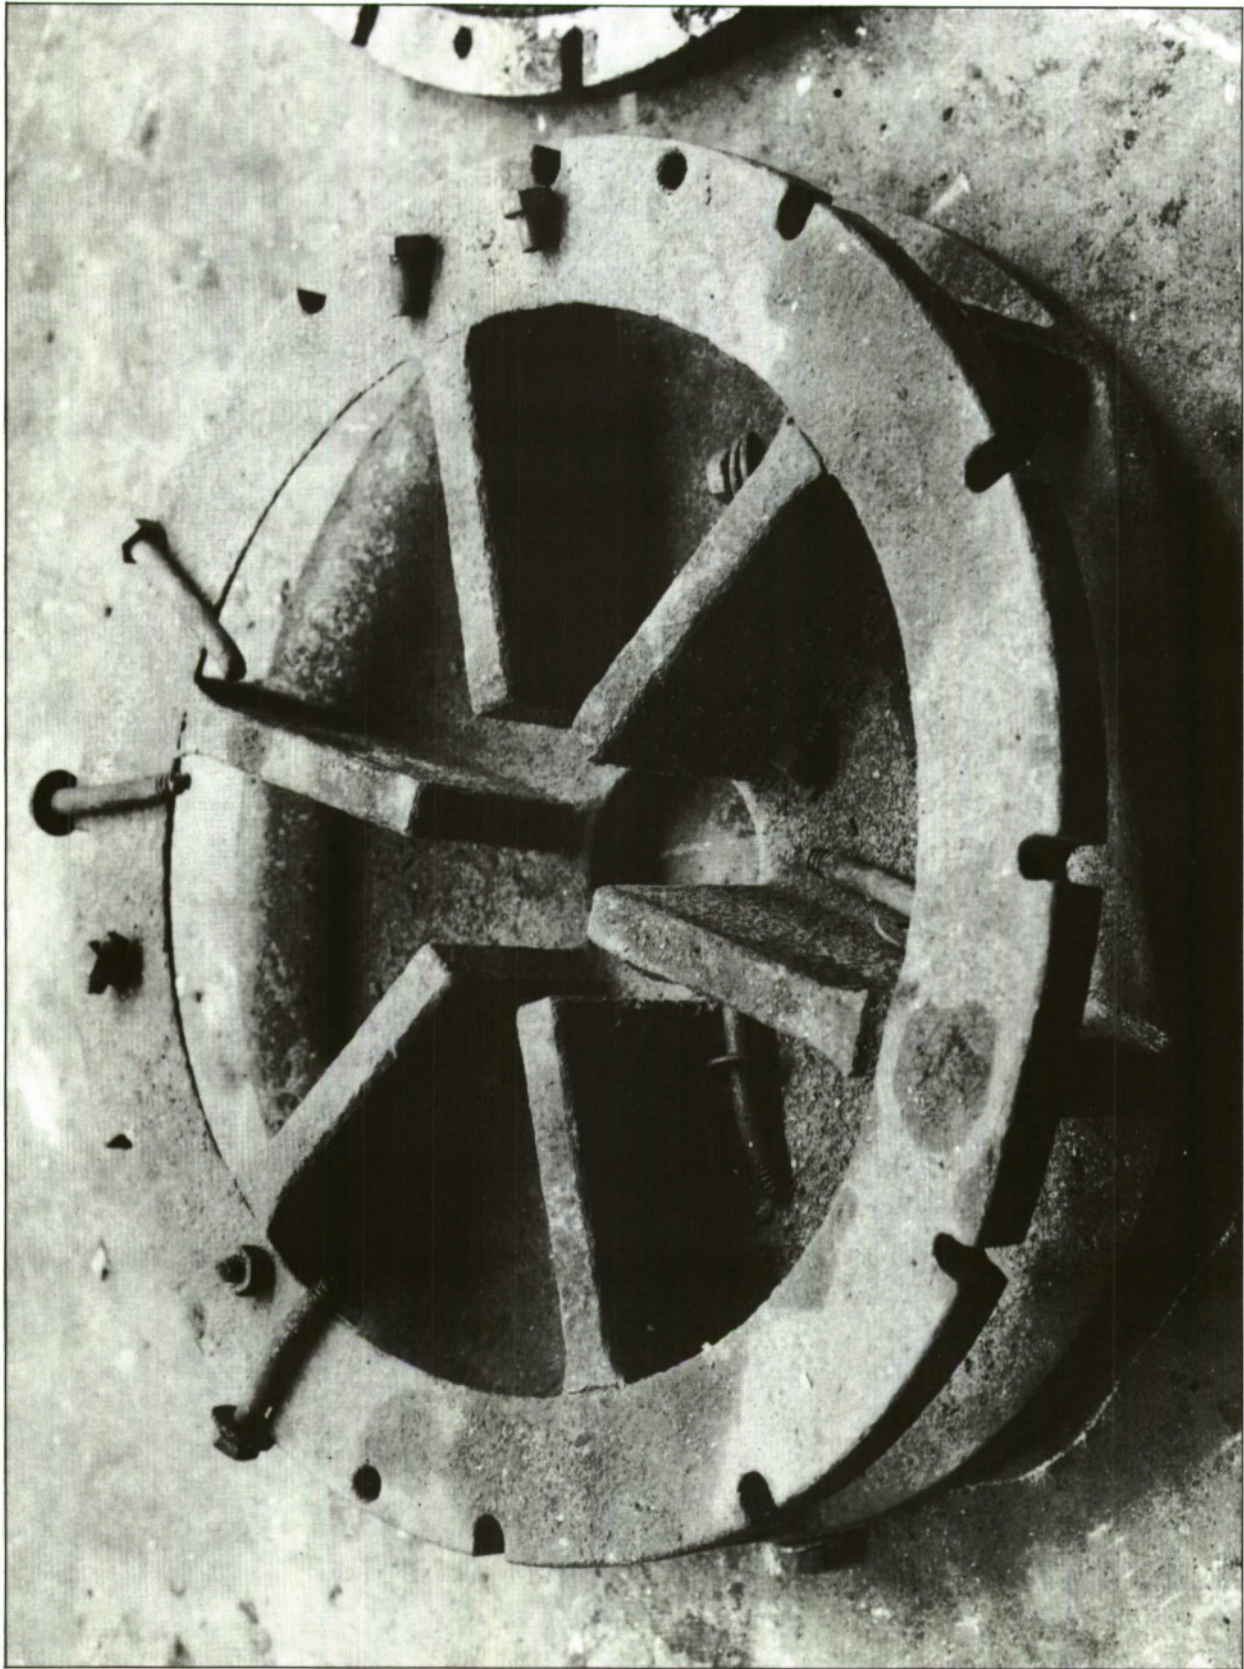
The overall supply of water is thought to have been adequate and to have been properly circulated everywhere except at the bottom of the crucible. Failure to protect the bottom is attributed to some modifications to the original equipment, and in particular to the use of a "spider" guide-vane system (Fig.5) without the water jets appropriate to it. The spider as fitted must inevitably have checked the flow of water in the critical region, and caused this to be by-passed. Furthermore, the geometry was such that the rim of the spider and the bottom of the crucible formed a shallow inverted bowl calculated to produce a steam or air lock.

The primary purpose of the spider was to give mechanical support to the copper bottom of the crucible, but it had originally been designed to do so without prejudicing the essential cooling. In this respect it would have been successful if water had been injected directly between the radial vanes. In this particular assembly, however, the entry holes or jets were not opposite the spider and so were relatively ineffective in the critical region.

FIG.5. SPIDER GUIDE-VANE UNIT SUPPORT FOR THE CRUCIBLE BOTTOM
