ARMY CONCEPT TEAM IN VIETNAM
APO 143, SAN FRANCISCO, CALIFORNIA

6
Mechanized Rifle Troop
(M13) (U).

INTERIM TEST REPORT NUMBER 8

SUBJECT: Interim Test Report Number 8 - Mechanized Rifle
Troop (1-30 September 1963) (U)

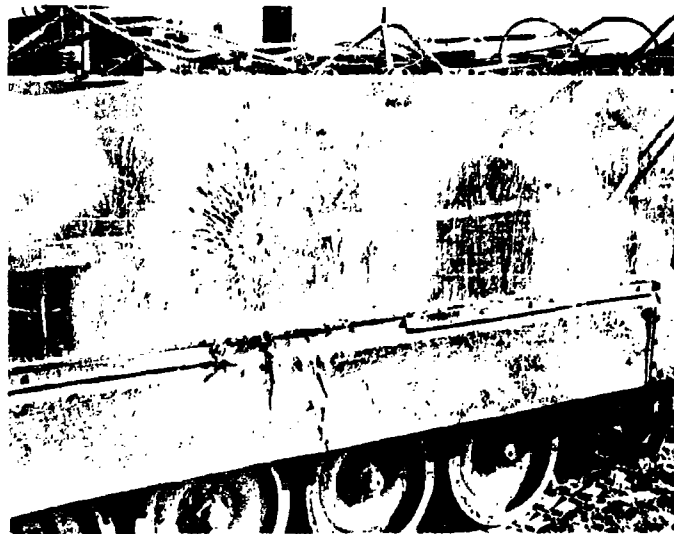
The second carrier was hit in the left side by a 57mm HEAT round. (See Figures 13 and 14.) This round penetrated the carrier and killed one man.

FIGURE 13 (C)
Effect of 57mm HEAT round.

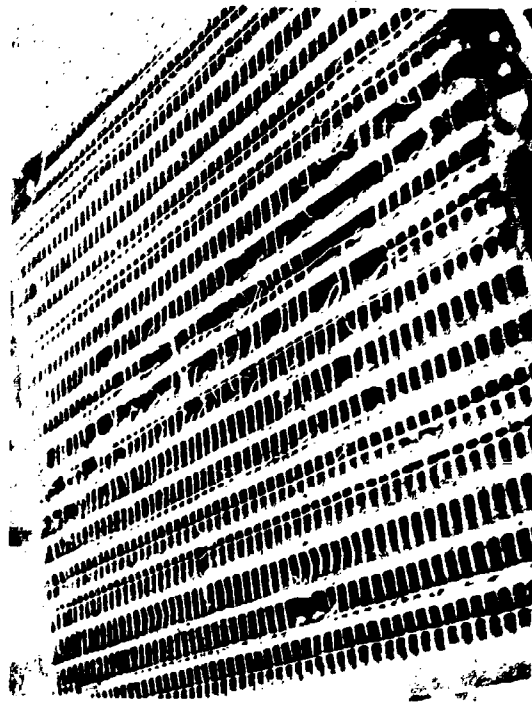
FIGURE 27 (C)
Effects of a rifle grenade on the intake grill.

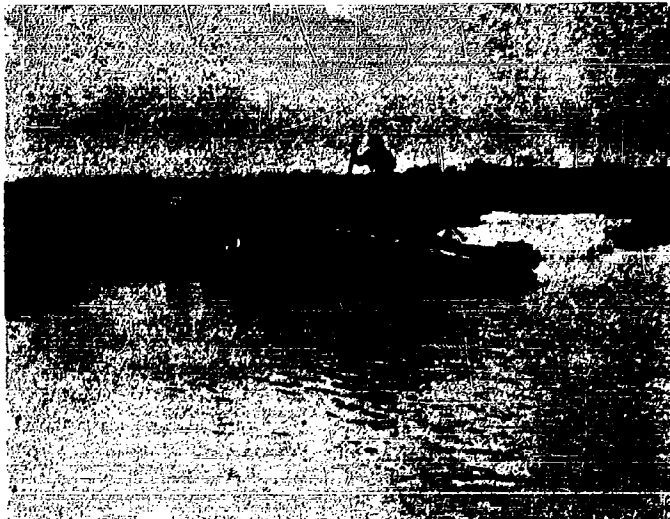
FIGURE 34 (U)
M113 cannot exit from the canal unassisted.
