OPERATION CASTLE

Project 3.5 []

BLAST EFFECTS ON MISCELLANEOUS STRUCTURES

REPORT TO THE SCIENTIFIC DIRECTOR

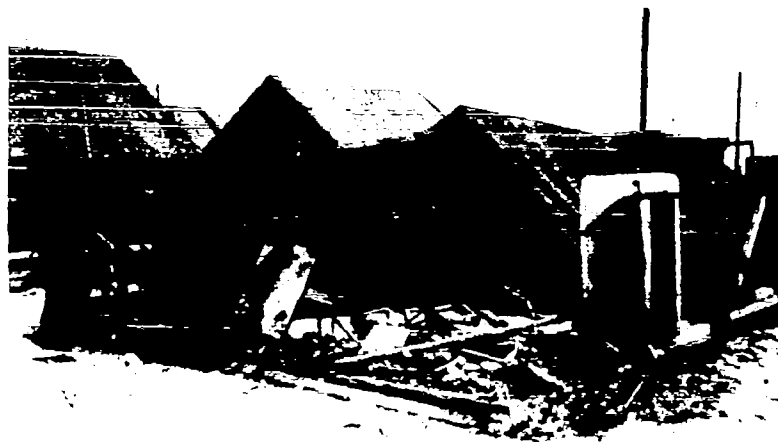
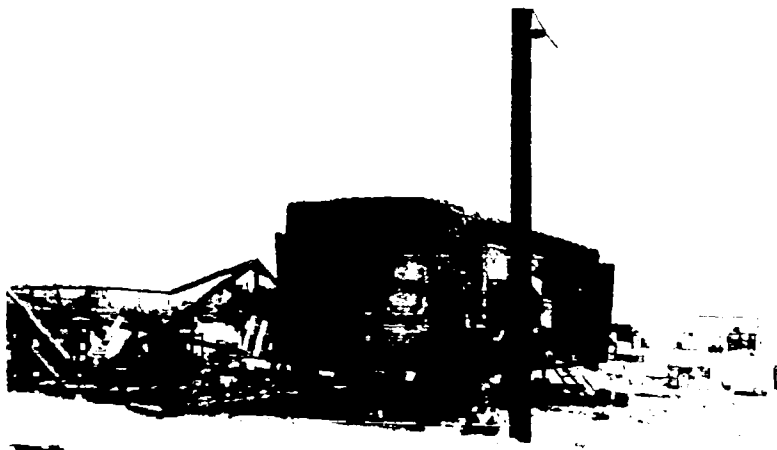
The fourth type of tent damage was fire in the technical area. It will be noted that a fire was started in the tent marked X (Origin I) in Fig. 3.6 and spread downwind (Figs. 3.8 - 3.10) finally engulfing a Signal Corps trailer. A similar fire (Fig. 3.11) started in the tent marked Y (Origin II) in Fig. 3.6 but did not spread. The initial fires

were caused by electrical shorts at the master switch control panels, the power having been left on during the shot. There was no evidence of damage due to primary thermal radiation. The reasons for the fire spreading from its origin can be fairly well established. First, the fire spread downwind. The surface winds were brisk and fairly constant in direction. Second, all the tents except one downwind of fire origin had gasoline stored in them. Also, some tents had paint, polyethylene, and other inflammables stored inside. Two of the tents contained portable gasoline-driven generators. The tent immediately downwind of the fire origin had six 5-gallon and two 1-gallon gasoline containers. The next tent downwind had a number of polyethylene bottles in storage.

Fig. 3.8 Fire from Shot 1 (Origin I) which Spread to Tents
Downwind, 14-3/4 Miles from GZ

Fig. 3.9 Fire Damage to Tents (Origin I), 14-3/4 Miles from GZ

Fig. 3.10 Fire (Origin I) Damage to Signal Corps Trailer, 14-3/4 Miles from GZ

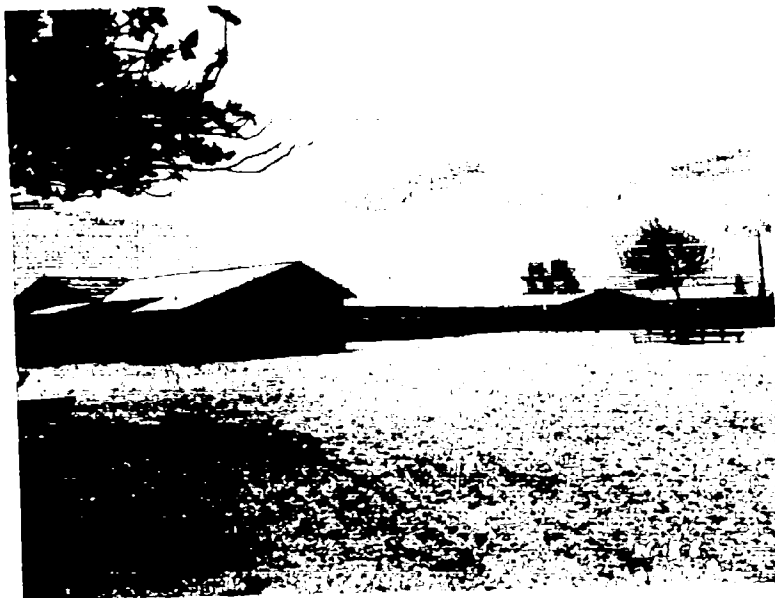
Figures 3.12 and 3.13 are pre- and postshot views of the north dining wing of the mess hall which most nearly faced ground zero. Most of the side was caved in and the rafters were badly damaged. Figures 3.14 and 3.15 are pre- and postshot views of the south dining wing. The entire side and large sections of the roof were blown out. One 16' x 40' section of roof was hurled a distance of 75 feet from its original location. Other views of interest are Figs. 3.2 and 3.16 - 3.19.

Fig. 3.13 North Dining Wing of Mess Hall, Tare Island, Postshot
14-3/4 Miles from GZ

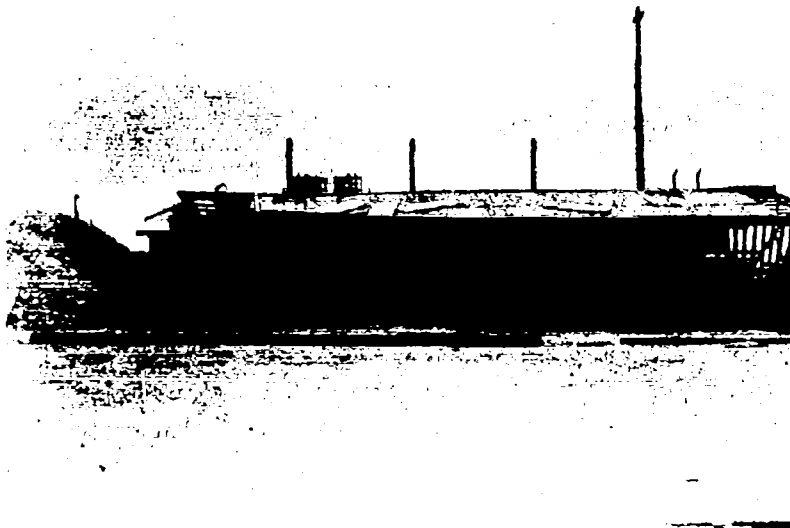
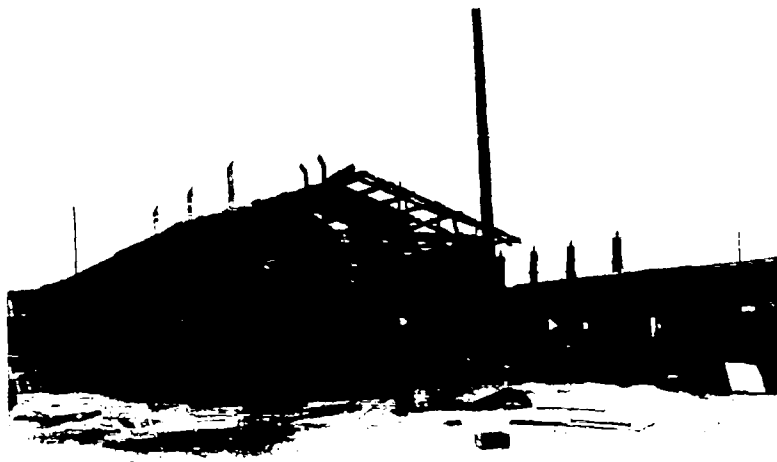
Fig. 3.21 Scientific Power House, Tare Island, Postshot,
14-3/4 Miles from GZ

Figures 3.20 and 3.21 are pre- and postshot views of the scientific generator station looking east. Some of the rafters were broken, some sheet metal was ripped off the roof, and most of the plywood siding on the end of the building away from ground zero was blown off. Figure 3.22 is the end of this same building facing away from ground zero.

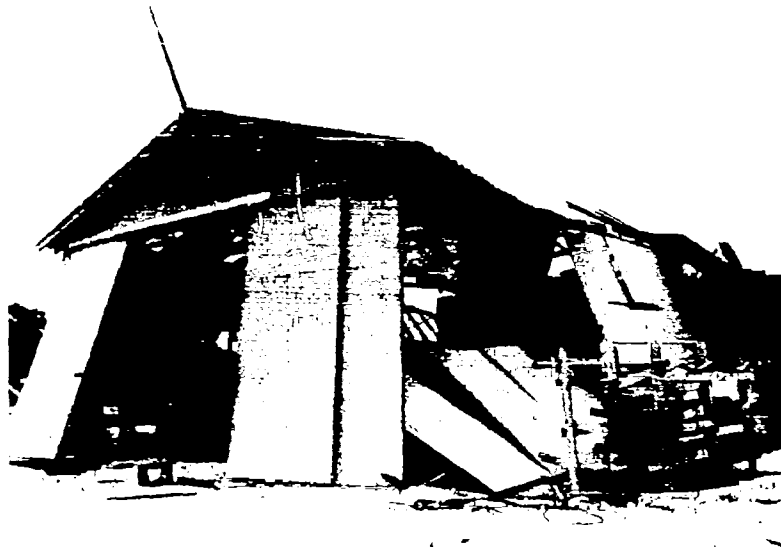
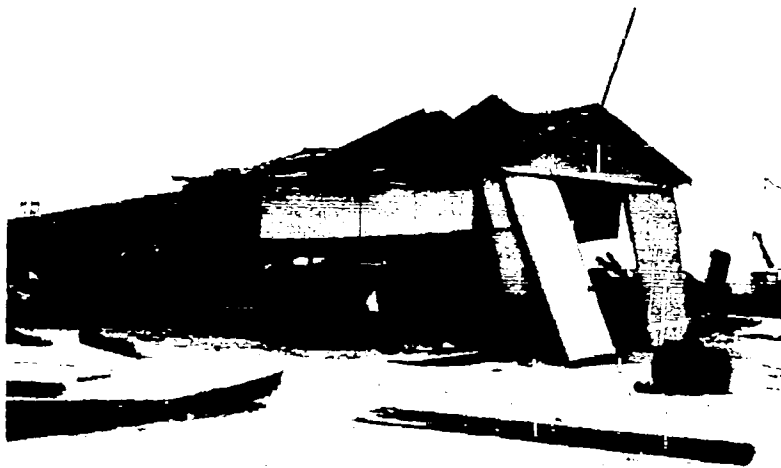
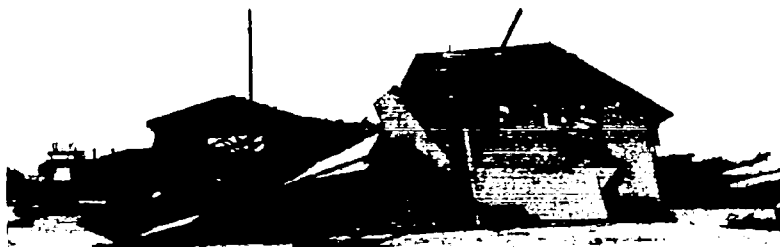
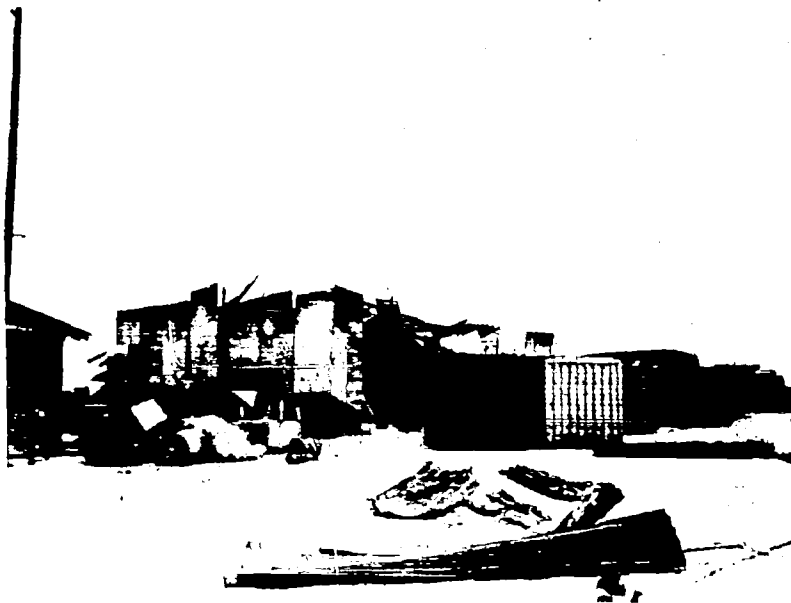
All the warehouses on Tare Island suffered severe damage. However, the shop buildings (Bldgs 19 and 20, Fig. 2.1) came through the blast with light damage even though the design of these buildings was similar. This is seen best by studying Fig. 3.1. No explanation is offered for this marked difference in degree of damage to similar structures in the same area. Figures 3.23 - 3.25 are views of the Holmes and Narver bin storage warehouse. Figures 3.26 - 3.28 show different views of the

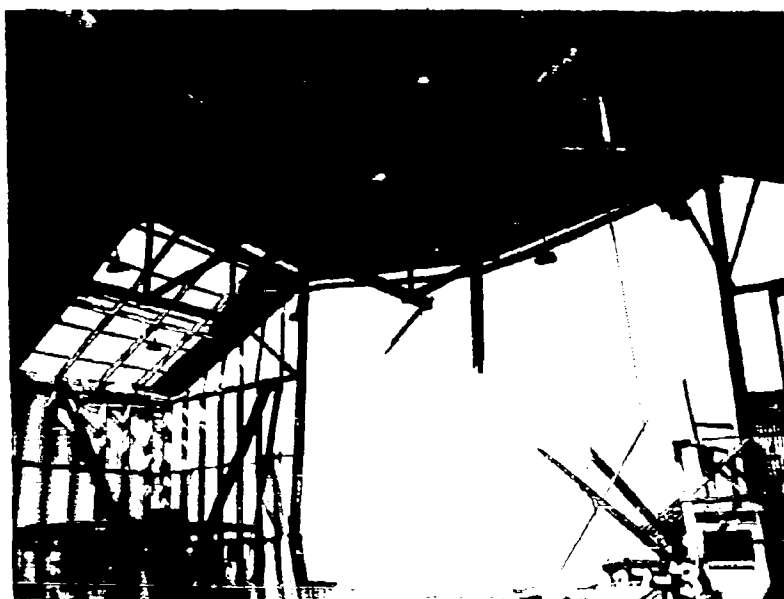
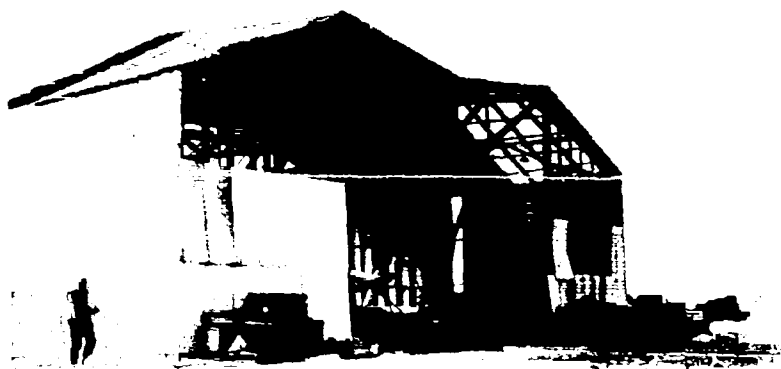
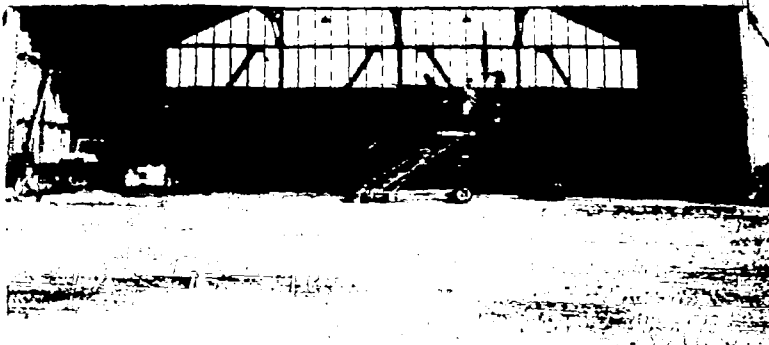
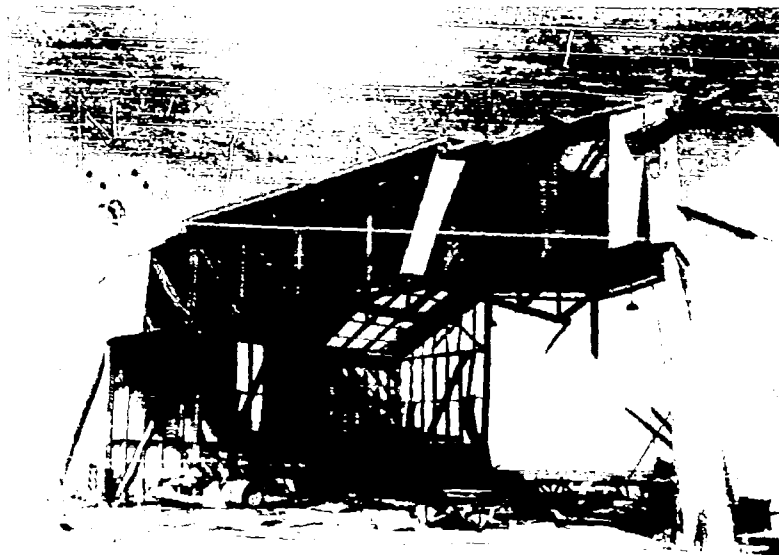
This structure suffered moderate to severe damage. The northwest (back) end of the hangar, including the 75-foot truss, had been almost completely blown out. This is best illustrated in Figs. 3.32 - 3.35. The lower chord of the 75-foot truss on the southeast (front) end was deflected outward several inches at the center of the span. Also, a considerable number of the 2" x 10" rafters were broken by the blast.

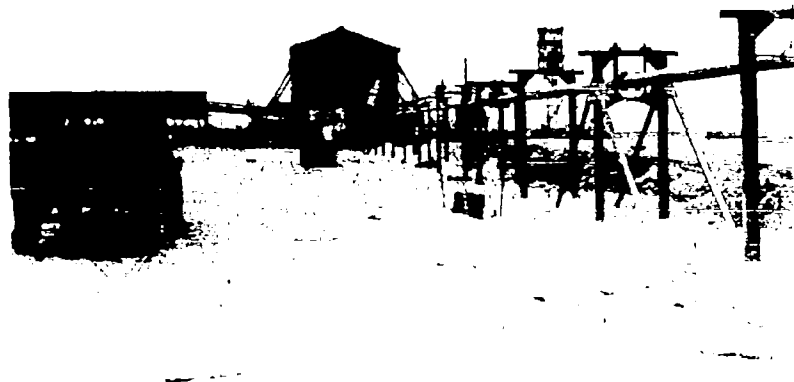
The steel photographic tower received no damage from the blast. The aluminum sheet metal siding on the steel frame building (Station 50) was dished inward on the west end and blown off on the east end. Figures 3.36 - 3.38 illustrate this damage. The sheet metal had been removed from the north side prior to shot time for Shot 1.

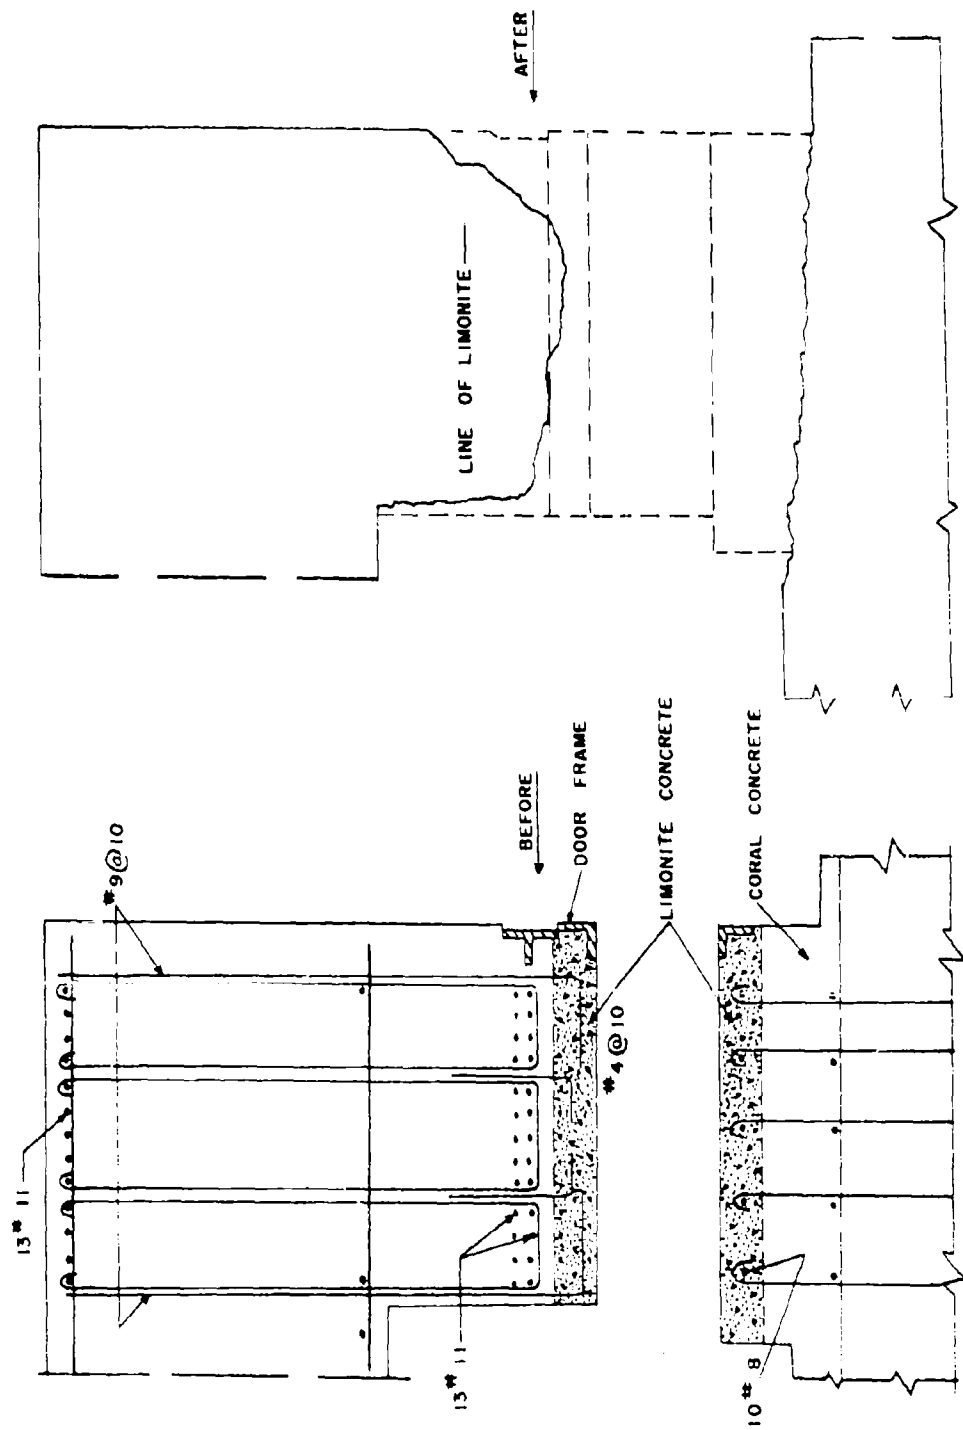
The front and side walls above the third floor received severe damage from the blast. Figures 3.39 and 3.40 show two views of the front wall above the third floor. Figure 3.41 indicates the design of this wall and shows the location of the reinforcing steel around the shutter door frame. This figure also shows the approximate failure surface of this wall. A tension failure due to bending of the wall above the opening can be seen in Fig. 3.40. Figure 3.42 is a schematic showing positions of the shutter door before and after failure. It could not be determined definitely that the shutter door was in position No. 2, as shown in Fig. 3.42, at the time of arrival of the blast wave. Several times during testing operations this door failed to latch shut when released. Figures 3.43 and 3.44 show primary shear cracks in the side walls adjacent to the shutter door opening.

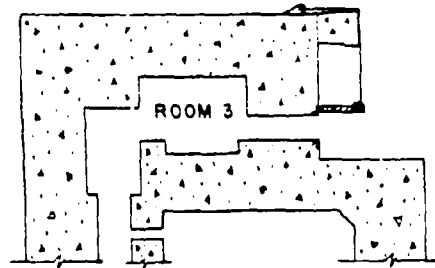
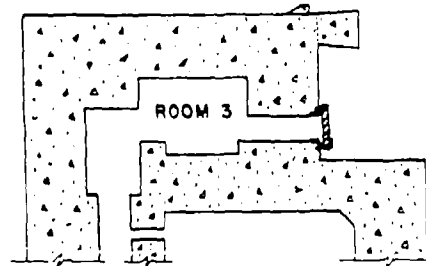
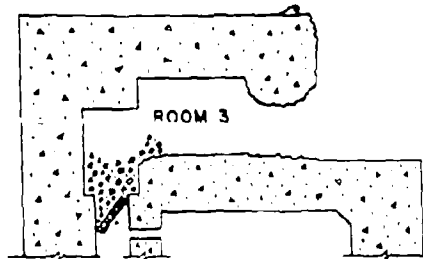
Fig. 3.42 Position of Shutter Door, Station 1341, Able Island,
7500 ft from GZ

Due to the failure of the wall supporting the shutter door, the blast wave entered the building. The shutter door was hurled inward and dropped part way down the chimney, lodging in a position No. 3 as shown in Fig. 3.42. The forces from the blast also broke the latches and hinges from three other doors, namely, the lead door entering the equipment room on the first floor, the light weight steel door between rooms No. 1 and No. 4 on the first floor, and the main personnel door on the second floor. This door is shown in Fig. 3.45. The following doors did not fail: two exterior lead doors on the side of room No. 4, and three steel doors on the outside of the back wall of the equipment room.

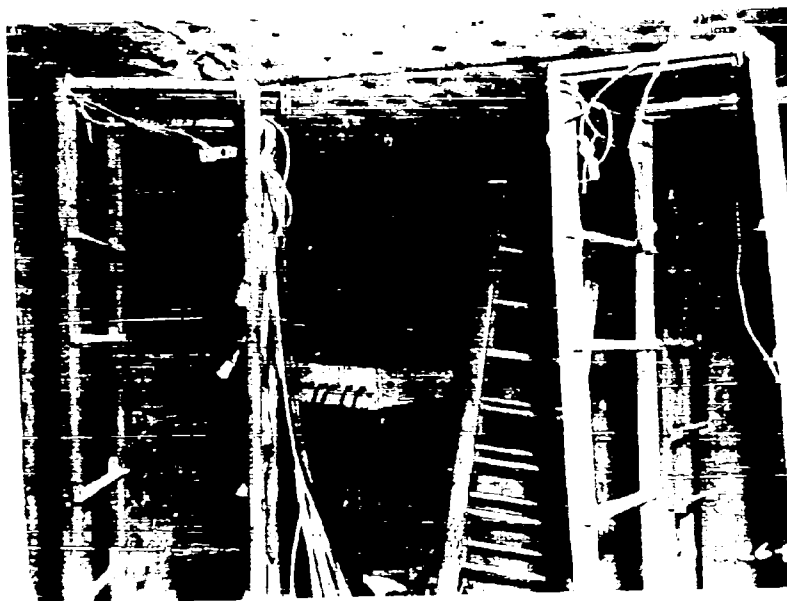
(3) The scientific equipment, equipment racks, and other interior structures were severely damaged. This damage can be noted in Figs. 3.48 and 3.51.
