# OPERATION CROSSROADS

BUREAU OF SHIPS INSTRUMENTATION GROUP

## SECTION IX

Displacements of  
Shock Mounted Equipment

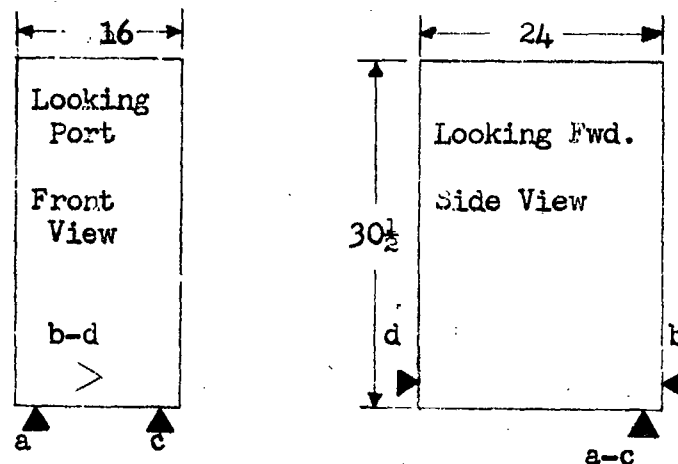
Location: On Radio Transmitter Model TDQ, in Radio Transmitter Room, First Superstructure Deck. The transmitter is in the port side of the room.

Type of Mounting: Short C type mounts on each bottom corner.

Baker: The ship was beyond the range of appreciable damaging action of the bomb. There was negligible shock and no appreciable damage of any kind.

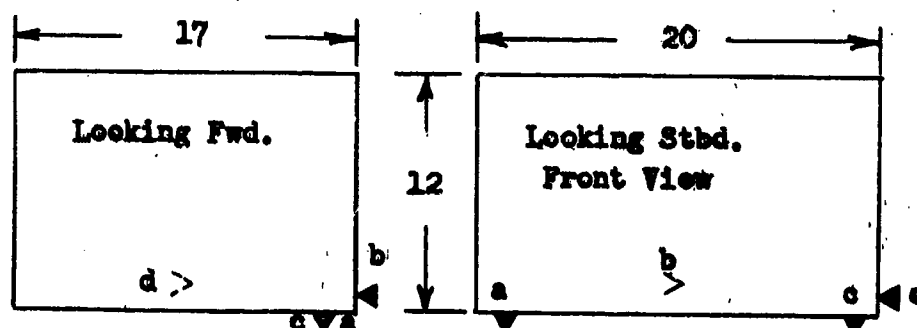
**Location:** On Radio Receiver Model RBO-2, in Radio Transmitter Room, First Superstructure Deck. The receiver is on the starboard side of the room, above a motor-generator set, and distant from all exterior bulkheads.

**Type of Mounting:** L type mounts on each of the four bottom corners. Clearance about 3/8 inch.

**Baker:** There were negligible shock displacements. The ship suffered no appreciable damage.

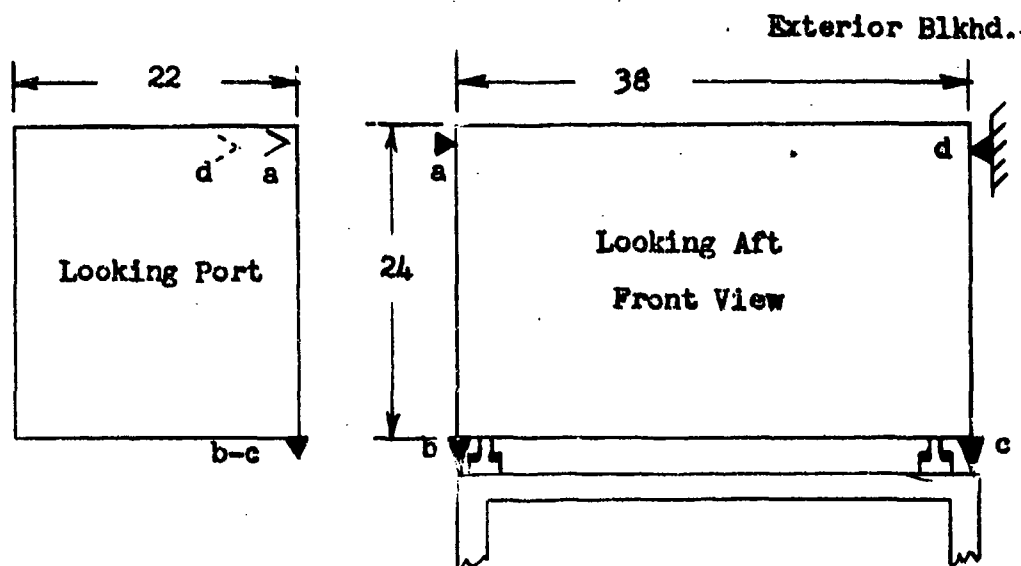
**Location:** On Range and Train Indicator Model SG type CRP. In C.I.C. Room which is located on the second superstructure deck.

Type of Mounting: C type mounts on each bottom end run the full depth of the equipment.

Baker: There was negligible shock and no appreciable damage to the ship or its equipment.

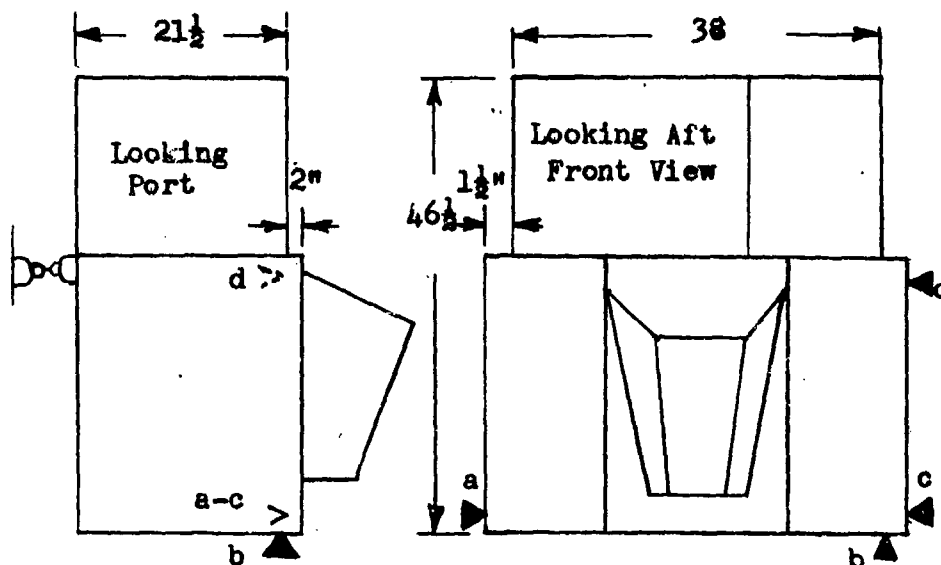
Location: On Plan Position Indicator in C.I.C. Room,  
Second Superstructure Deck (starboard aft side of room).

**Type of Mounting:** Short C type mounts on each of the four bottom corners. L type mounts on the upper back corners of the lower unit. Clearance slightly over 1/4 inch for the bottom mounts.

**Able:** This ship was not instrumented during Able test.  
**Baker:** There was negligible shock and no appreciable damage.

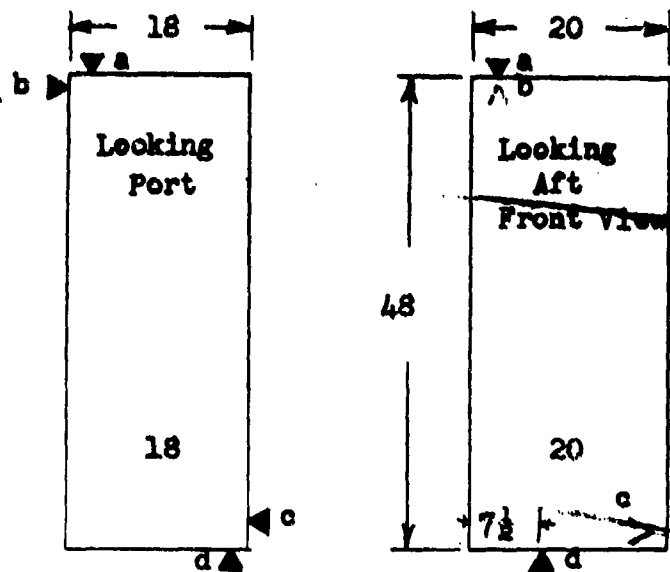
**Location:** On Radar Transmitter Model SC3 type CG, in Radar Transmitter Room, Second Superstructure Deck. (Near aft bulkhead.)

Type of Mounting: C type mounts on the four bottom corners and on bottom edges between the corners (total eight mounts on bottom). Two C type mounts on the upper back corners. About one inch vertical clearance.

Baker: There was negligible shock and damage. In spite of the negligible shock intensity the displacement of the top of the tall narrow transmitter was 1.3 inches. This indicated the large displacements caused by rocking modes of poorly mounted equipment.

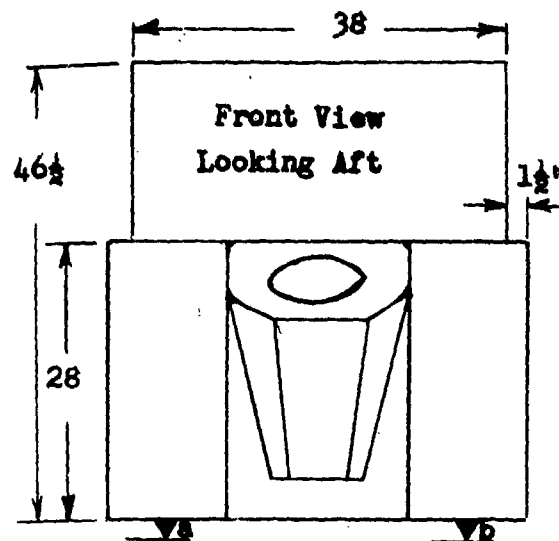
DDAO3 #5 Gages:

Location: On Plan Position Indicator, type CG, in C.I.C. Room, Aft Starboard Side, Second Superstructure Deck.

Type of Mounting: Short C type mounts on each of four bottom corners. L type mounts in back upper corners of main unit.

Baker: The ship was beyond the effective damaging range of the bomb. While no appreciable damage occurred, the shock mounts bottomed in many cases.

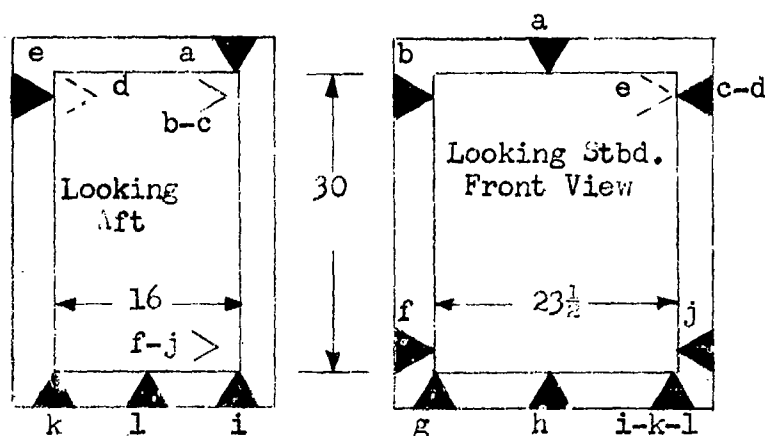
Location: On Radio Transmitter Model TDQ, in Radio Central Transmitter Room, First Superstructure Deck. (Starboard side of forward interior bulkhead.)

Type of Mounting: Unit is mounted in an angle iron frame. C type mounts are at each of the four bottom corners. Vertical clearance is slightly greater than 1/4 inch.

Able: The starboard side of the transmitter room was pushed in about 3 inches. In spite of the bottoming of the mounts and the collisions of the unit with the angle iron framing, the TDQ appeared to be in good condition and to key properly. A near by transmitter.

properly. A near by transmitter model TBK had a tube broken and did not key properly.  
Baker: No data was obtained for this unit.

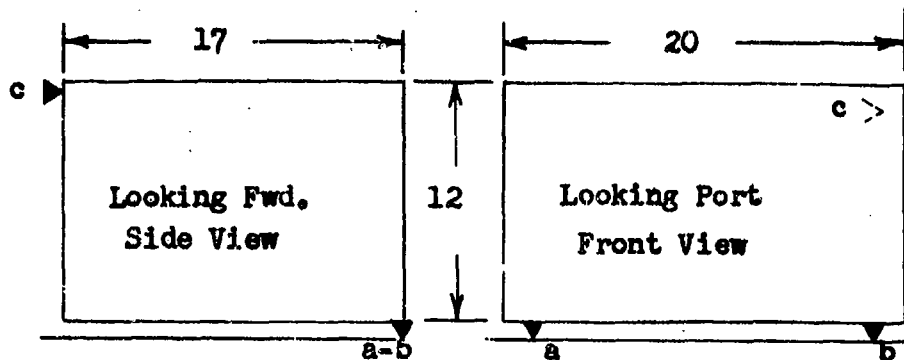
Location: On Model BBC Radio Receiver, in Radio Central Receiving Room, First Superstructure Deck.

Type of Mounting: L type mount under each of four bottom corners. Clearance is about 1/4 inch.

Able: The mounts bottomed, but the receiver remained in operable condition.

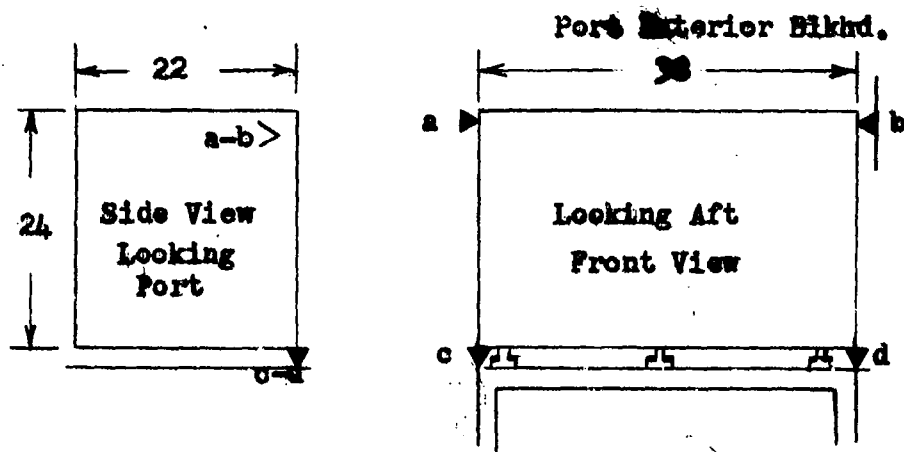
Location: On Range and Train Indicator, in C.I.C. Room,  
Second Superstructure Deck.

Type of Mounting: Three C type mounts on bottom that extend the full length of equipment. Clearance 1/2 inch.

Able: The entire starboard side of the C.I.C. room was broken open by the blast. The Range and Train Indicator, which was located in the after port side of the room, suffered a considerable horizontal shock, but little vertically. The unit appeared to be in good condition.

Baker: The intensity of shock caused by Baker test was negligible.

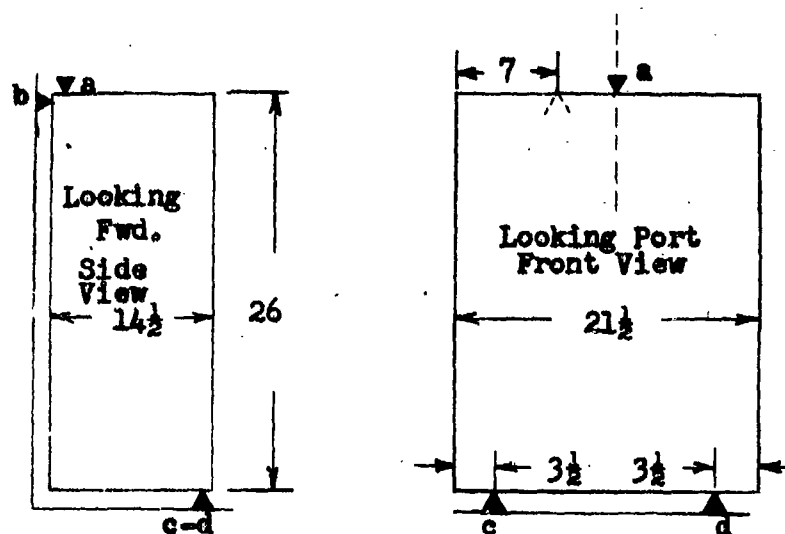
Location: On High Voltage Rectifier type CW-20280, in  
Rear Transmitter Room. Second Superstructure Deck.

Type of Mounting: L type mounts on each bottom corner and on two upper back corners.

Able: Although the mounts bottomed the intensity of shock did not appear severe. There was no apparent damage to the unit.

Baker: The shock intensity caused by Baker test was negligible.

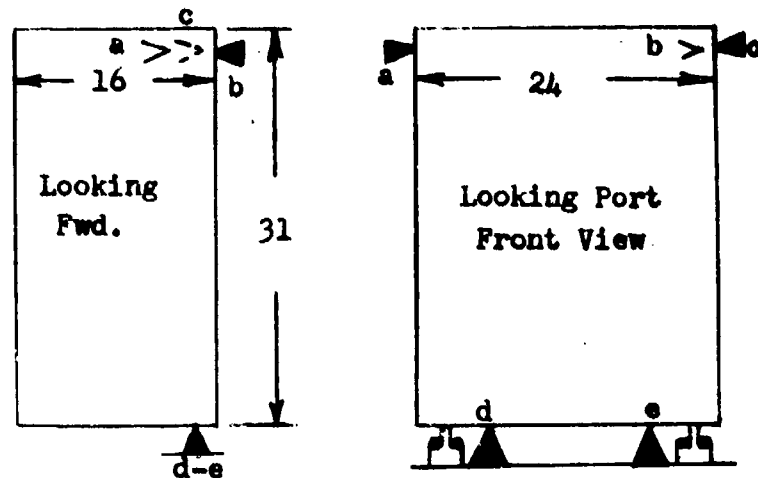
**Location:** On Radio Transmitter Model TDQ, in Radio Transmitter Room on Second Superstructure Deck.

**Type of Mounting:** C type mounts are used on each of four bottom corners. Clearance about 1/4 inch.

\*Gages crushed to full length.  
The mounts bottomed.  
Compartment and equipment not damaged.

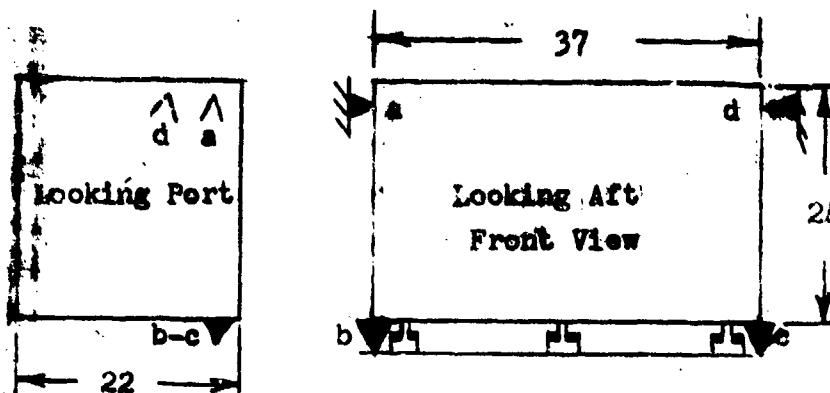
Location: On Range and Train Indicator type CRP in C.I.C. Room, Second Superstructure Deck (Aft port side of room).

Type of Mounting: Three C type mounts, as shown, extend full depth of equipment. Clearance before bottoming is about 1/4 inch.

The starboard bulkhead was pushed in several inches by the Able shot, otherwise there was no observable damage.

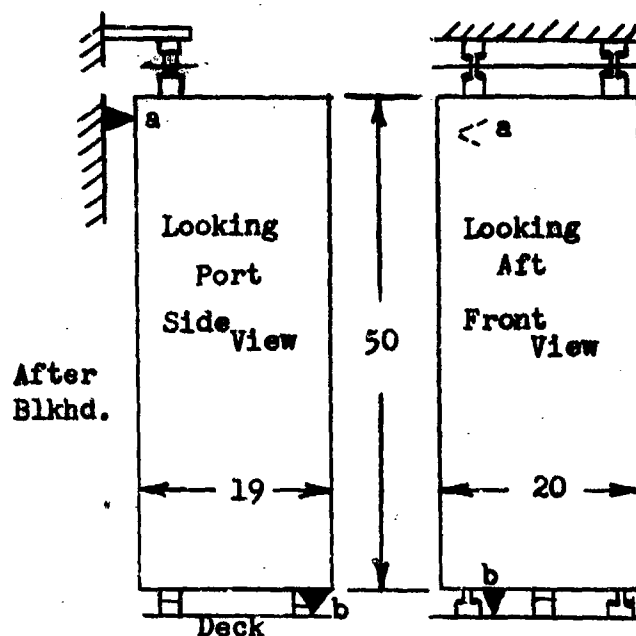
**Location:** On Radar Transmitter Model SC-3, in Radar Transmitter Room, Second Superstructure Deck (located near center of Aft bulkhead).

**Type of Mounting:** Six short C type mounts under base plus two head braces on upper back edge. Clearance is about 1/4 inch before mounts bottom.

No noticeable damage for either test. The deflections are less than would be caused by a sustained acceleration of 2 g.

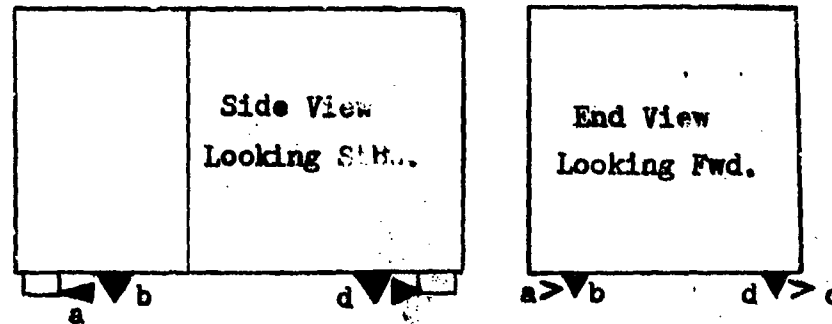
**Location:** On Emergency Diesel Generator, in Compartment A-206-E (frame 56, deck below main deck).

**Type of Mounting:** Rubber mounts in compression. Less than 1/8 inch clearance laterally.

The diesel generator was quite rigidly mounted. No knowledge was obtained of the detailed properties of its supports. No damage was suffered by the equipment.

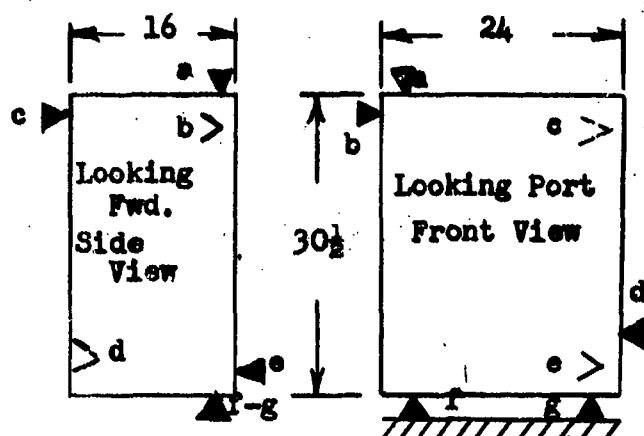
Location: On Model TDQ Radio Transmitter, in Radio Transmitter Room (forward port corner near exterior bulkhead), First Superstructure Deck.

Type of Mounting: C type mounts on four bottom corners.  
Clearance about 1/4 inch.

Gage DD410 #1	a	b	c	d	e	f	g
Able	0.21	0.15	0.80	0.07	0.07	0.23	0.21
Baker	Room badly damaged by Baker, no readings possible.

Able: There was negligible shock or damage caused by test Able.

Baker: The shock caused by Baker test was of great severity. The transmitter room and its contents were in such disorder that no quantitative measurements were possible.

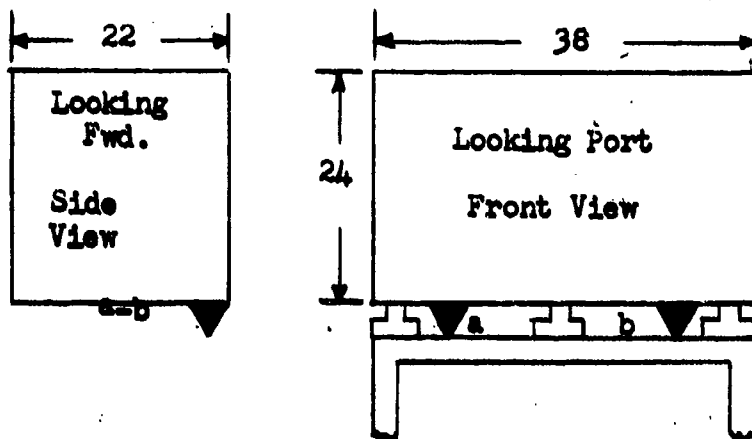
Location: On Range and Train Indicator type CRP-55ABC-3  
Room, Second Superstructure Deck (port side).

Type of Mounting: Three C type mounts, as shown, run the full depth of the equipment. Clearance is about 1/2 inch.

Able: There was negligible shock or shock damage caused by test Able.

Baker: The shock caused by Baker test was very severe. The mounts did not fail although they were not stiff enough to be effective.

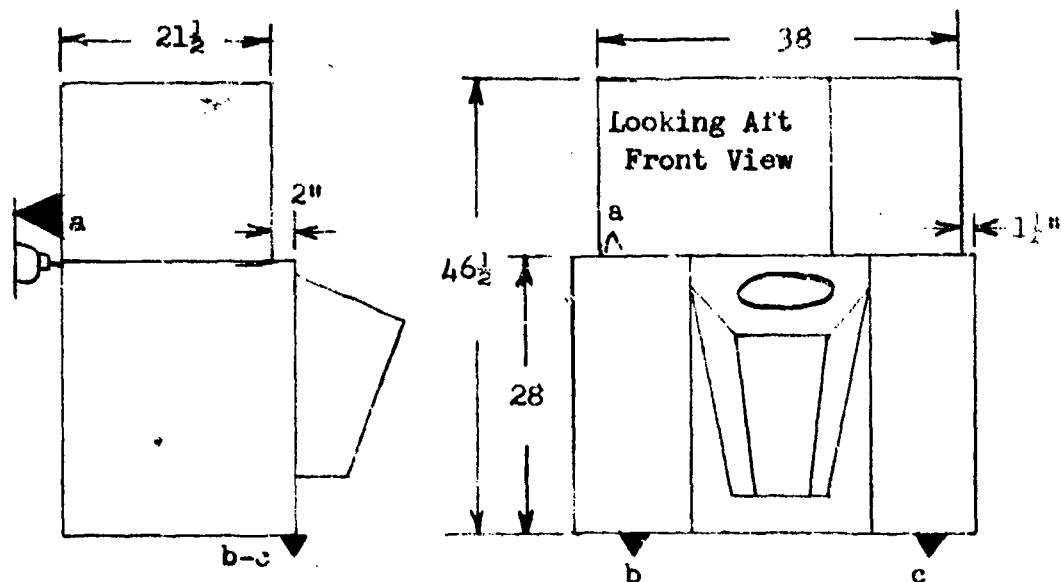
Location: On Plan Position Indicator type CG, in C.I.C.  
Room (after starboard corner), Second Superstructure Deck.

Type of Mounting: Short C type mounts on each of four bottom corners. L type mounts on the back upper corners of the lower unit. Clearance from 1/4 to 3/8 inch before mounts bottom.

Able: The deflections caused by test Able were small.  
Baker: The unit was knocked entirely free of its supports during test Baker. All mounts on the base of the equipment failed. The upper rear mounts pulled a bulkhead "T" section loose.

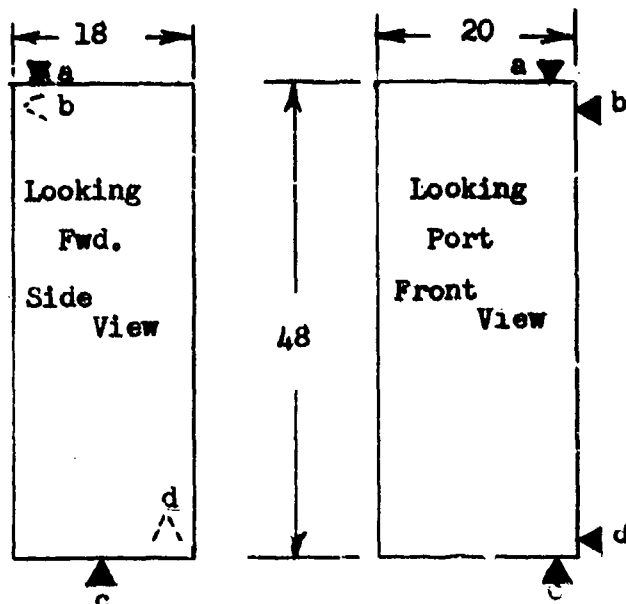
Location: On Radar Transmitter Model SC-2, type CG, in Radar Transmitter Room, Second Superstructure Deck.

Type of Mounting: Short C type mounts on four bottom corners and in middle of front and back bottom edges. C type mounts on upper back corners. Vertical clearance less than 1/8 inch (rubber had crept).

Able: Only small deflections and no damage were caused by test Able.

Baker: All of the mounts failed for test Baker, allowing the gear to become loose. The compartment was wrecked.

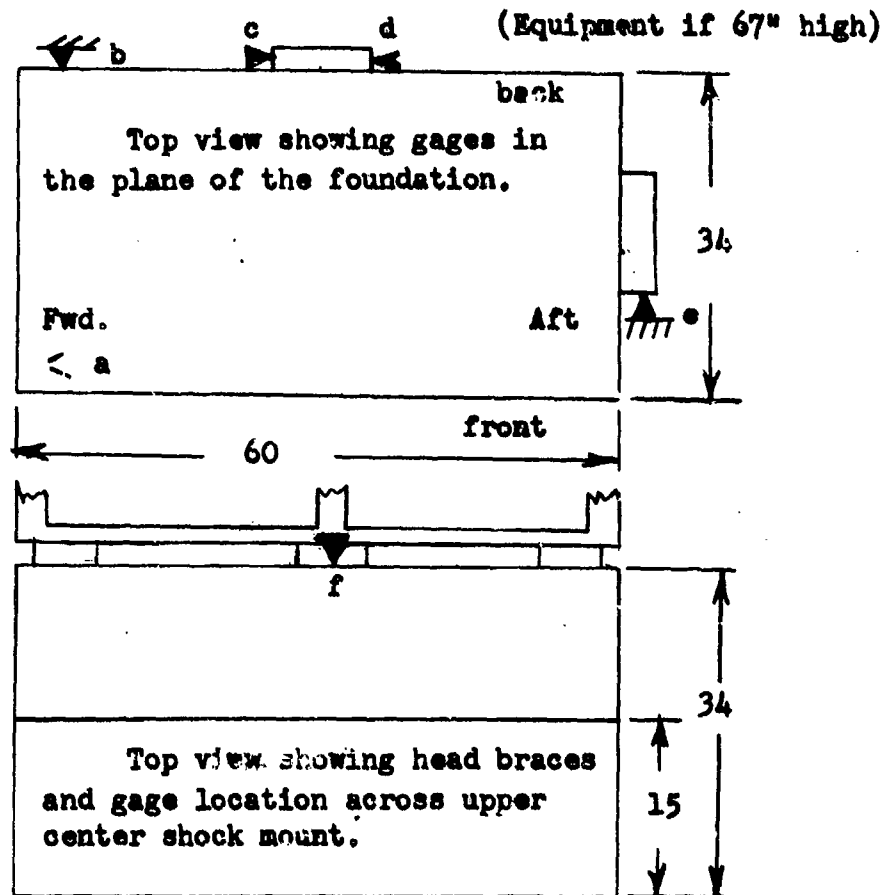
Type of Mounting: Special built-in mounts using rubber in compression.

\* Deflection believed caused almost entirely by the impact of falling hatch covers against the top of the unit.

Able: There was no evidence of shock other than that caused by the impacts of falling hatch covers.  
Baker: Shock of a very minor nature at this location is indicated by the small deflections of the shock mounted control bench. There was no damage to this gear.

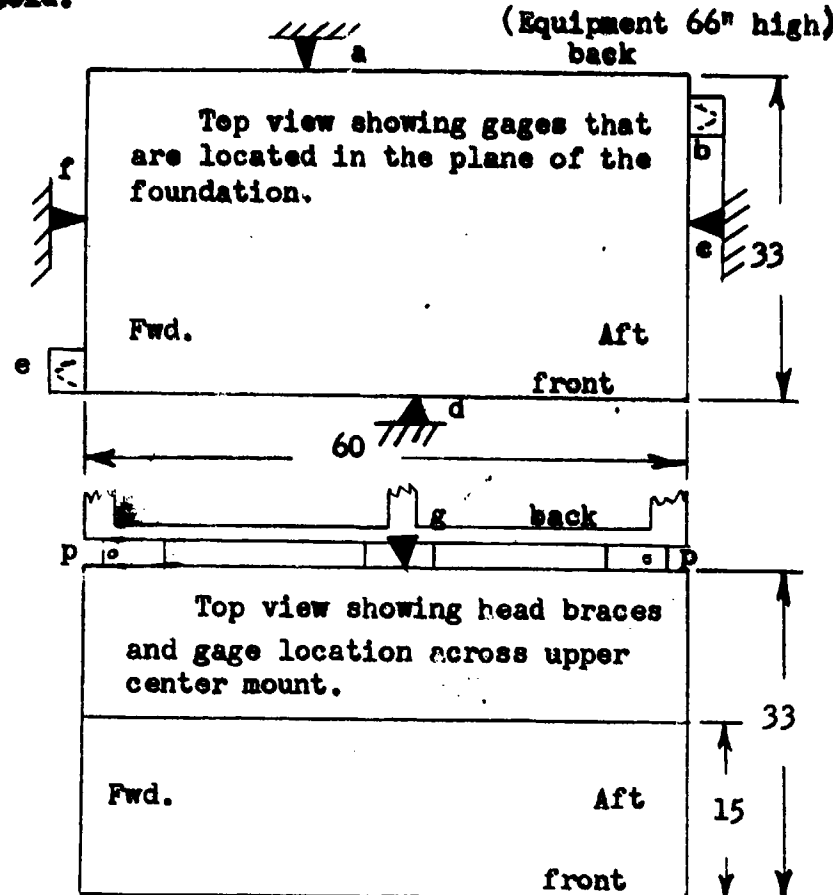
Type of Mounting: Special built-in mounts using rubber in compression.

Able: The hatch cover collapsed into this hold and the overhead was bent down over the switchboard. However there was no damage from other causes at the switchboard location or to the switchboard caused by the Able test.

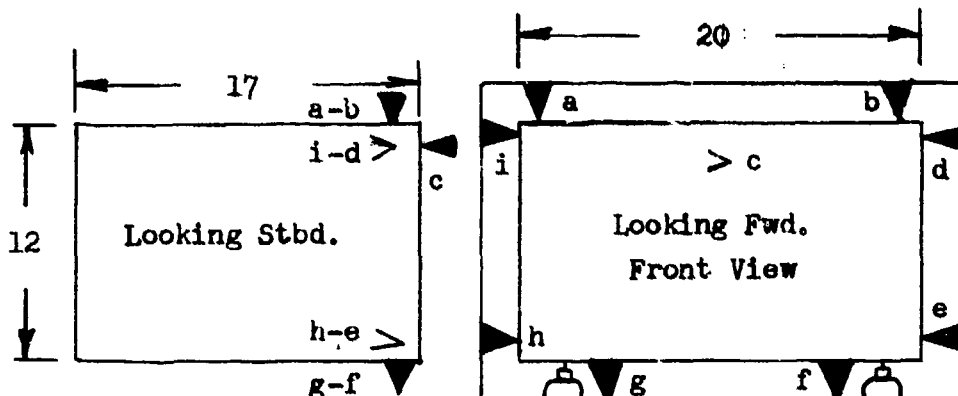
Type of Mounting: L type mounts on the four bottom corners. Clearance is not apparent but is on the order of 3/8 to 1/2 inch. The unit is mounted in an angle iron frame that is attached to a forward interior bulkhead.

Able: The shock at this interior part of the ship was negligible. The deflections are generally less than would be caused by a sustained acceleration of  $1g$ .

Baker: The vertical component of the shock was severe causing  $3/4$  inch upward motion and solid bottoming. However, there was no apparent damage to the receiver. The shock in the horizontal direction was negligible.

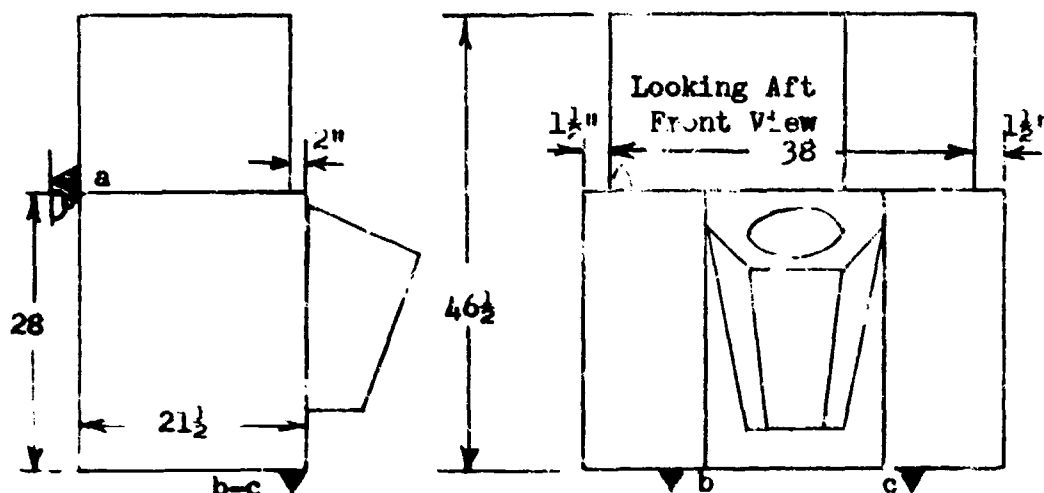
Type of Mounting: Short C type mounts on each four bottom corners. L type mounts on back upper corners of the lower unit. Clearance of mounts is between  $1/4$  and  $3/8$  inch.

\*Equipment broke loose and moved about two feet forward.

Baker: The shock mounts failed and allowed equipment to come loose.

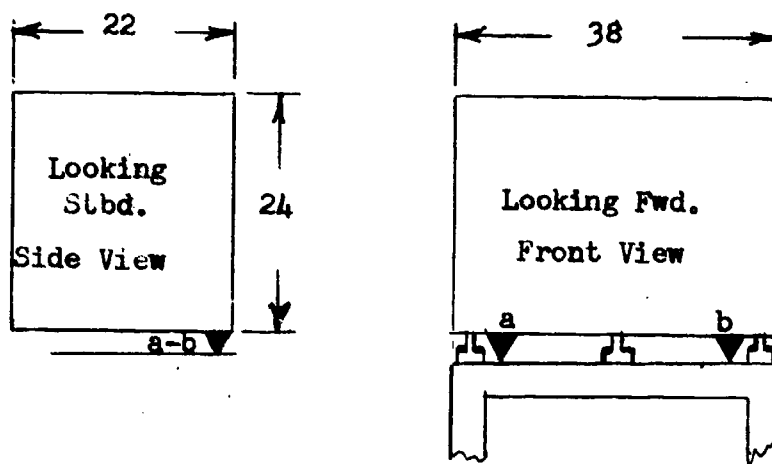
Type of Mounting: Three C type mounts run the full depth of the equipment as shown above. Vertical clearance of mounts is about 1/2 inch.

Baker: It is probable that the apparatus bottomed, but with little excess energy. If it is assumed, as a reasonable approximation, that the frequency of vertical vibration is 10 cps, then at least 1/2 inch clearance is required. This is about 5 times the static deflection. The equipment was not obviously damaged.
