# BUREAU OF SHIPS GROUP

## TECHNICAL INSPECTION REPORT

### WELDING

OPERATION CROSSROADS

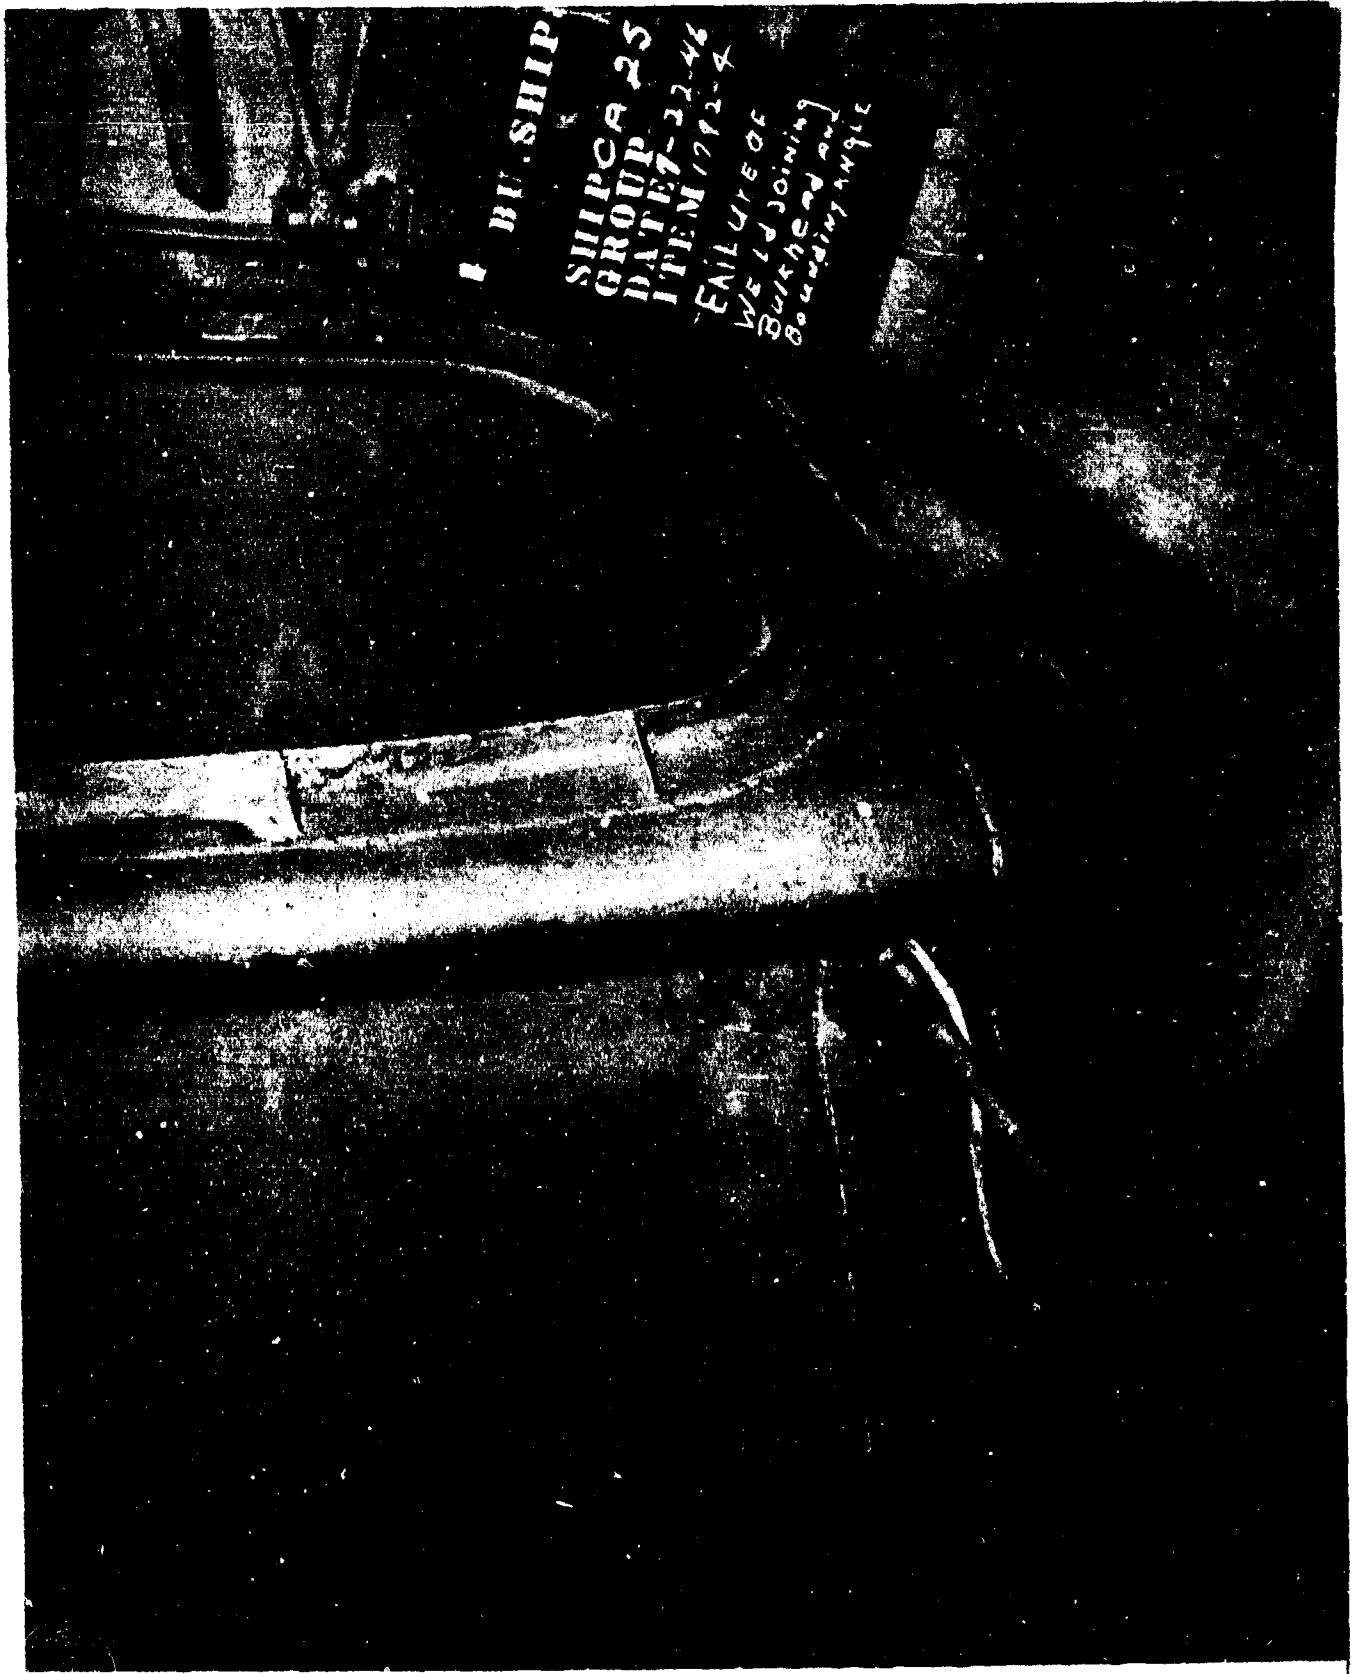
AA-CR-92-1782-4. USS SALT LAKE CITY (CA25). Failure of bulkhead bounding welds at main deck connection, port side, athwartship passage aft of wardroom, looking forward.

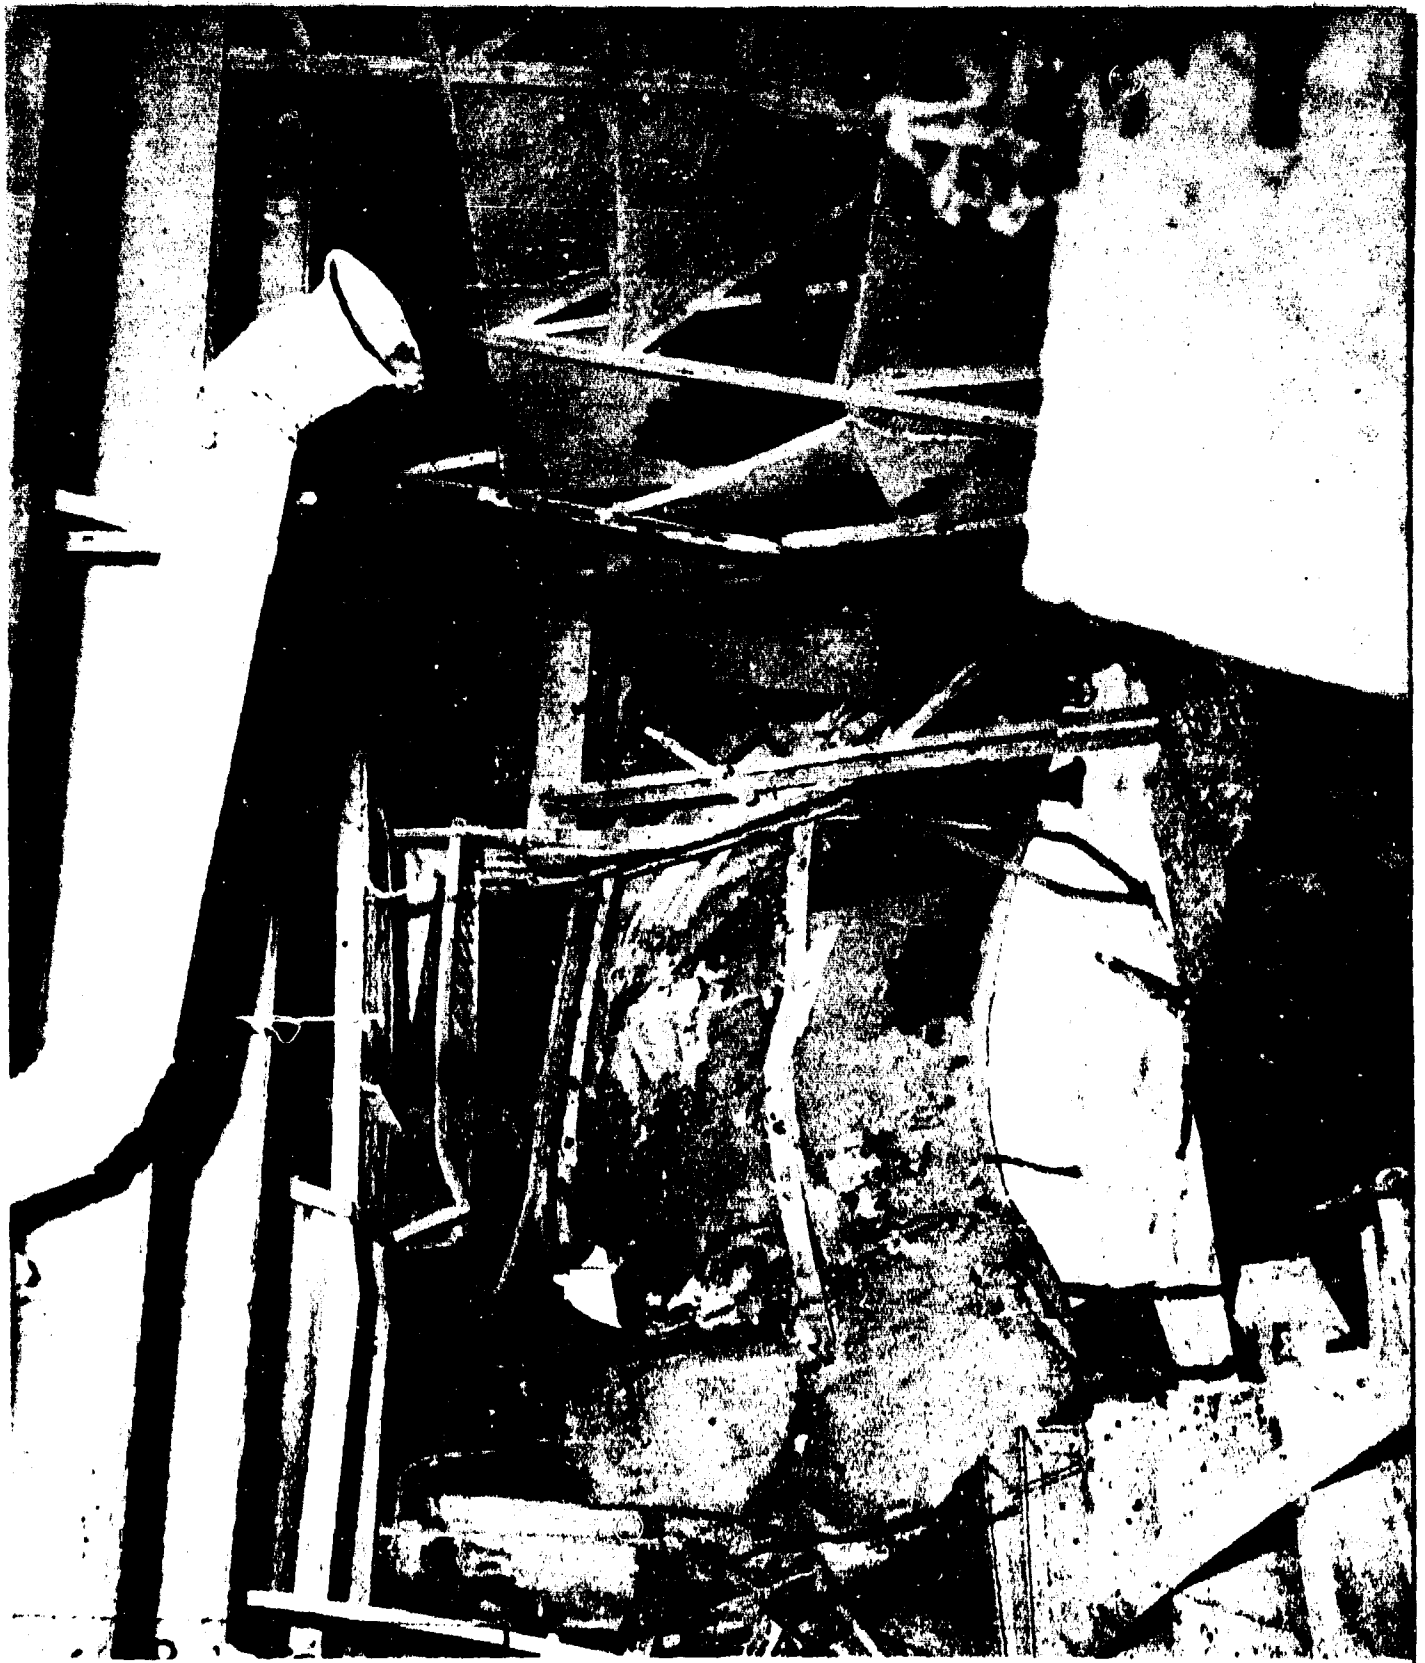
(a) Failure occurred along welded butts and seams in shell plating on the USS INDEPENDENCE as shown in photographs 2216-2, 2216-7, 1733-11, 1734-1, 2114-1, 2117-10 and 2117-11, pages 35, 36, 37, 39, 40, 43 and 44. Certain of these failures occurred in the welds while others occurred in the plate material adjacent to welds. Incomplete weld penetration of the joint caused failure in the former cases, and slight undercut at the edges of the welds contributed to failure in the latter cases. Shell plating in the area of greatest damage varied from 12 to 15 pounds in weight.

Damage to the superstructure on the INDEPENDENCE aft of the hangar space was severe. As shown in photographs 2216-2, 2216-7, 1734-1 and 2114-1, pages 35, 36, 39, and 40 there were numerous failures in side plating which followed welding seams. Certain of the failures occurred in the welds where incomplete joint penetration was observed. Others followed the seams in the plate material adjacent to the welds, and in certain cases appeared to have been caused by slight undercut at the edges of welds.

AA-CR-17-2114-1. USS INDEPENDENCE (CVL22). Failure of side plating along welded seam at level of poop deck. Port side looking outboard.

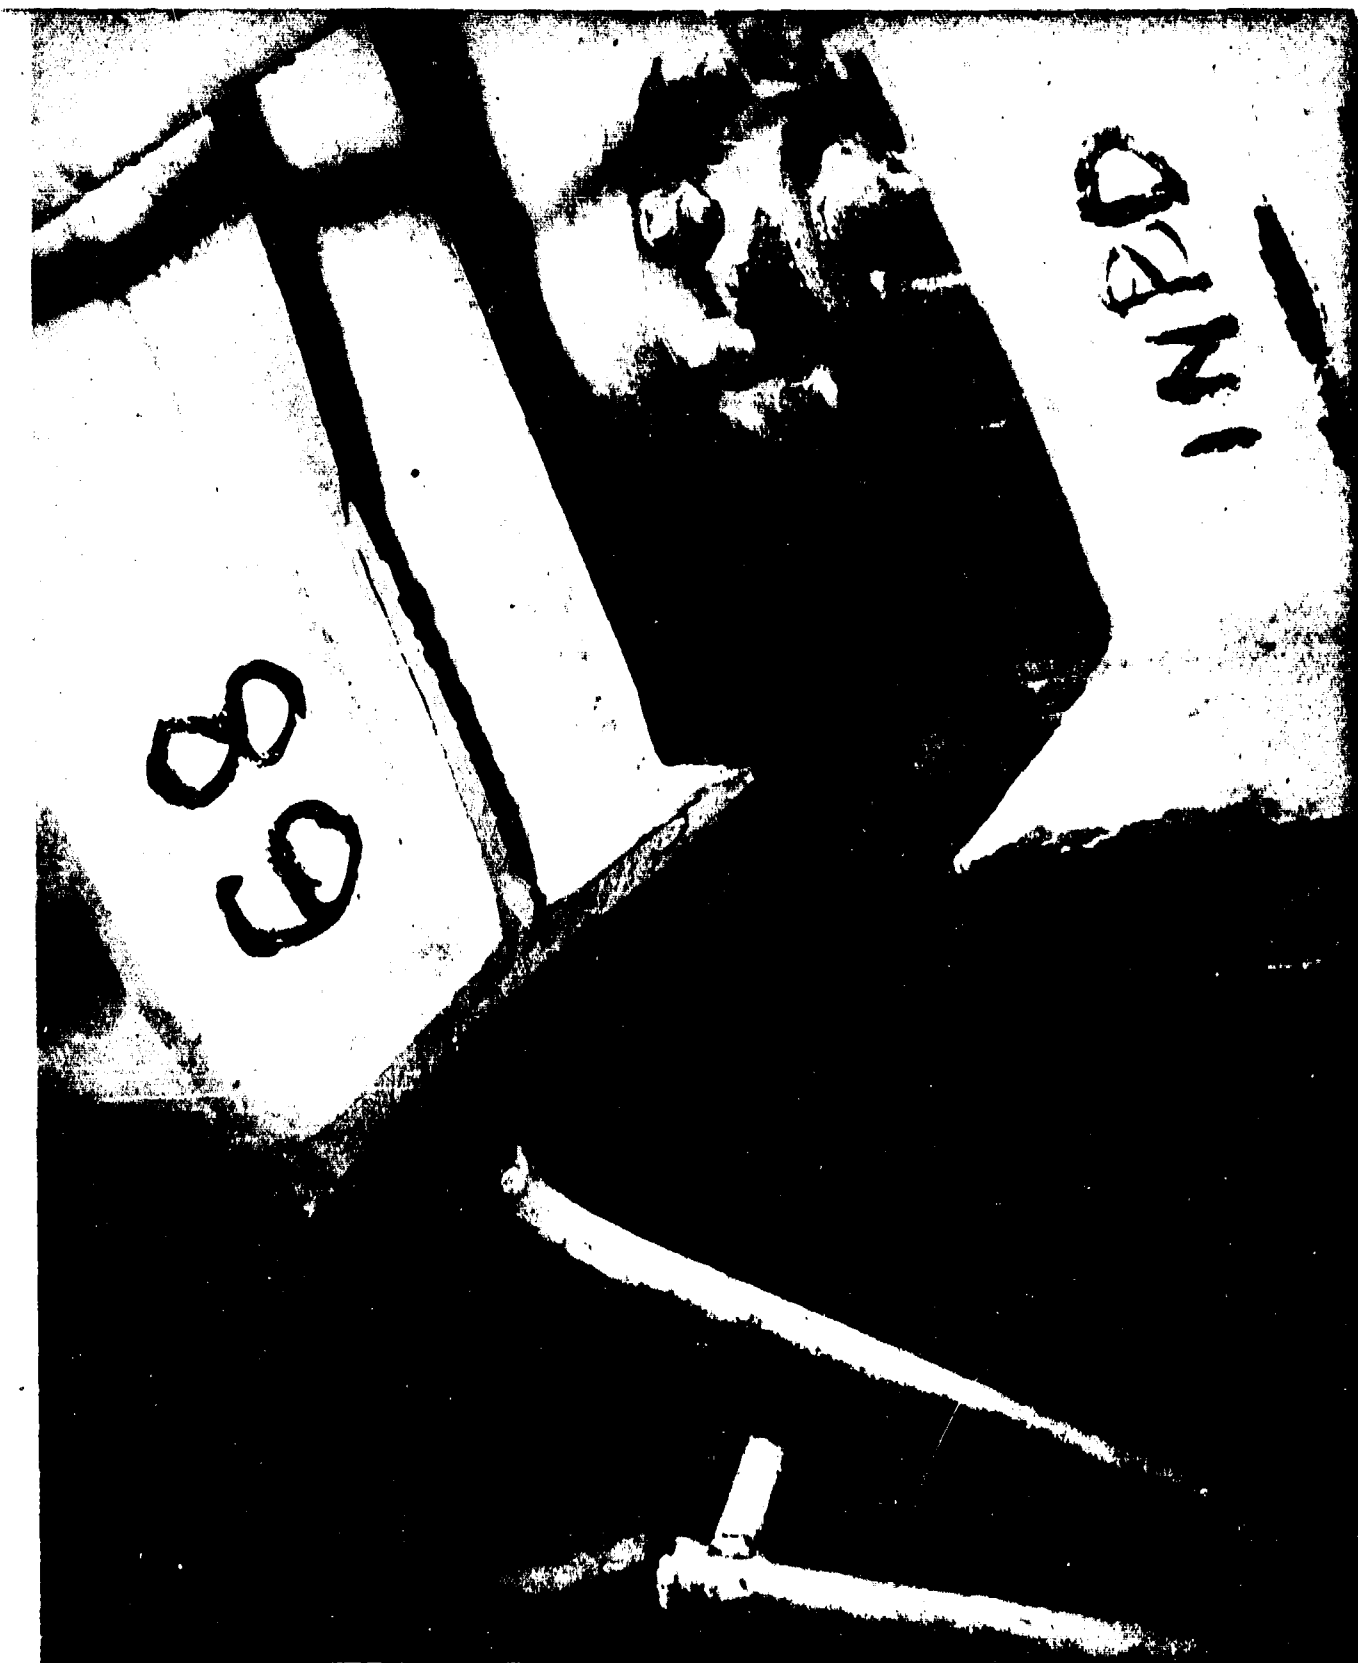
AA-CR-59-4149-5. USS INDEPENDENCE (CVL22). Fracture in flight deck bent column at port overhead bracket. Note herring bone pattern of fracture pointing to origin at toe of fillet weld at left.

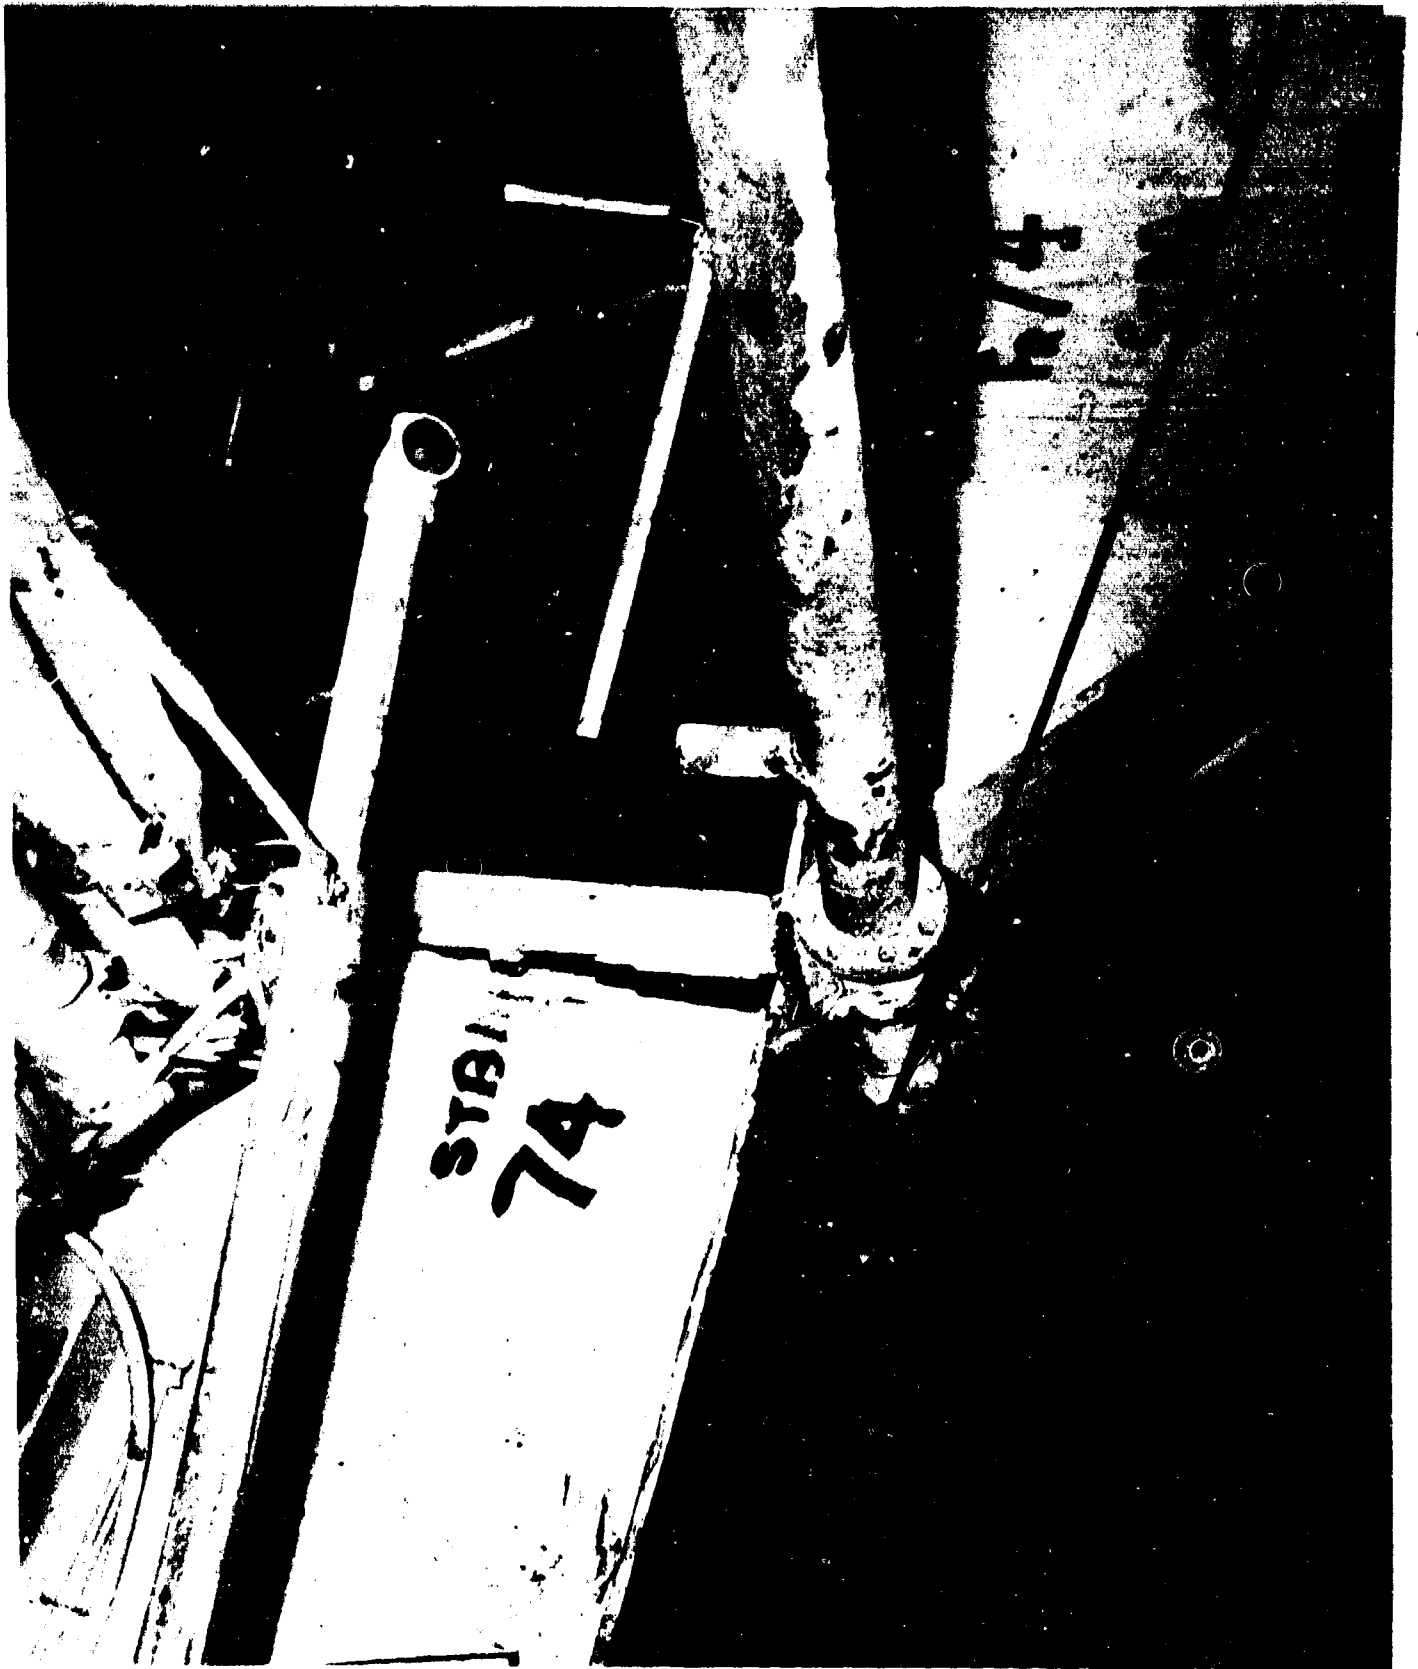
AA-CR-59-4148-11. USS INDEPENDENCE (CVL22). Fracture in flight deck bent overhead connection along inboard edge of vertical weld. Frame 74, looking forward.

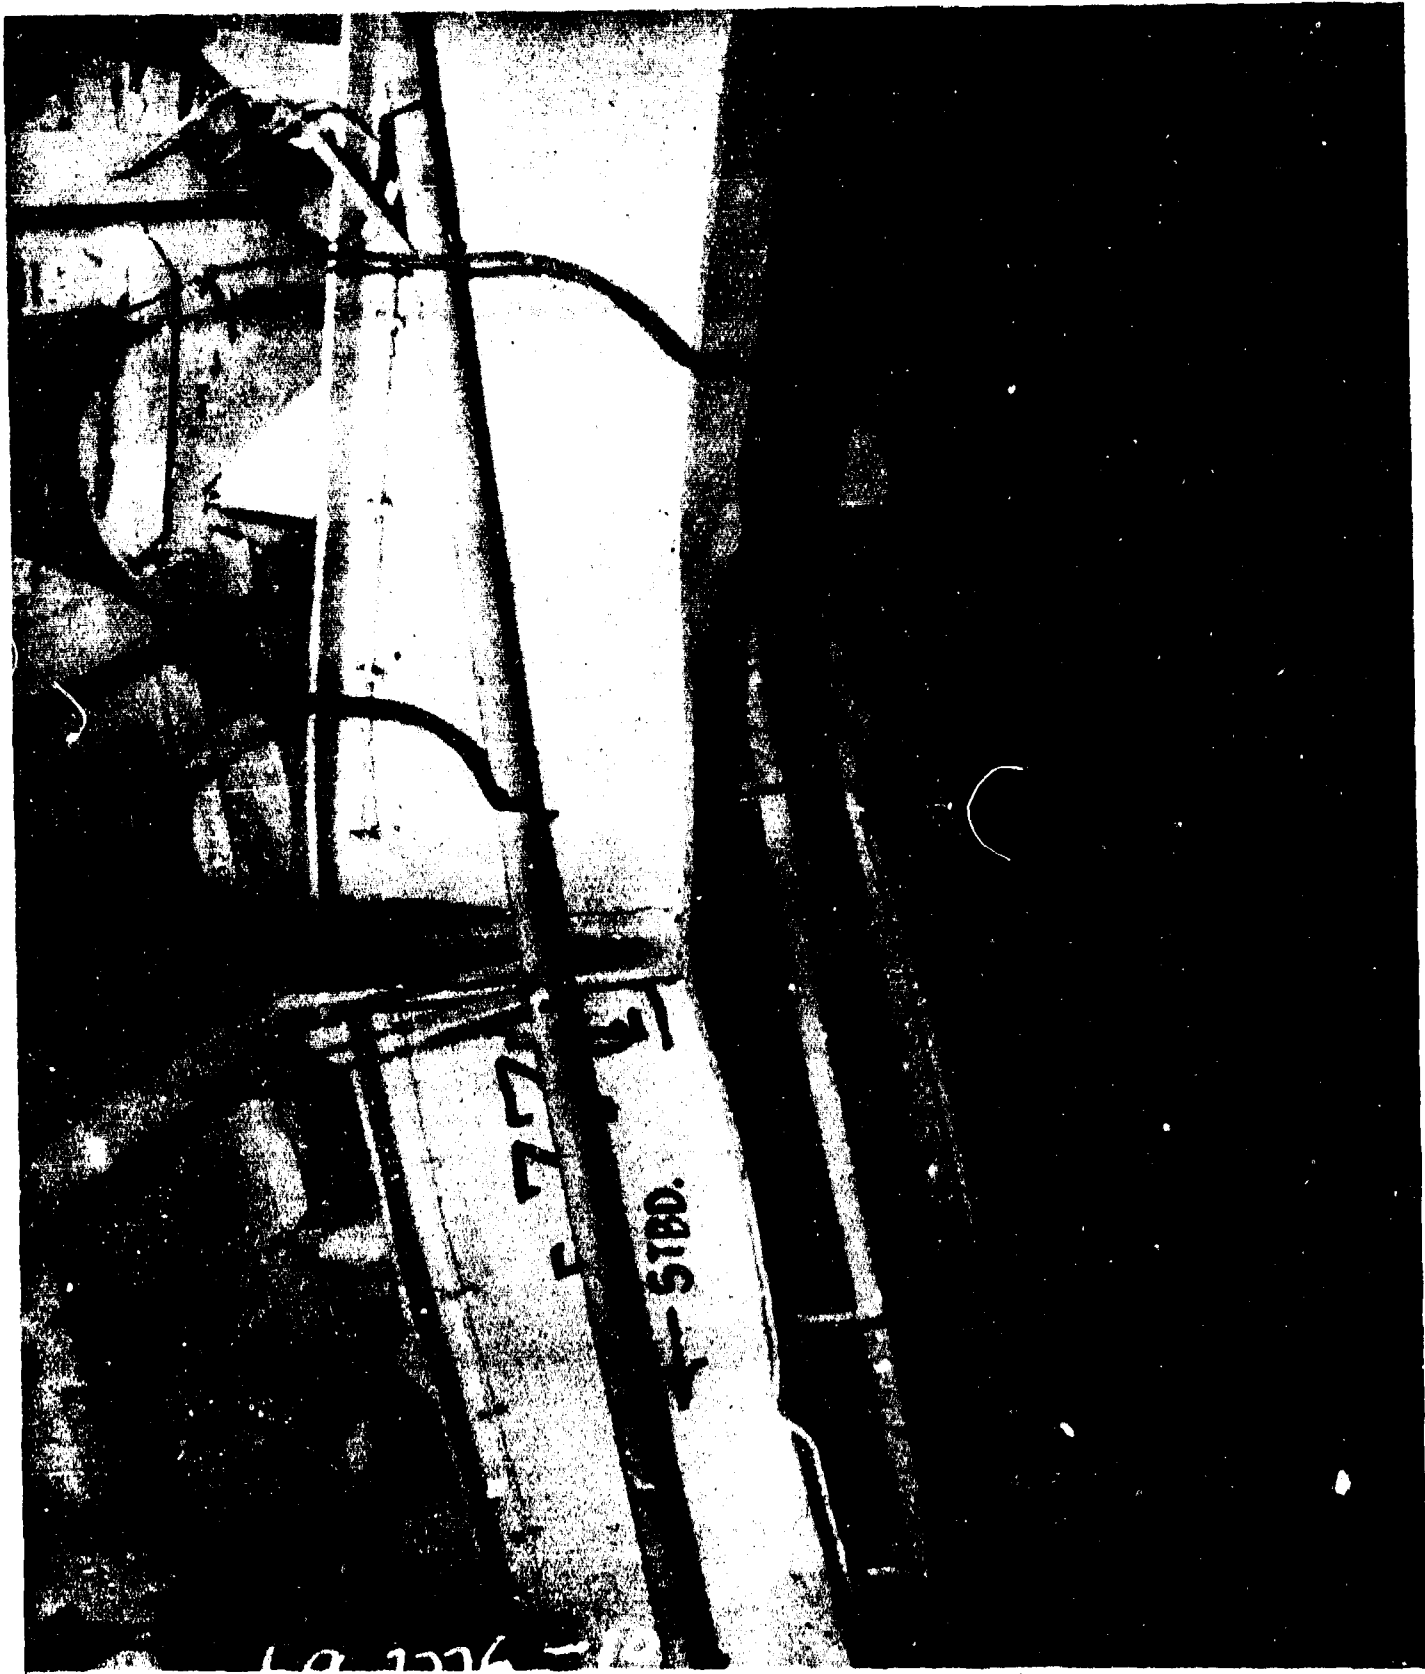
AA-CR-59-2226-10. USS INDEPENDENCE (CVL22). Fracture in center-line butt weld in flight deck bent girder. Fracture originated in weld in upper flange. Looking aft.

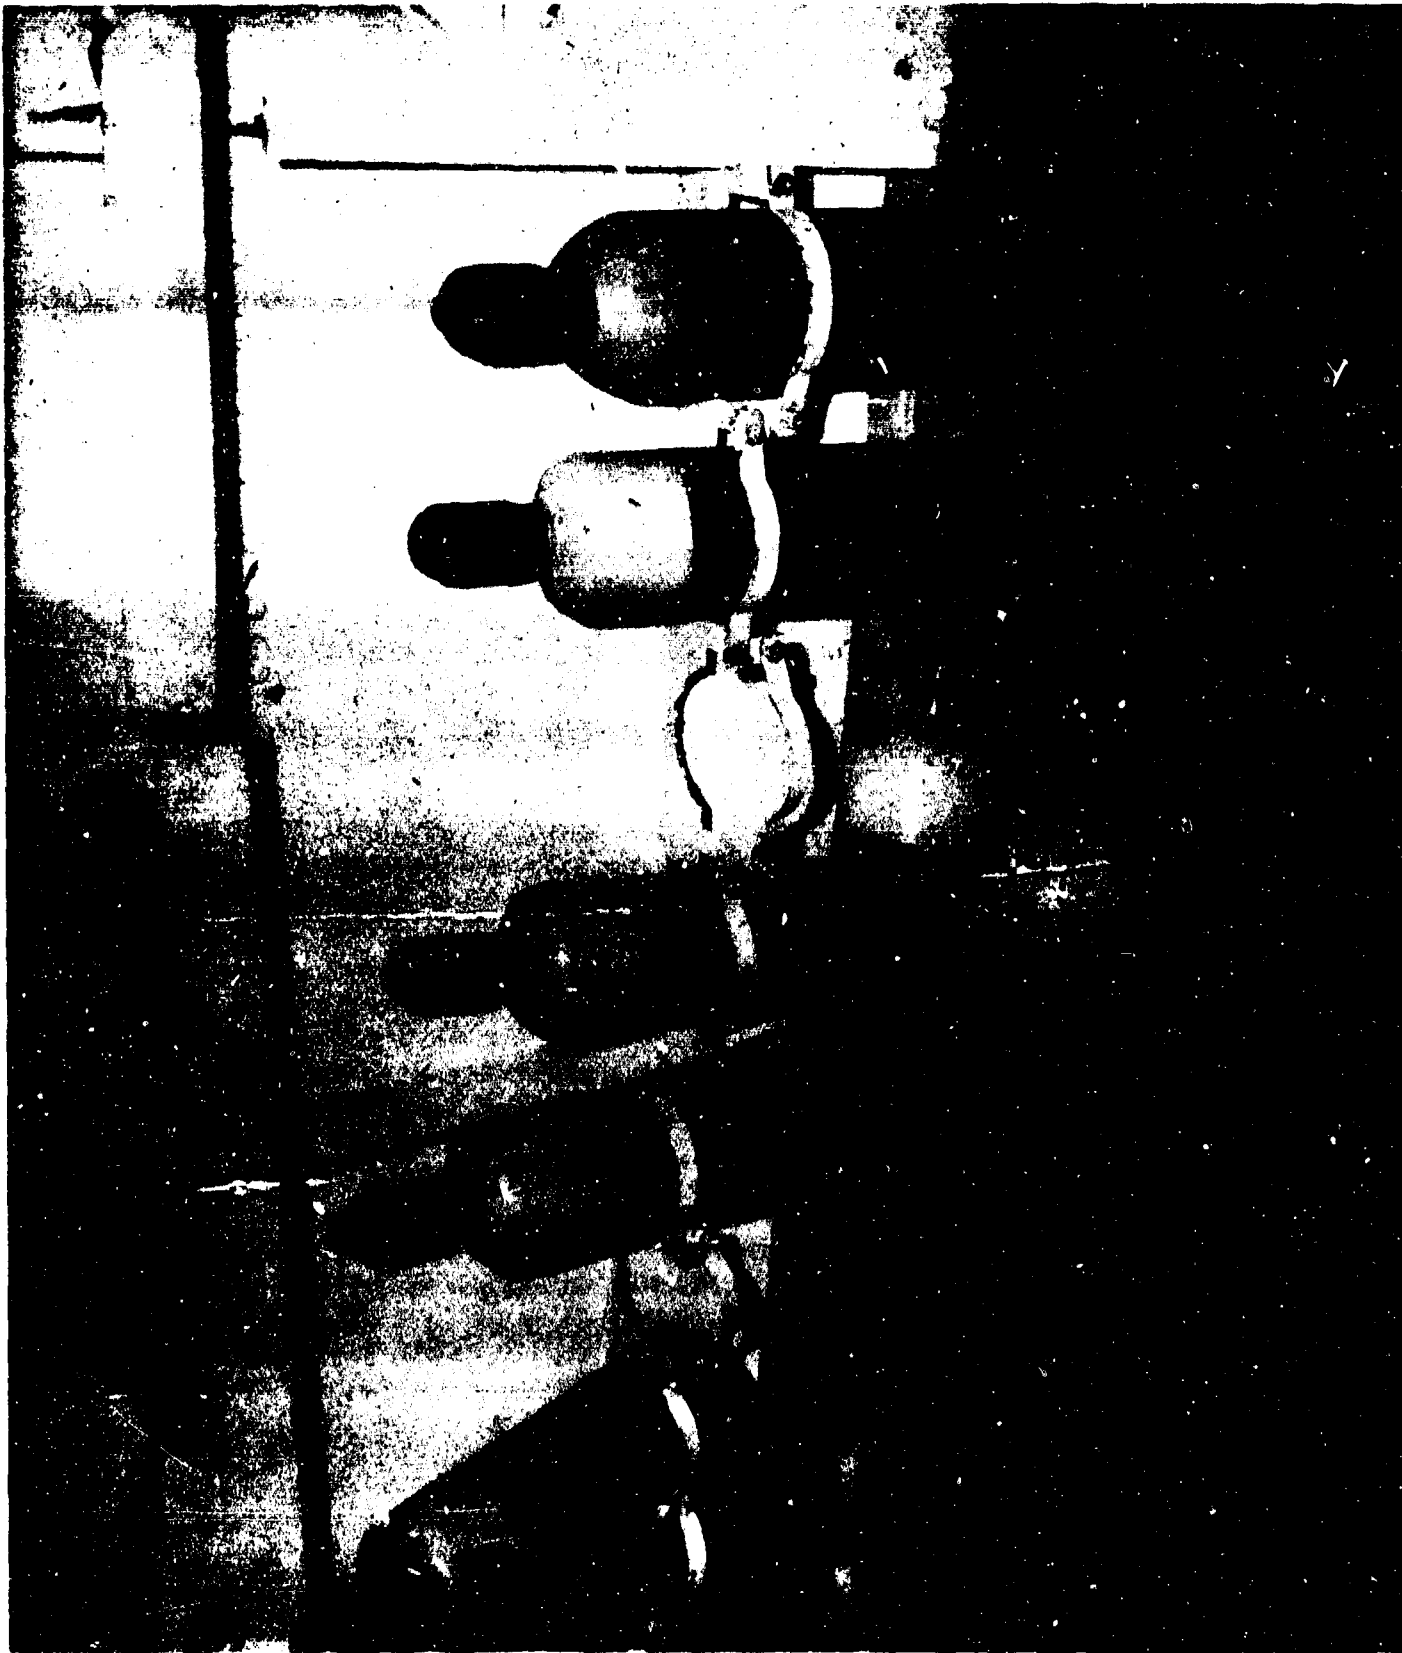
(c) Oxygen, acetylene and other gas cylinders. In most cases gas cylinders were stowed on weather decks. In many instances, such as shown in photographs 1867-2, 1868-3 and 2116-12, pages 22, 23 and 65, cylinders were displaced from stowage racks by the force of air blast against structures to which they were secured. Similar occurrences were observed on Test B target ships moored close to the bomb. Displacement of cylinders in this test was caused by underwater shock. As far as could be ascertained displaced cylinders were undamaged.

Although the main and second decks aft on the INDEPENDENCE were severely deformed on the port side in way of the severely damaged area, as shown in photographs 2216-2, 2216-7, 2071-1, 2116-12, 2041-7 and 2116-7, pages 35, 36, 64, 65, 68 and 70, no failures were observed in welds. Photographs 2040-2 and 2226-12, pages 48 and 50 show deflection of the all welded hangar deck. No failures were found in welds in this deck. In the forward elevator pit on the INDEPENDENCE a failure occurred in a weld in a make up joint in a flush patch in the main deck. Examination of the fracture revealed that the joint edges of the 20 pound plate had not been beveled for welding with a result that very little of the joint was penetrated by the weld. Photograph 2100-4, page 49 shows the fracture which is approximately 6 1/2 feet long. No failures were observed in welds in STS deck plating.

AA-CR-175-2116-12. USS INDEPENDENCE (CVL22). Weld fractures in mid-height stringer and shell frame in way of bulged port shell. Third deck frames 124 and 125. Note displaced gas bottles.

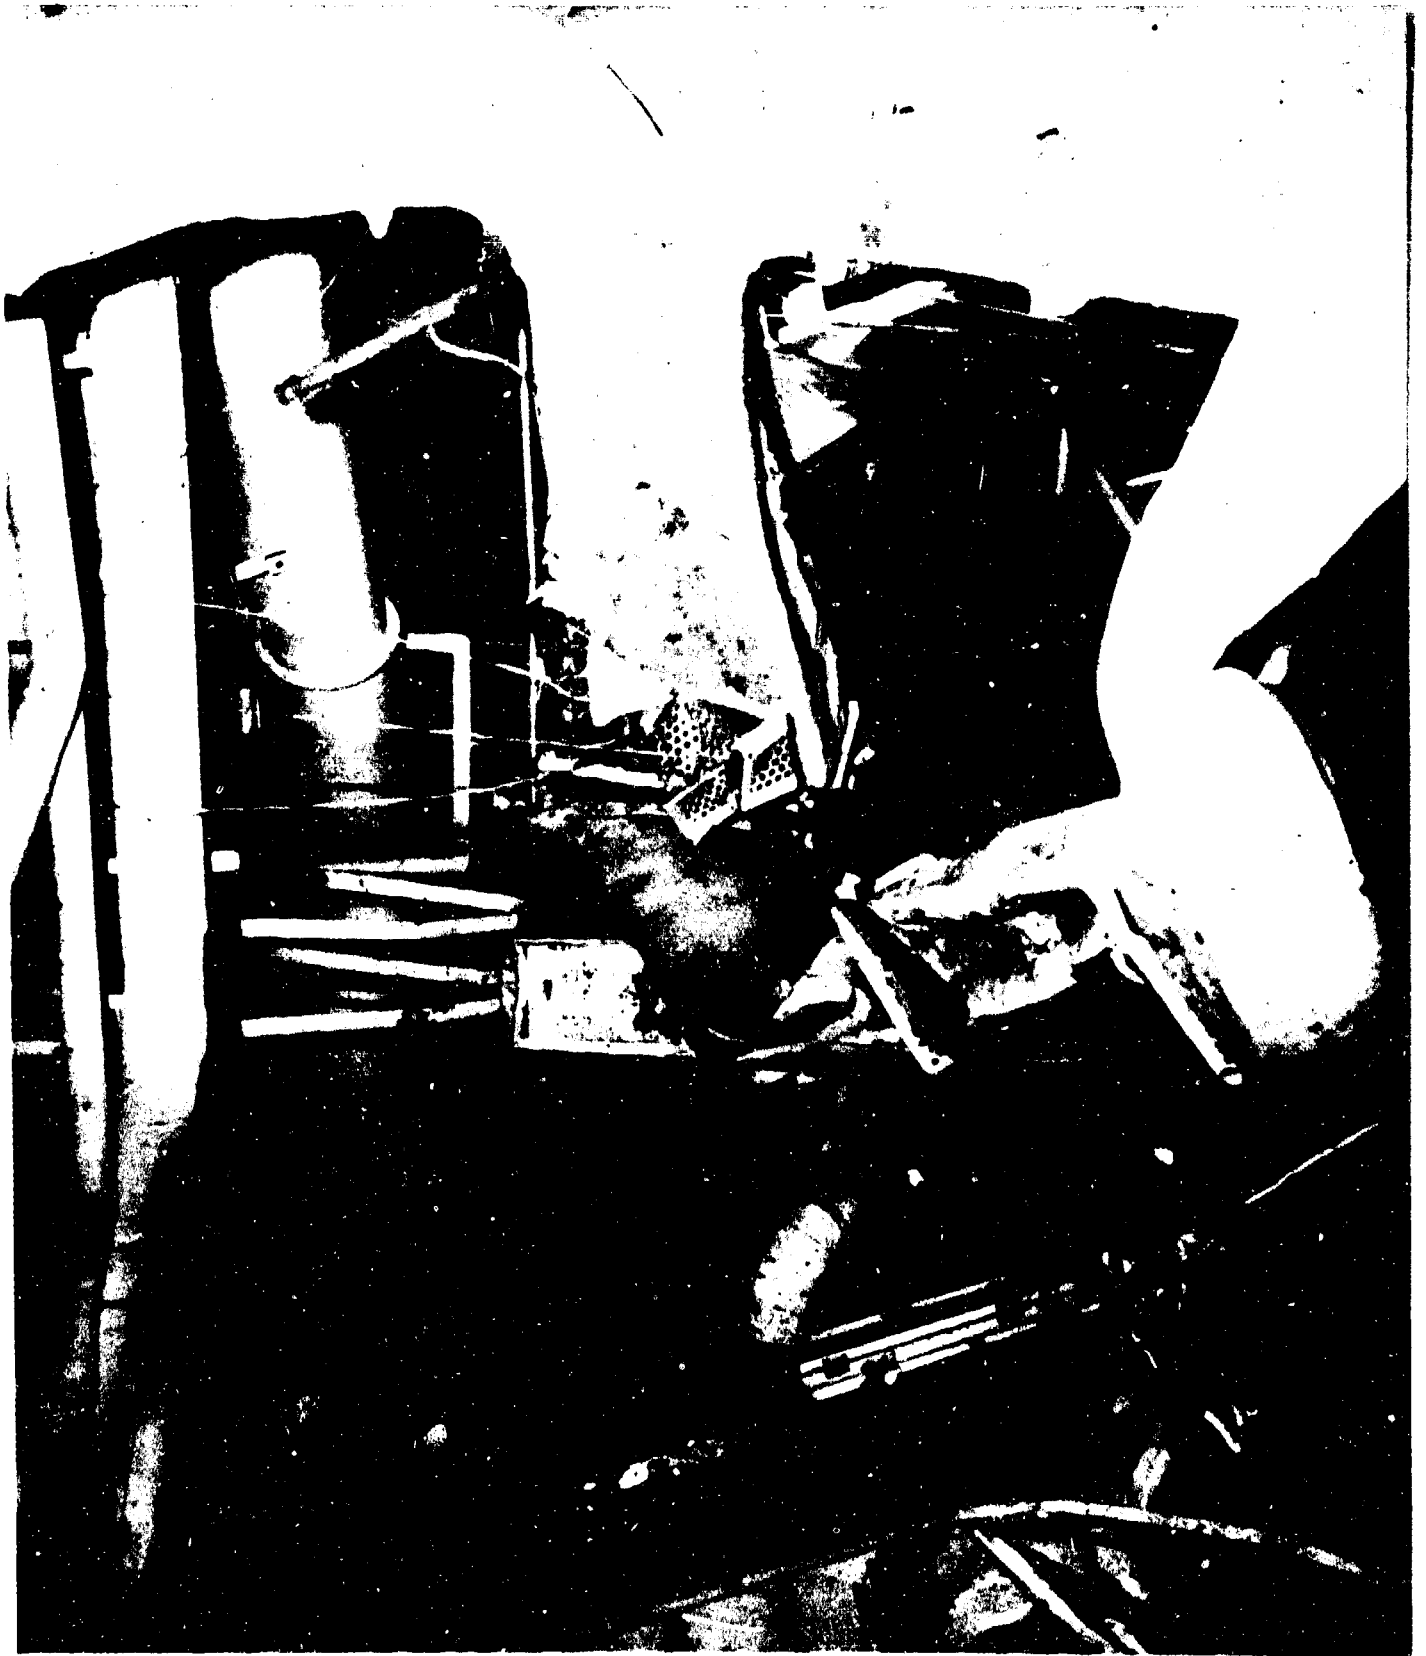
AA-CR-175-2118-2. USS INDEPENDENCE (CVL22). General view of damage to ventilation ducts, second deck port side aft of bulkhead 144.

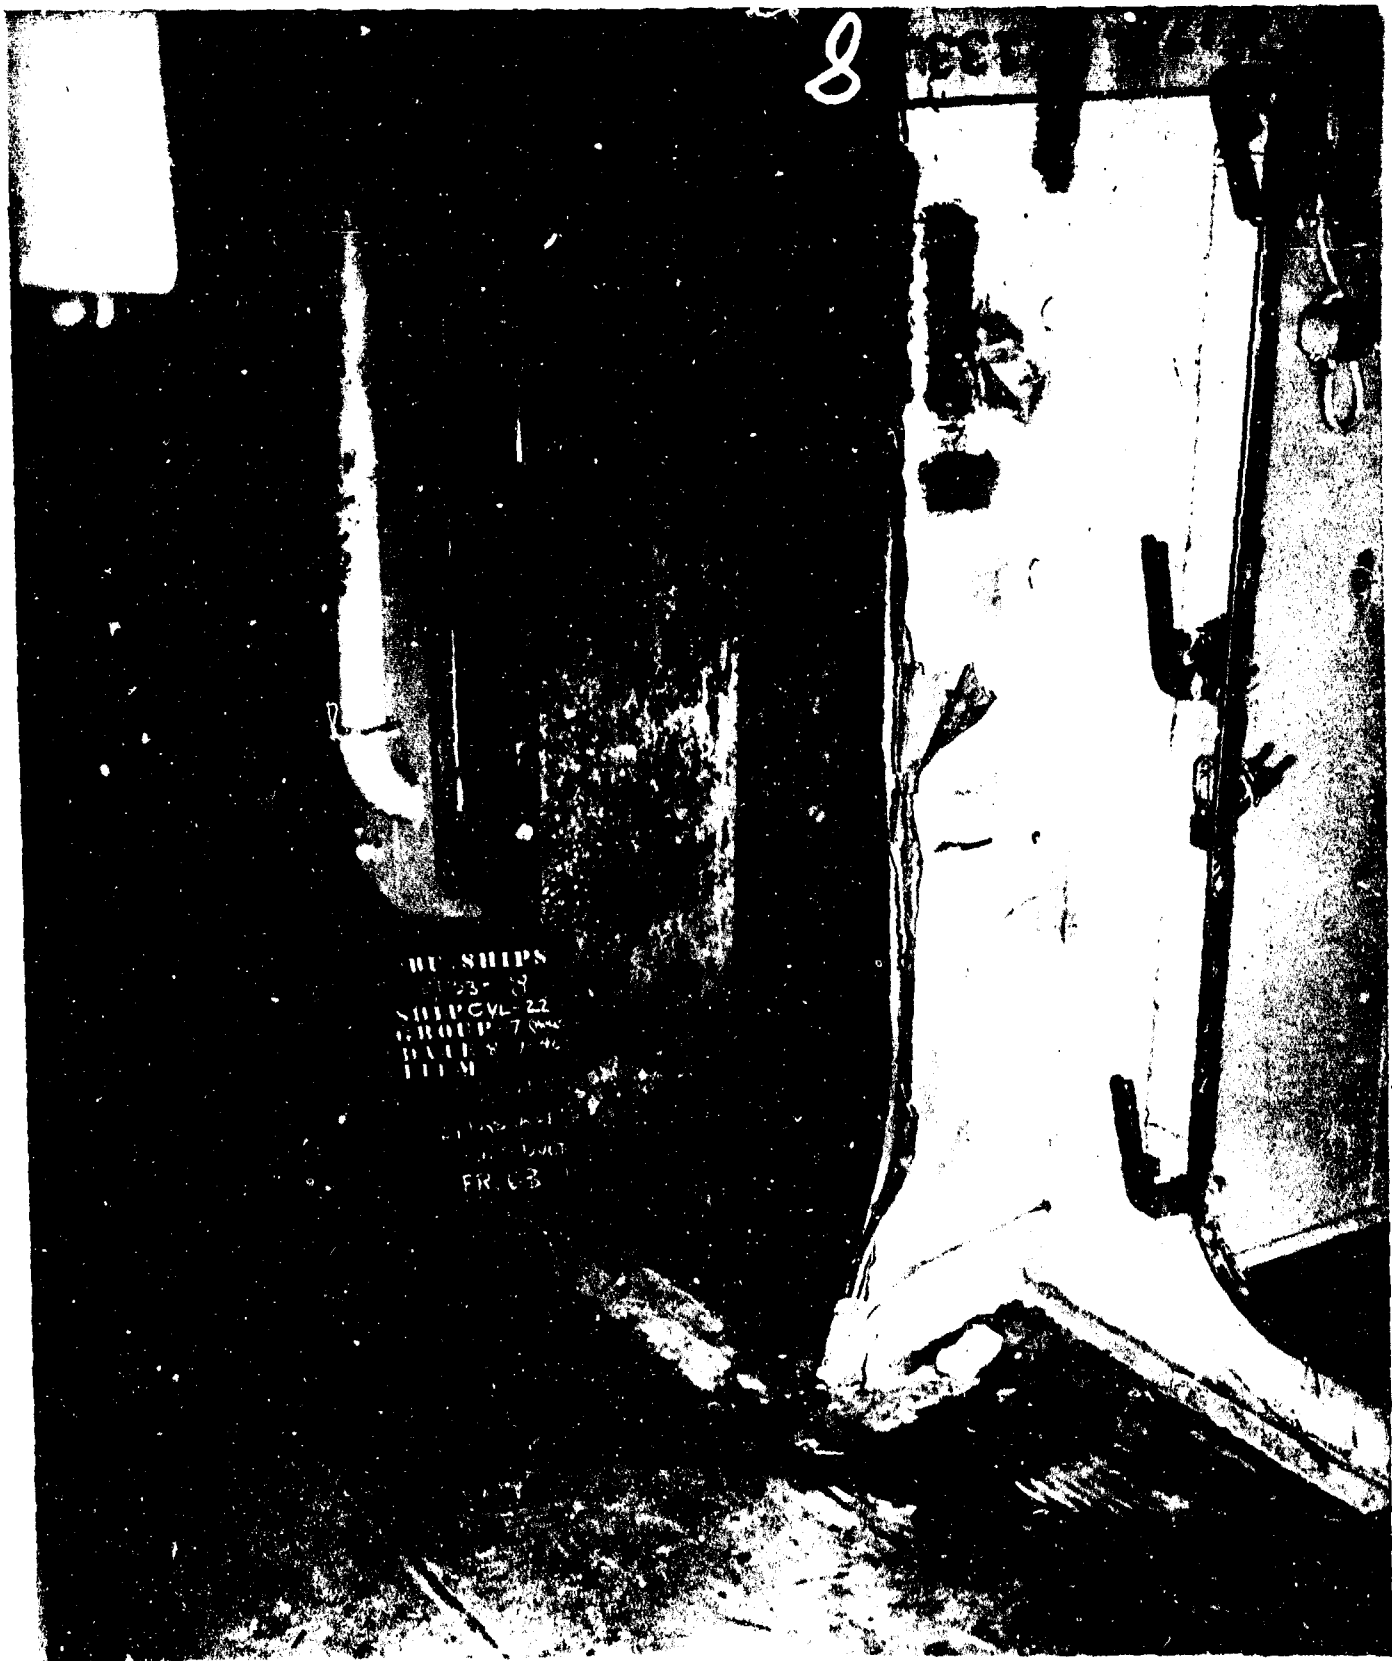
AA-CR-175-2133-8. USS INDEPENDENCE (CVL22). Failure of arc welded ventilation duct. Second deck, port passage, frame 63. Blast penetrated ventilation system.

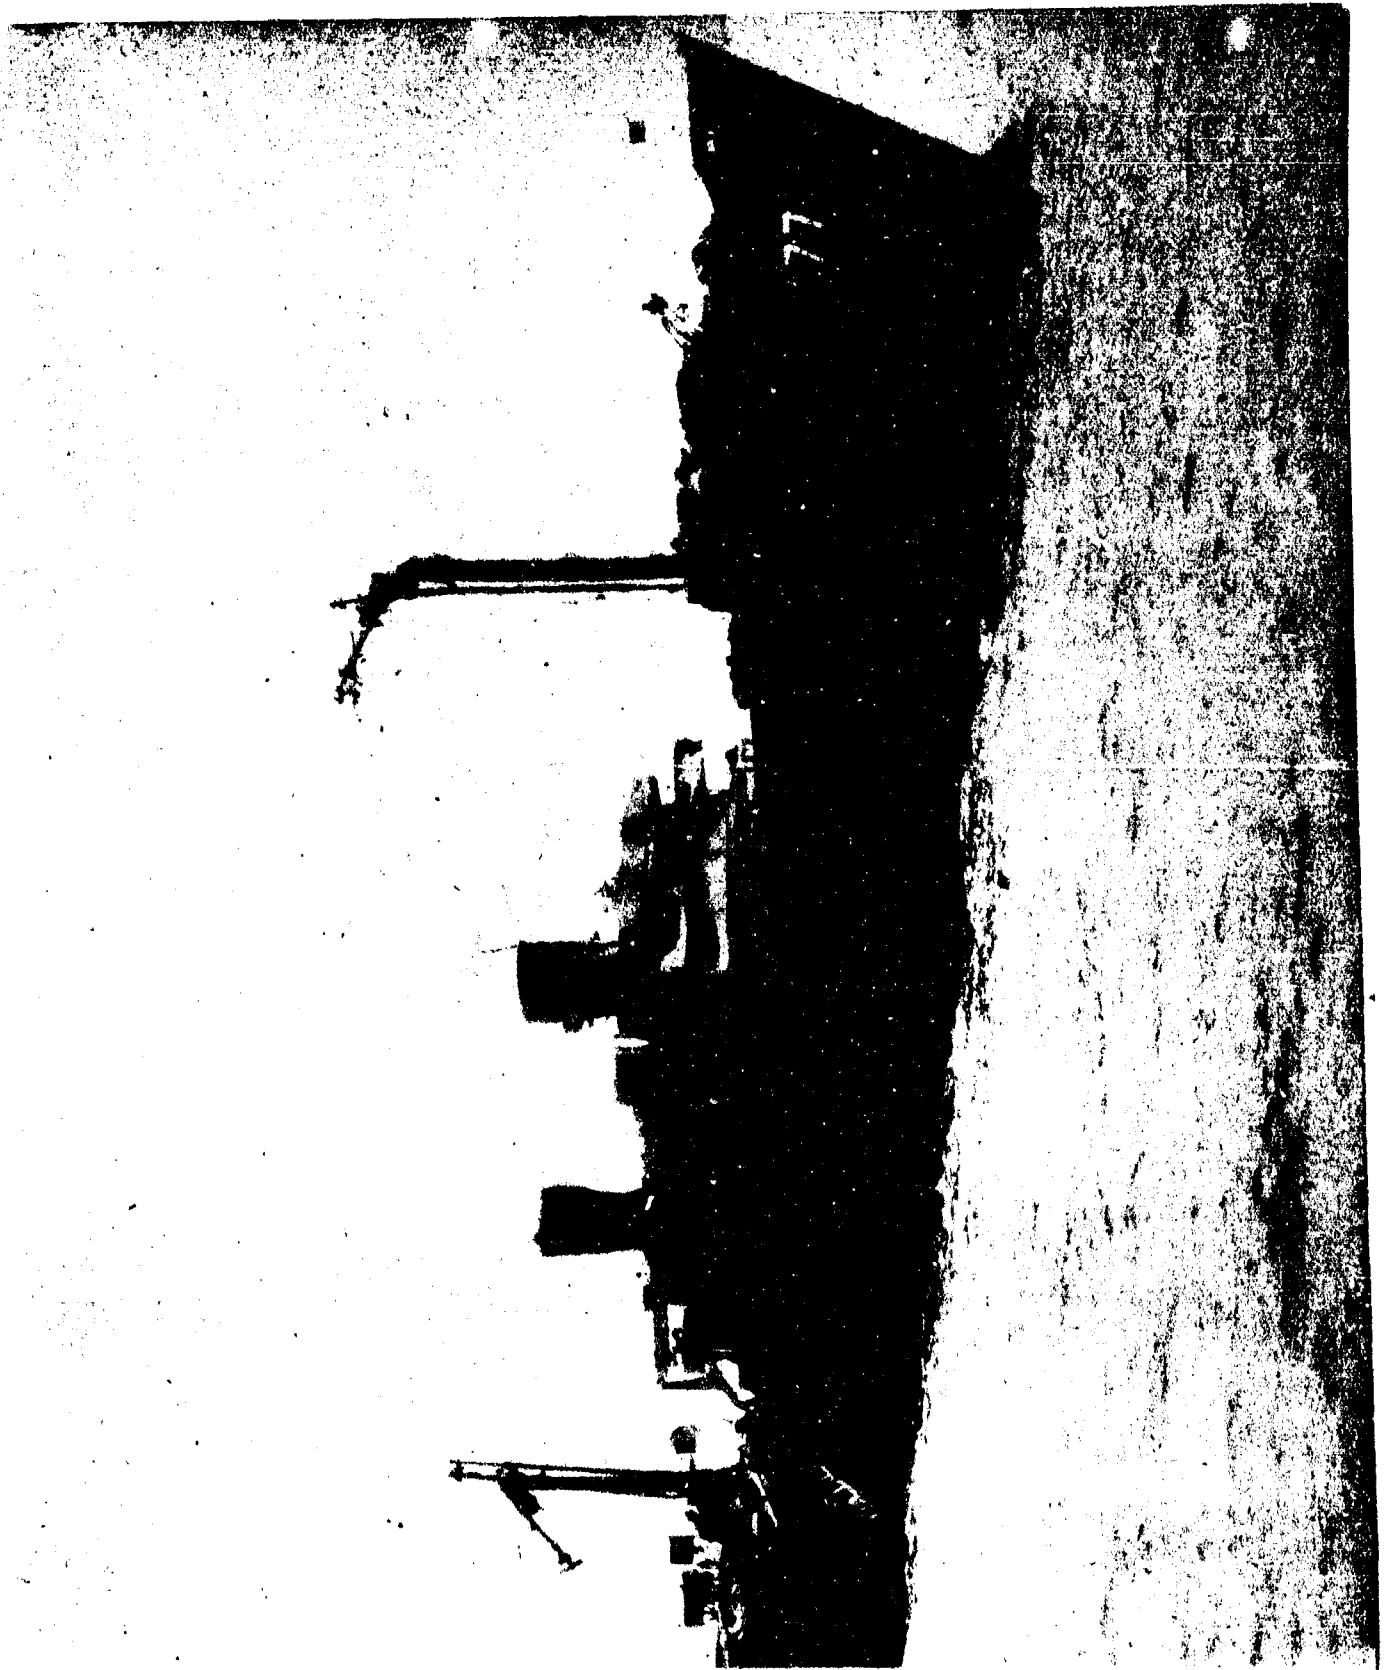
AA-CR-227-49-117. USS CRITTENDEN (APA77). General view of blast damage to superstructure - starboard bow view.
