# BUREAU OF SHIPS GROUP

## TECHNICAL INSPECTION REPORT

### WELDING

OPERATION CROSSROADS

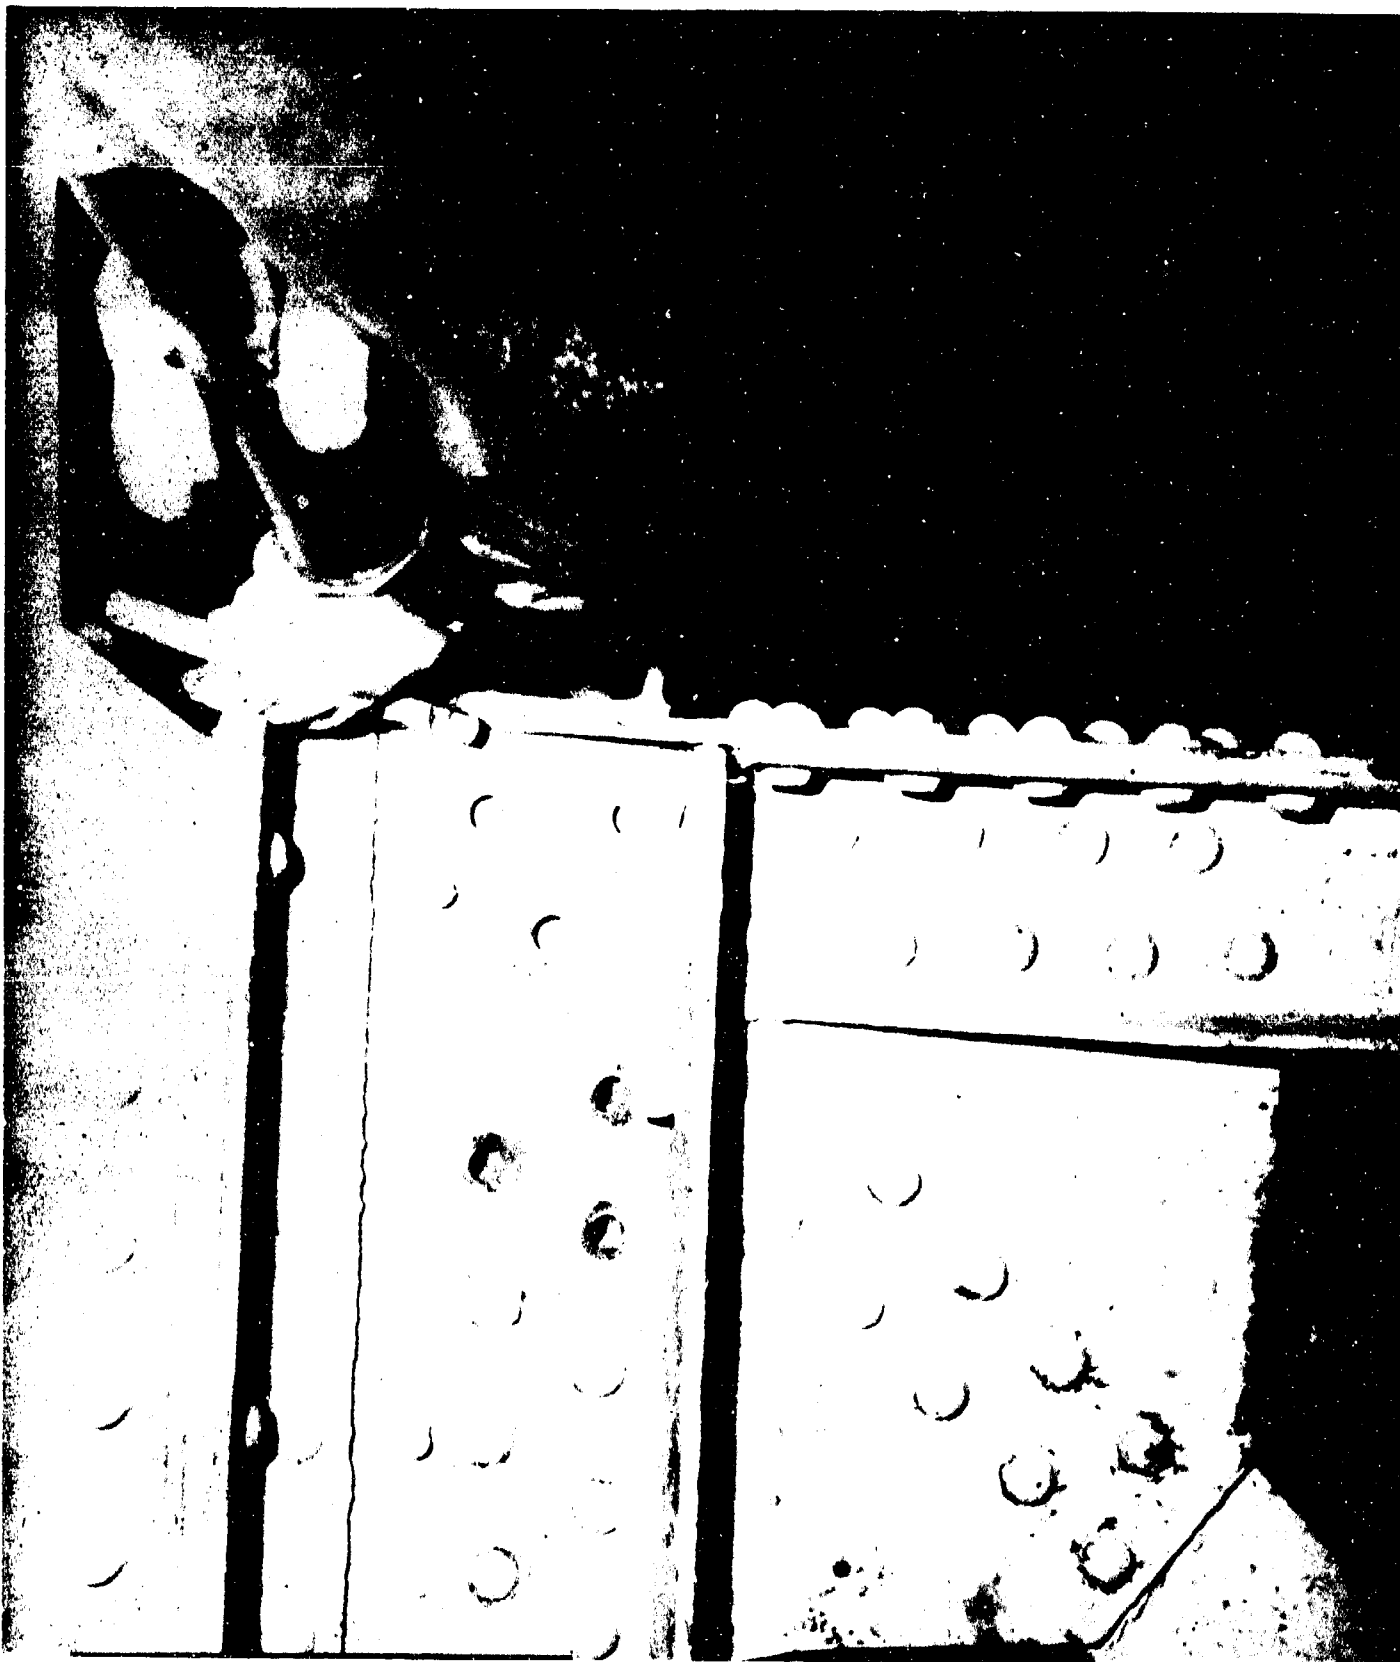
AB-CR-68-1691-5. USS PENSACOLA (CA24). Failure of forward end of port main condenser foundation due to underwater shock. Note sheared rivets.

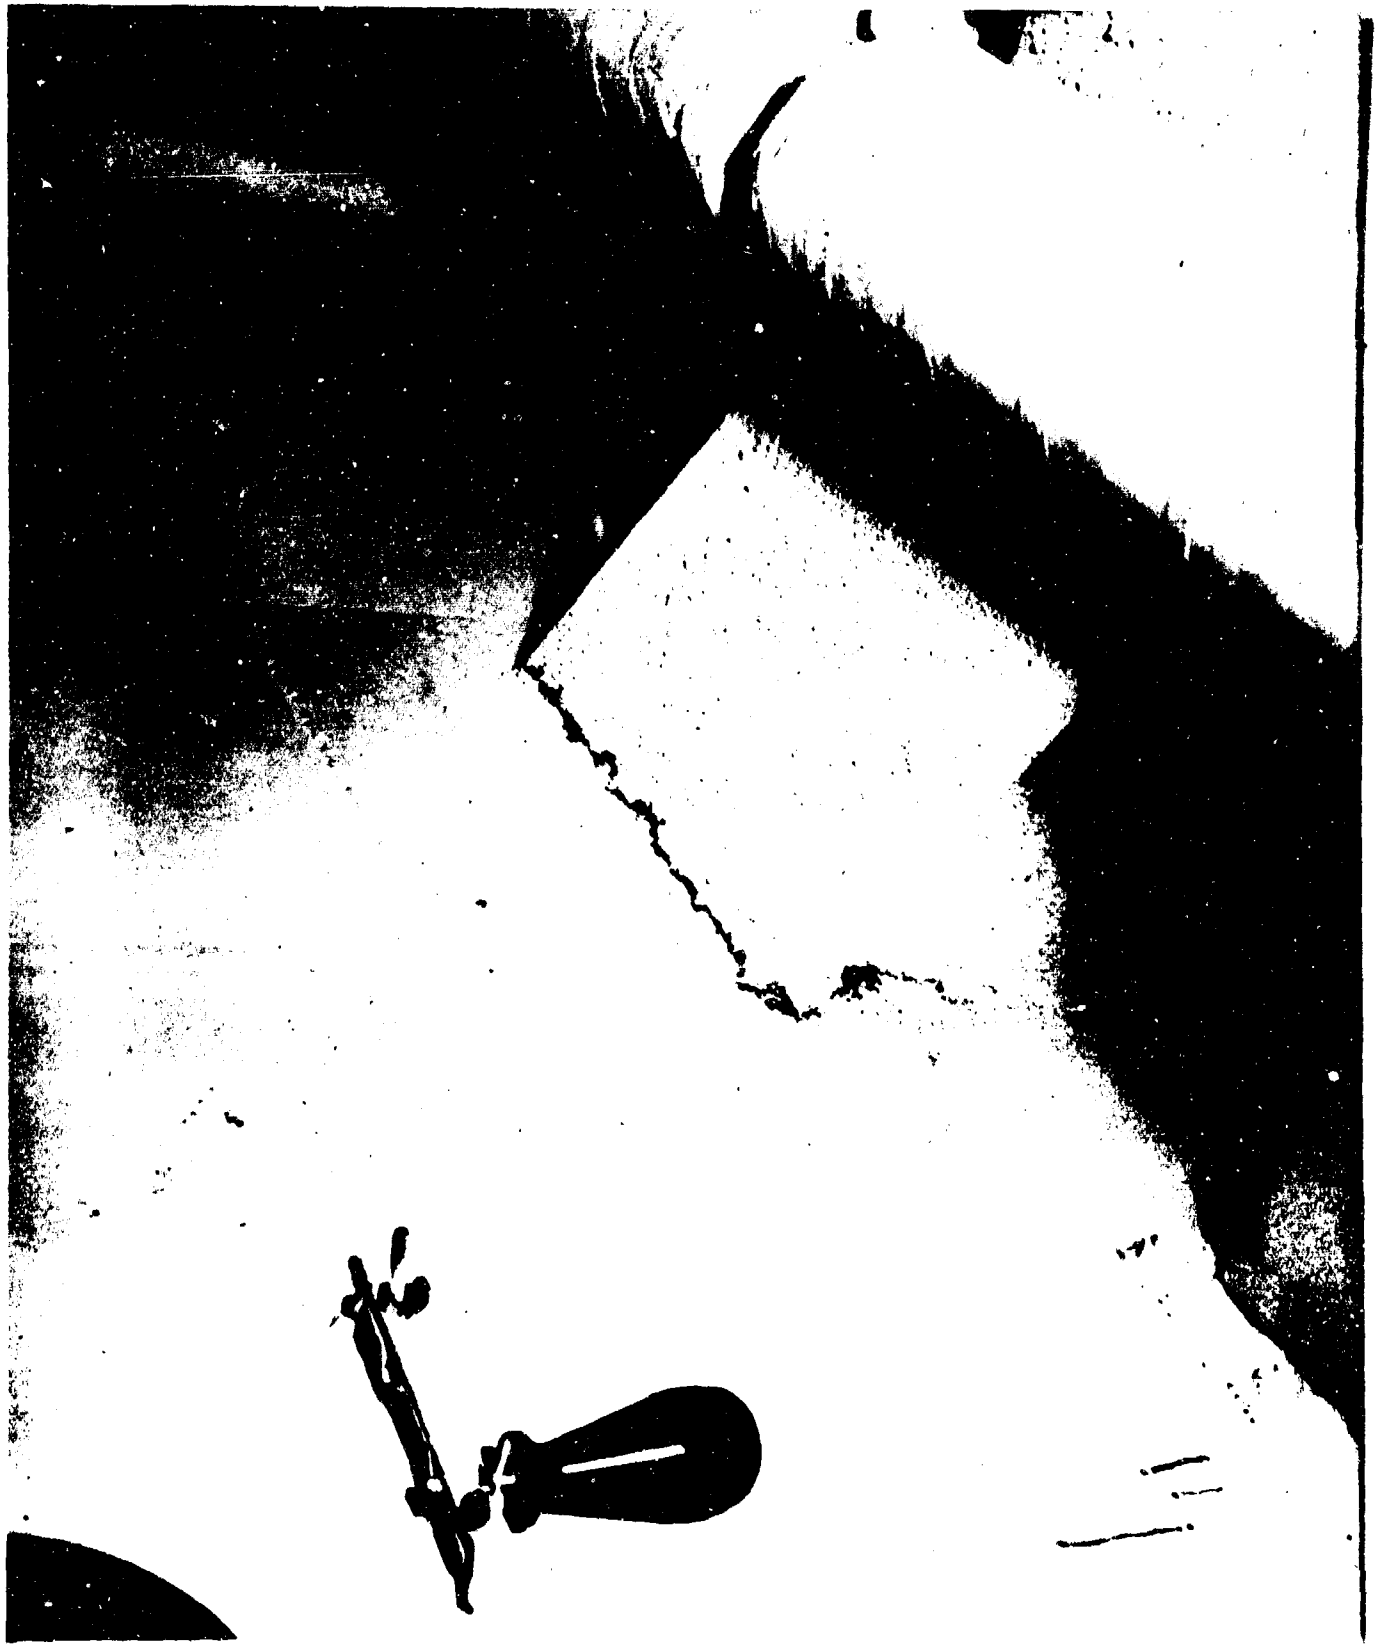
AB-CR-76-2083-11. USS FALLON (APA81). Failure of welded connection at intersection of deck longitudinal with transverse structural bulkhead. Underwater shock damage. Bulkhead 124, looking forward and upward from main deck.
