⑨ BUREAU OF SHIPS GROUP  
TECHNICAL INSPECTION REPORT.

⑥ OPERATION CROSSROADS.  
SPECIAL REPORTS  
ON  
HULL ITEMS [U]. ⑧

DIRECTOR OF SHIP MATERIAL

JOINT TASK FORCE ONE

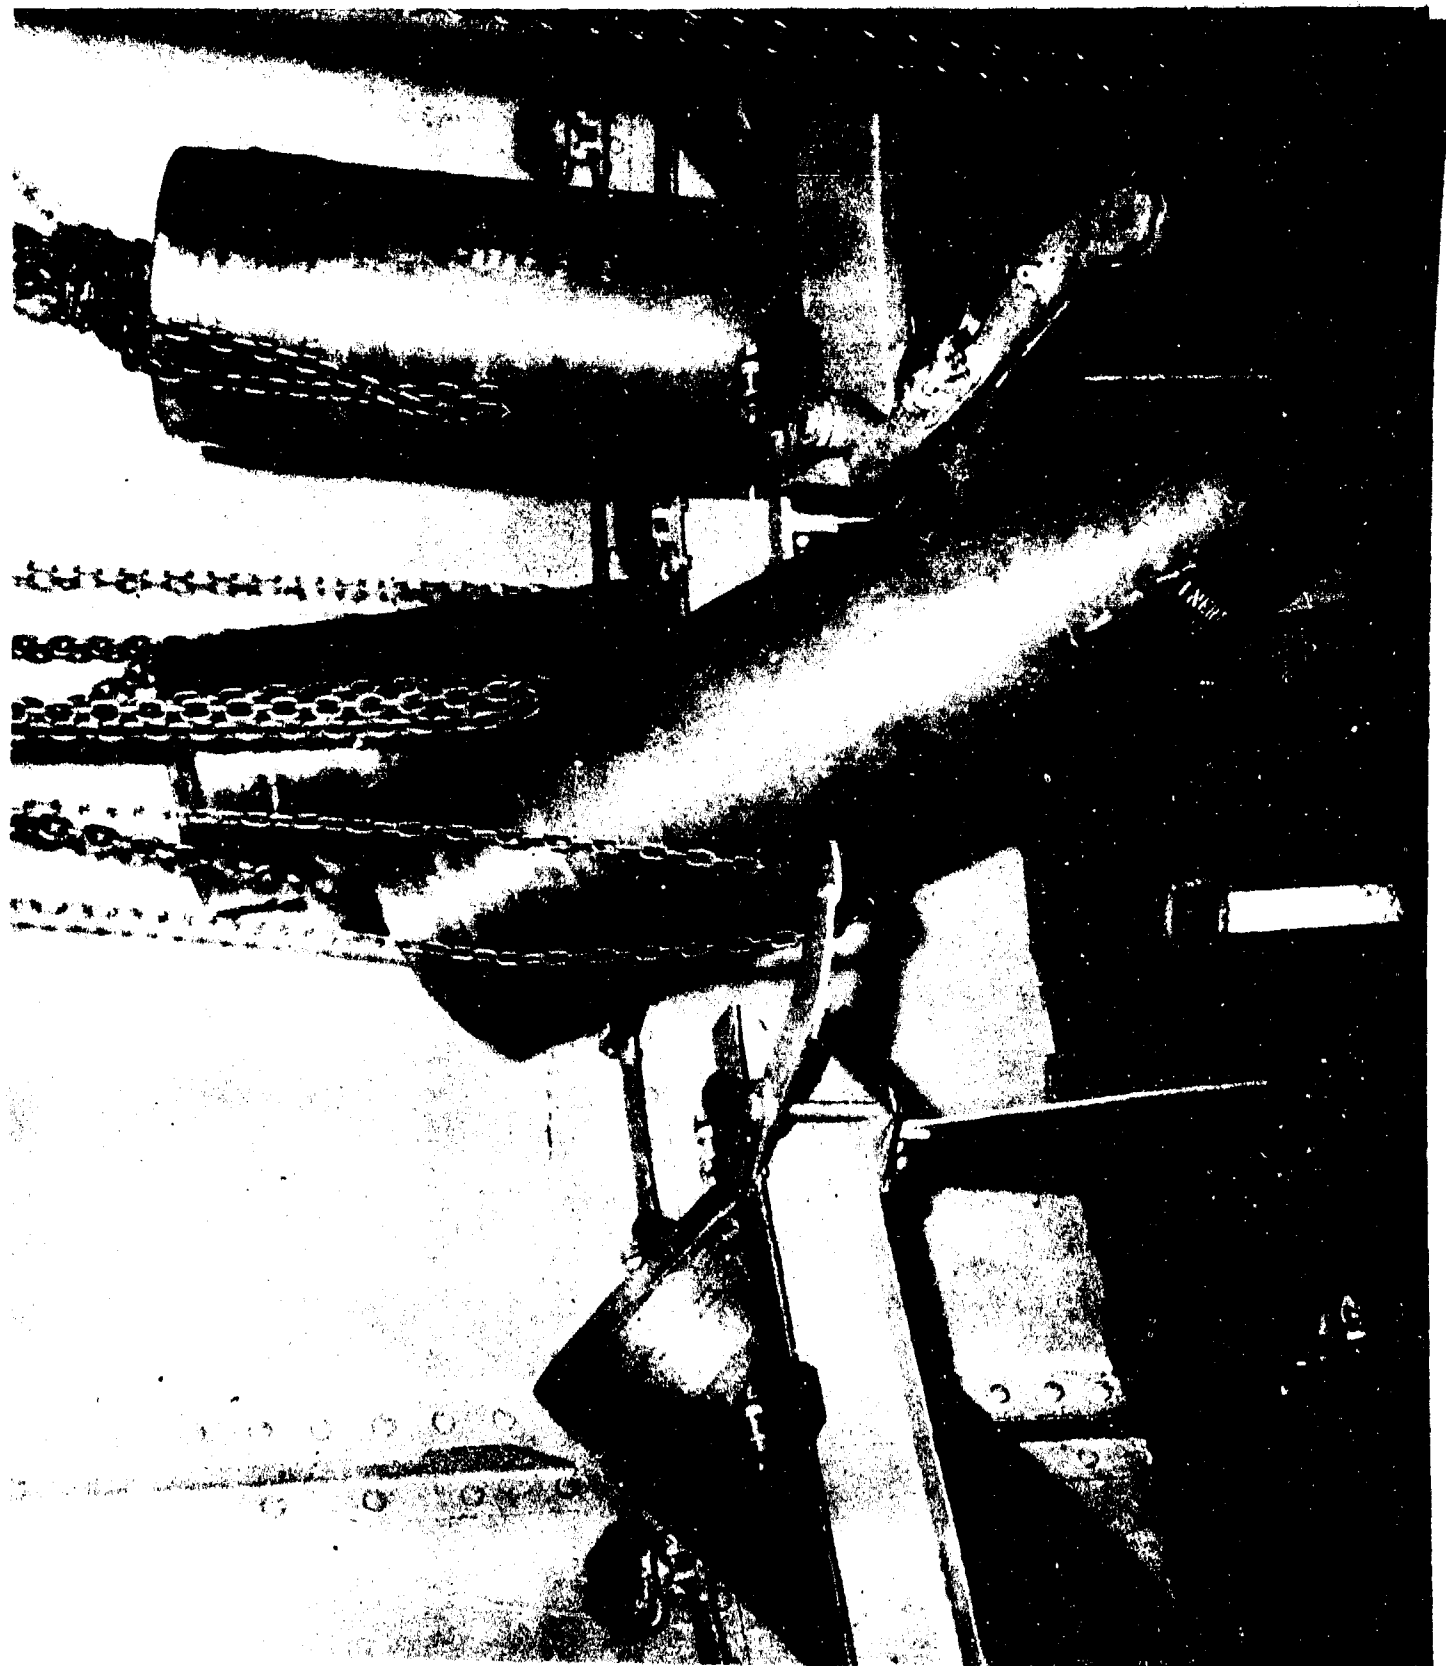
AB-CR-82-4222-11. NEW YORK. Turret 4. Projectile transfer level.  
Disarrangement of projectiles after Test B.
