TECHNICAL INSPECTION REPORT

OPERATION CROSSROADS.

U.S.S. ARKANSAS (BB33).

TEST ABLE.

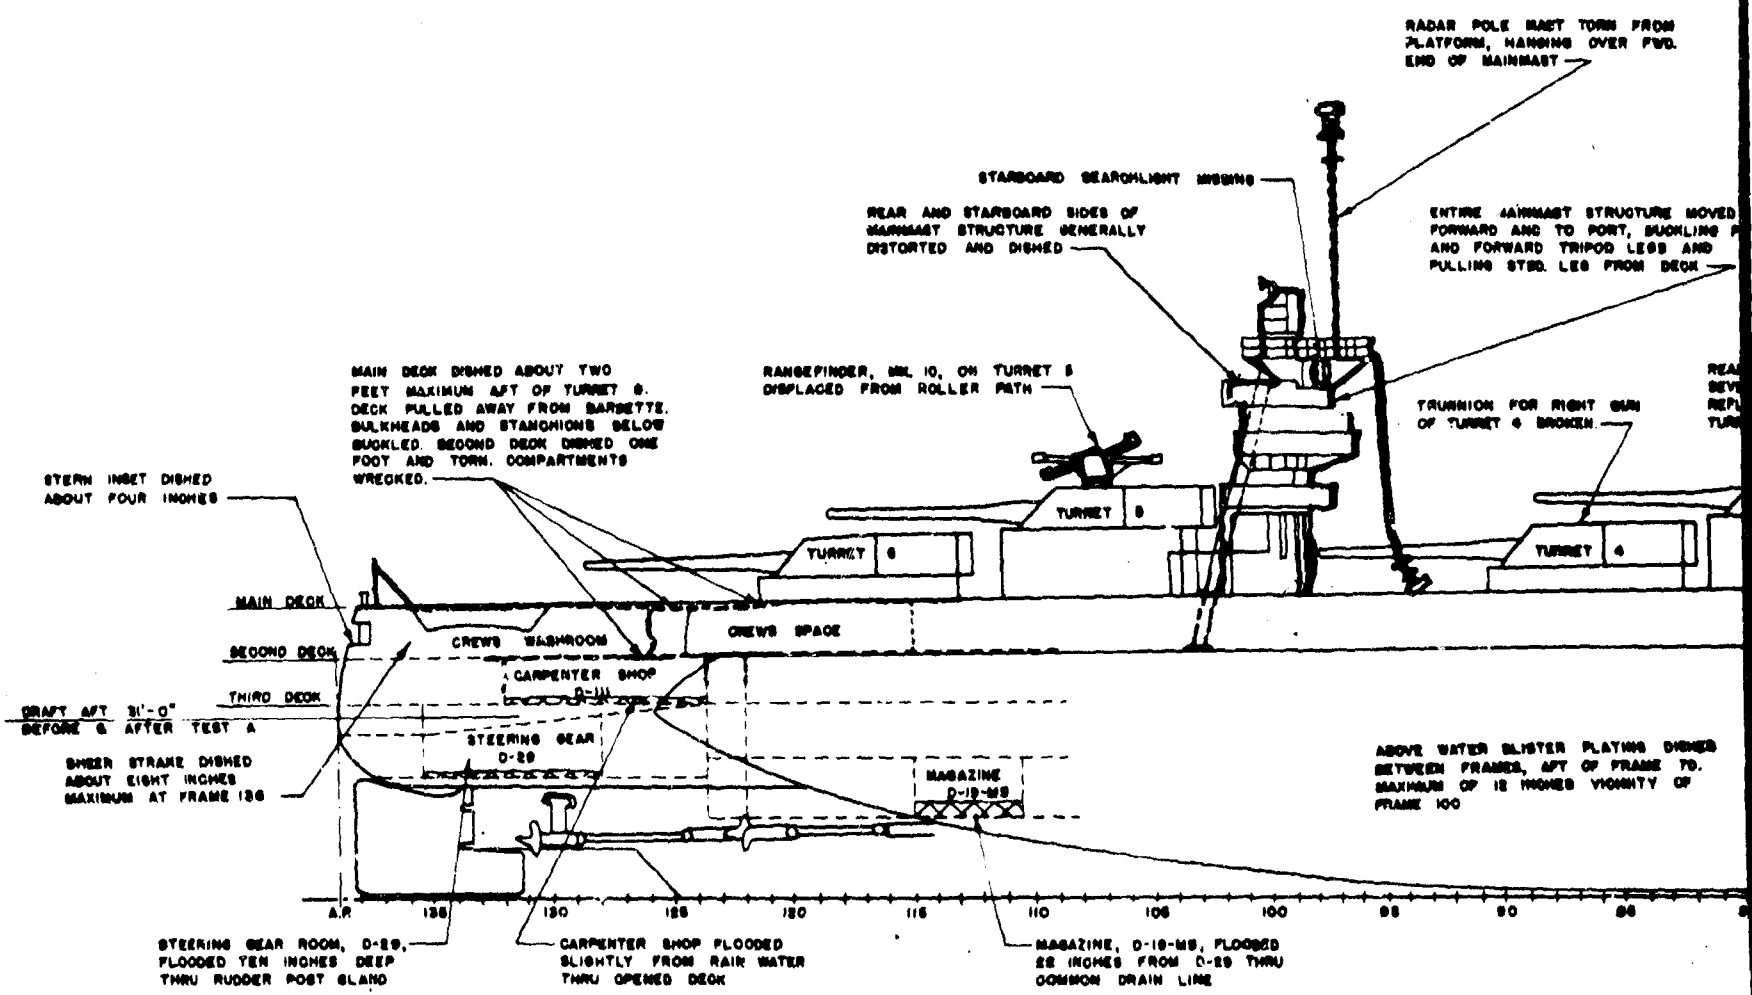
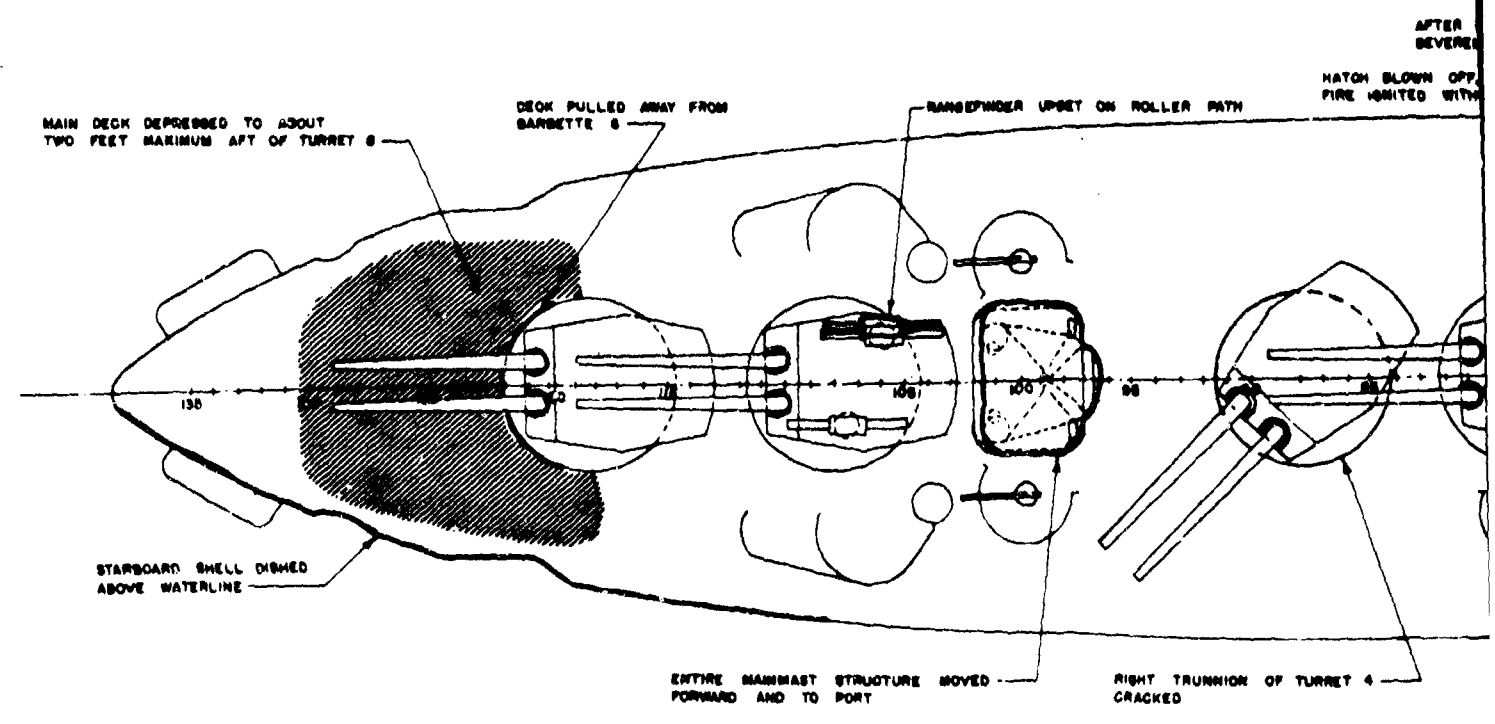
ADAR POLE MAST TORN FROM PLATFORM, HANGING OVER FWD. END OF MAINMAST

'66" RADAR MAST COLLAPSED TO PORT AND FORWARD

OVERHANGS BLOWN UPWARD AND DECKHOUSE SIDES SEVERELY DISHED

WATER BLISTER PLATING DISHED IN FRAMES, AFT OF FRAME 70. 18 OF 18 INCHES VIGNITY OF 100

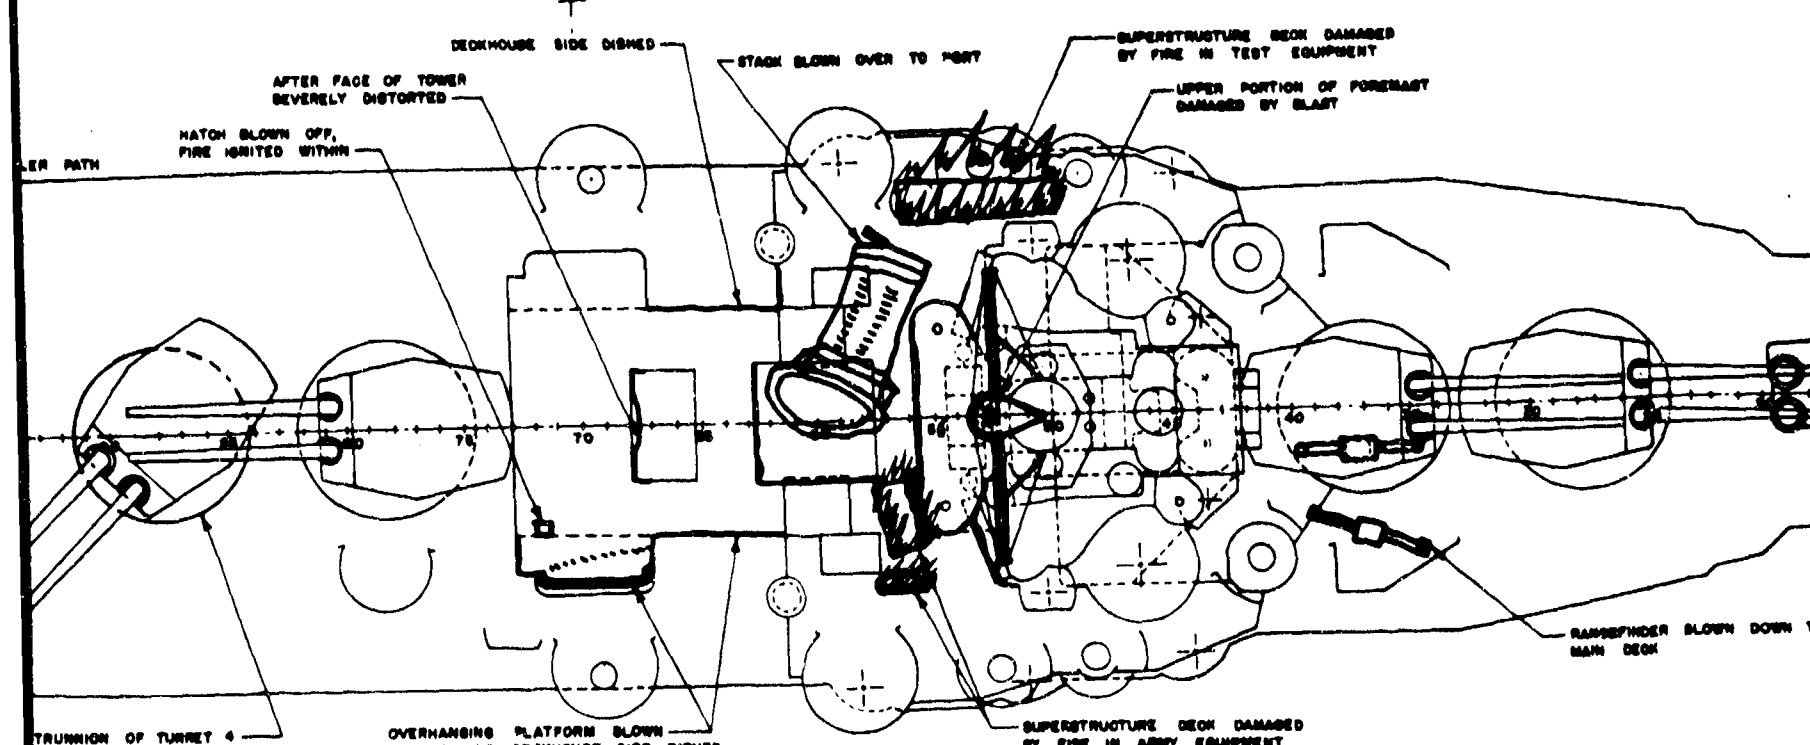
AFTER FACE OF TOWER SEVERELY DISTORTED

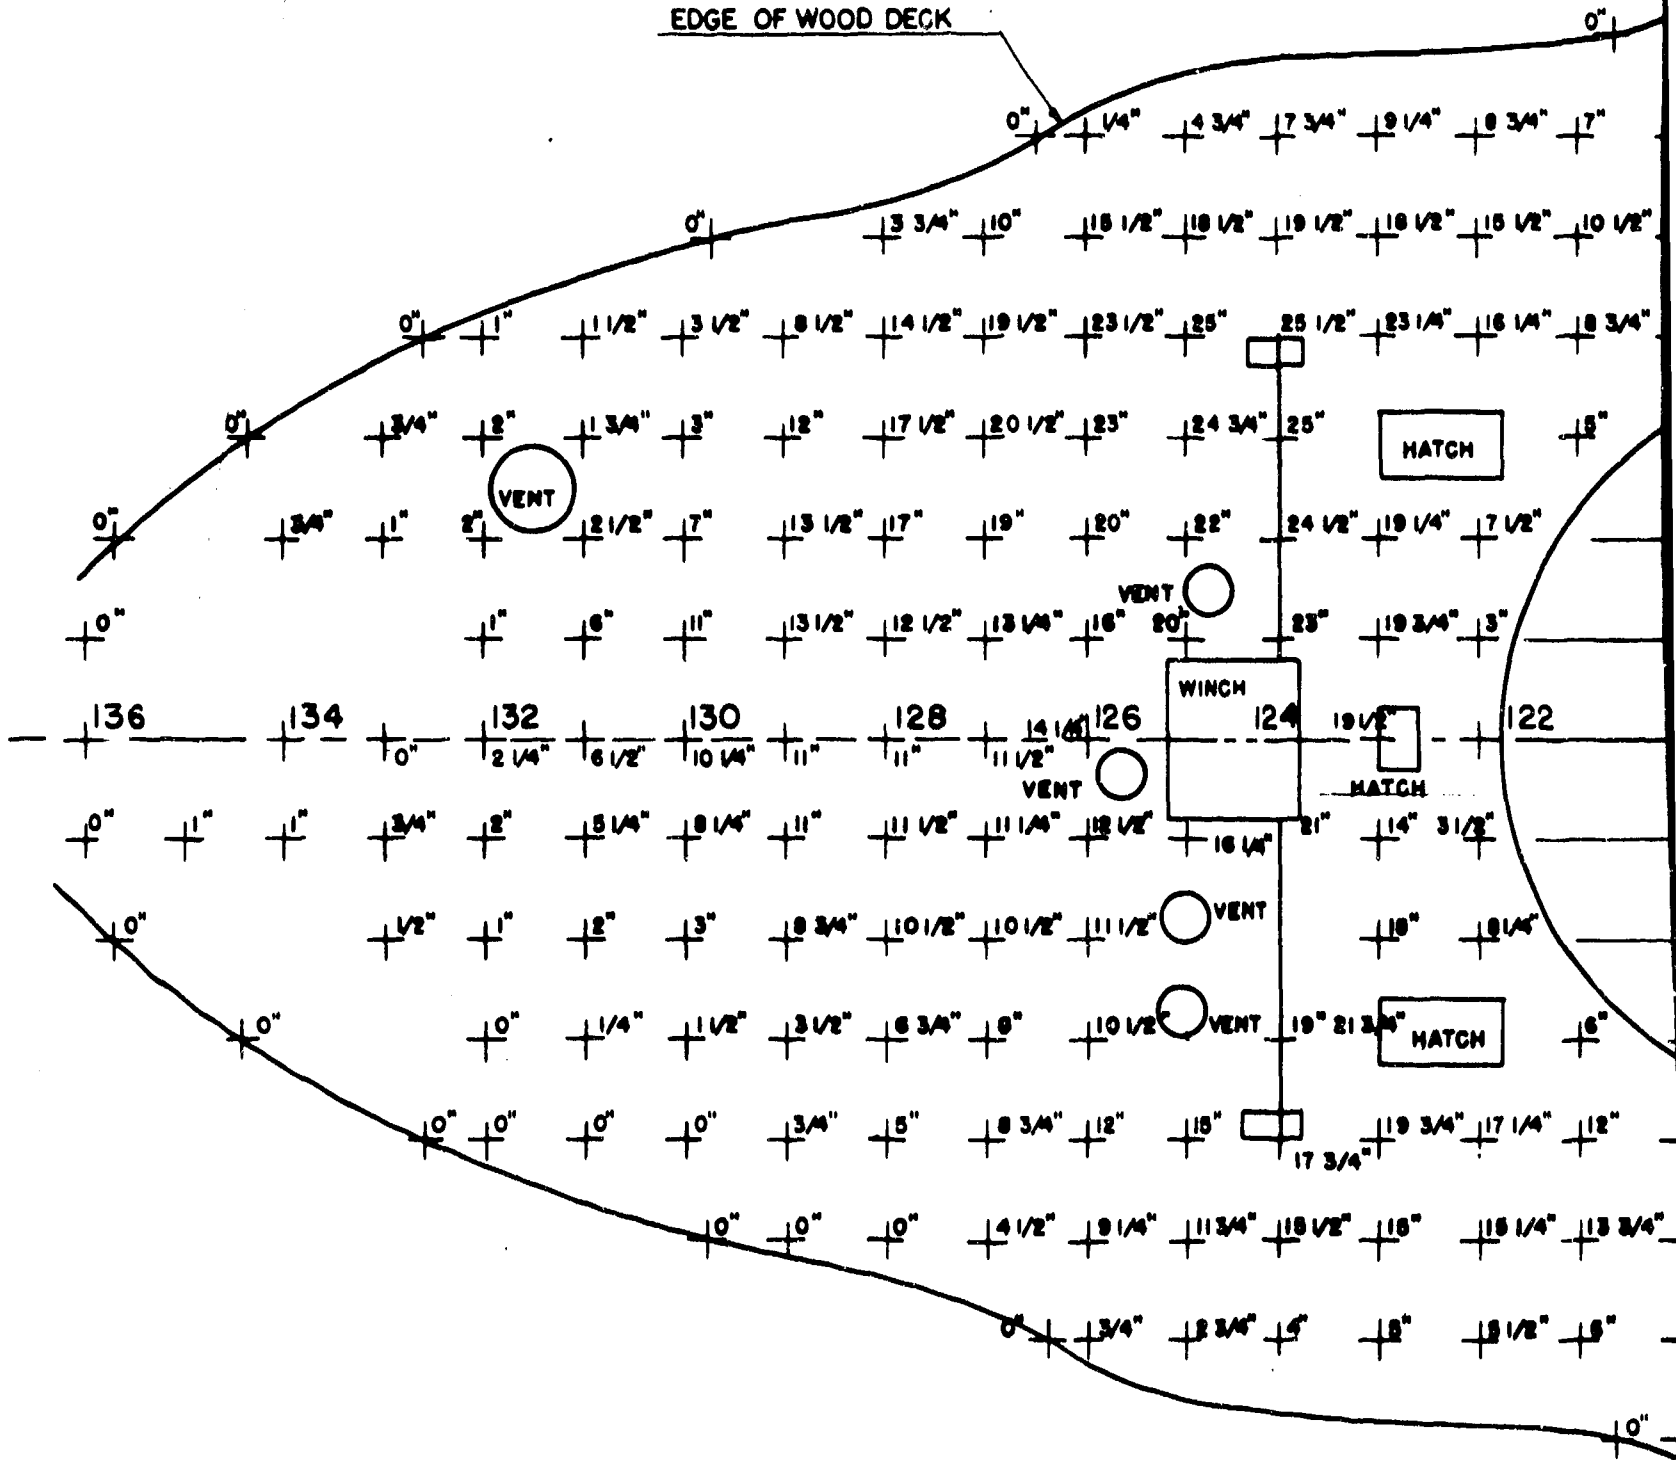
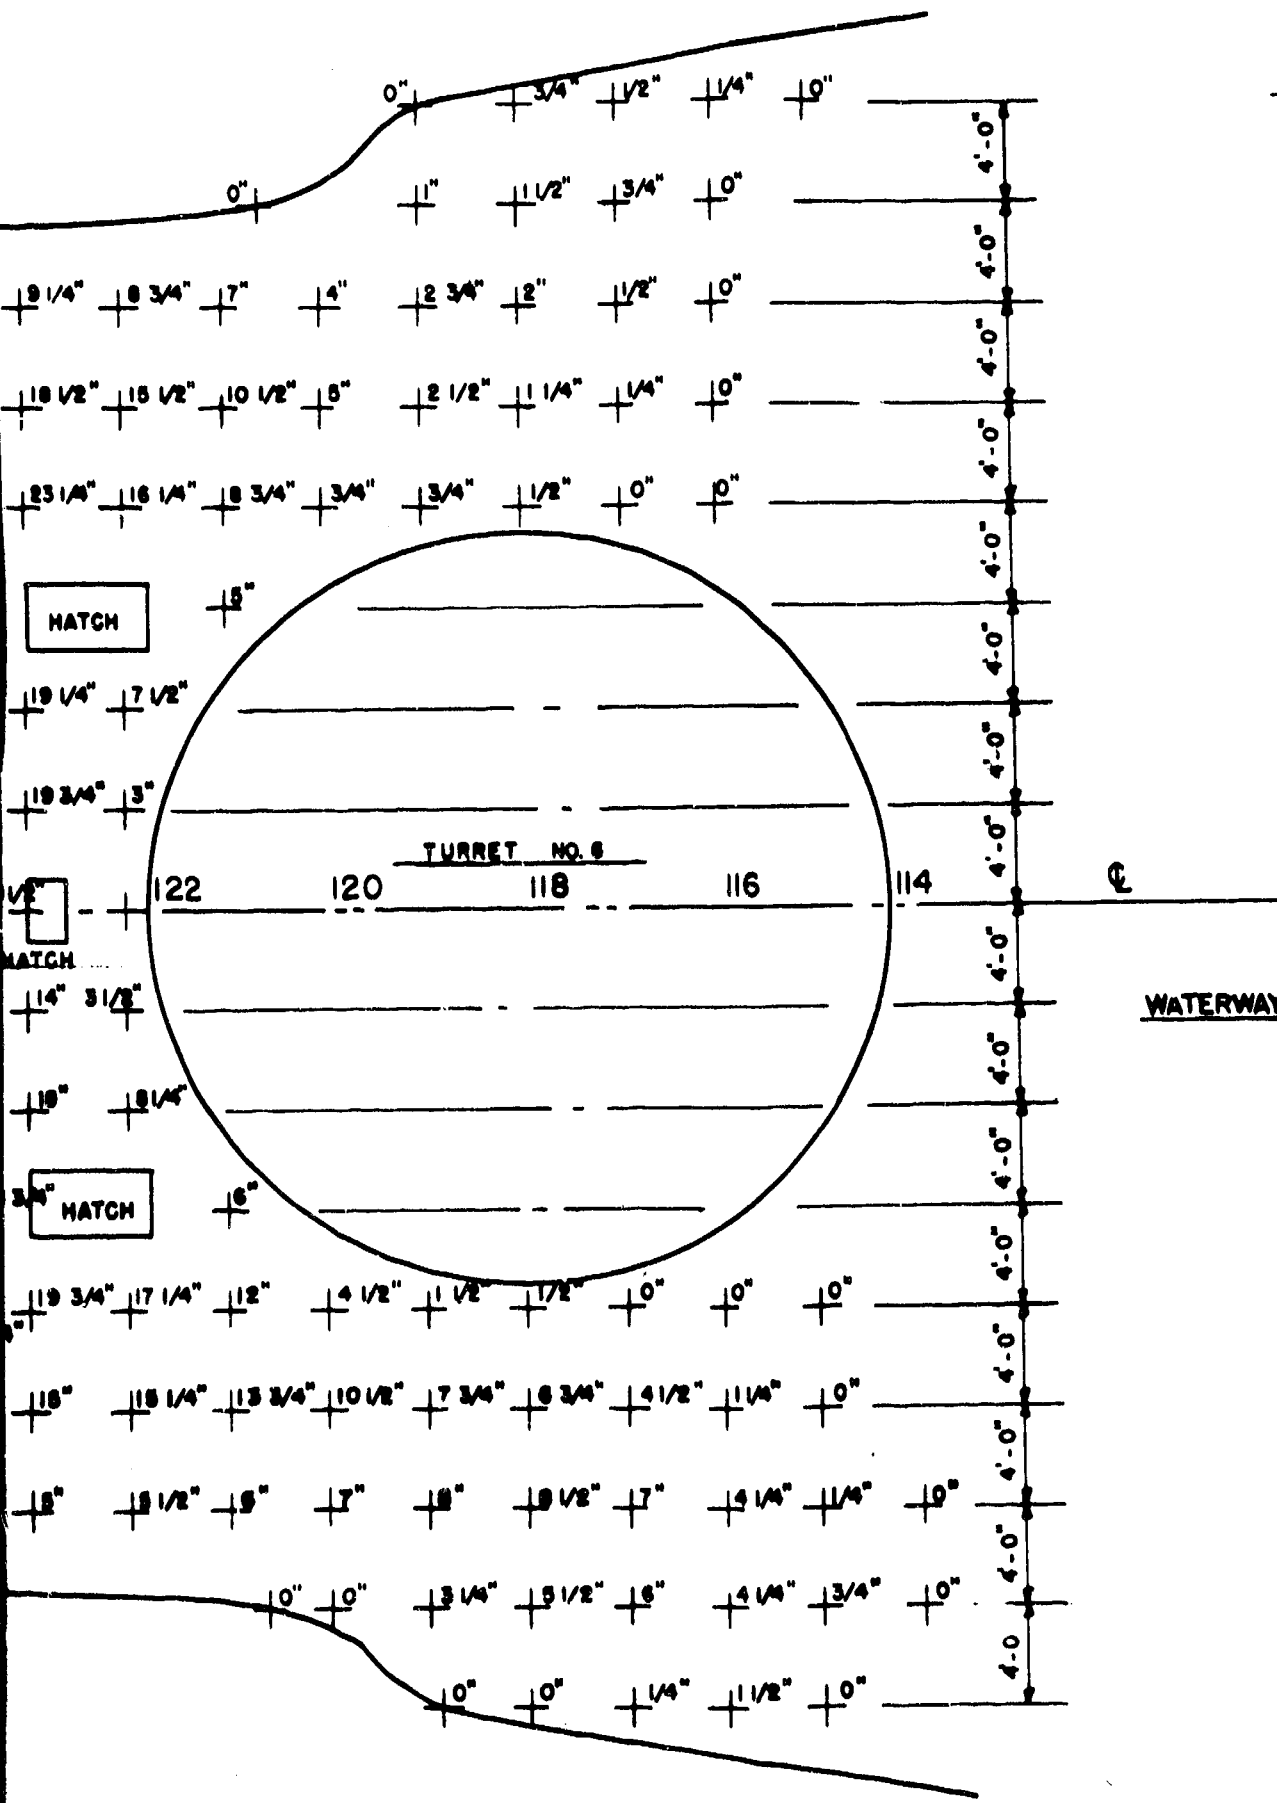
PLAN OF MAIN DECK

The main deck is undamaged from the bow to about frame 10 except for slight charring of the wood deck where exposed to the heat radiation. (Photo 2091-2, page 118). Between bulkhead 10 and bulkhead 18, the deck is deflected ~~downward~~ **downward** very slightly, the maximum deflection being about one inch at frame 14. The deck is also slightly deflected in the vicinity of frame 36. Between frames 40 and 61, the main deck is protected by the superstructure deck. The condition of the weather deck from frame 40 to 61 is discussed in Item B. Aft of frame 61 on the starboard side, the main deck is dished somewhat locally, particularly around access openings and over second deck passageways. (Photo 2090-1, page 119). The wood deck on the starboard side is slightly charred. The deck is deflected downward slightly between barbettes 3 and 4 (Photo 2090-2, page 120). Between frames 90 and 118 on the starboard side, the main deck is deflected downward to form a wrinkle about two inches deep, running fore and aft about eight feet inboard of the deck edge.
