TECHNICAL INSPECTION REPORT

U.S.S. NEW YORK (BB34)

TEST ABLE

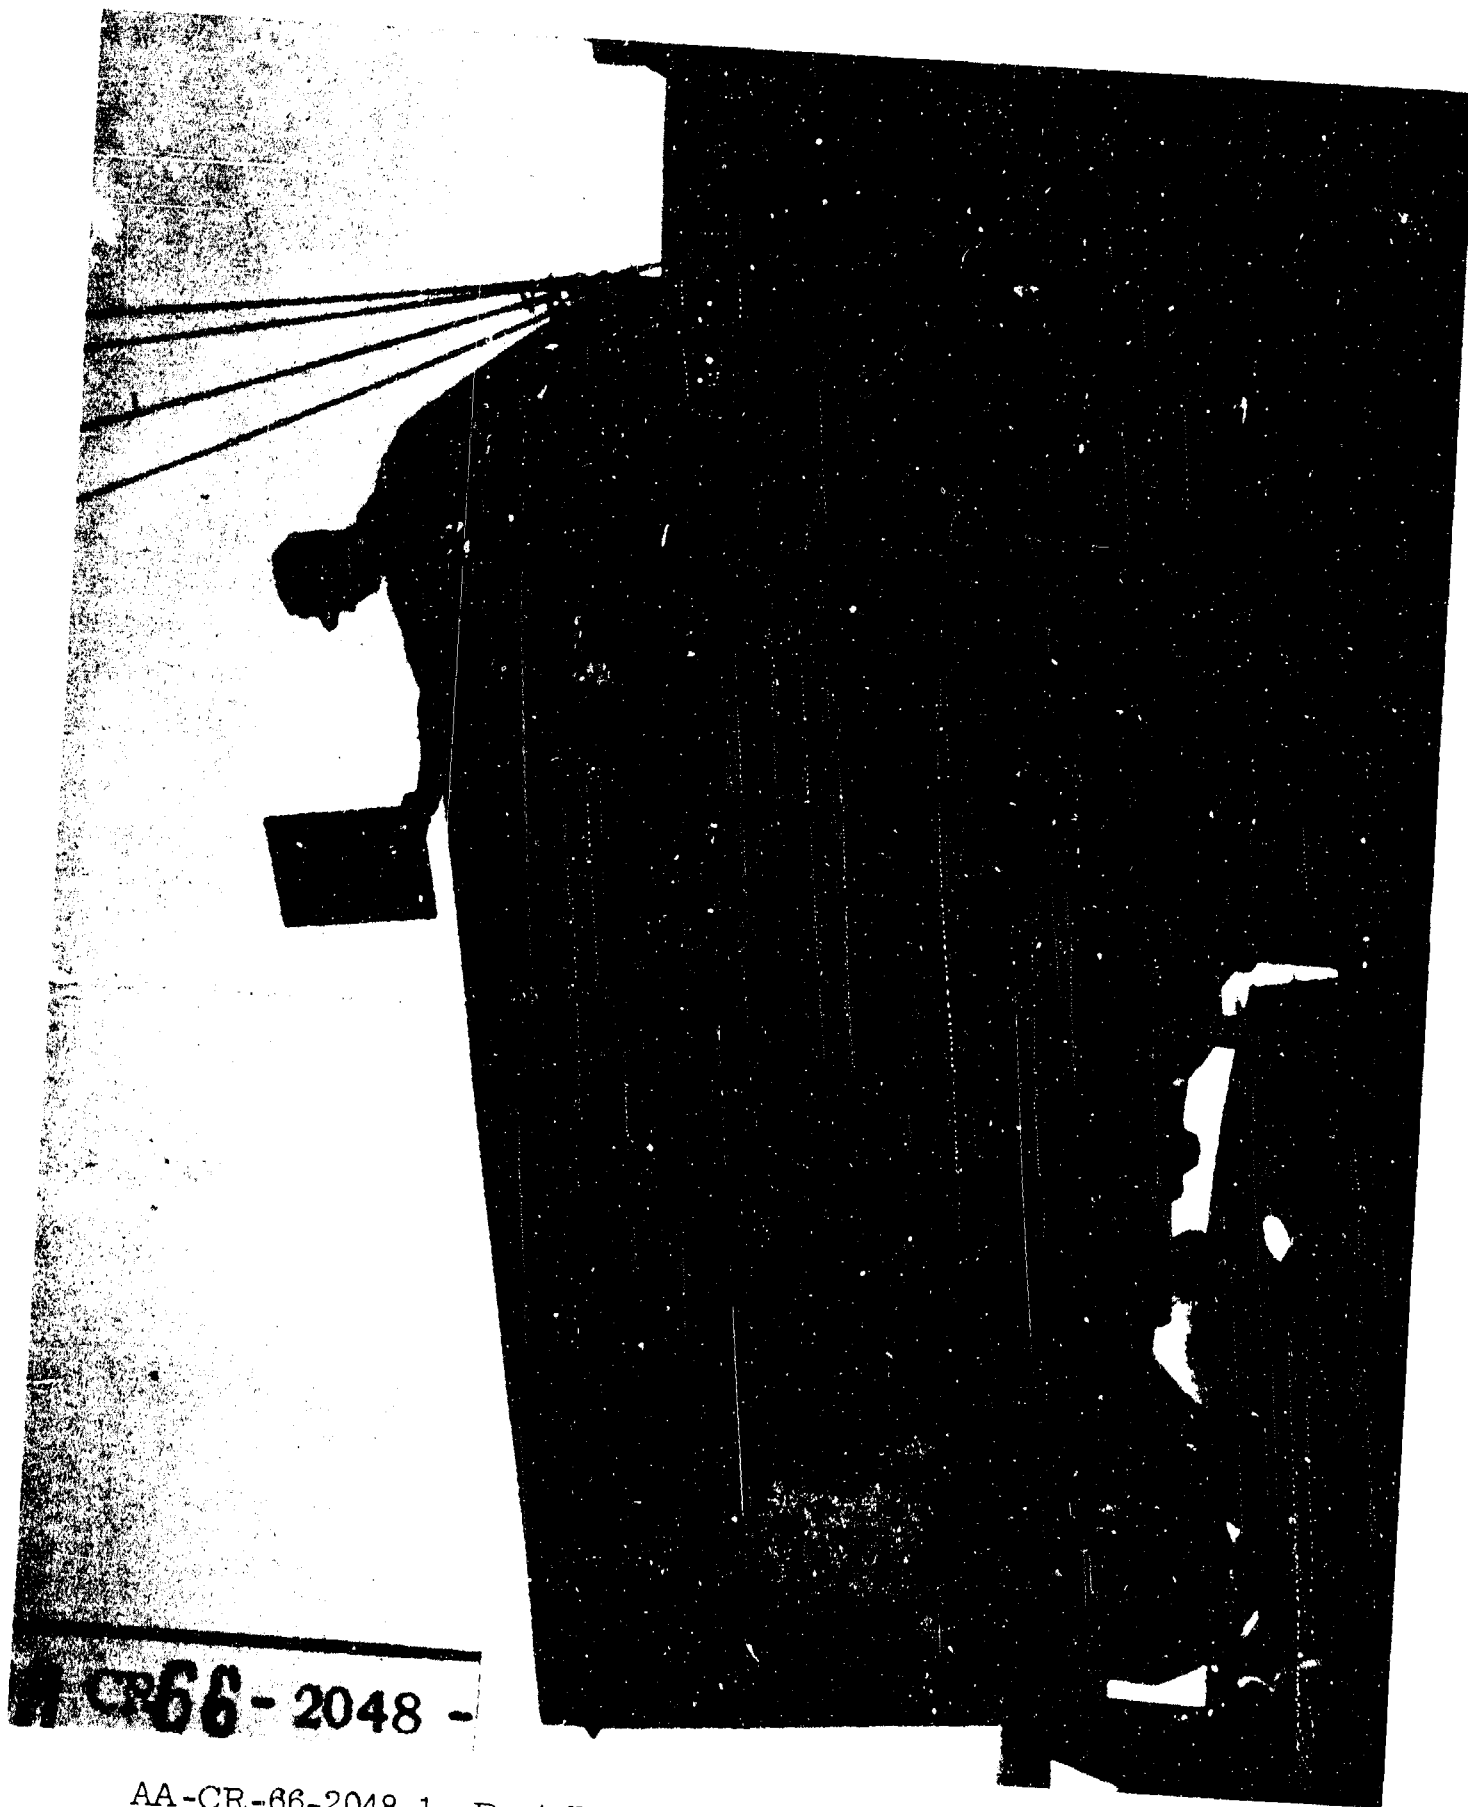
2. A second fire began in the port flag bag on the signal bridge and spread to Army Quartermaster equipment on the deck below when burning flags fell on the equipment. The flag bag was not covered at the time of the test. Foreign matter in considerable quantity was found in the bottom of the flag bag. These pieces had been highly oxidized and appear to be composed of porous carbon with burned fragments of flags adhering to them. Photographs illustrating the damage to flag bag and deck are 2048-1, 2, 3, 8; 2047-9, 1811-4; pages 57 , 65 , 66 , 58 , 59 , and 67 .

AA-CR-66-2048-1. Port flag bag, showing heat and blast damage.

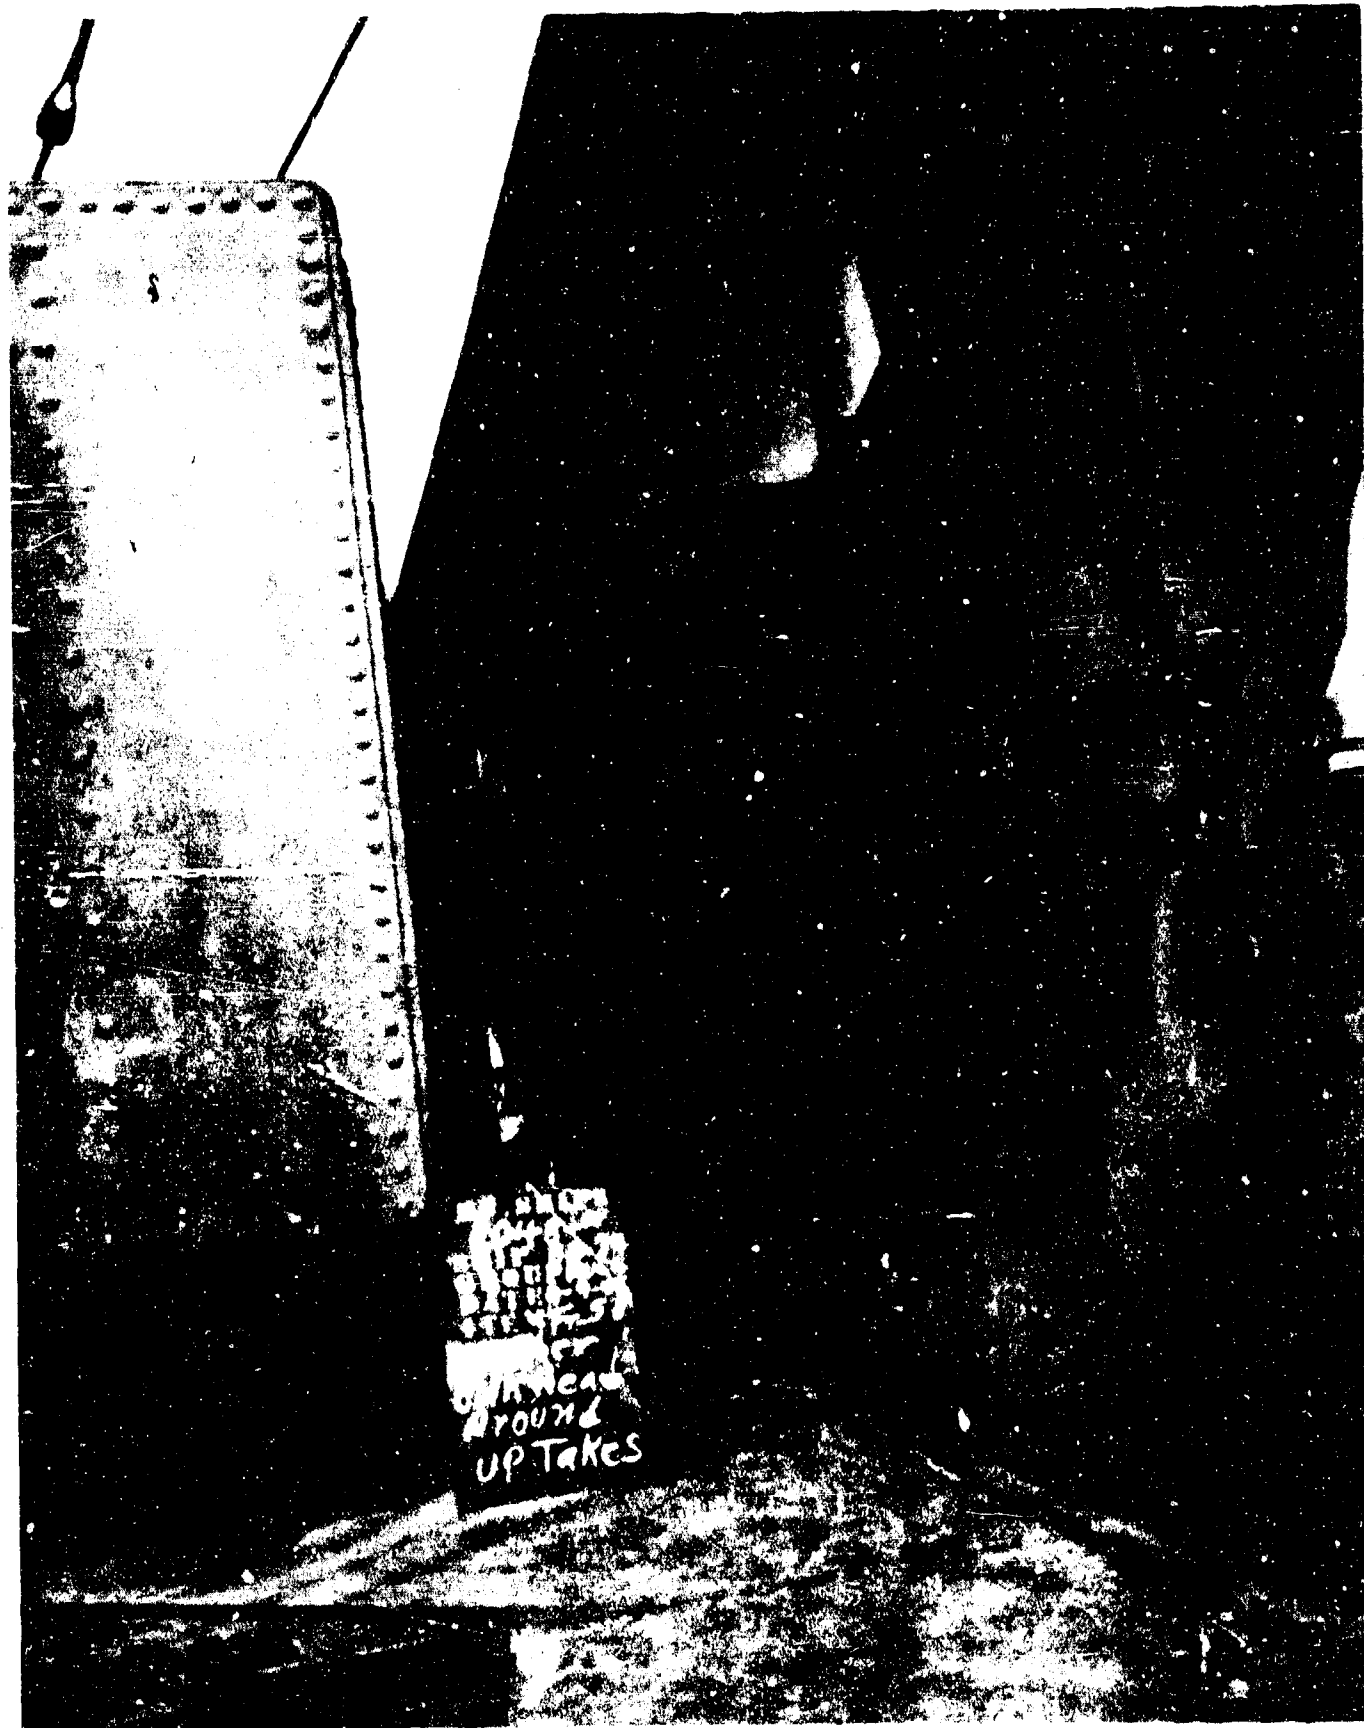
AA-CR-66-2048-9. Forward bulkhead of uptake enclosure, showing blast damage.

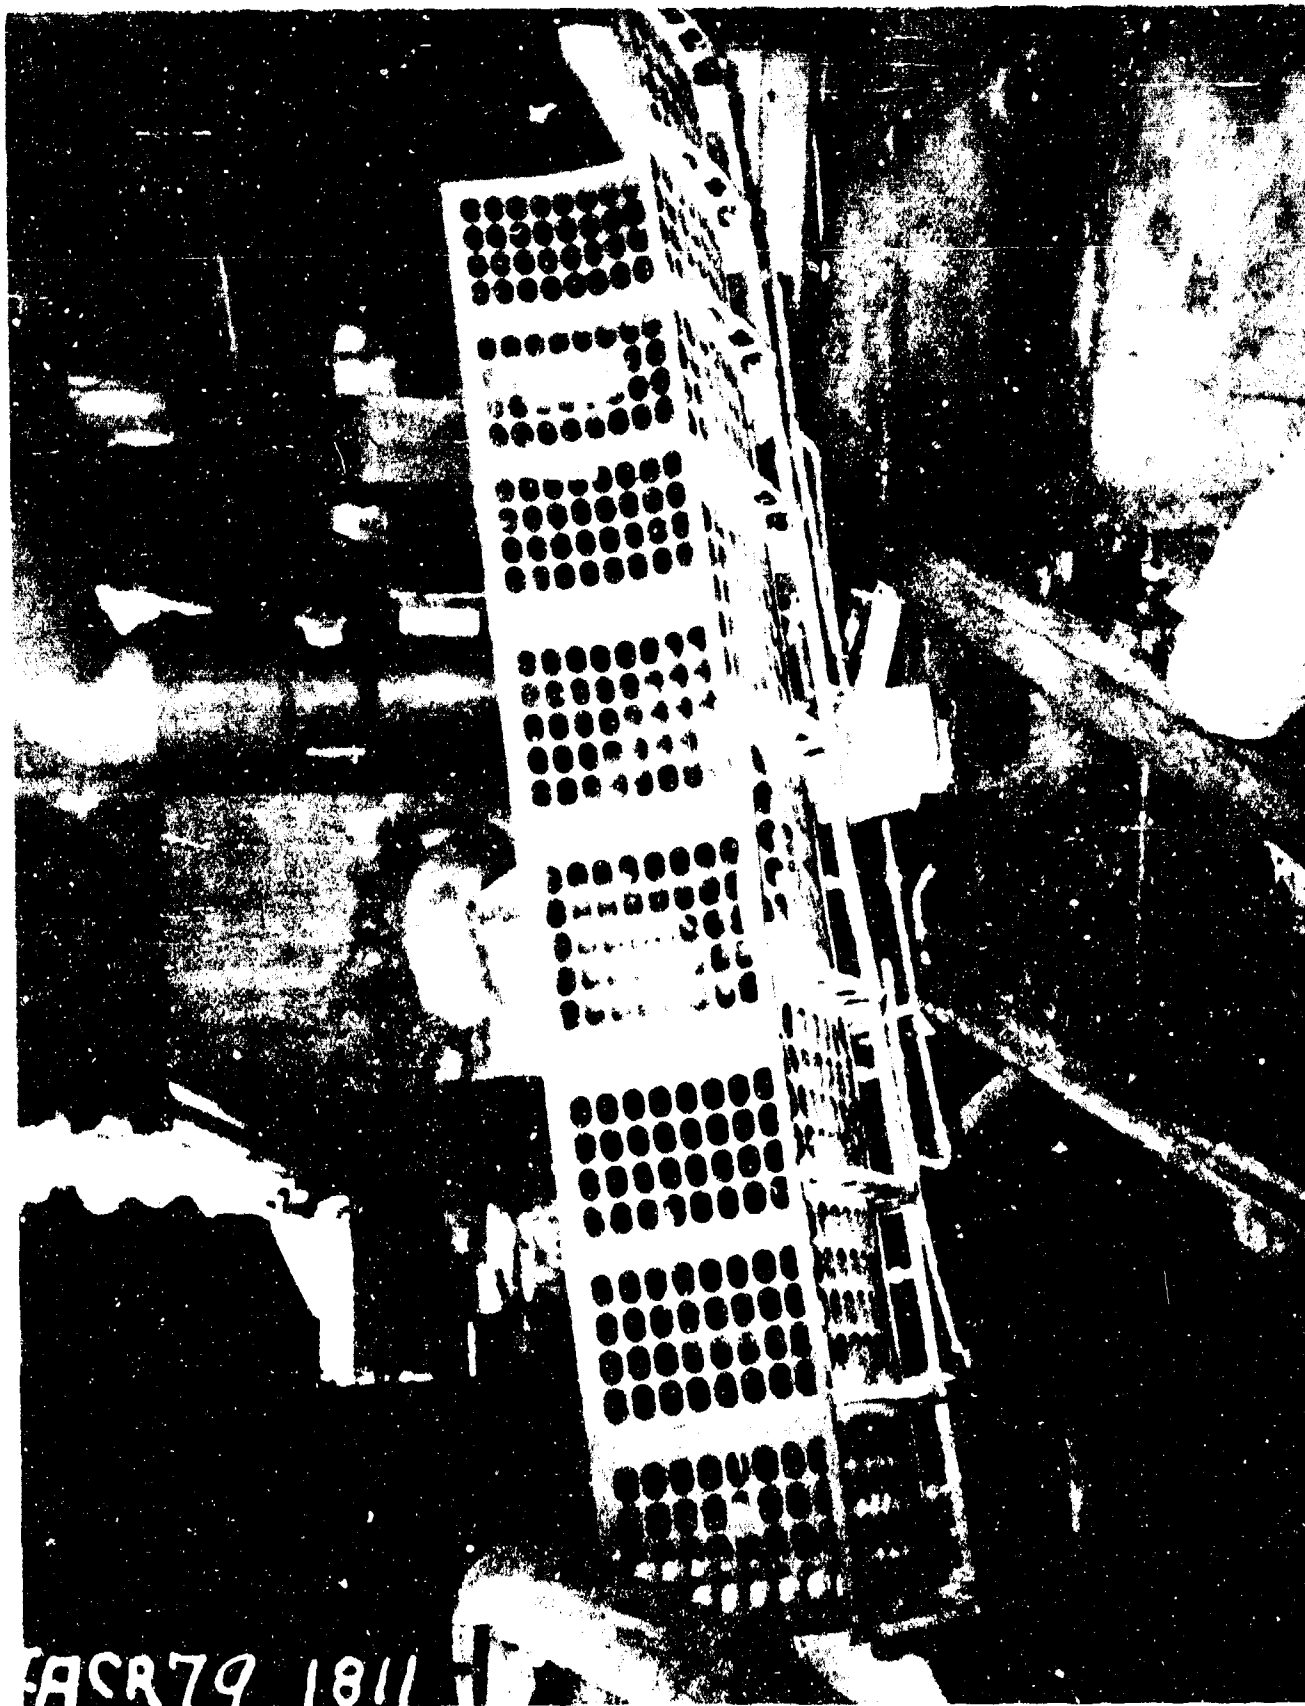
AA-CR-79-1811-5. Looking forward on port side of superstructure deck level from frame 76 showing radar array from top of main battery control station fallen at frame 72.
