# BUREAU OF SHIPS GROUP

## TECHNICAL INSPECTION REPORT

### U.S.S. PENNSYLVANIA (BB38)

#### OPERATION CROSSROADS

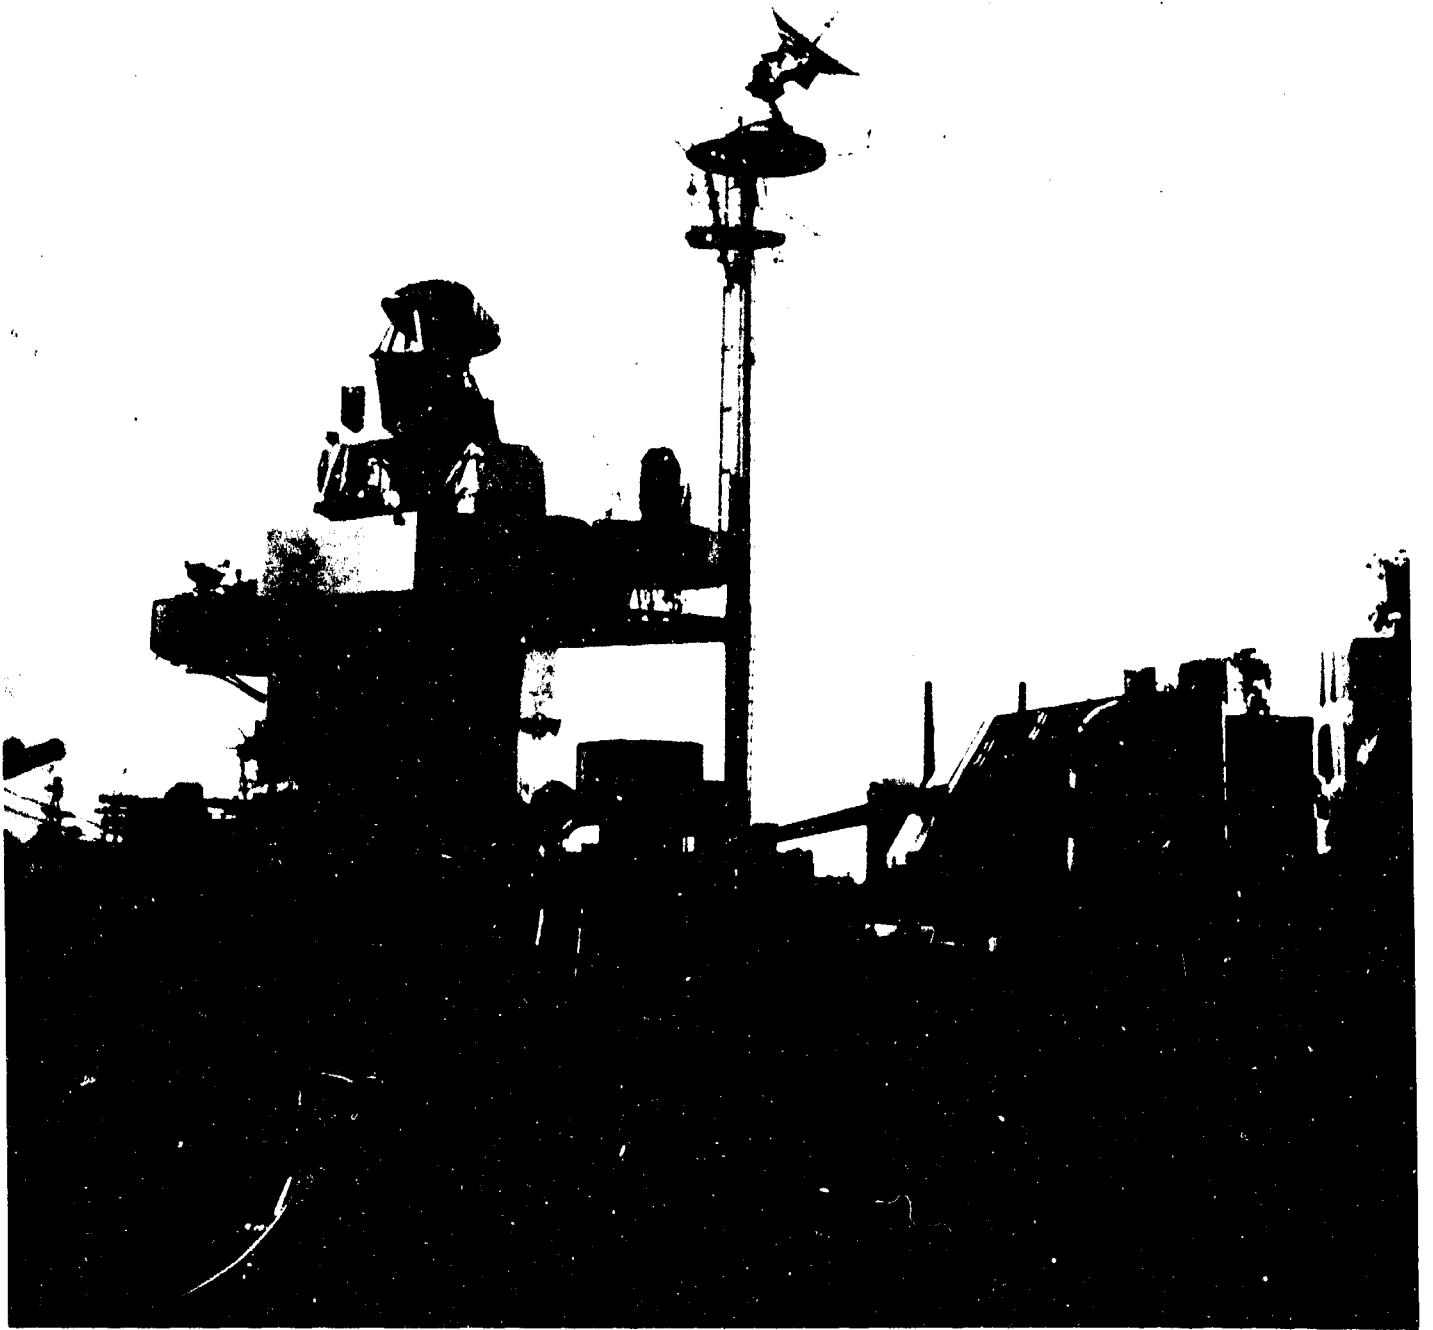
AA-CR-62-1831-3. Looking at mainmast area, frame 85, starboard side.
