TECHNICAL INSPECTION REPORT

NAGATO (Ex-Jap BB)

TEST ABLE

OPERATION CROSSROADS

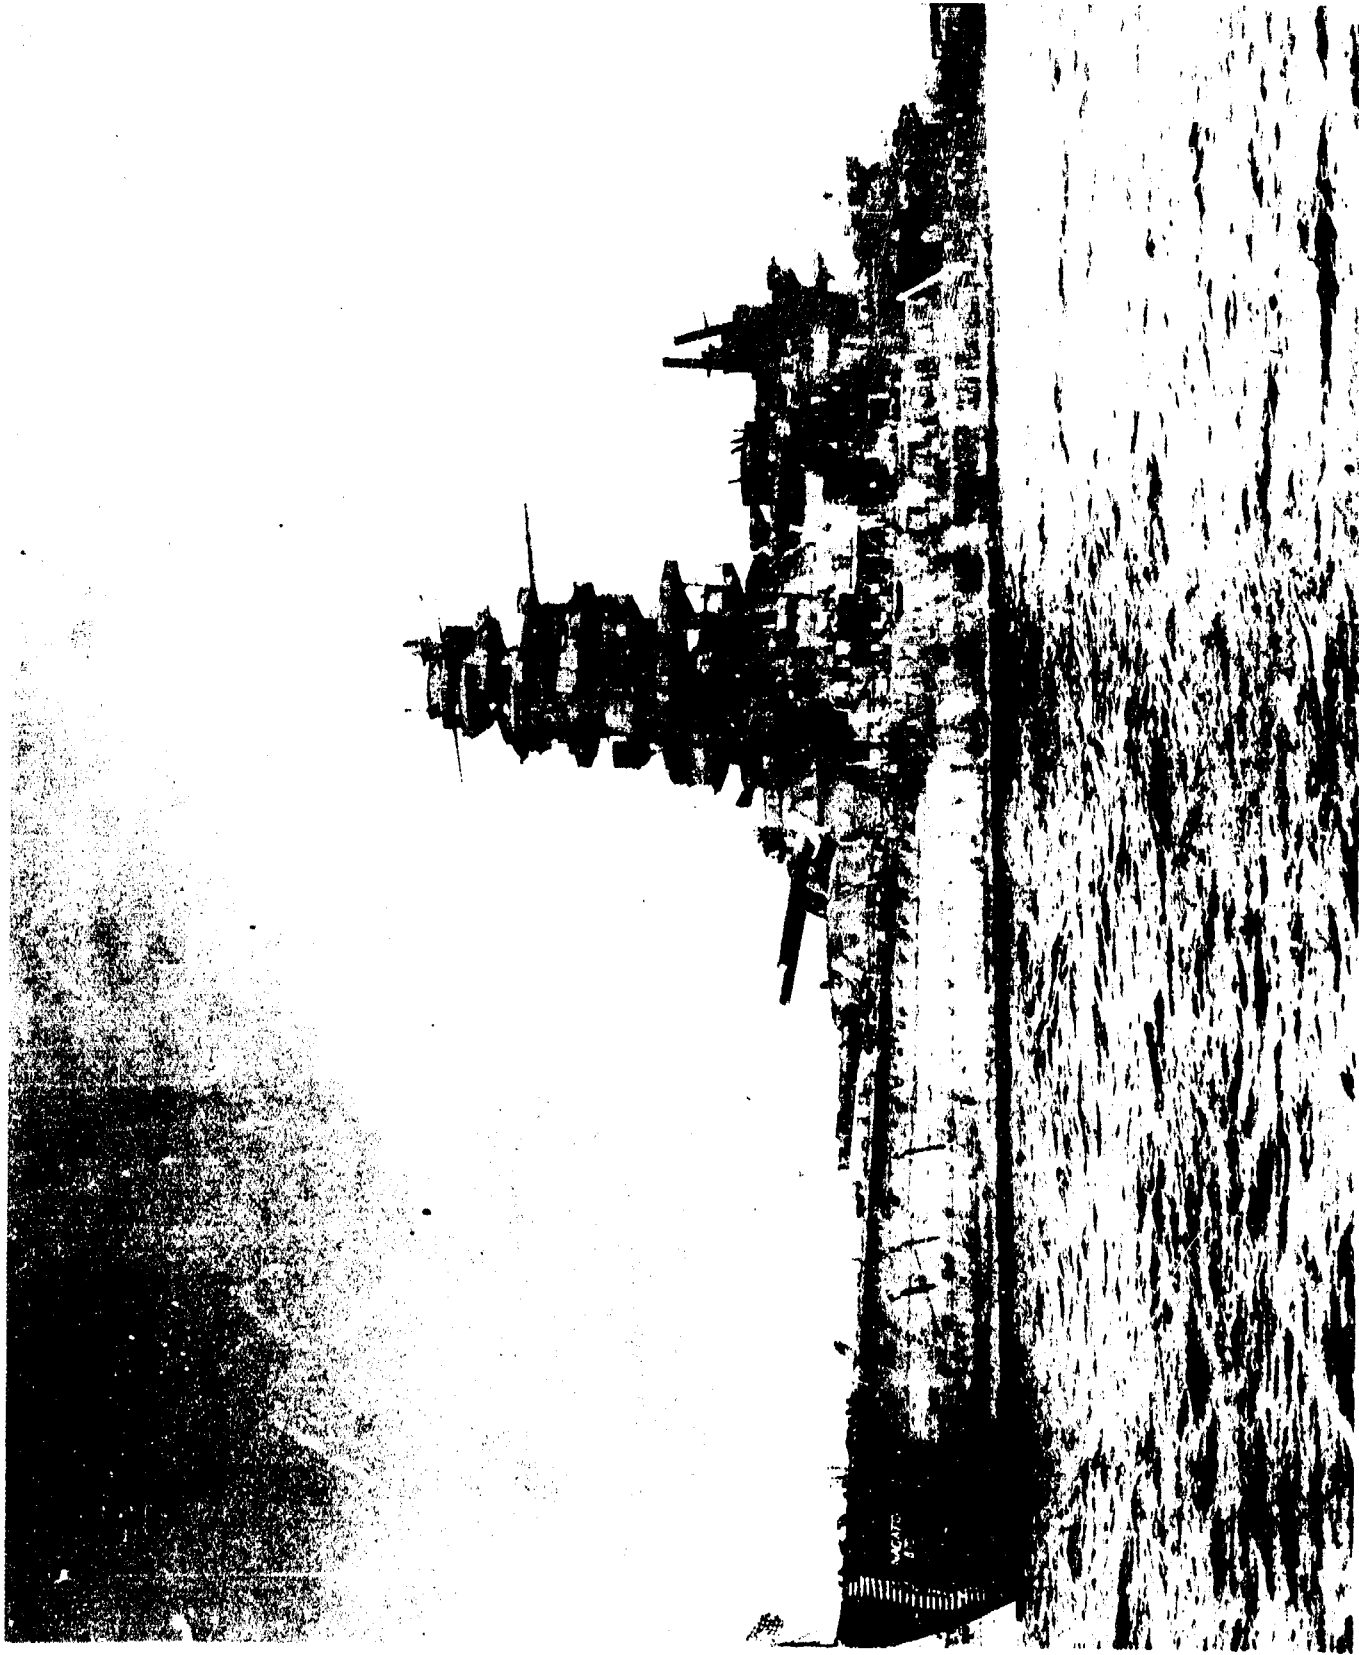
BB-CR-227-513-6. View from off port bow after Test A.

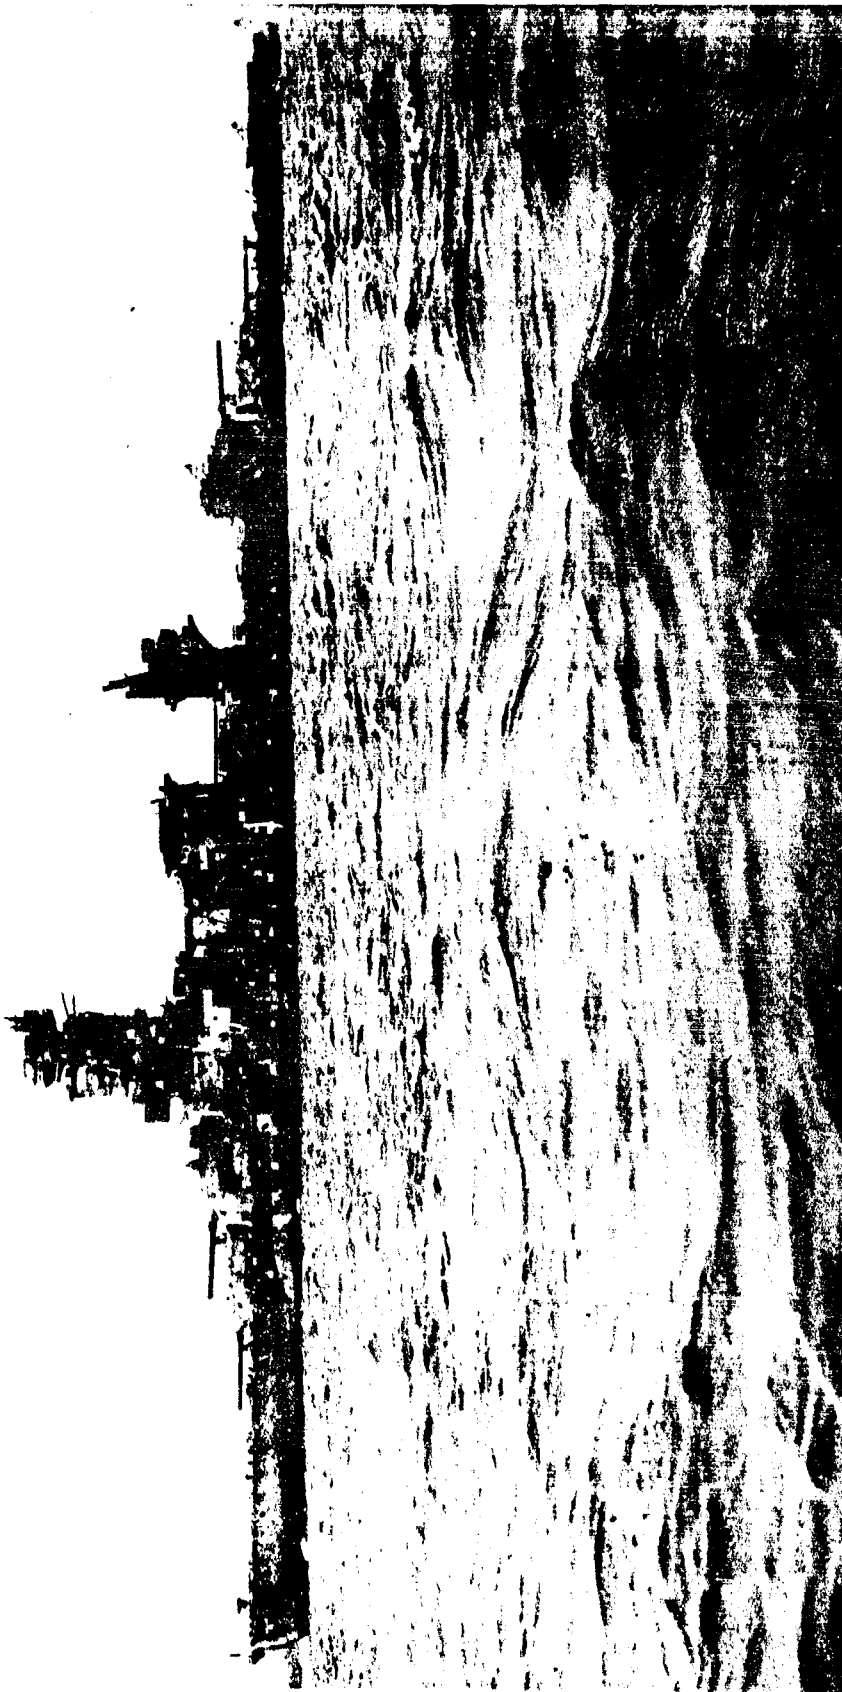
AA-CR-227-91-37. View from off port beam after Test A.

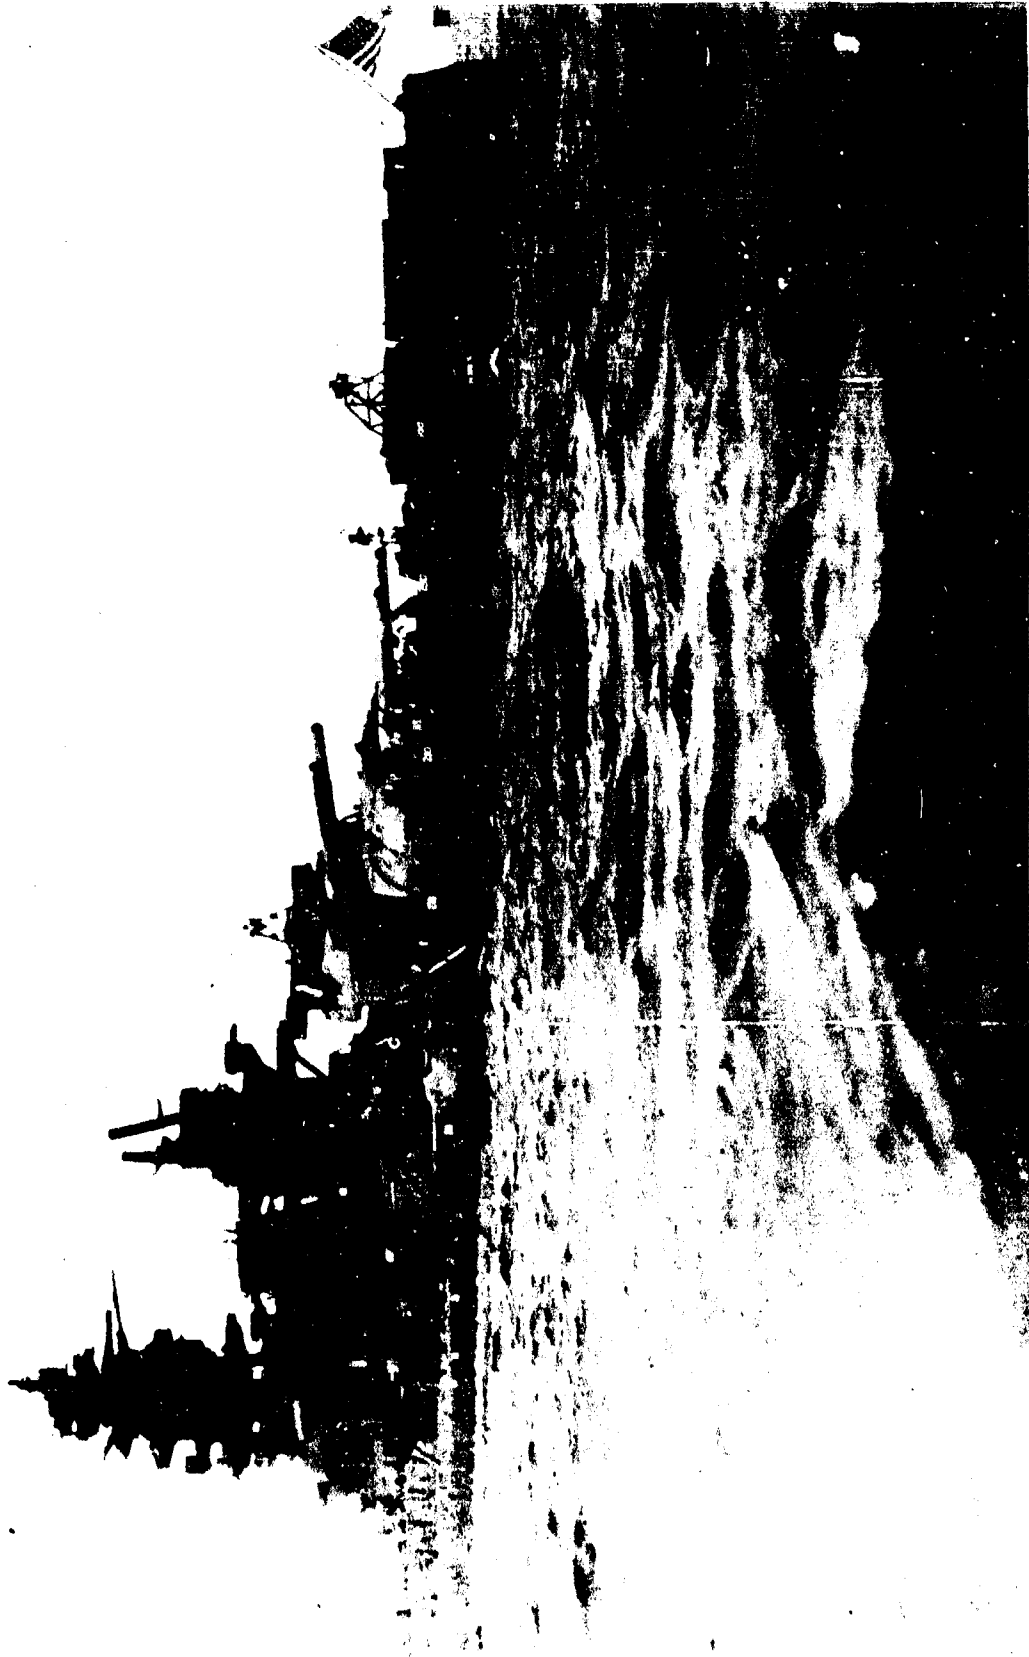
AA-CR-227-91-30. View from off port quarter after Test A.

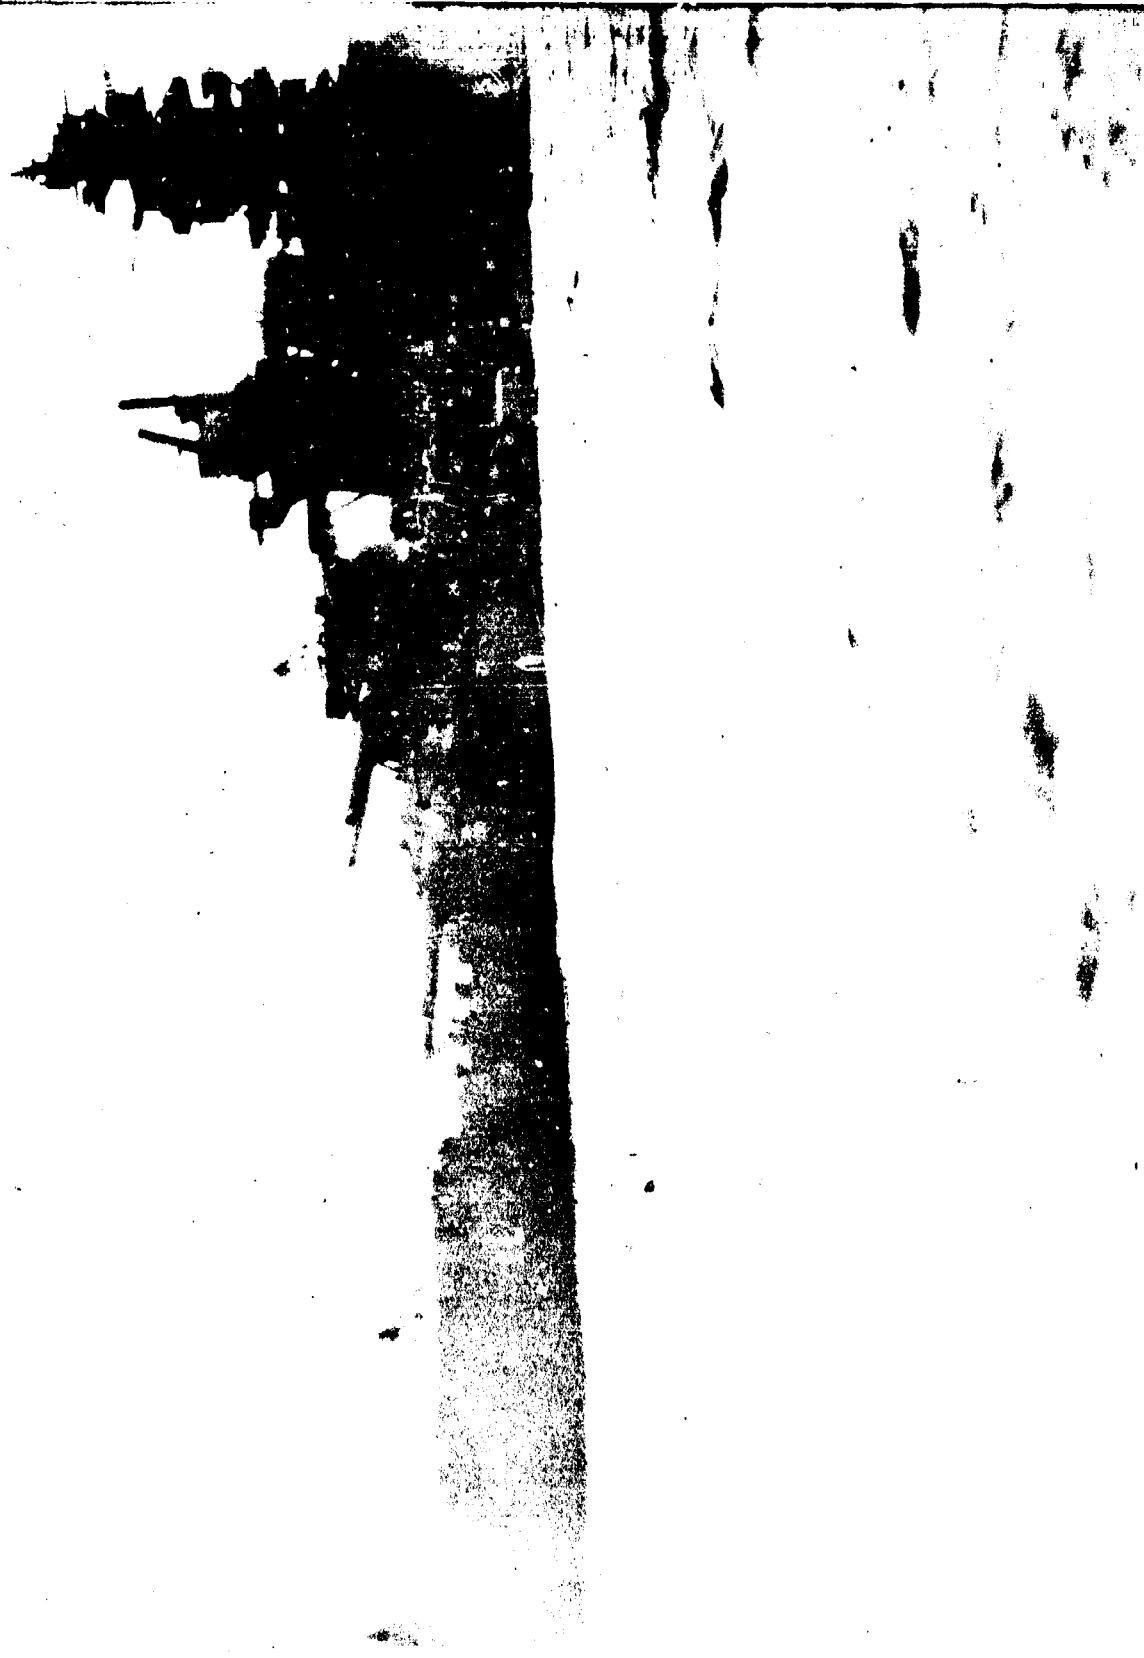
AA-CR-227-91-32. View from off starboard quarter after Test A.

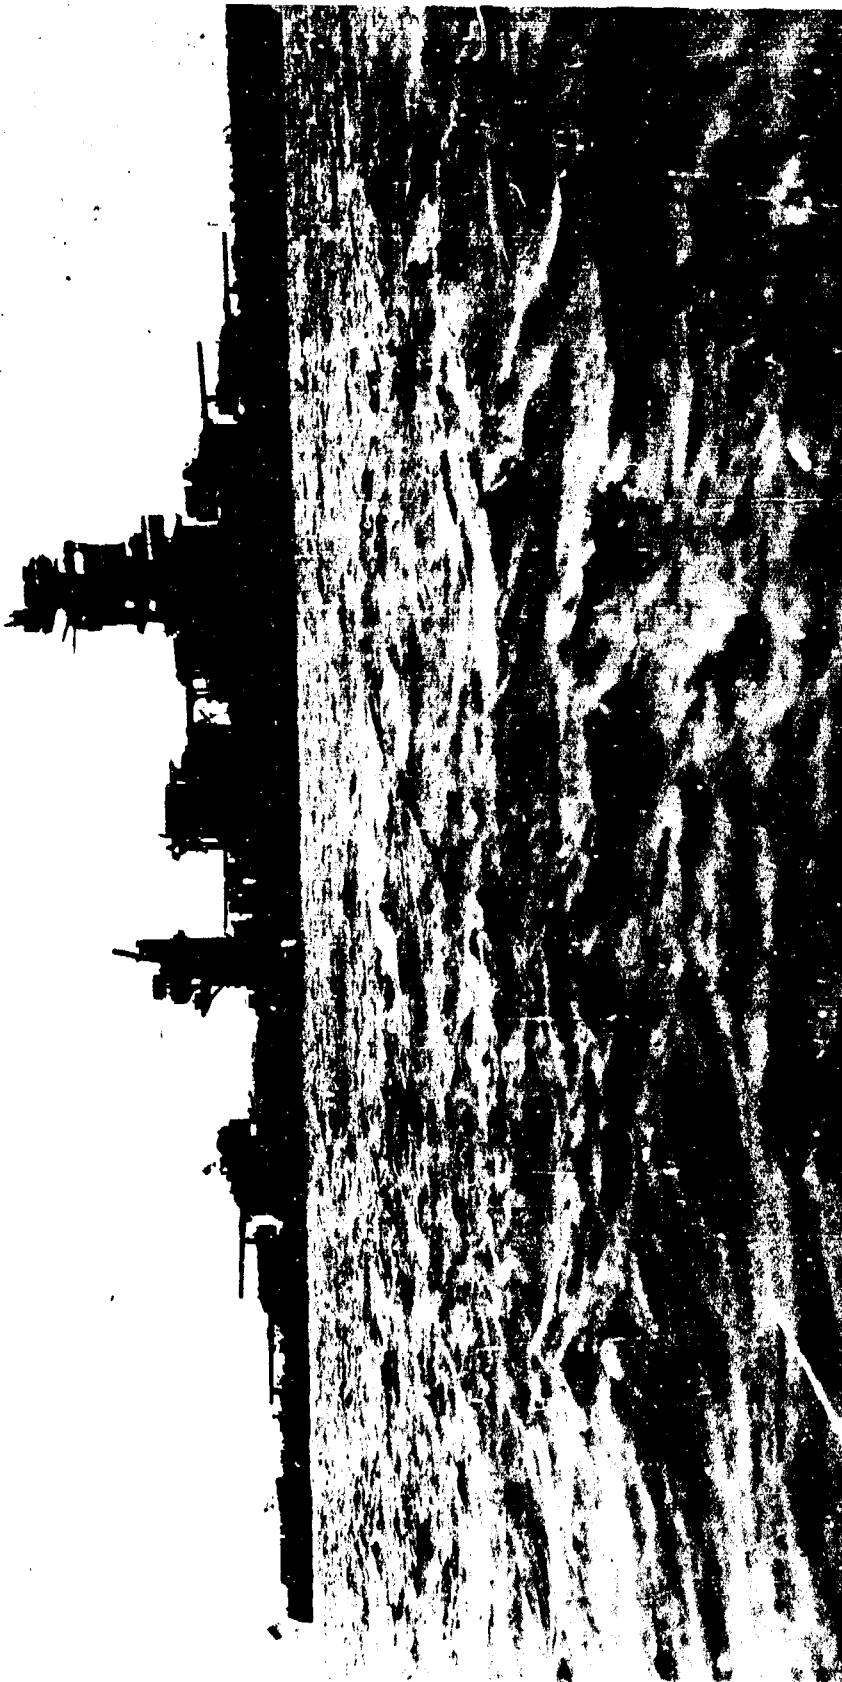
AA-CR-227-91-33. View from off starboard beam after Test A.

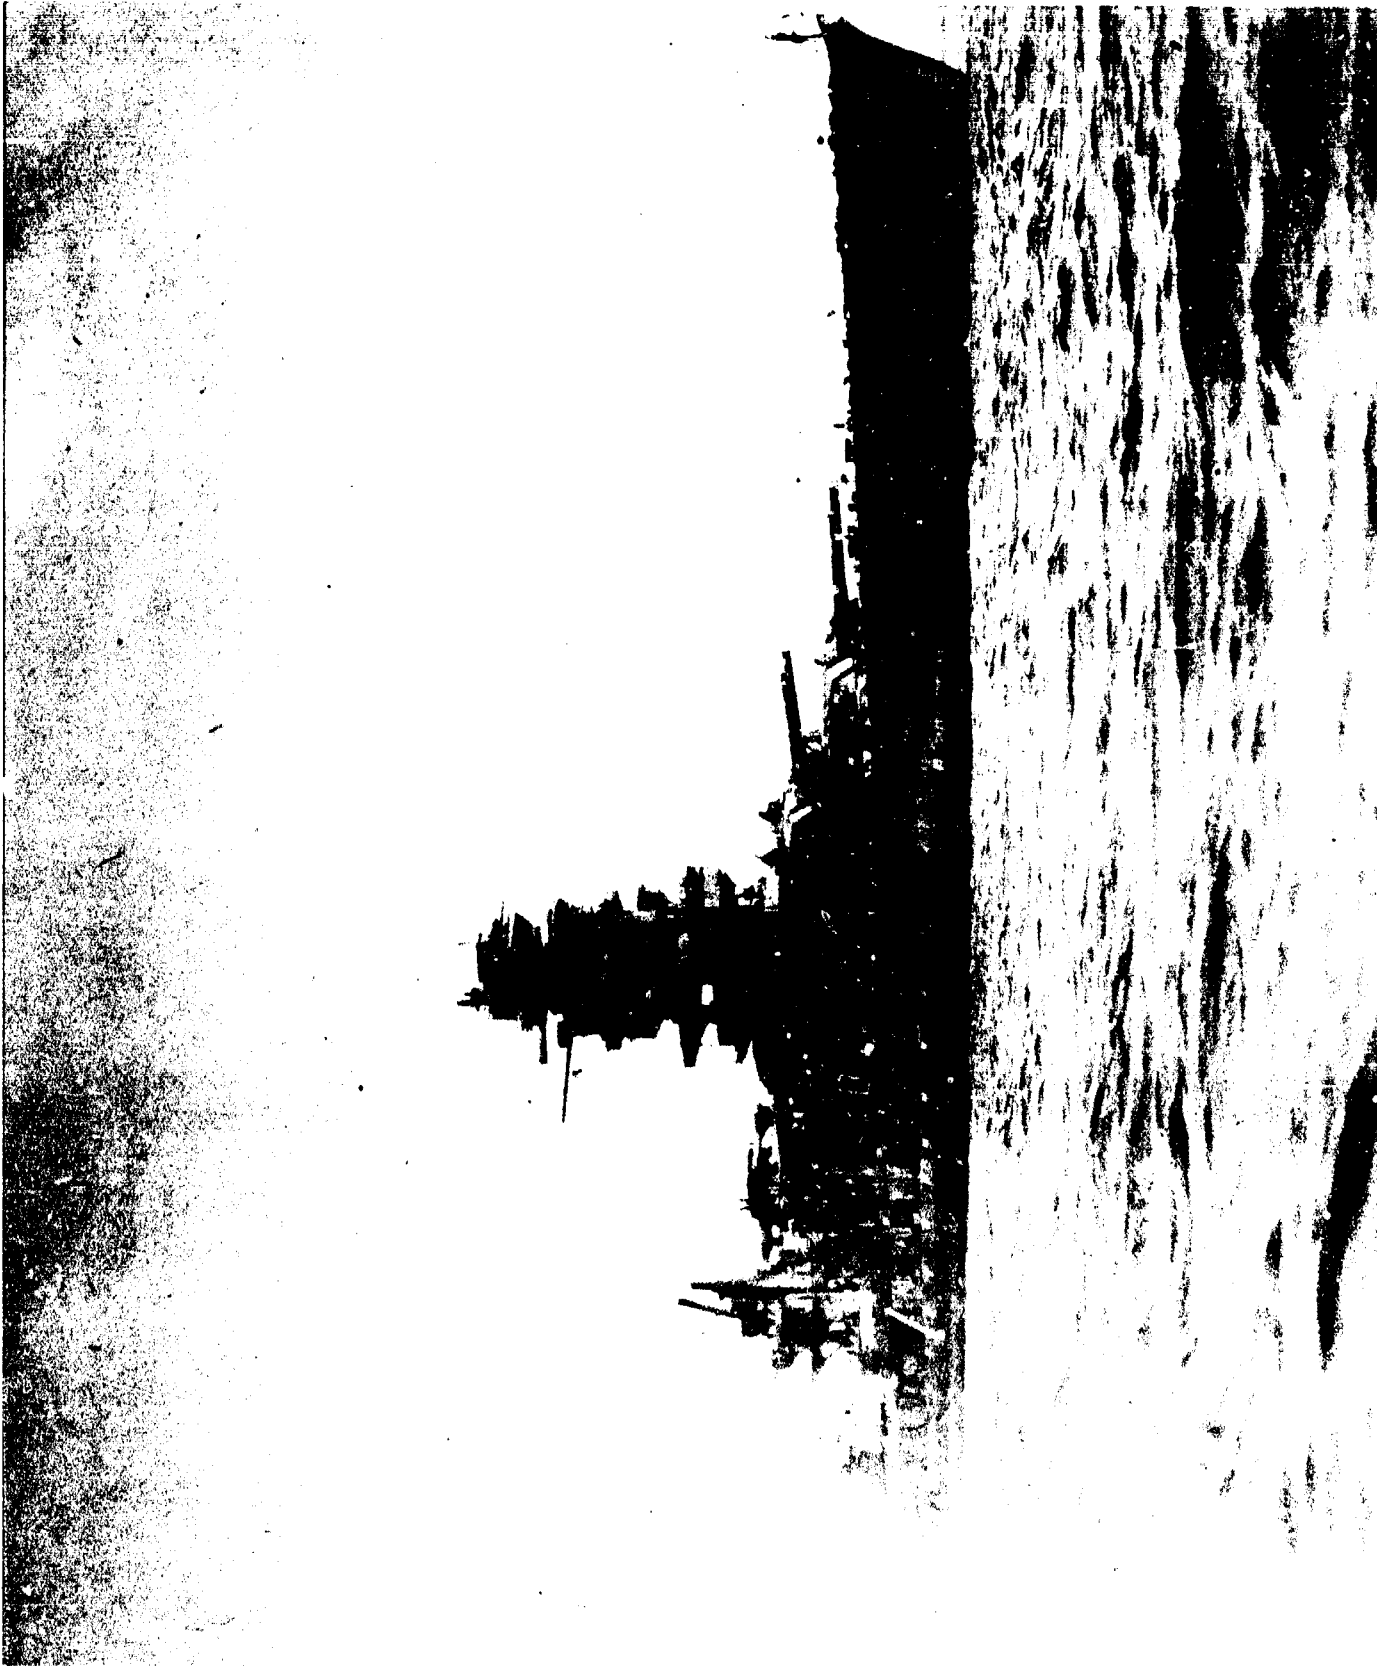
AA-CR-227-91-34. View from off starboard bow after Test A.

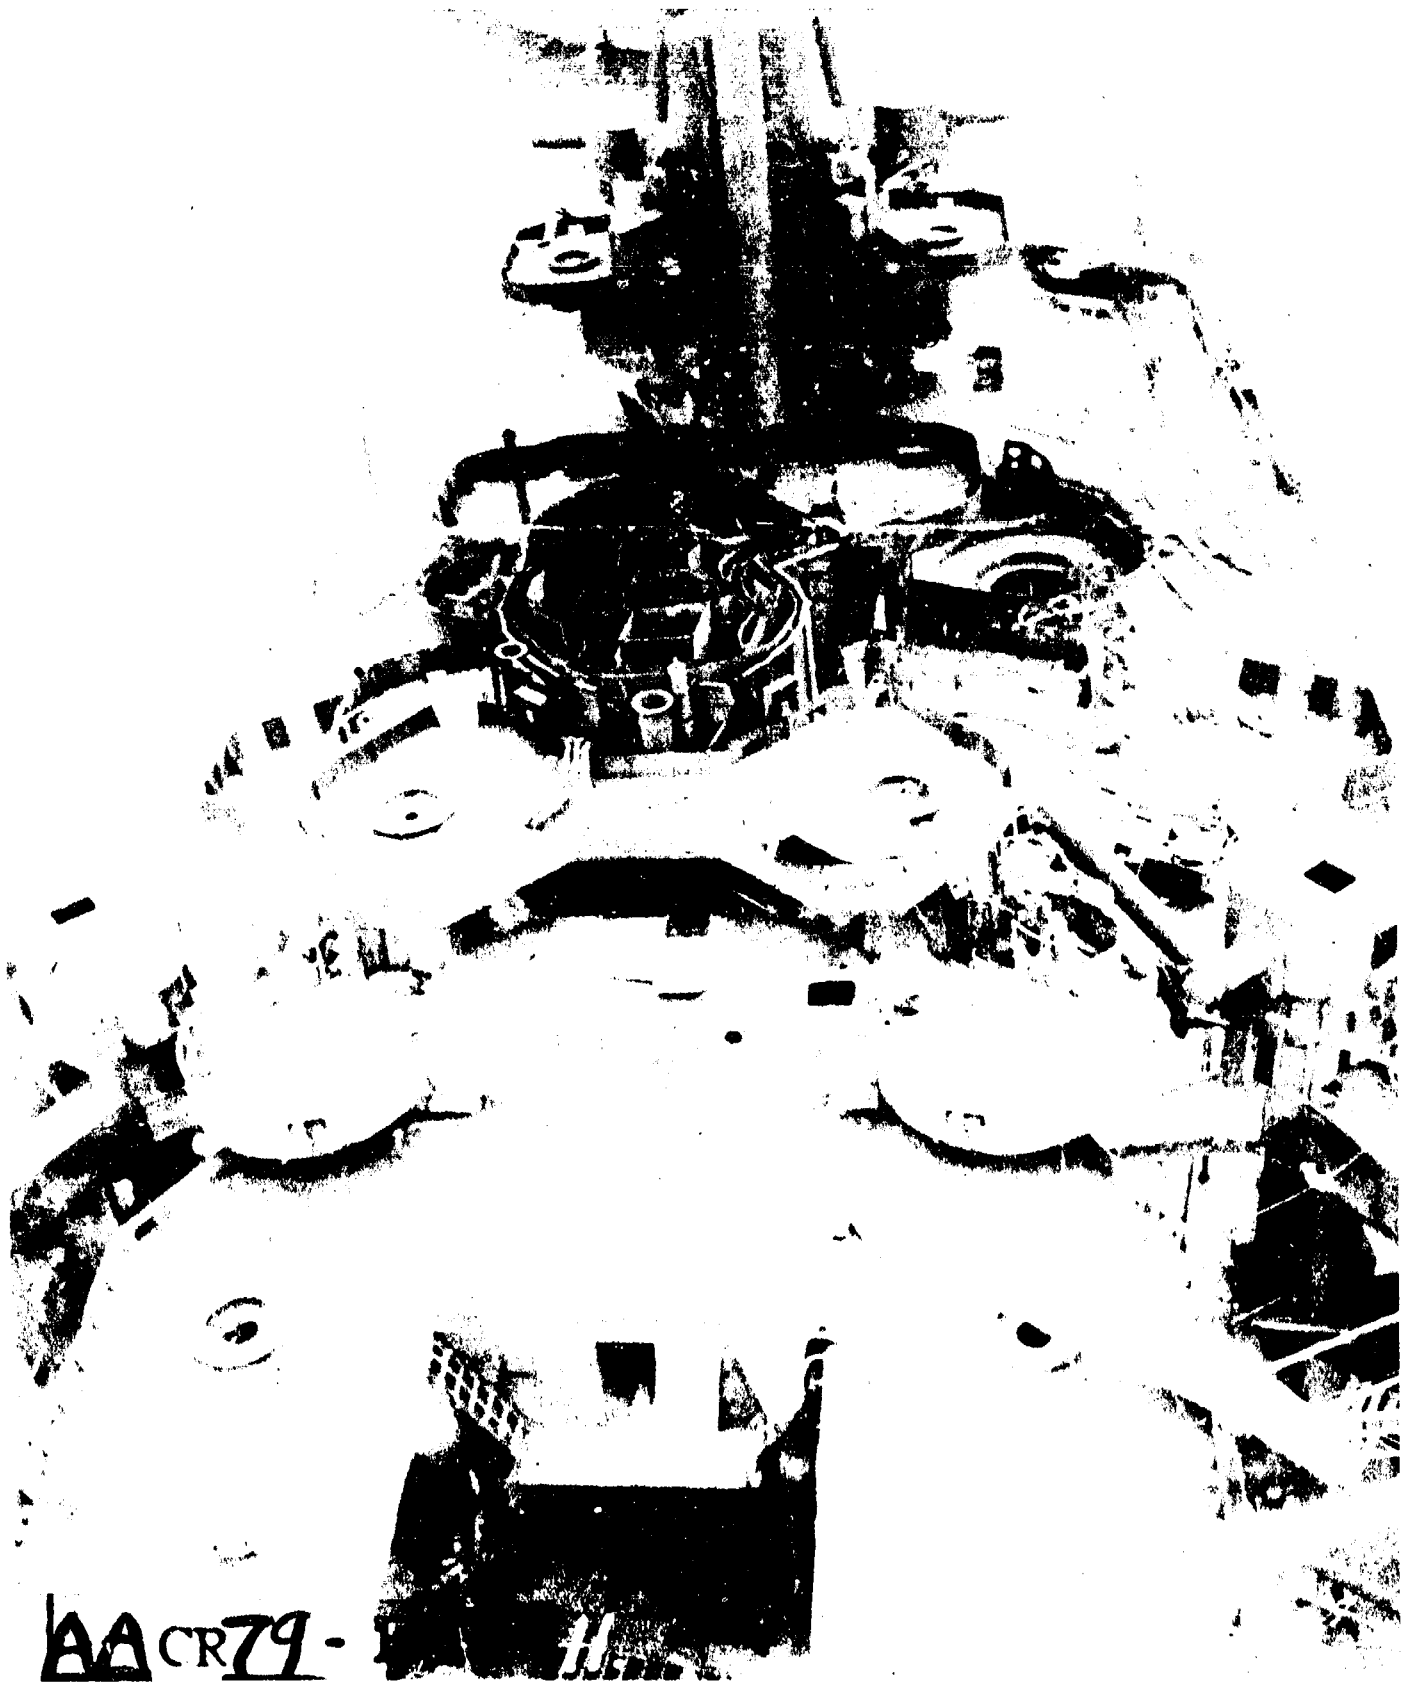
the light metal fins on the after top part of the stack are missing (photo 1763-12, page 71 .)

A wooden boat stored on the O2 deck, frame 130, port, was blown upward and demolished. (Photos 1816-11, 1763-12, 1816-9, pages 70, 71, and 75). The boat boom is undamaged. Several liferafts, standard U.S. Navy issue, had small fires which started on the canvas and burned out large sections of the interior.

AA-CR-79-1816-11. Looking down and aft from foremast. Note that fins are missing from top of the smokestack and parts of boat on 04 deck.

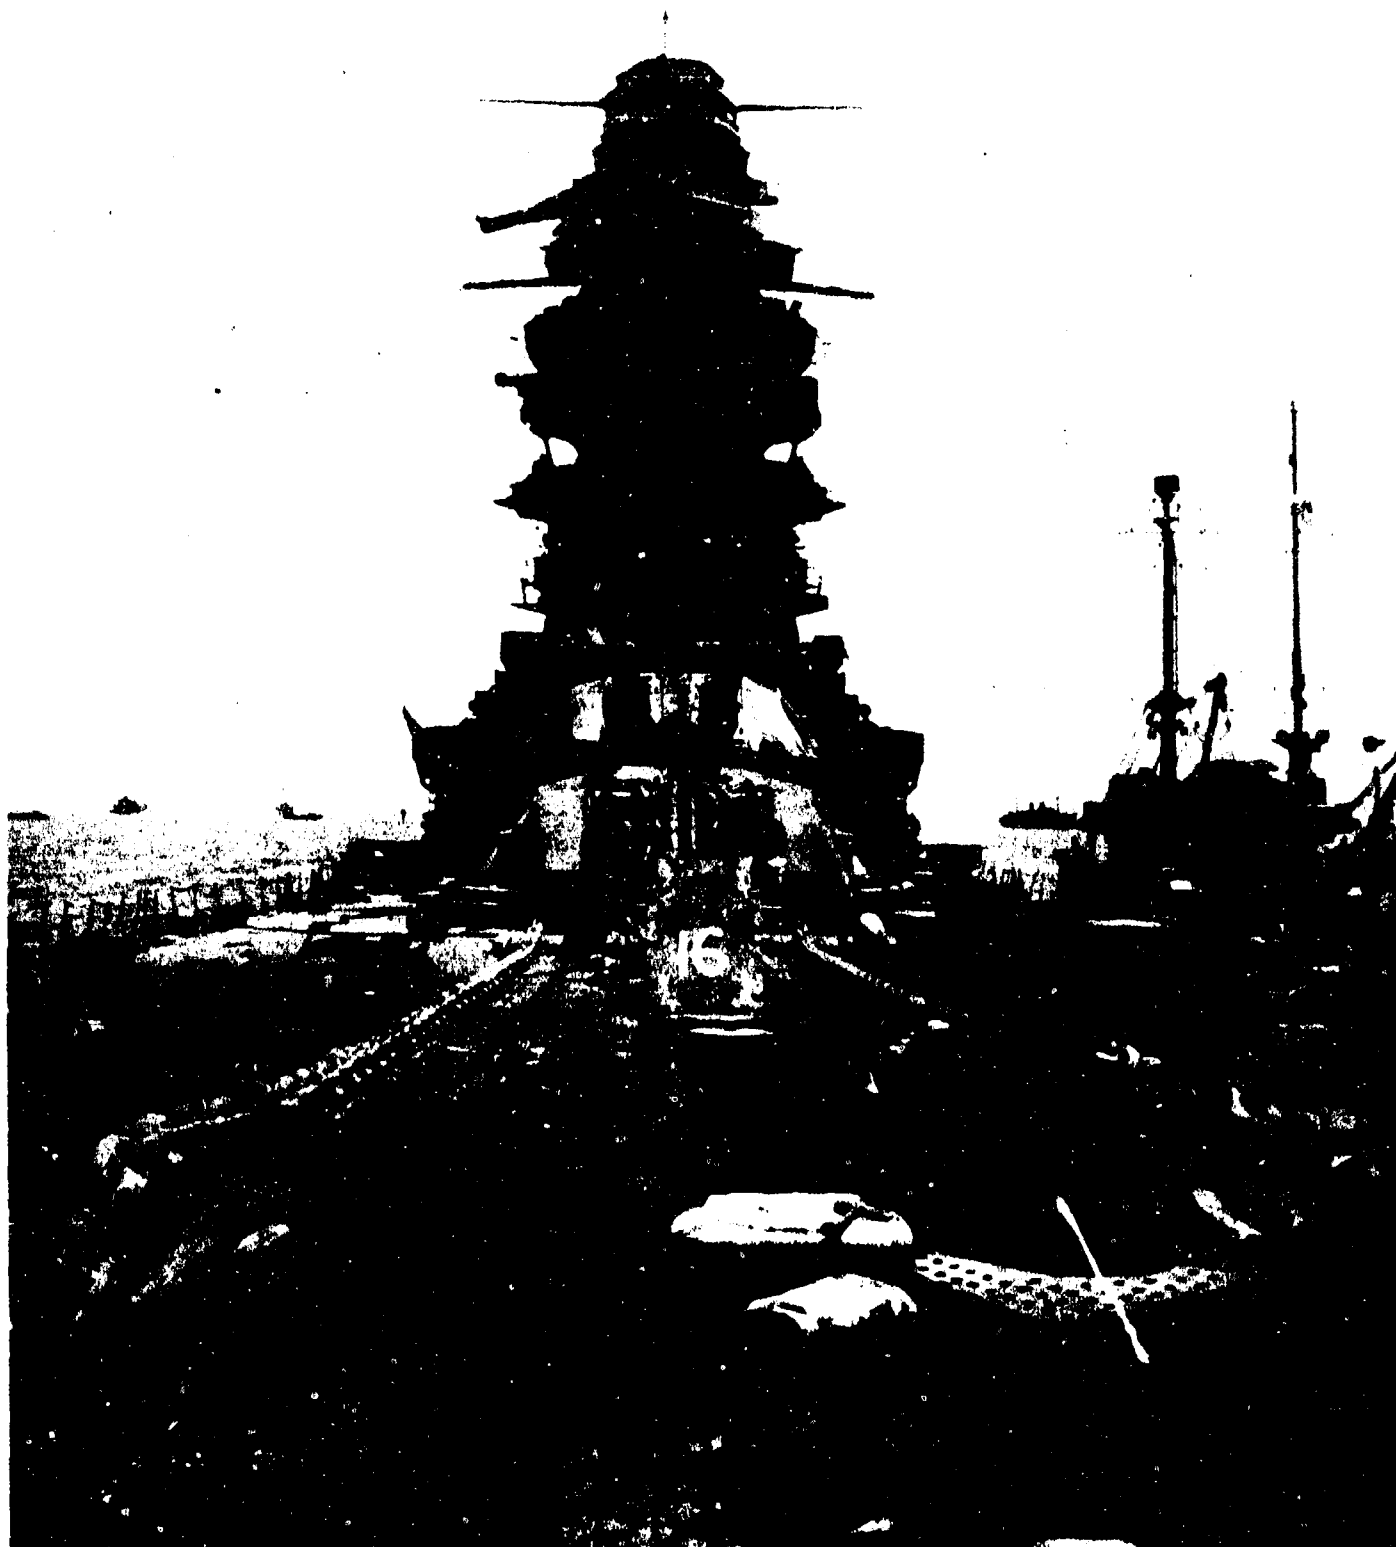
There is no change, due to the test, in the usability of the weather decks. (Photos 1763-10 and 1764-3, pages 72 and 73). The small fires in the wood deck covering generally covered an area of two or three square feet. A few exposed ladders were bent or had broken rungs. (Photo 1816-2, page 74).

AA-CR-68-1763-10. Looking aft from forecastle.

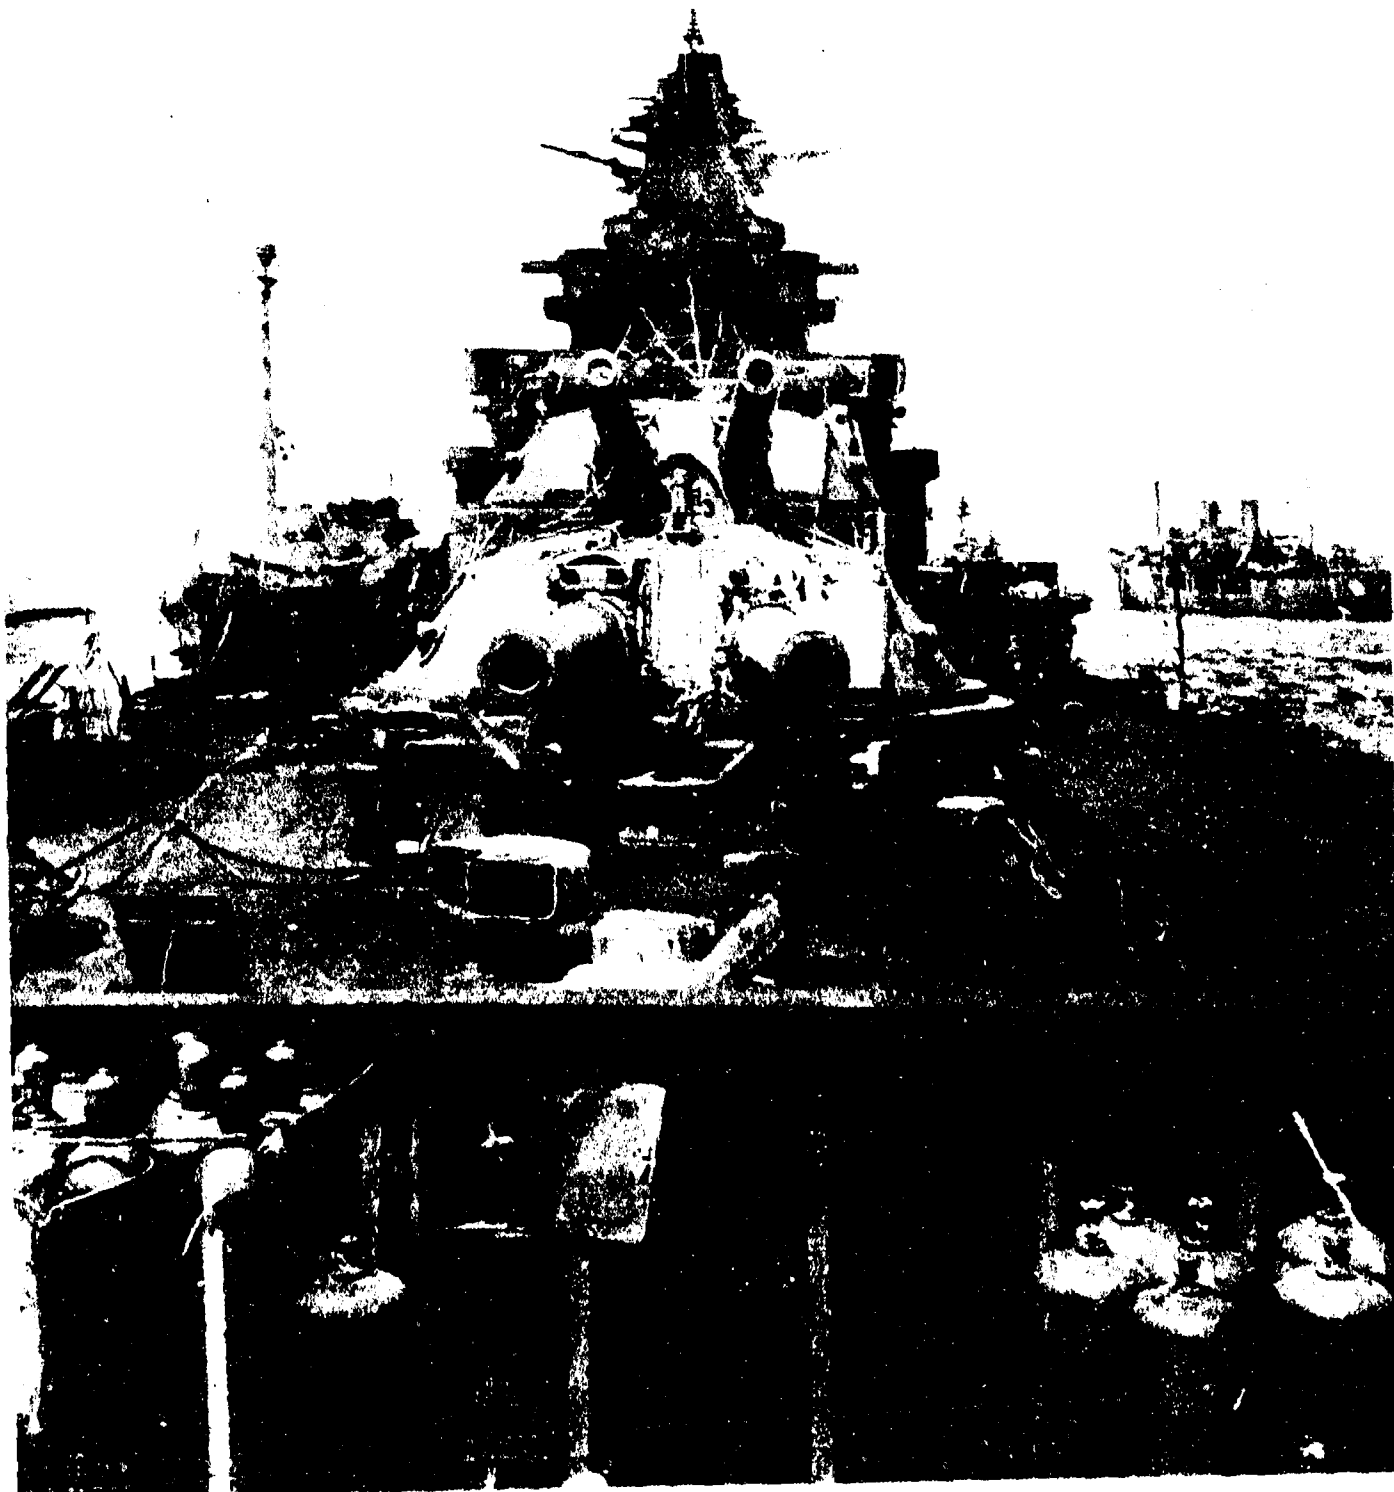
AA-CR-68-1764-3. Looking forward from stern. Note gas stowage has been rearranged.

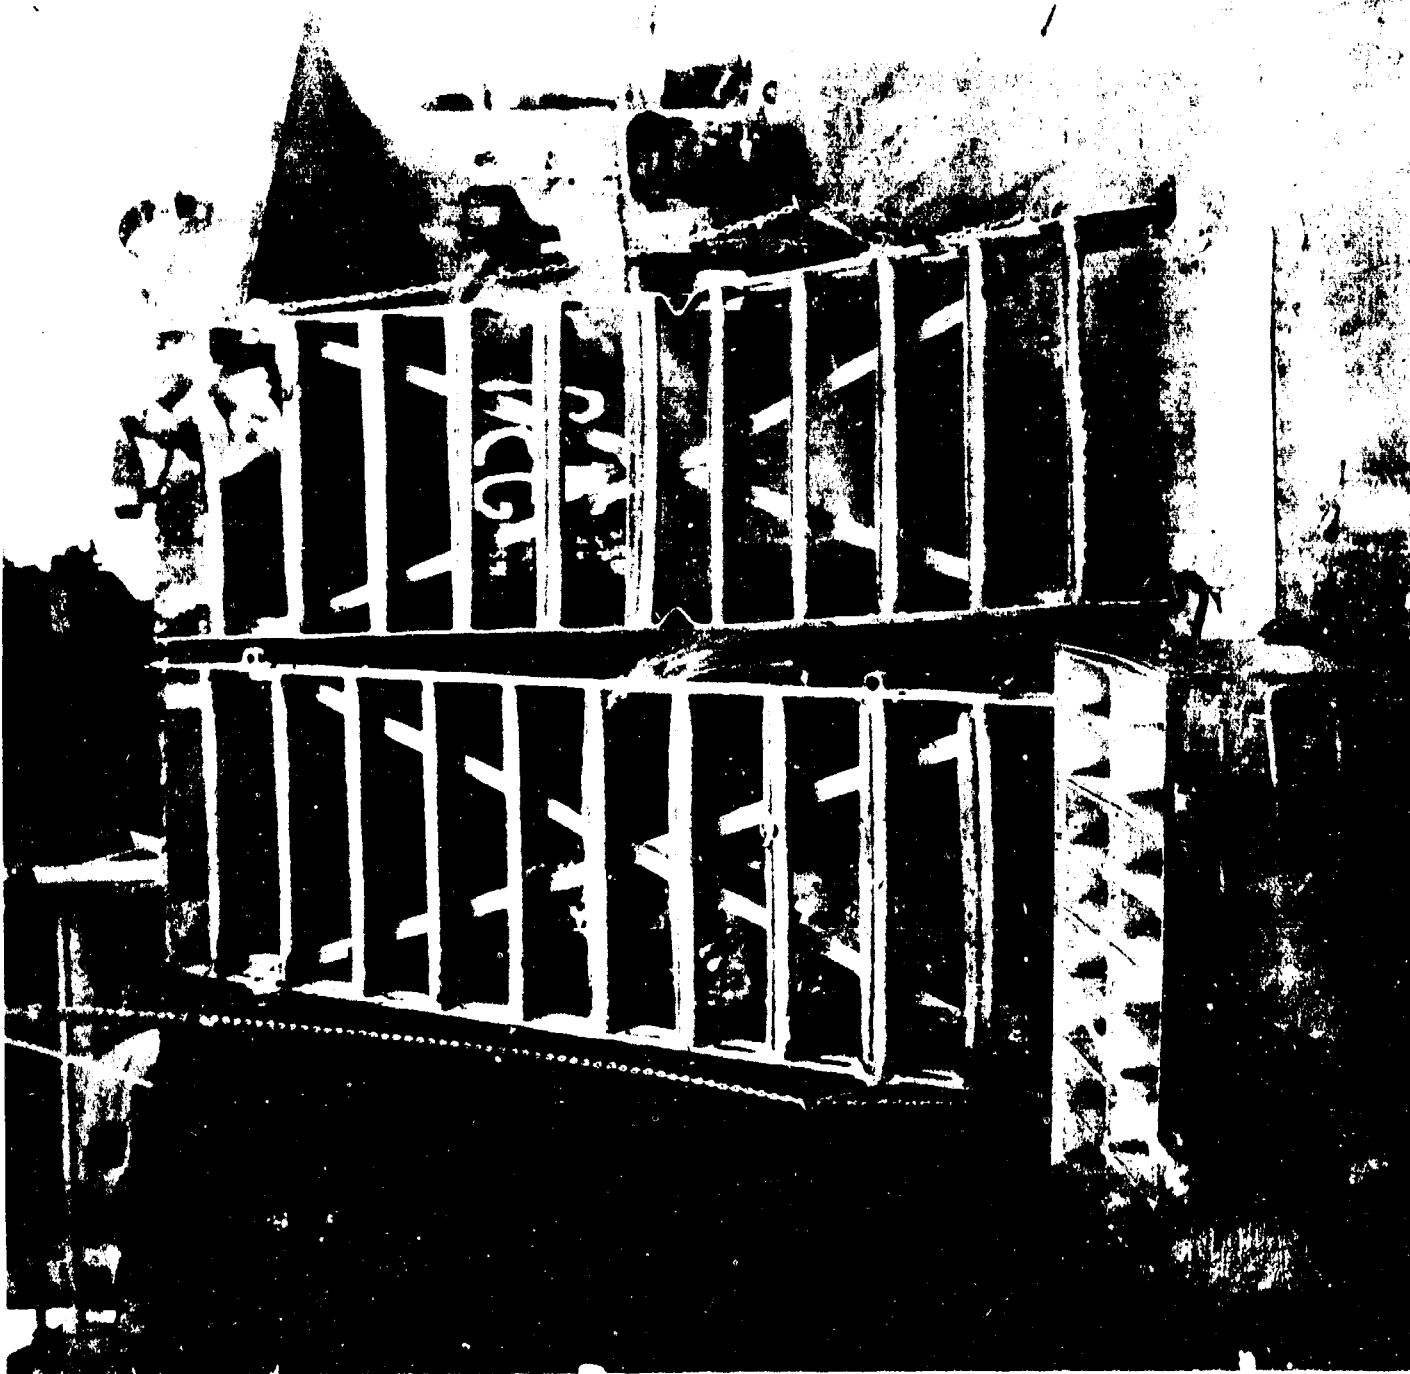
AA-CR-79-1816-2. Looking forward at buckled ladder, frame 235, main deck.

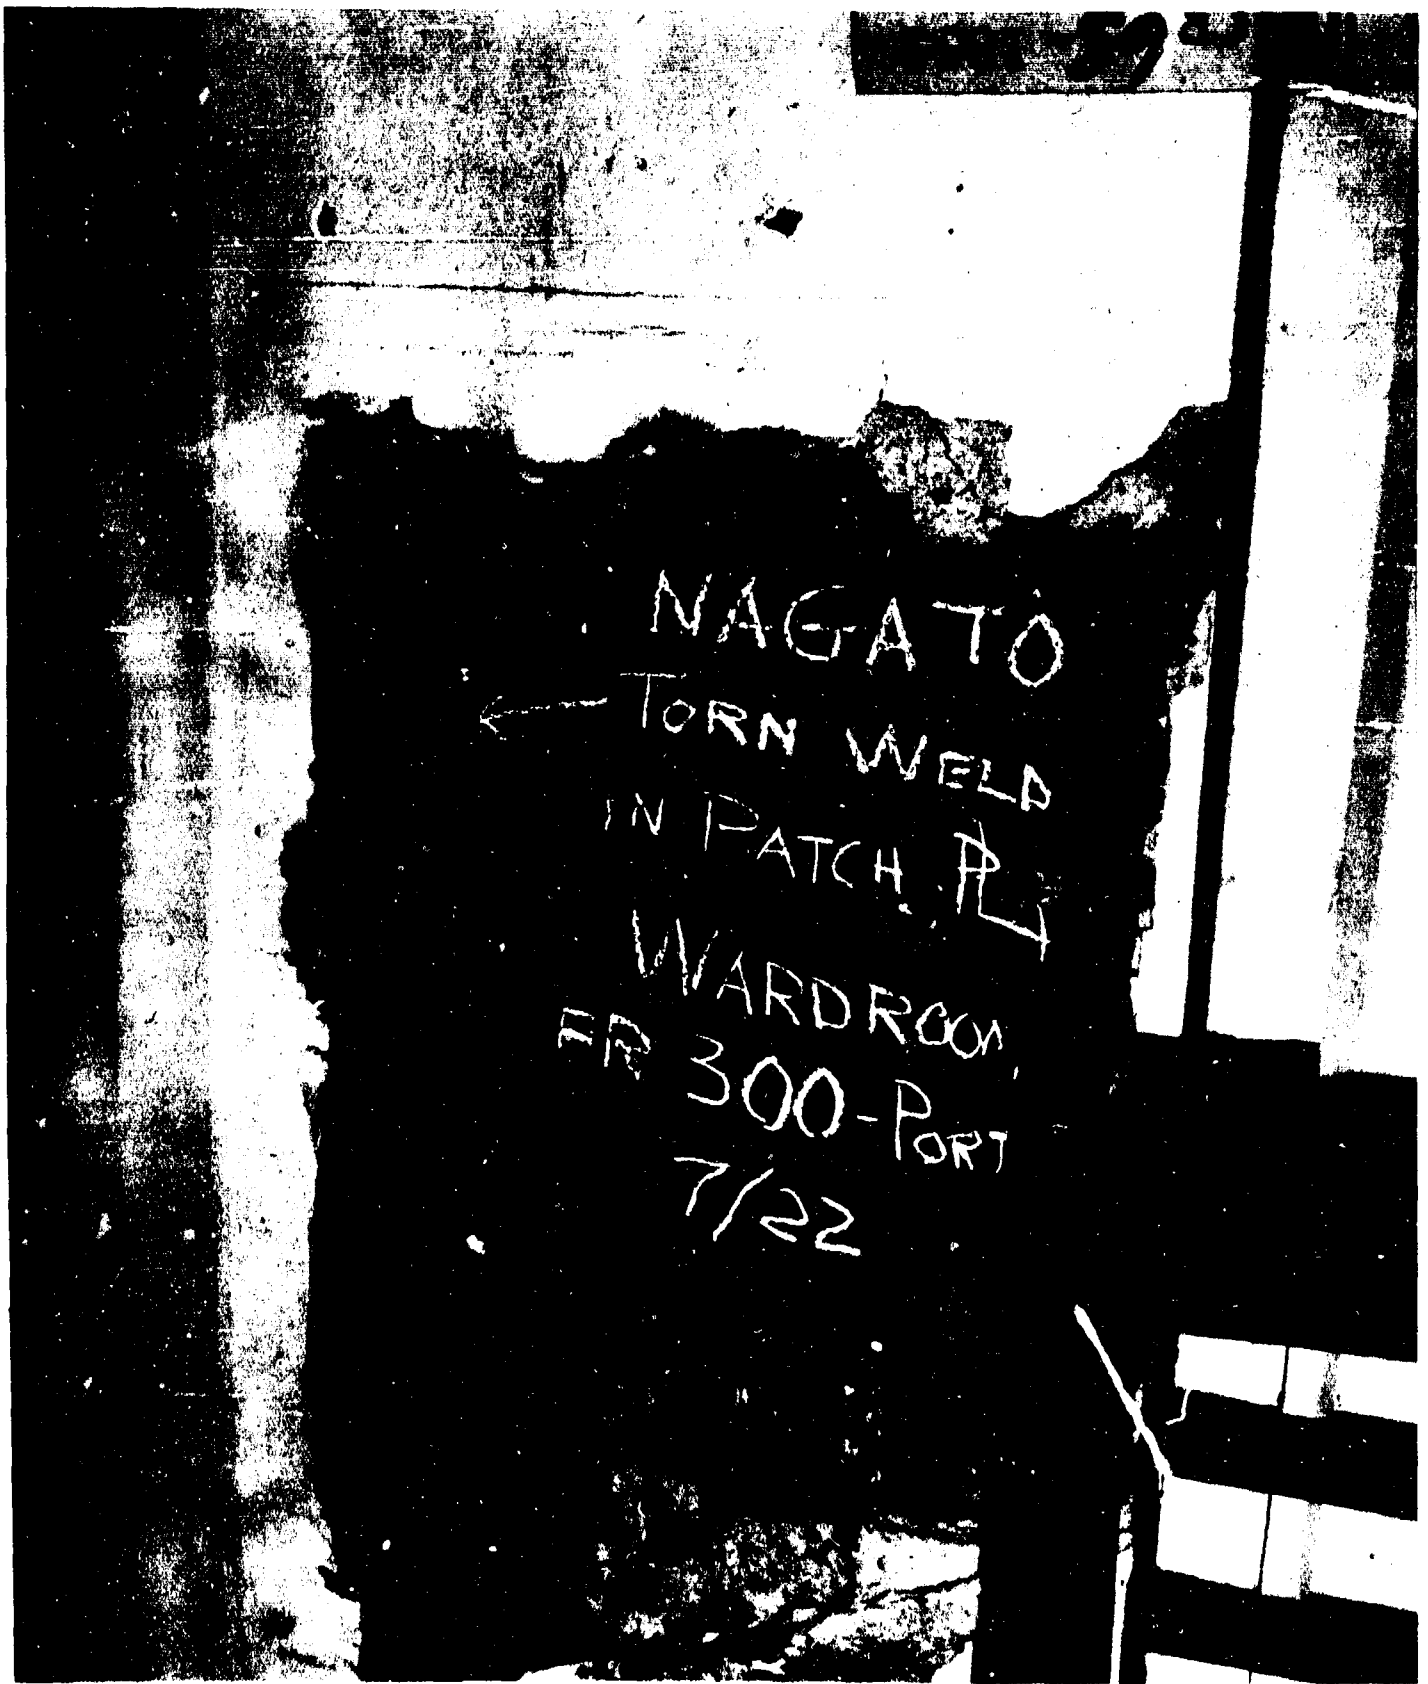
There is a cracked weld in way of a pre-test patch plate at frame 300, port side, about four feet above the second deck., (photo 1851-9, page 80 .)

AA-CR-65-1851-9. Looking outboard at frame 300, second deck, port side at cracked weld in way of patch plate.
