TECHNICAL INSPECTION REPORT

U.S.S. PENSACOLA (CA24)

TEST ABLE

VOLUME 1 OF 2

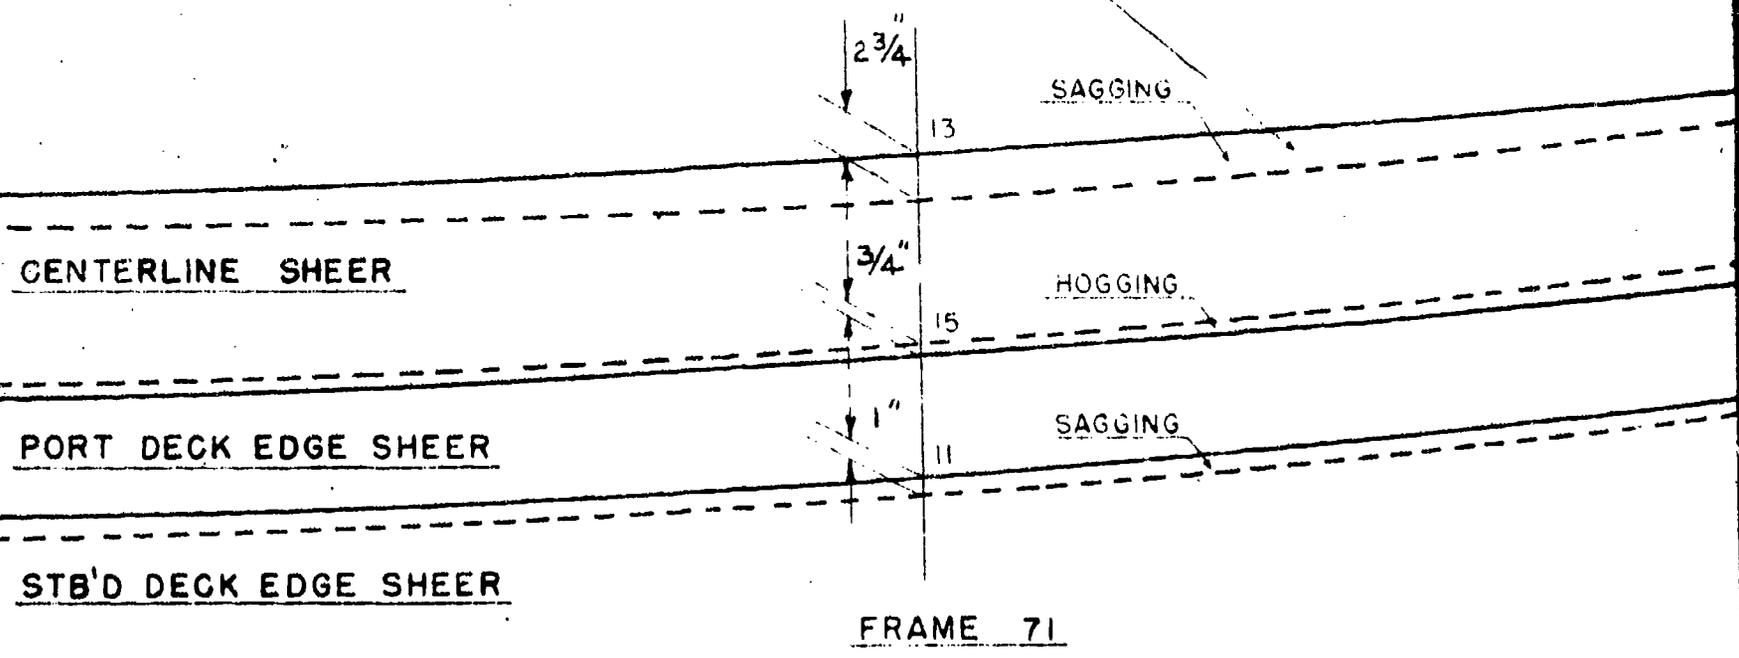
SAGGING OF CENTERLINE, AS SHOWN,
IS PARTLY ATTRIBUTABLE TO LOCAL
DECK DEFLECTION, SEE PLOTS OF
TRAN'S SECTIONS AND SPECIAL SURVEY.

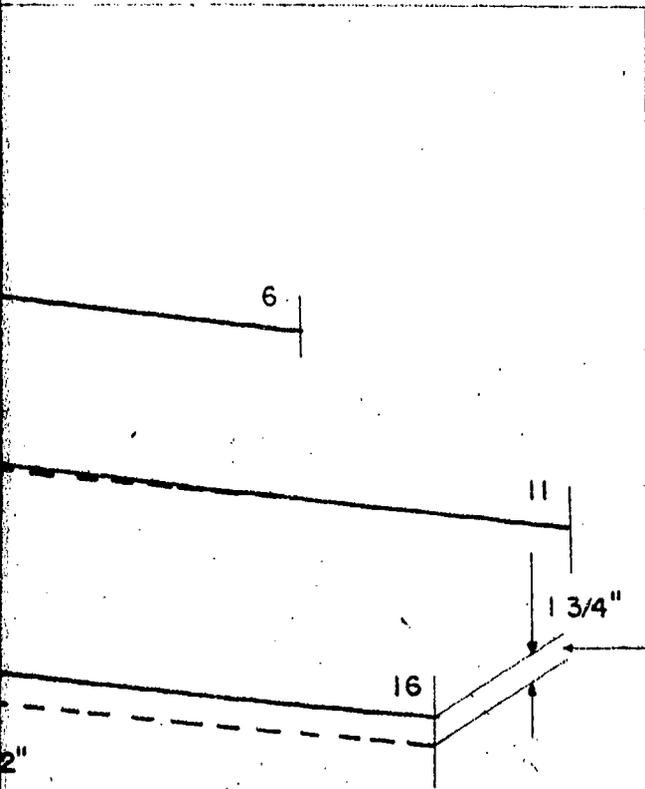
MAX. TWIST IS THE SUM
 RECORDED AT FR. 29 & 97
 TOTAL TWIST = 5"

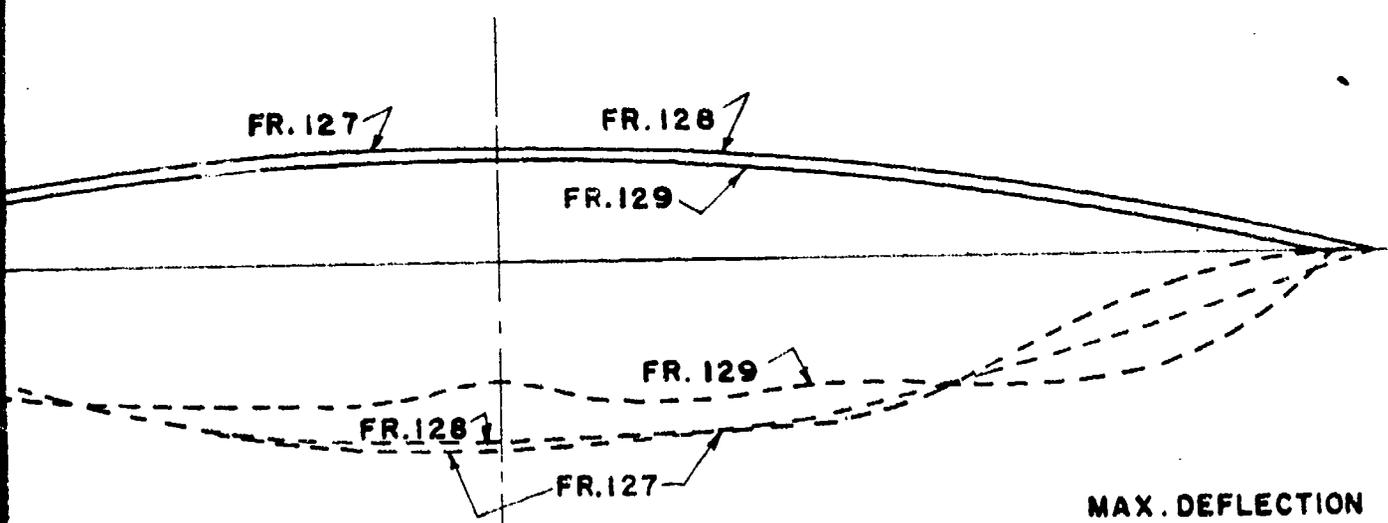
A fairly large fire occurred when Army Quartermaster's gear, located on the main deck, between frames 112 and 128, was ignited by radiant heat. The vessel's teak deck was destroyed in way of the burned equipment, as were all life rafts that hung from turret 4 and those stowed on deck at about frame 125.

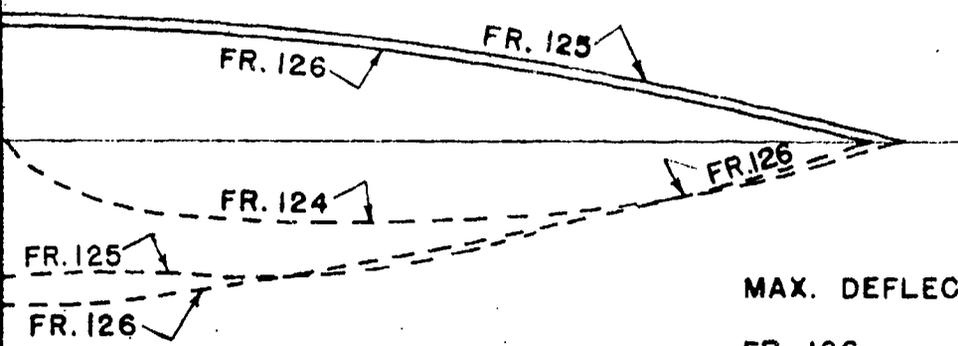
Since there was no flooding and no appreciable displacement of heavy material, there was no effect on stability. All watertight boundaries and closures below the second deck remained intact, so that watertight integrity was not impaired below that level. Aft of amidships above the second deck watertight integrity was somewhat impaired by failure in the main deck and by the distortion of bulkheads and door frames.
