# U.S.S. PENSACOLA (CA24)

TEST ABLE

VOLUME 2 OF 2

OPERATION CROSSROADS DDC

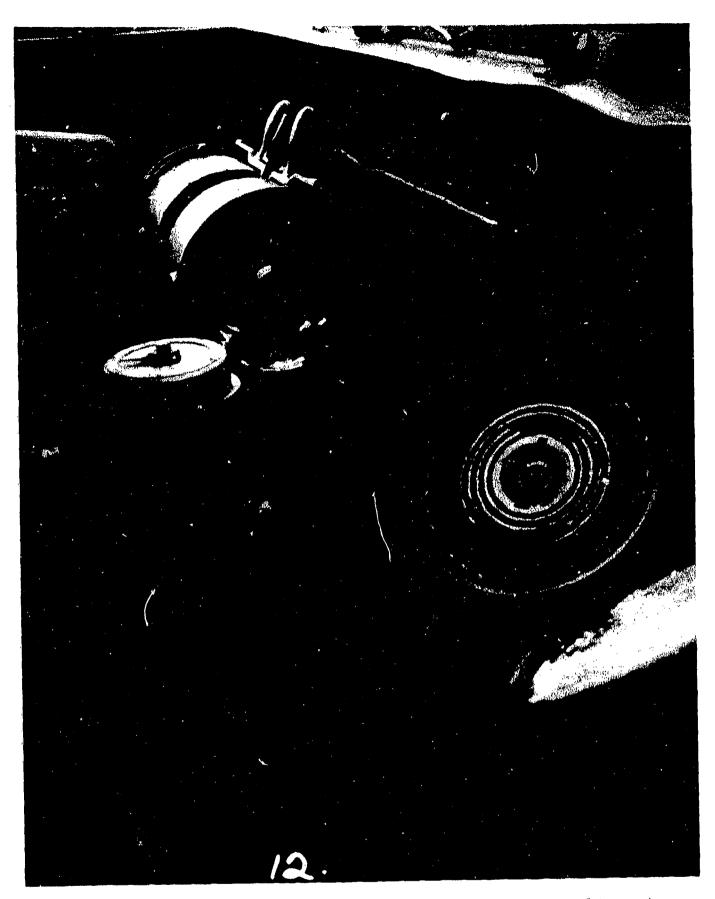
AA-CR-98-1967-12. Navigating bridge, looking forward and to port, showing condition of equipment and bent wind-screen.

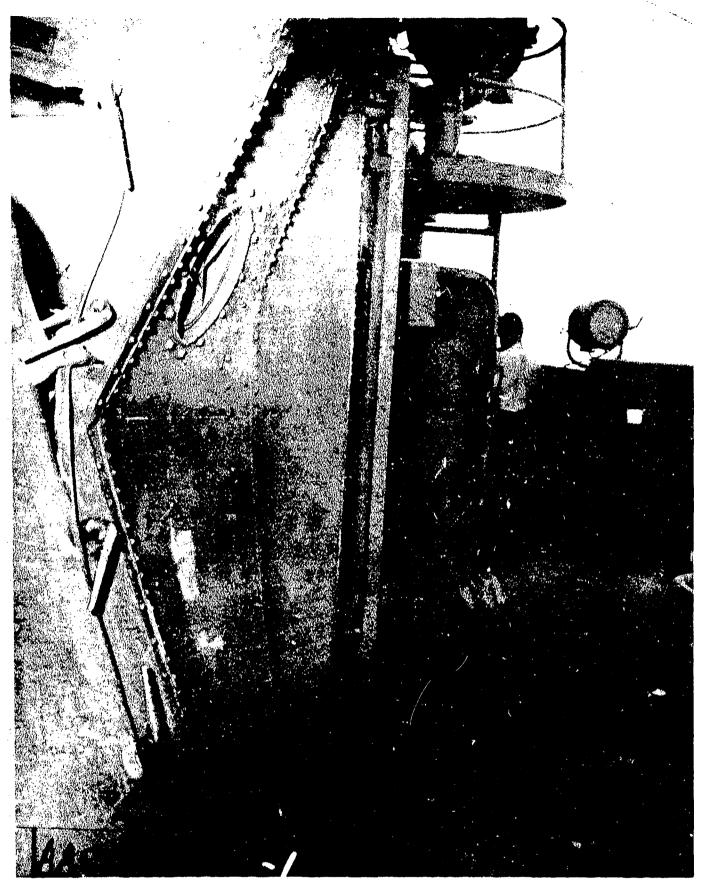
AA-CR-68-1761-1. Looking forward on starboard side of navigating bridge showing damage to sluminum deck house.

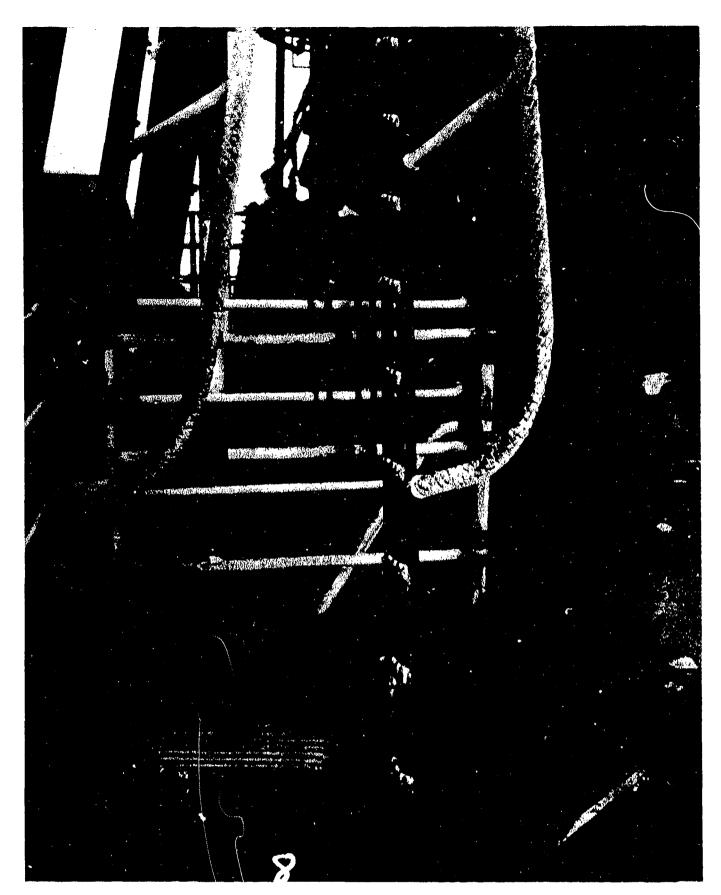
AA-CR-98-1967-8. Damage to ladder between communication platform and emergency platform, frame 48, starboard side. Cast aluminum treads failed at connections.

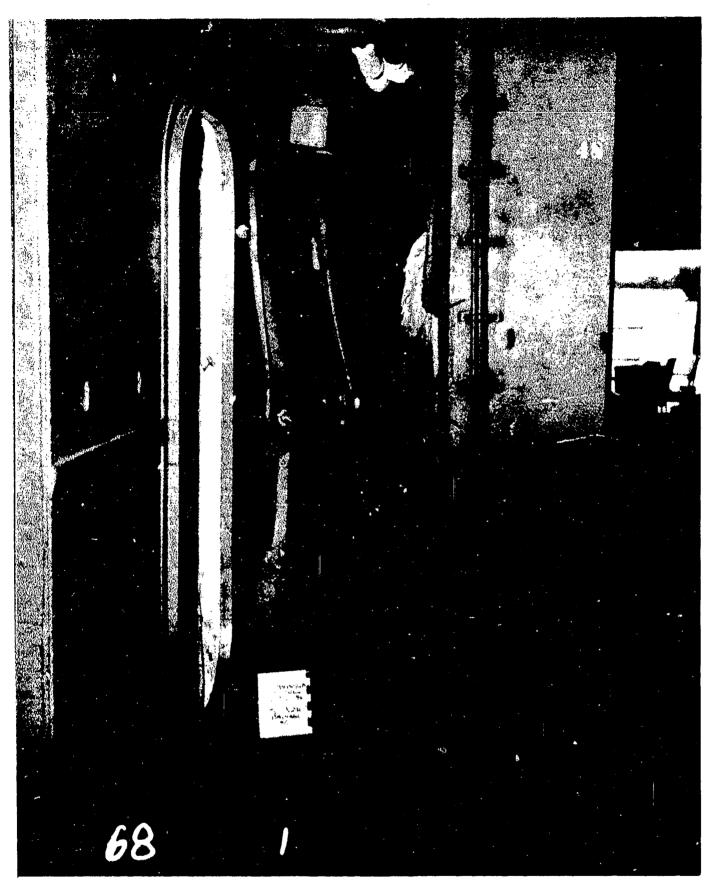
AA-CR-68- 1755-1. Looking to port on main deck showing damaged doors in bulkhead 49.

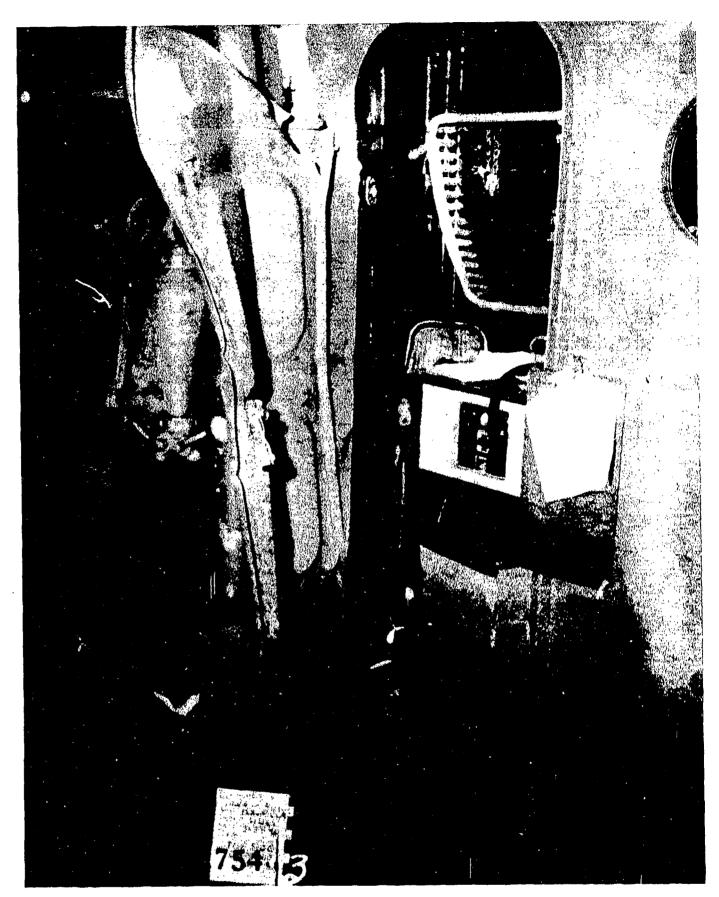
AA-CR-68-1754-3. Damage to door in bulkhead 49 on port side of main deck looking aft and to starboard.

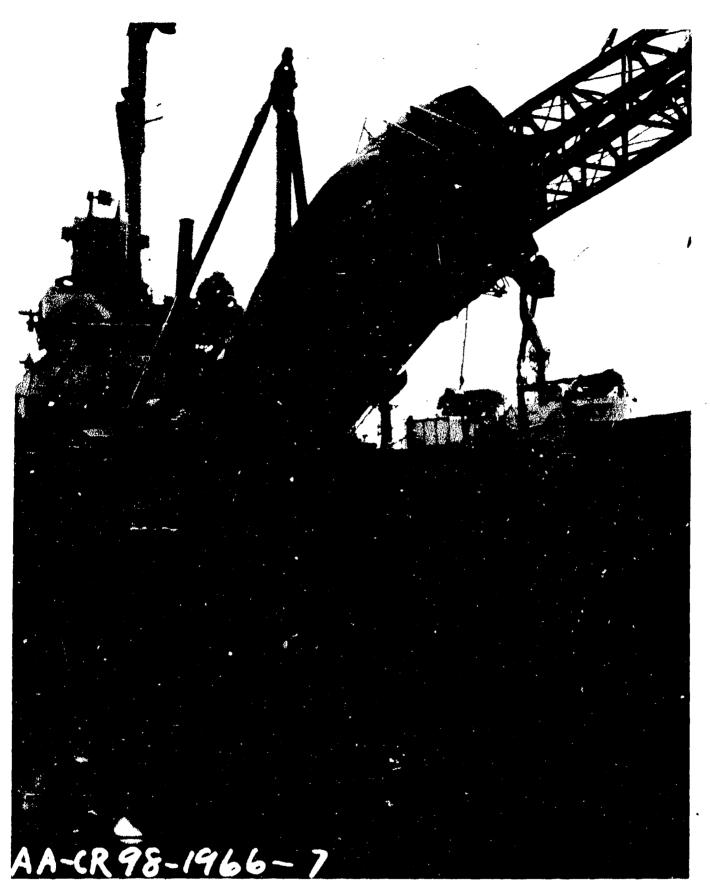
AA-CR-98-1966-7. Damage to after stack from starboard side of main deck at frame 60, looking aft.

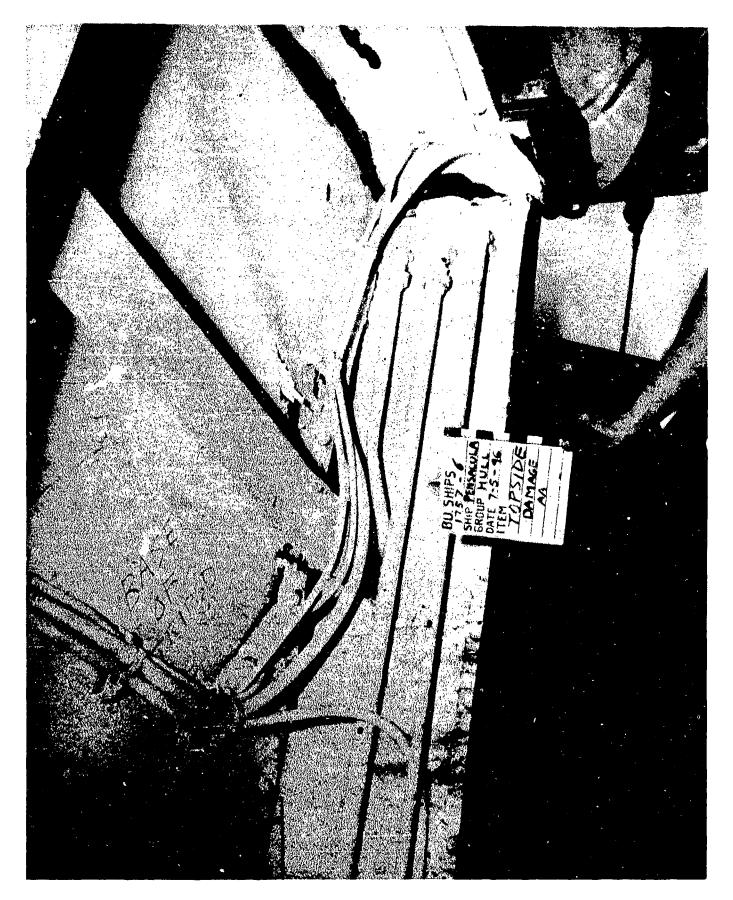
AA-CR-68-1757-6. Looking upward and aft at underside of superstructure deck in way of damage to base of port mainmast strut.

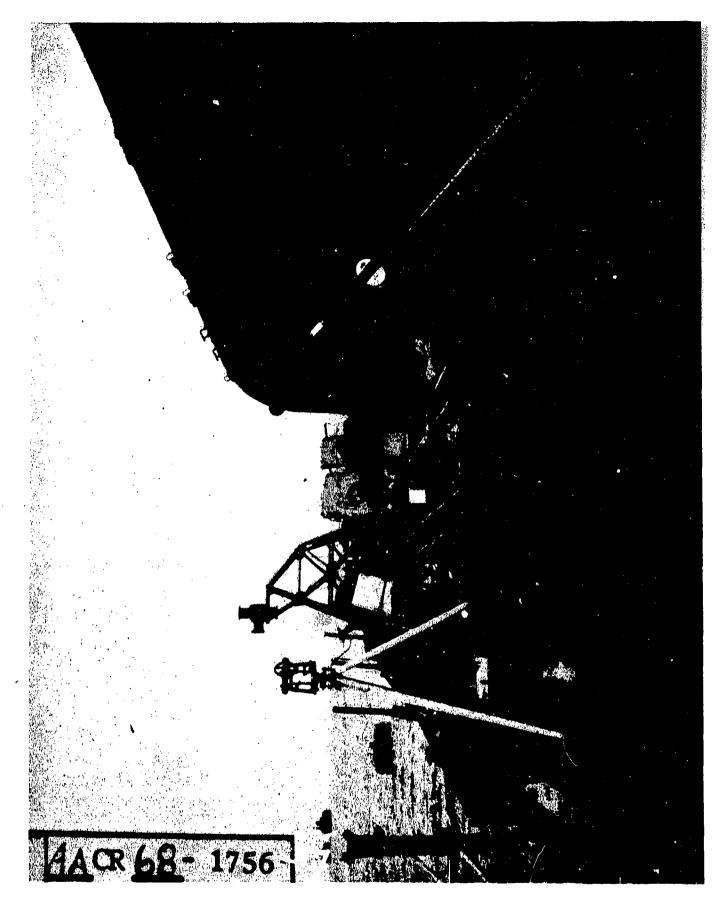
AA-CR-68-1756-7. General view looking aft from frame 160 showing condition of starboard side of main deck.

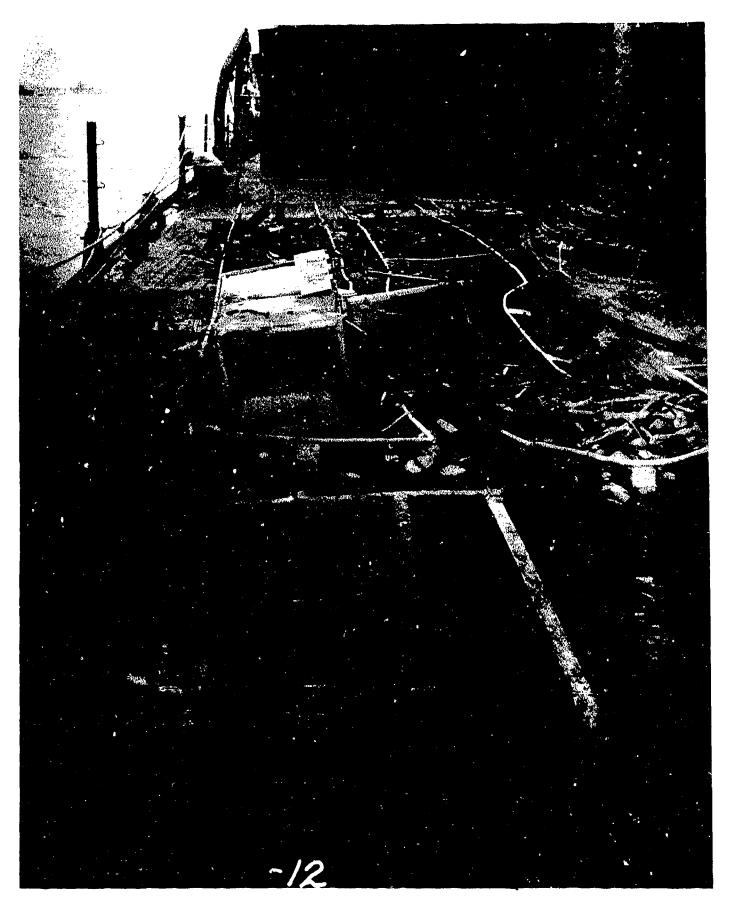
AA-CR-68-1756-12. Port side of weather deck, looking forward from frame 125 showing some of remains of burned Army equipment.

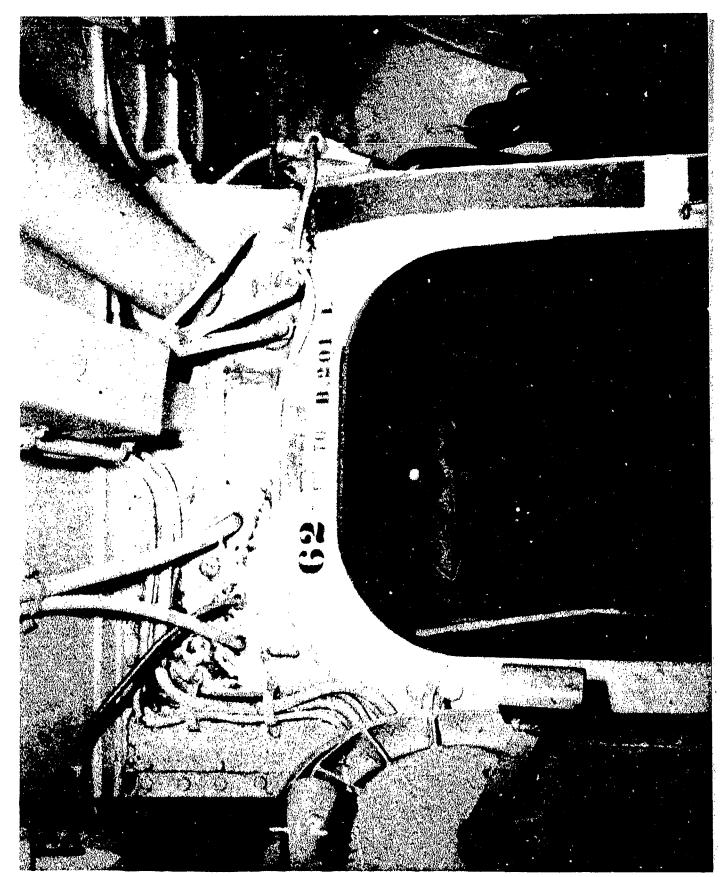
AA-CR-175-2157-12. C-201-L. Looking forward on 2nd deck through door in bulkhead 62 showing damage in port passageway B-201L caused by blast pressure in air intake area. Note crushing of bulkhead 62 near overhead as a result of deflection of the overhead.

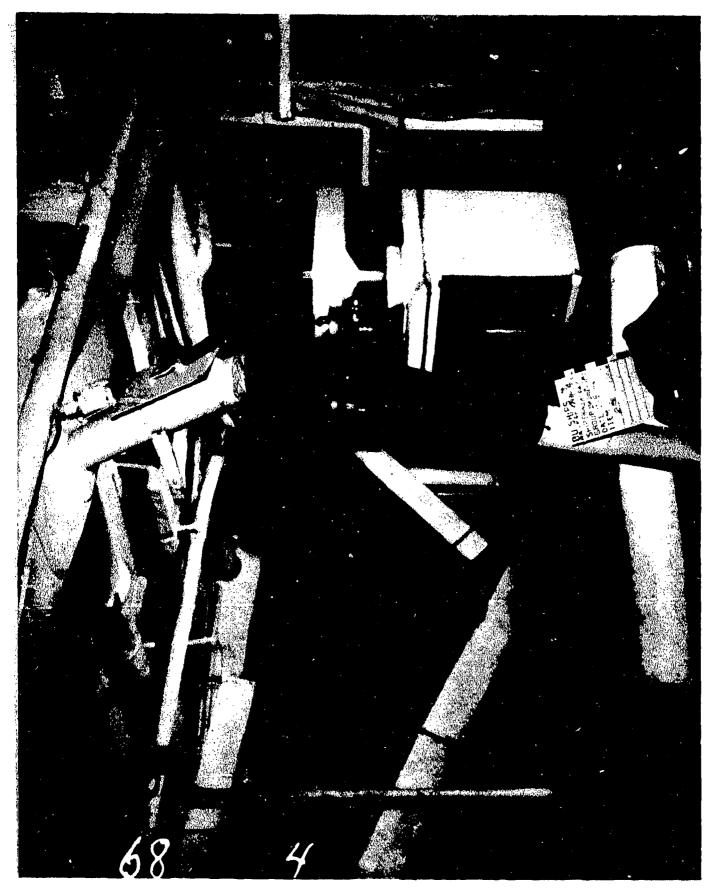
AA-CR-68-1768-4. C-201L. Looking forward and to starboard on 2nd deck in crew's space on port side showing buckled stanchion at frame 68 and damaged ventilation duct.

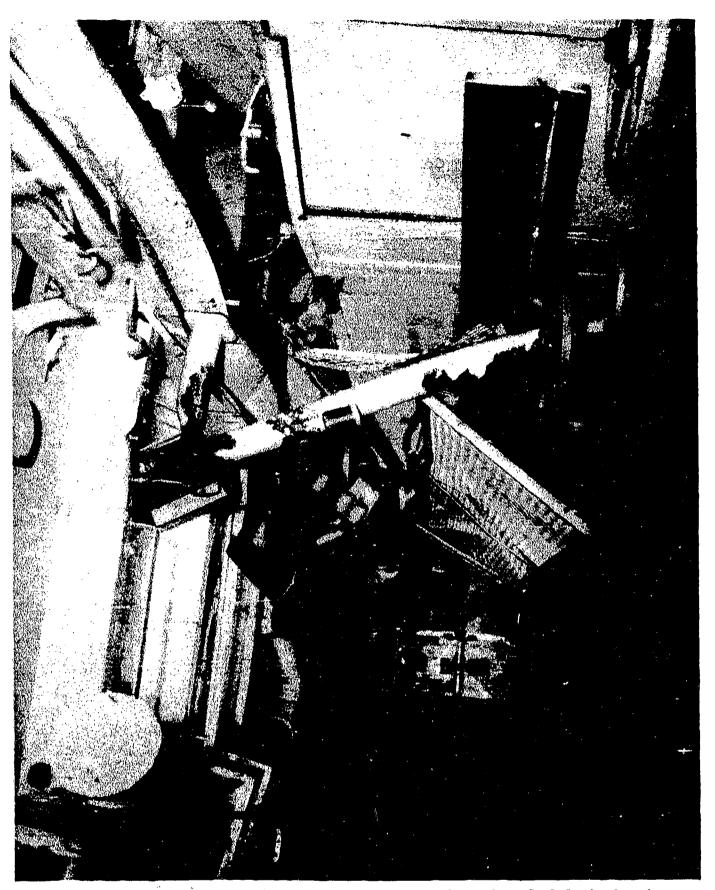
AA-CR-175-2158-1. C-201L. Looking to starboard on 2nd deck showing stanchion failures at web frame 65.

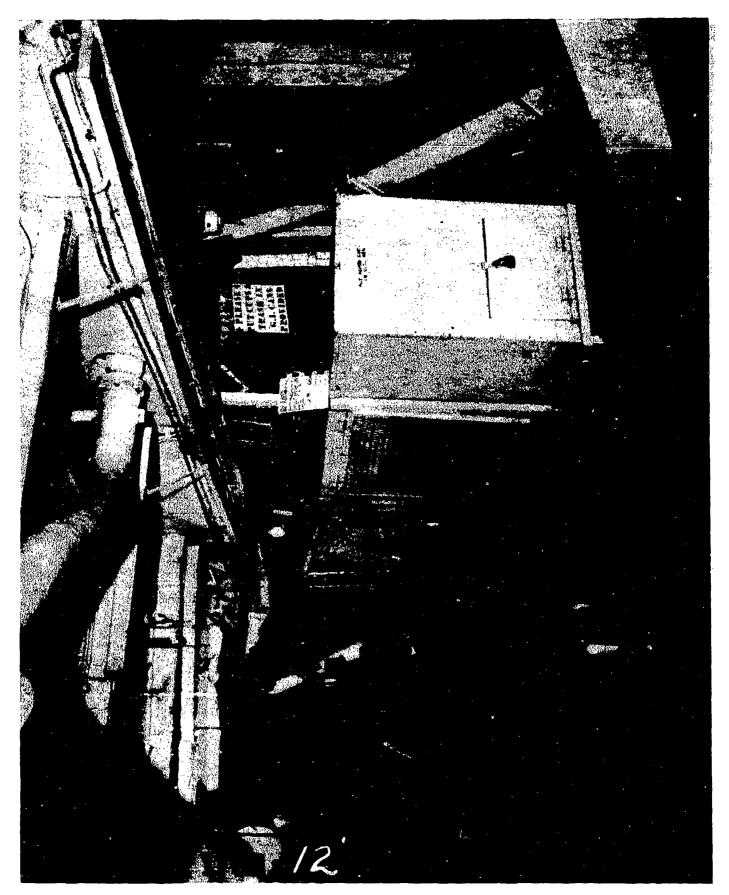
AA-CR-68-1767-12. C-201L Looking to starboard on 2nd deck along forward side of ship's service store showing stanchion failure at web frame 65.

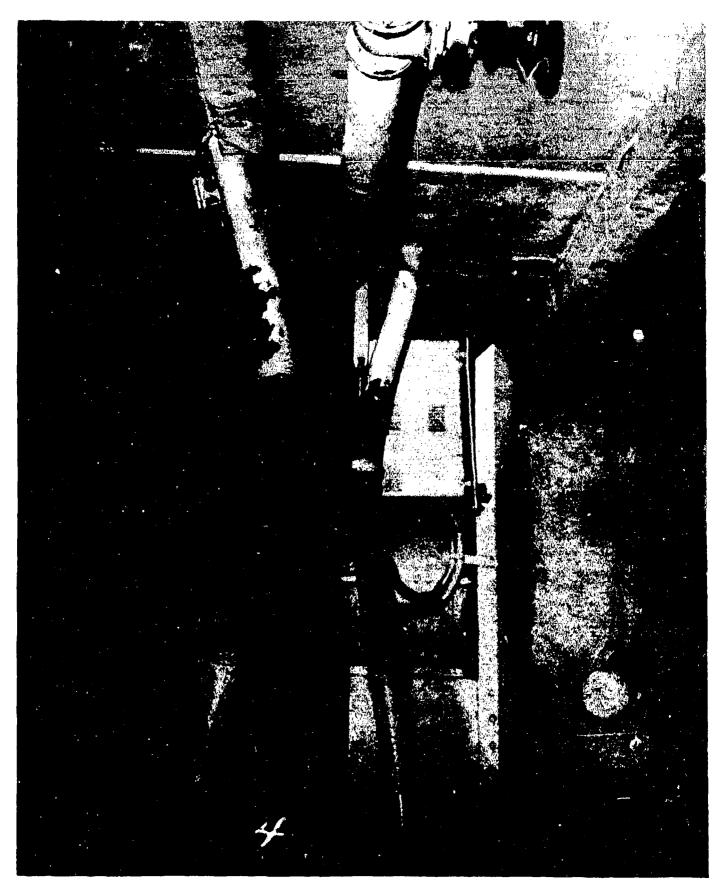
AA-CR-175-2158-4. C-201L. Looking forward on port side, 2nd deck, to bulkhead 62 and passage B-201L showing stanchion failures at frames 63 and 64. Note crushing of bulkhead 62 near overhead.

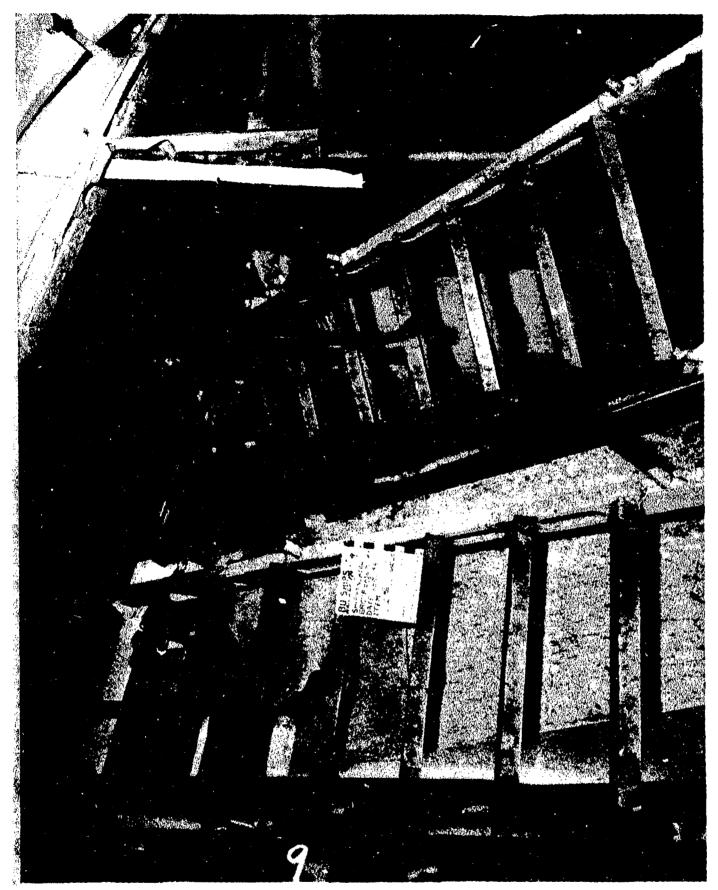
AA-CR-68-1767-9. C-201L. Looking to starboard on 2nd deck at frame 61 in crew's space showing failure of main deck longitudinal at frame 62 1/2.

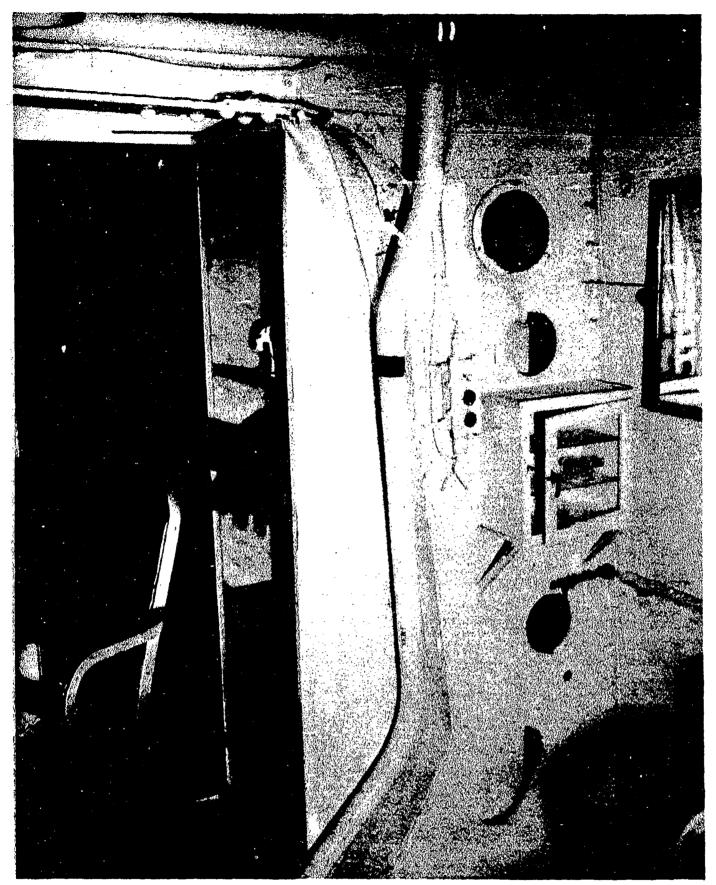
AA-CR-175-2157-11. Looking aft on 2nd deck port side in barber shop showing damage to web frame 65.

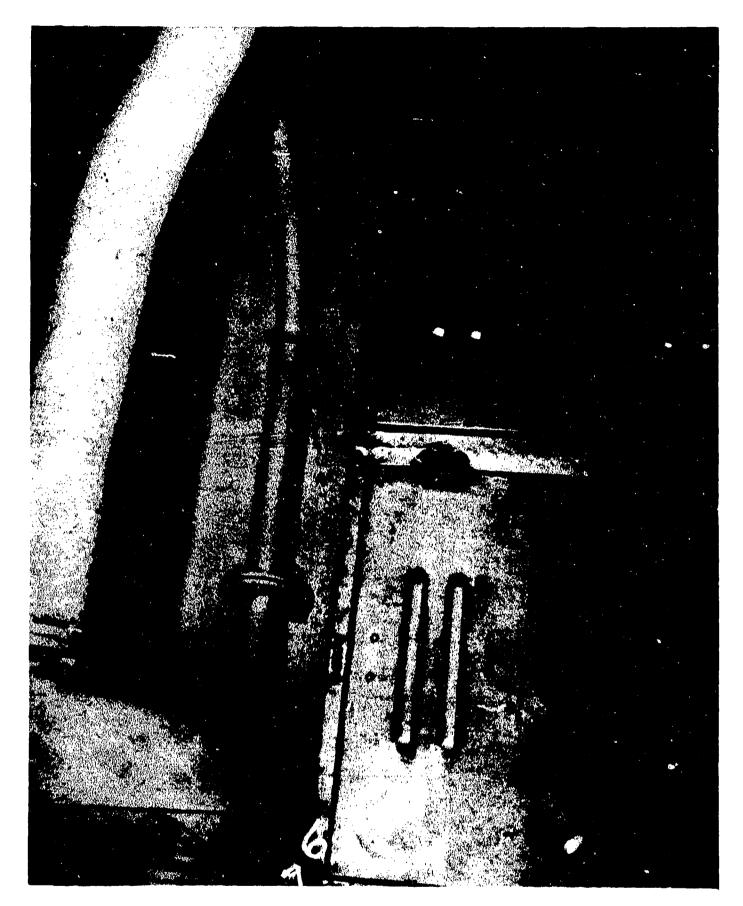
AA-CR-68-1768-6. C-201L. Looking to starboard on 2nd deck in crew's space showing damage to port side of port engine room exhaust trunk just aft of frame 70.

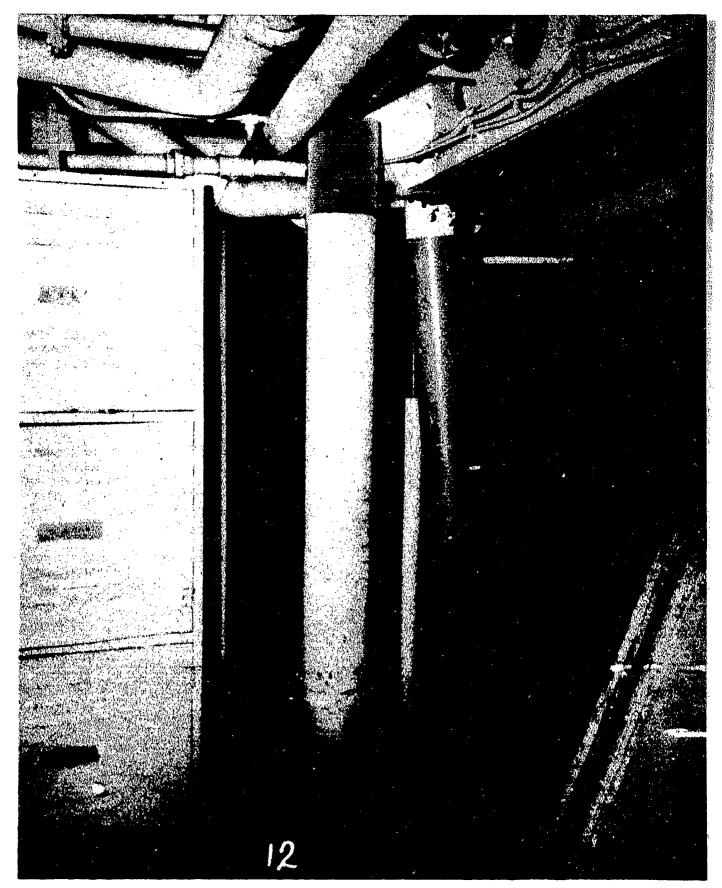
AA-CR-90-574-12. C-202-L. Second deck, frame 97, port side. Note deformation of stanchions and crack around top under beam.

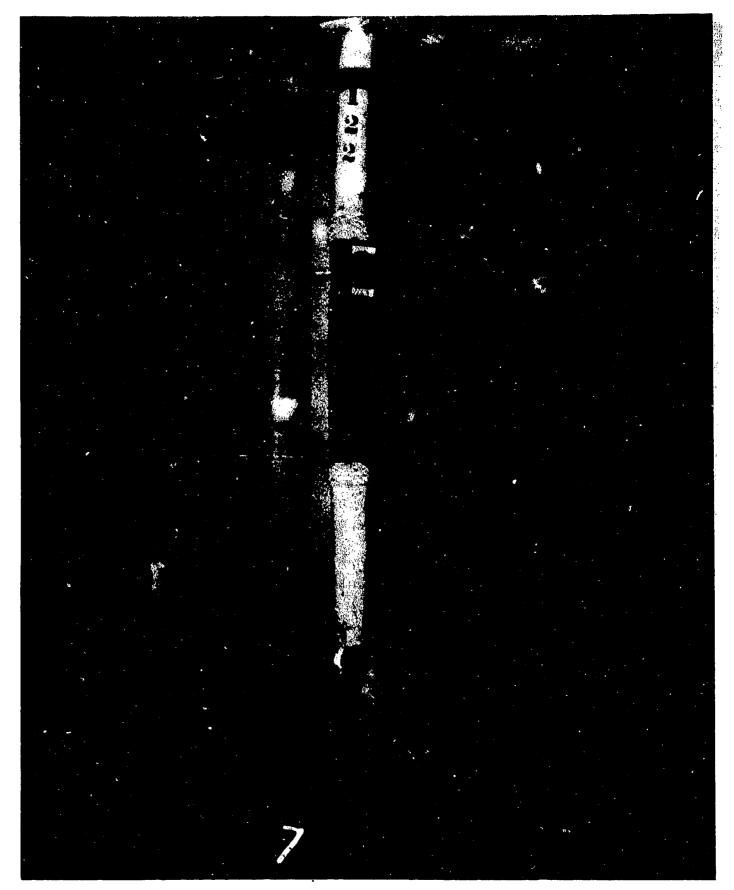
AA-CR-175-2178-7. Looking forward and to starboard on 2nd deck, port side aft of No. 4 barbette, showing stanchion failure at web frame 122. (Note crushing at stanchion foot).

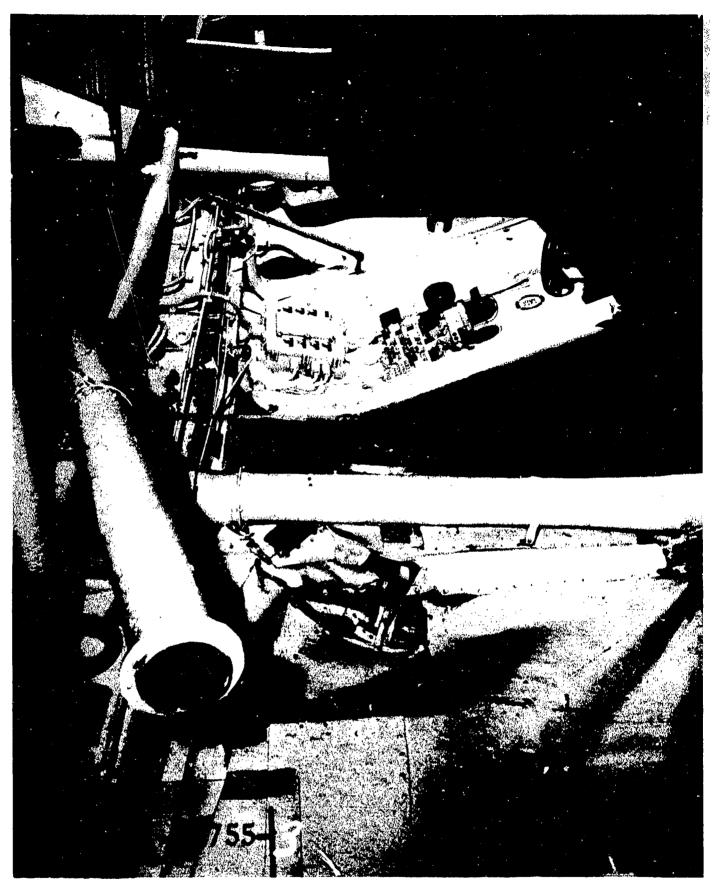
AA-CR-68-1755-3. D-203-L. Test A damage. Looking aft and to port at bulkhead 128, starboard.

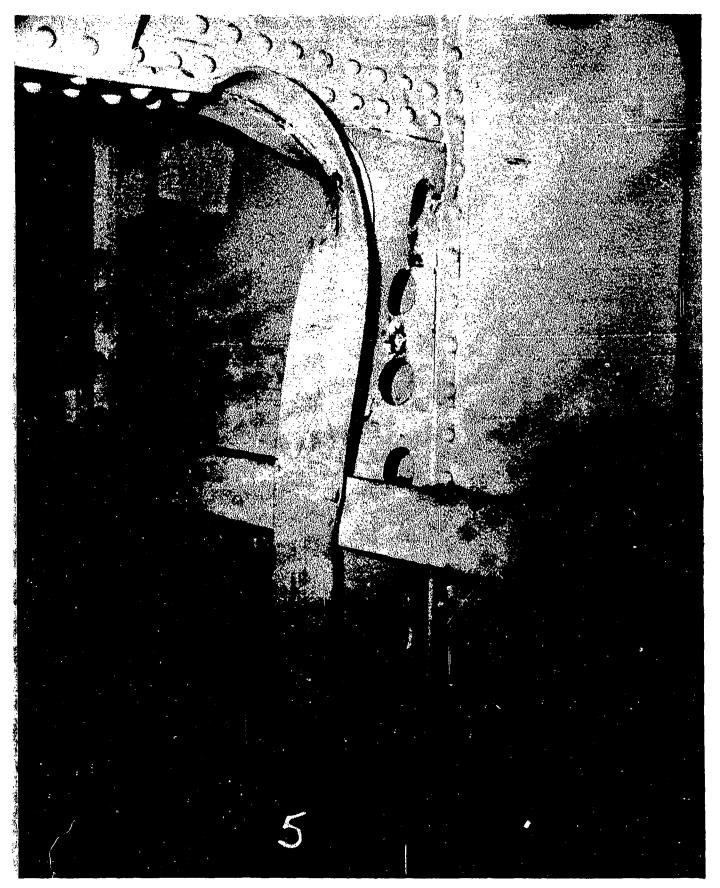
AA-CR-175-2178-5. Looking aft and to port shell on 2nd deck showing failure of web frame 125.

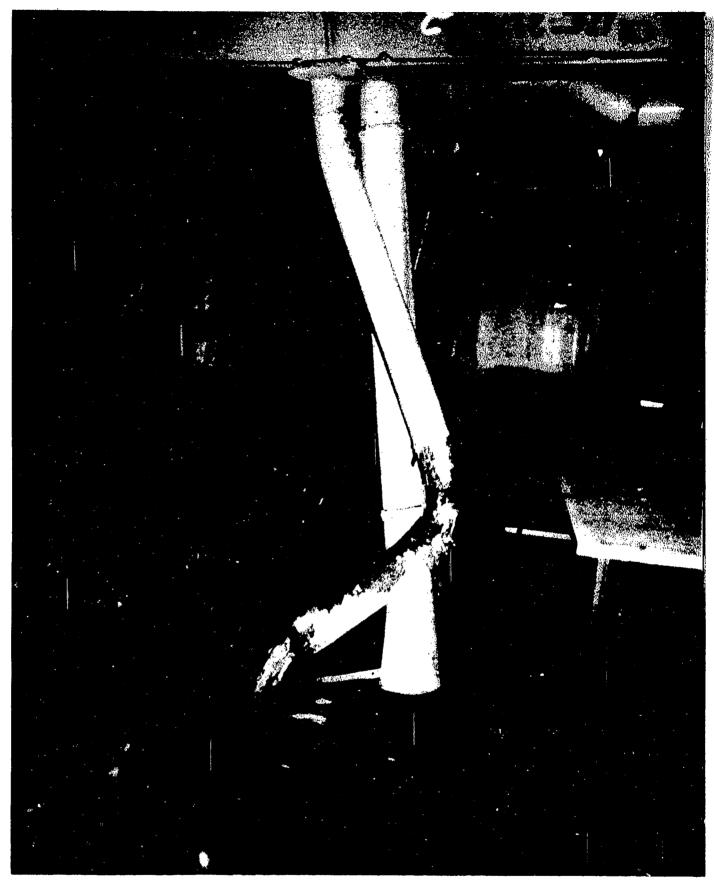
AA-CR-175-2178-2. Looking forward on 2nd deck showing failure of stanchion at web frame 125.

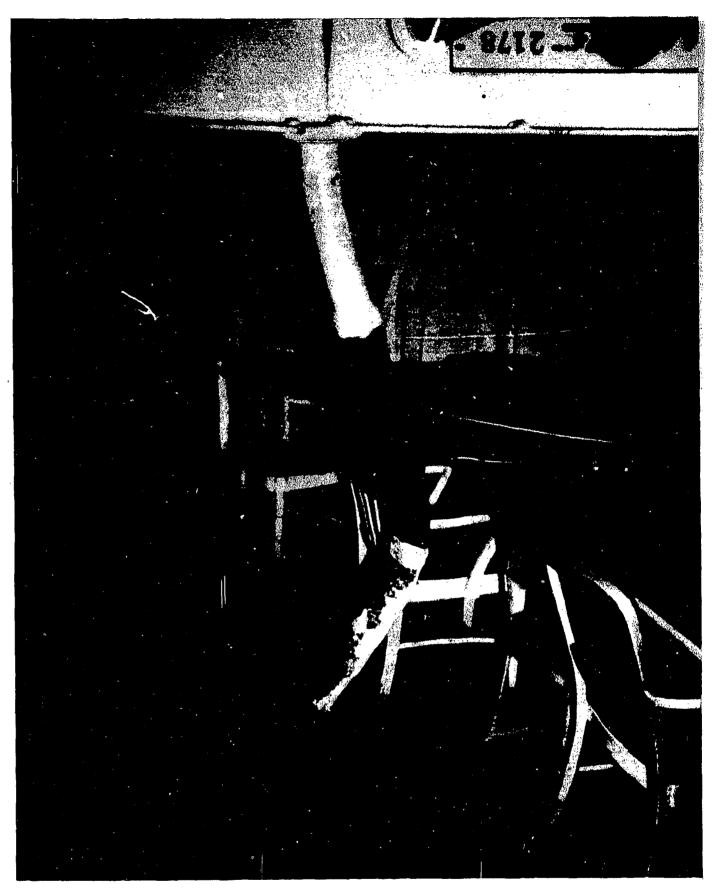
AA-CR-175-2178-4. Looking aft on 2nd deck showing stanchion failure, starboard side, in way of web frame 125.

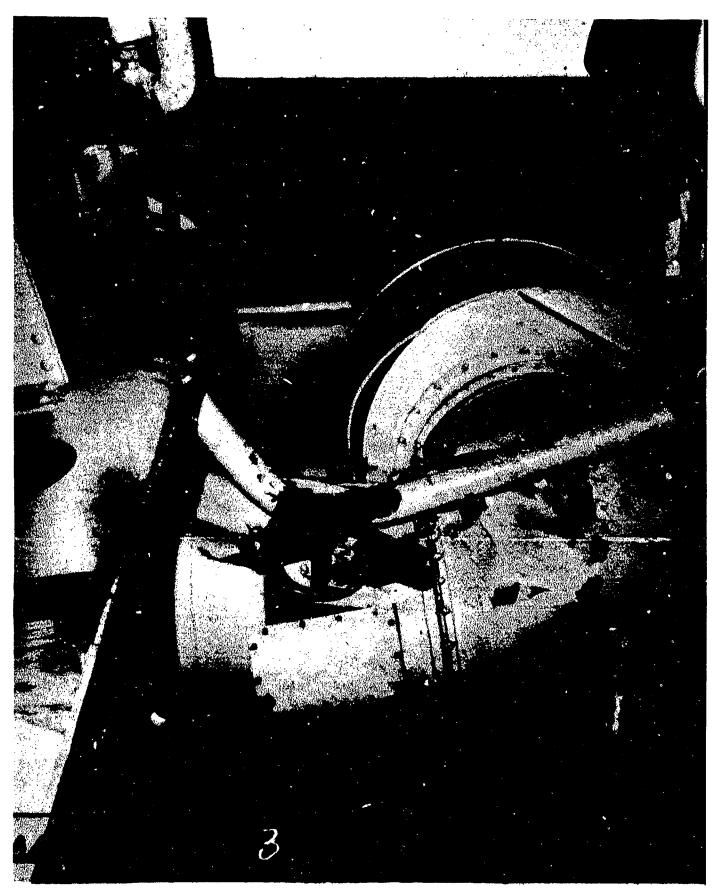
AA-CR-175-2178-3. Looking to port on 2nd deck showing failure of center-line stanchion at web frame 125 and damage to blower duct.

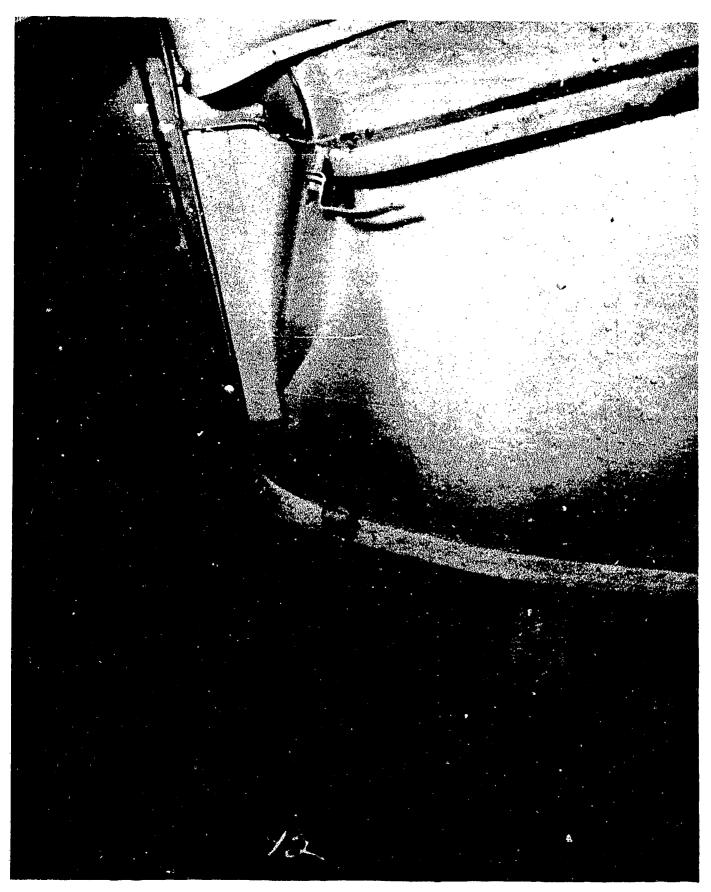
AA-CR-175-2178-12. Looking aft and to starboard shell on 2nd deck showing damage to bulkhead 128 and web frame.

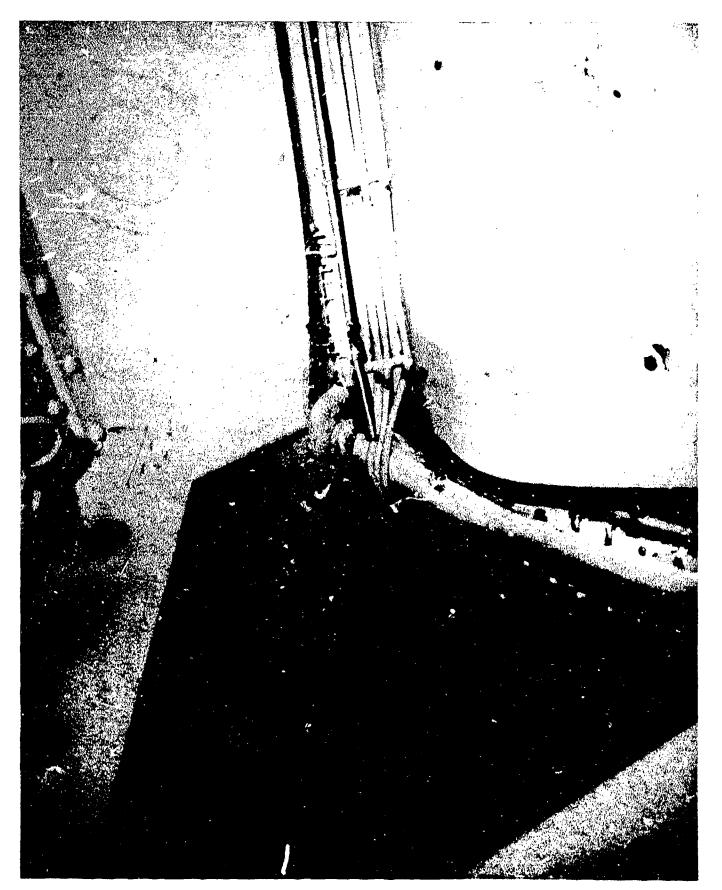
AA-CR-175-2179-1. D-203L. Looking aft and to starboard on 2nd deck showing stanchion failure at bulkhead 128 starboard.

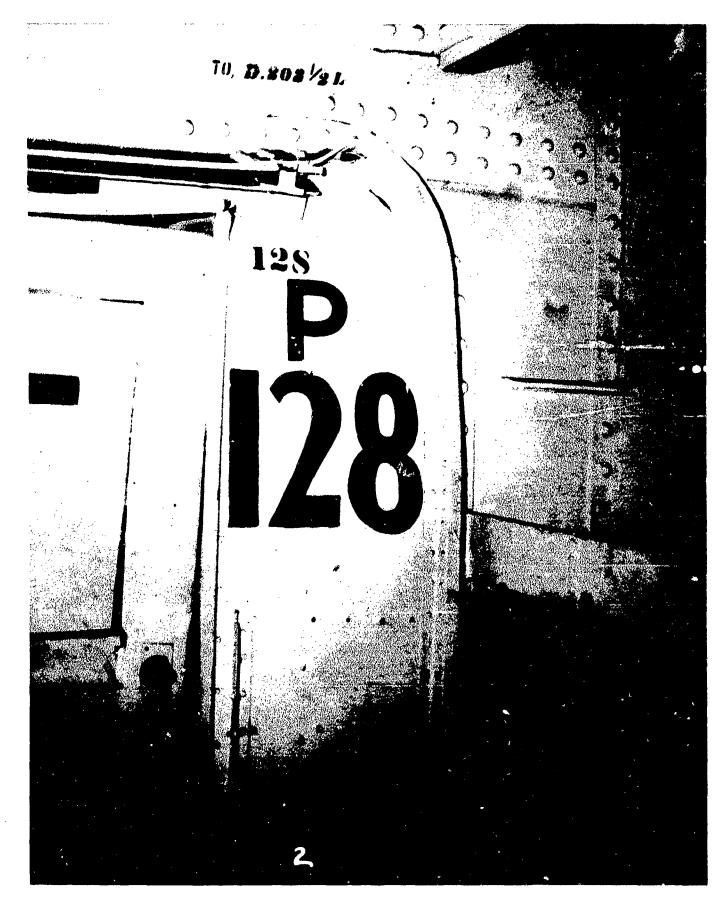
AA-CR-175-2179-2. D-203L. Looking aft on 2nd deck, port side, showing damage to web frame 128 and door to C.P.O. Mess.

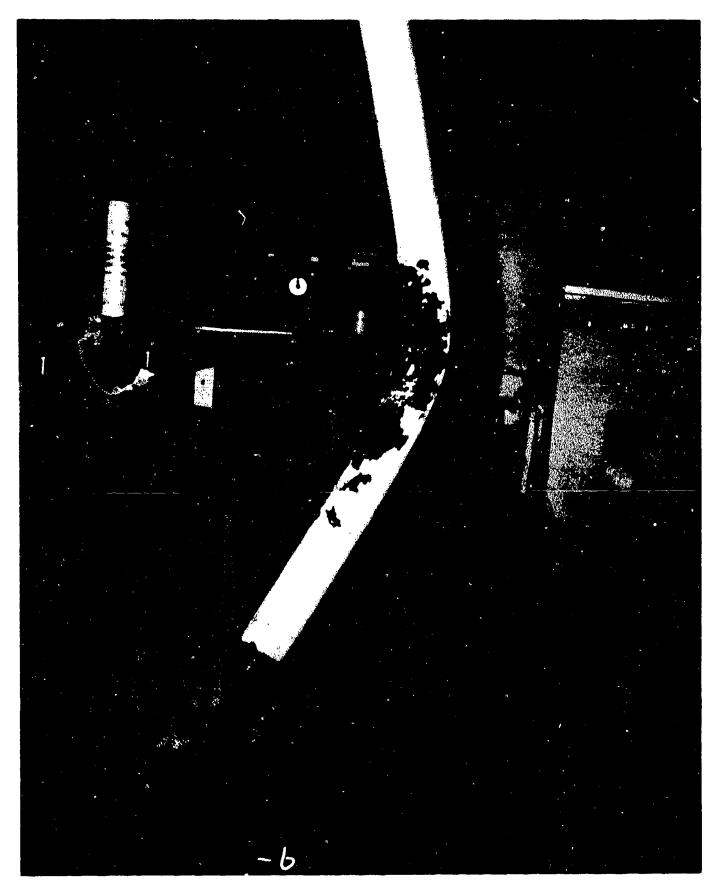
AA-CR-175-2179-6. D-203-2L. Looking aft on 2nd deck in C.P.O. mess showing damage to stanchion at frame 130, port.

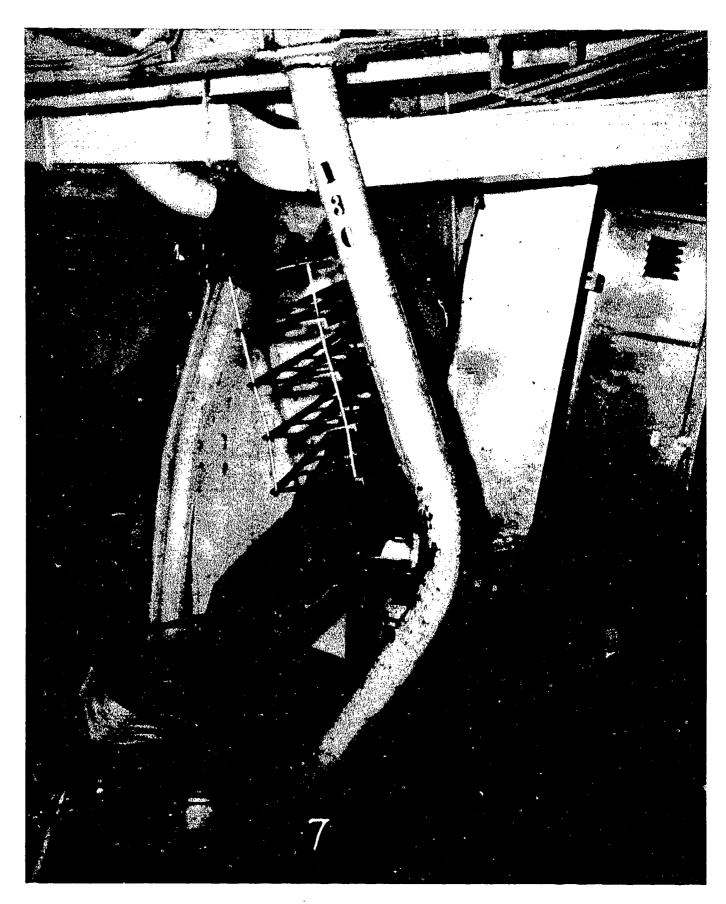
AA-CR-68-1766-7. Compartment D-203-2L. C.P.O.'s mess, 2nd deck, looking to starboard showing buckled and fractured stanchion at frame 130 and damage to C.P.O. pantry.

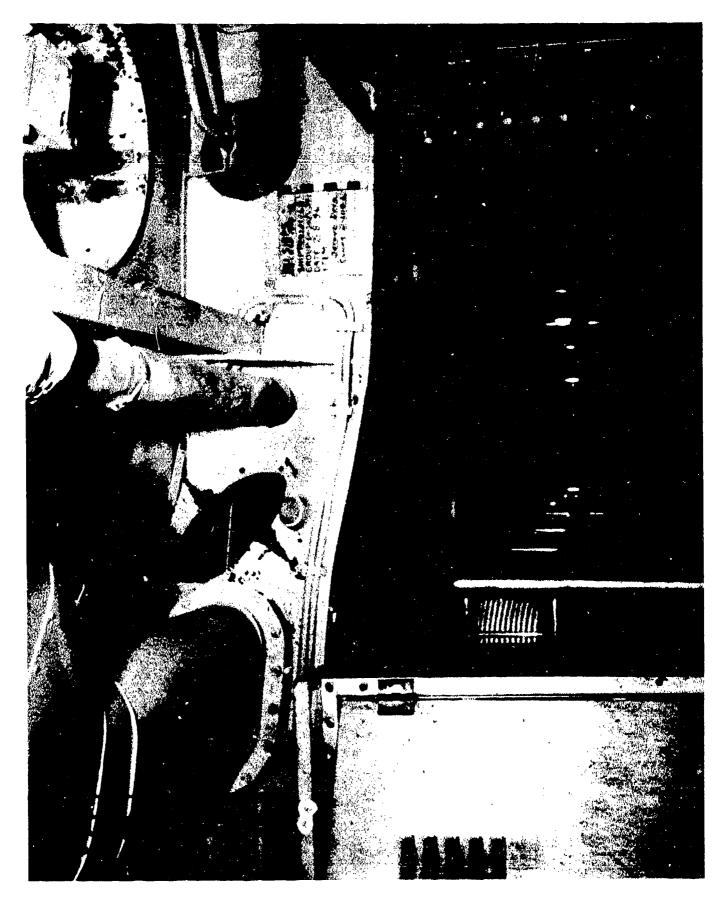
AA-CR-68-1766-8. Compartment D-204-L. C.P.O. quarters, 2nd deck, looking aft on starboard side showing damage to frame 135.

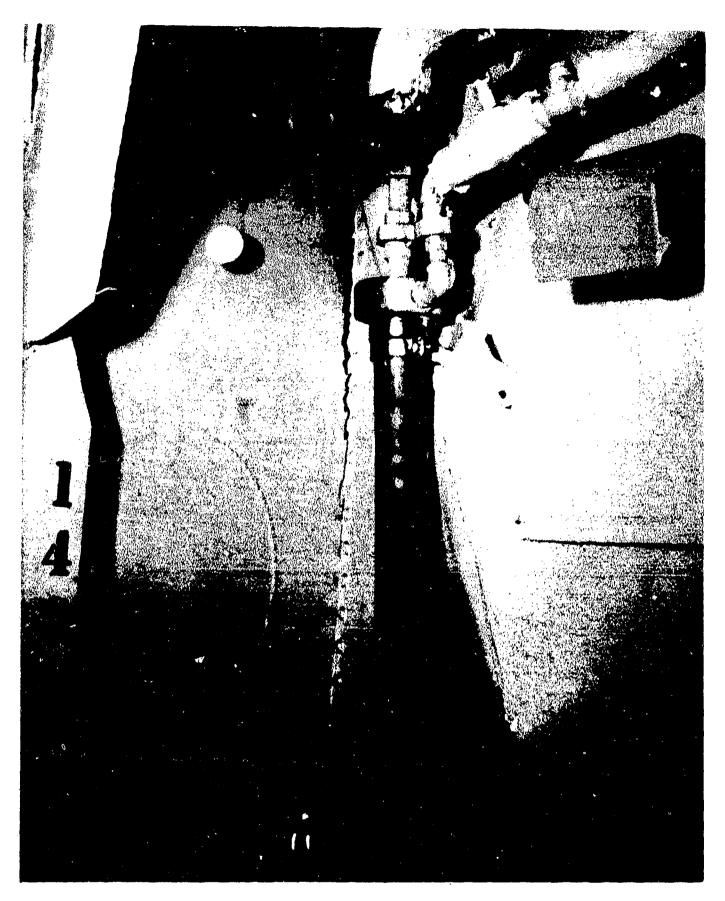
AA-CR-175-2179-11. D-204L. Looking forward and to port on 2nd deck showing failure of bulkhead 139 1/2 at port shell.

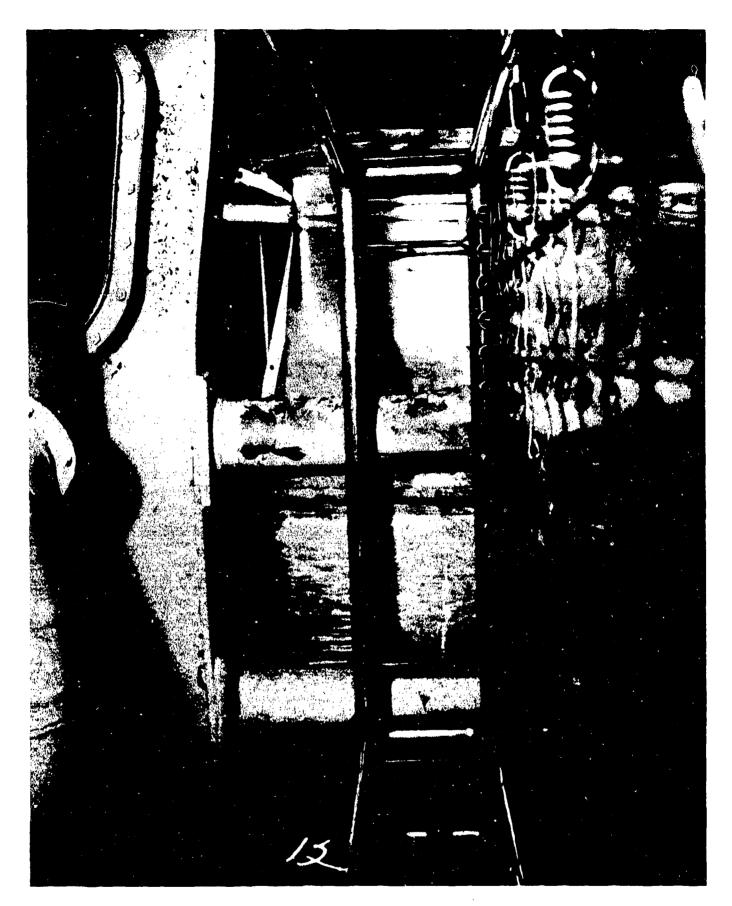
AA-CR-175-2179-12. Looking forward on 2nd deck showing failure of port side stanchion at frame 135. Note deflection of deck beam toward centerline.

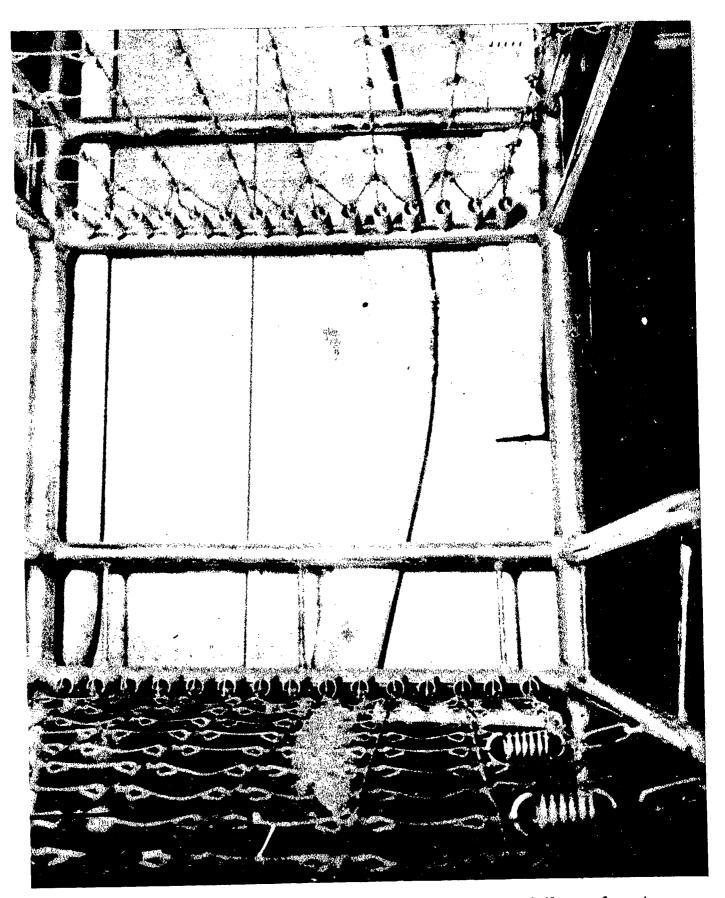
AA-CR-175-2180-1. Looking forward on 2nd deck showing failure of center-line stanchion at frame 135 in C.P.O. quarters.

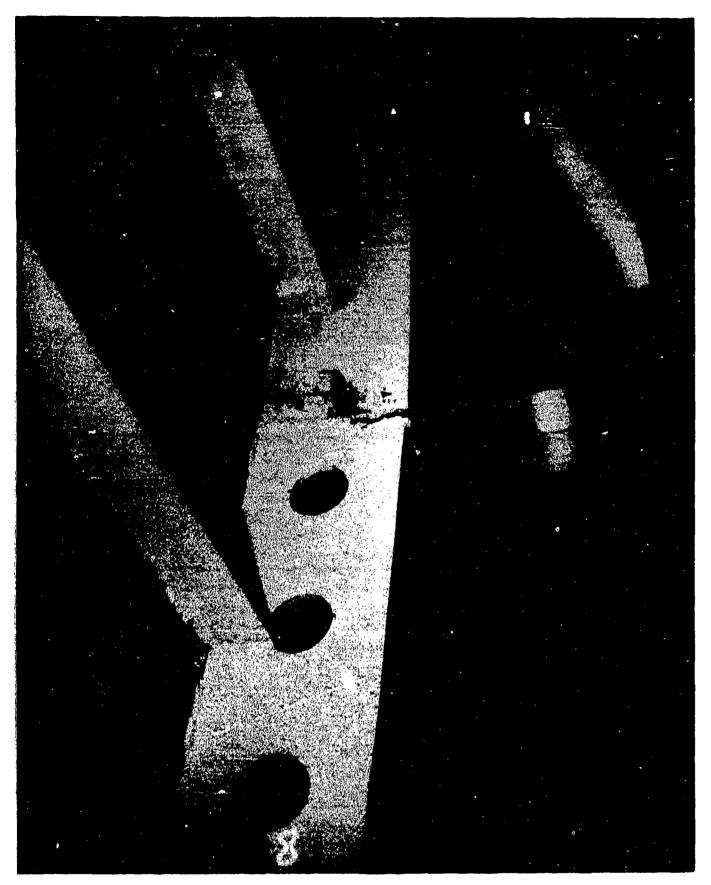
AA-CR-175-2179-8. D-204L. Looking aft and to starboard on 2nd deck showing failure of main deck longitudinal at frame 137.
