# U.S.S. PENSACOLA (CA24)

TEST ABLE

VOLUME 2 OF 2

OPERATION CROSSROADS DDC

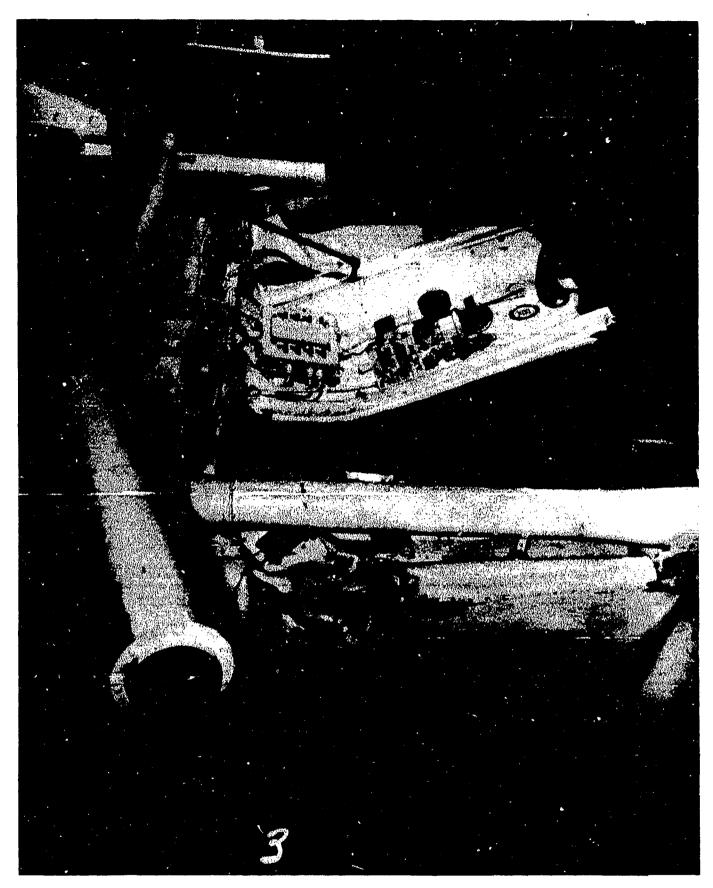
AA-CR-68-1755-3. Various electrical wiring and appliances on ruptured bulkhead.

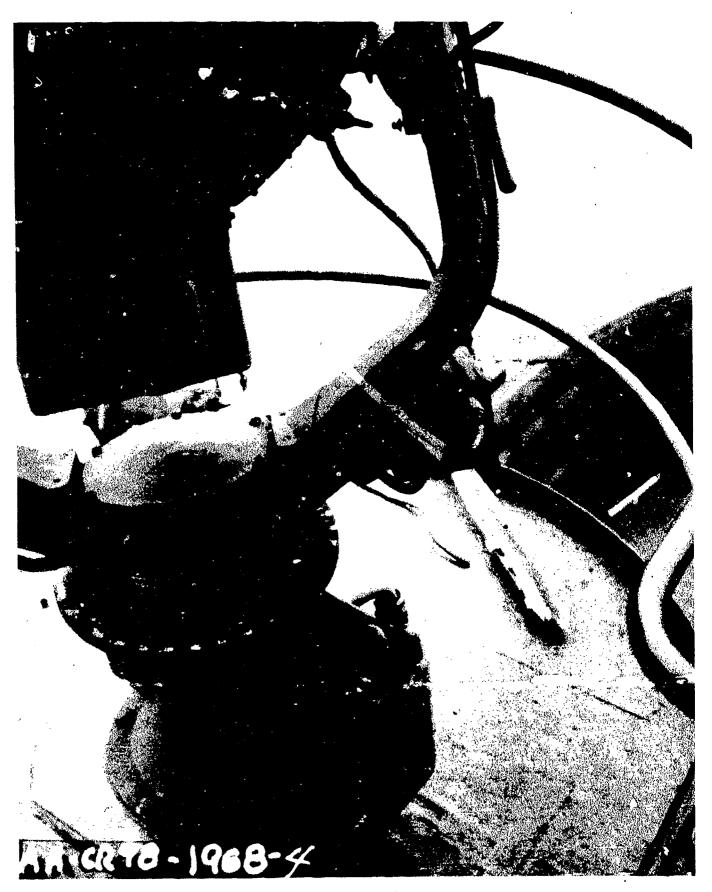
AA-CR-98-1968-4. Cracked pedestal of 24" searchlight, starboard side of radar control room house top, frame 45.
