BUREAU OF SHIPS GROUP TECHNICAL INSPECTION REPORT

U.S.S. SALT LAKE CITY (CA25)

TEST ABLE

OPERATION CROSSROADS

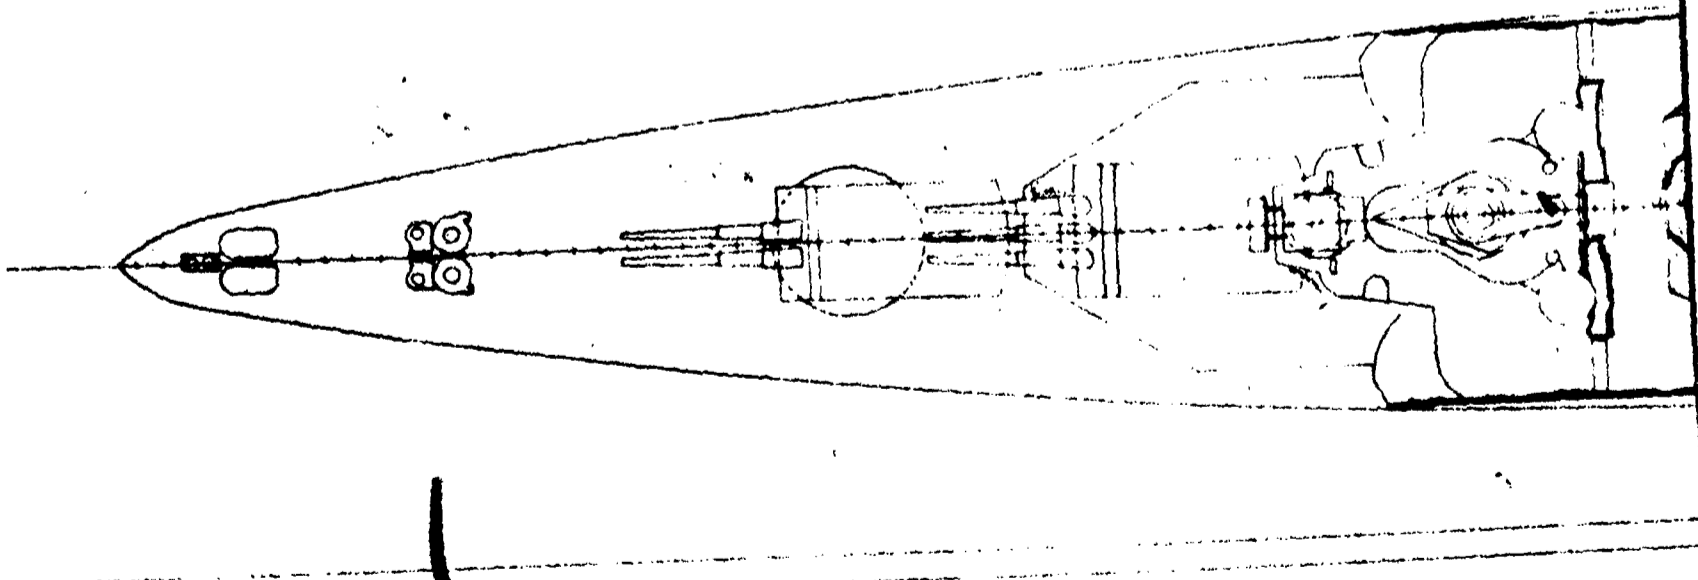
BOTH SEARCHLIGHTS BROKEN AT THE BASE RING
STBD LIGHT THROWN ONTO NAV BRIDGE

BENT TO STBD AND FORD APPROXIMATELY 25°

DECK TORN AT EXHAUST VENT

STACK TORN AWAY ABOVE DECK

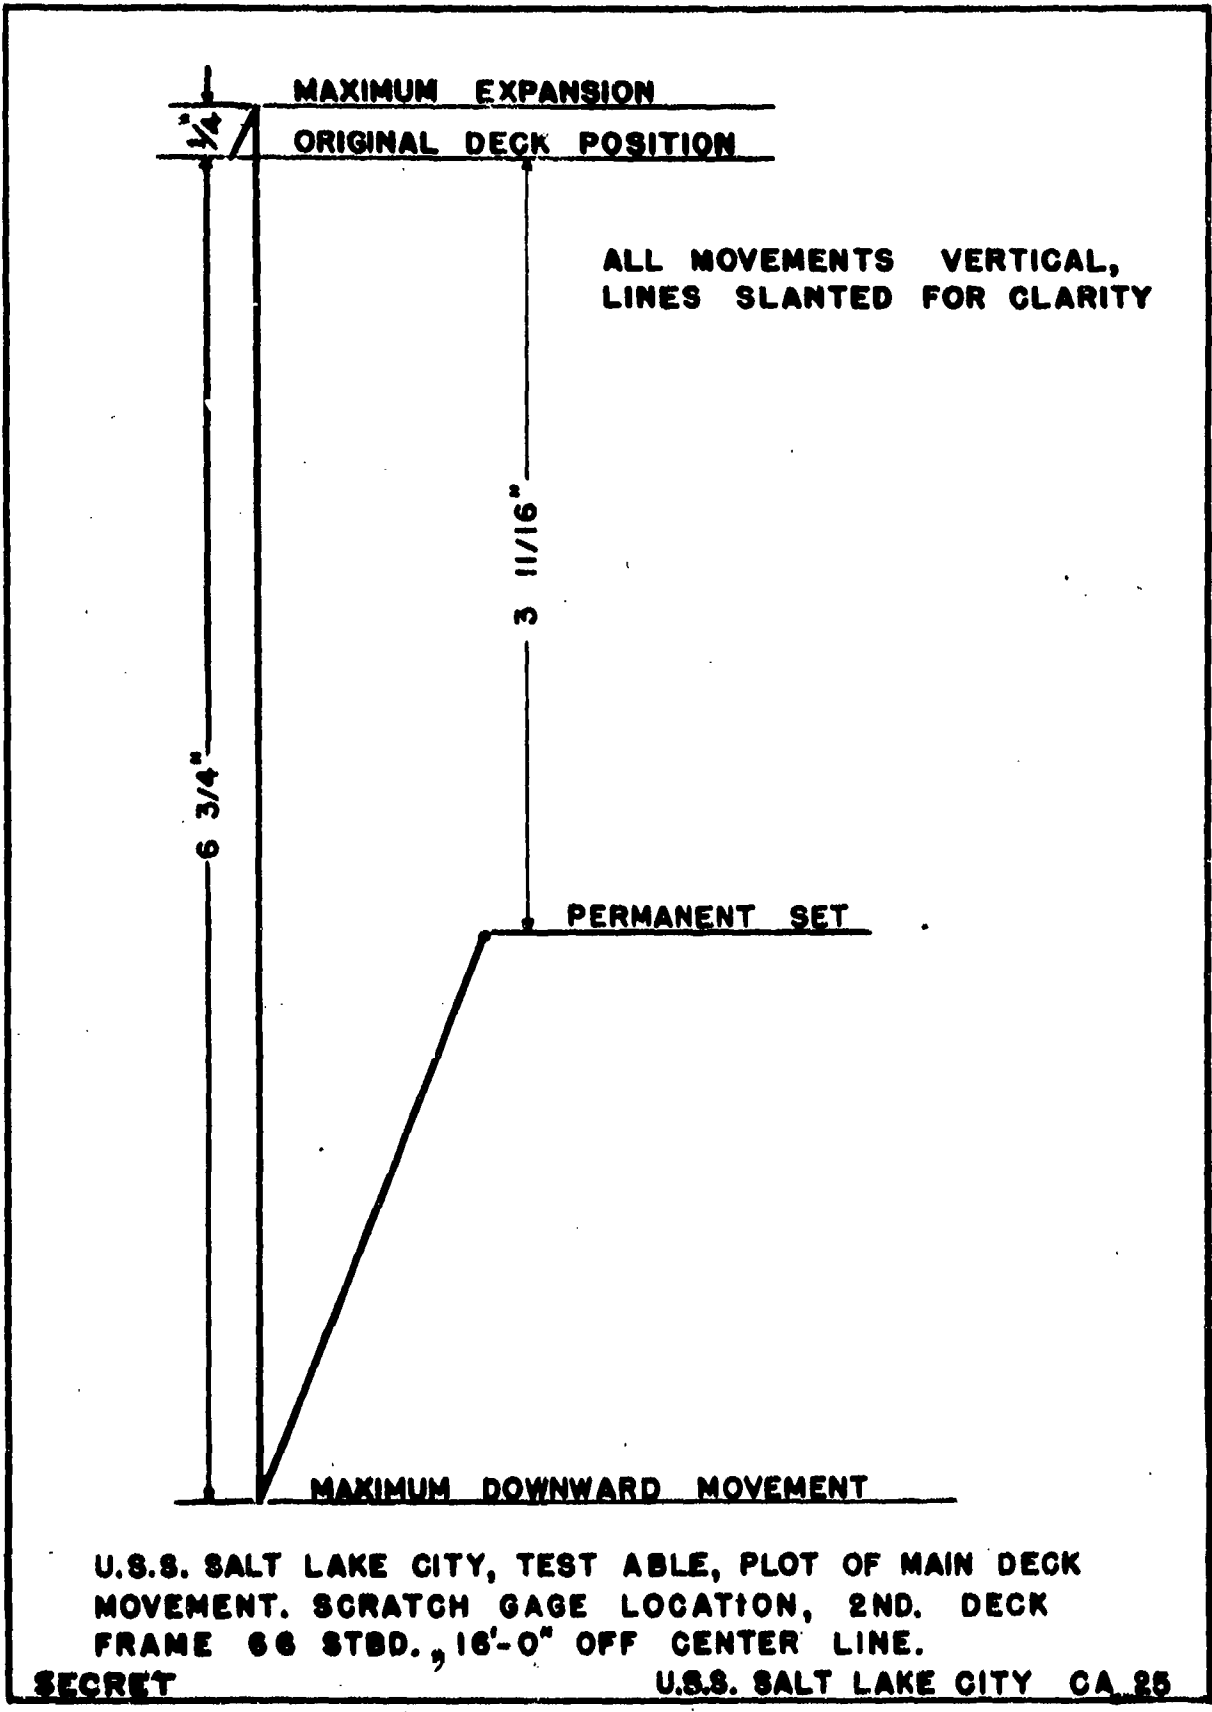
U.S.S. SALT LAKE CITY, TEST ABLE, PLOT OF MAIN DECK
 MOVEMENT. SCRATCH GAGE LOCATION, 2ND. DECK
 FRAME 66 STBD., 16'-0" OFF CENTER LINE.

The main deck has sustained a major deflection between bulkheads 61 and 71 1/2 with resultant buckling of stanchions below. There are also areas of minor dishing aft. There is no hull damage below the second deck, except for a leak in innerbottom tank C-909-F.

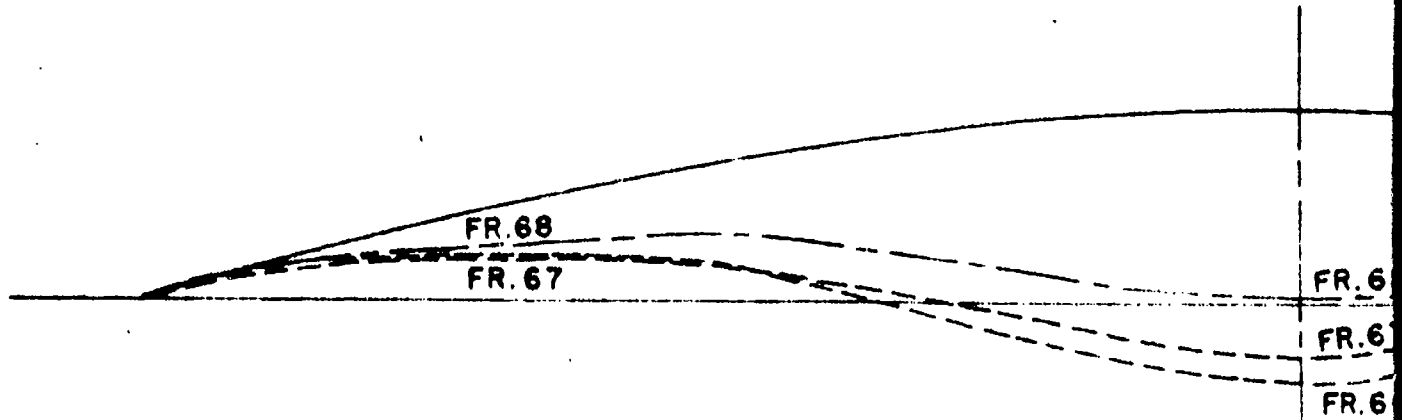
Light topside structure is damaged extensively. Both stacks are demolished. The principal structural damage is to the main deck. Maximum deflection of the deck is 16 3/4 inches at frame 66.

MAX. DEFLECTION _____ INCHES

FR. 66 ----- 16 1/4

FR. 67 ----- 14 1/2

FR. 68 ----- 11

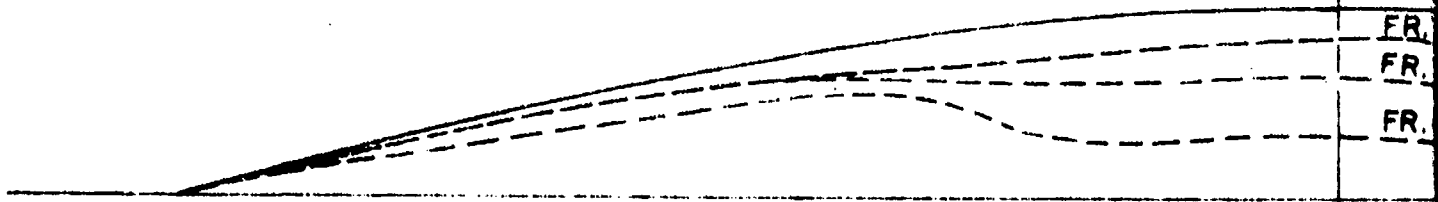
MAX. DEFLECTION _____ INCHES

FR. 69 ----- 7 1/2

FR. 70 ----- 4

FR. 71 ----- 1 3/4

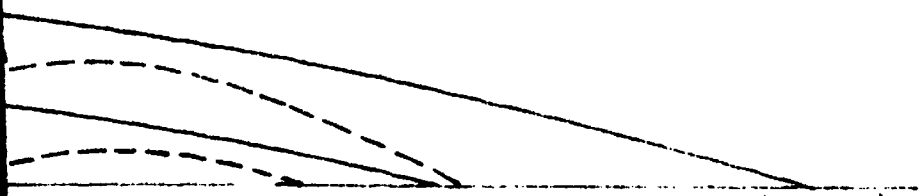
MAX. DEFLECTION _____ INCHES
 FR. 61 _____ 6 7/8
 FR. 62 _____ 12 1/2

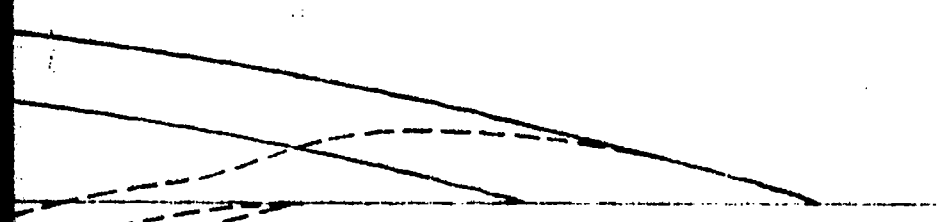
MAX. DEFLECTION _____ INCHES
 FR. 63 _____ 14 3/4
 FR. 64 _____ 15 1/4
 FR. 65 _____ 15 3/8
