⑨ BUREAU OF SHIPS GROUP TECHNICAL INSPECTION REPORT

⑥ OPERATION CROSSROADS.
PRINZ EUGEN (Ex-German CA)

TEST ABLE U.S. ⑧

DETAILED DESCRIPTION OF HULL DAMAGE

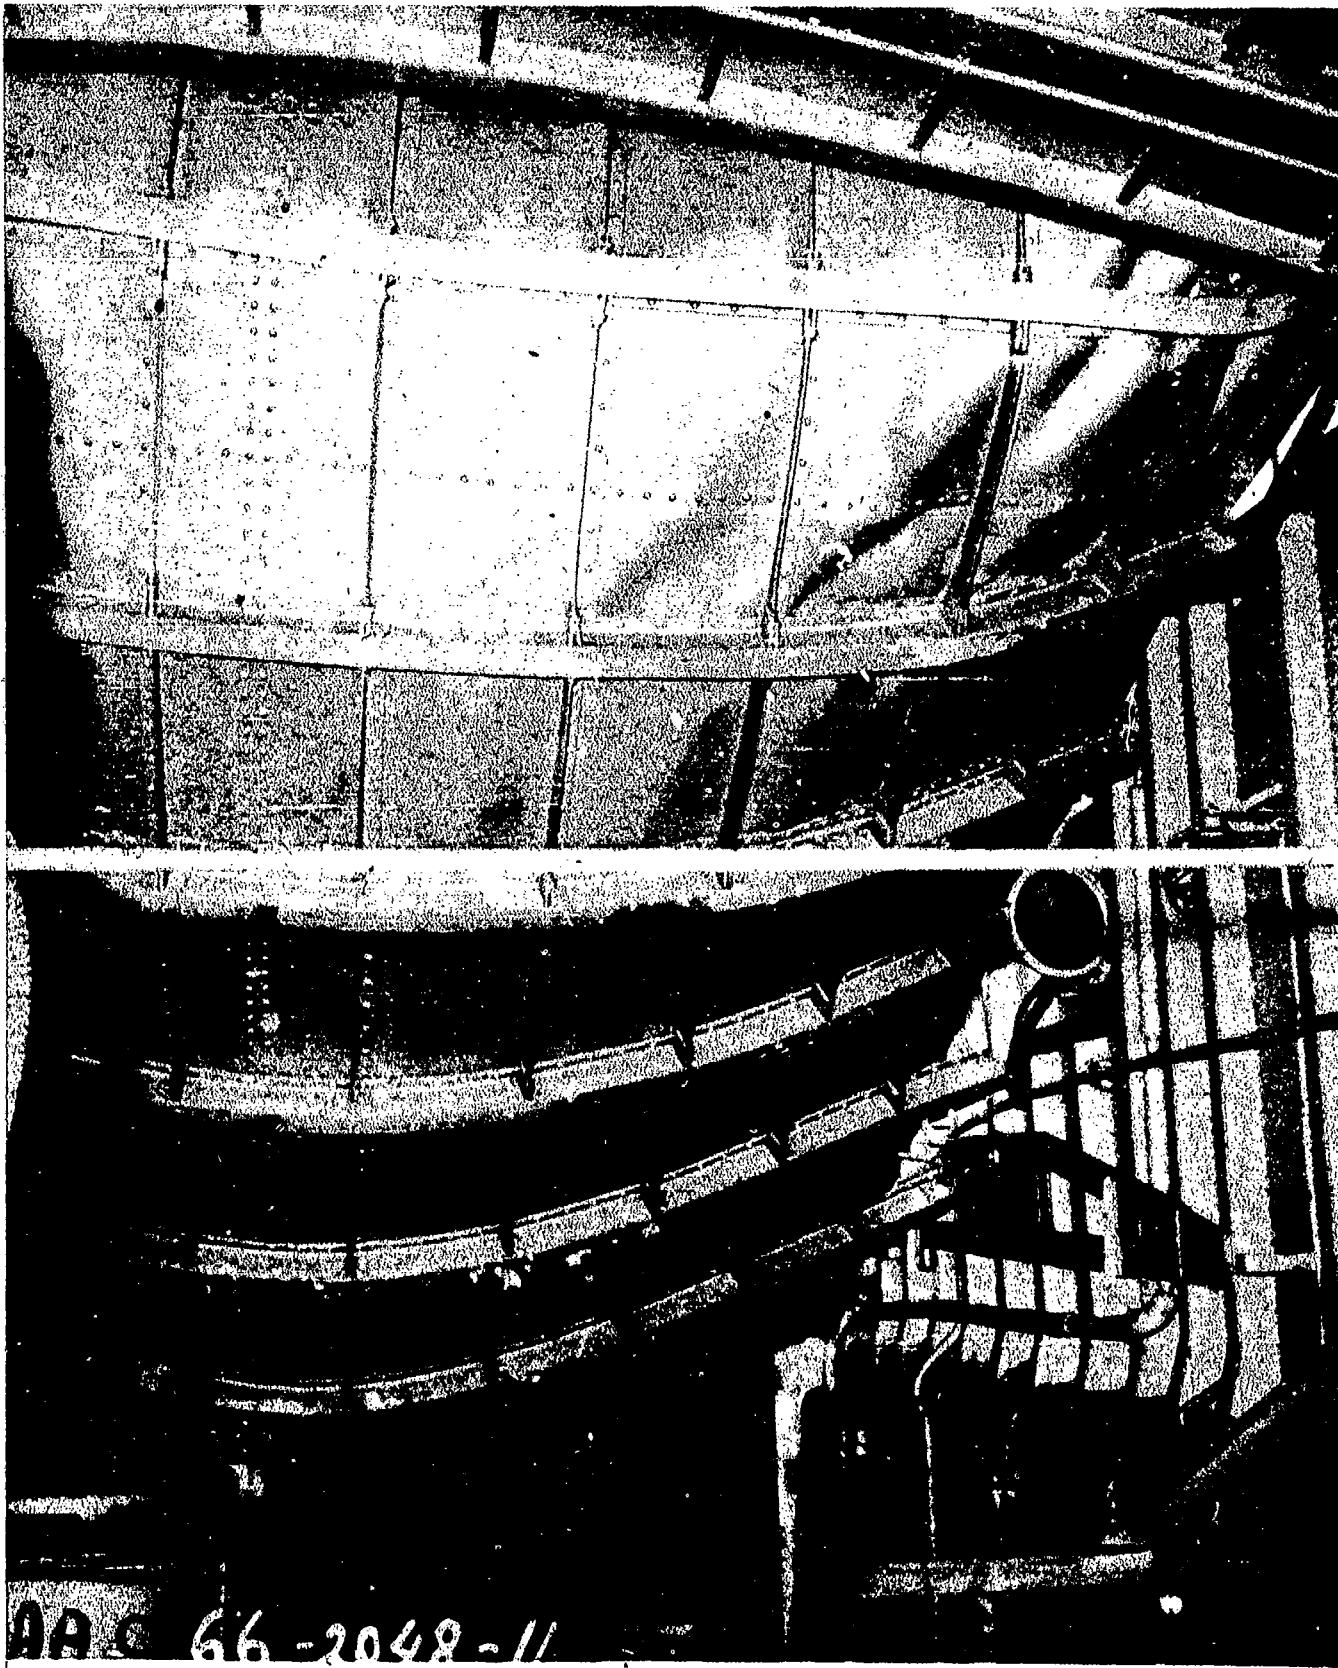
The sliding hangar cover on the second superstructure deck has been blown in and damaged beyond use. This cover is aluminum alloy with six inch "I" stiffeners. (Photos 2049-3, 1774-4, 2049-1, 5, 4, 2048-11 and 2049-2, pages 65 ; 66 , 67 , 68 , 69 , 70 , and 71).

AA-CR-66-2048-11. Looking aft and up at wrecked hangar cover.

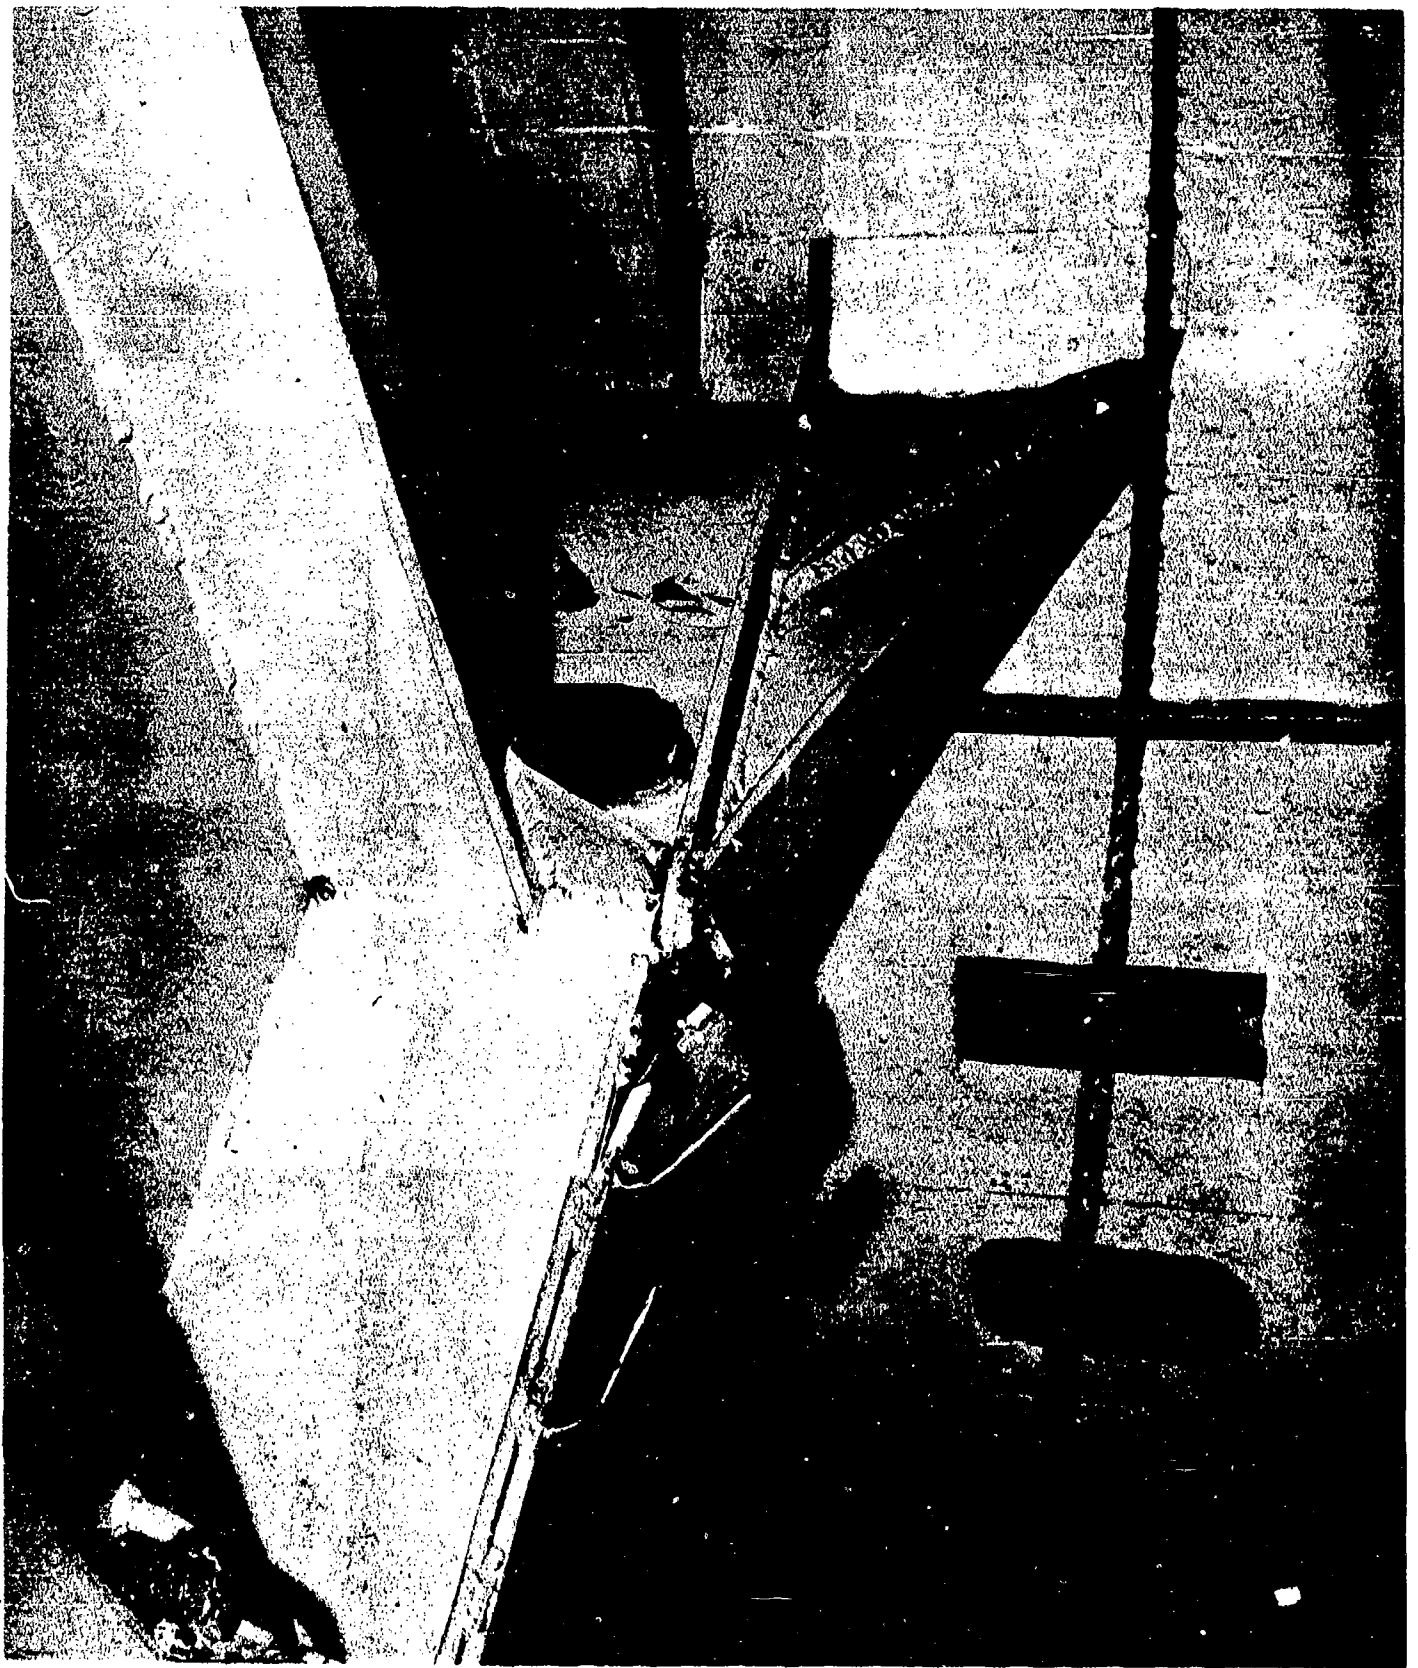
The superstructure deck and supporting structure, aft of turret 2, frames 141.6 to 147.3, show evidence of compression. The two deck longitudinals, two meters to port and starboard of the ship's centerline are built up T's with a 10 x 1/2 inch web, 4 x 3/8 inch flange, and 3 x 1/2 inch face plate. In both cases the flange and face plate connection to brackets from turret 2 have failed. The longitudinals show strain where welded to deck beams at frame 141, 142, 143, 144, 145, and 146. Some of these beams are deflected slightly upwards and some slightly downward. This damage appears to have resulted from combined loading exerted by the blast pressure on the deck and forward face of the turret. (Photos 1850-12, 2049-6, 2049-7, 1850-11, 2049-9, 2049-11, pages 73 , 74 , 75 , 76 , 77 , and 78). Joiner bulkheads under the superstructure deck are buckled sharply.

The only panels deflected are a few joiner bulkheads and the sliding cover of the hangar. It is considered that the damage to the superstructure deck aft of turret 2 is the combined effect of pressure loading on the deck and on the face of the turret.

AA-CR-65-1850-12. Connection of longitudinal under superstructure deck, 2 meters to starboard of ships centerline to the face of turret 2. Note buckling of web and failure of flange and face plate.

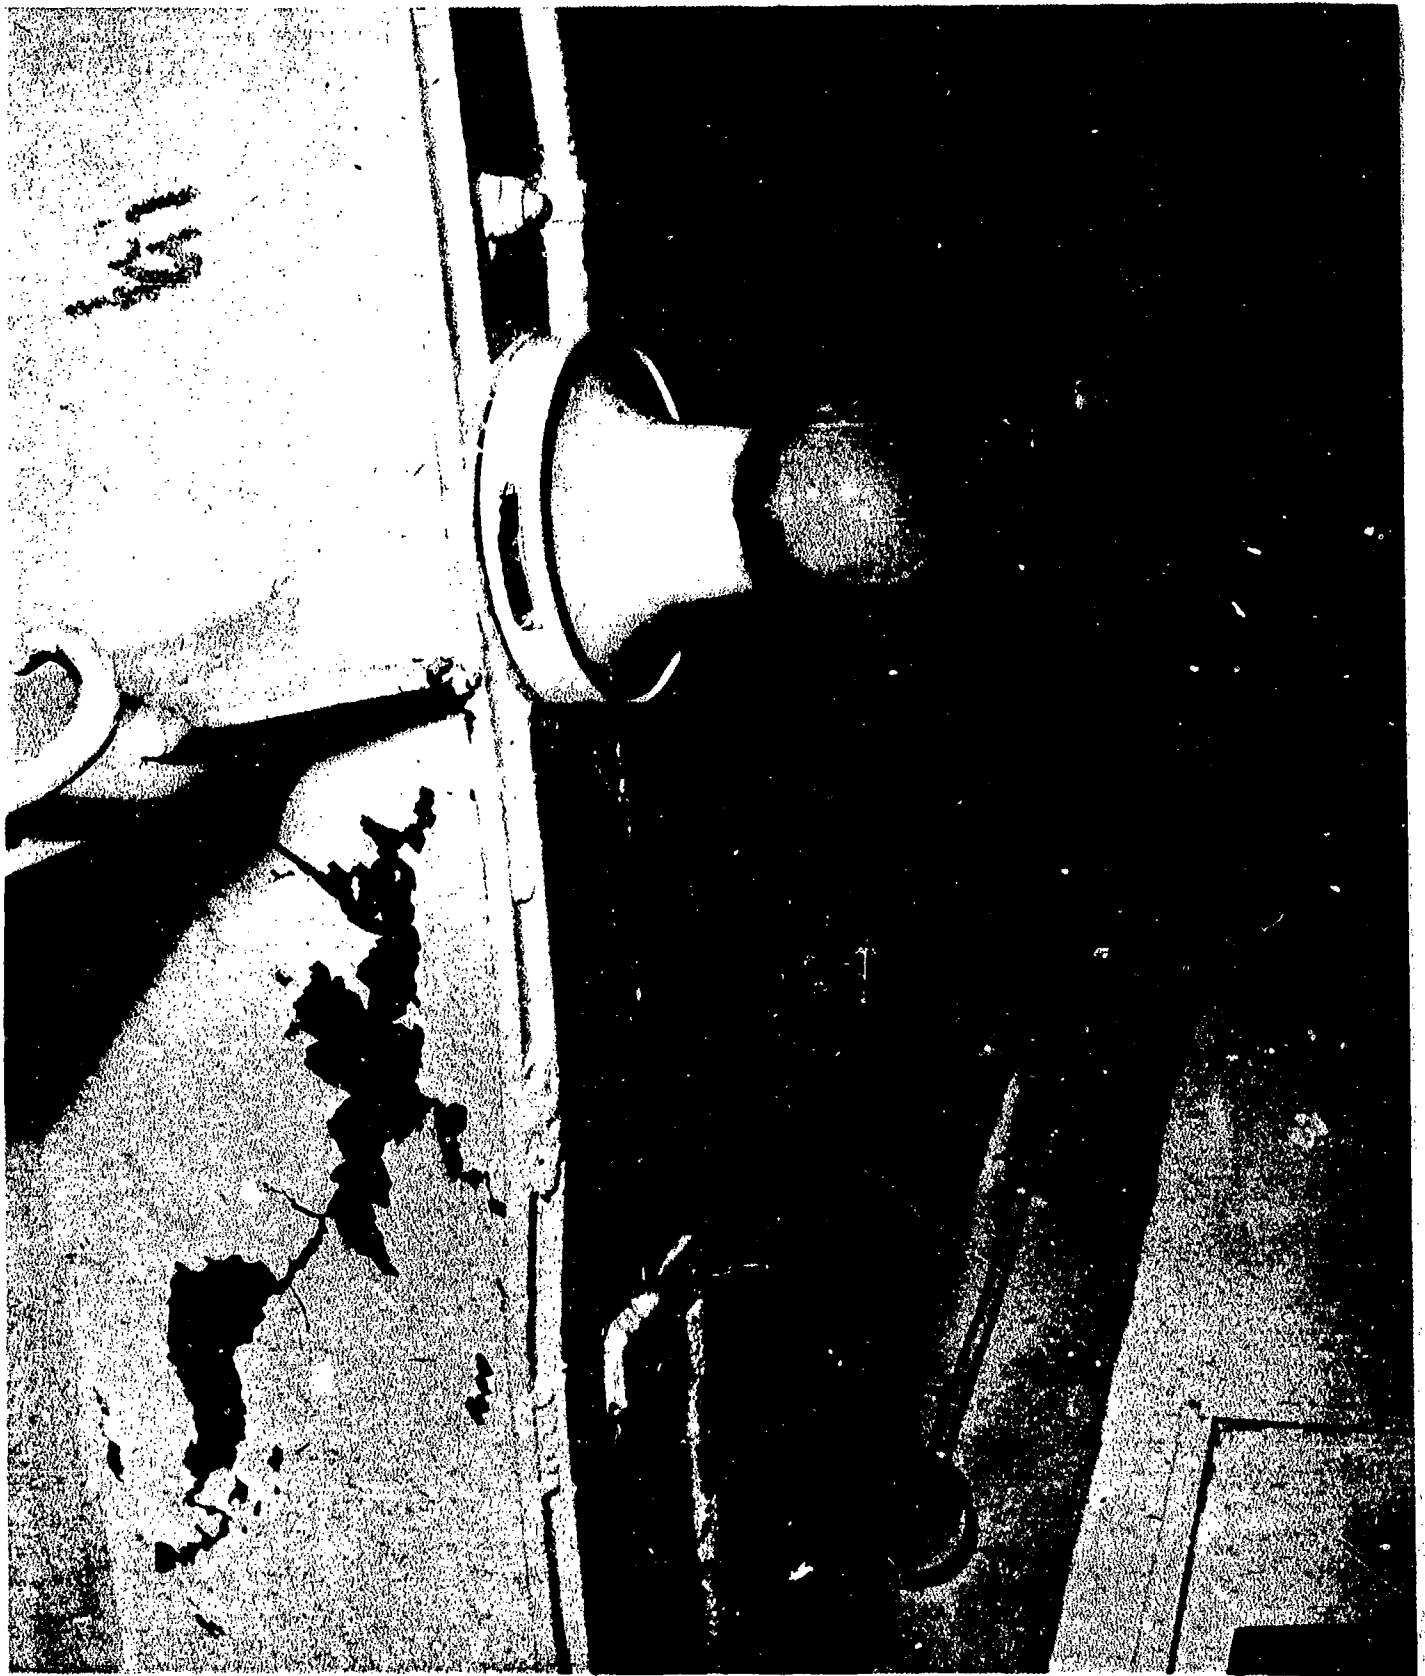
AA-CR-66-2049-9. Looking inboard at longitudinal under super-structure deck, 2 meters to port of centerline. View is at frame 146. Note buckle of web and flange.
