BUREAU OF SHIPS GROUP TECHNICAL INSPECTION REPORT

OPERATION CROSSROADS. U.S.S. INDEPENDENCE (CVL22)

TEST ABLE

VOLUME 1 OF 4 [W]

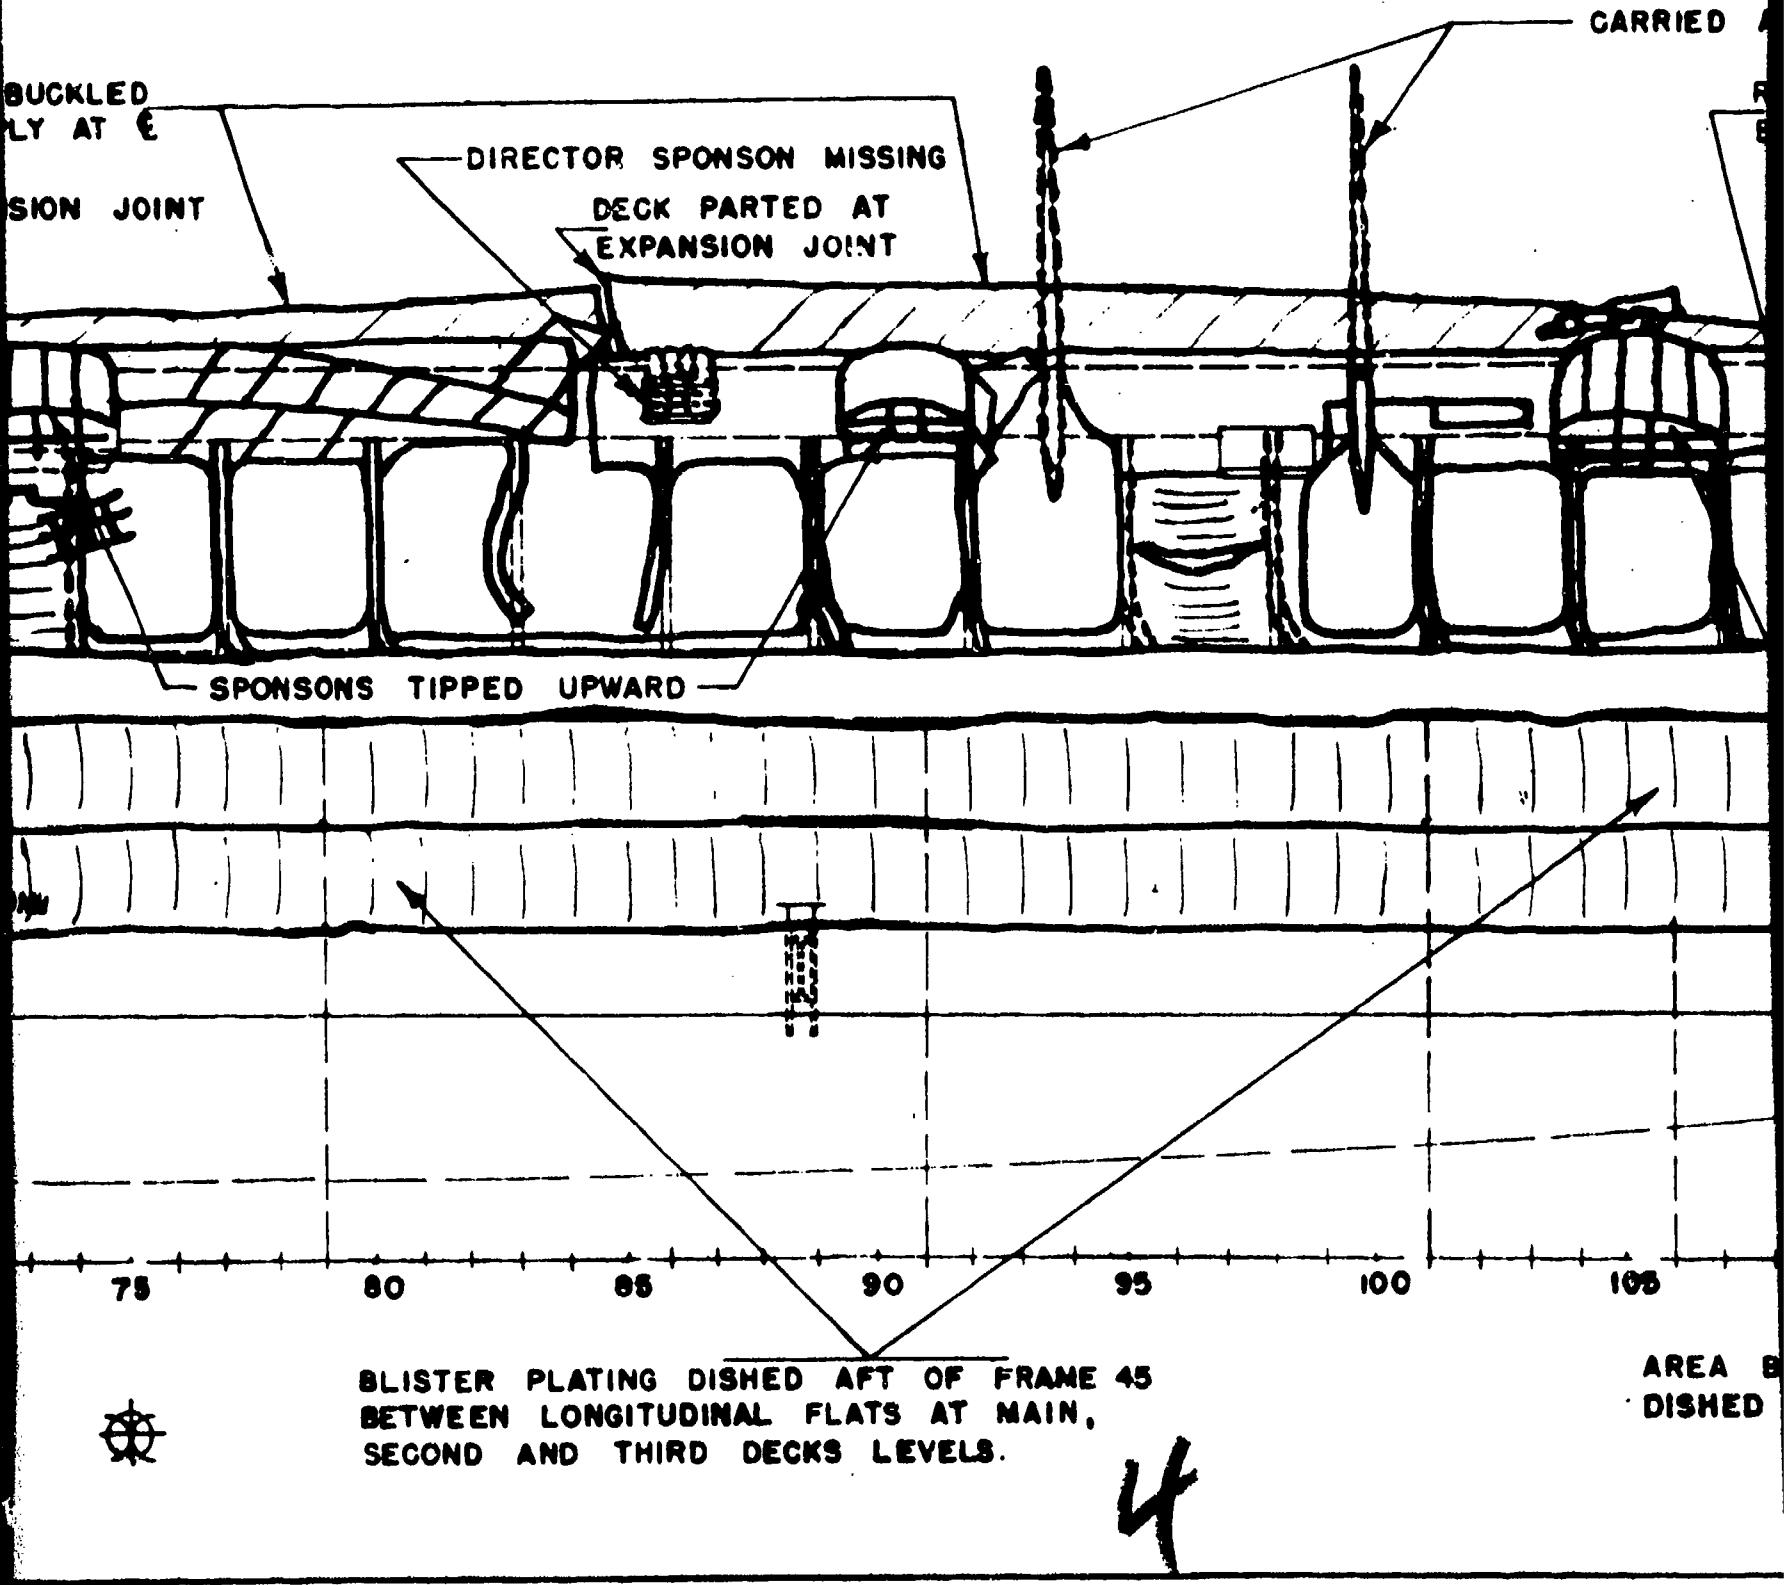
ROLLER CURTAINS CARRIED AWAY TO STARBOARD BY BLAST.

CARRIED AWAY BY BLAST

MAIN DECK EXPOSED THROUGH TEAR AND TURNED DOWNWARD

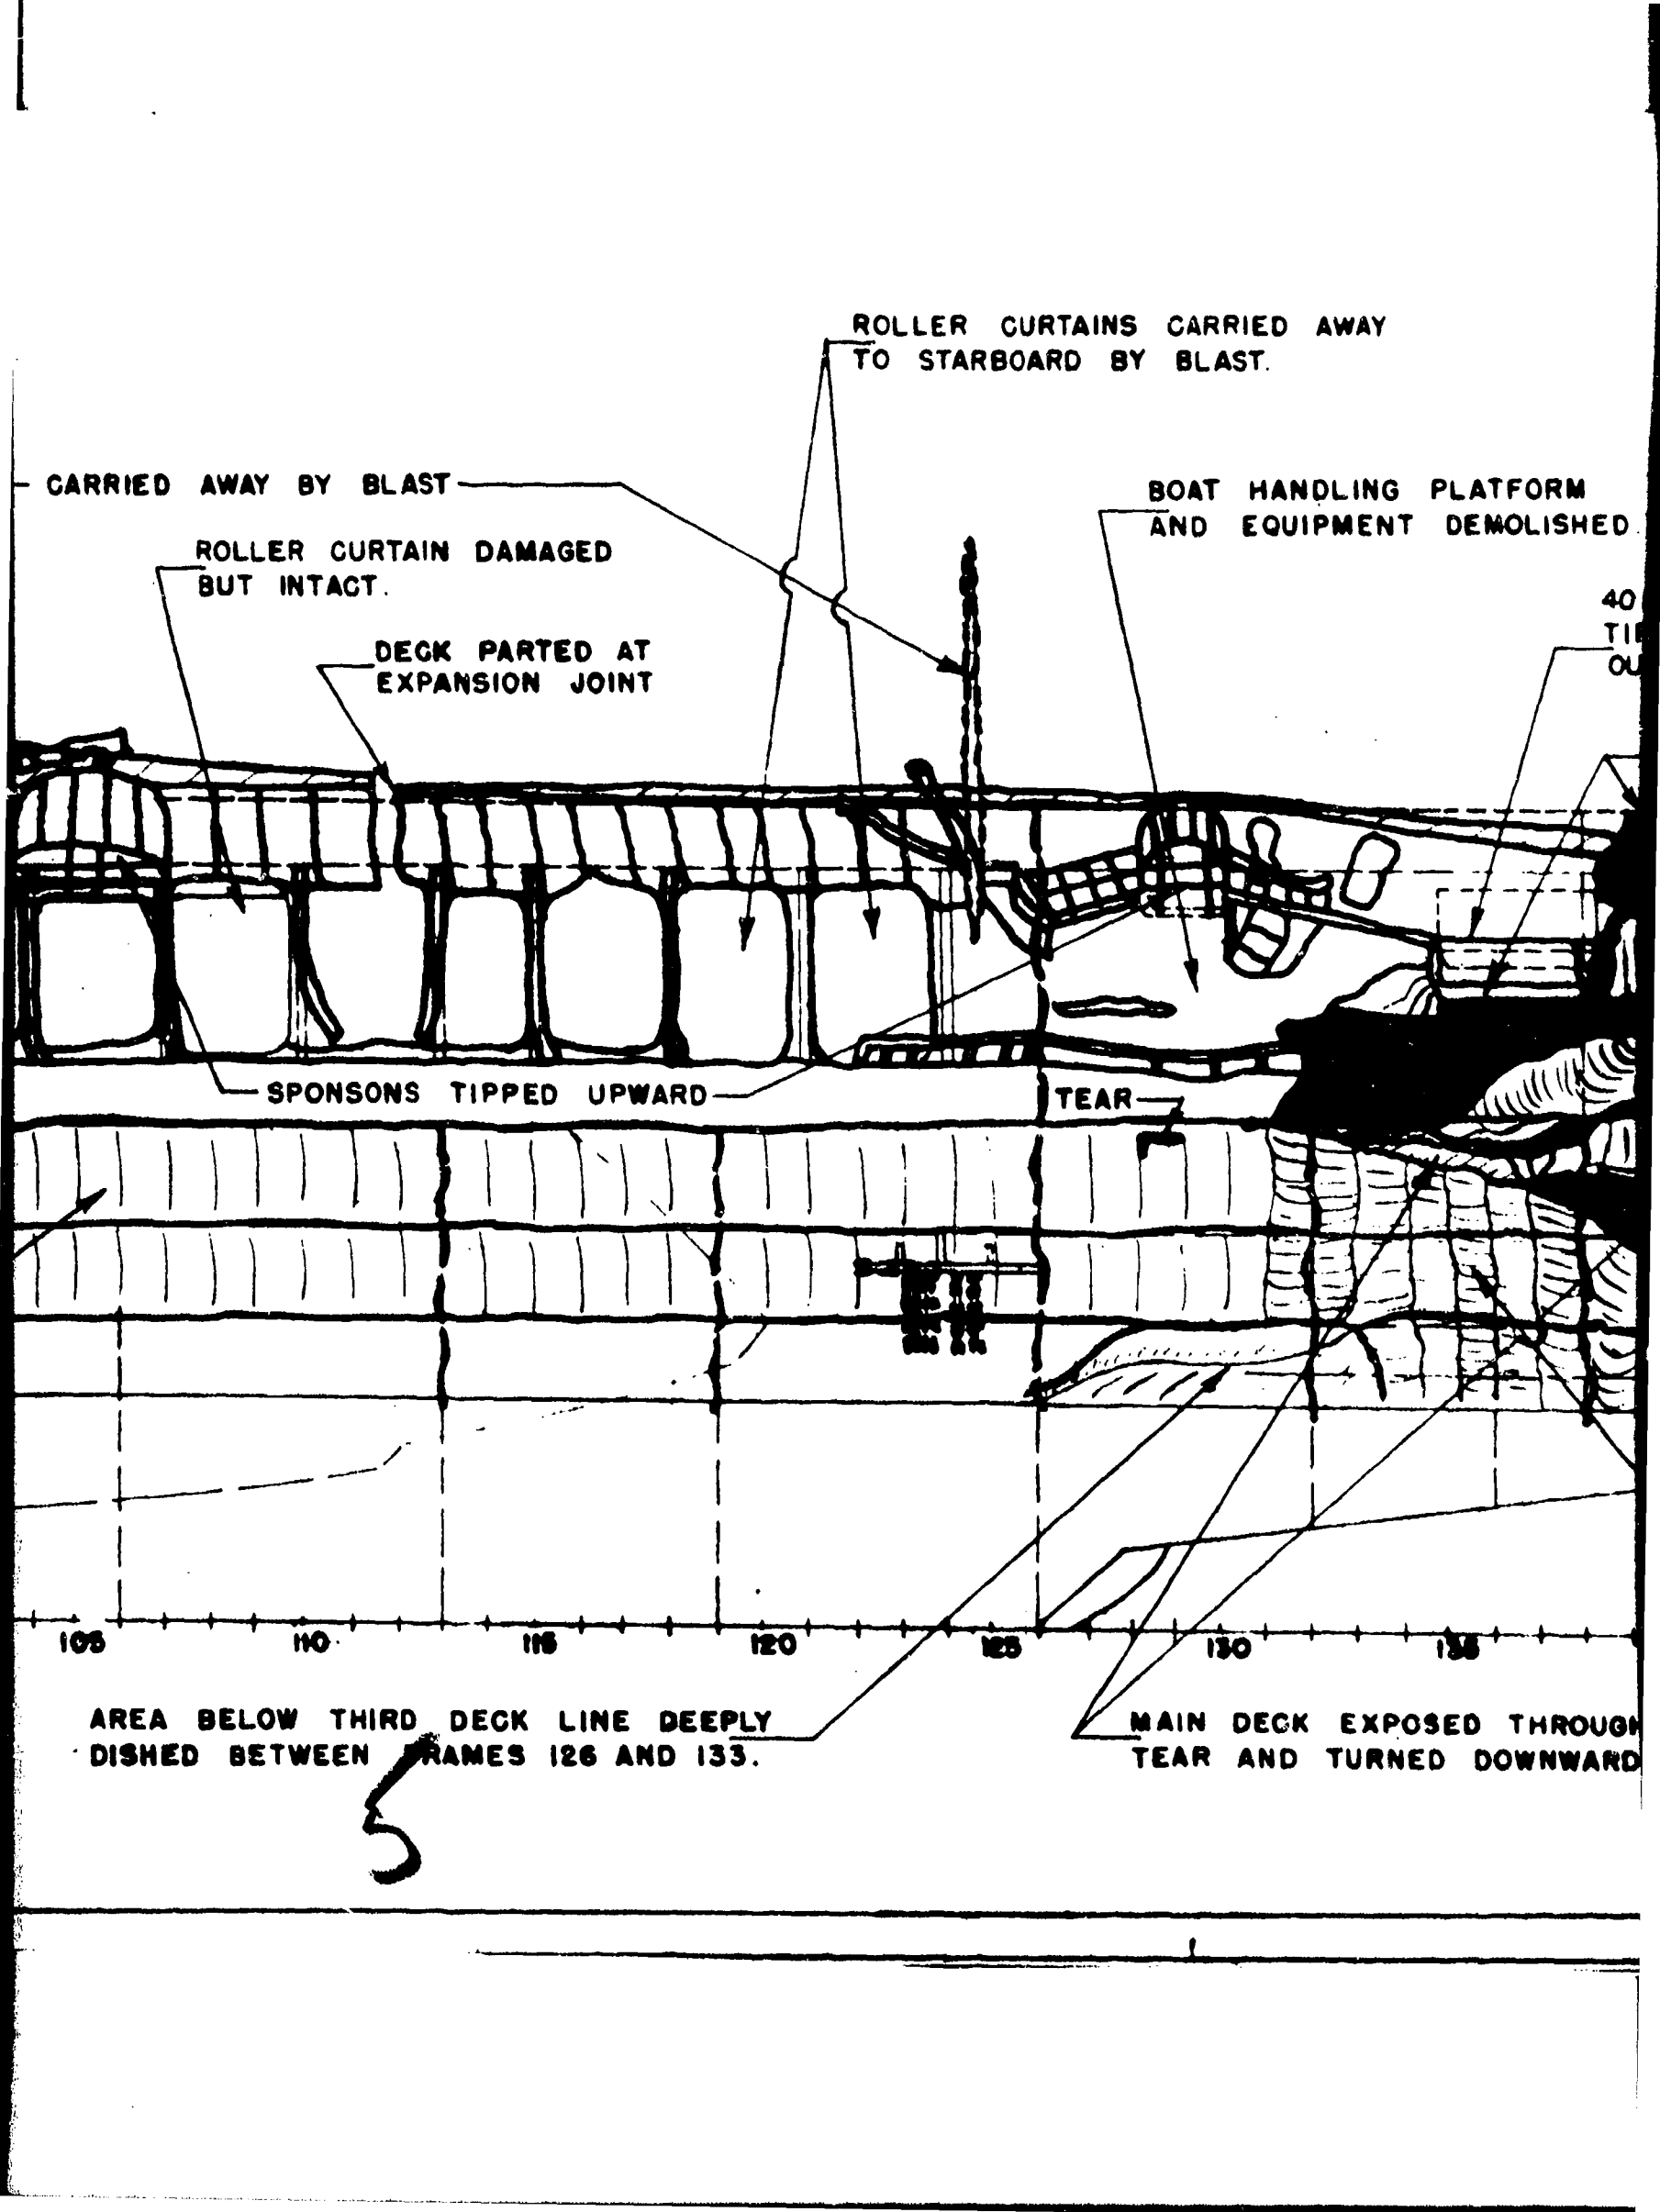
R CURTAINS CARRIED AWAY
ARBOARD BY BLAST.

BOAT HANDLING PLATFORM
AND EQUIPMENT DEMOLISHED

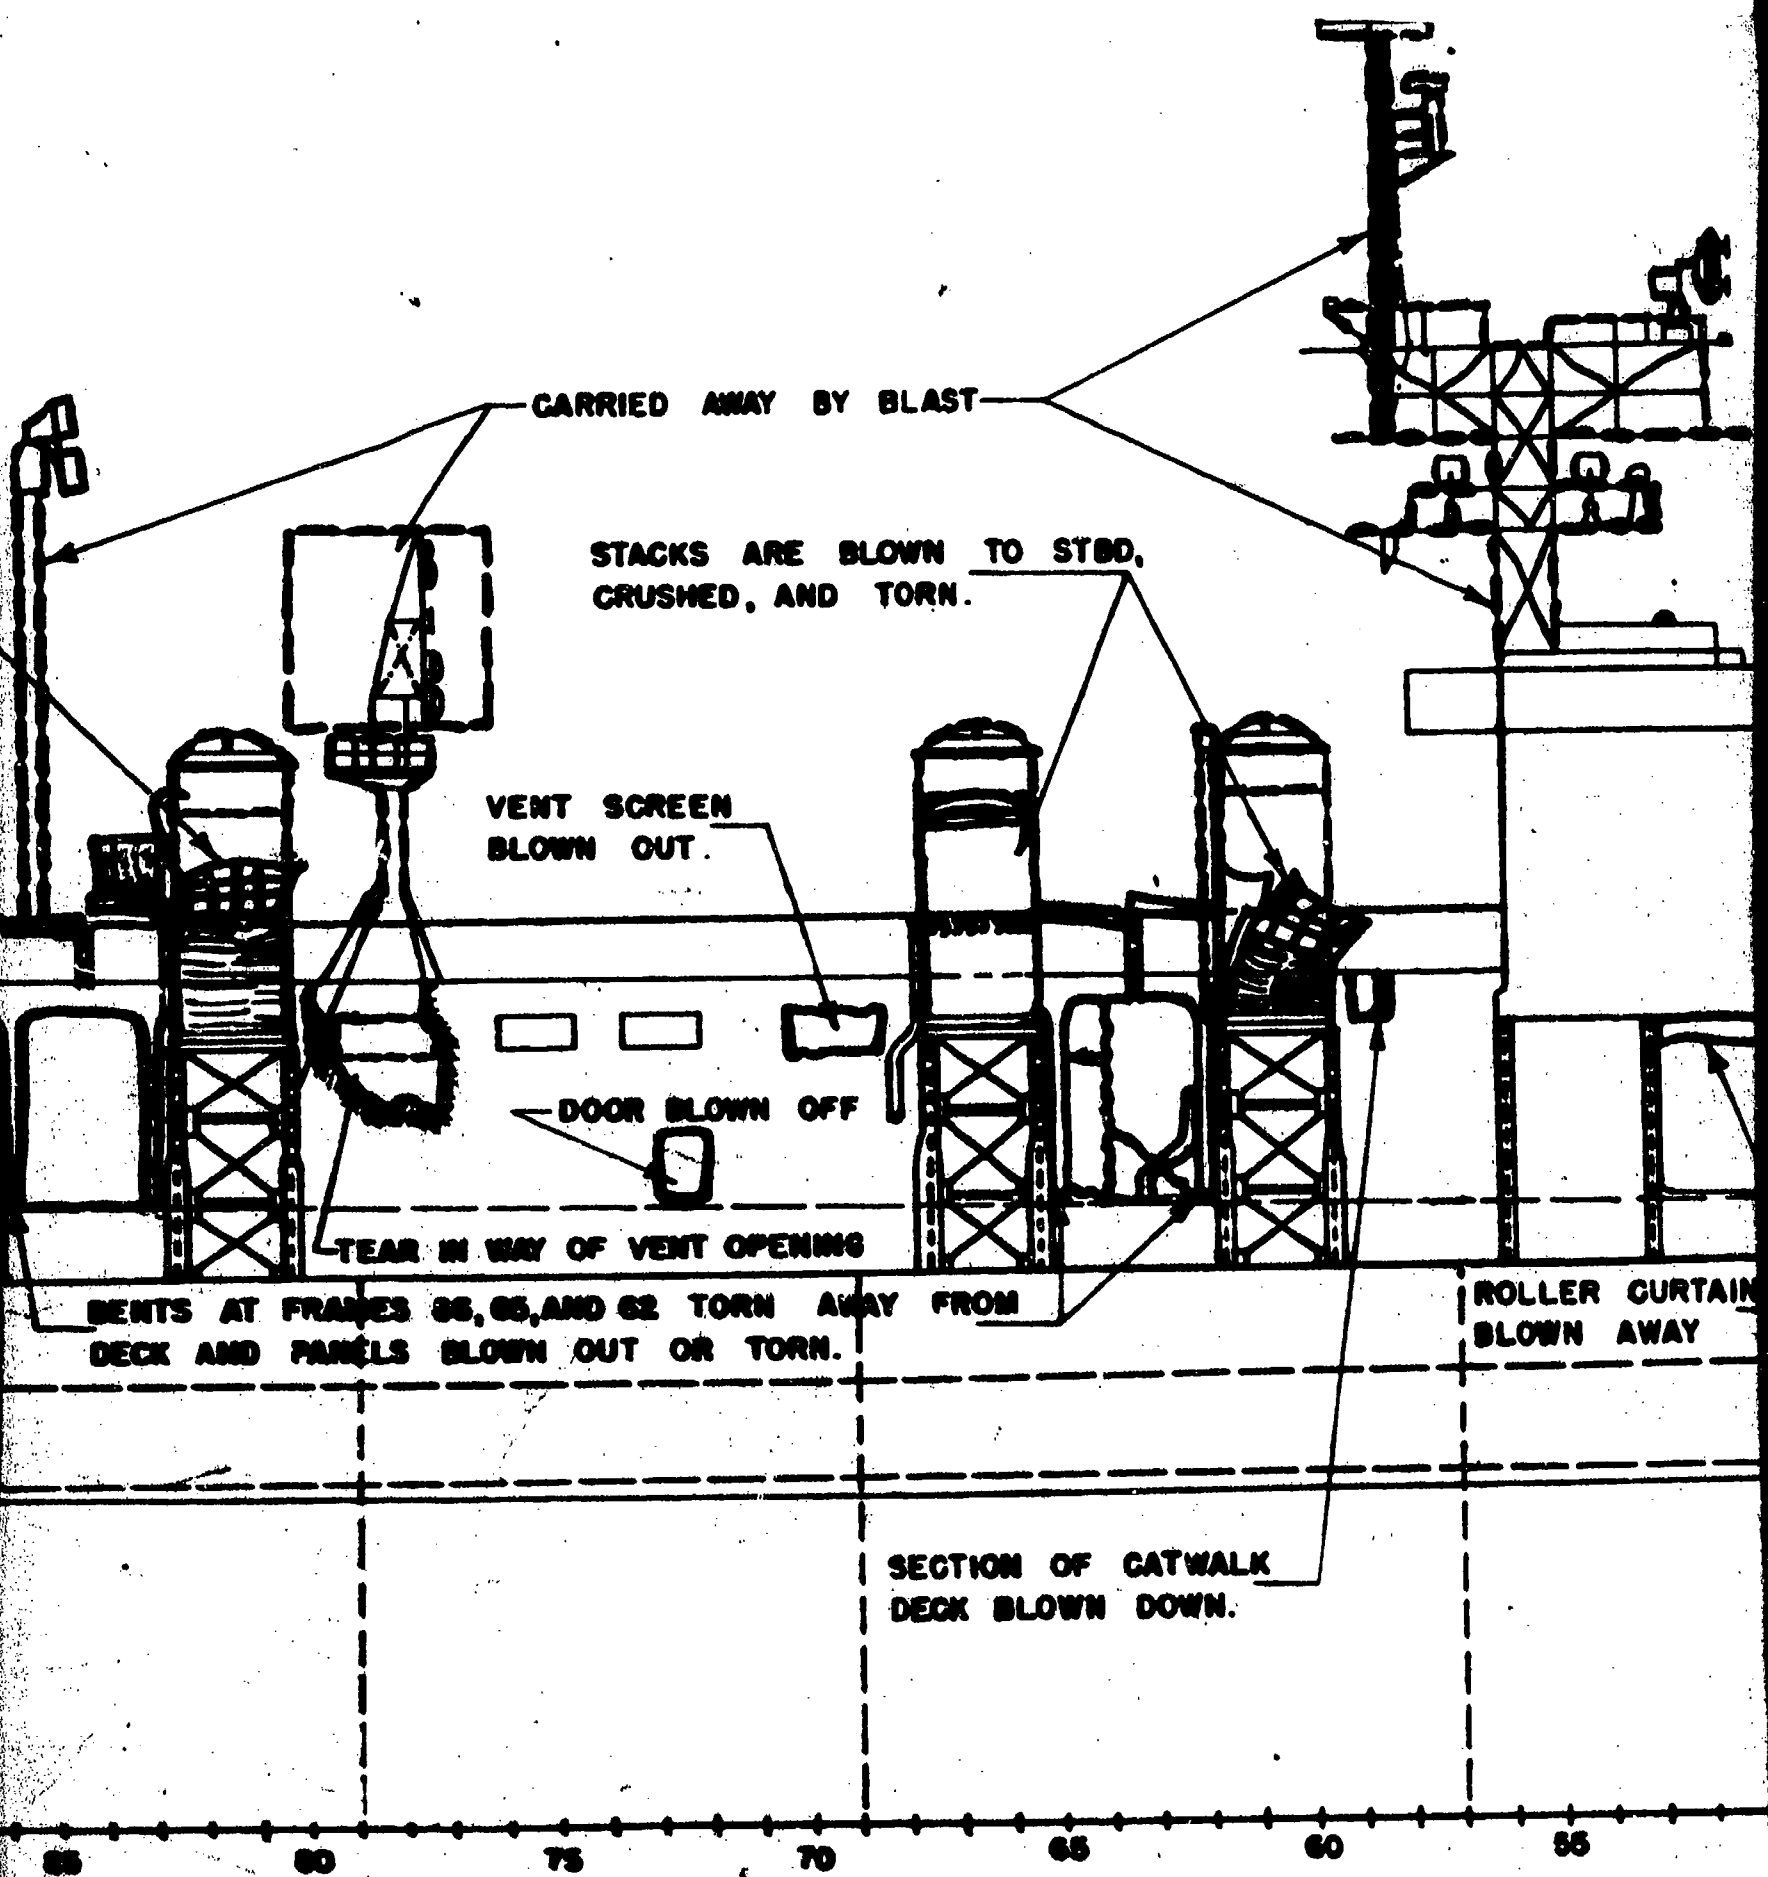
CARRIED AWAY BY BLAST

STACKS ARE BLOWN TO STBD,
CRUSHED, AND TORN.

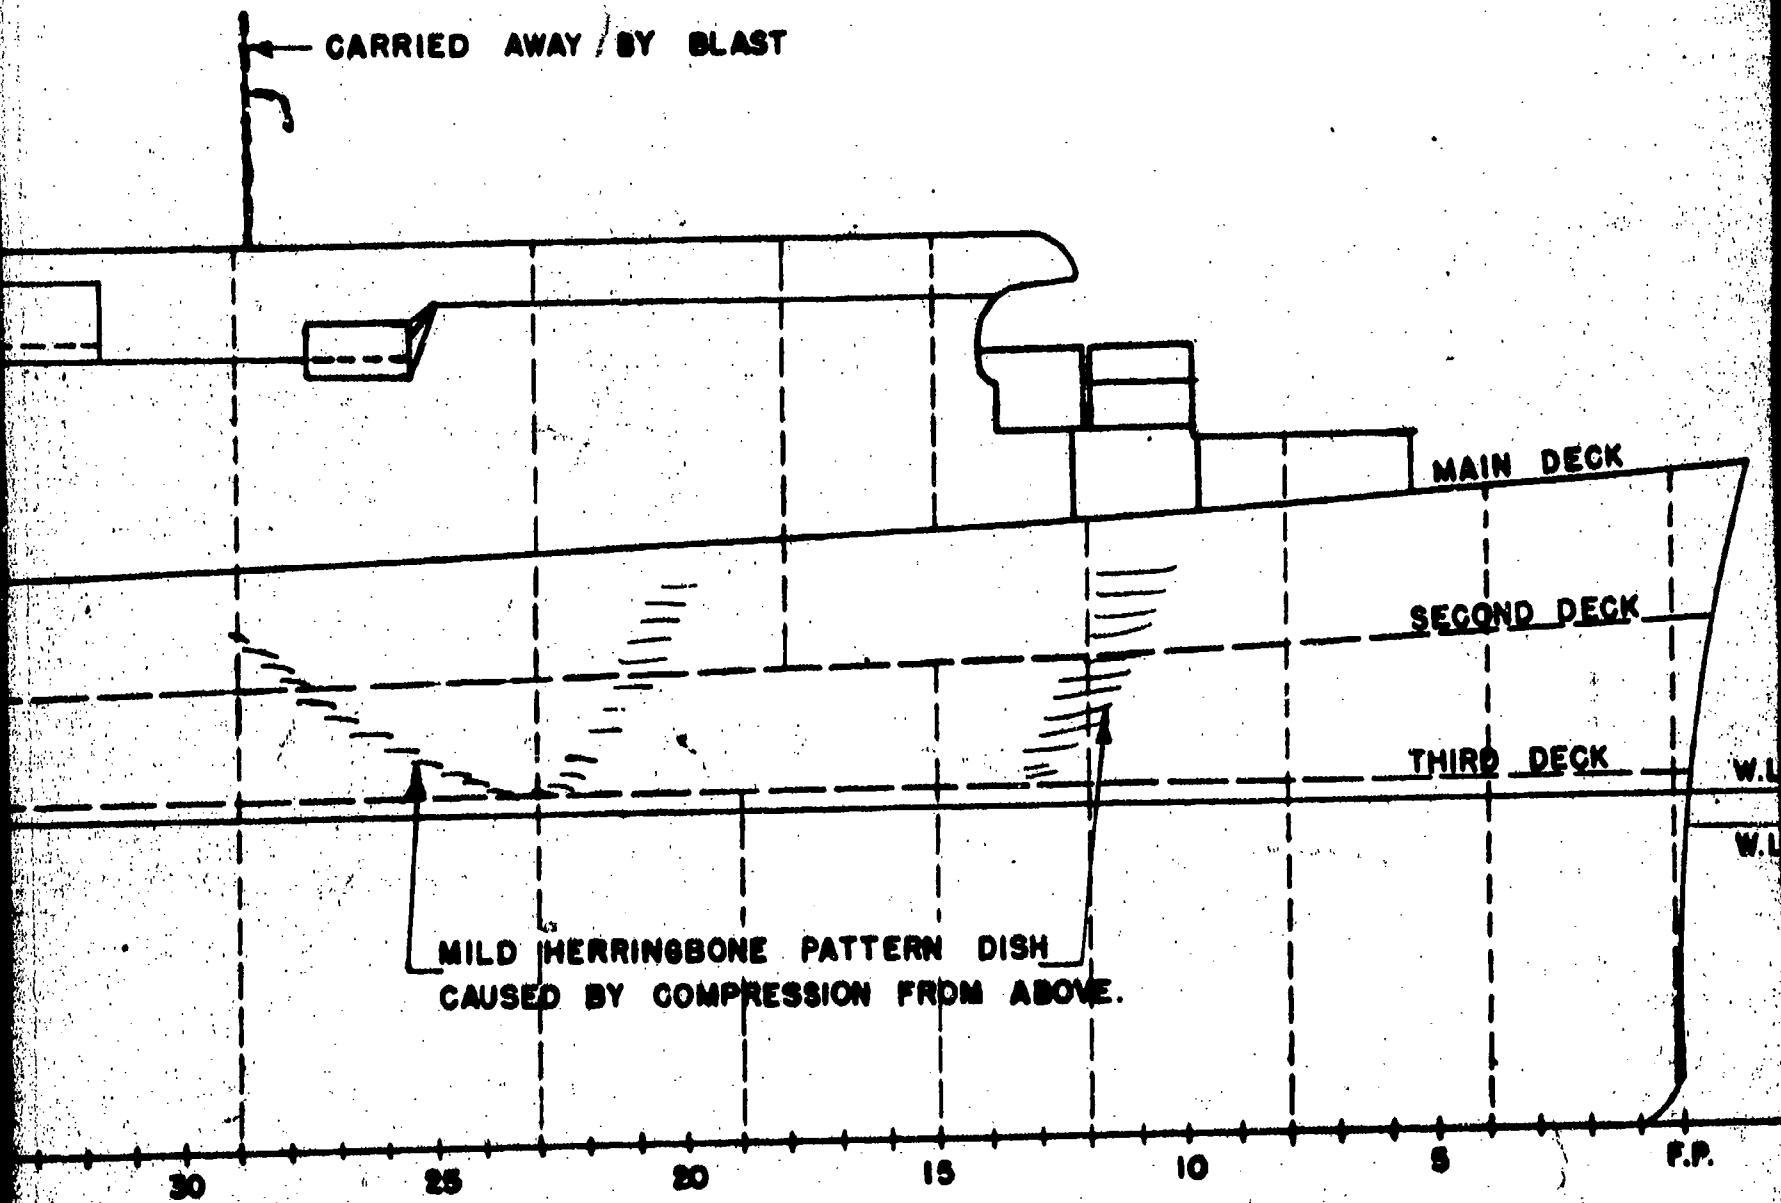
MILD HERRINGBONE PATTERN DISH
CAUSED BY COMPRESSION FROM ABOVE.

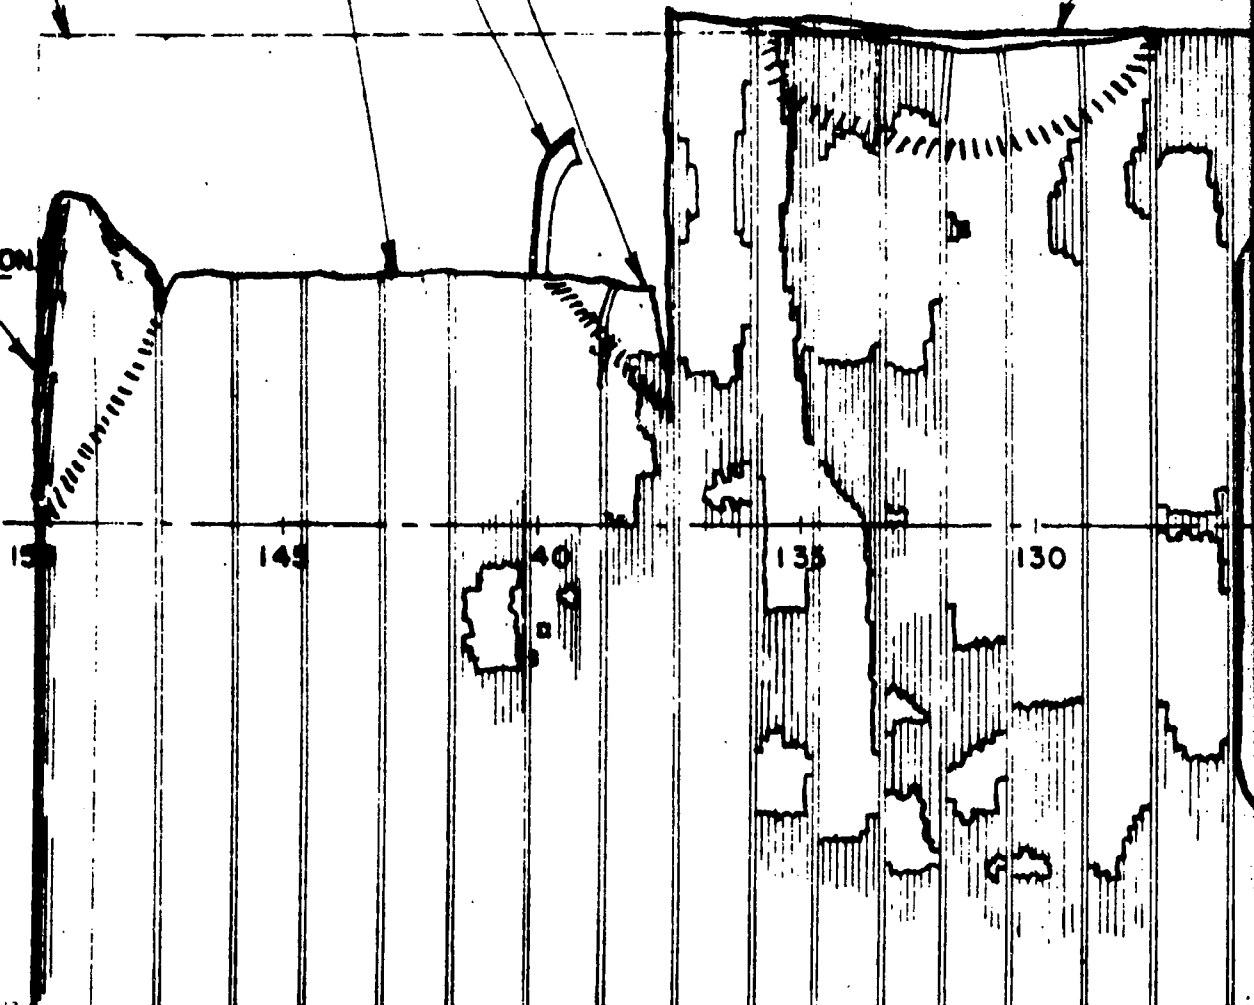
7" 14" 18"
115 113 111 1/2 110
REMNANT OF DECK BEAM AT FR.140
BENT SHARPLY UPWARD.

DECK
PORTION OF DECK TORN
AND BENT UPWARD.

FLIGHT DECK BADLY WARPED AND
WOOD DECKING BURNED FROM FIRE
BELOW.

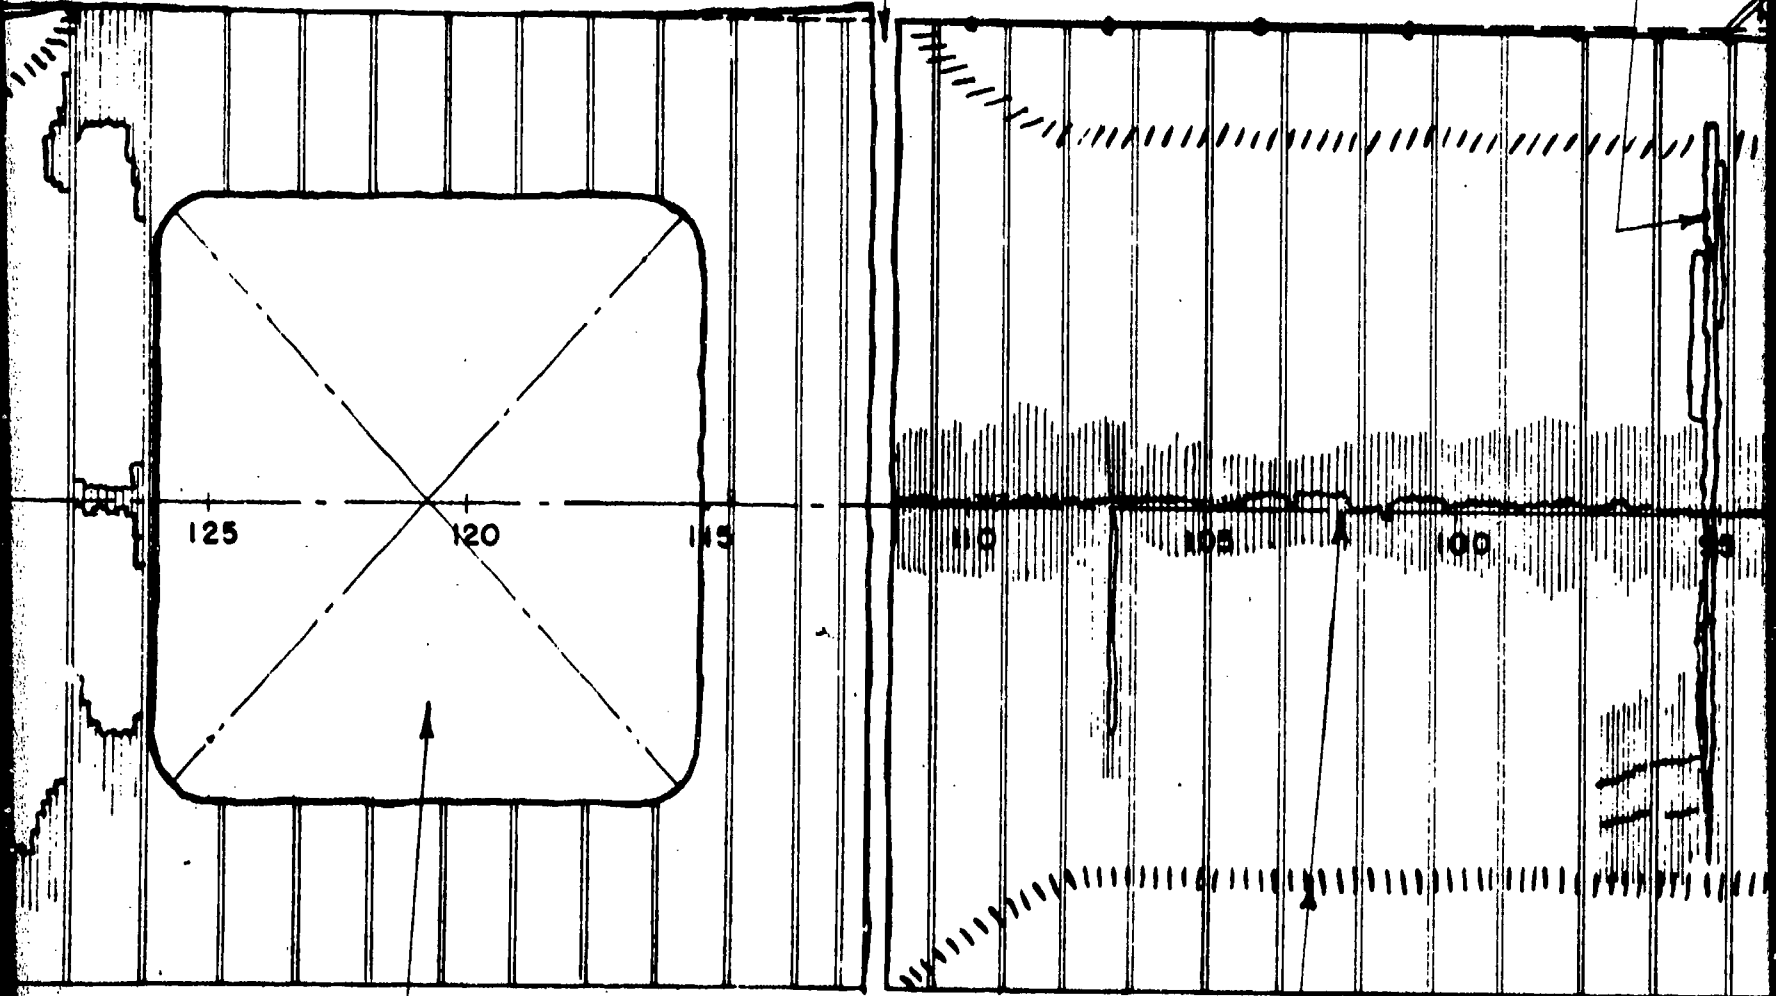
EXPANSION JOINT FLEXED AND DISTORTED.

5 LB. PLATING TORN ACROSS RAISED PORTION OF DECK BETWEEN FRAMES 95 AND 96. SEE PHOTO. PAGES 201 AND 202

ELEVATOR MISSING

EXPANSION JOINT AND SPREAD AP

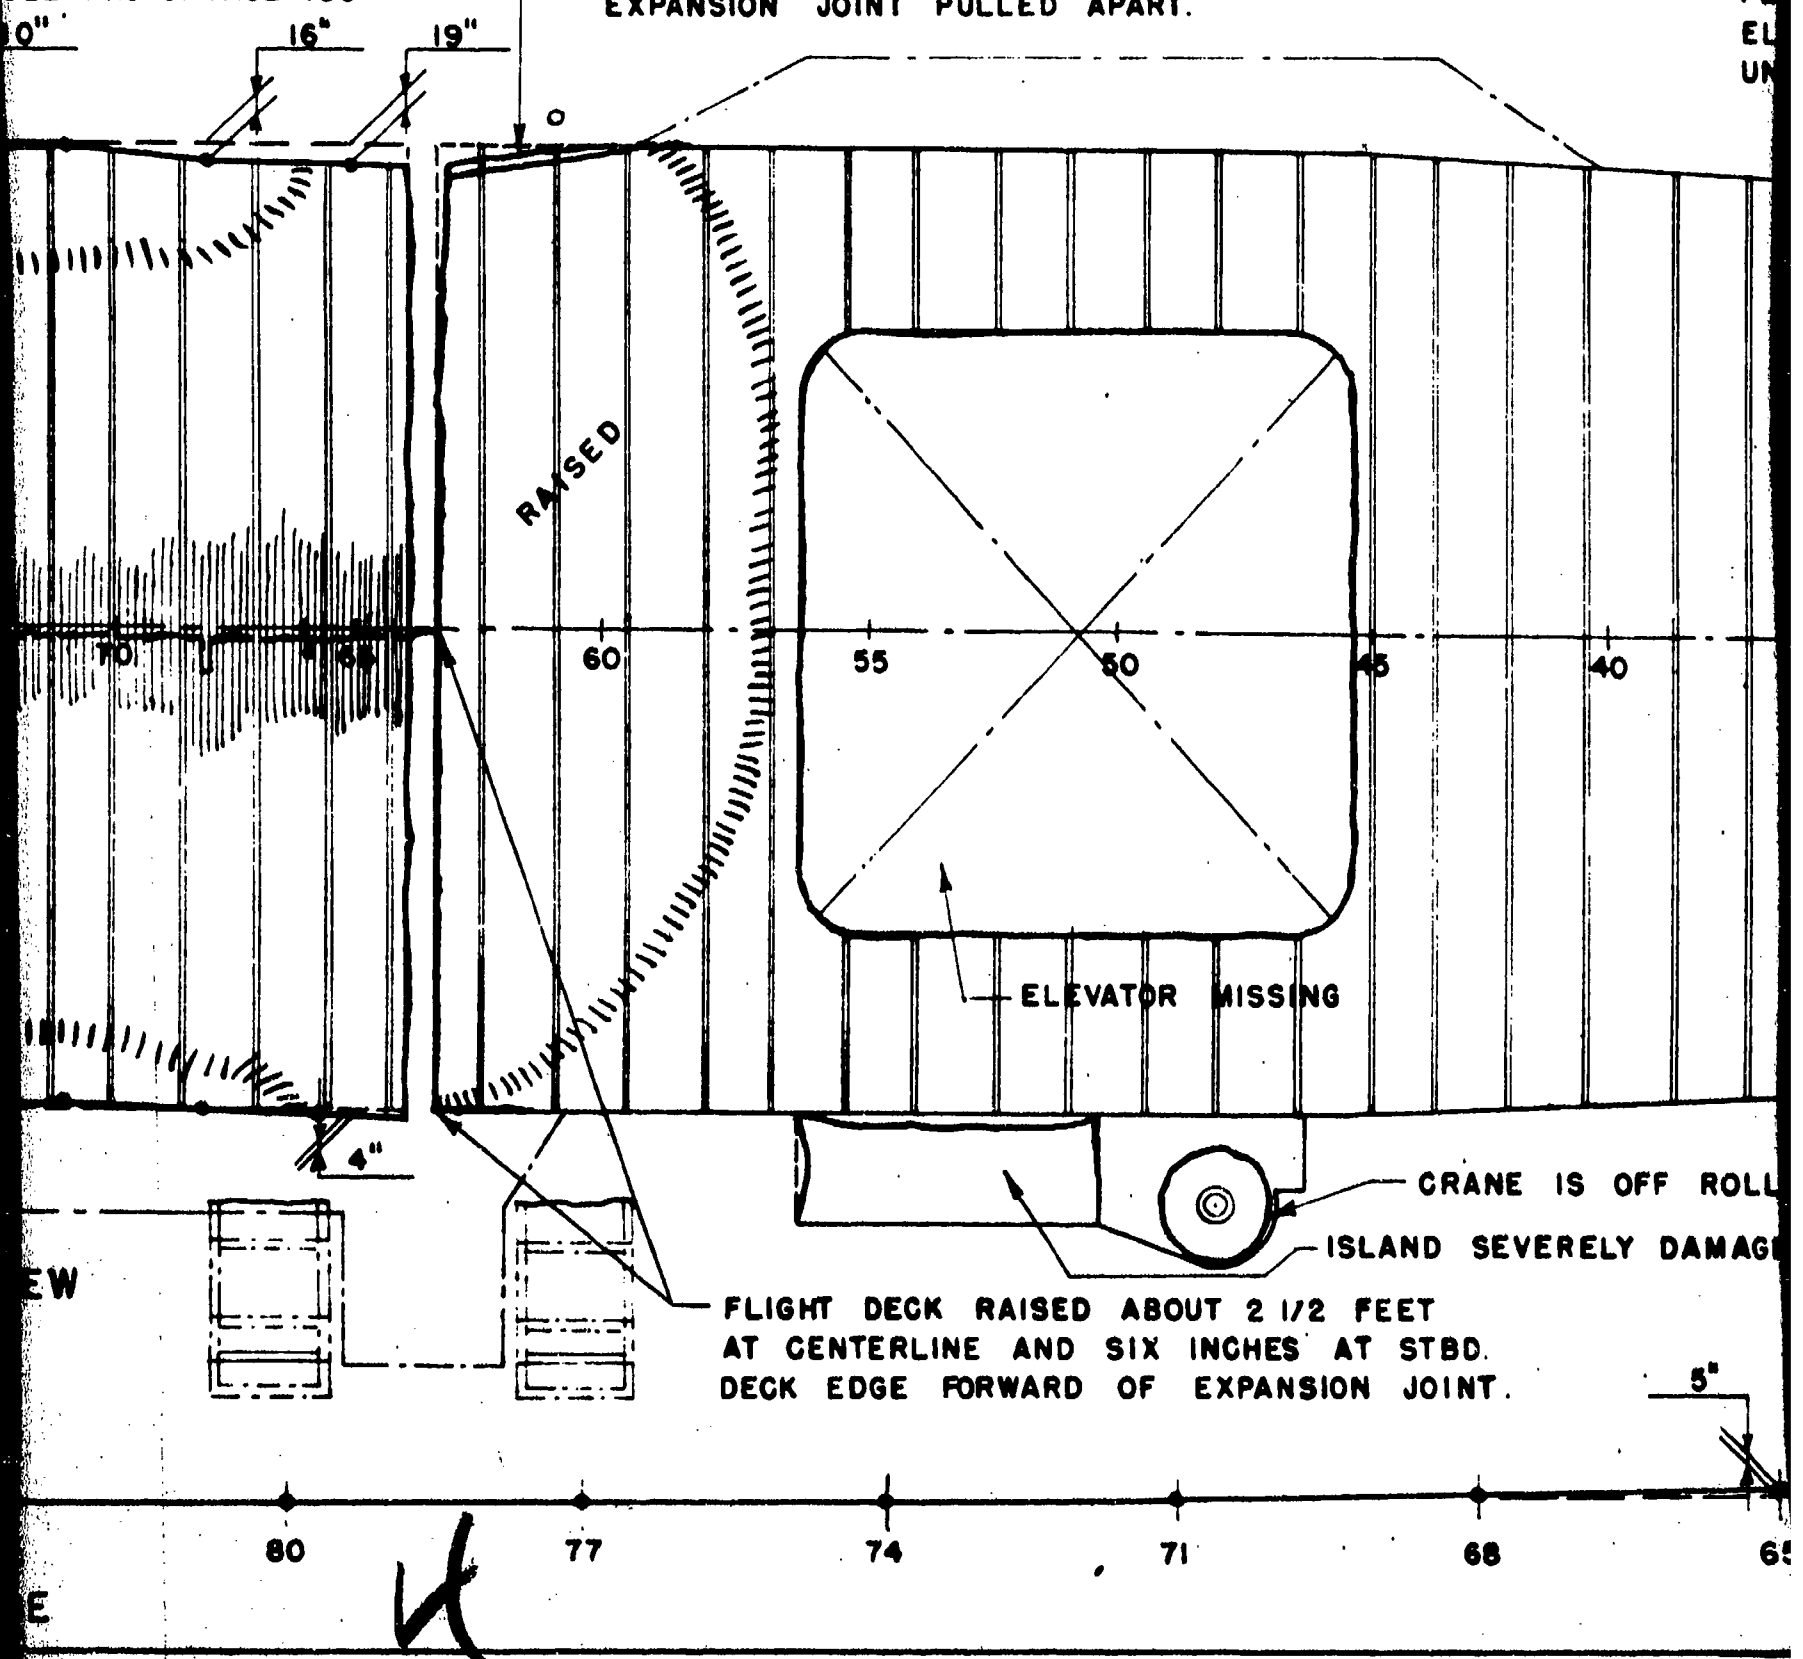
PORT EDGE OF FLIGHT DECK LIFTED FOUR FEET IN WAY OF EXPANSION JOINT. EXPANSION JOINT PULLED APART.

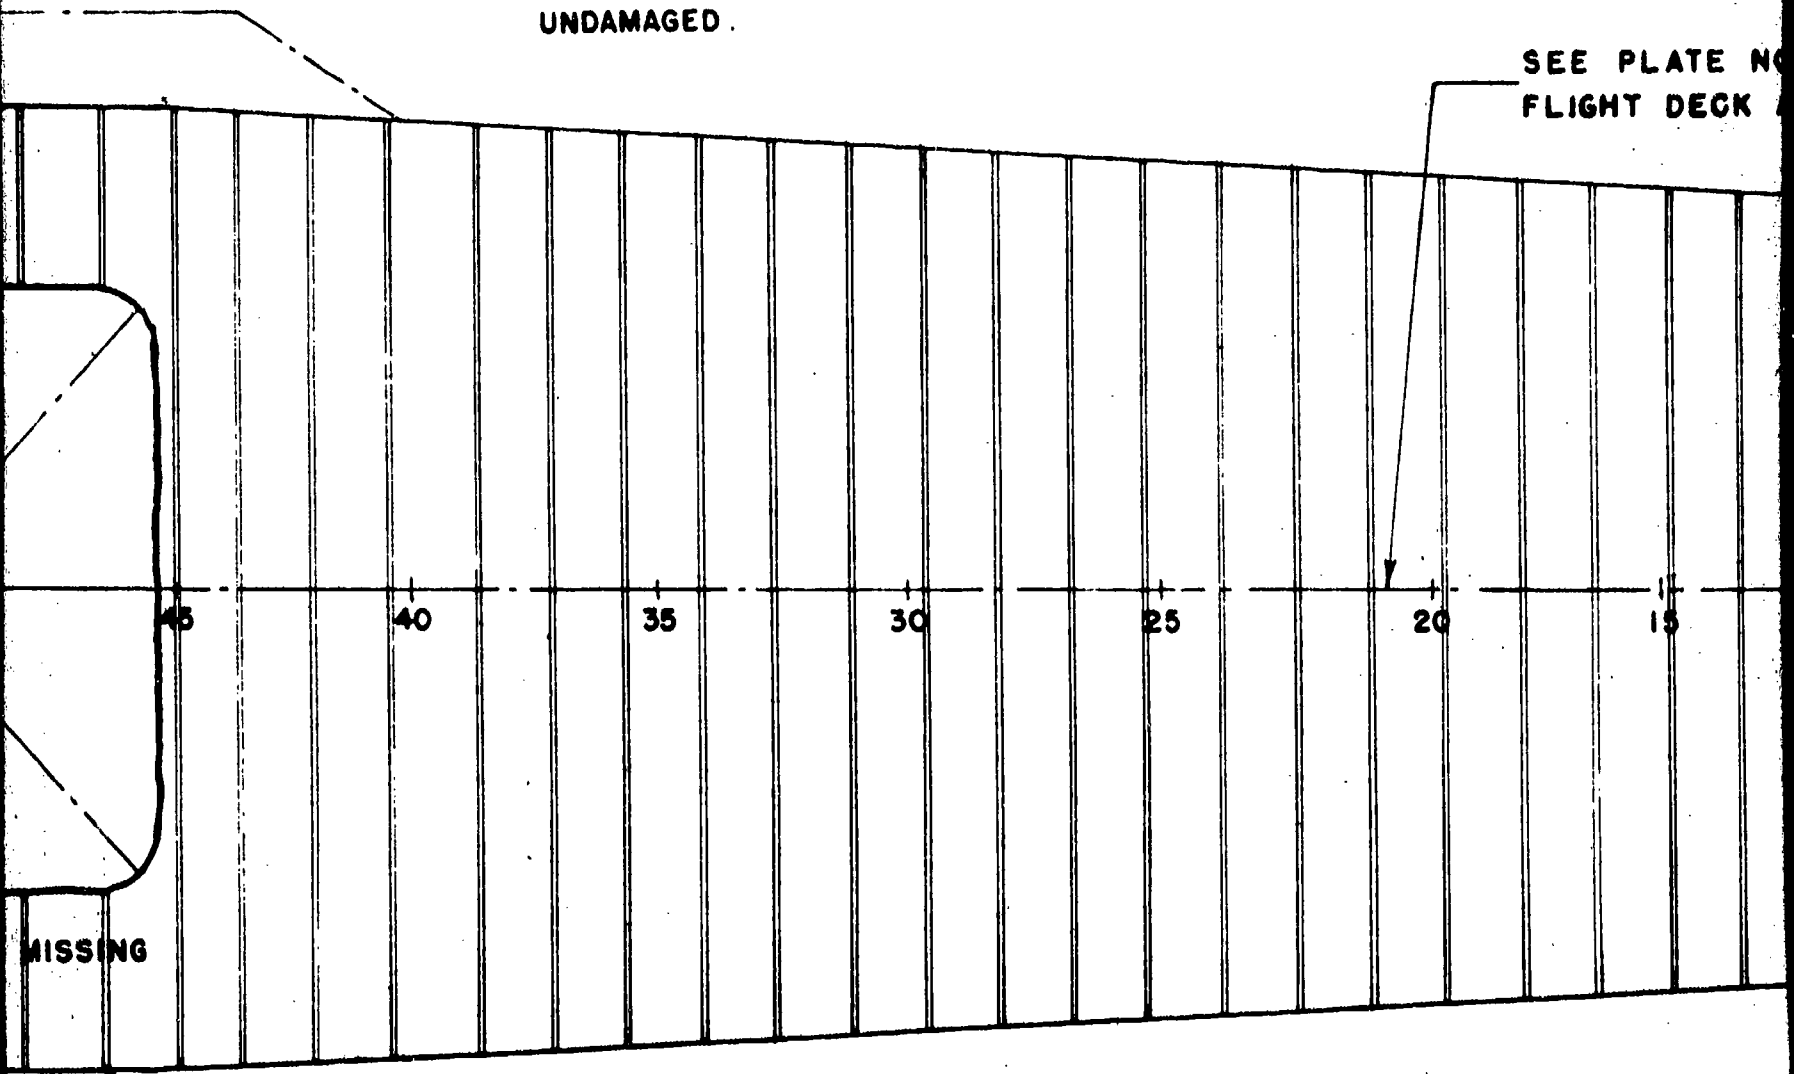
FLIGHT DECK ABREAST AND FORWARD OF FORWARD ELEVATOR IS SLIGHTLY DISTORTED BUT ESSENTIALLY UNDAMAGED.

MISSING

CRANE IS OFF ROLLER PATH

ISLAND SEVERELY DAMAGED AND TOP-HAMPER MISSING

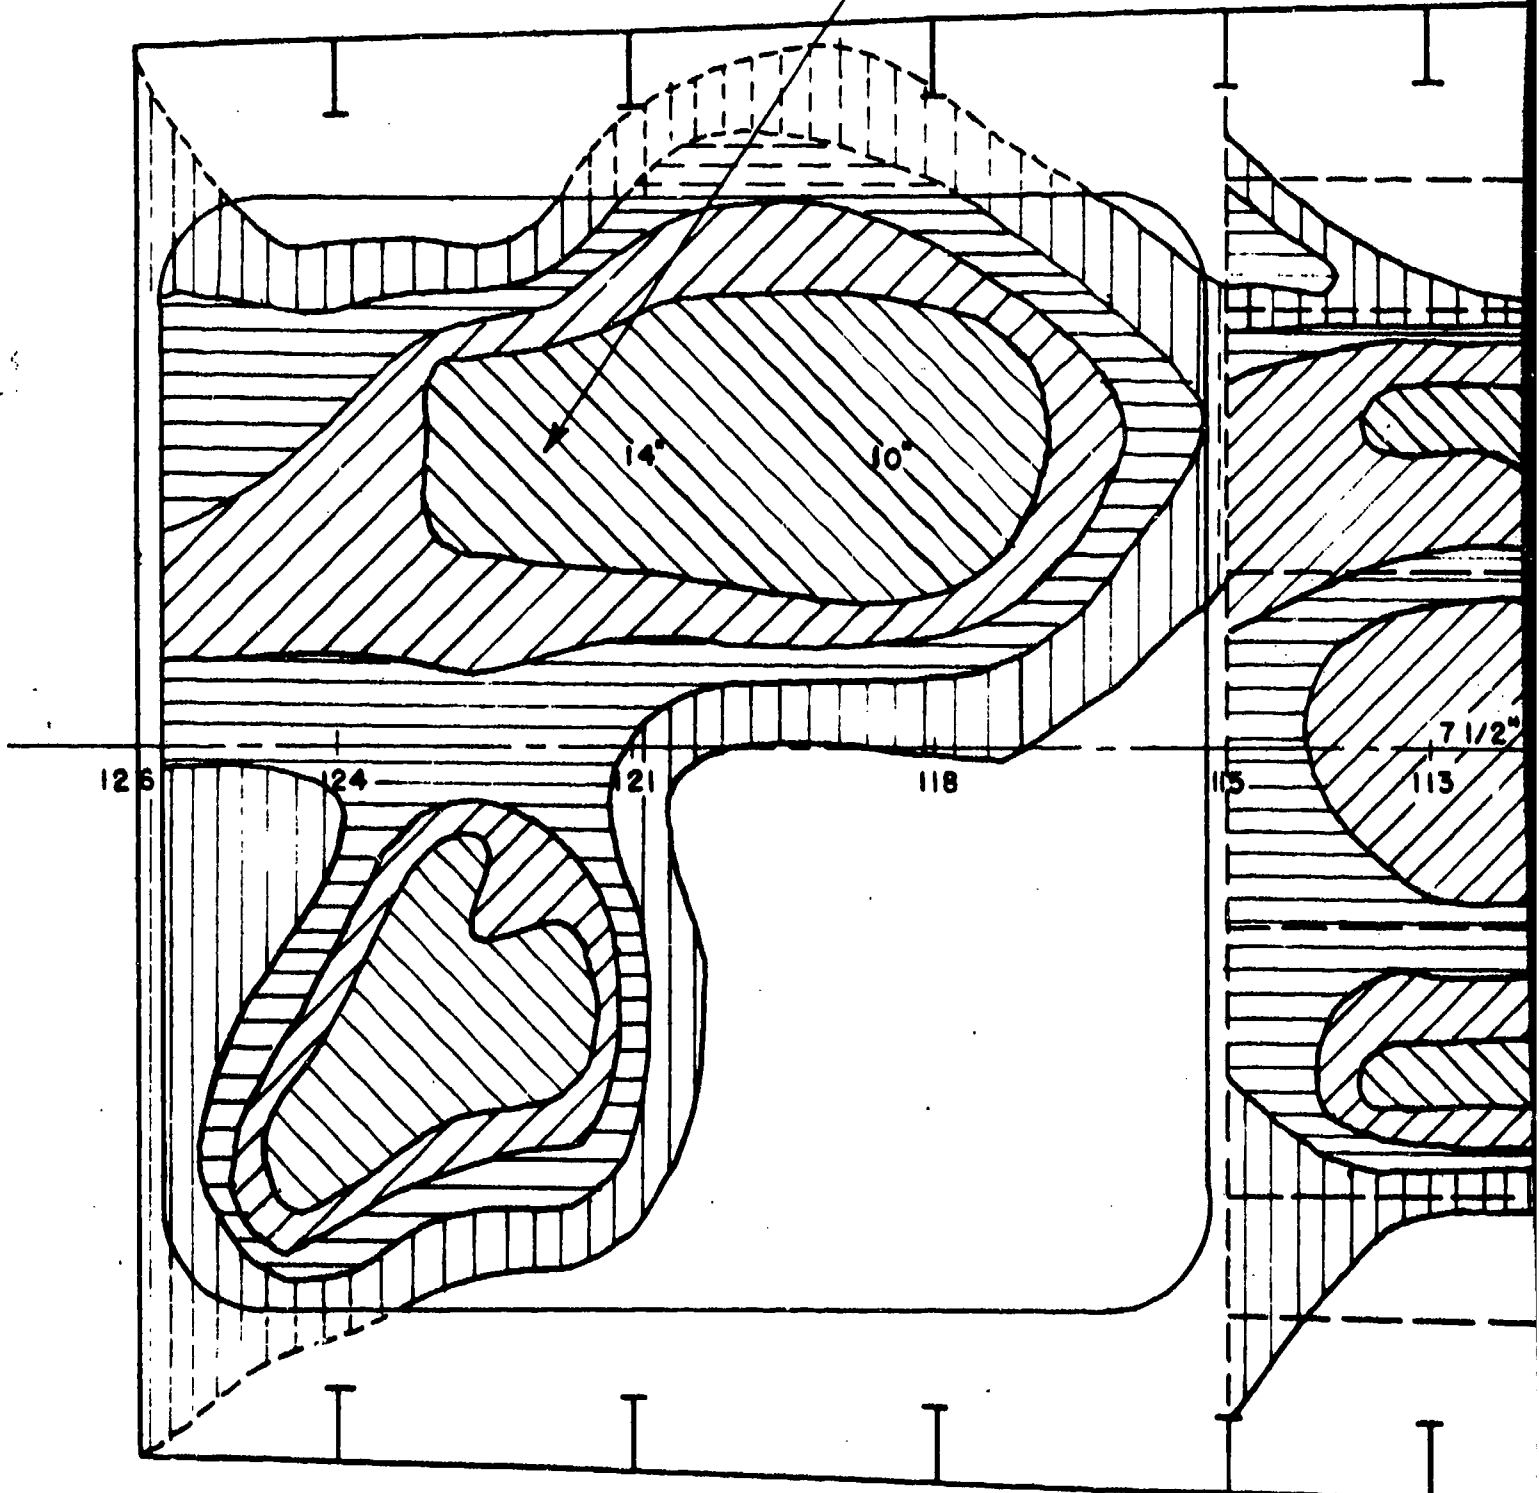
TRANSVERSE BEAM FAILED BE
MAIN DECK FRAME 122.

FAILED BELOW
122 .
