BUREAU OF SHIPS GROUP TECHNICAL INSPECTION REPORT

OPERATION CROSSROADS. U.S.S. INDEPENDENCE (CVL22)

TEST ABLE

VOLUME 1 OF 4 [W]

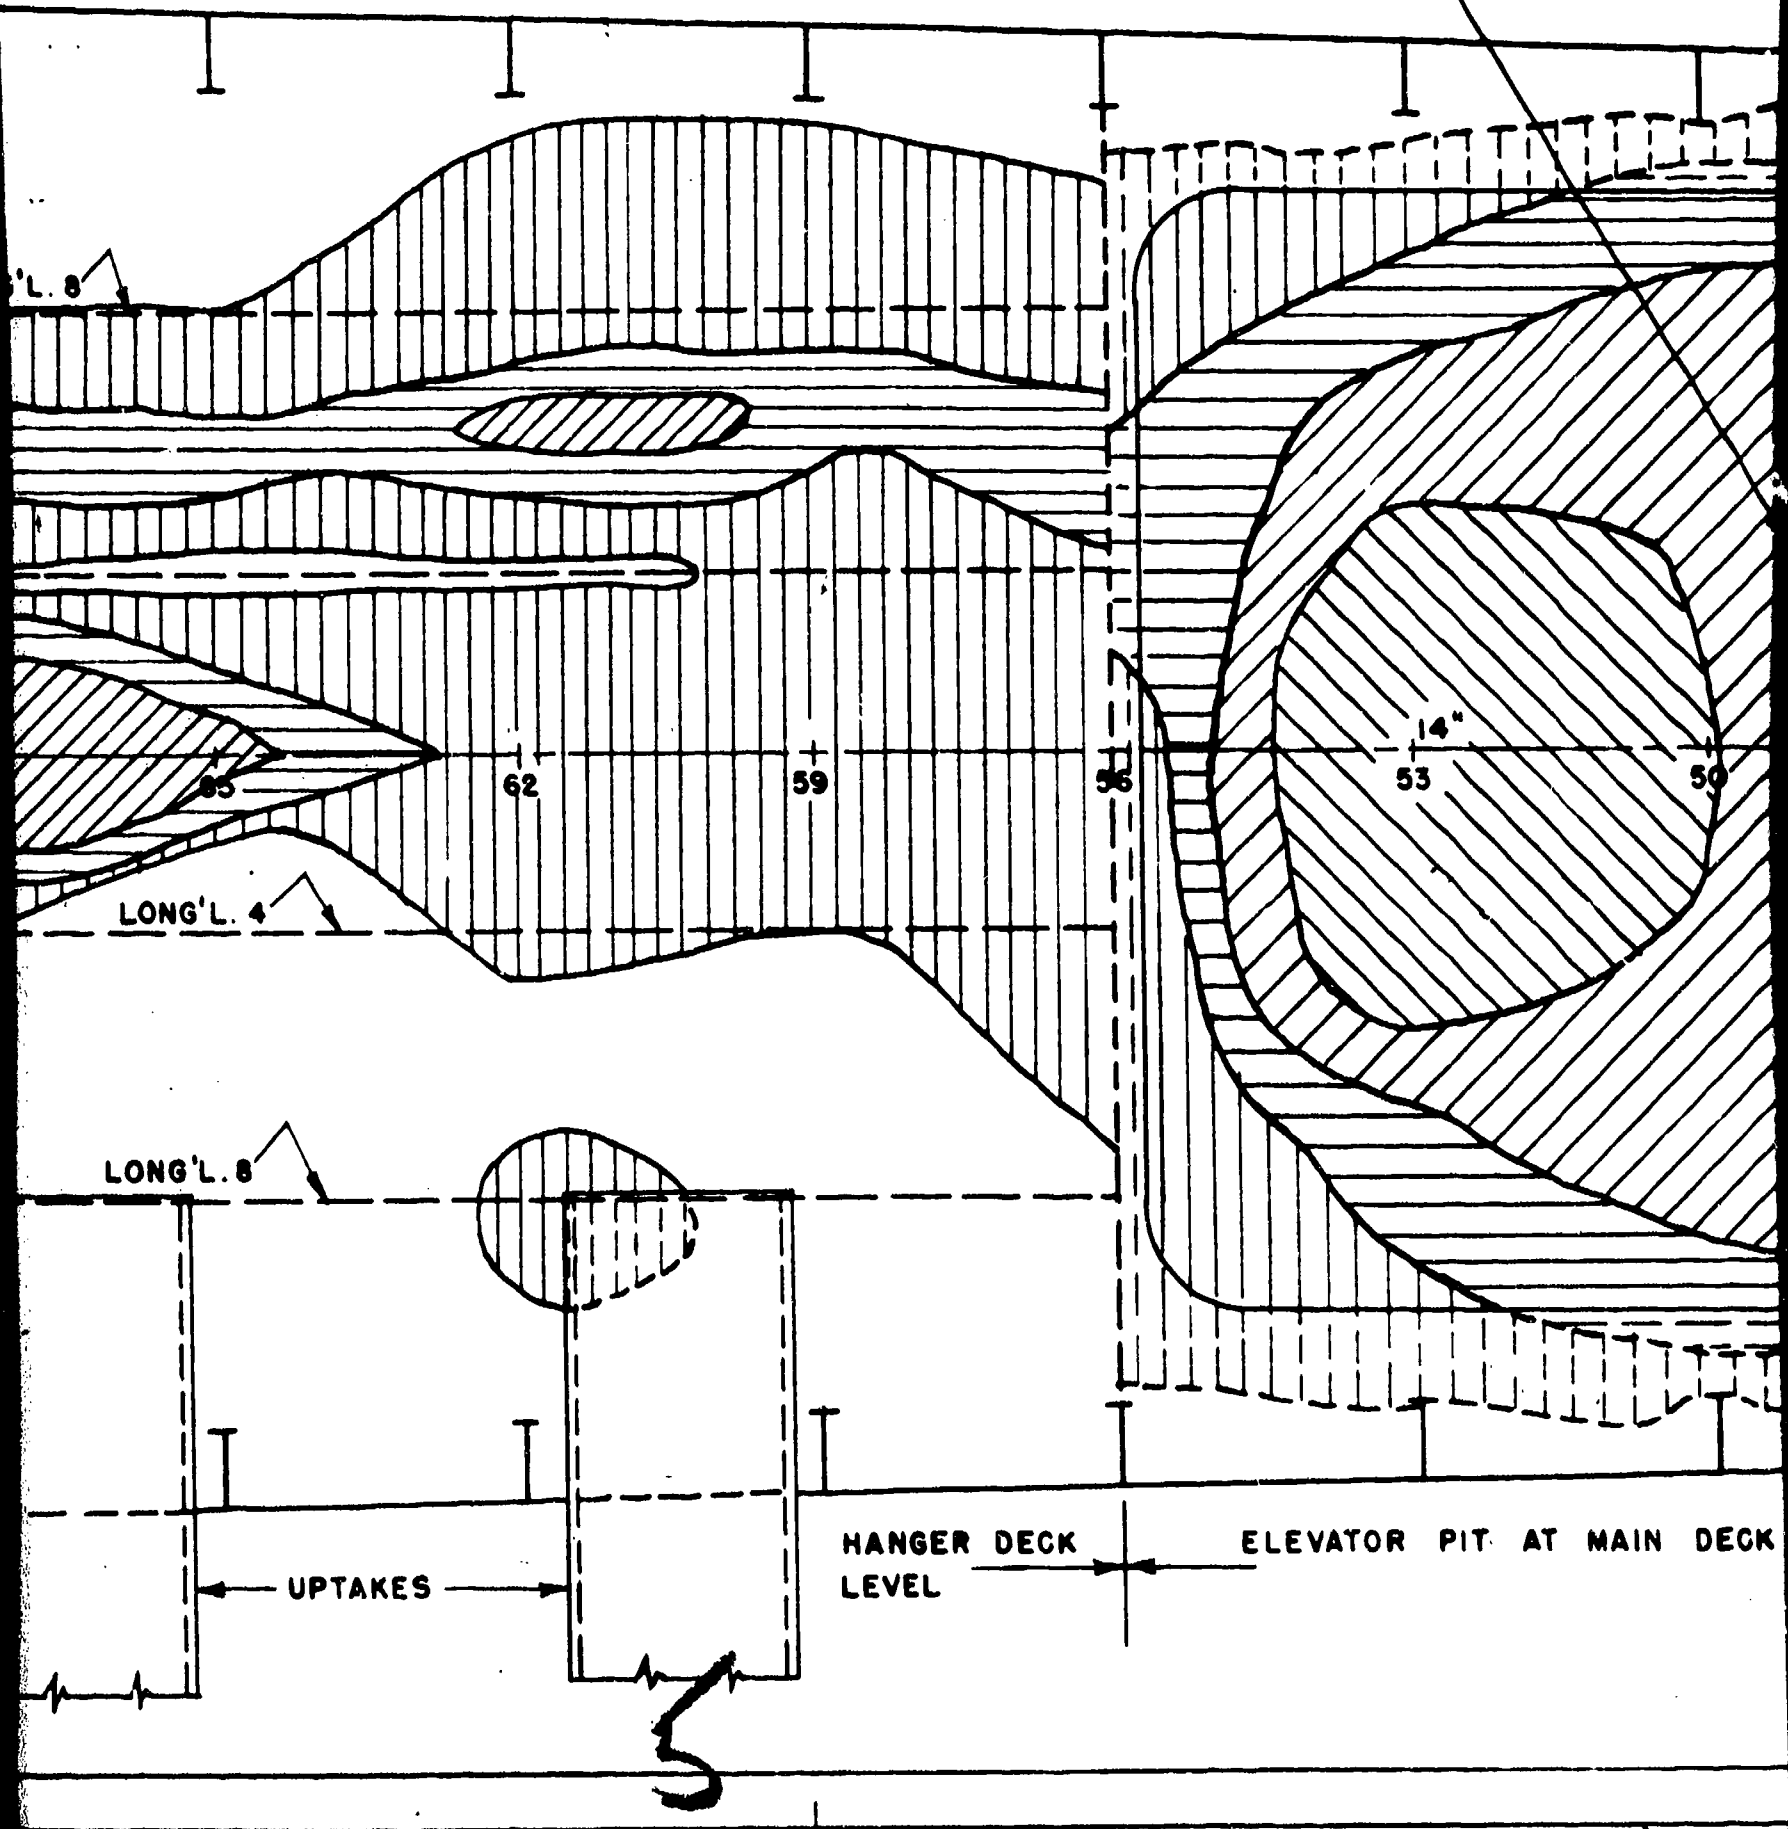
FAILURE IN WAY OF RIVETED CONNECTION
TO UNDERSIDE OF MAIN DK. OVER BHD. 49.

IN WAY OF RIVETED CONNECTION
SIDE OF MAIN DK. OVER BHD. 49.

FAILURE IN WELDED BUTT
IN MAIN DECK.

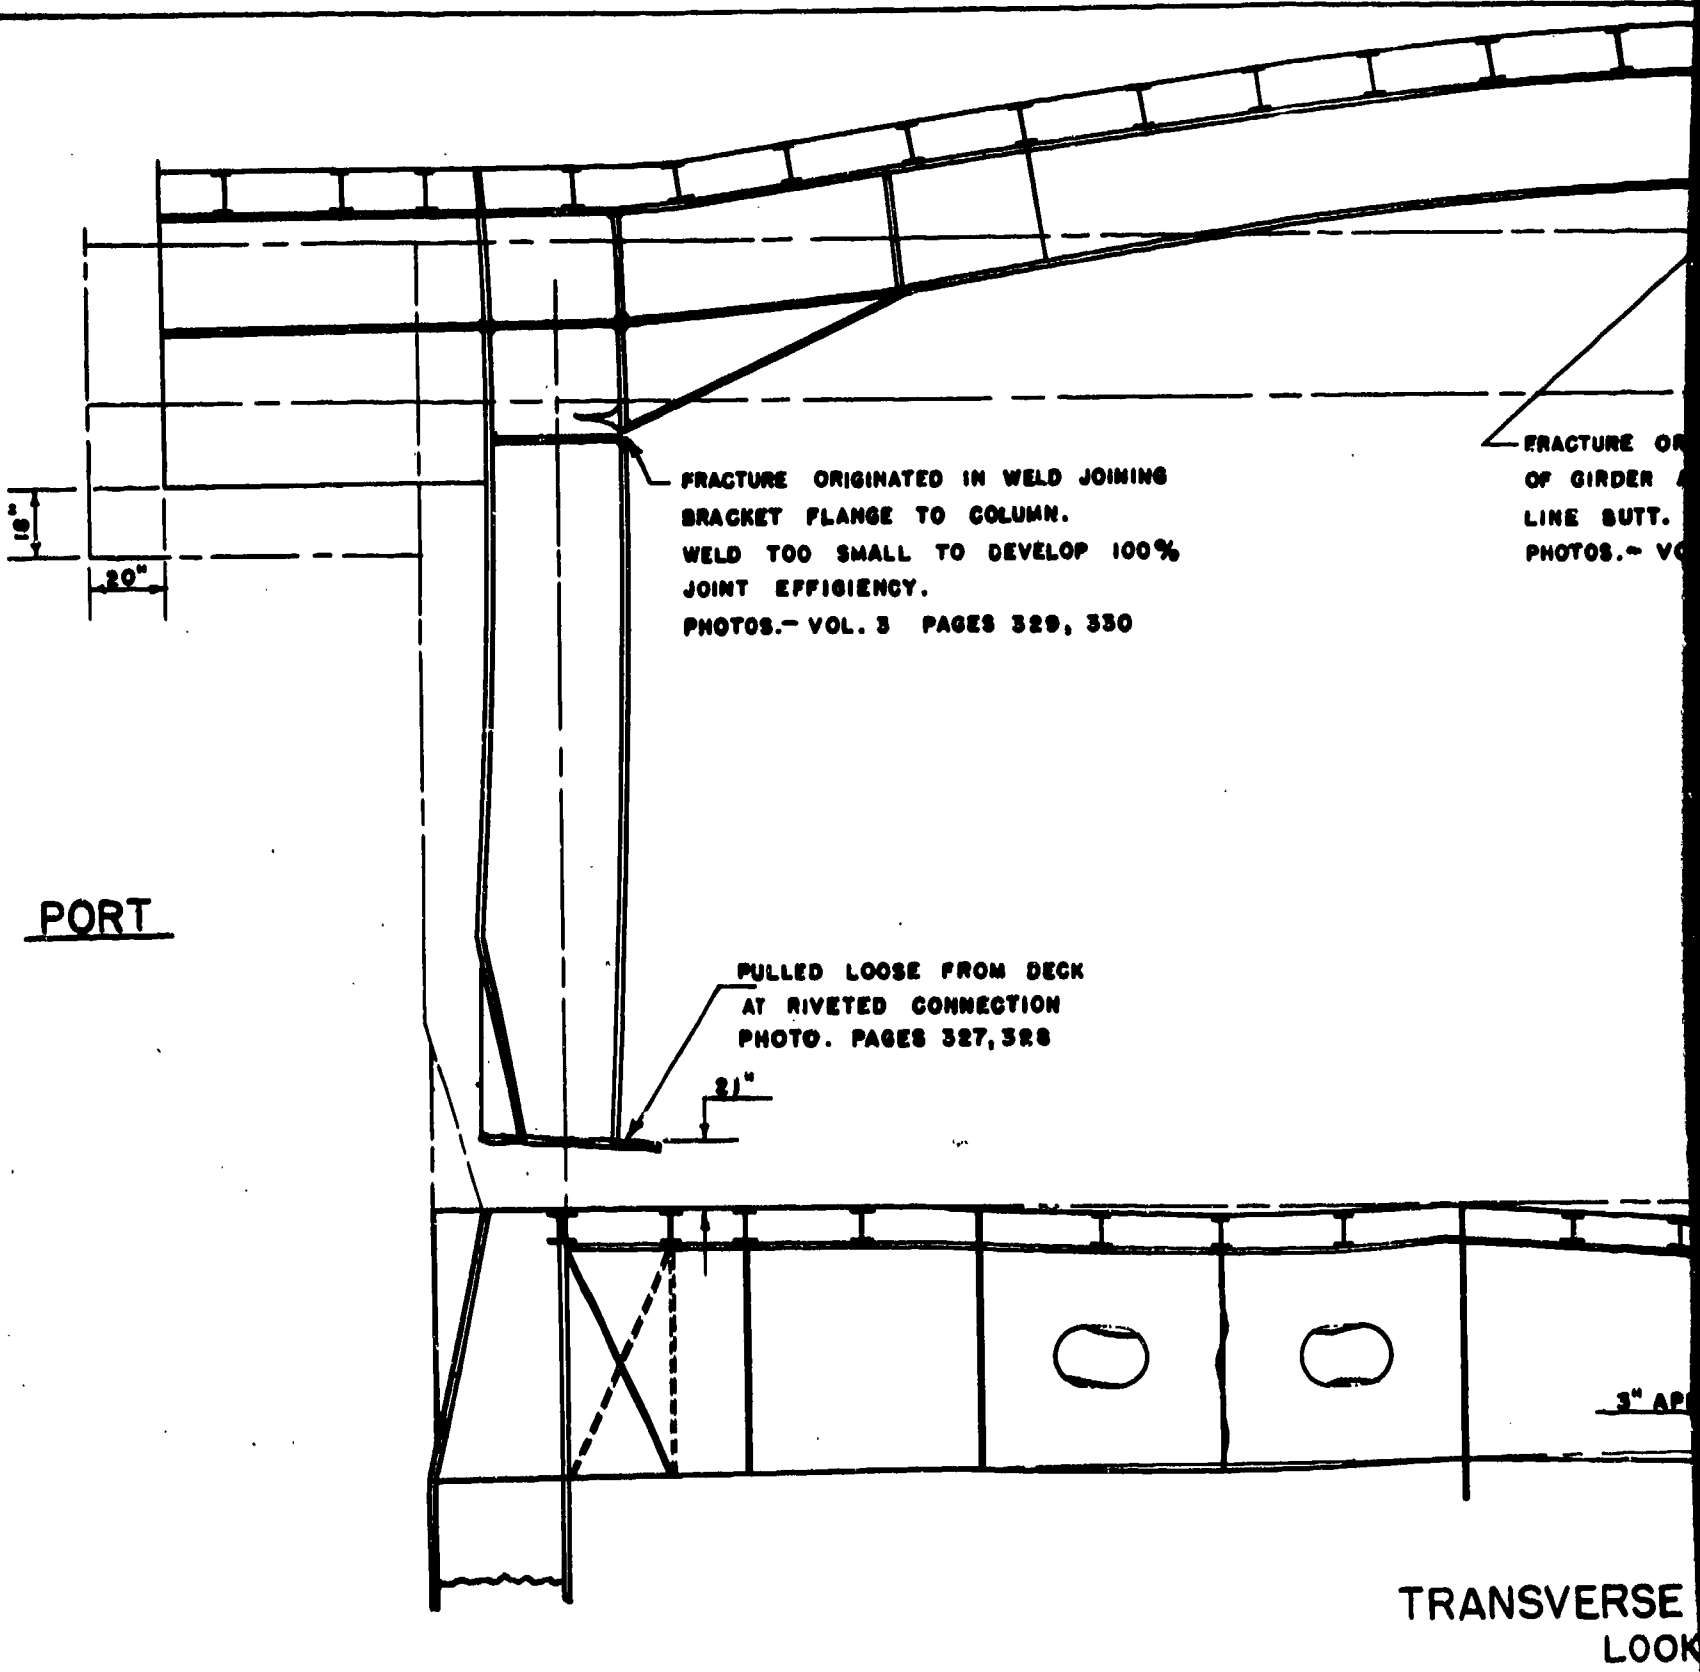
FRACTURE ORIGINATED IN WELD JOINING
 BRACKET FLANGE TO COLUMN.
 WELD TOO SMALL TO DEVELOP 100%
 JOINT EFFICIENCY.
 PHOTOS.- VOL. 3 PAGES 329, 330

FRACTURE OF
 OF GIRDER
 LINE BUTT.
 PHOTOS.- VOL. 3

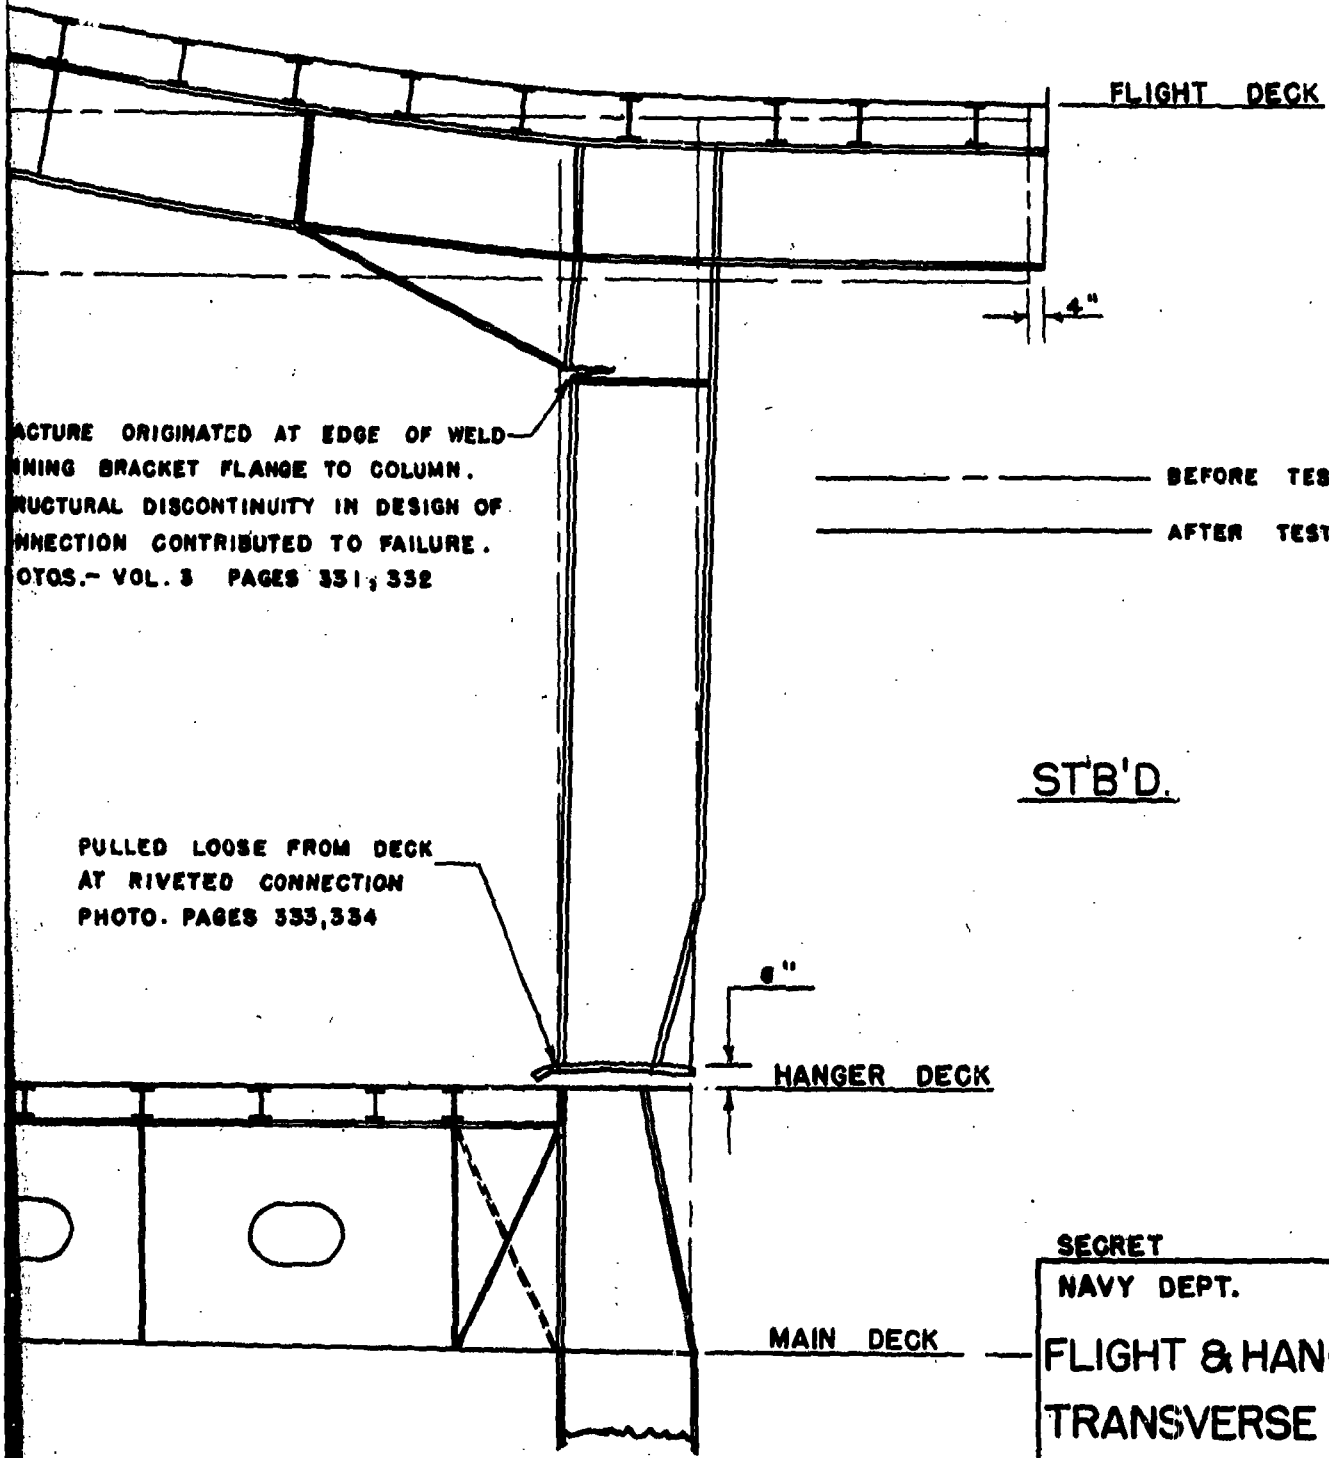
SECRET PAGE 210 OF 280
 NAVY DEPT. BUREAU OF SHIPS
 FLIGHT & HANGER DK. DEFLECTION
 TRANSVERSE SECTION, FRAME 65
 TEST A
 U.S.S. INDEPENDENCE CVL 22

FAILURE ORIGINATED AT EDGE OF WELDING
 BRACKET FLANGE TO COLUMN.
 STRUCTURAL DISCONTINUITY IN DESIGN OF
 CONNECTION CONTRIBUTED TO FAILURE.
 OTOS.- VOL. 3 PAGES 331, 332

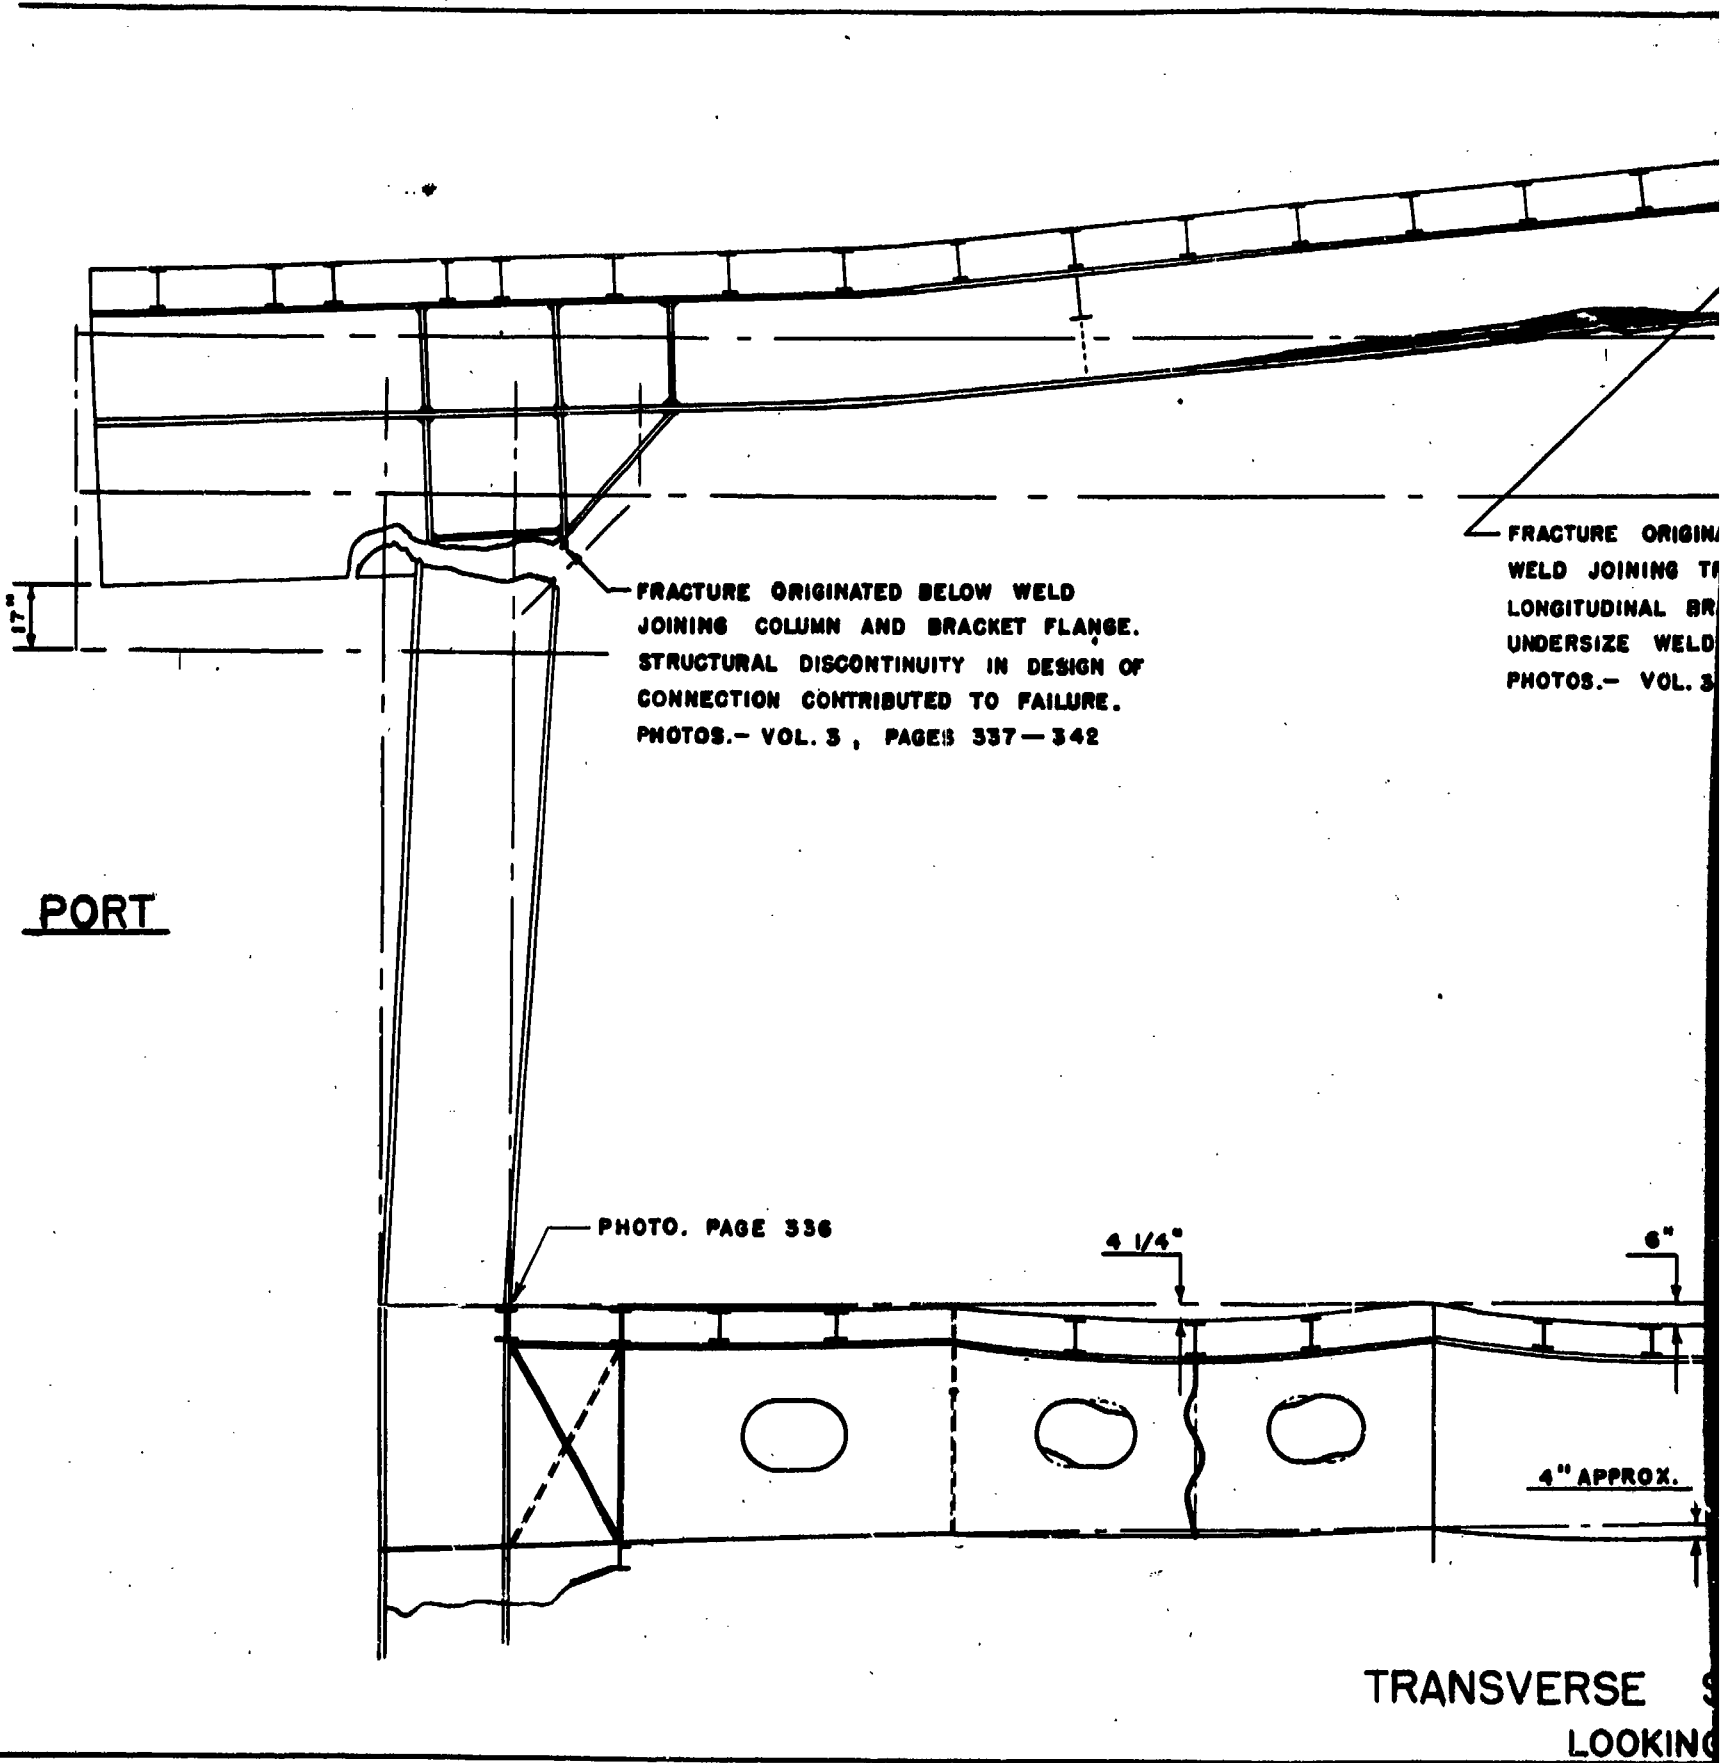
FRACTURE ORIGINATED BELOW WELD JOINING COLUMN AND BRACKET FLANGE. STRUCTURAL DISCONTINUITY IN DESIGN OF CONNECTION CONTRIBUTED TO FAILURE. PHOTOS.- VOL. 3 , PAGES 337-342

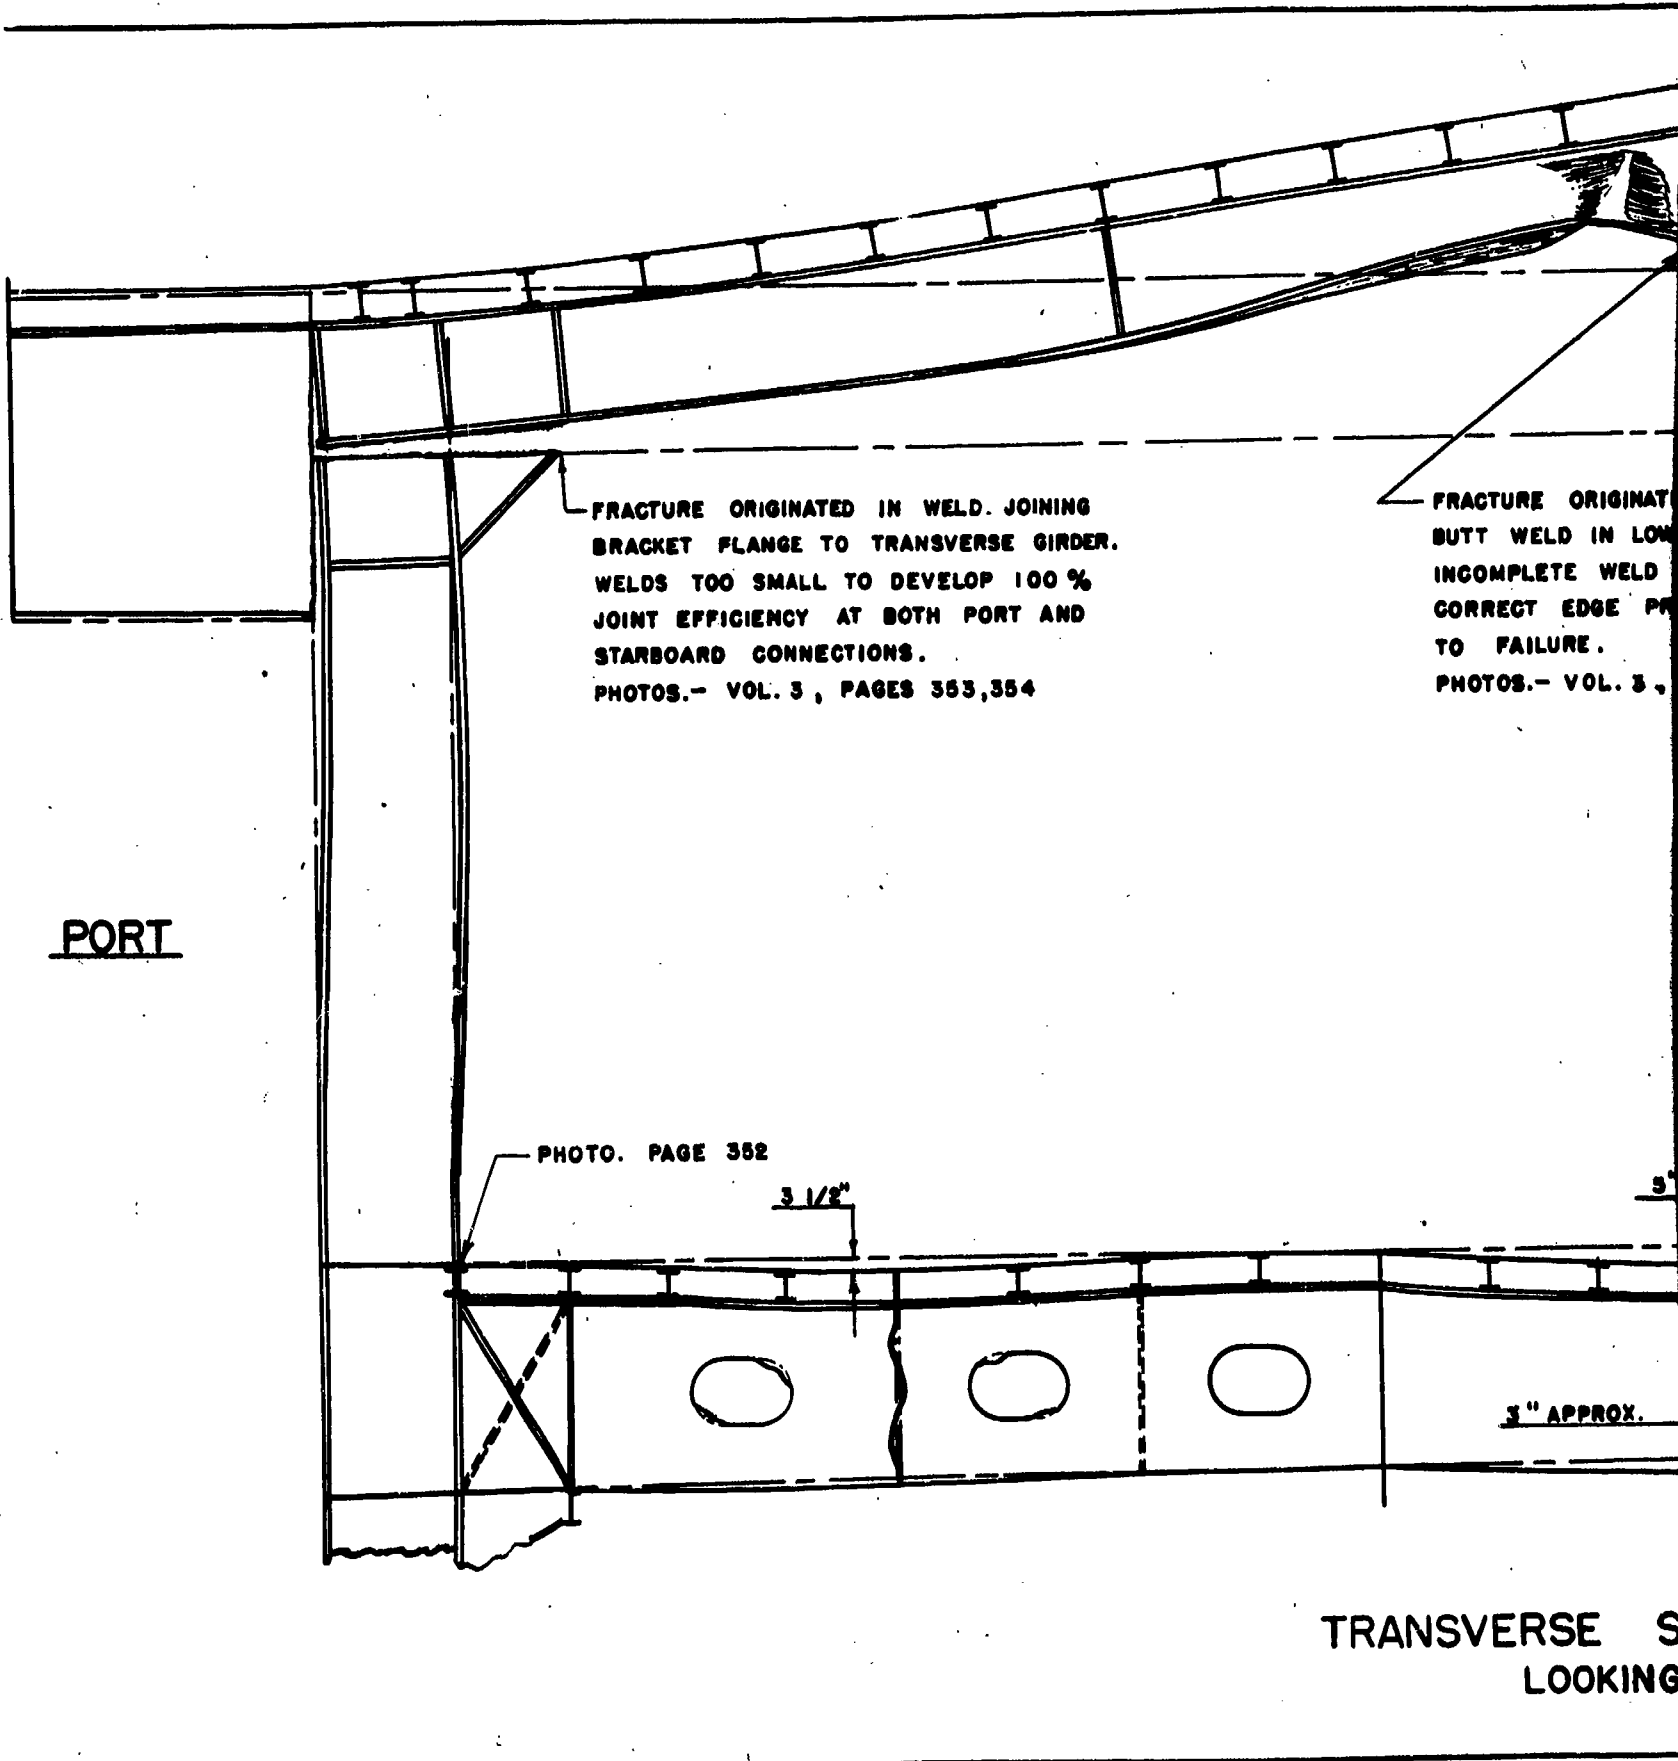
FRACTURE ORIGINATED IN WELD JOINING BRACKET FLANGE TO TRANSVERSE GIRDER. WELDS TOO SMALL TO DEVELOP 100% JOINT EFFICIENCY AT BOTH PORT AND STARBOARD CONNECTIONS. PHOTOS.- VOL. 3 , PAGES 353,354

FRACTURE ORIGINATED IN BUTT WELD IN LOWER SECTION. INCOMPLETE WELD CORRECT EDGE PORT TO FAILURE. PHOTOS.- VOL. 3 ,

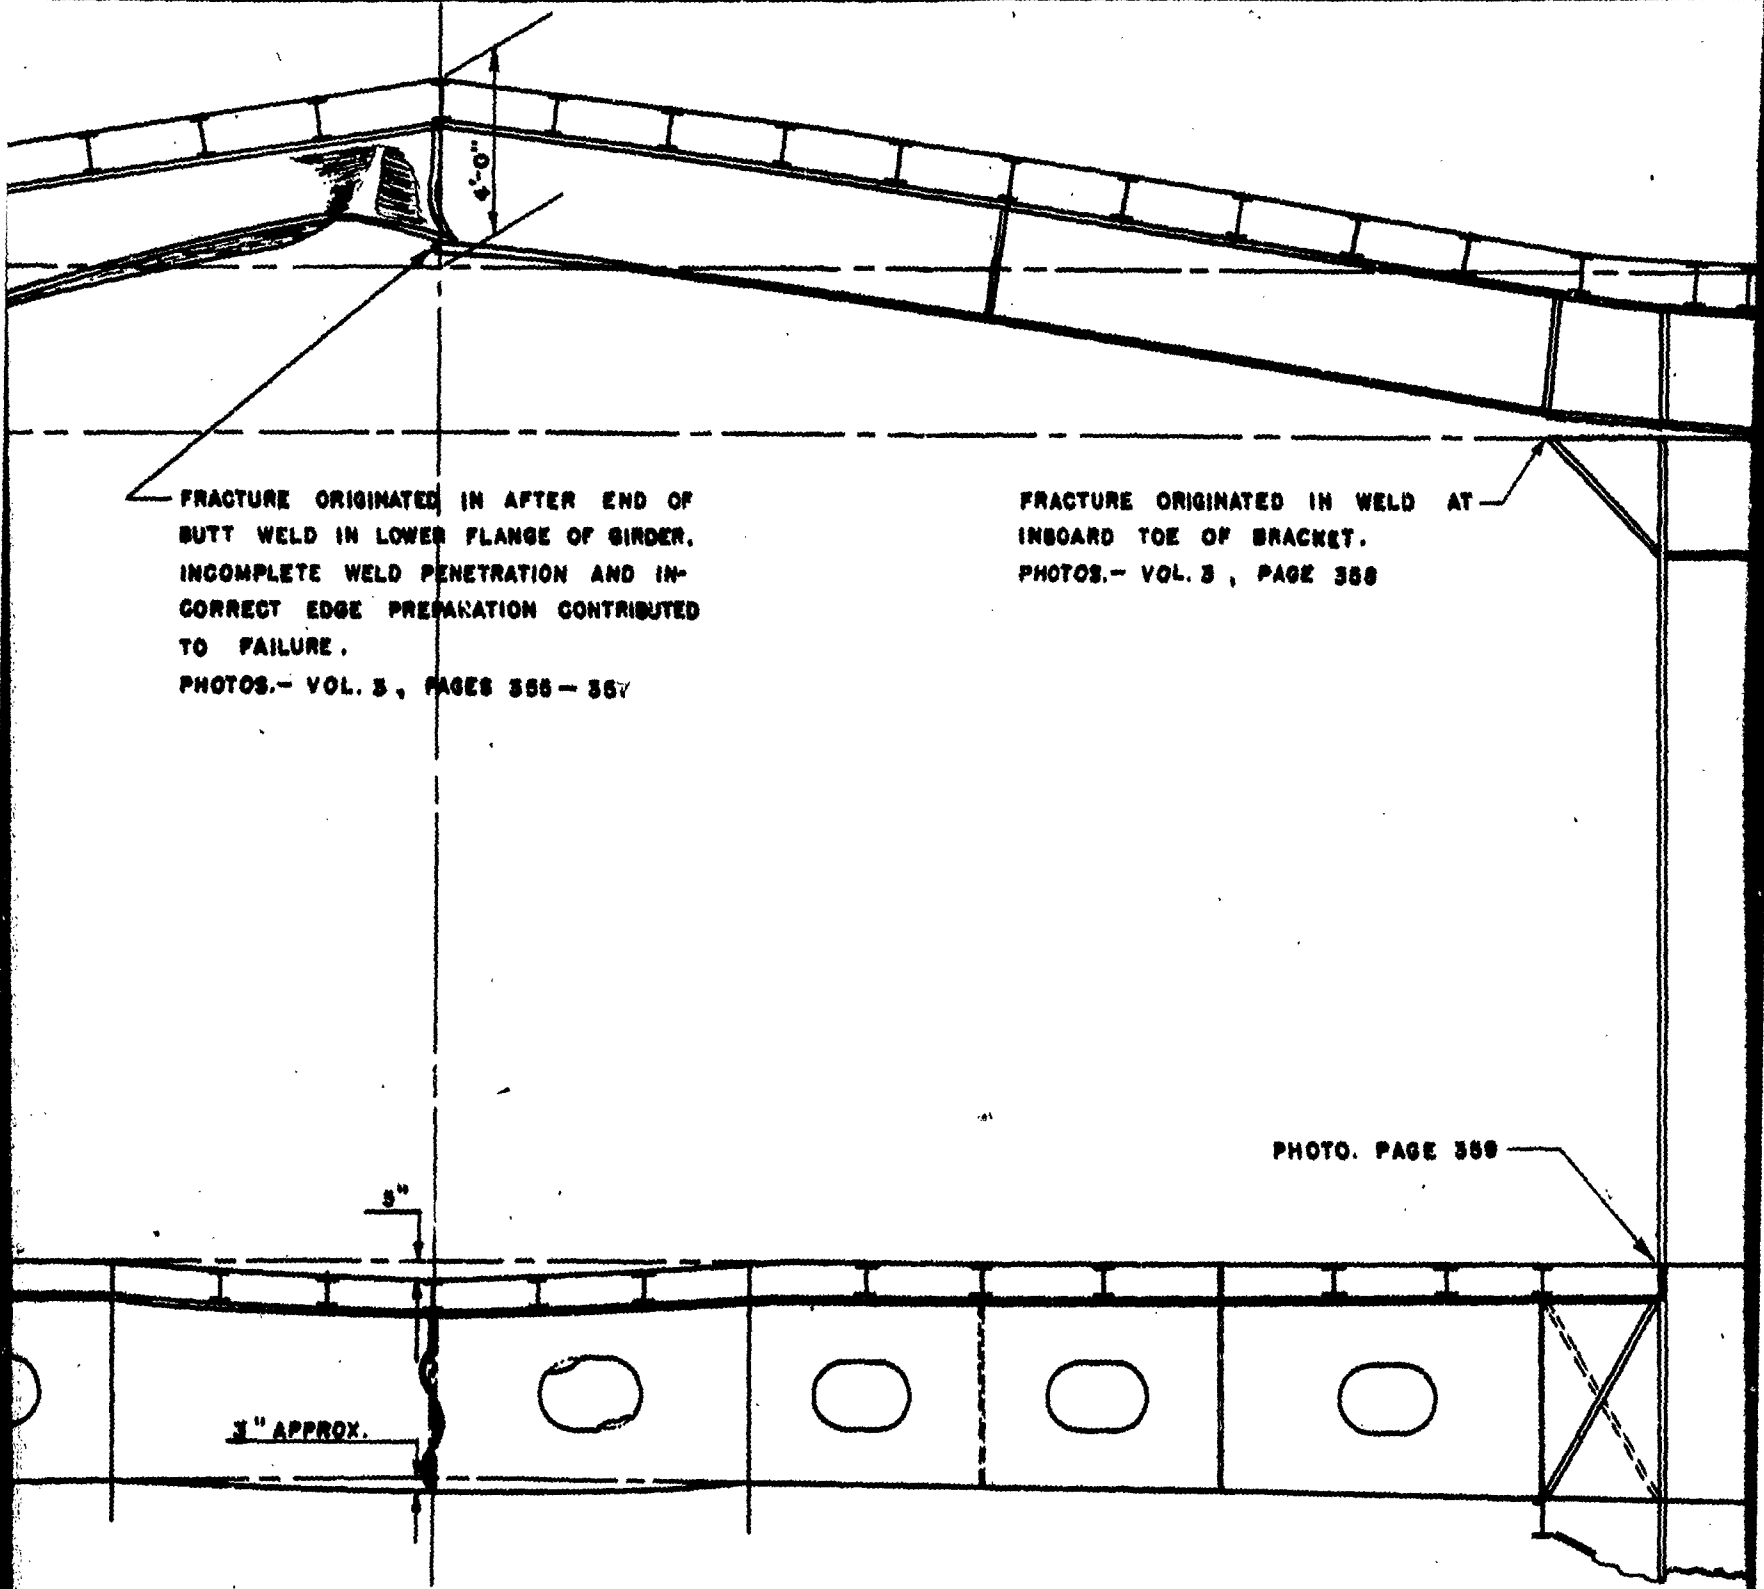
— FRACTURE ORIGINATED IN AFTER END OF BUTT WELD IN LOWER FLANGE OF GIRDER. INCOMPLETE WELD PENETRATION AND INCORRECT EDGE PREPARATION CONTRIBUTED TO FAILURE.
PHOTOS.— VOL. 3, PAGES 355 — 357

FRACTURE ORIGINATED IN WELD AT INBOARD TOE OF BRACKET.
PHOTOS.— VOL. 3, PAGE 358

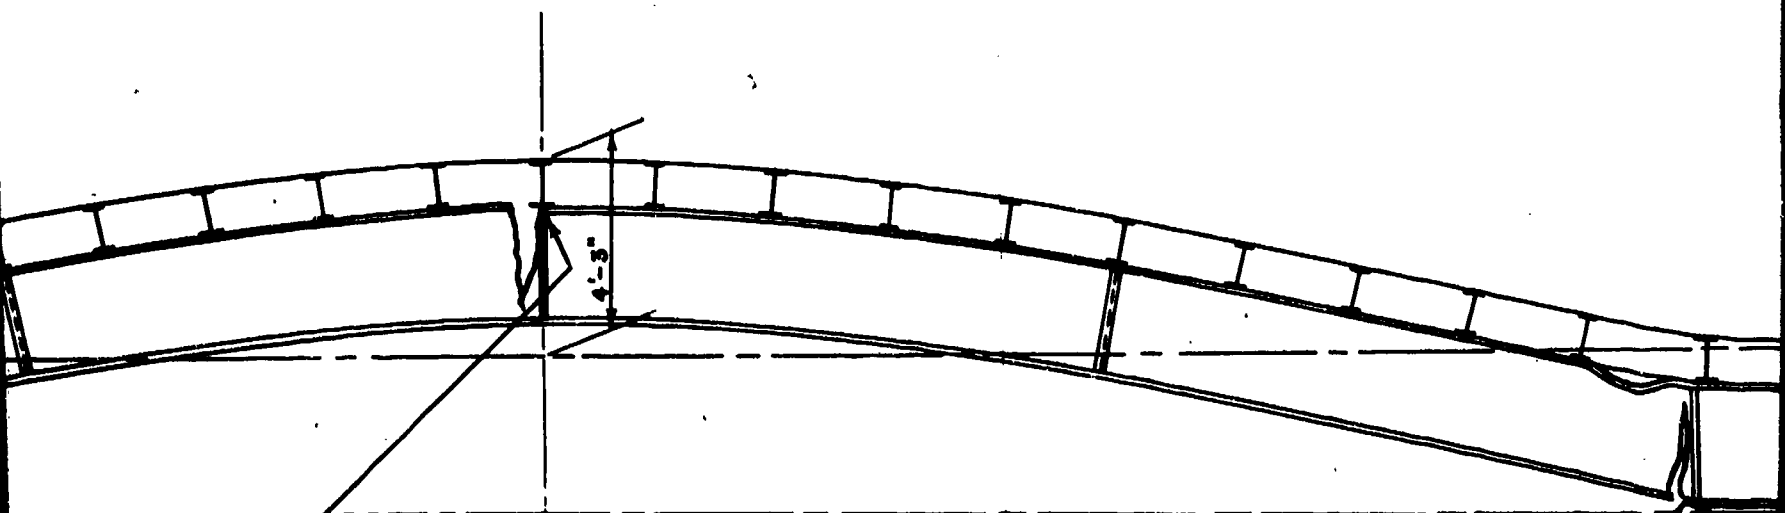
← FRACTURE ORIGINATED AT EDGE OF WELD
 IN TOP FLANGE OF GIRDER.
 PHOTOS.- VOL. 3, PAGES 366-369, 375, 376

FRACTURE ORIGINATED AT UPPER EDGE
 OF WELD JOINING GIRDER AND
 BRACKET FLANGES.
 DISCONTINUITY IN STRUCTURAL DESIGN
 OF CONNECTION CONTRIBUTED TO FAILURE.
 PHOTOS.-VOL. 3, PAGES 370, 372

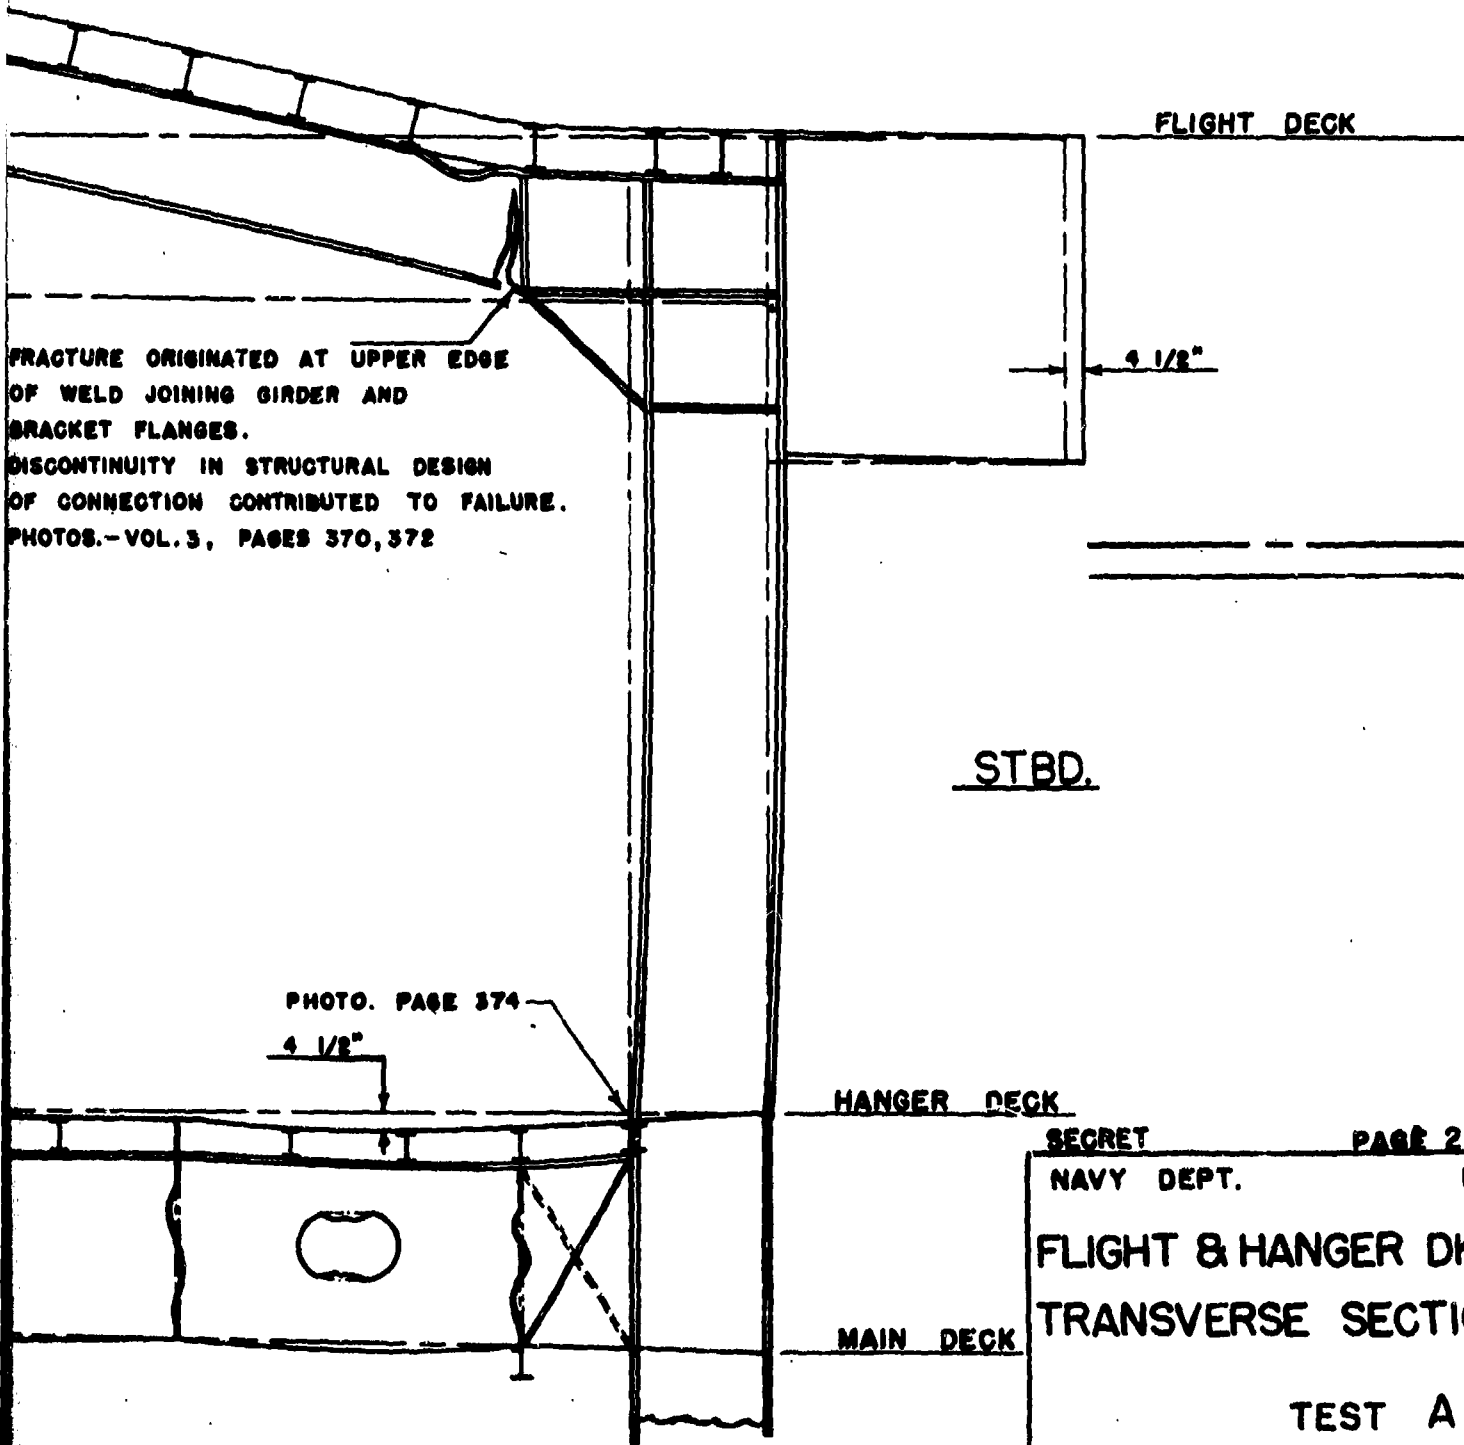
SECRET PAGE 213 OF 280
NAVY DEPT. BUREAU OF SHIPS
FLIGHT & HANGER DK. DEFLECTION
TRANSVERSE SECTION, FRAME 74
TEST A
U.S.S. INDEPENDENCE CVL 22

FRACTURE ORIGINATED AT UPPER EDGE
OF WELD JOINING GIRDER AND
BRACKET FLANGES.
DISCONTINUITY IN STRUCTURAL DESIGN
OF CONNECTION CONTRIBUTED TO FAILURE.
PHOTOS.-VOL. 3, PAGES 370, 372

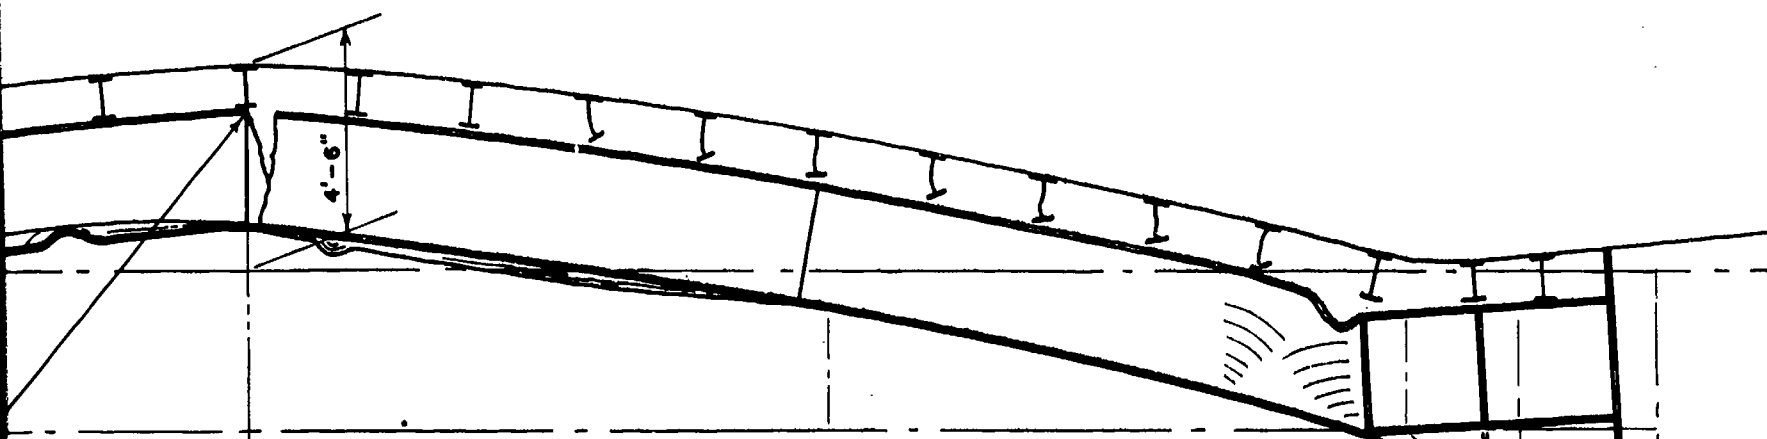
RACTURE ORIGINATED AT EDGE OF WELD
TOP FLANGE OF GIRDER.
PHOTOS.- VOL. 3, PAGES 379 - 382

SLIGHT FRACTURE WITH ORIGIN AT UPPER
EDGE OF WELD JOINING COLUMN AND
BRACKET FLANGE.
PHOTOS.- VOL. 3 PAGE 378

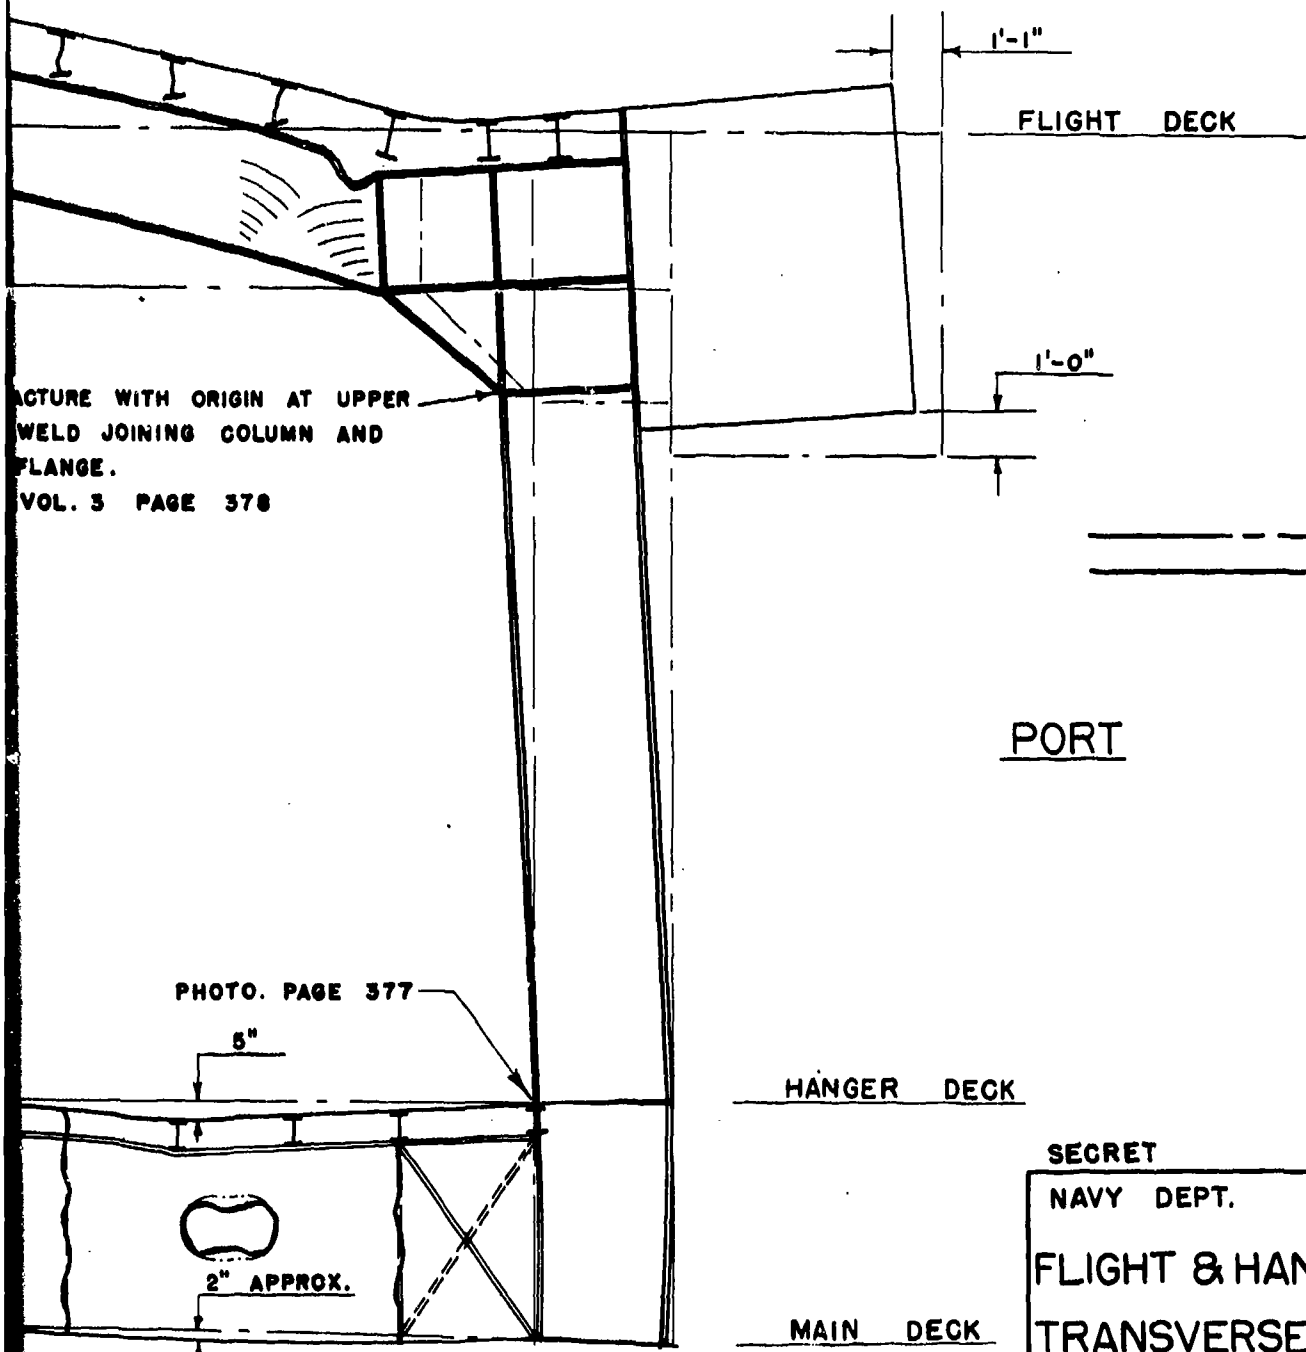
FRACTURE WITH ORIGIN AT UPPER
 WELD JOINING COLUMN AND
 FLANGE.
 VOL. 3 PAGE 378
