BUREAU OF SHIPS GROUP TECHNICAL INSPECTION REPORT

OPERATION CROSSROADS. U.S.S. INDEPENDENCE (CVL22)

TEST ABLE

VOLUME 1 OF 4 [W]

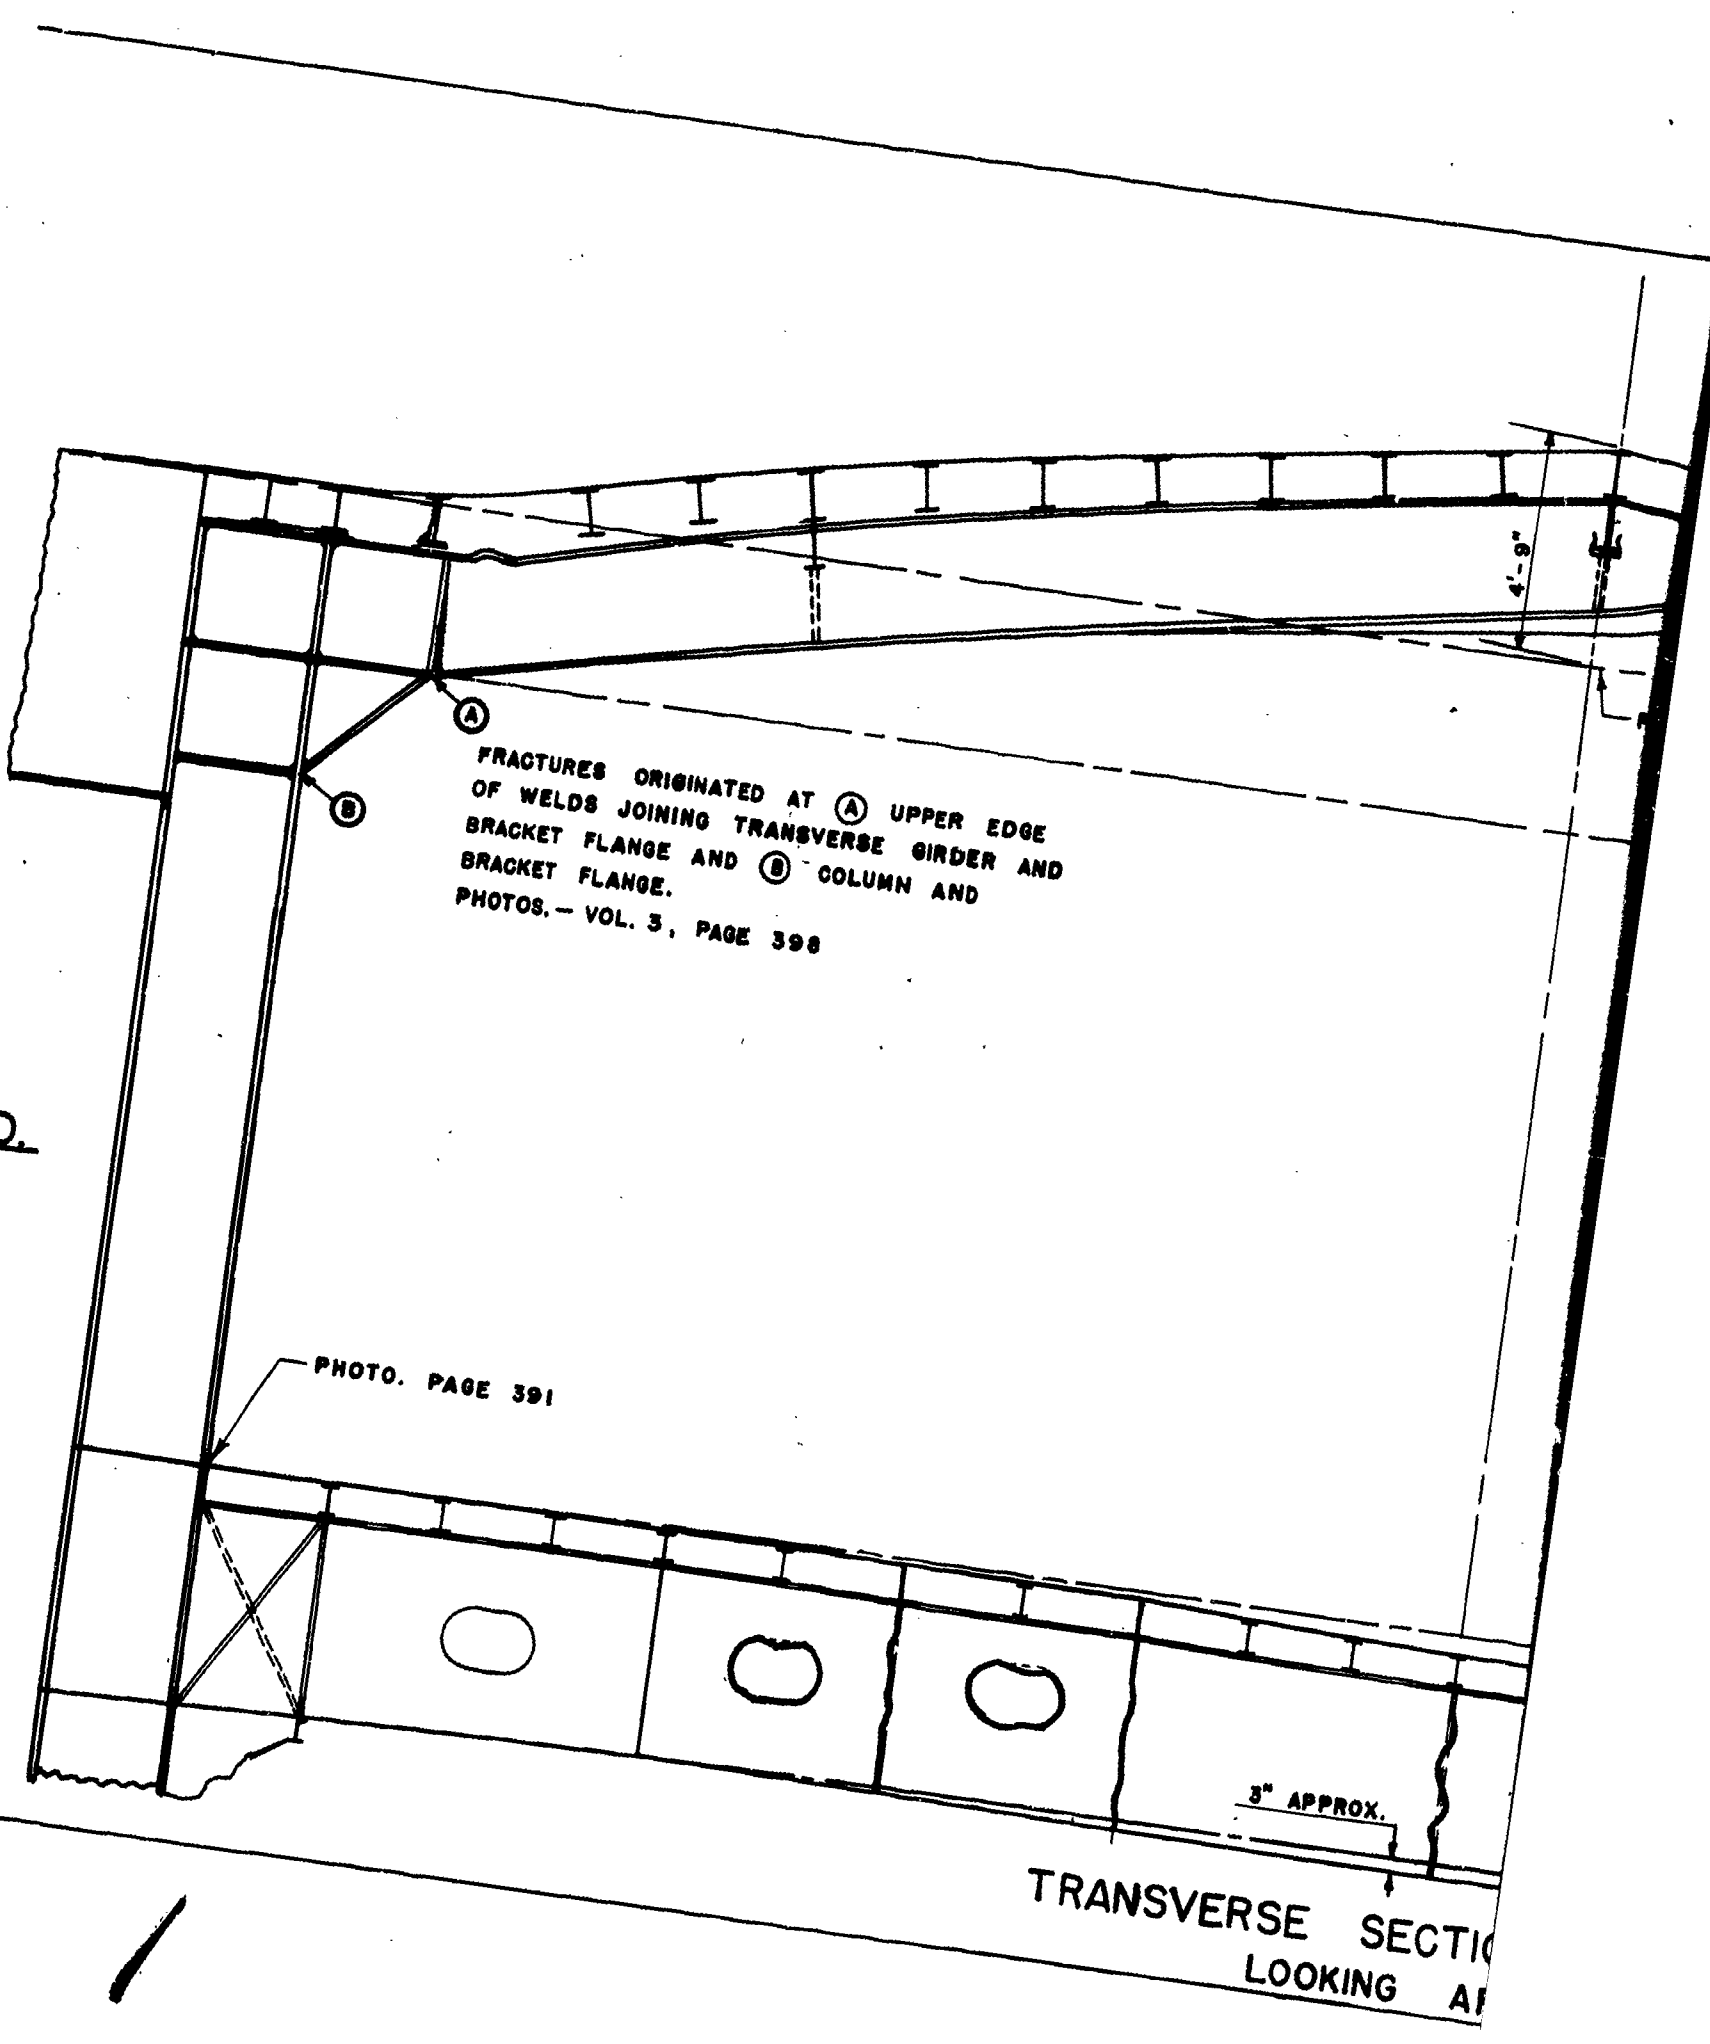
FRACTURES ORIGINATED AT (A) UPPER EDGE
OF WELDS JOINING TRANSVERSE GIRDER AND
BRACKET FLANGE AND (B) COLUMN AND
BRACKET FLANGE.
PHOTOS. - VOL. 3, PAGE 398

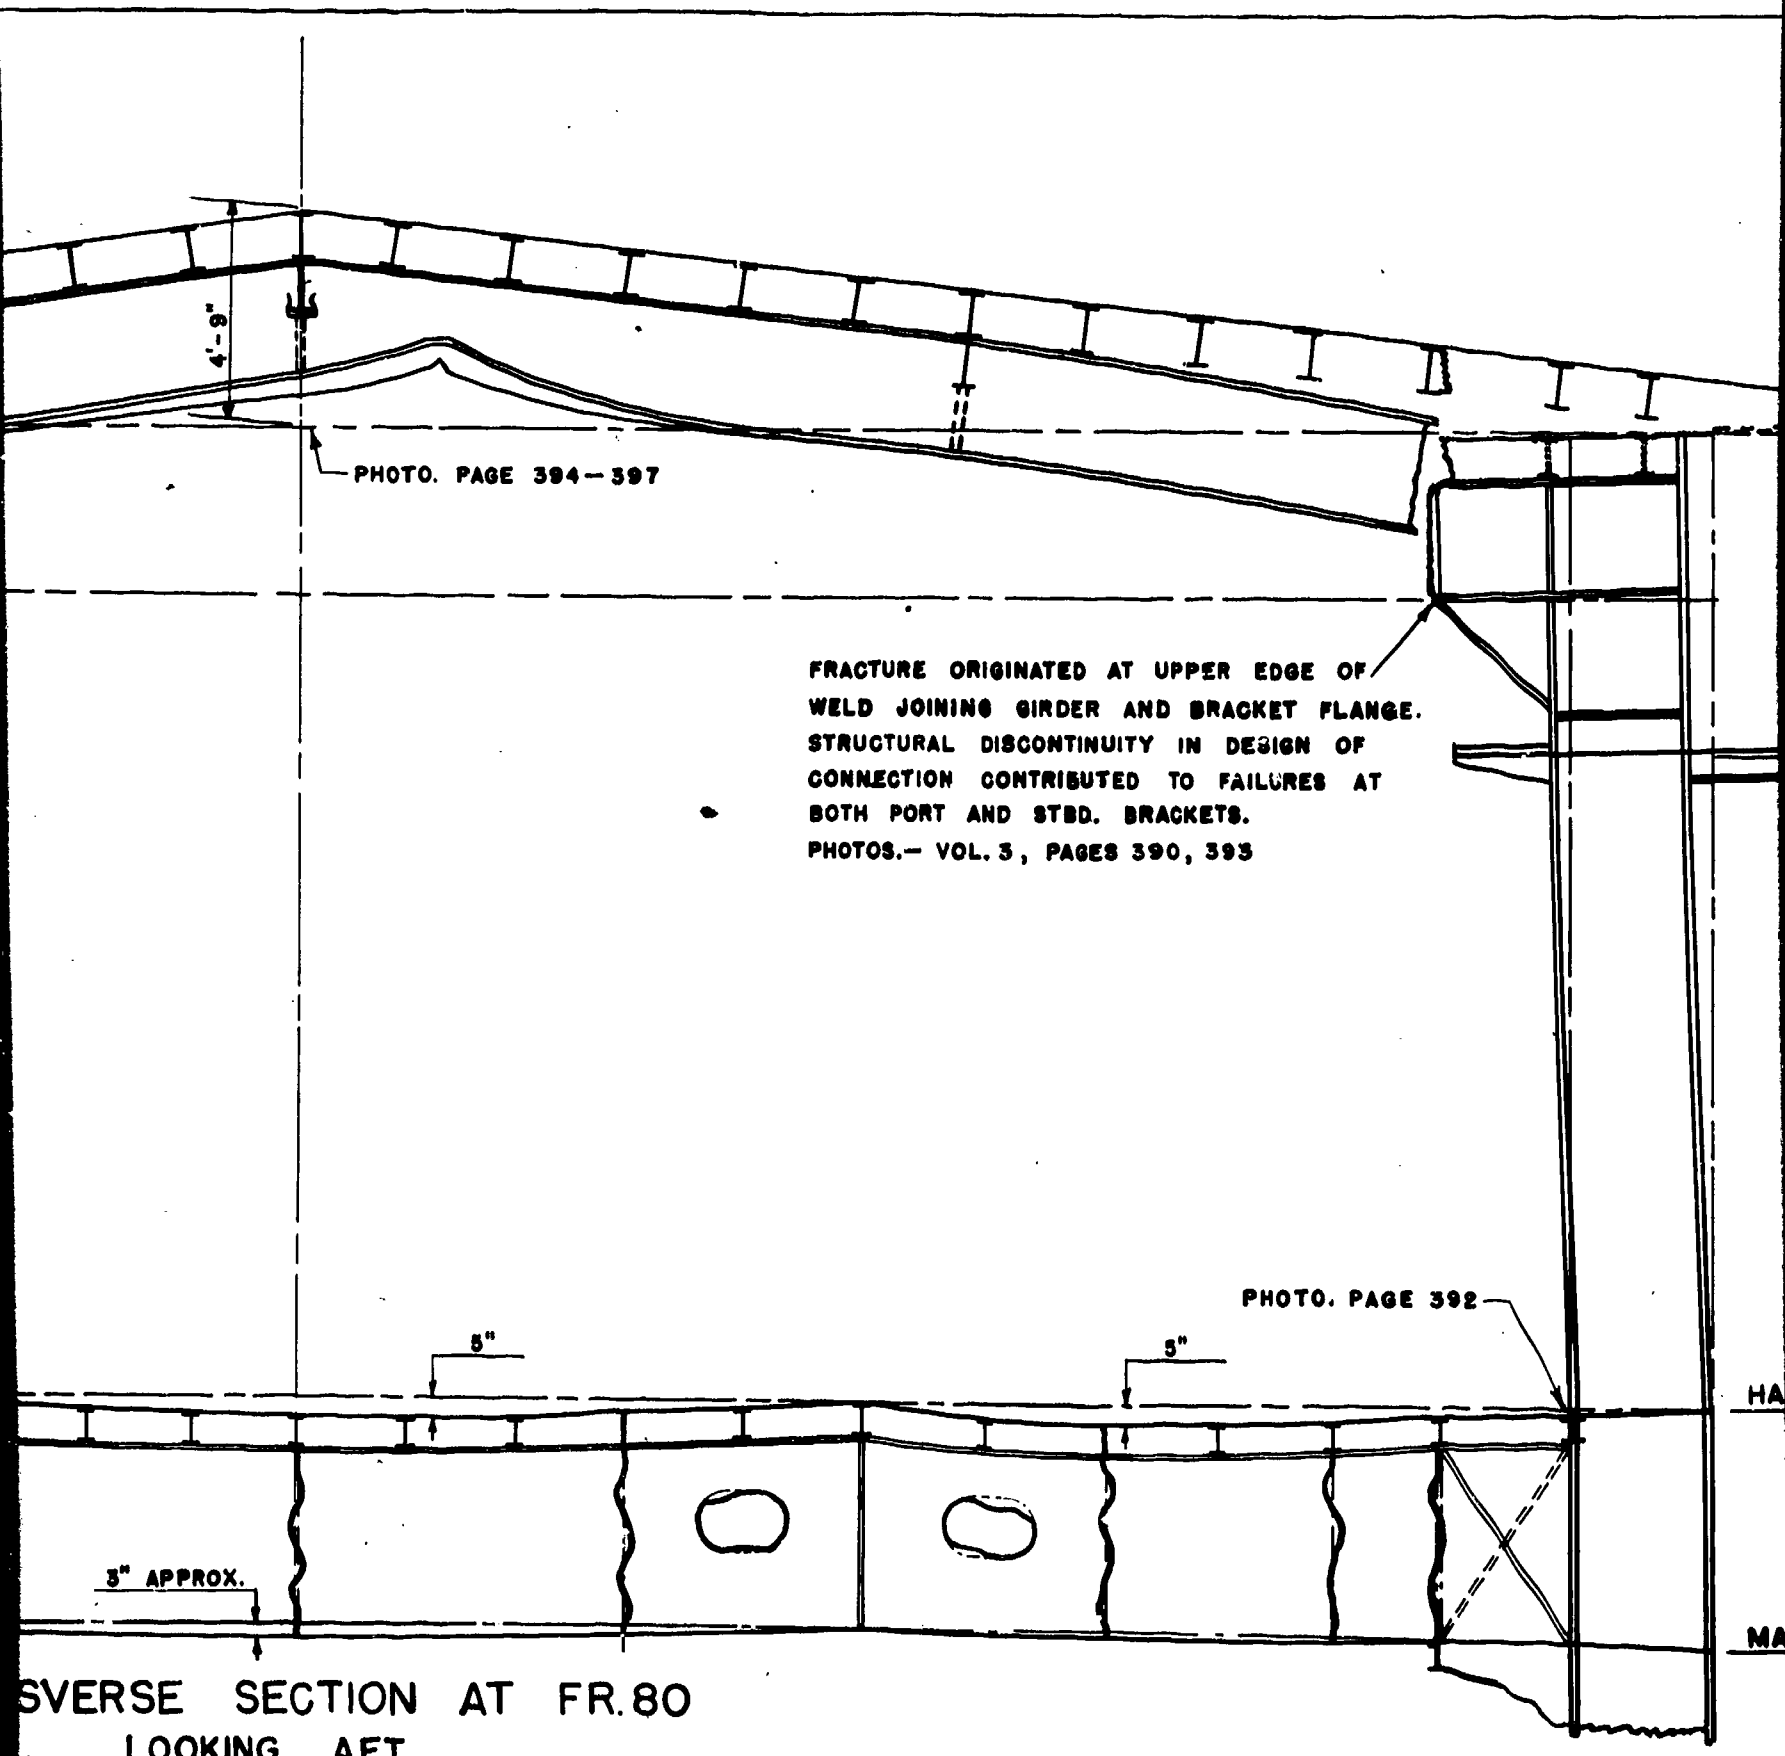
FRACTURE ORIGINATED AT UPPER EDGE OF WELD JOINING GIRDER AND BRACKET FLANGE. STRUCTURAL DISCONTINUITY IN DESIGN OF CONNECTION CONTRIBUTED TO FAILURES AT BOTH PORT AND STBD. BRACKETS. PHOTOS.- VOL. 3, PAGES 390, 393

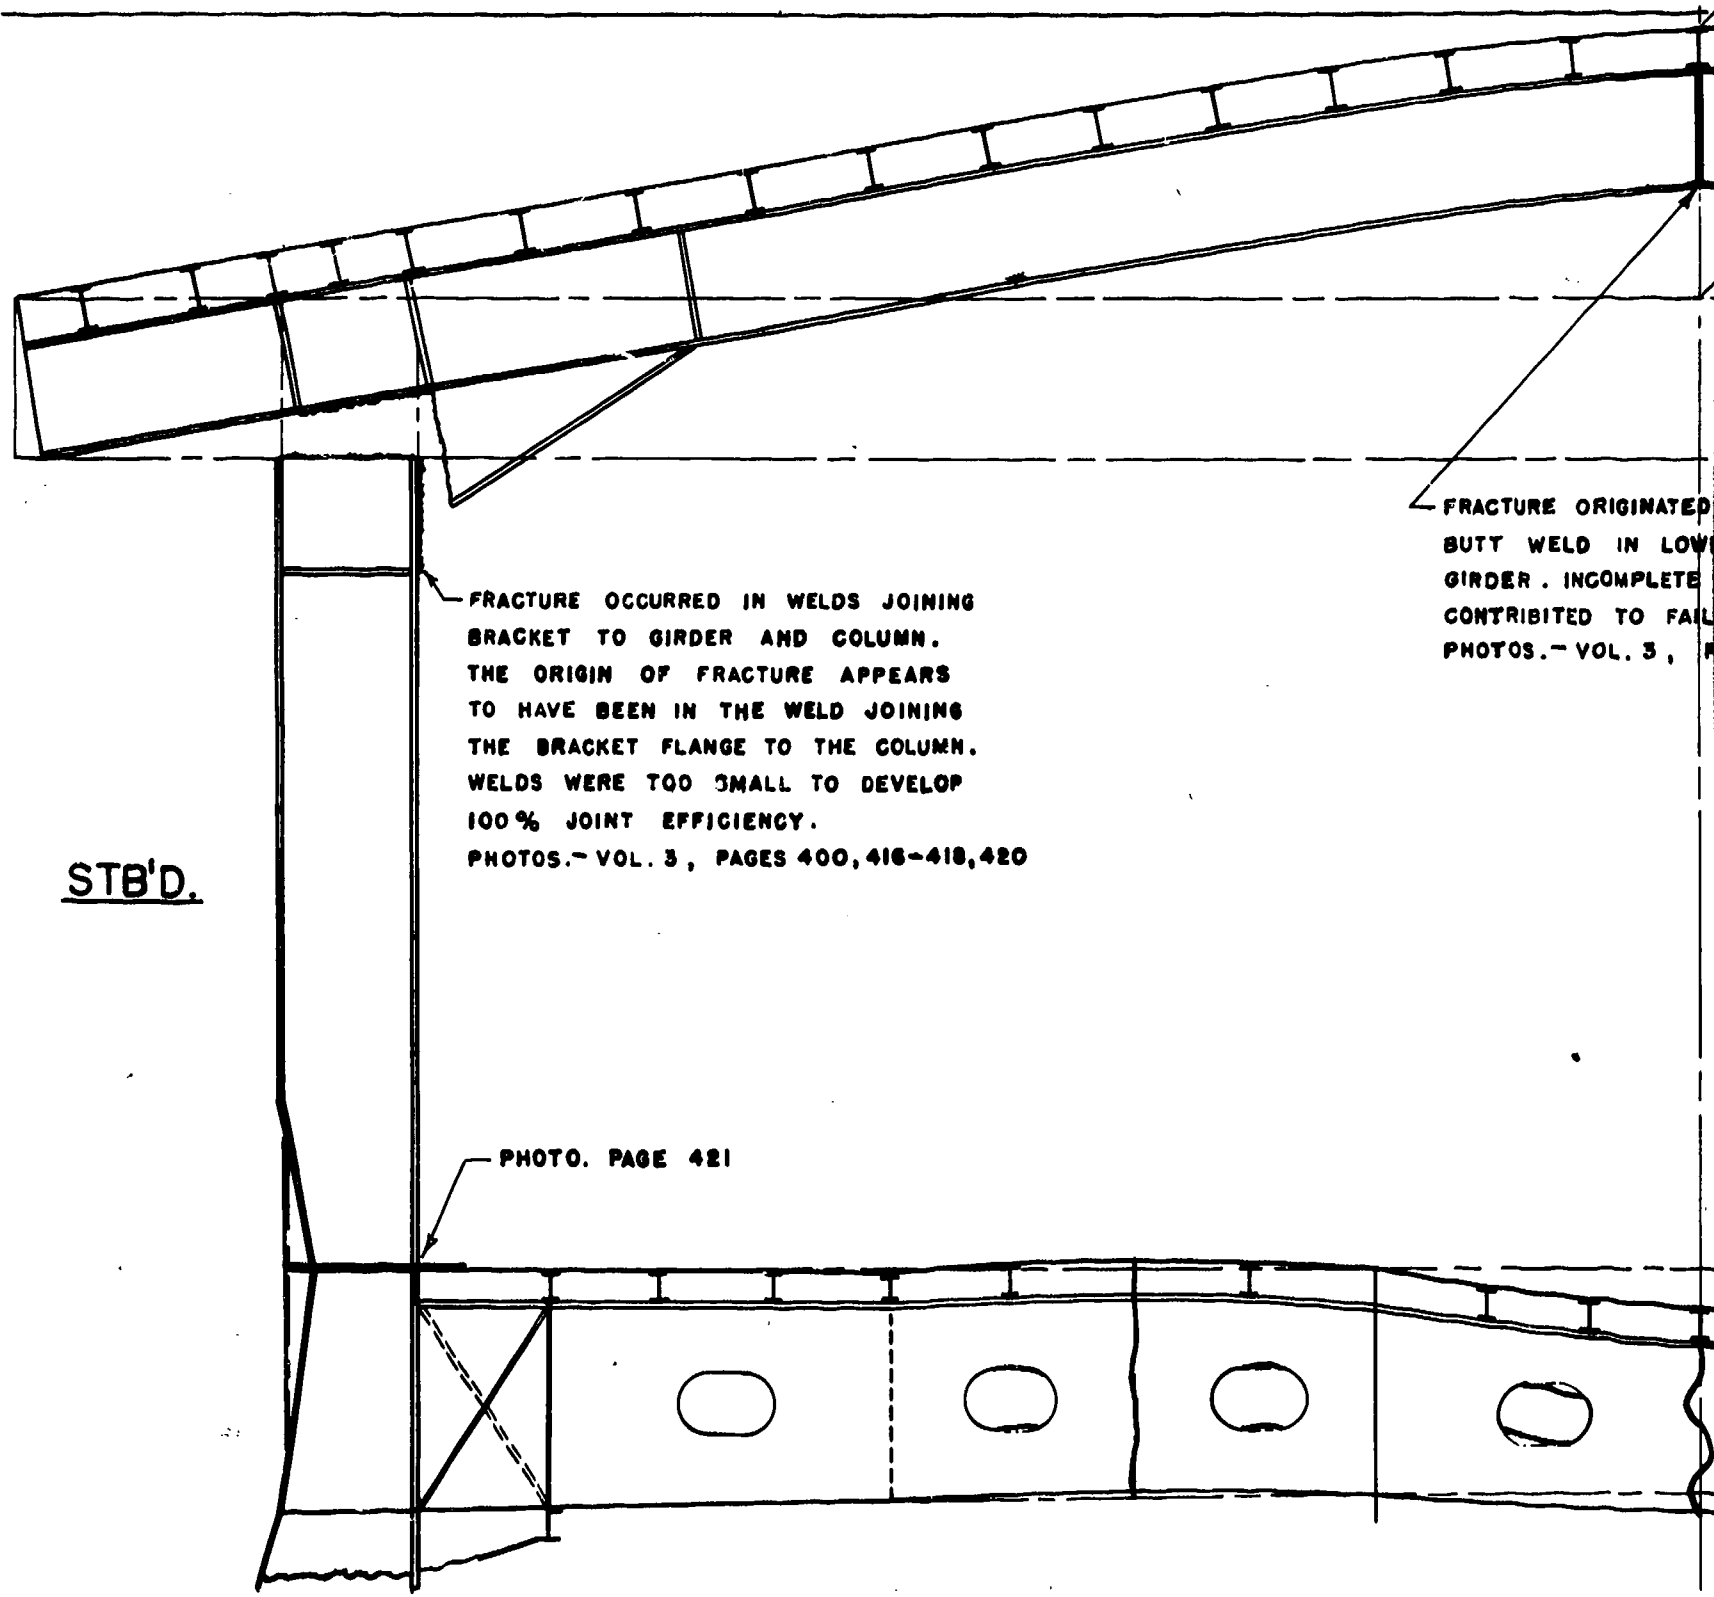
SECRET PAGE 216 OF 280
 NAVY DEPT. BUREAU OF SHIPS
 FLIGHT & HANGER DK. DEFLECTION
 TRANSVERSE SECTION, FRAME 83
 TEST A
 U.S.S. INDEPENDENCE CVL 22

FRACTURE OCCURRED IN WELDS JOINING BRACKET TO GIRDER AND COLUMN. THE ORIGIN OF FRACTURE APPEARS TO HAVE BEEN IN THE WELD JOINING THE BRACKET FLANGE TO THE COLUMN. WELDS WERE TOO SMALL TO DEVELOP 100% JOINT EFFICIENCY. PHOTOS.- VOL. 3, PAGES 400, 416-418, 420

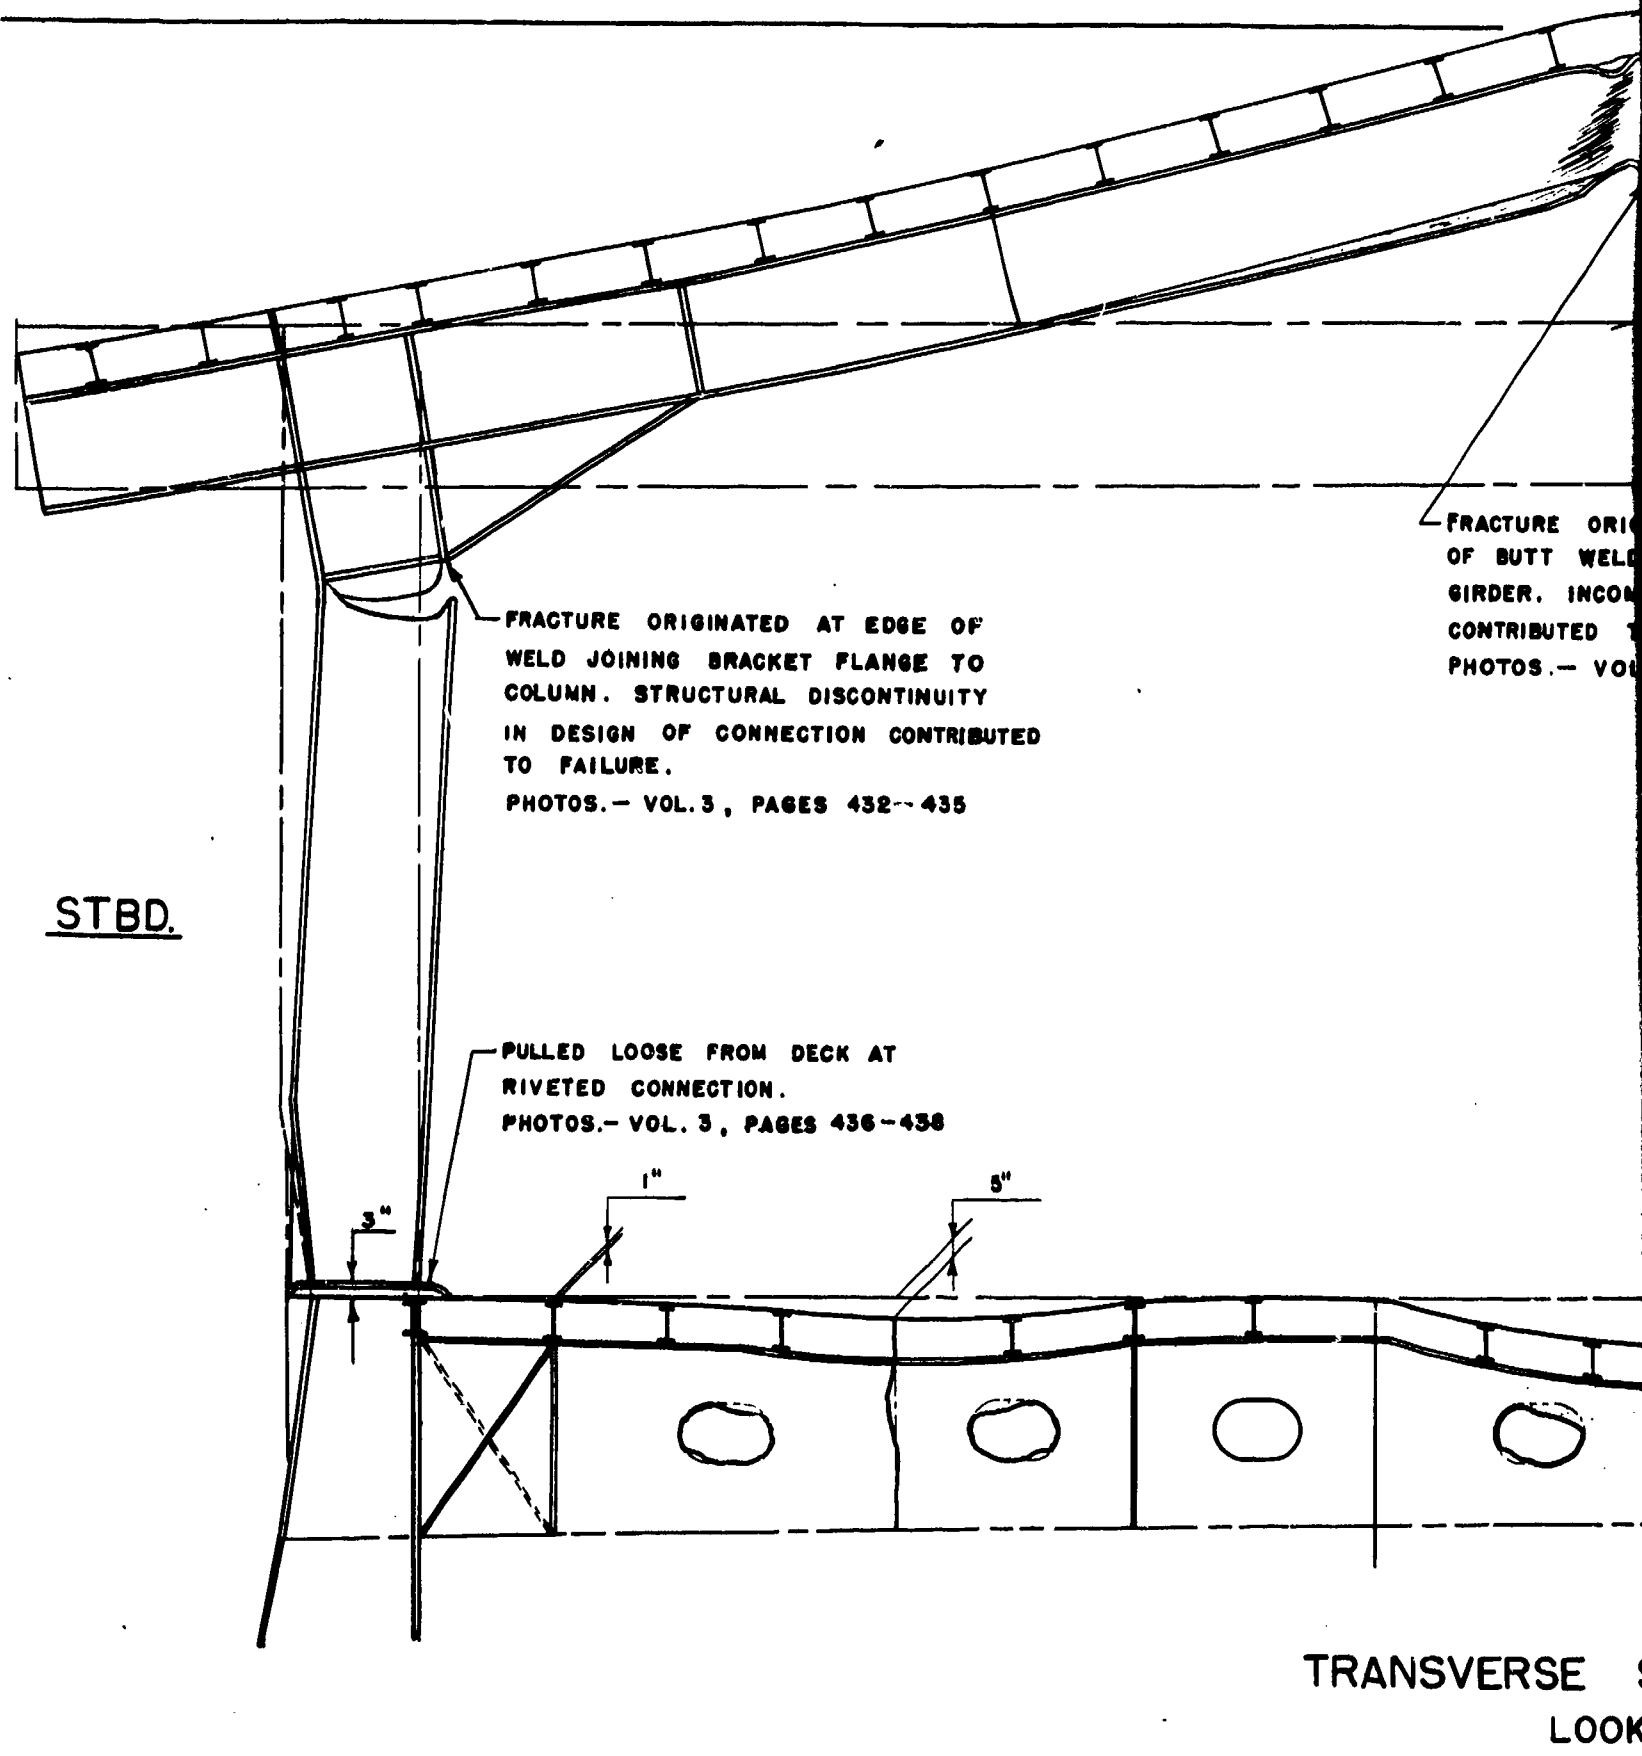
3 PLATE NO.14 10386

FRACTURE ORIGINATED AT EDGE OF WELD JOINING BRACKET FLANGE TO COLUMN. STRUCTURAL DISCONTINUITY IN DESIGN OF CONNECTION CONTRIBUTED TO FAILURE.
PHOTOS.— VOL. 3, PAGES 432--435

FRACTURE ORIGINATED AT EDGE OF BUTT WELD JOINING GIRDER. INCOMPLETE WELD CONTRIBUTED TO FAILURE.
PHOTOS.— VOL. 3, PAGES 432--435

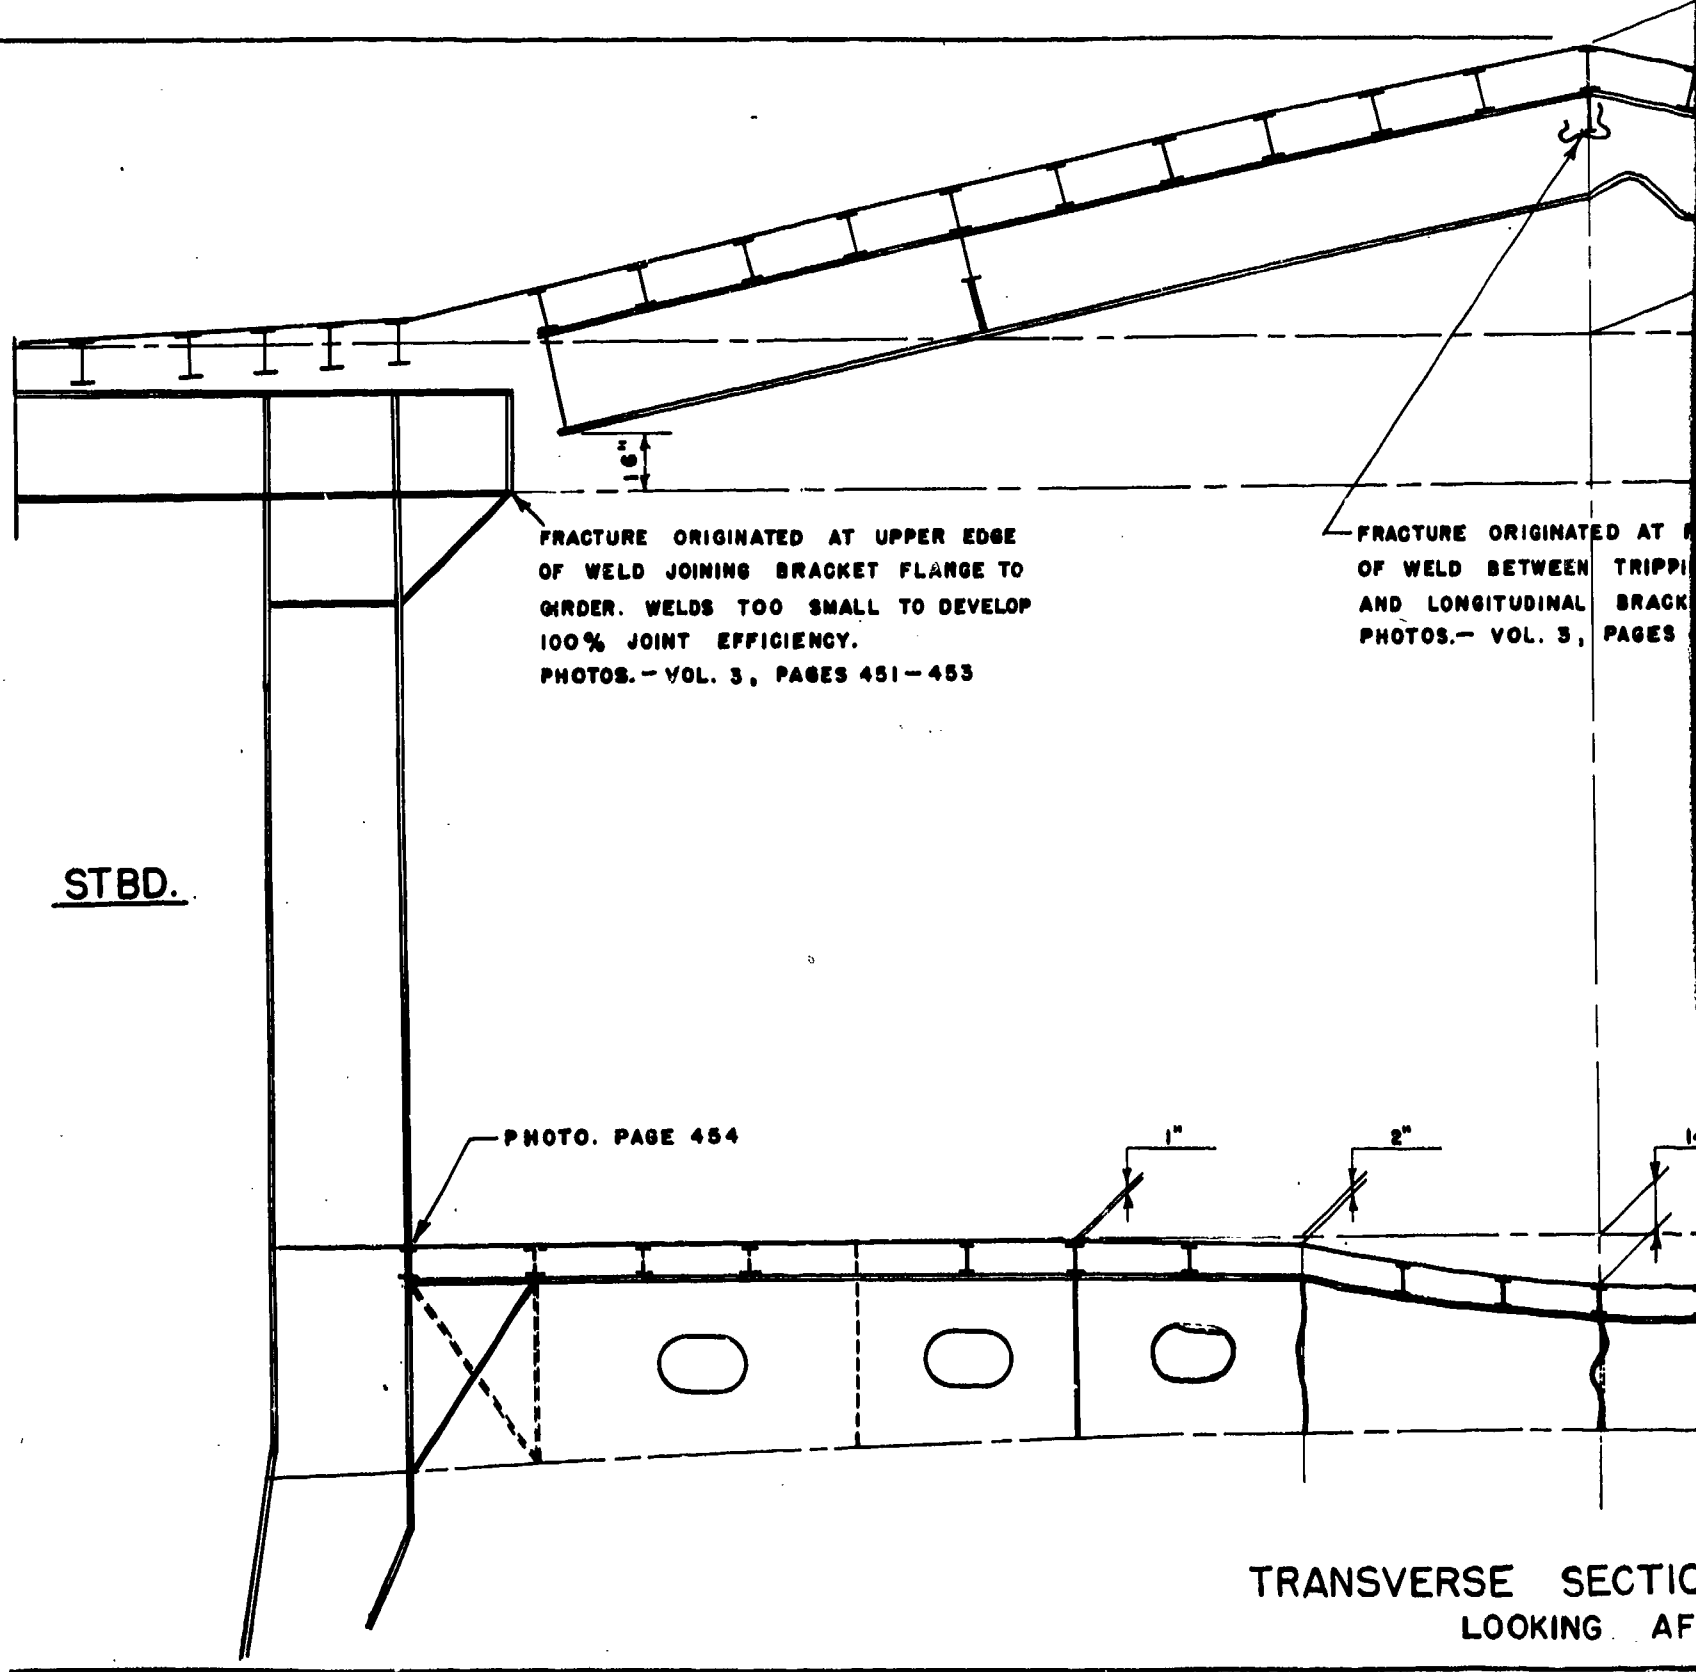
3 PLATE NO. 15 10386

FRACTURE ORIGINATED AT UPPER EDGE OF WELD JOINING BRACKET FLANGE TO GIRDER. WELDS TOO SMALL TO DEVELOP 100% JOINT EFFICIENCY. PHOTOS. - VOL. 3, PAGES 451-453

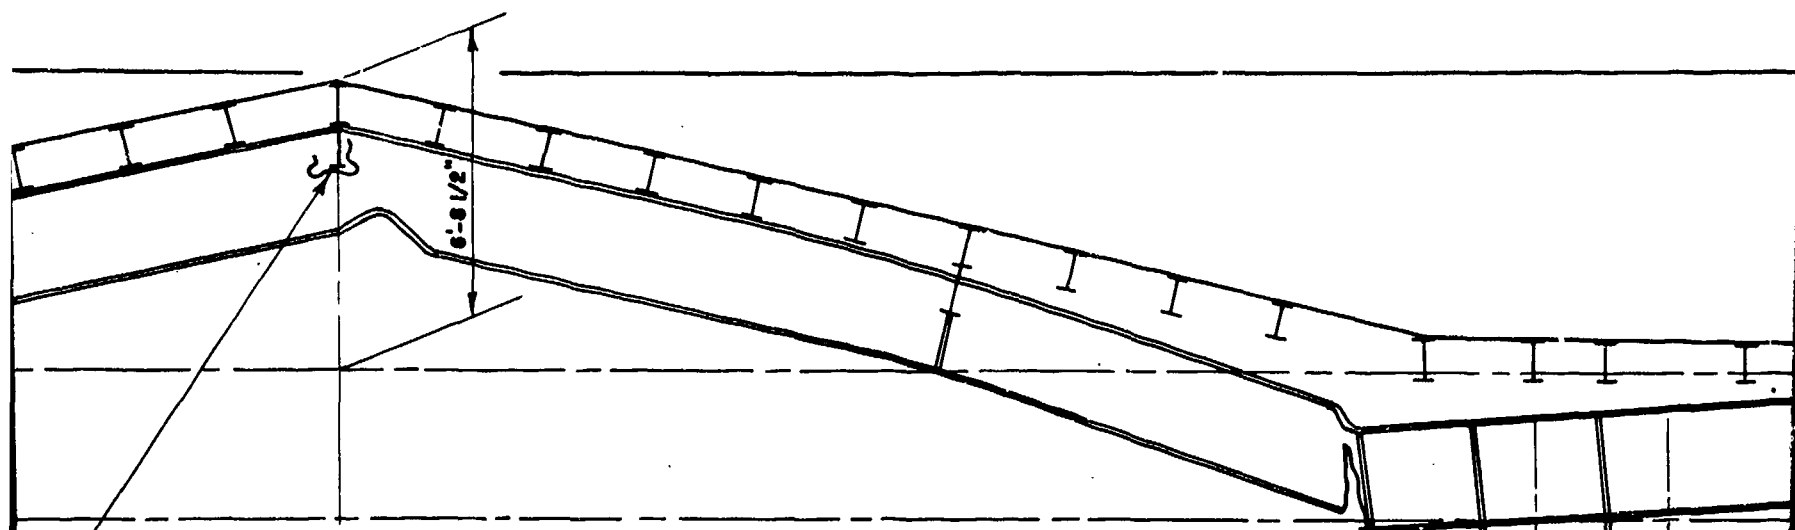
FRACTURE ORIGINATED AT FORWARD END OF WELD BETWEEN TRIPPING BRACKET AND LONGITUDINAL BRACKET.
PHOTOS.— VOL. 3, PAGES 448—450

FRACTURE ORIGINATED AT UPPER EDGE OF WELD JOINING BRACKET FLANGE TO GIRDER. STRUCTURAL DISCONTINUITY IN DESIGN OF CONNECTION CONTRIBUTED TO FAILURE.
PHOTOS.— VOL. 3, PAGES 445—447

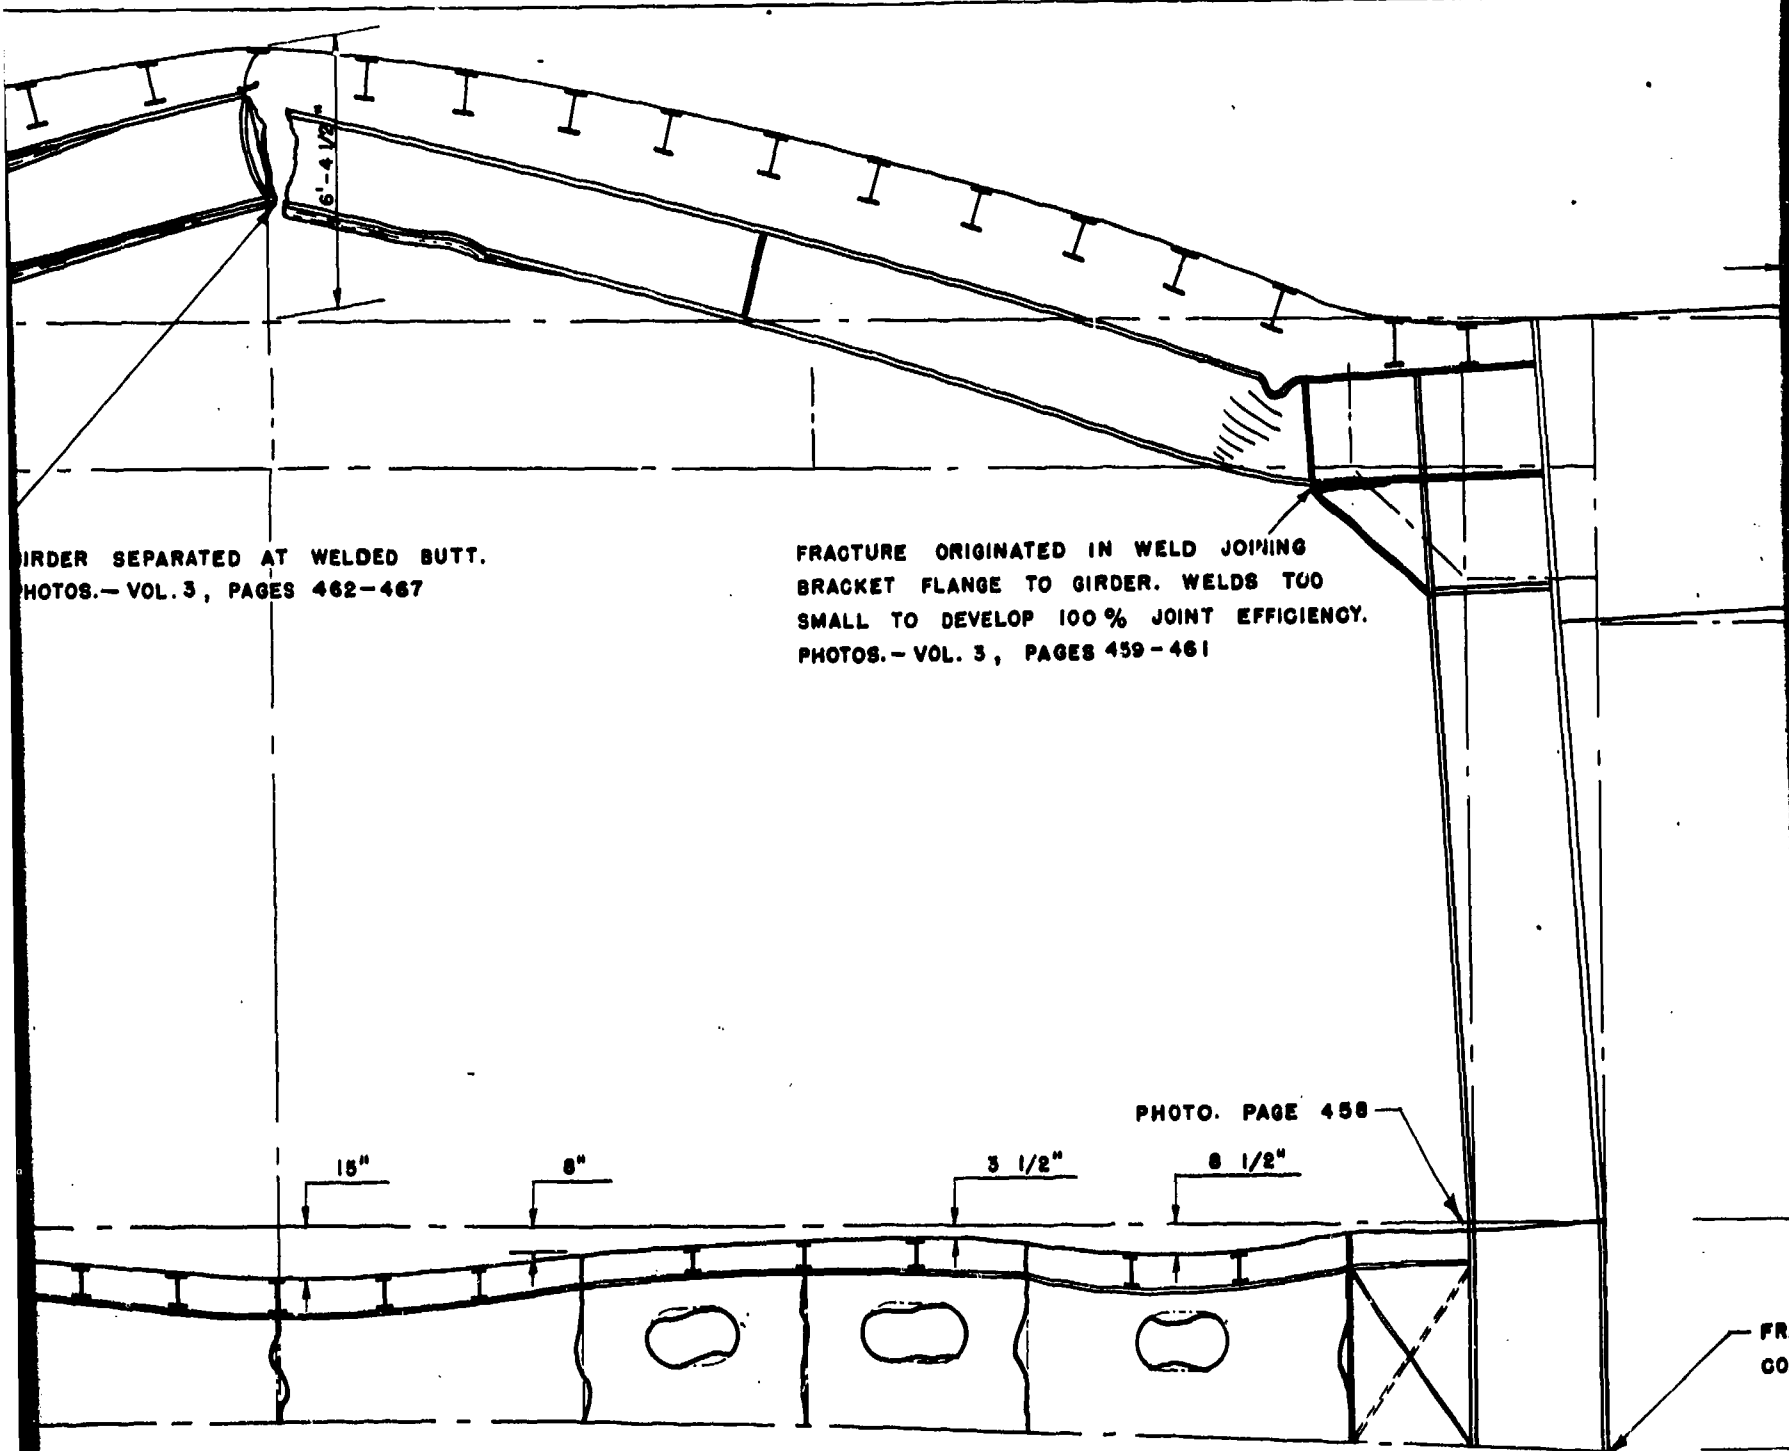
GIRDER SEPARATED AT WELDED BUTT.
 PHOTOS.— VOL. 3, PAGES 462-467

FRACTURE ORIGINATED IN WELD JOINING
 BRACKET FLANGE TO GIRDER. WELDS TOO
 SMALL TO DEVELOP 100% JOINT EFFICIENCY.
 PHOTOS.— VOL. 3, PAGES 459-461

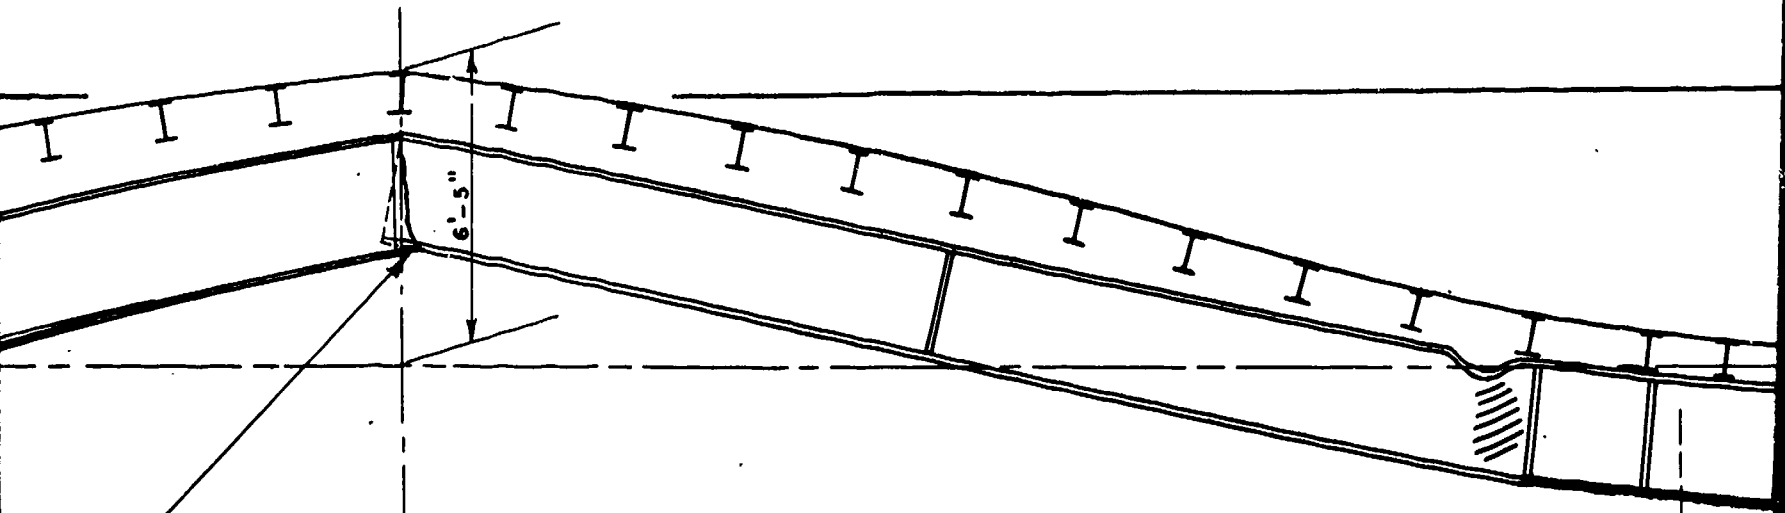
FRACTURE ORIGINATED IN BUTT WELD IN
 LOWER FLANGE OF GIRDER.
 PHOTOS.- VOL. 3, PAGES 475-483

FRACTURE ORIGINATED IN WELD JOINING
 BRACKET FLANGE TO TRANSVERSE GIRDER.
 WELDS TOO SMALL TO DEVELOP 100%
 JOINT EFFICIENCY.
 PHOTOS.- VOL. 3, PAGES 473, 474

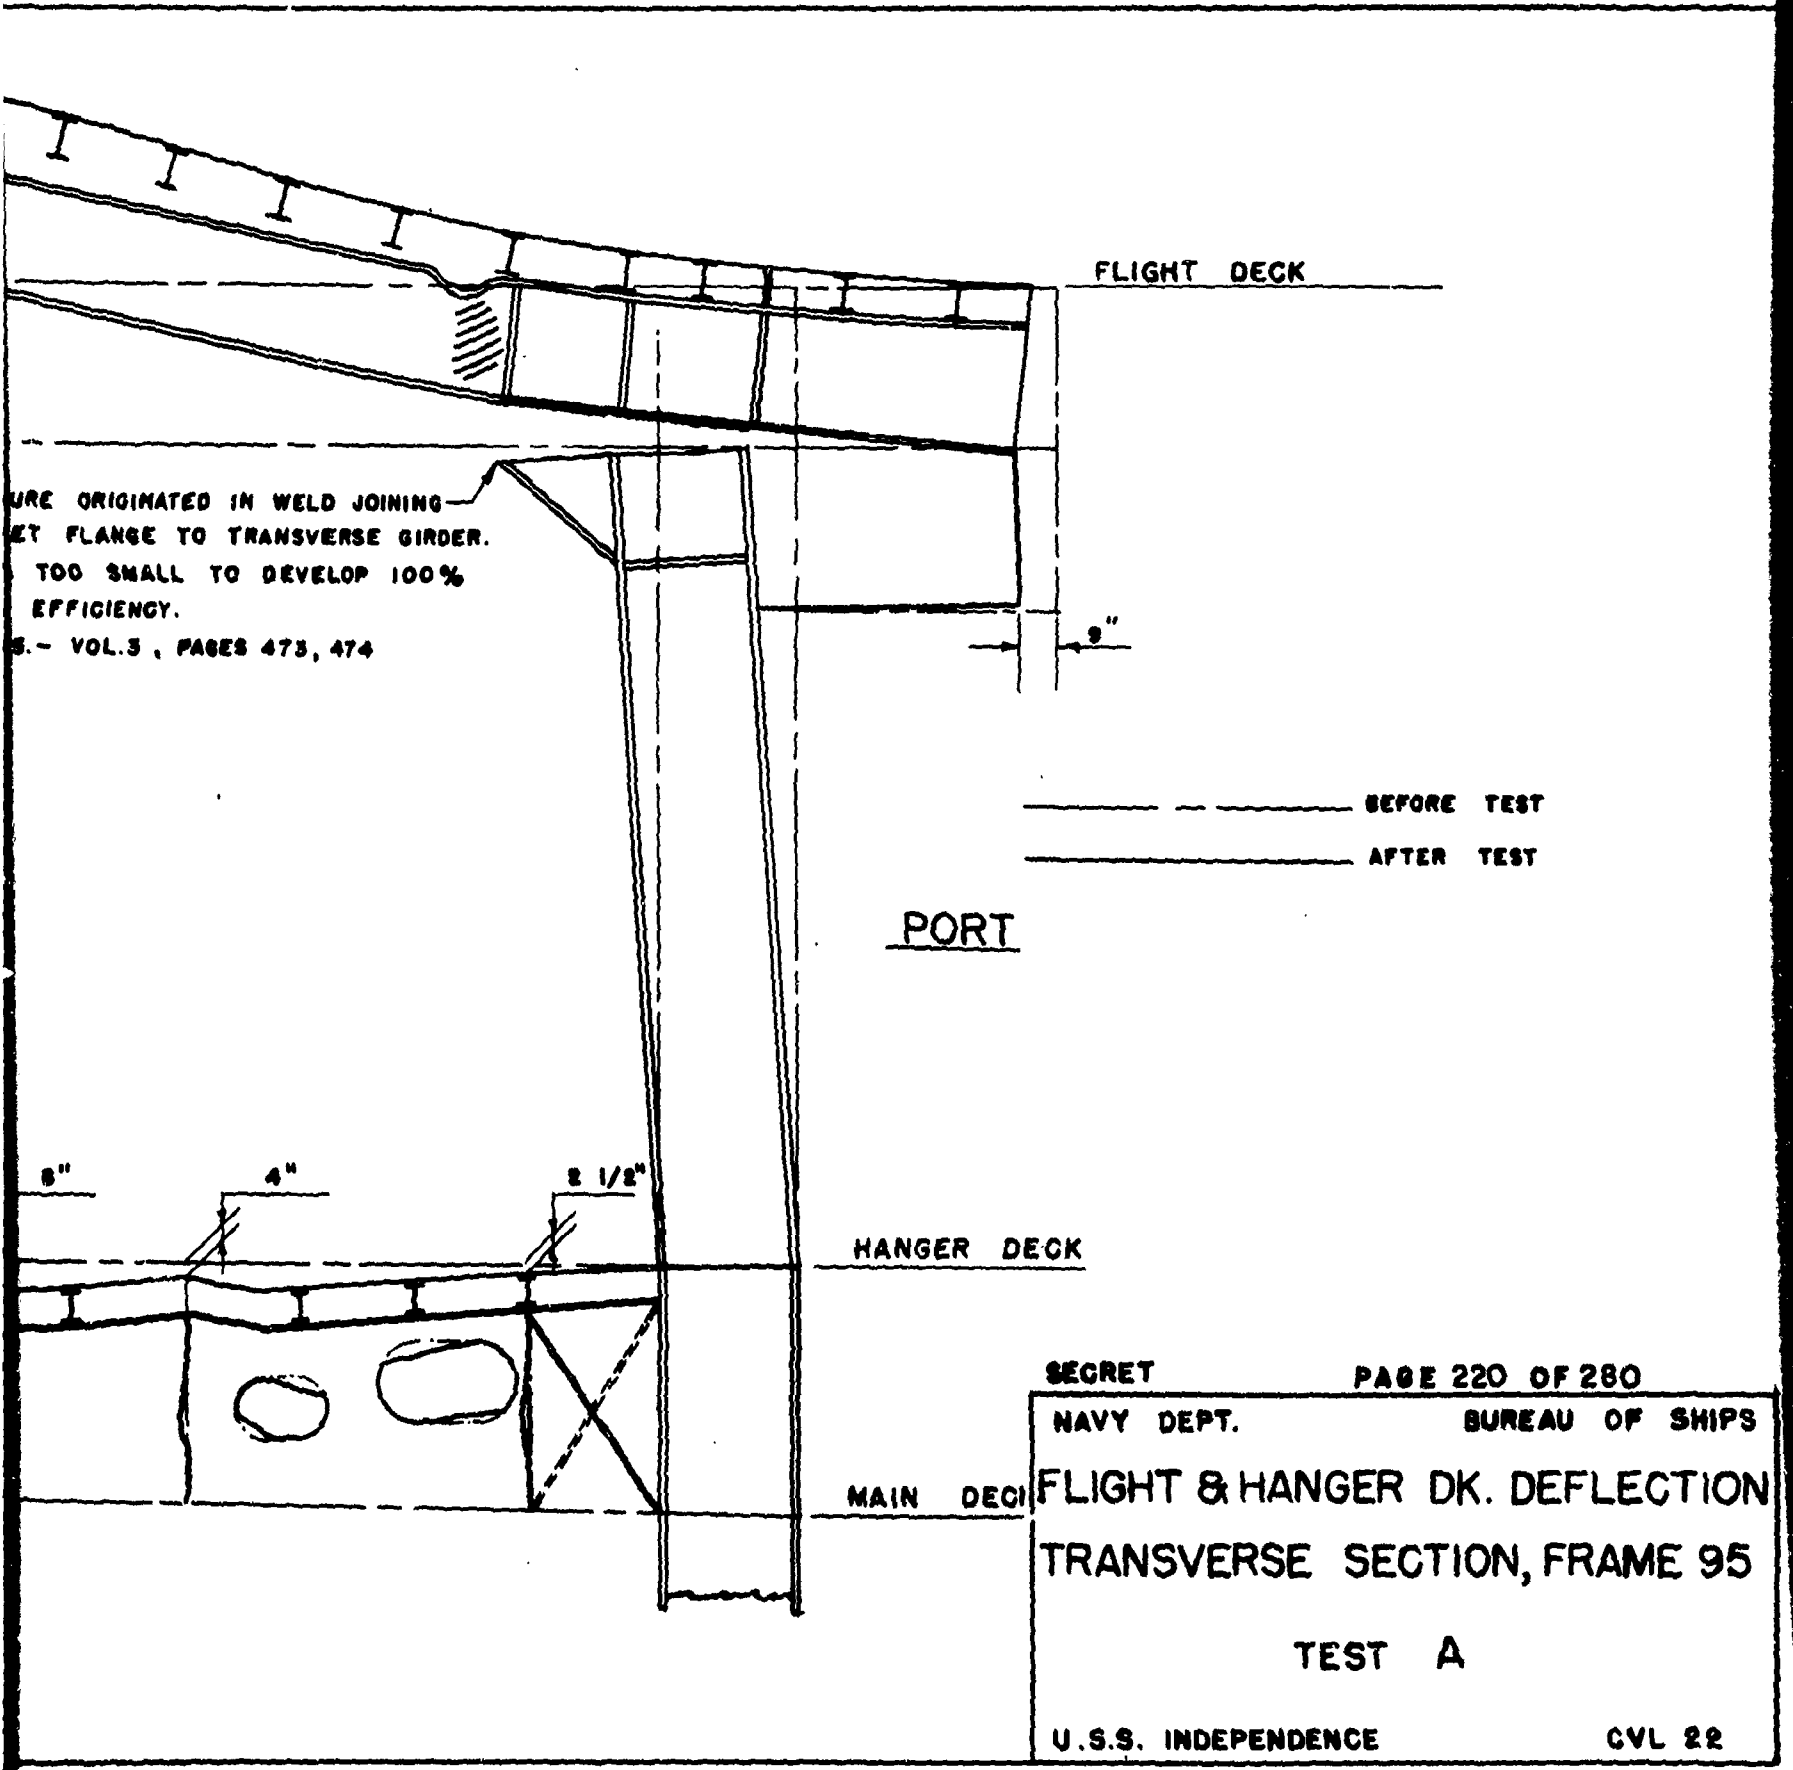
CRACKS ORIGINATED IN WELD JOINING
 PORT FLANGE TO TRANSVERSE GIRDER.
 TOO SMALL TO DEVELOP 100%
 EFFICIENCY.
 S. - VOL. 3, PAGES 473, 474
