BUREAU OF SHIPS GROUP TECHNICAL INSPECTION REPORT

OPERATION CROSSROADS. U.S.S. INDEPENDENCE (CVL22)

TEST ABLE

VOLUME 1 OF 4 [W]

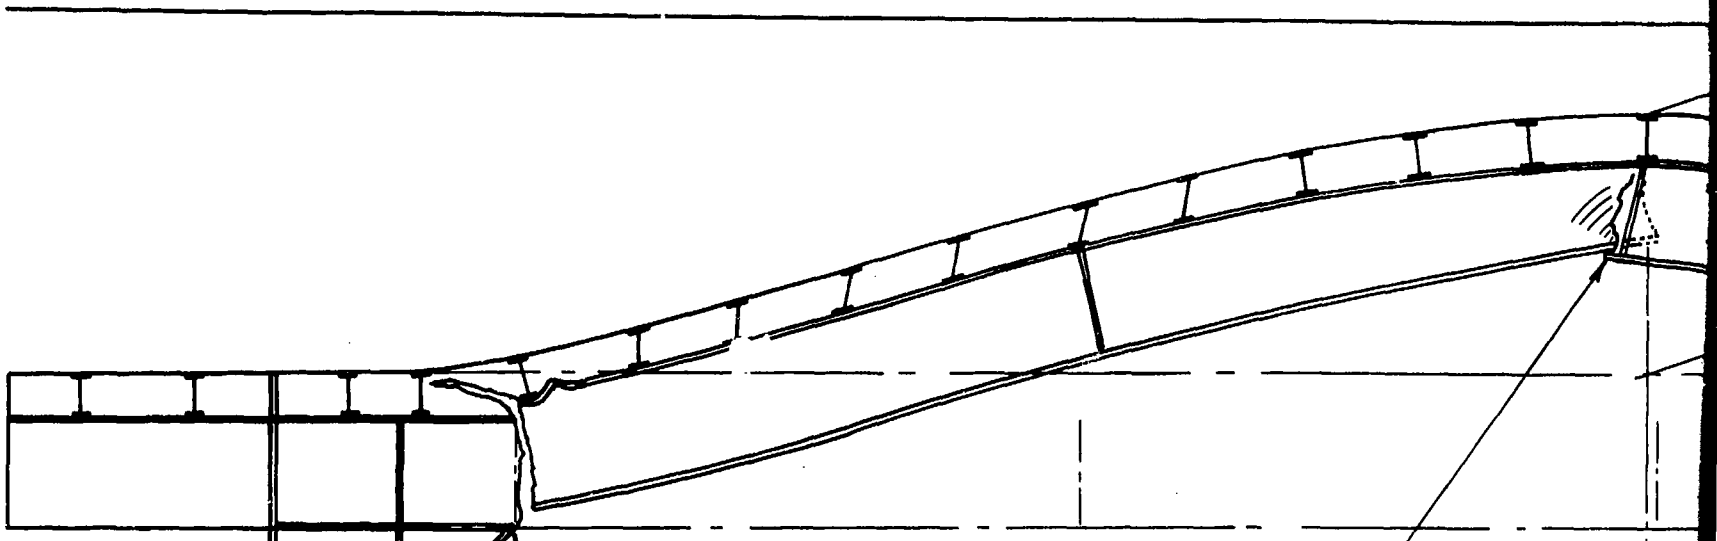
PLATE NO. 18 10386

FRACTURE ORIGINATED AT UPPER EDGE OF WELD JOINING BRACKET FLANGE TO GIRDER. STRUCTURAL DISCONTINUITY IN DESIGN OF CONNECTION CONTRIBUTED TO FAILURE.
 PHOTOS.— VOL. 3 , PAGE 496

FRACTURE ORIGINATED IN LOWER FLANGE OF GIRDER.
 PHOTOS.— VOL. 3 , PAGE 496

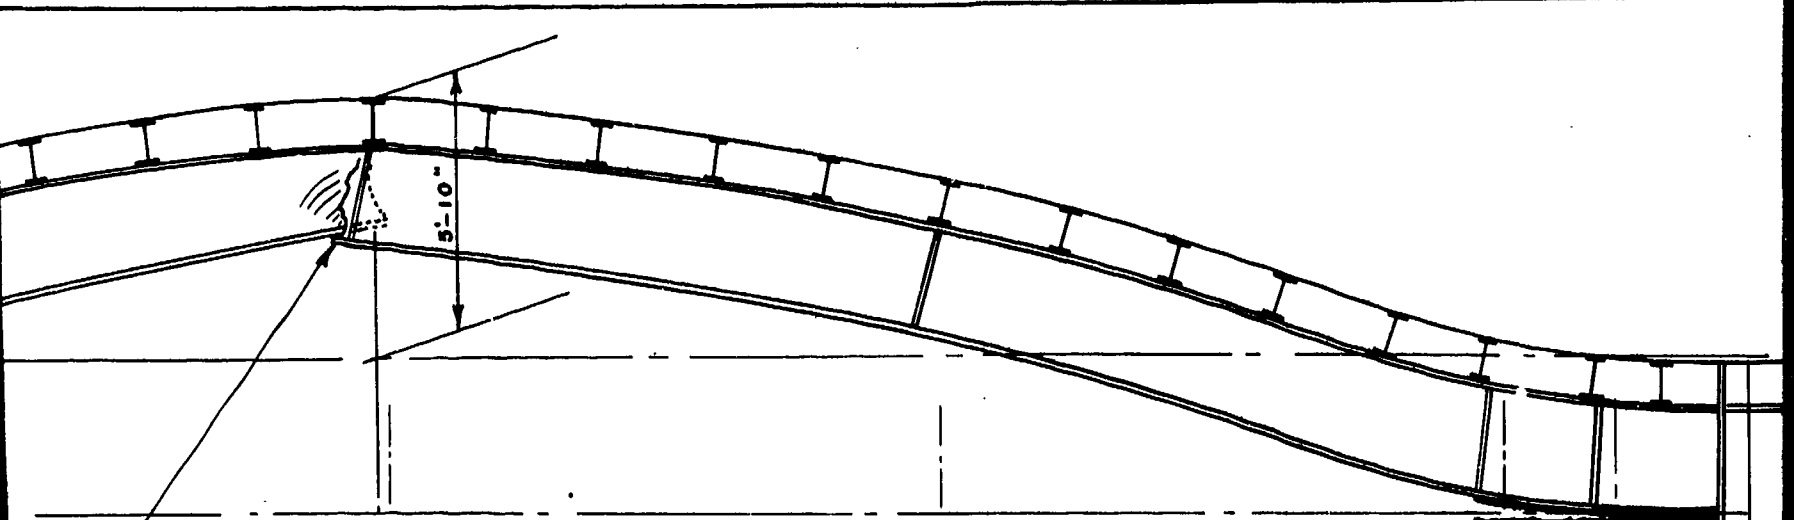
FRACTURE ORIGINATED AT BUTT WELD
 IN LOWER FLANGE OF GIRDER.
 PHOTOS.— VOL. 3, PAGES 492-495

FRACTURE ORIGINATED IN WELD JOINING
 BRACKET FLANGE AND GIRDER.
 WELDS TOO SMALL TO DEVELOP 100%
 JOINT EFFICIENCY.
 PHOTOS.— VOL. 3, PAGES 489-491

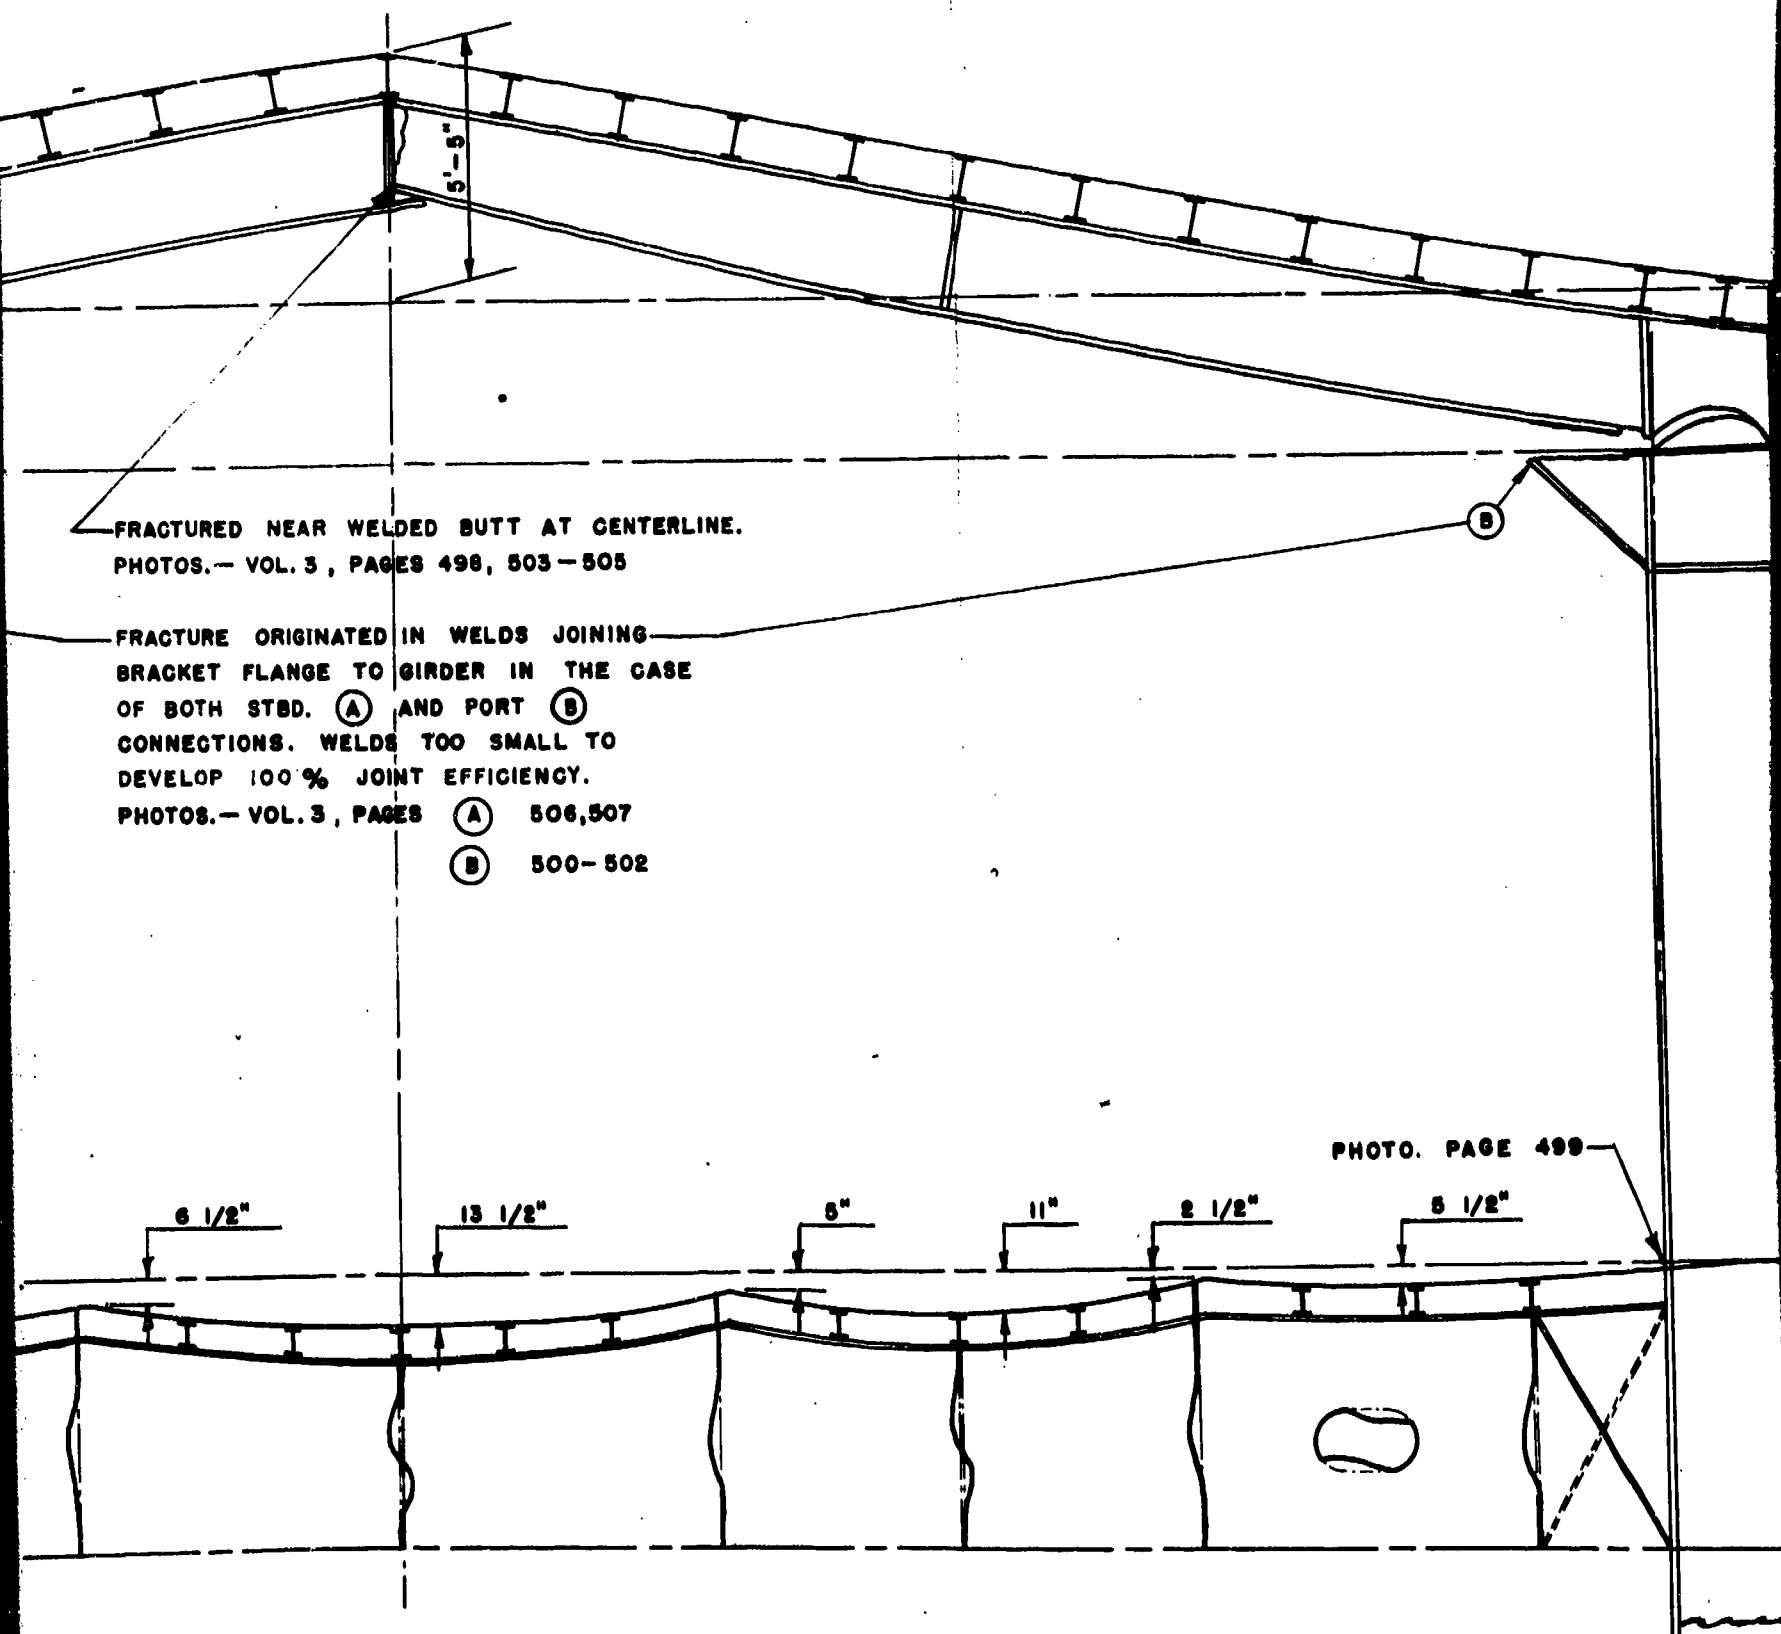
FRACTURED NEAR WELDED BUTT AT CENTERLINE.
 PHOTOS.— VOL. 3, PAGES 498, 503—505

FRACTURE ORIGINATED IN WELDS JOINING
 BRACKET FLANGE TO GIRDER IN THE CASE
 OF BOTH STBD. (A) AND PORT (B)
 CONNECTIONS. WELDS TOO SMALL TO
 DEVELOP 100% JOINT EFFICIENCY.

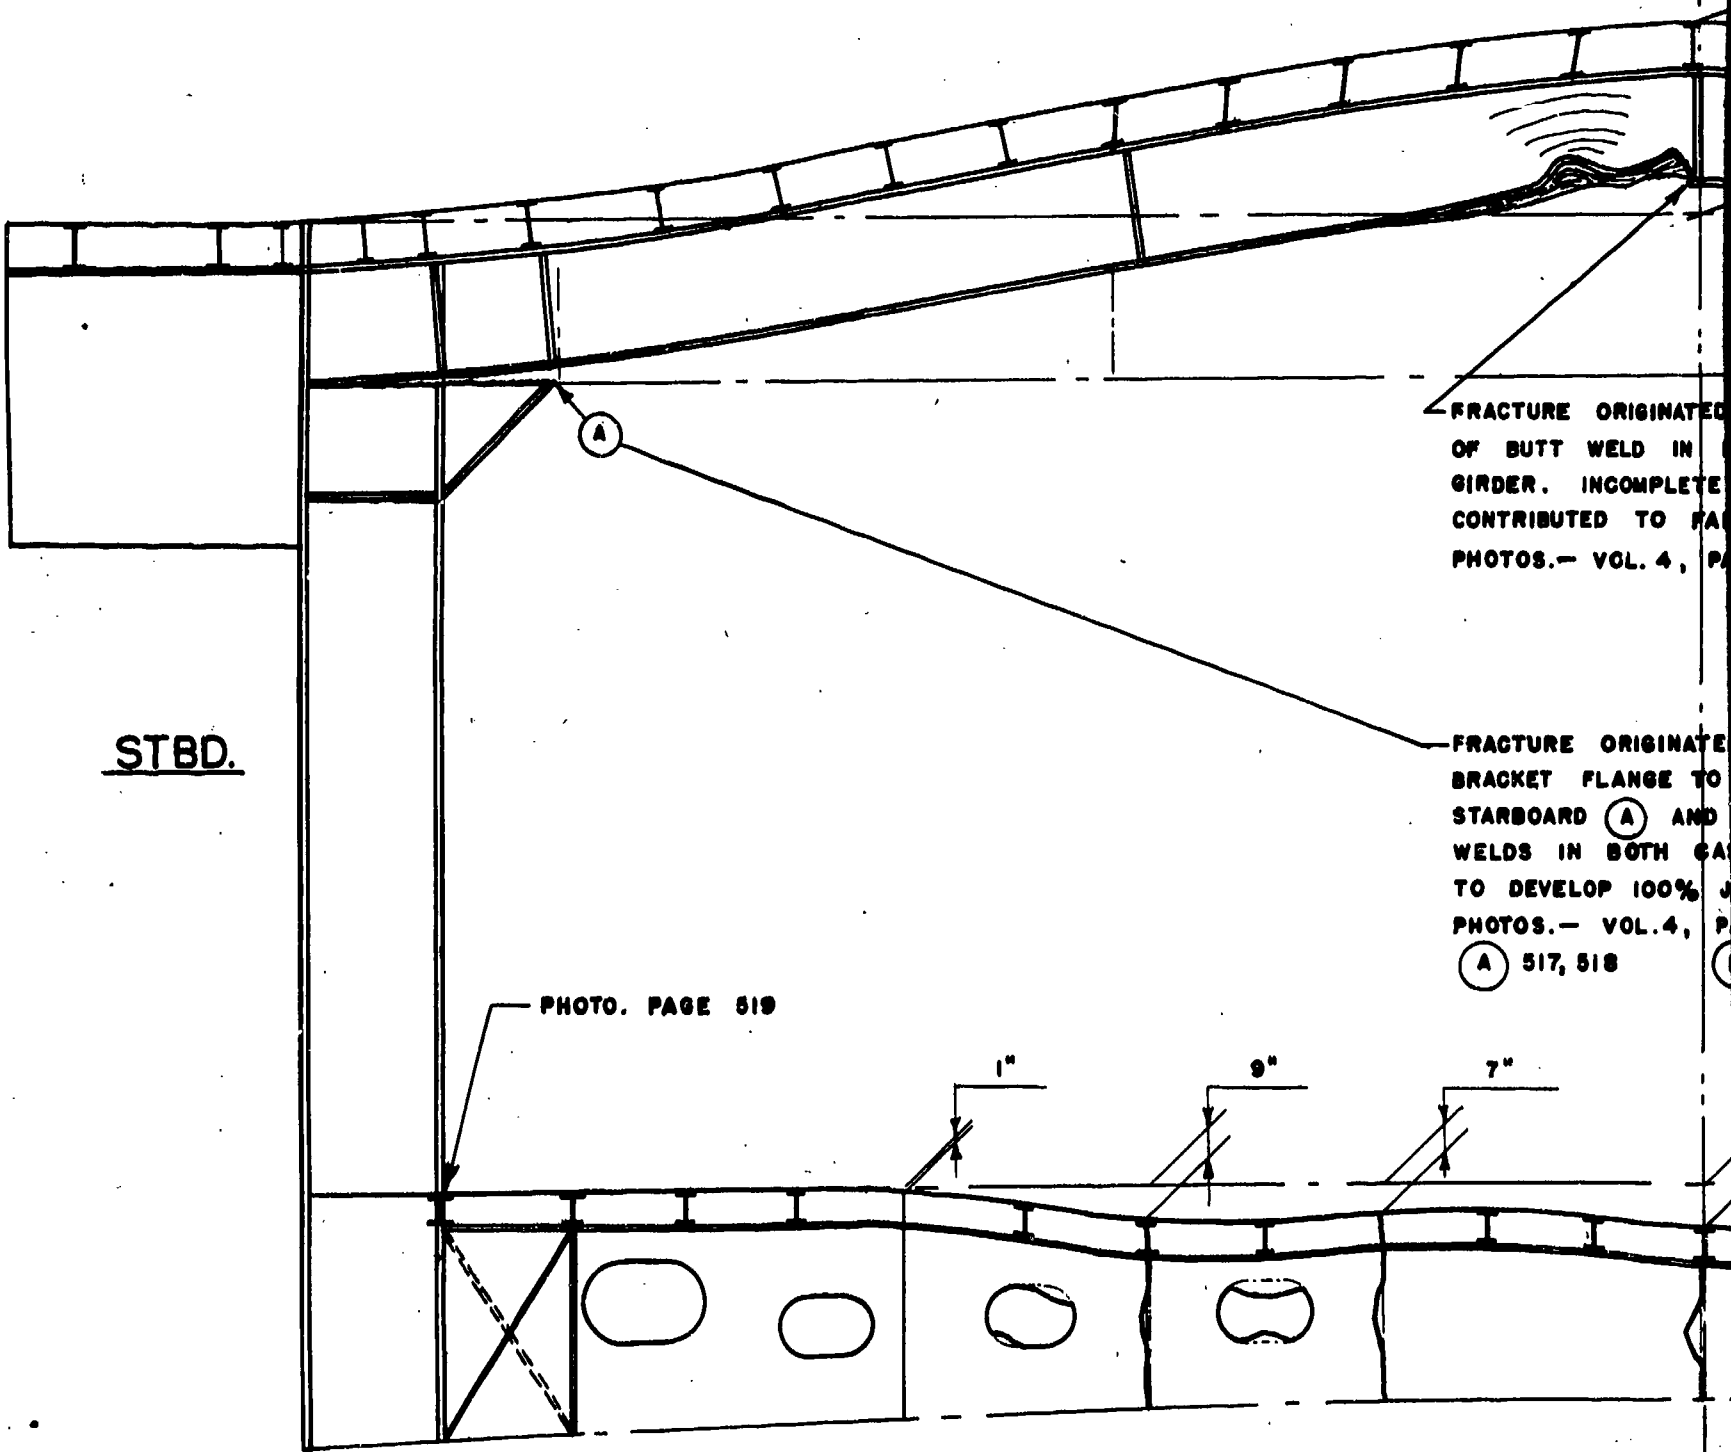
FRACTURE ORIGINATED
 OF BUTT WELD IN
 GIRDER. INCOMPLETE
 CONTRIBUTED TO FAILURE
 PHOTOS.— VOL. 4, P. 517

FRACTURE ORIGINATED
 BRACKET FLANGE TO
 STARBOARD (A) AND
 WELDS IN BOTH GIRDERS
 TO DEVELOP 100% JOINT
 PHOTOS.— VOL. 4, P. 518
 (A) 517, 518

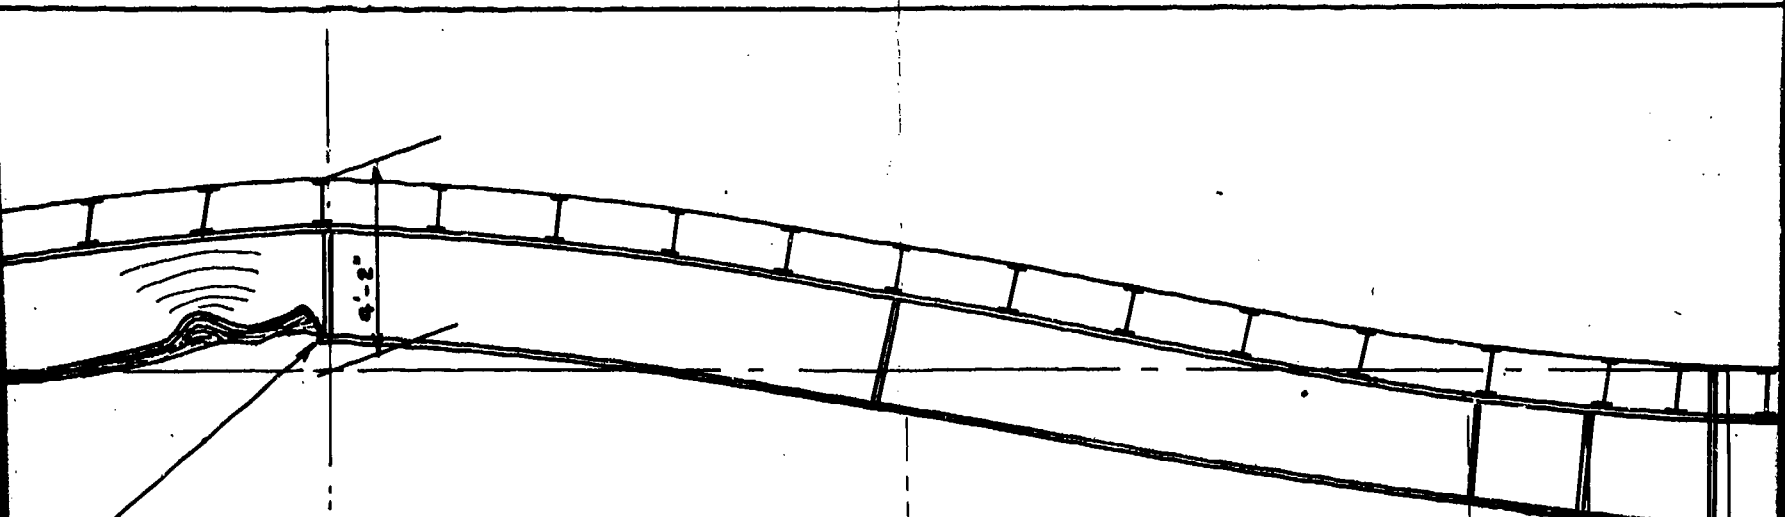
FRACTURE ORIGINATED IN FORWARD END OF BUTT WELD IN LOWER FLANGE OF GIRDER. INCOMPLETE WELD PENETRATION CONTRIBUTED TO FAILURE.

PHOTOS.— VOL. 4, PAGES 513-516

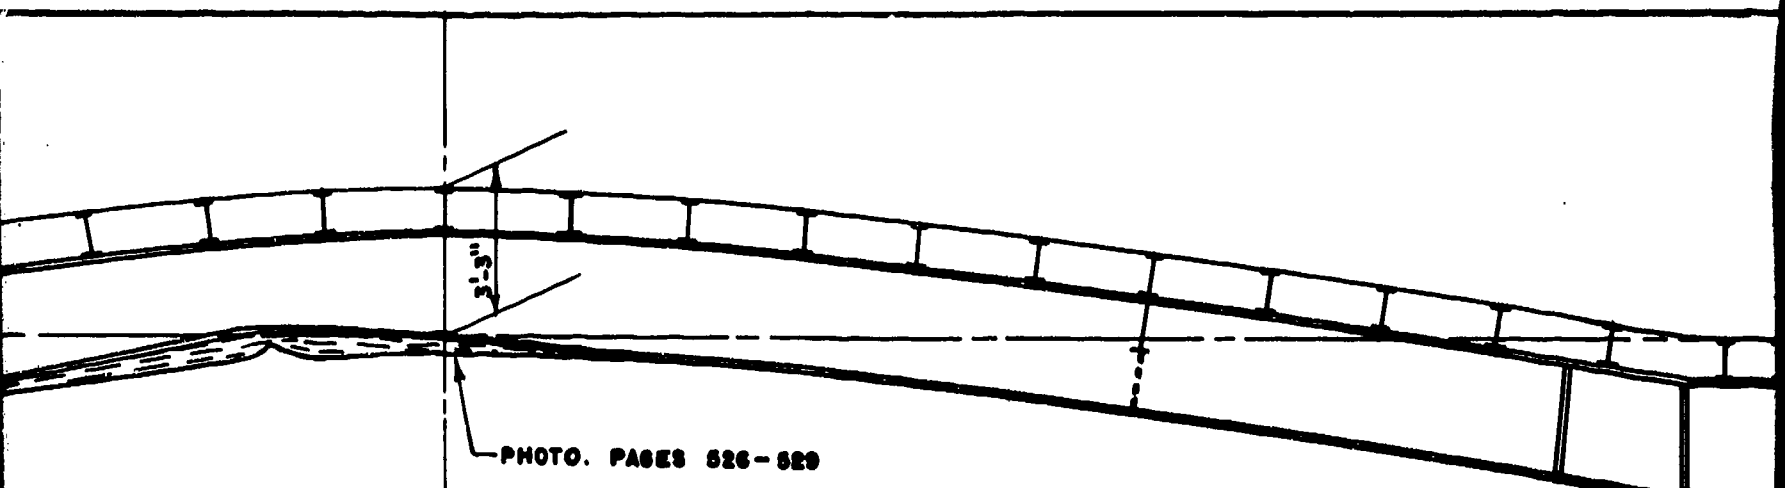
FRACTURE ORIGINATED IN WELDS JOINING BRACKET FLANGE AND GIRDER IN BOTH PORT (A) AND STARBOARD (B) CONNECTIONS. WELDS TOO SMALL TO DEVELOP 100% JOINT EFFICIENCY. PHOTOS.- VOL. 4, PAGES (A) 520, 524, 525 (B) 523, 530

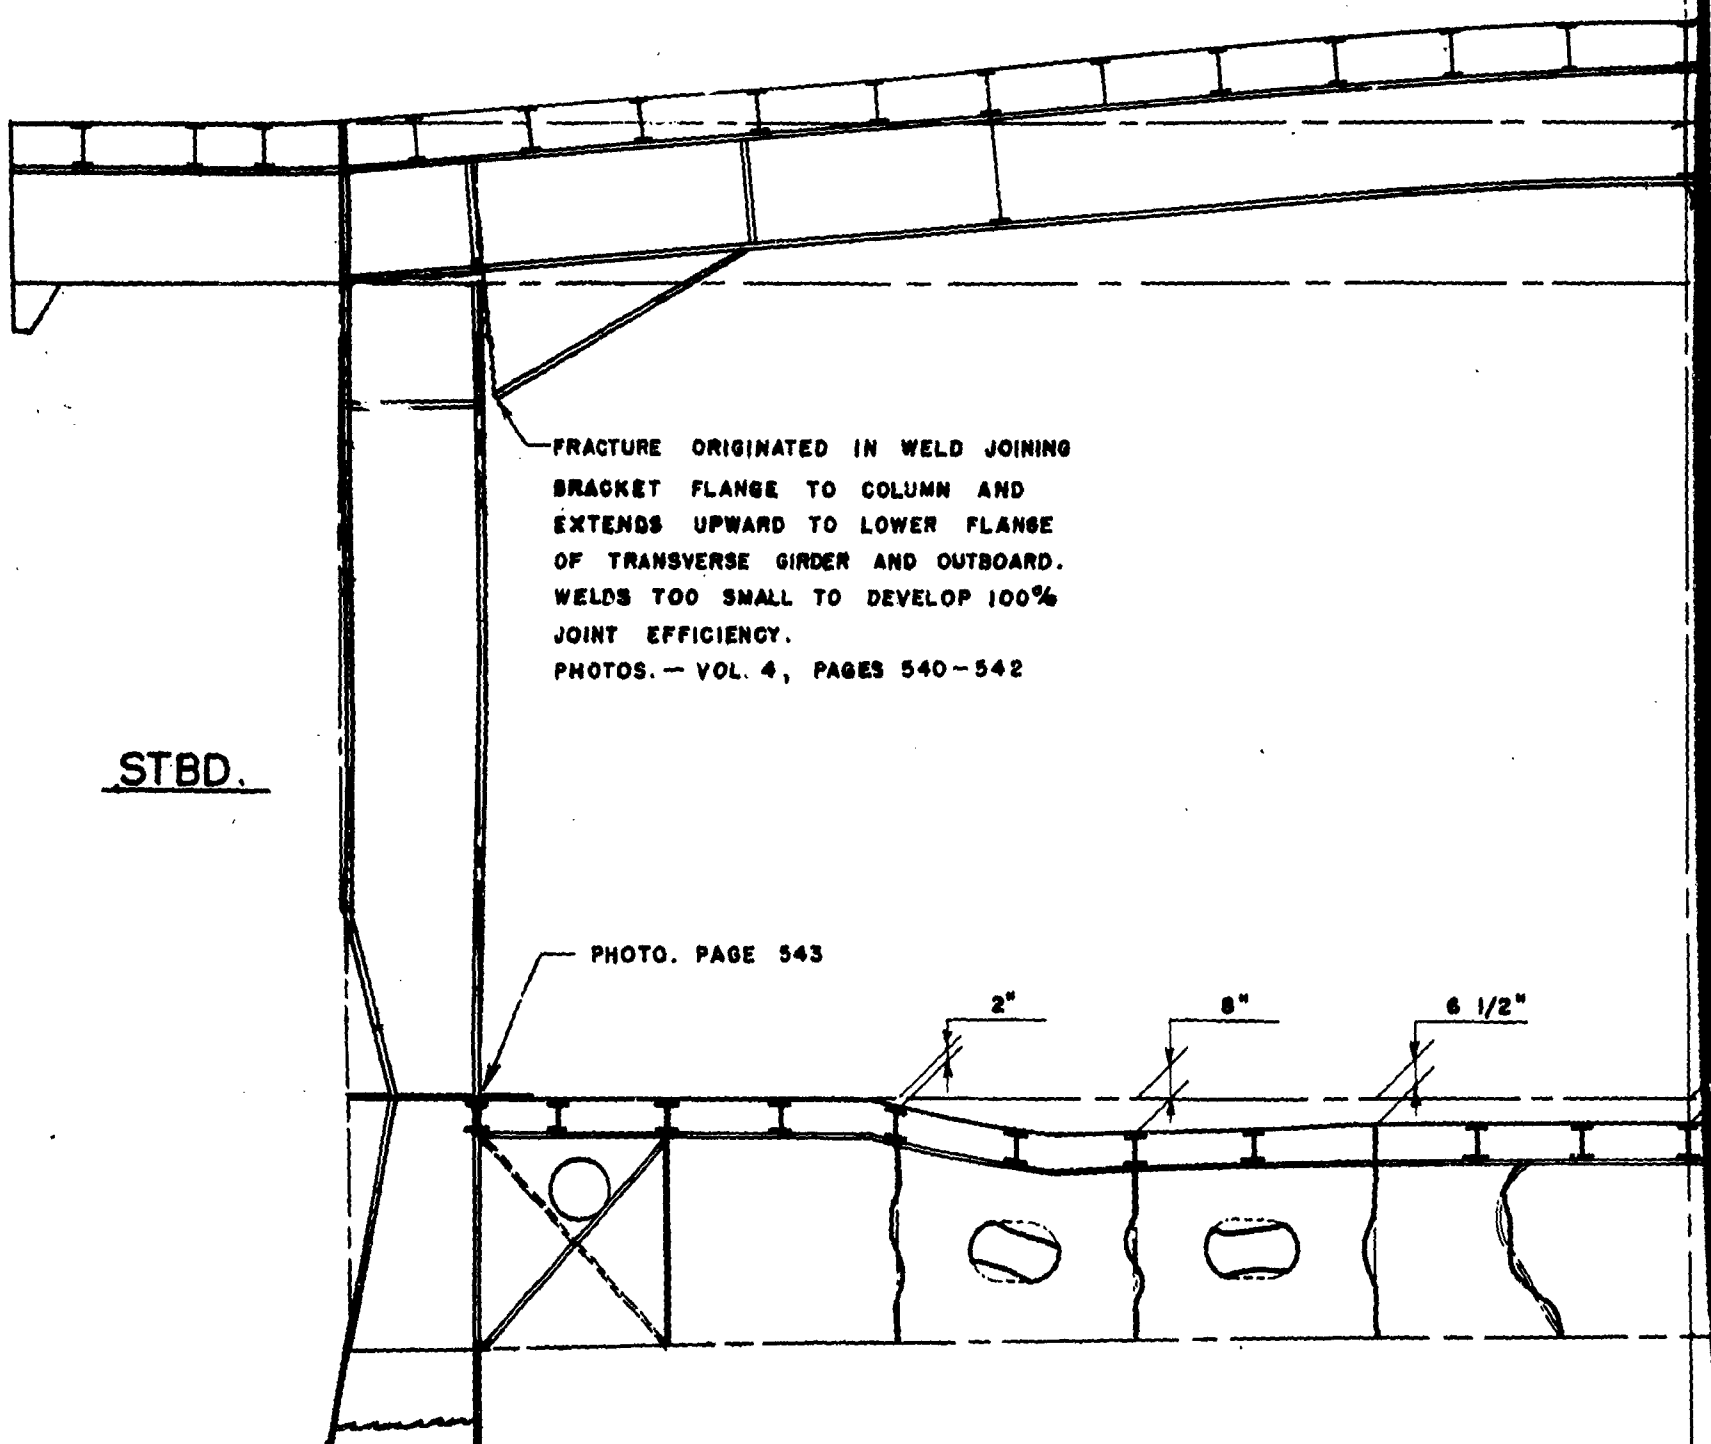
PLATE NO. 22 10 386
 3

FRACTURE ORIGINATED IN WELD JOINING
BRACKET FLANGE TO COLUMN AND
EXTENDS UPWARD TO LOWER FLANGE
OF TRANSVERSE GIRDER AND OUTBOARD.
WELDS TOO SMALL TO DEVELOP 100%
JOINT EFFICIENCY.
PHOTOS. — VOL. 4, PAGES 540-542

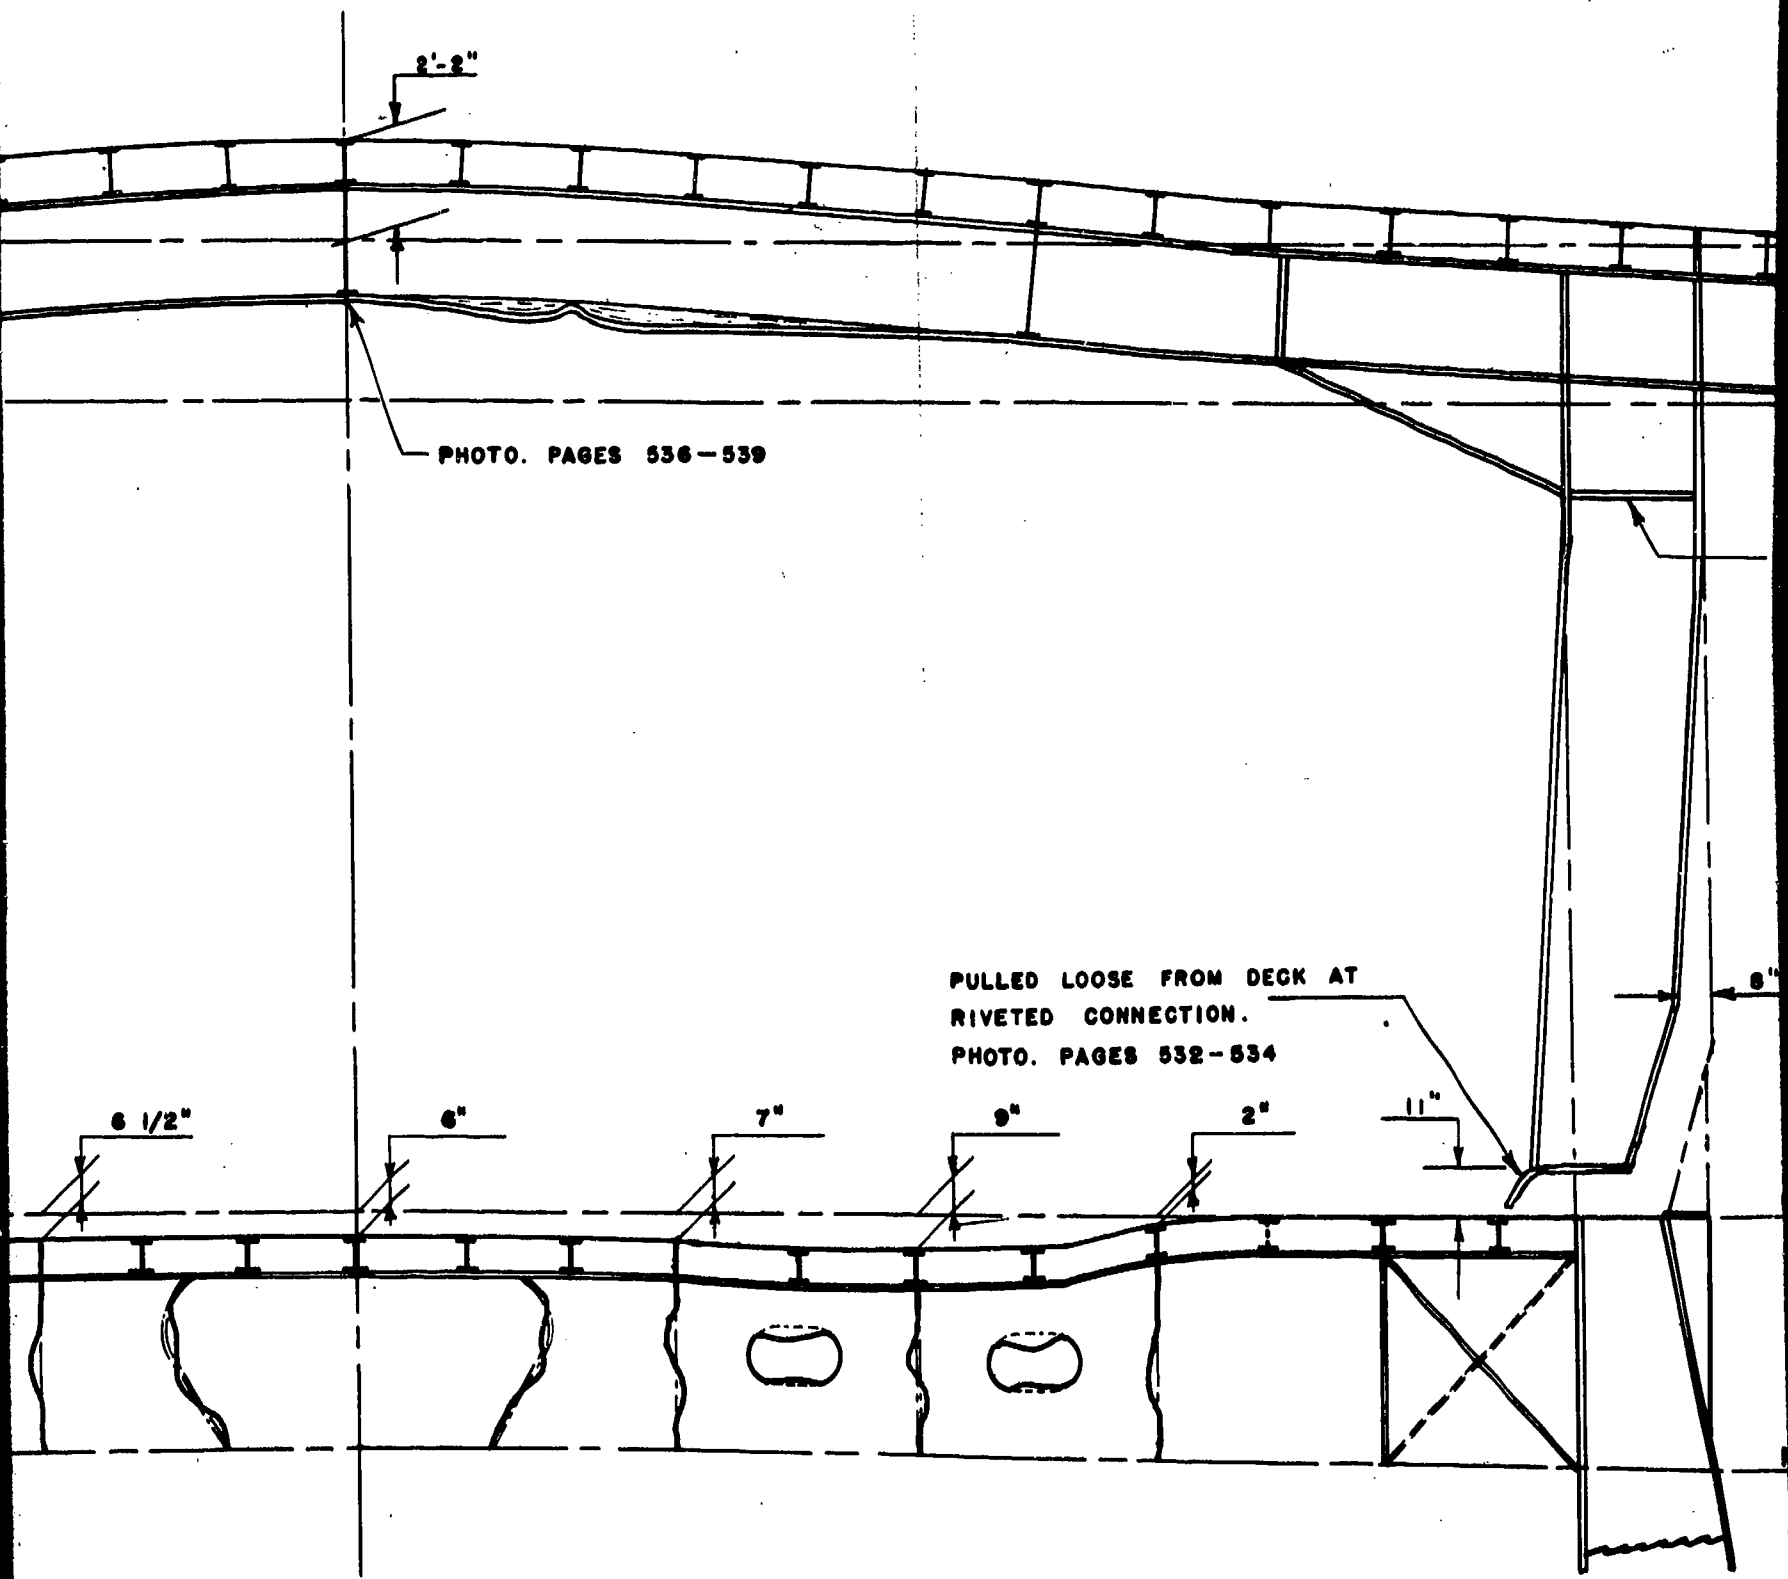
PULLED LOOSE FROM DECK AT
RIVETED CONNECTION.
PHOTO. PAGES 532-534
