U.S.S. INDEPENDENCE (CVL22)

TEST ABLE

OPERATION CROSSROADS

BUREAU OF SHIPS GROUP
TECHNICAL INSPECTION REPORT

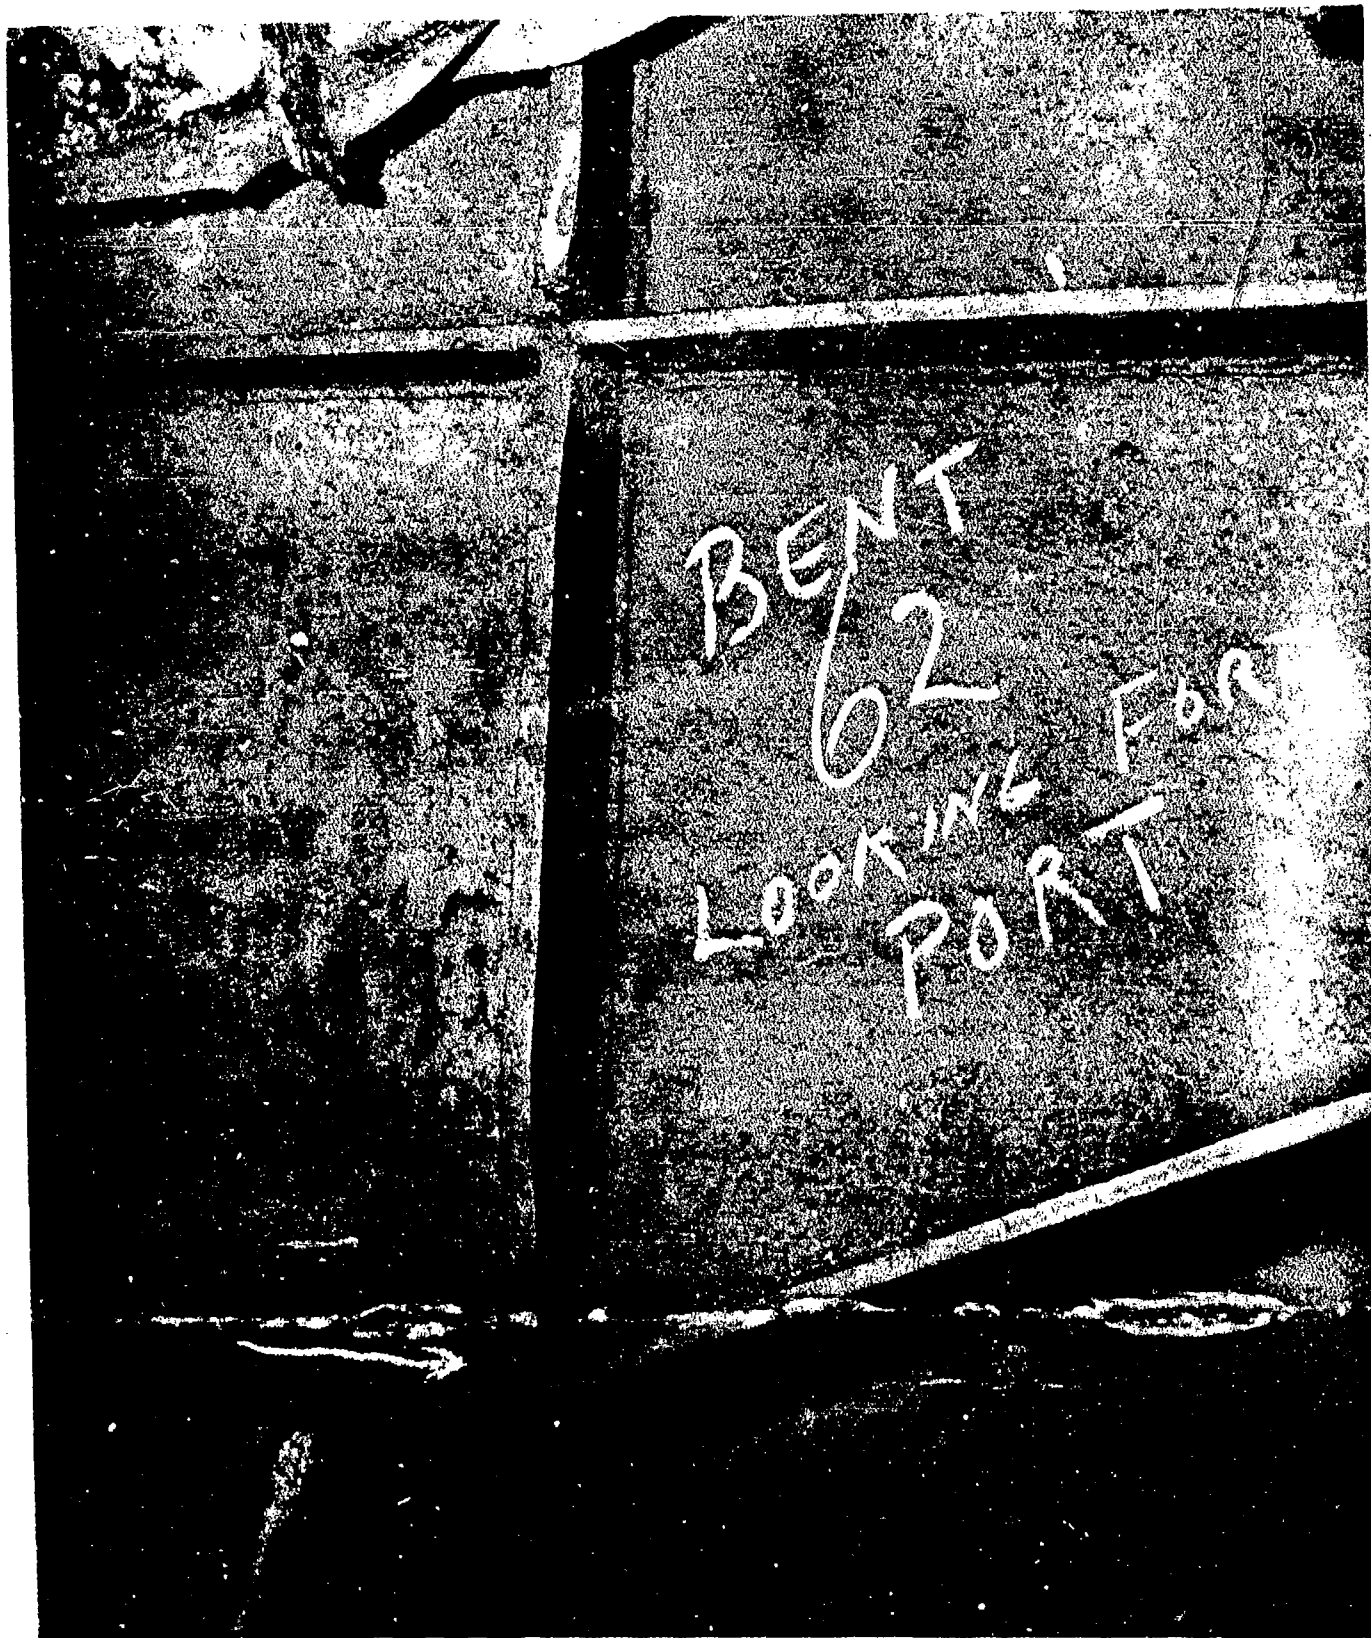
AA-CR-59-2222-9. Flight deck Wobble Bent 62. Port side, looking forward. Column of bent is missing. Note that arrows point to failure of welds.

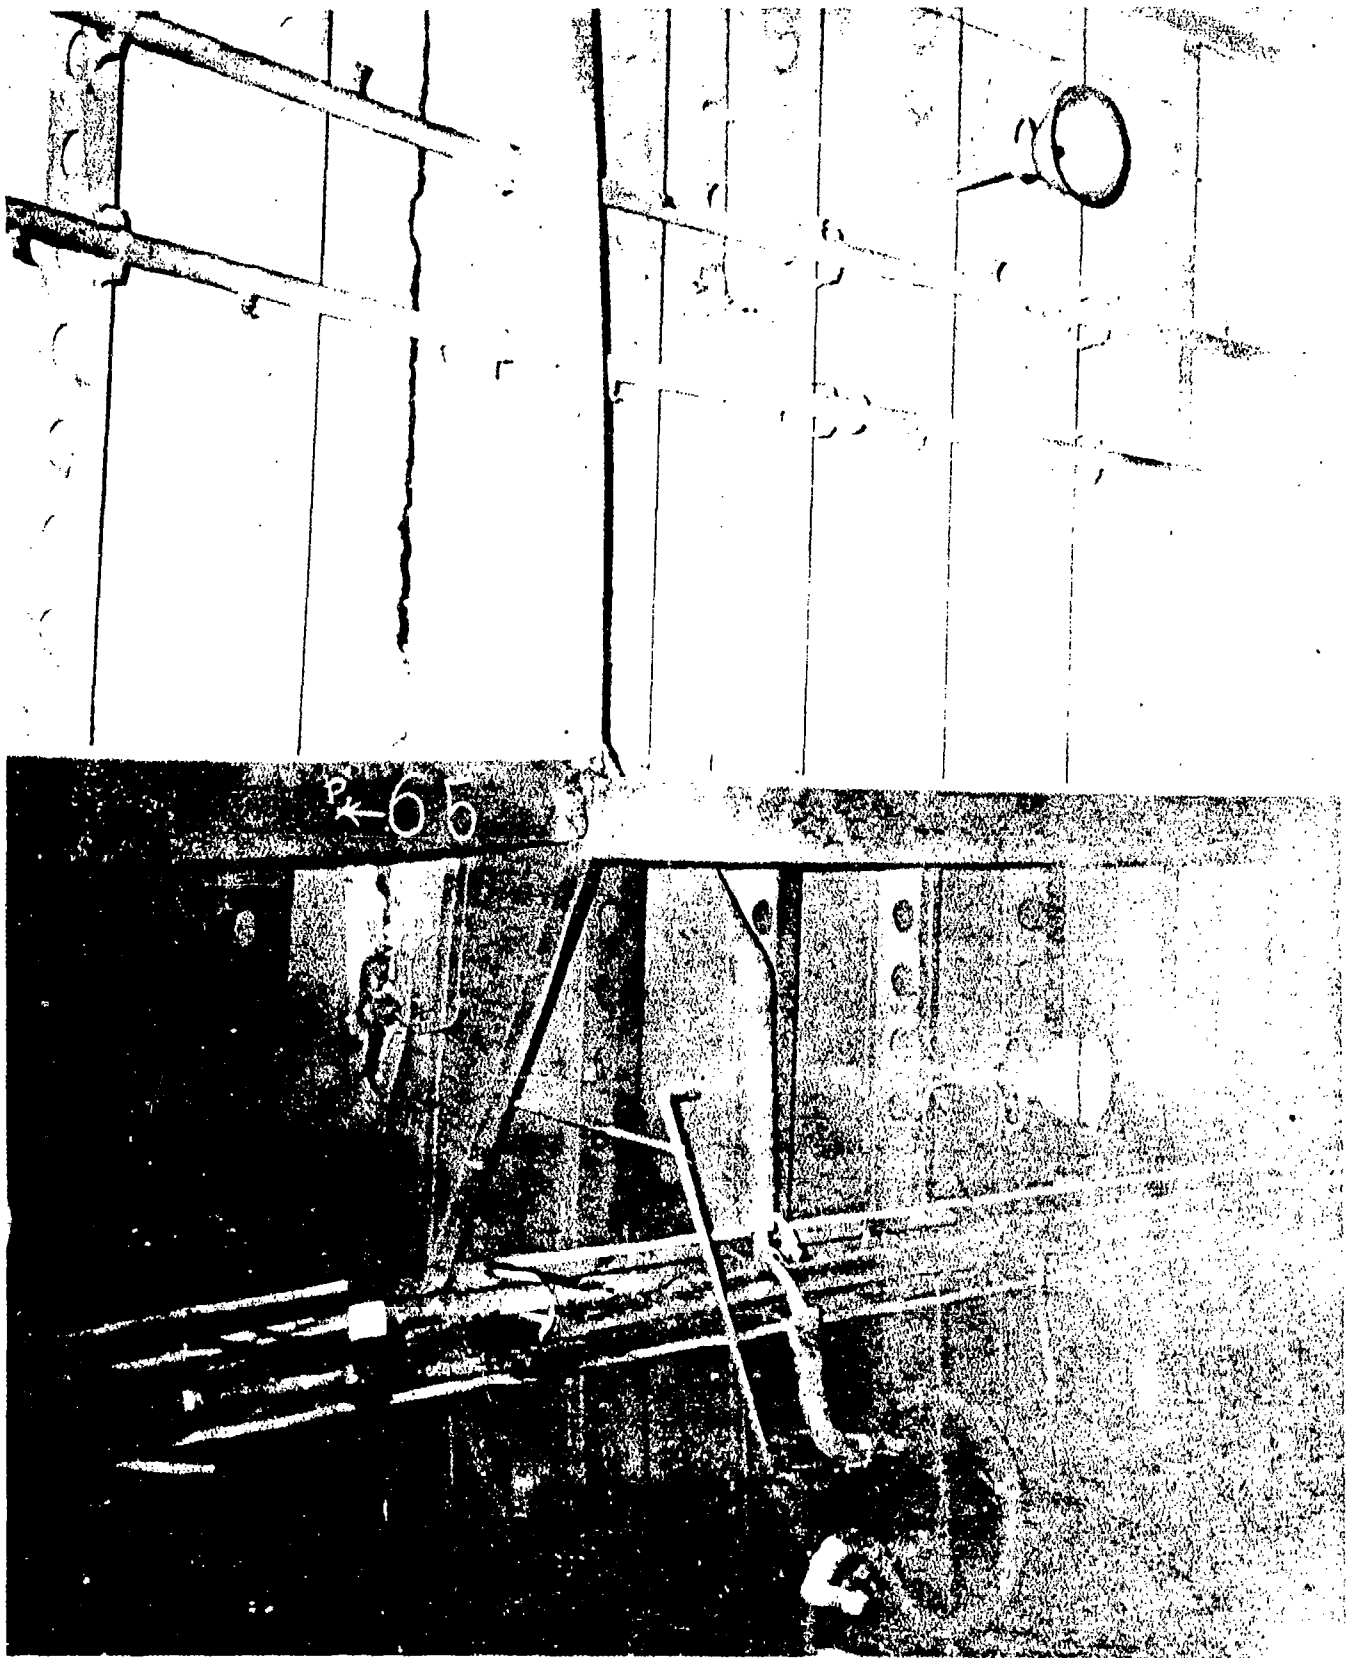
AA-CR-59-2217-12. Flight deck Wobble Bent 65, centerline. Failure of welded girder flange. Looking upward and to starboard.

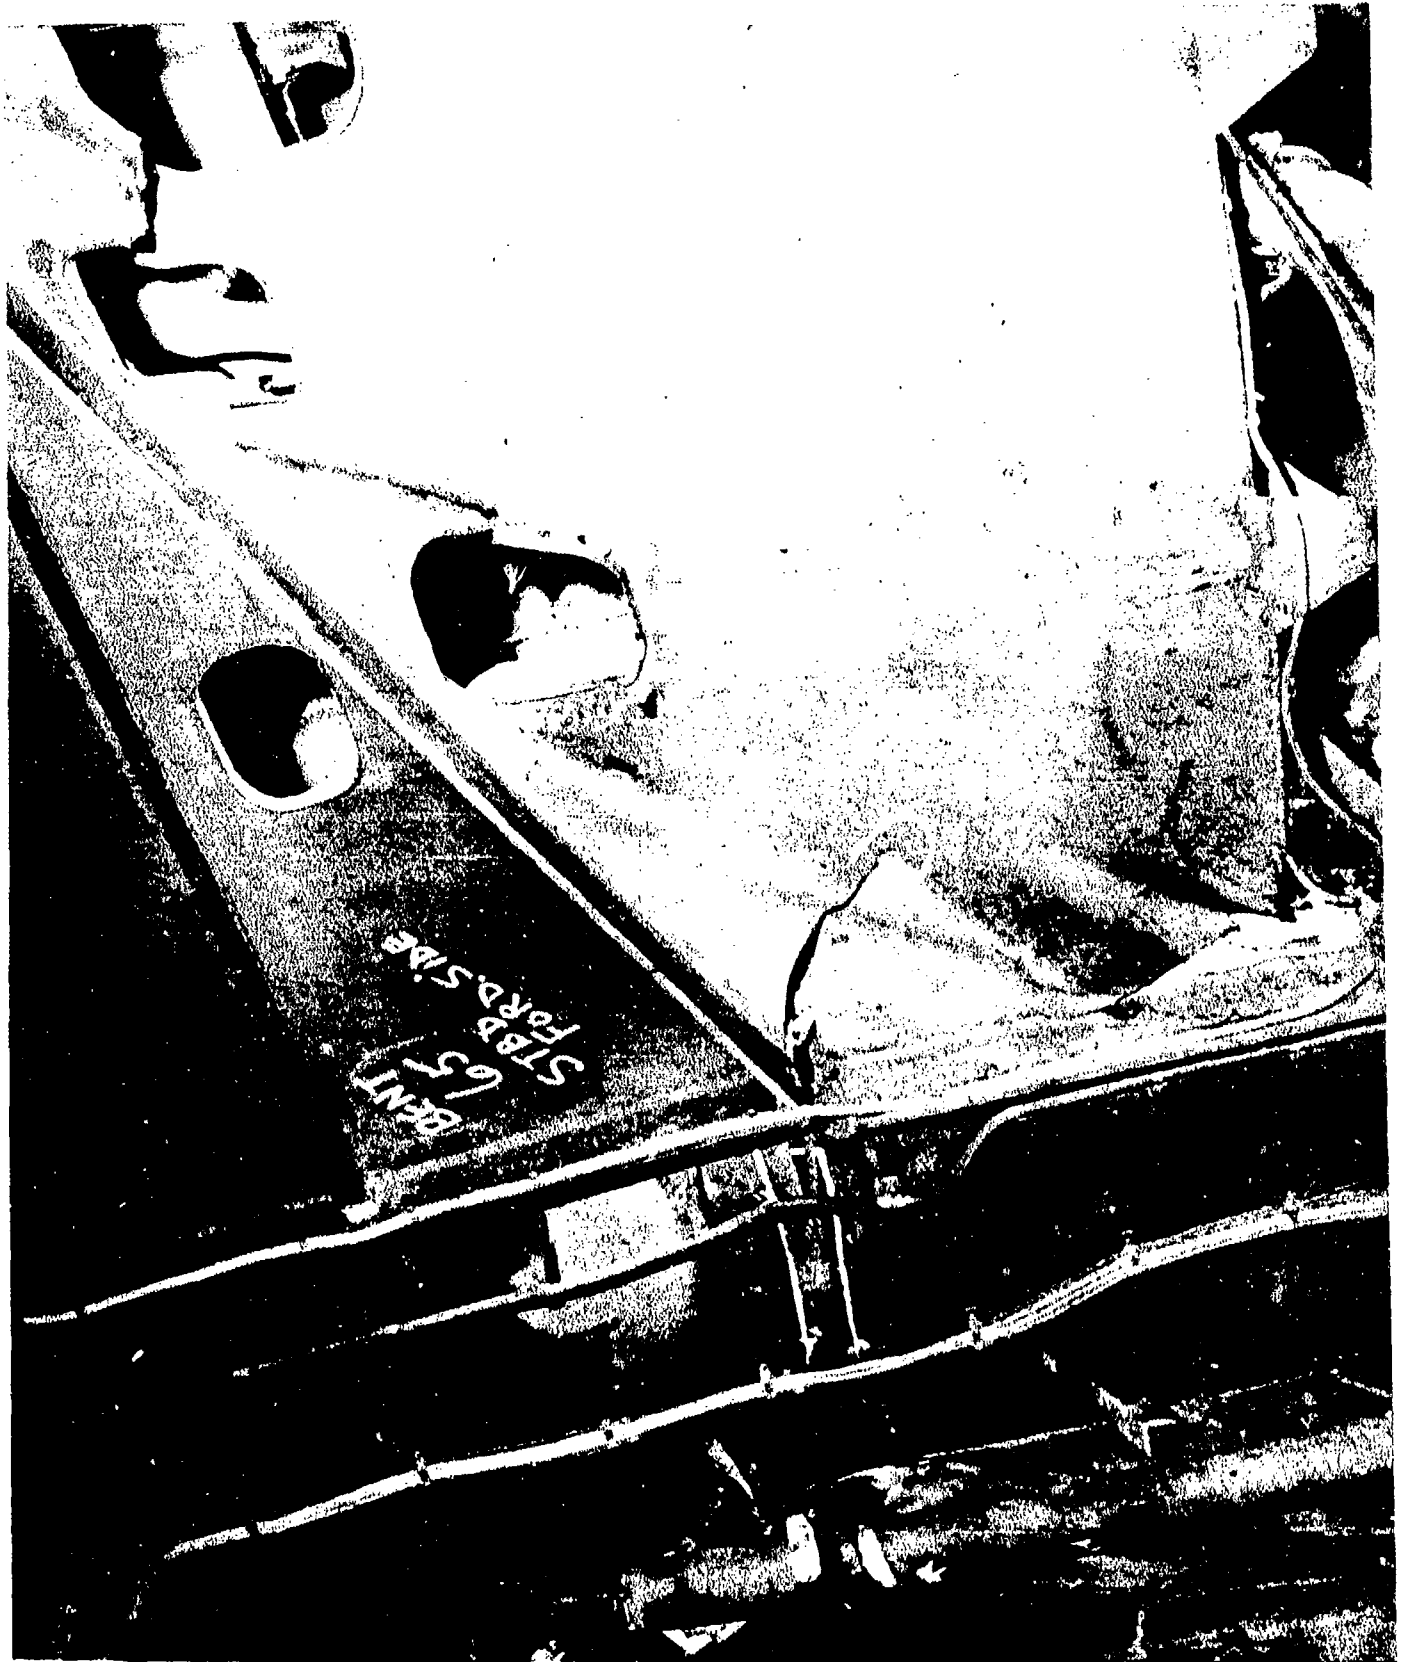
AA-CR-59-2222-5. Flight deck Wobble Bent 65, starboard side. Failure of overhead connection stemming from weld fracture at intersection of bracket and vertical member. Looking aft.

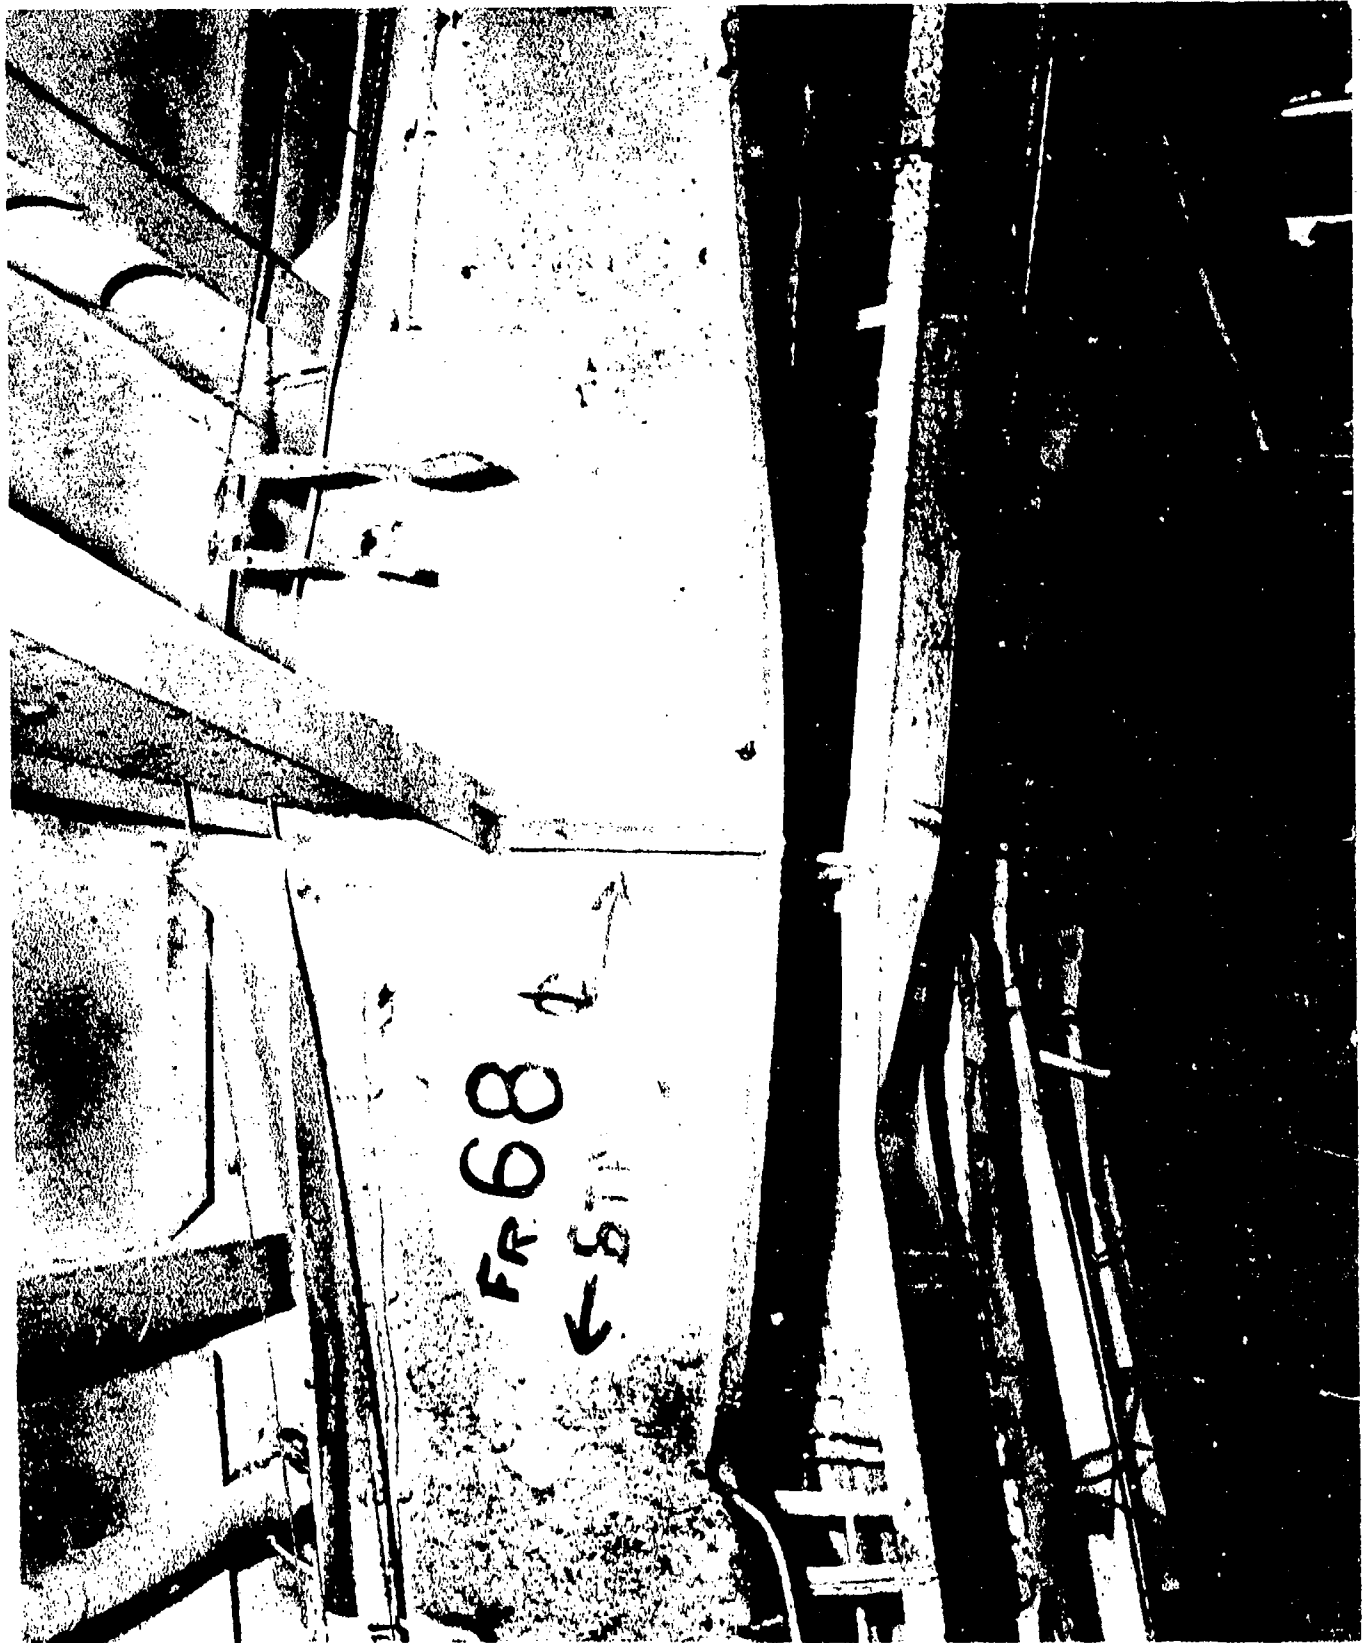
AA-CR-59-2227-4. Flight deck Bent 68, centerline. Buckled transverse girder and fractured weld joining web stiffener to deck longitudinal. Looking aft.

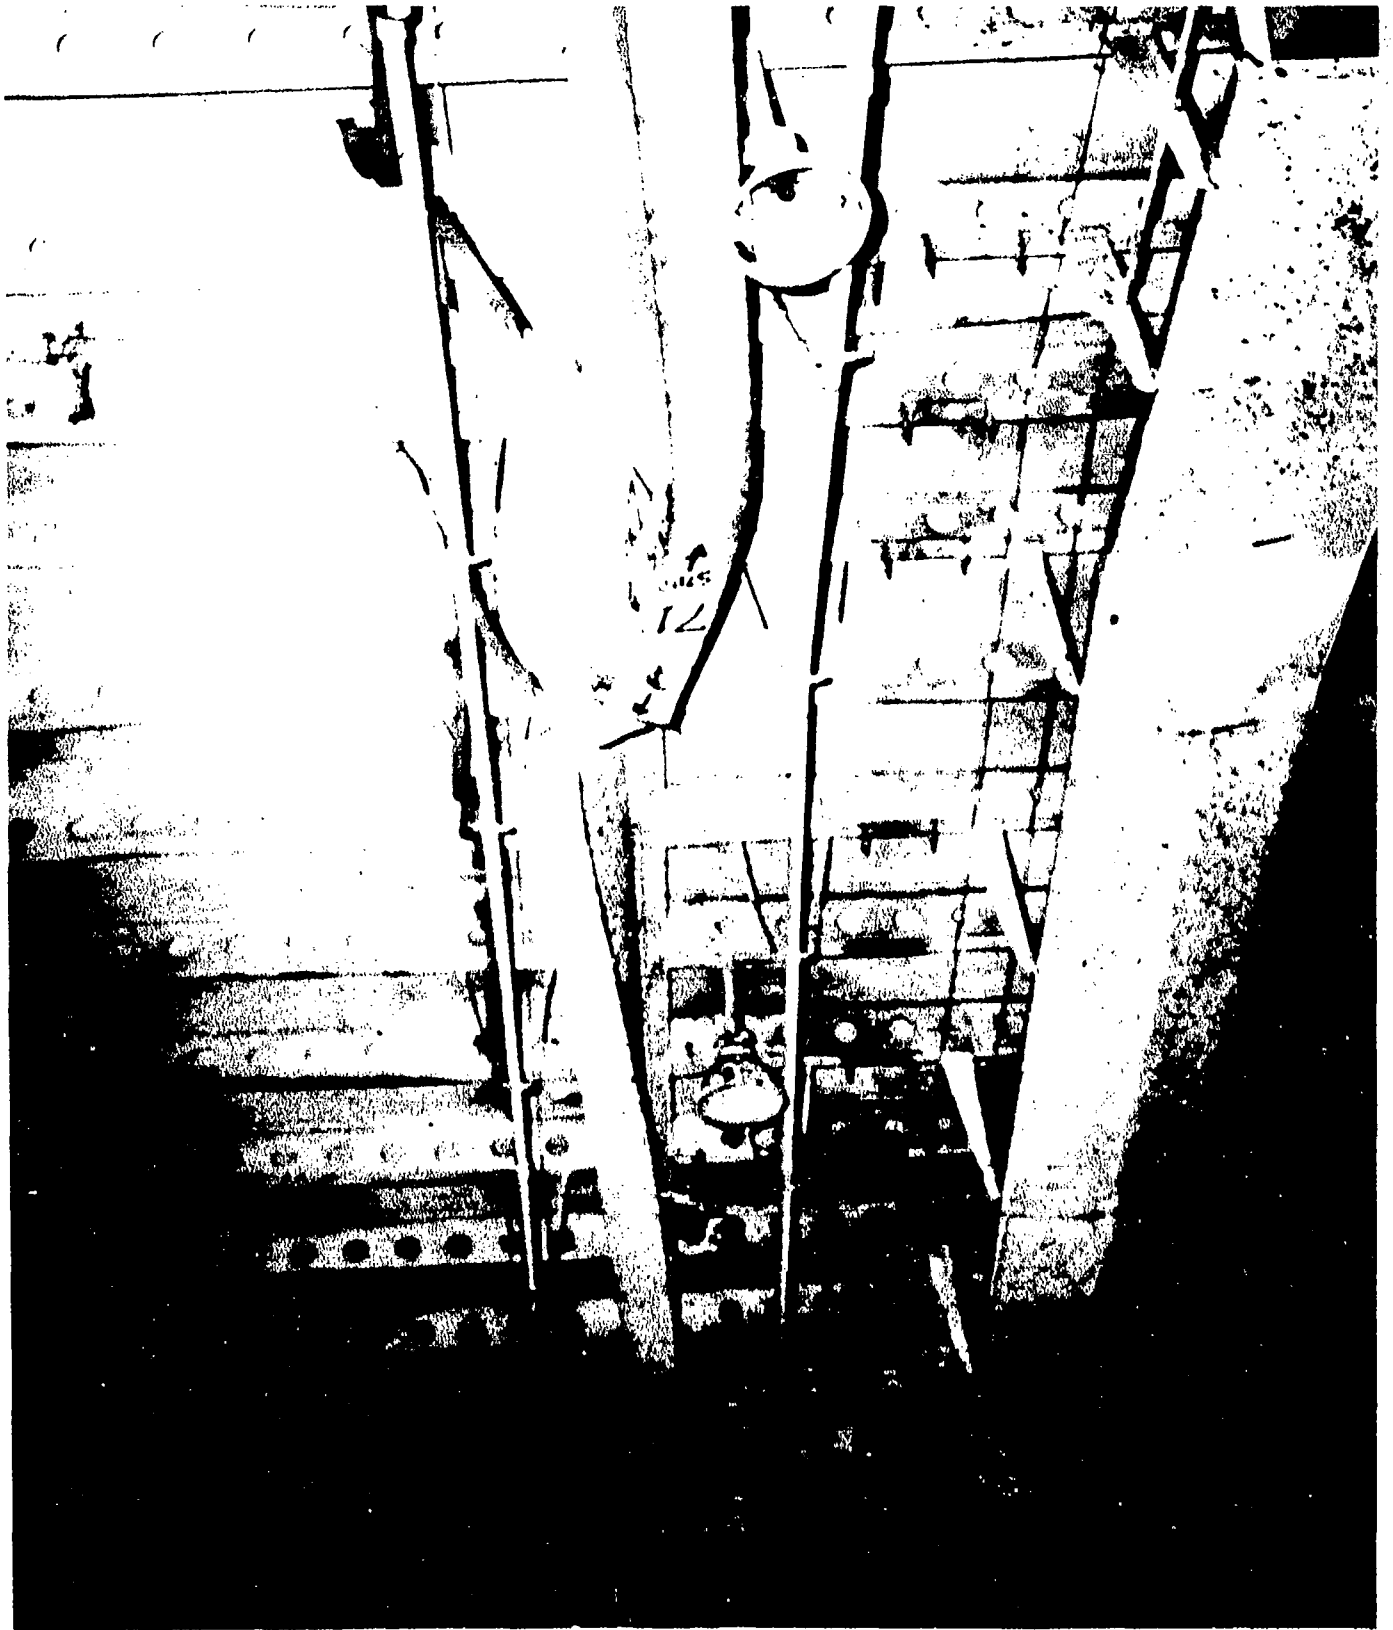
AA-CR-100-4162-8. Flight deck Bent 71, centerline, showing buckling and failure at welded butt. Looking to port.

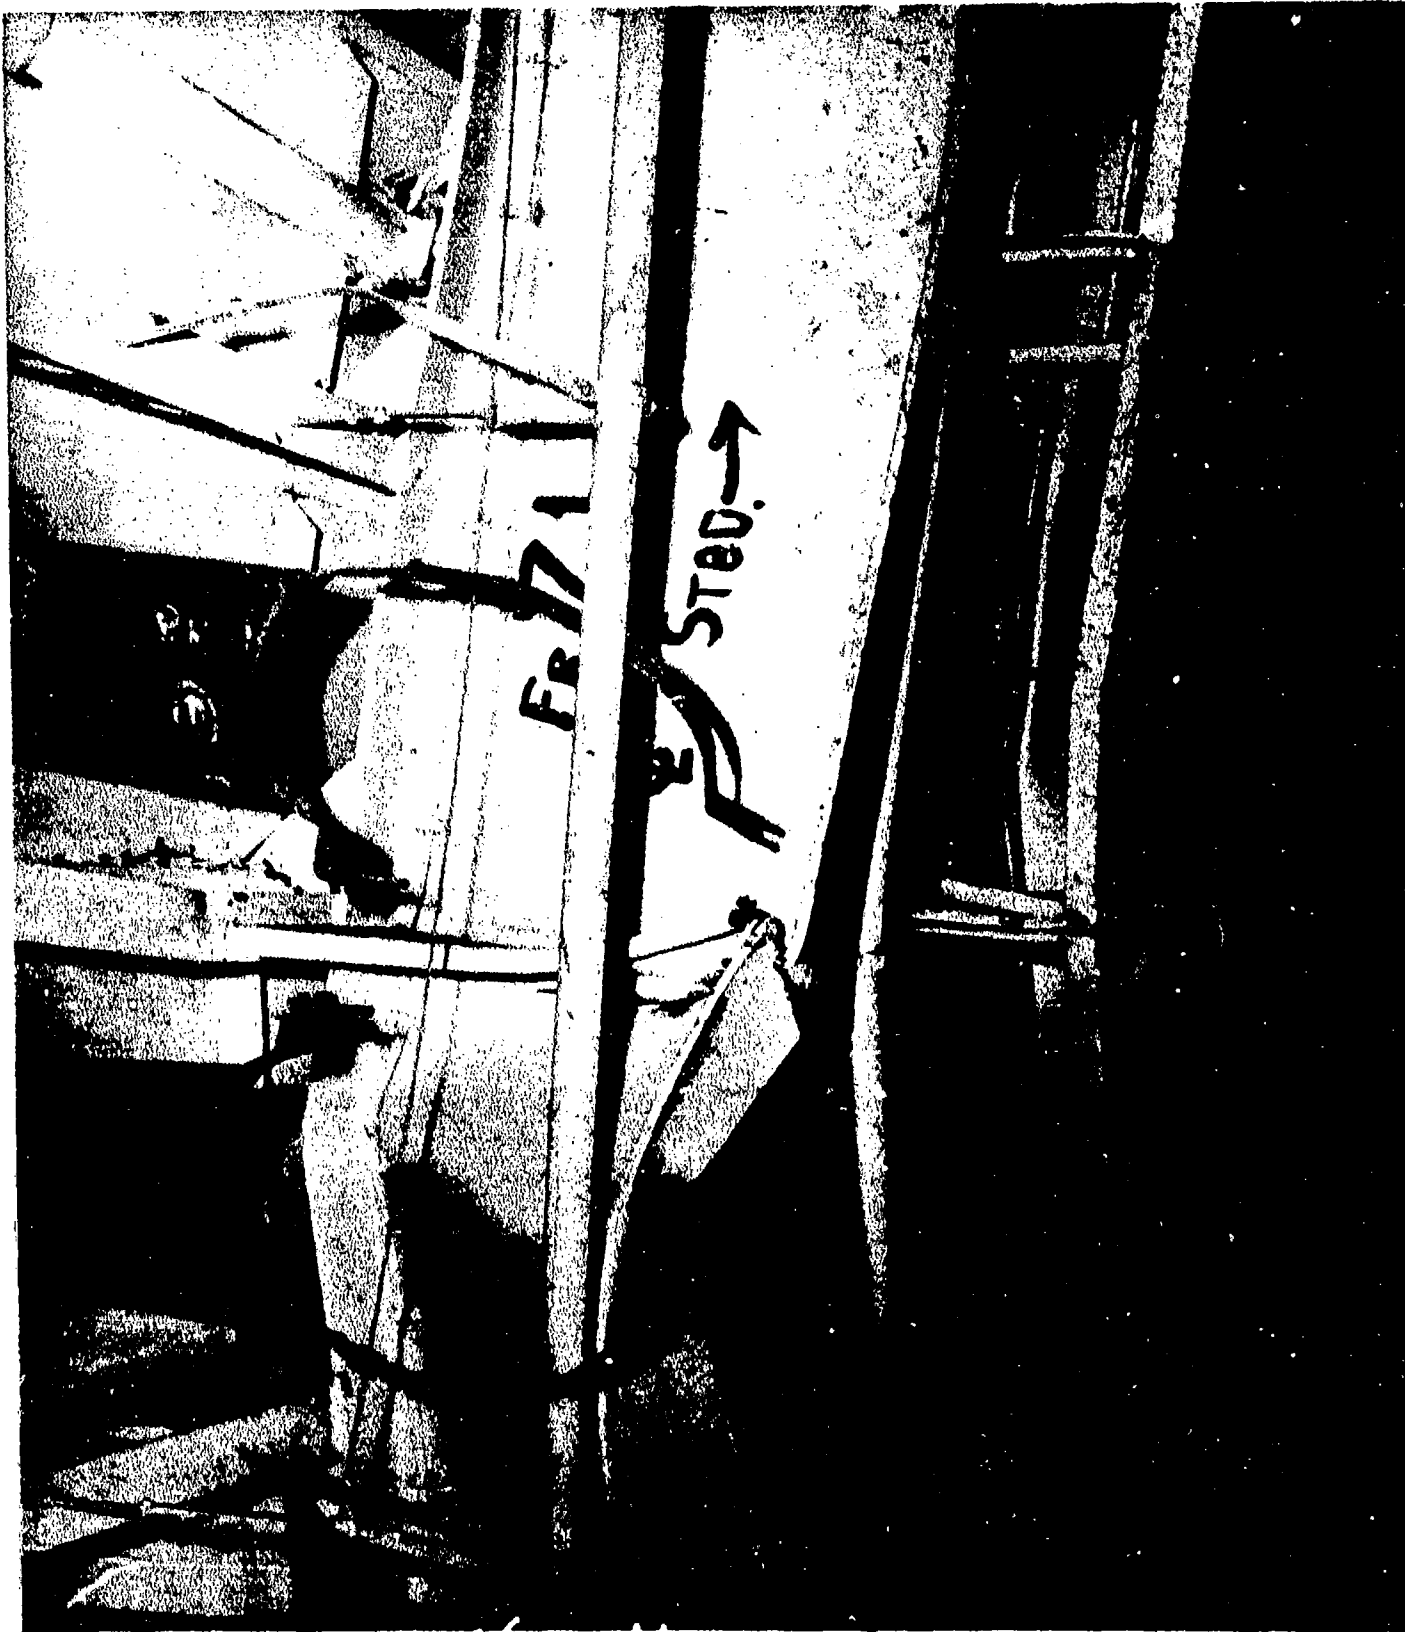
AA-CR-59-2226-11. Flight deck Bent 71, centerline. Buckling and failure at welded butt. Looking forward.

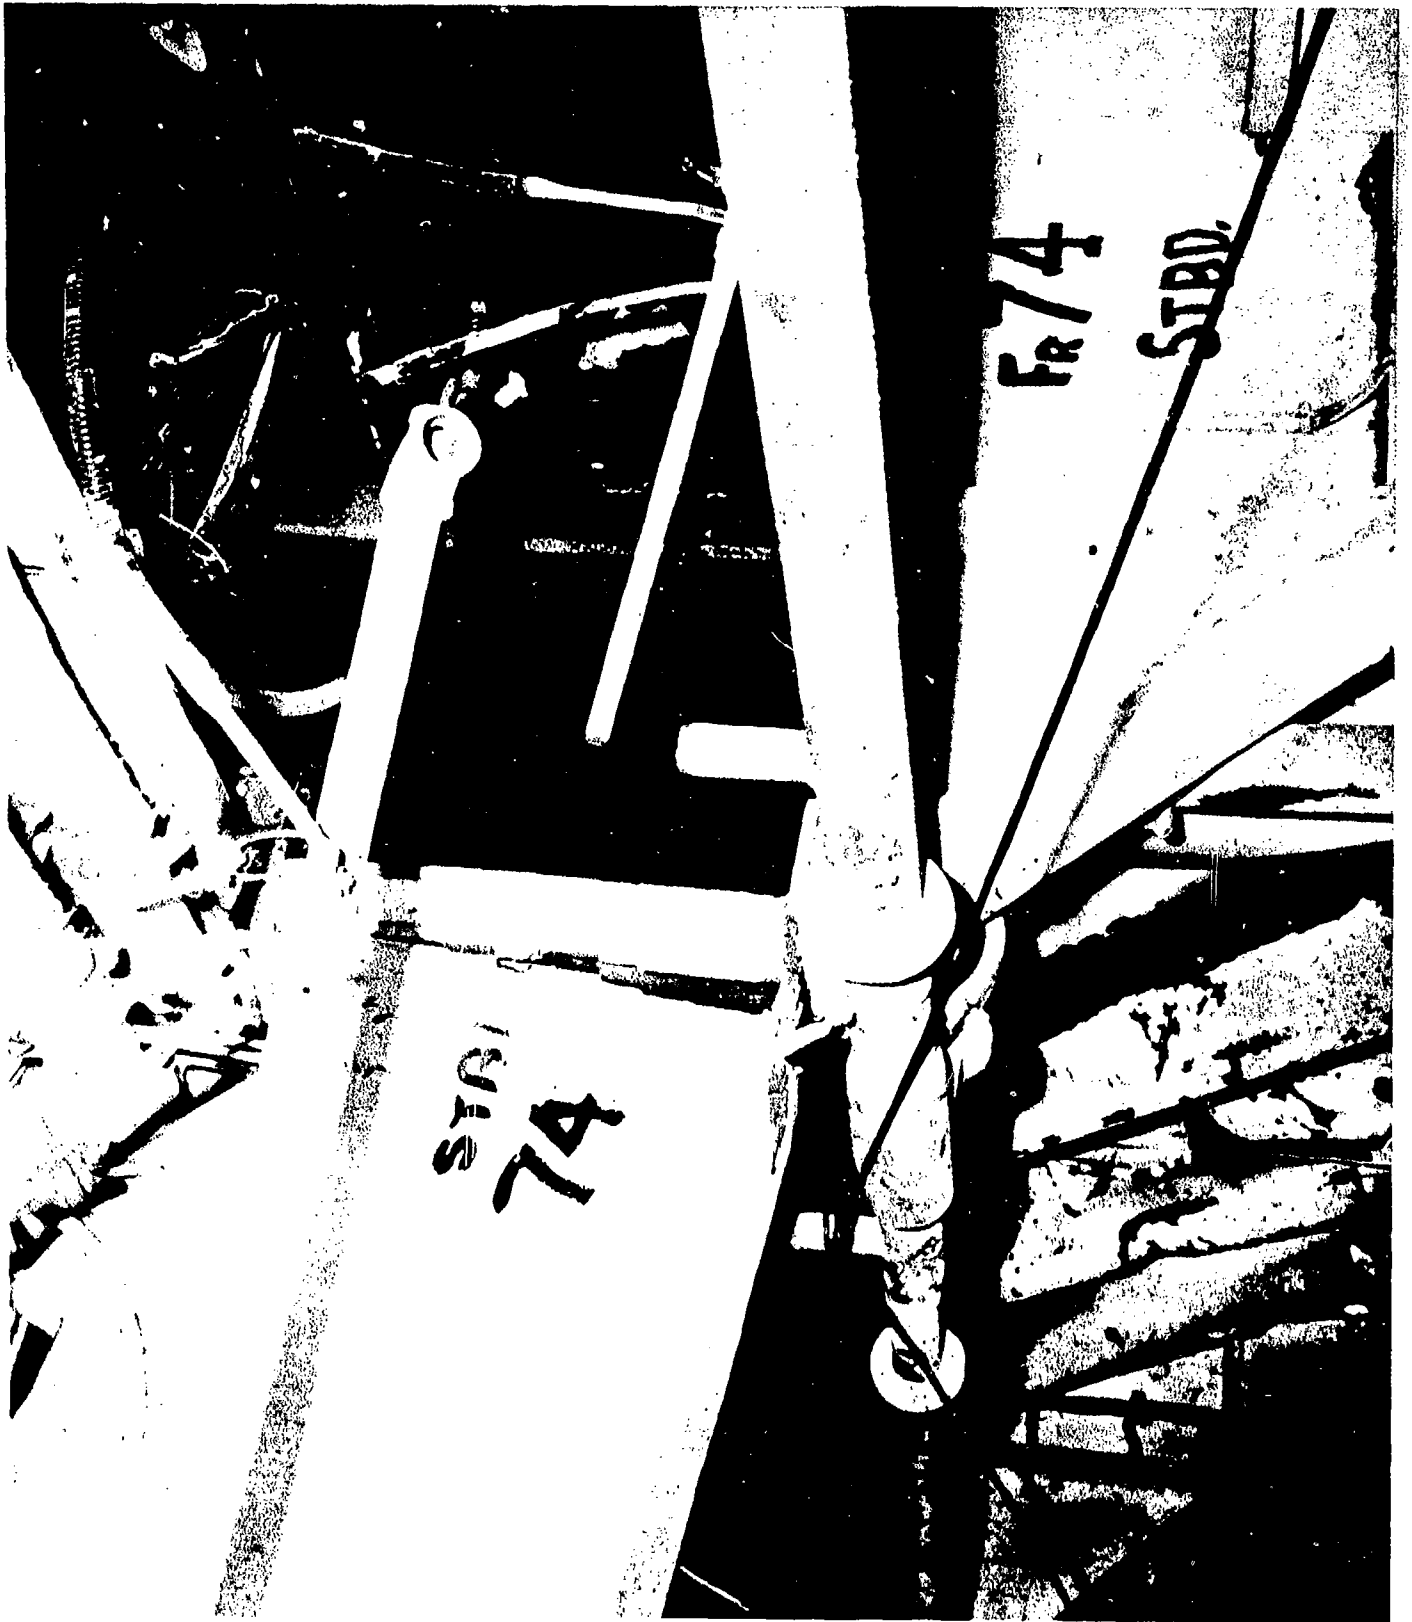
AA-CR-59-4148-11. Flight deck Bent 74, starboard side, showing failure adjacent to weld. Looking forward.

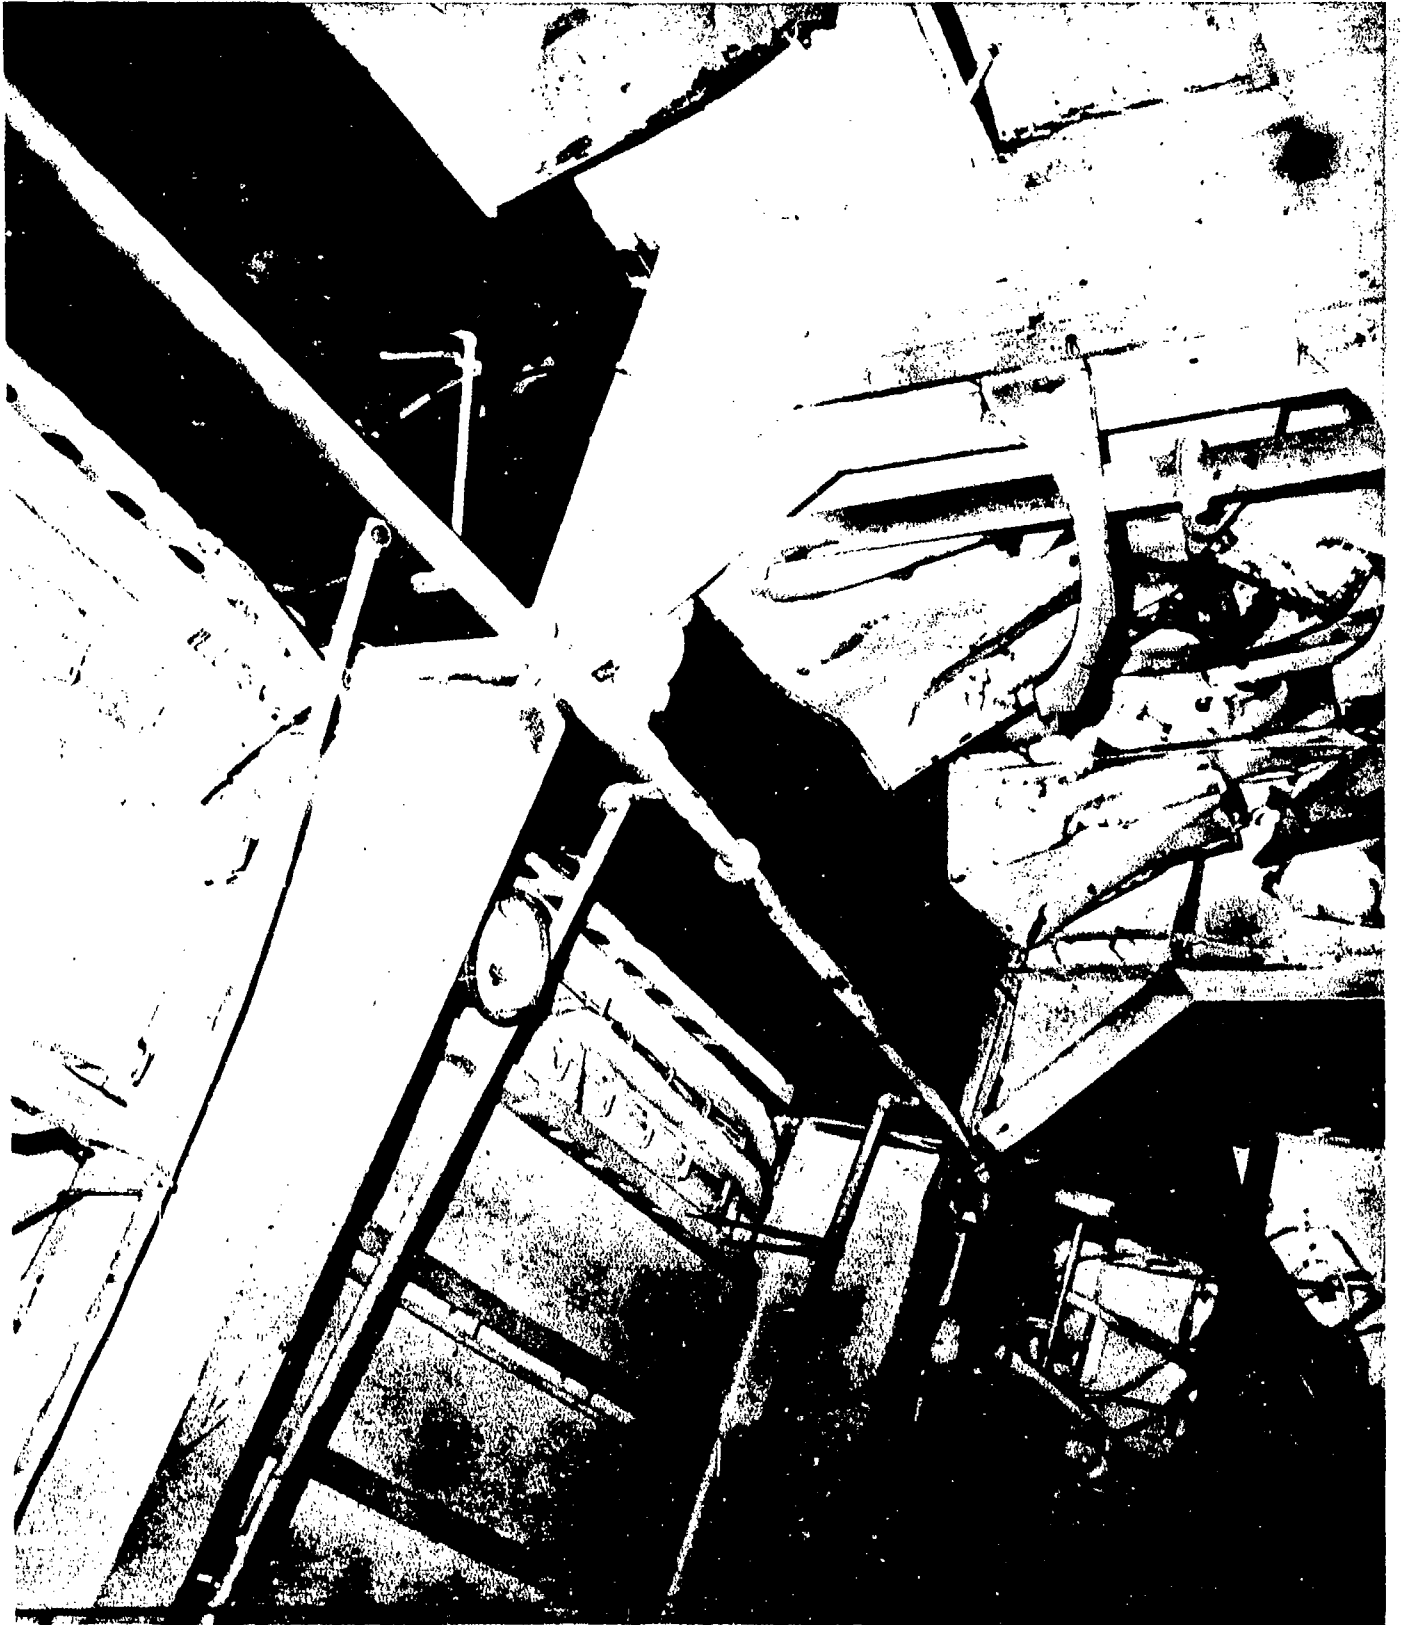
AA-CR-17b-2131-2. Flight deck Bent 74, starboard side, showing failure adjacent to weld. Looking forward.

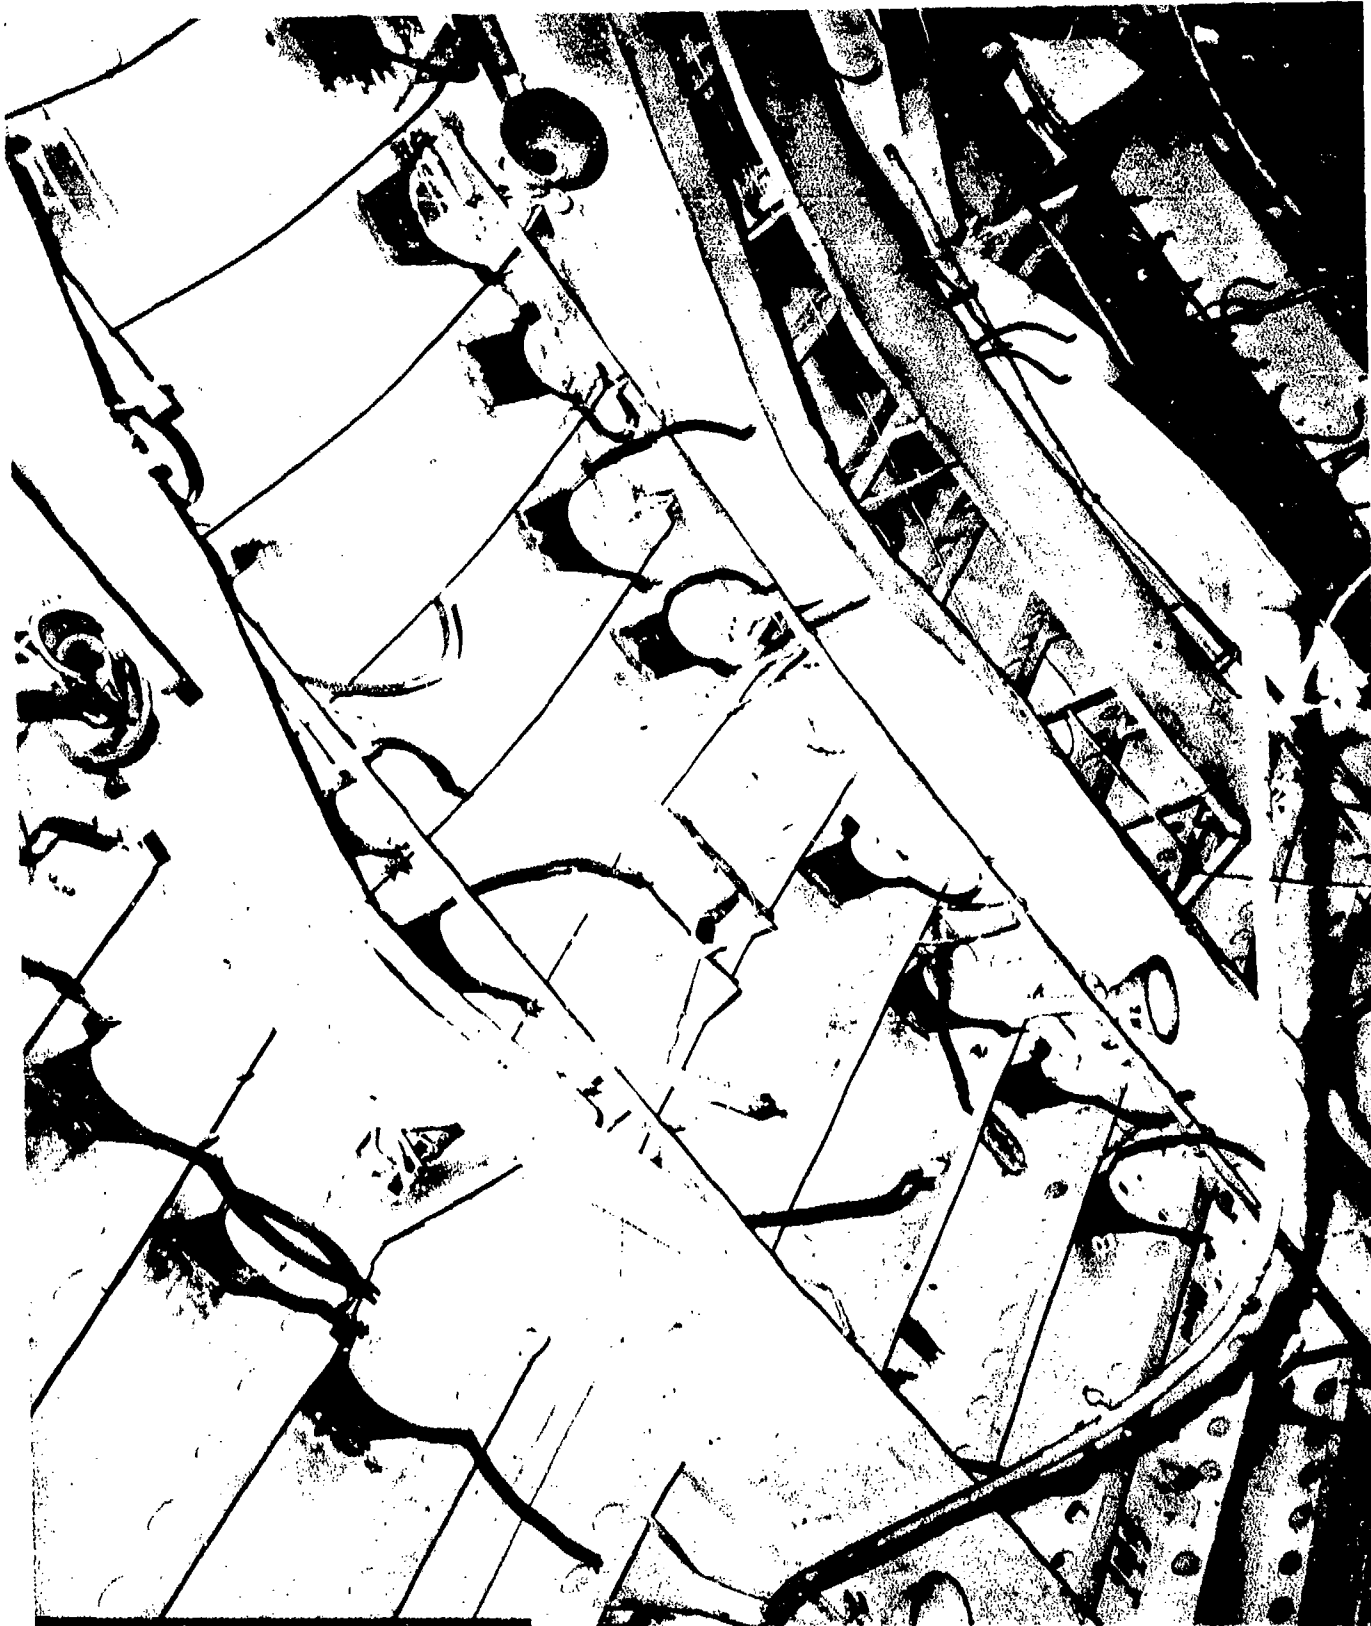
AA-CR-175-2119-2. Flight deck Bents 74 and 77, showing deformation and fractured welds and separation of transverse girders from deck longitudinals. Looking aft.

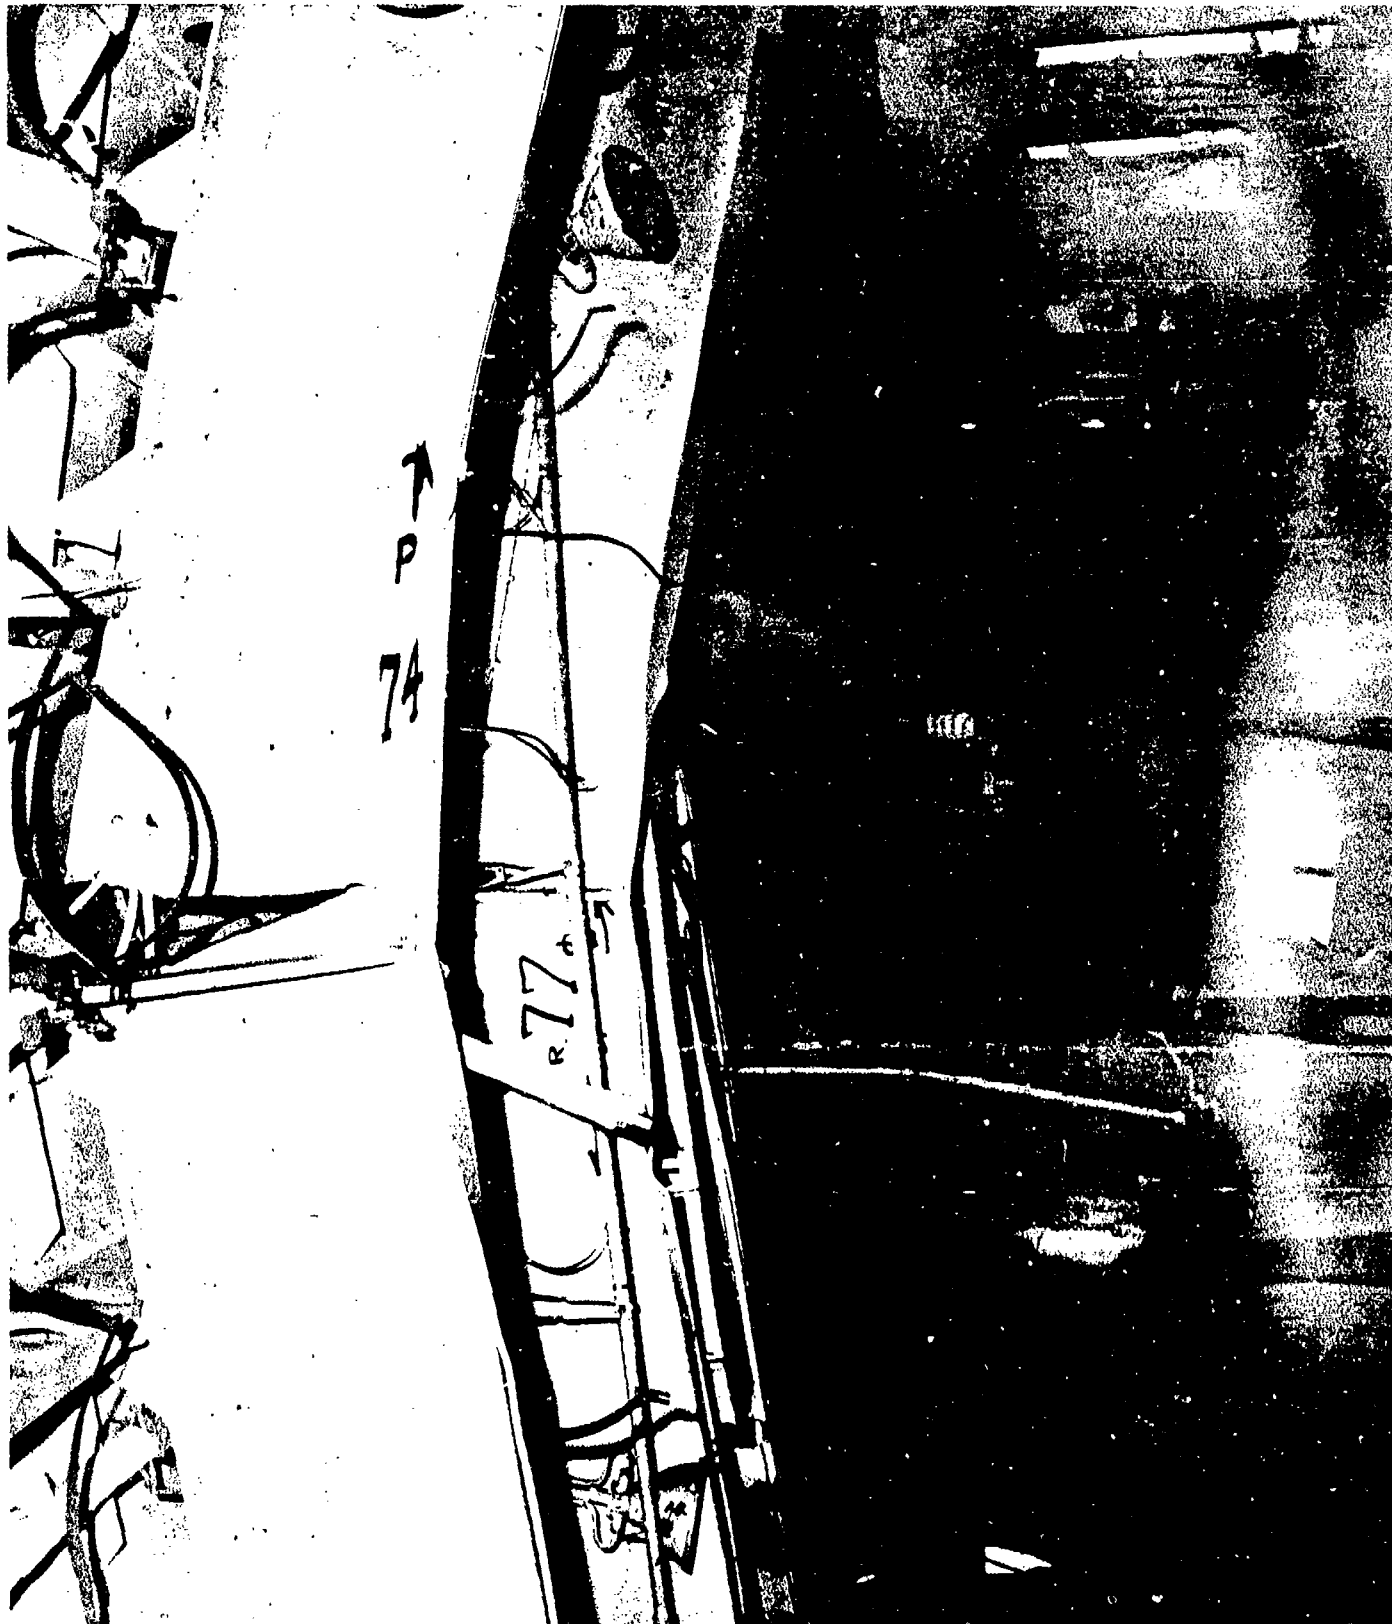
AA-CR-59-2227-3. Flight deck Bent 74, showing failure of upper flange at centerline and adjacent to weld. Looking aft.
