U.S.S. INDEPENDENCE (CVL22)

TEST ABLE

OPERATION CROSSROADS

BUREAU OF SHIPS GROUP
TECHNICAL INSPECTION REPORT

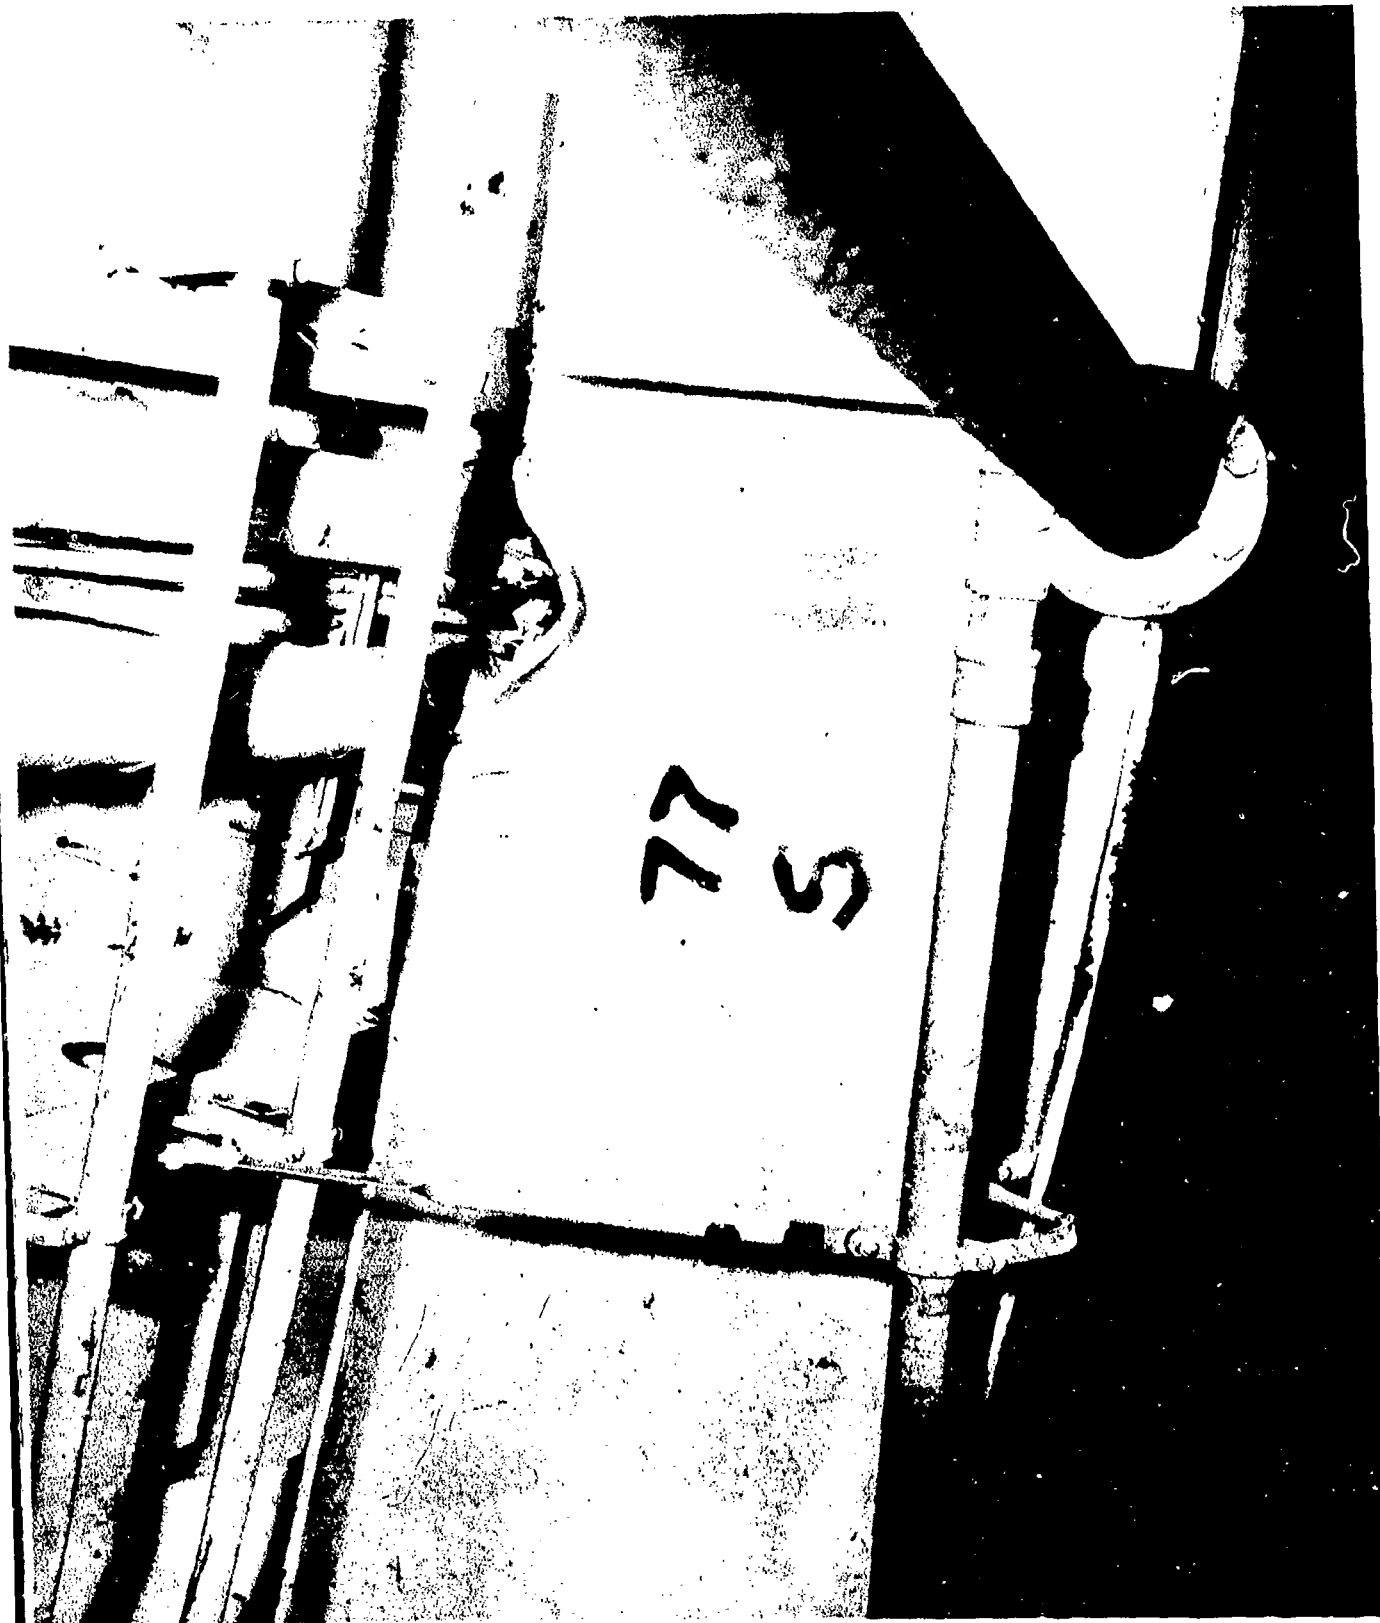
AA-CR-59-4148-12. Flight deck Bent 77, starboard side, showing failure of transverse girder. Looking forward.

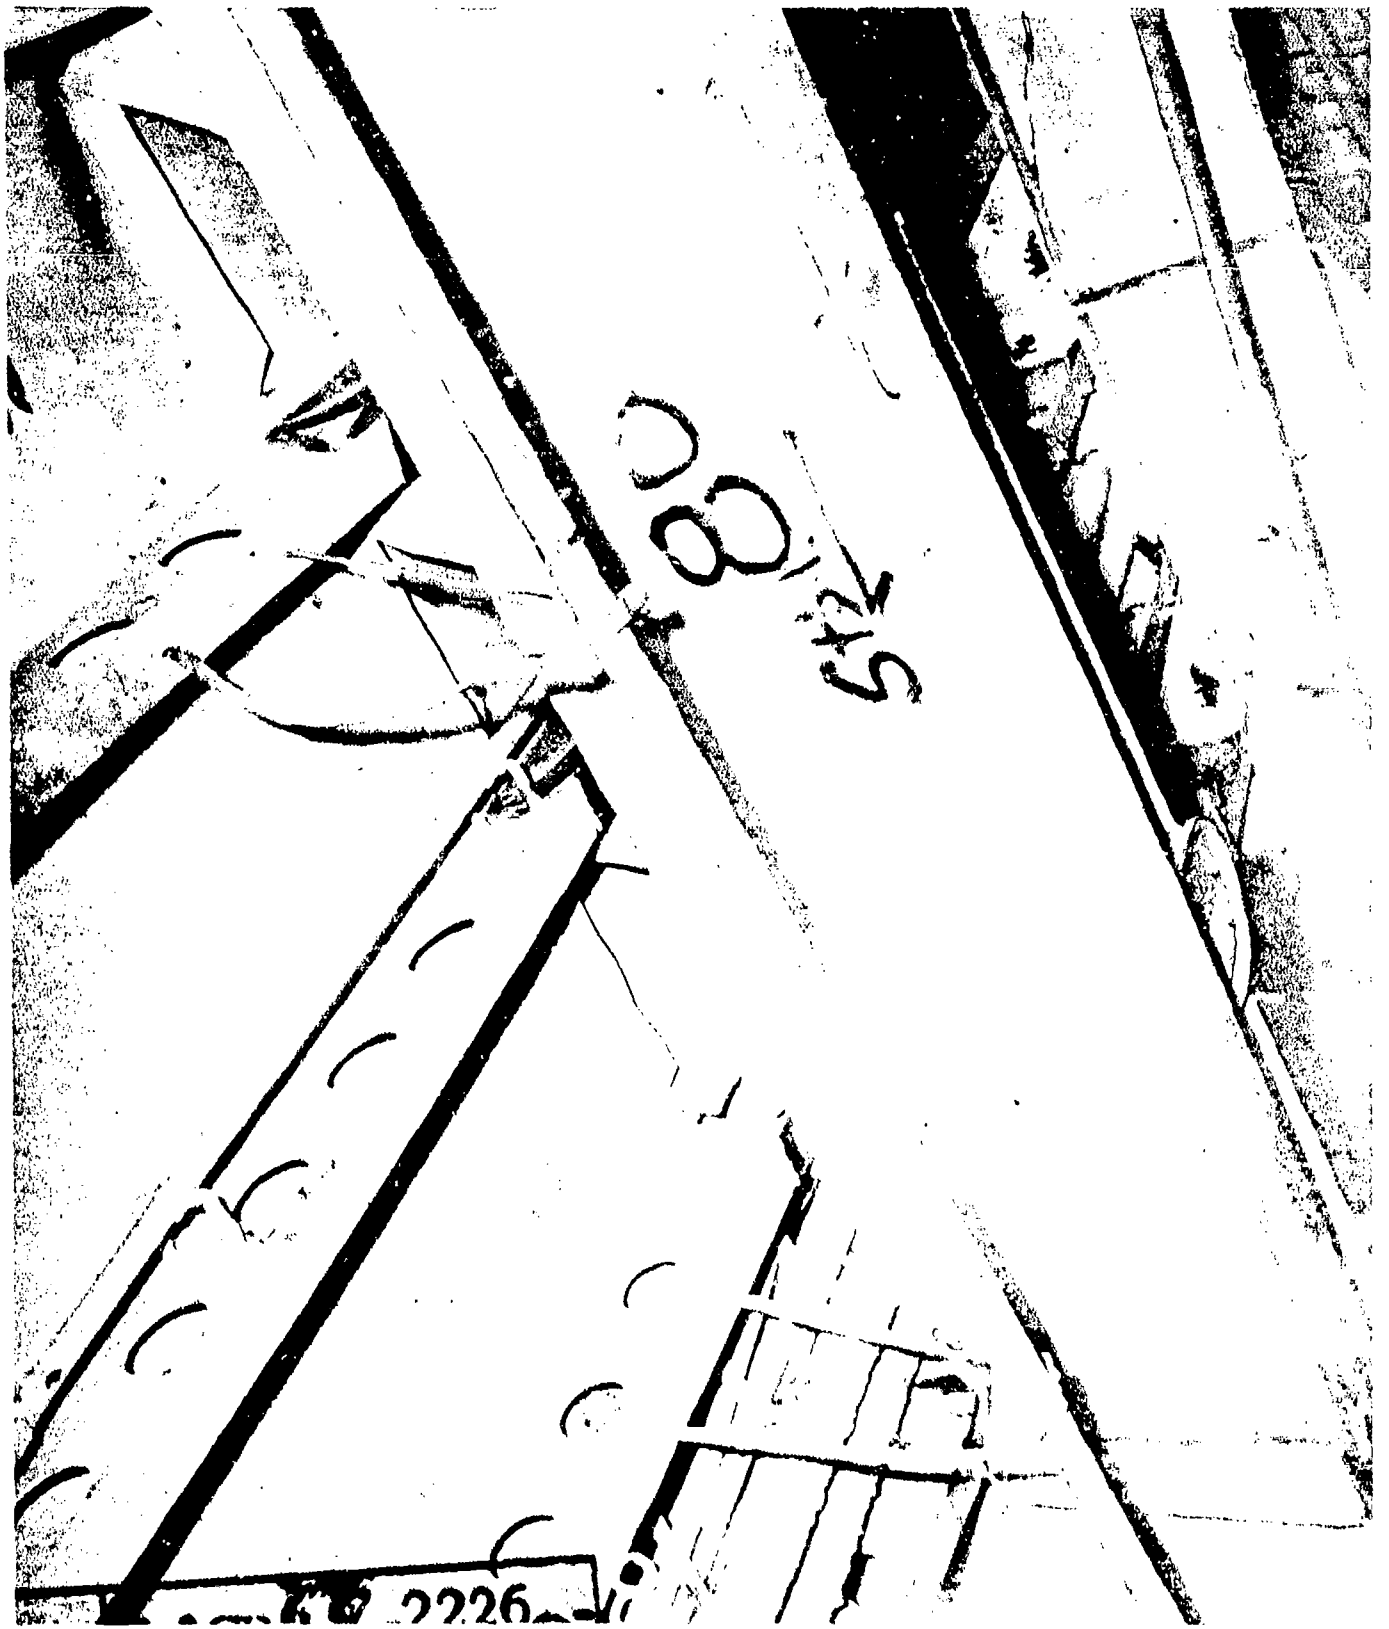
AA-CR-59-2226-8. Flight deck Bent 80, starboard side showing failure of overhead connection adjacent to weld and failure of welds connecting Bent to deck longitudinals. Looking aft.

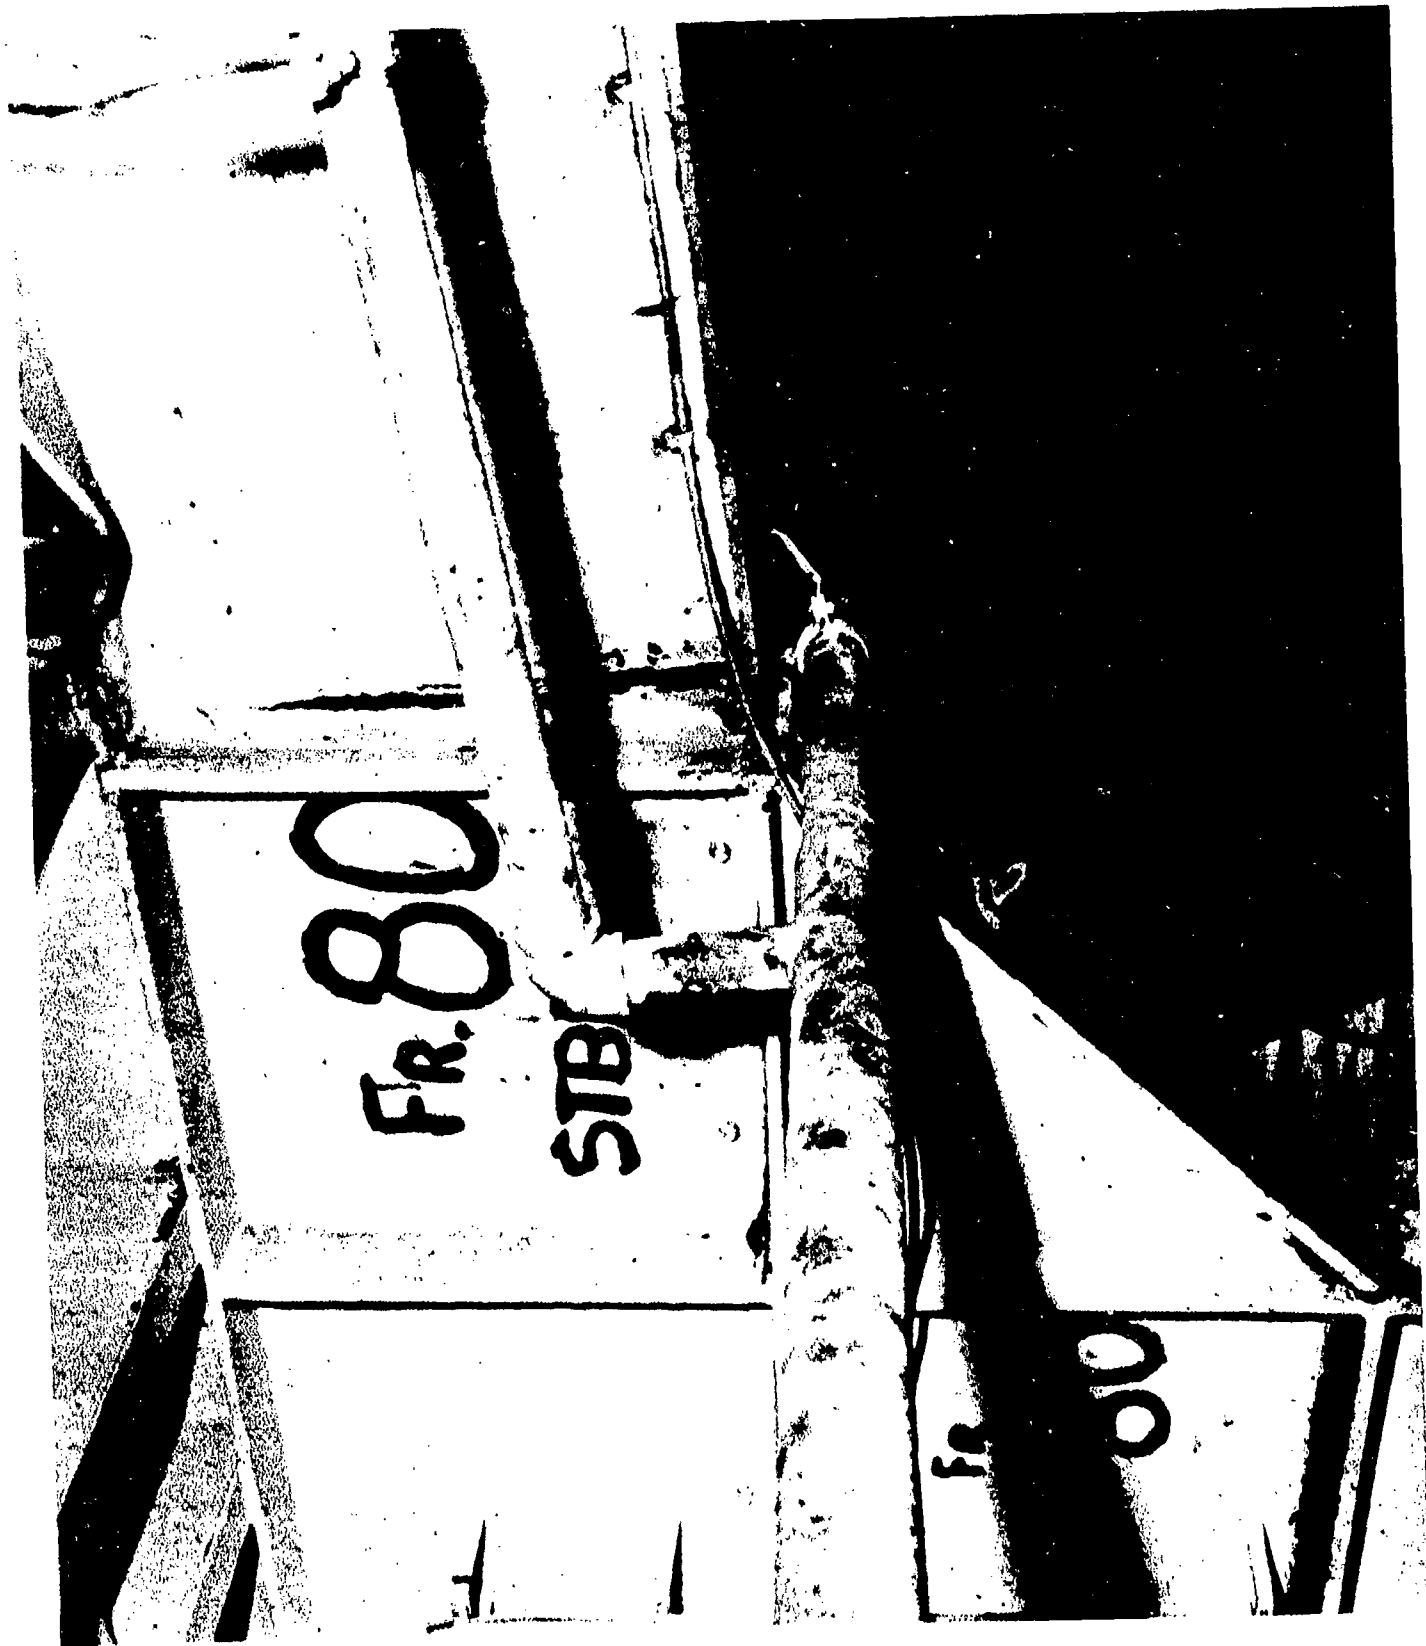
AA-CR-59-4149-1. Flight deck Bent 80, starboard side, showing fracture of transverse girder adjacent to vertical fillet weld.

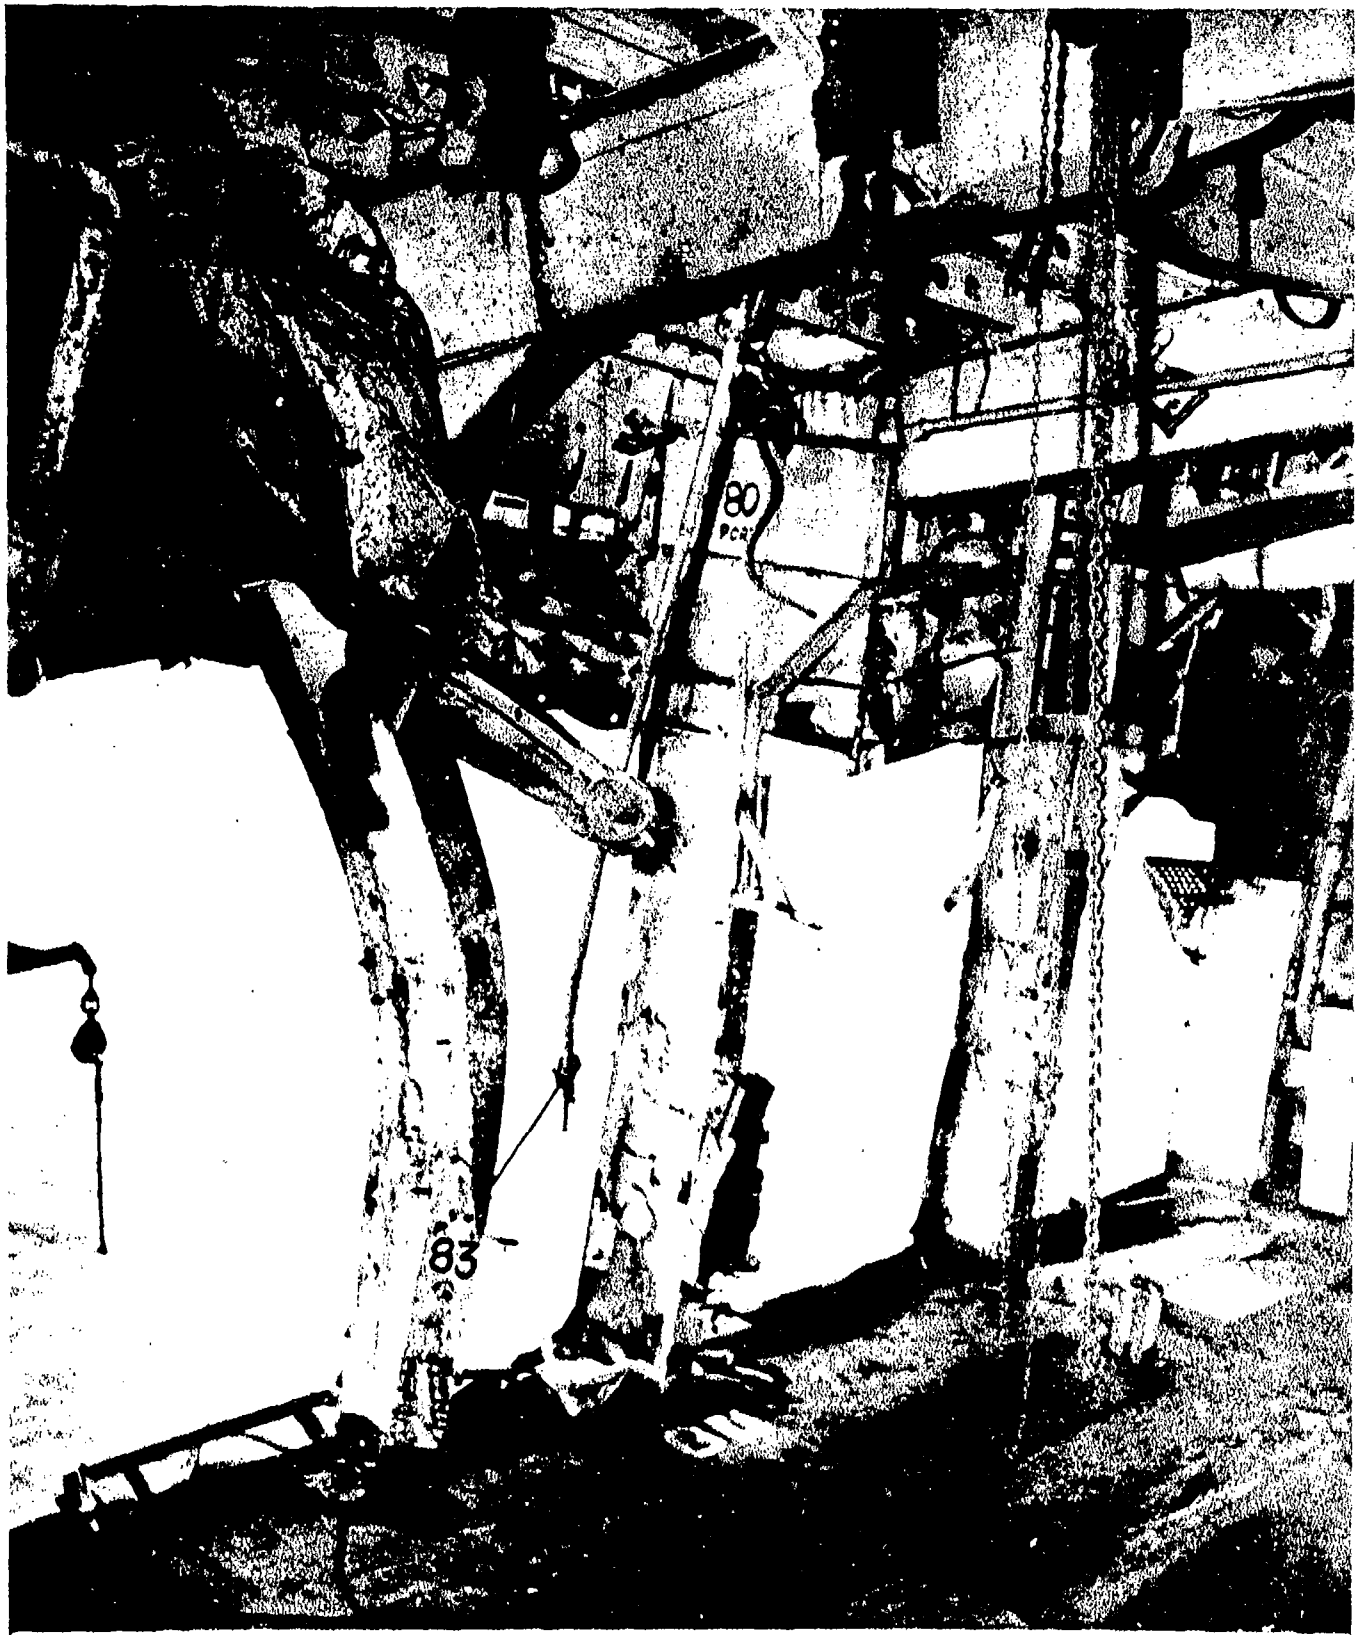
AA-CR-59-2225-6. Hangar-General view between Bents 74 and 86, showing failure of Wobble Bent 83 at deck.

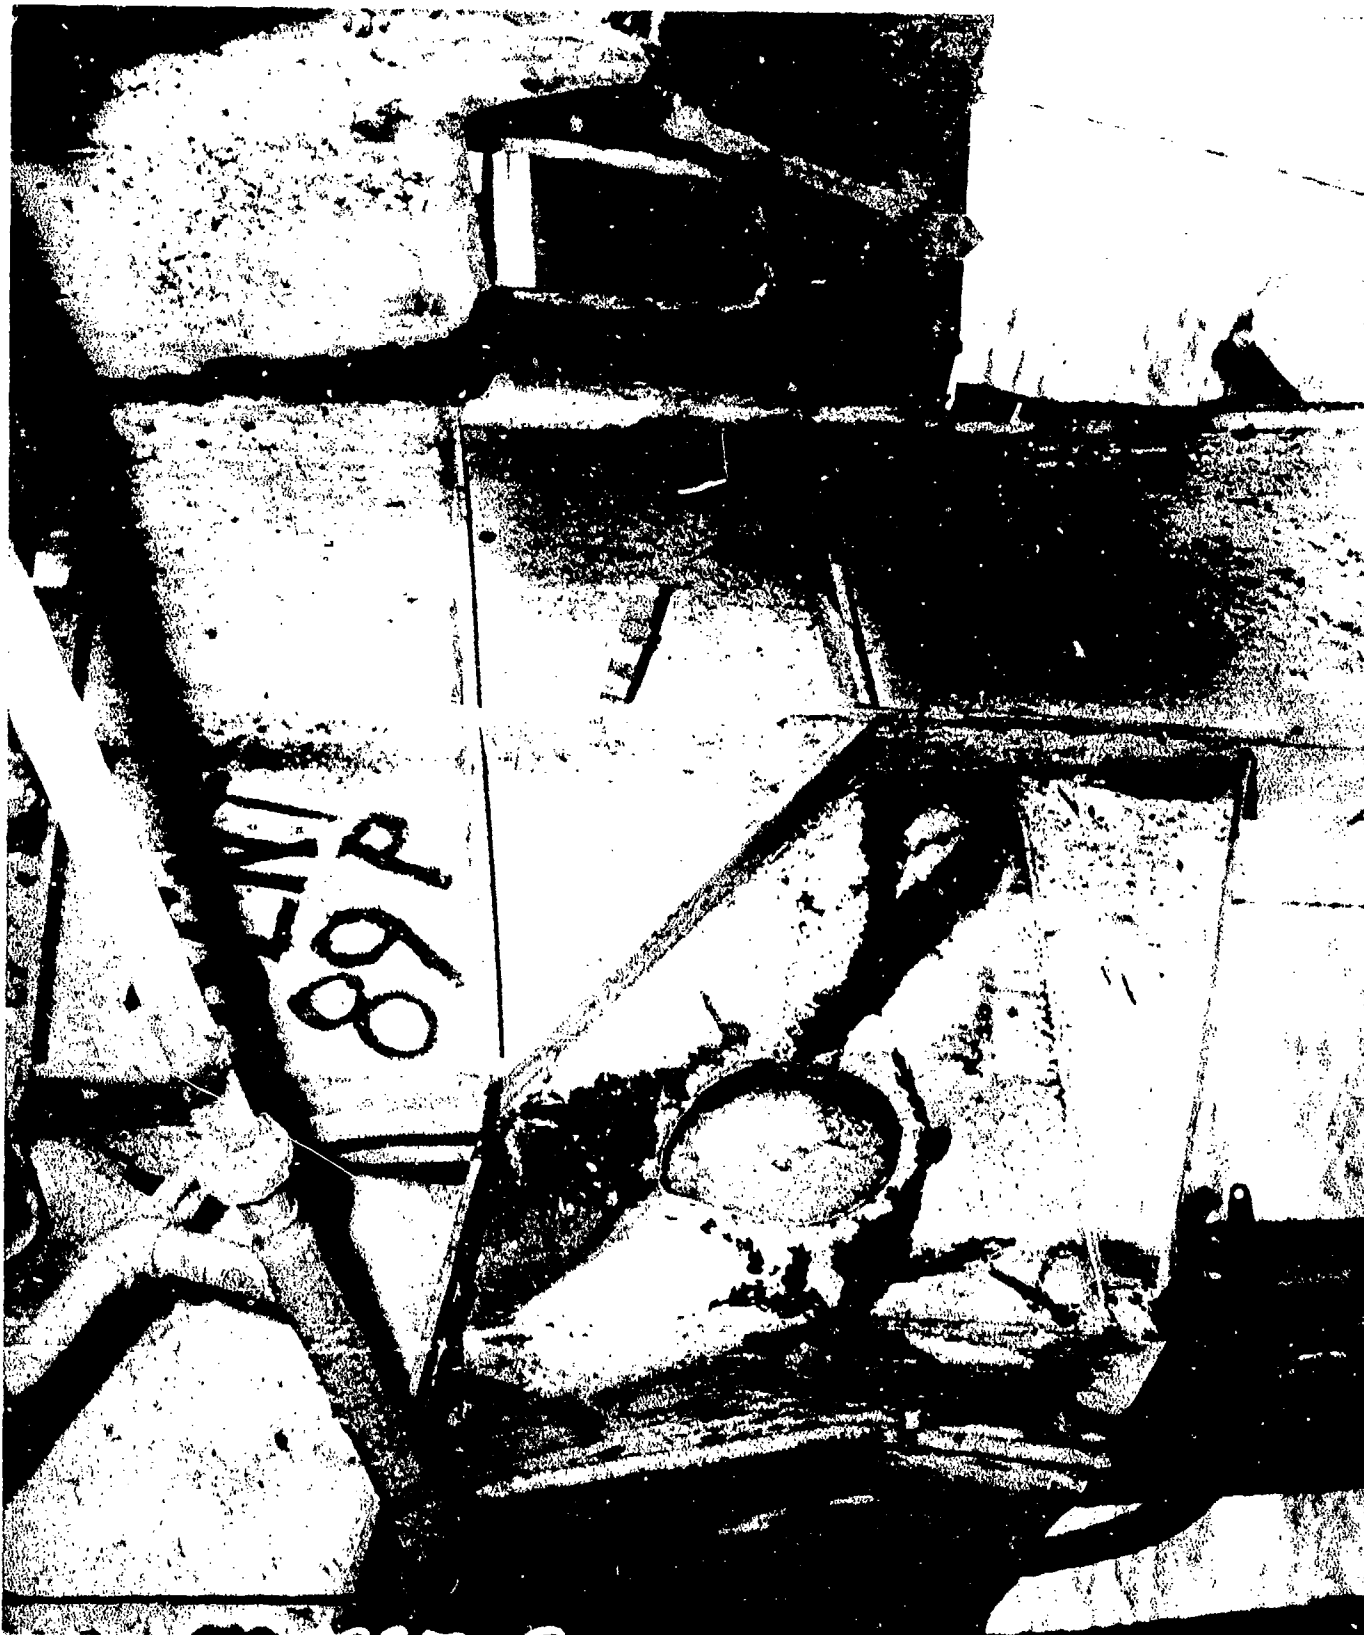
AA-CR-59-2223-9. Flight deck Bent 89, port side, showing failure of transverse girder and origin of fracture adjacent to weld at upper end of bracket. Looking aft.

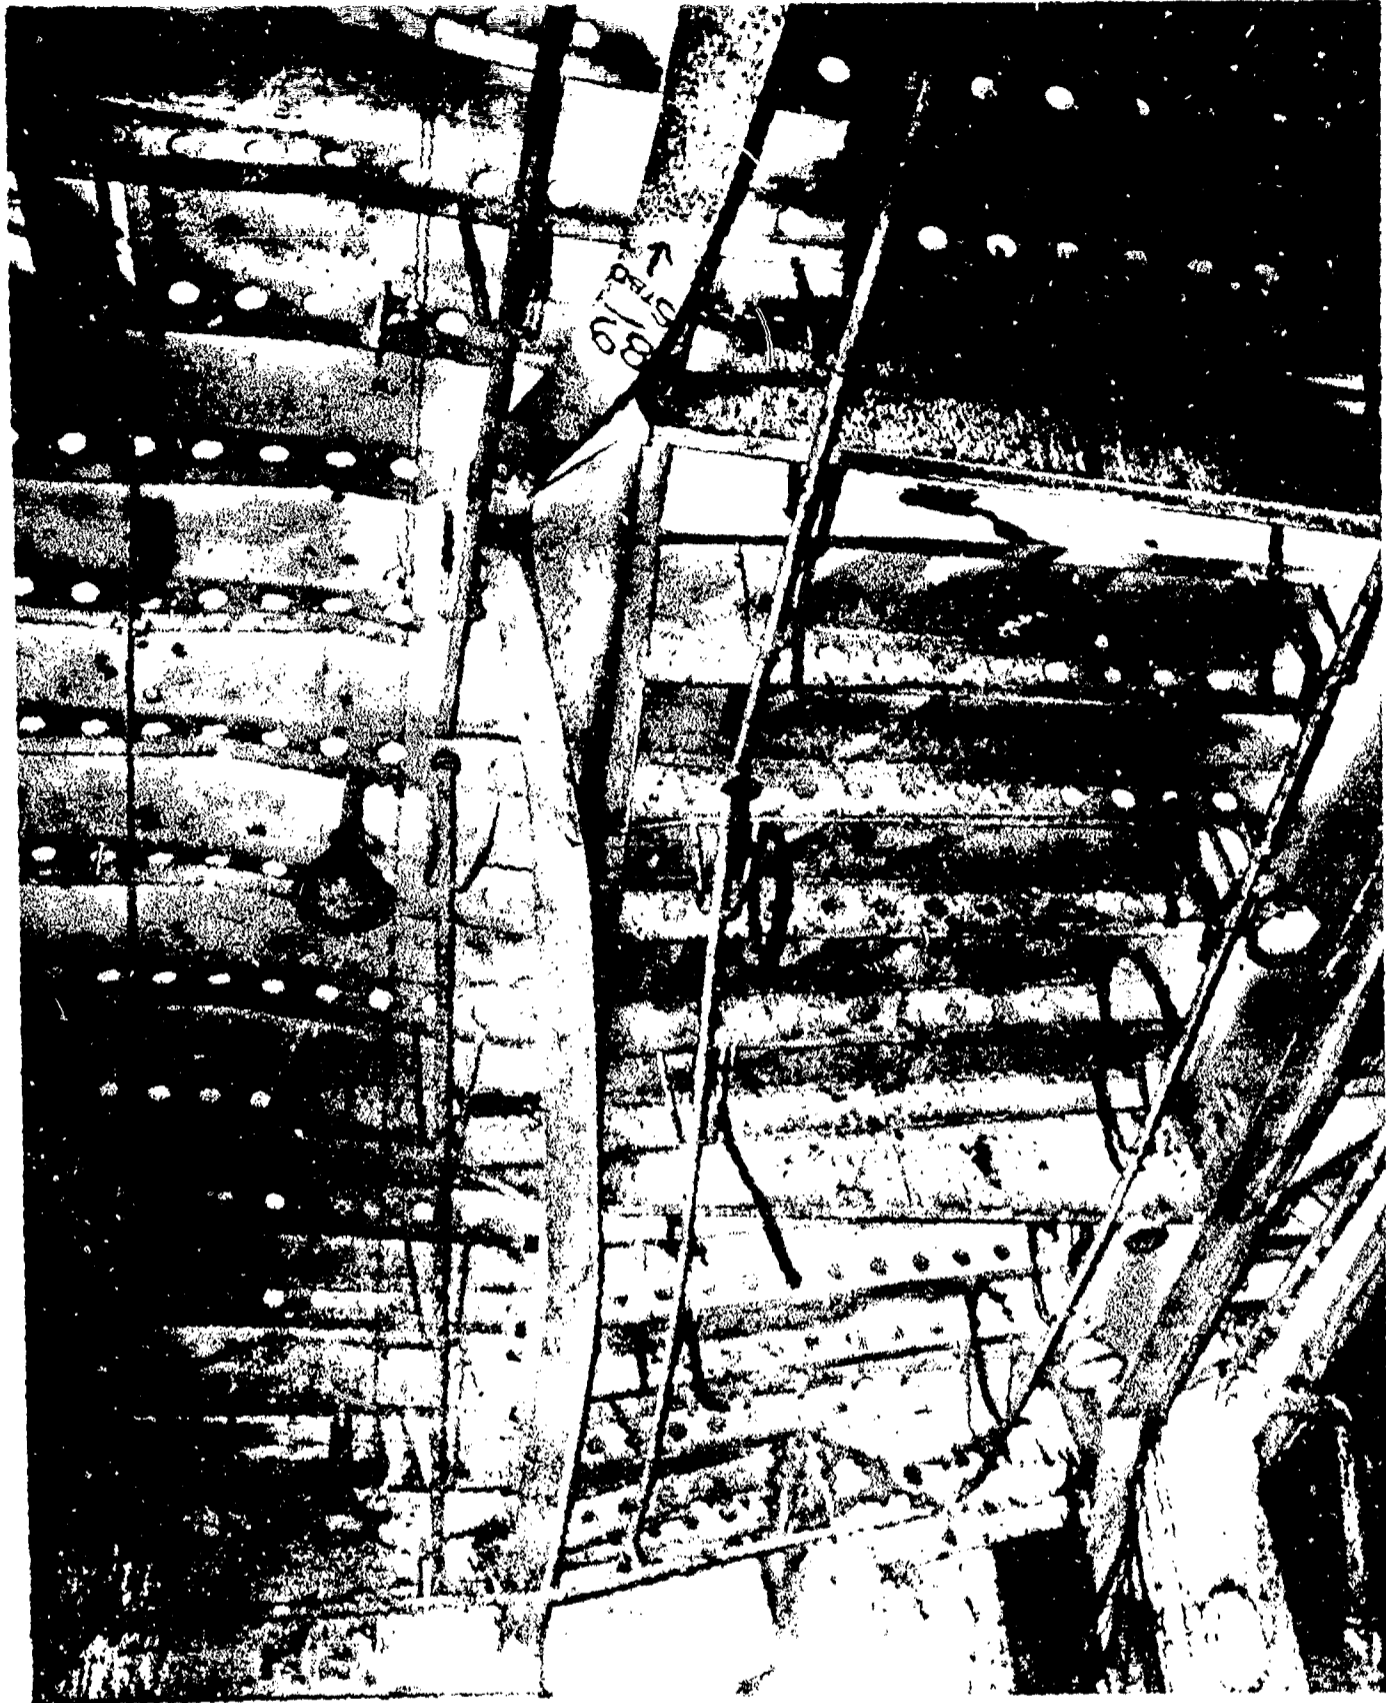
AA-CR-59-4161-5. Flight deck Bent 89, deformation and failure of weld at upper end of centerline web stiffener. Looking to port,

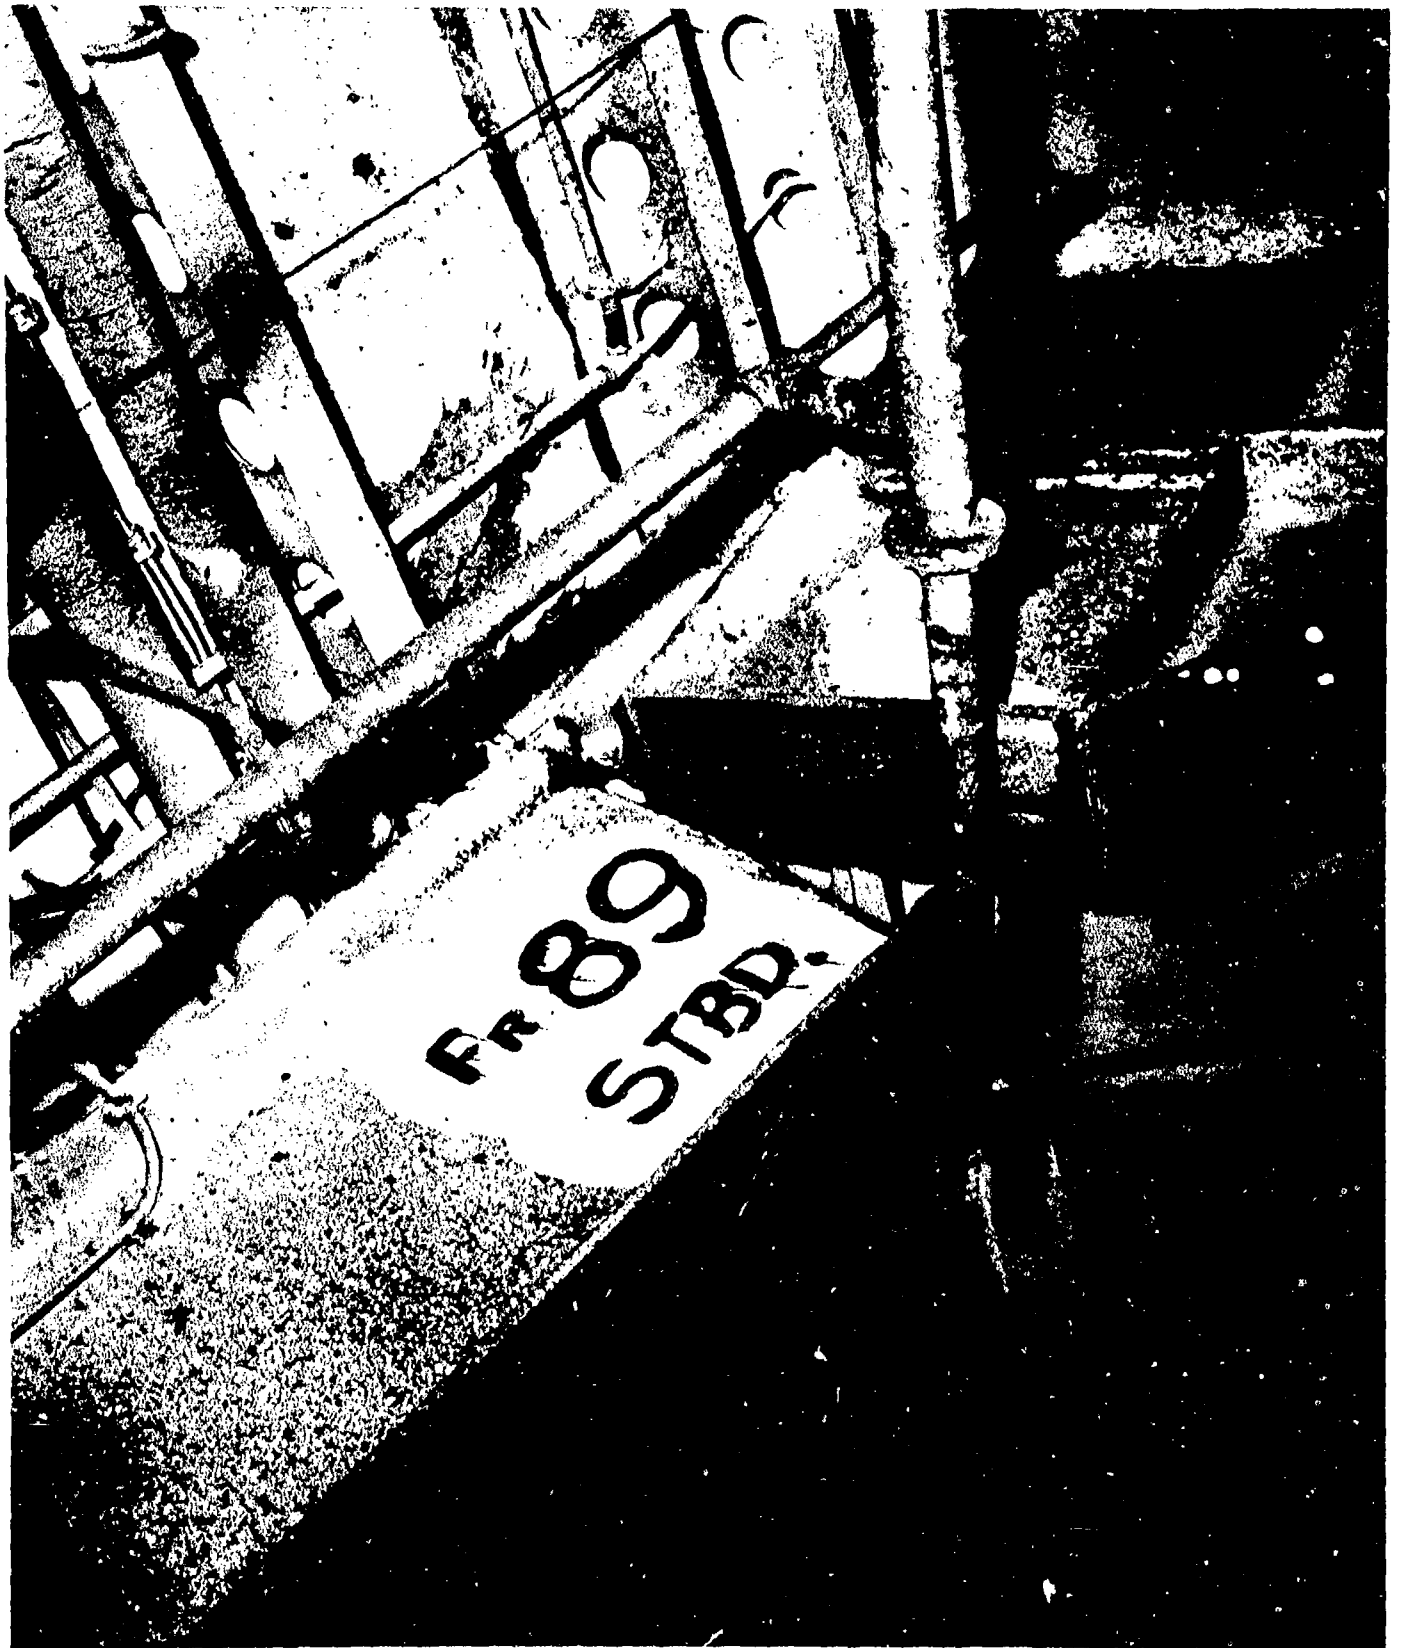
AA-CR-59-4149-6. Flight deck Bent 89, starboard side, showing complete failure of transverse girder and origin of fracture at upper edge of fillet weld at end of bracket. Looking forward.

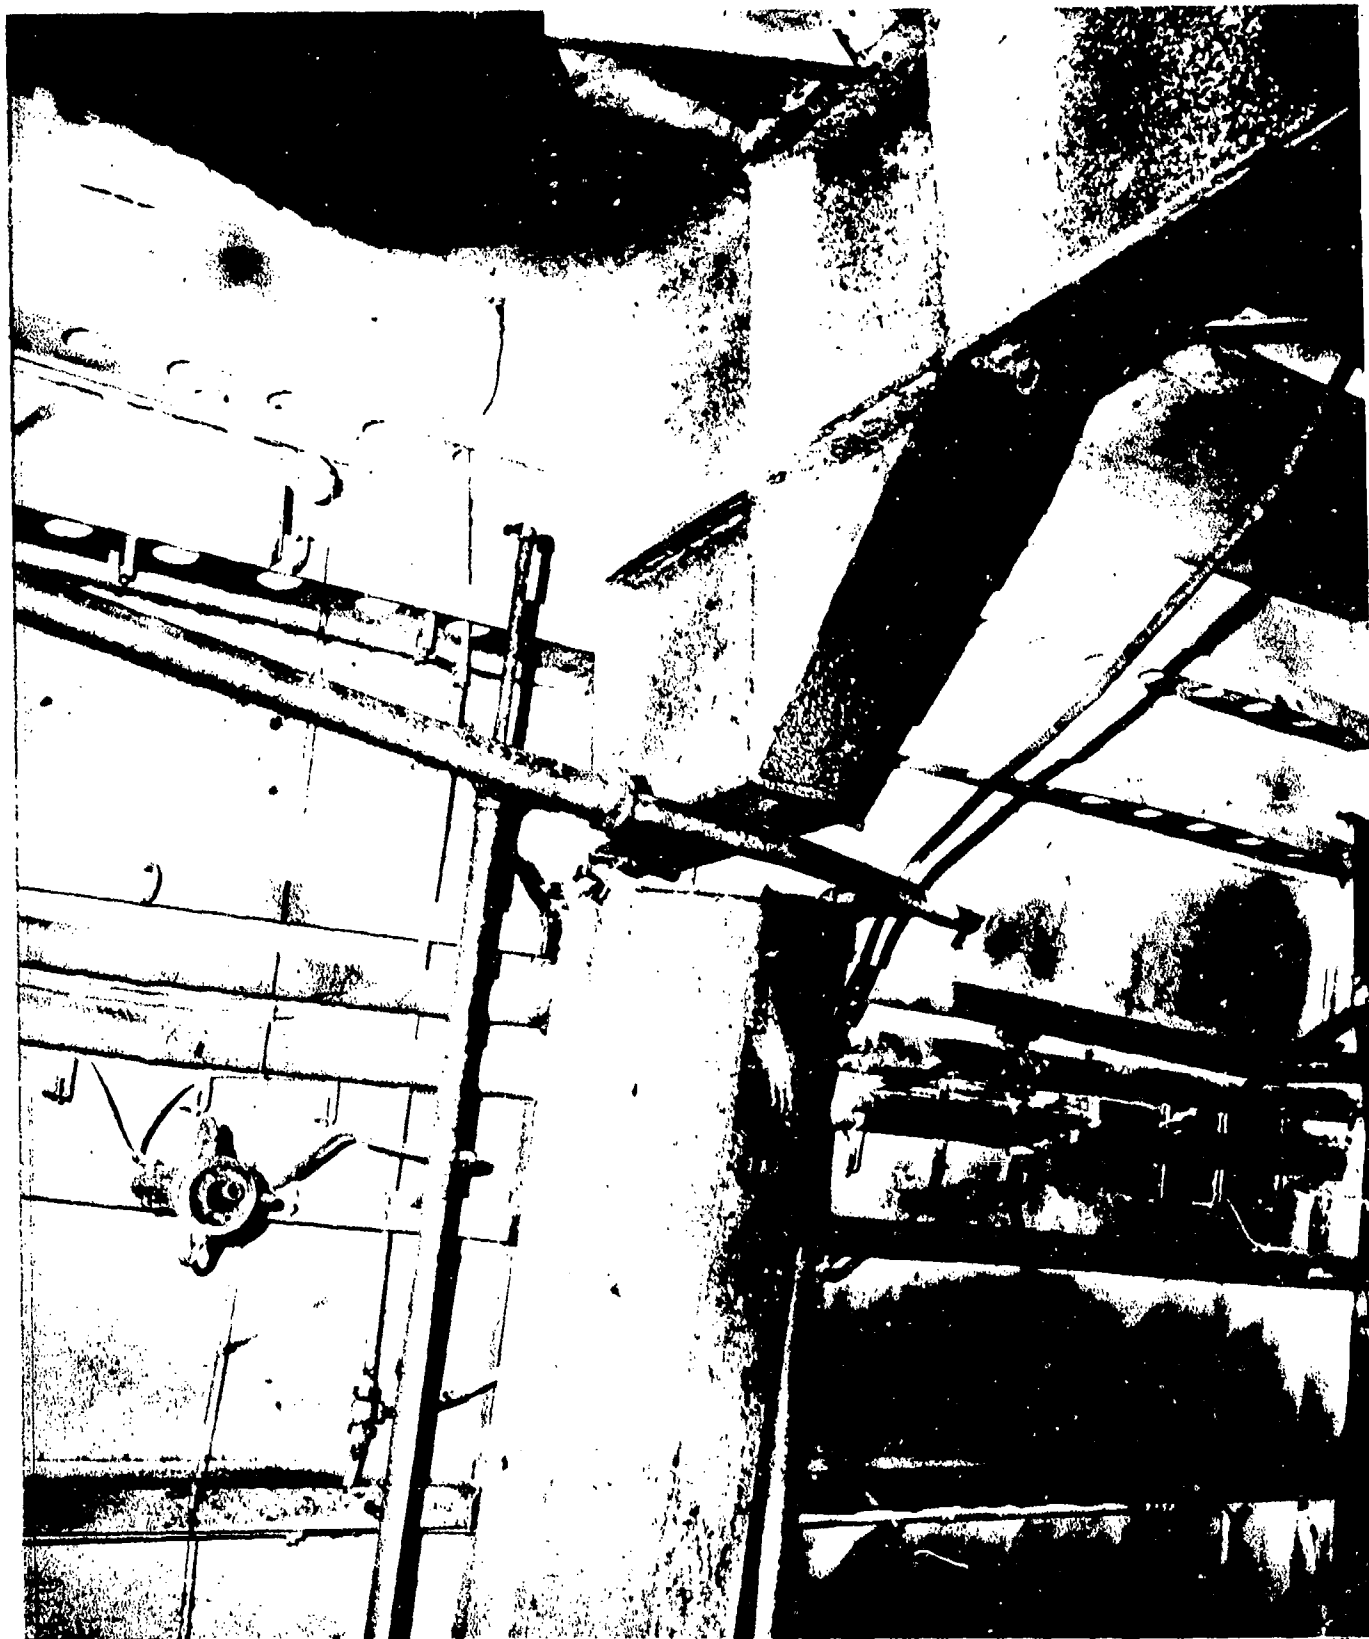
AA-CR-175-2132-1. Flight deck Bent 89, starboard side, showing failure of transverse girder and origin of fracture adjacent to weld at upper end of bracket. Looking forward.

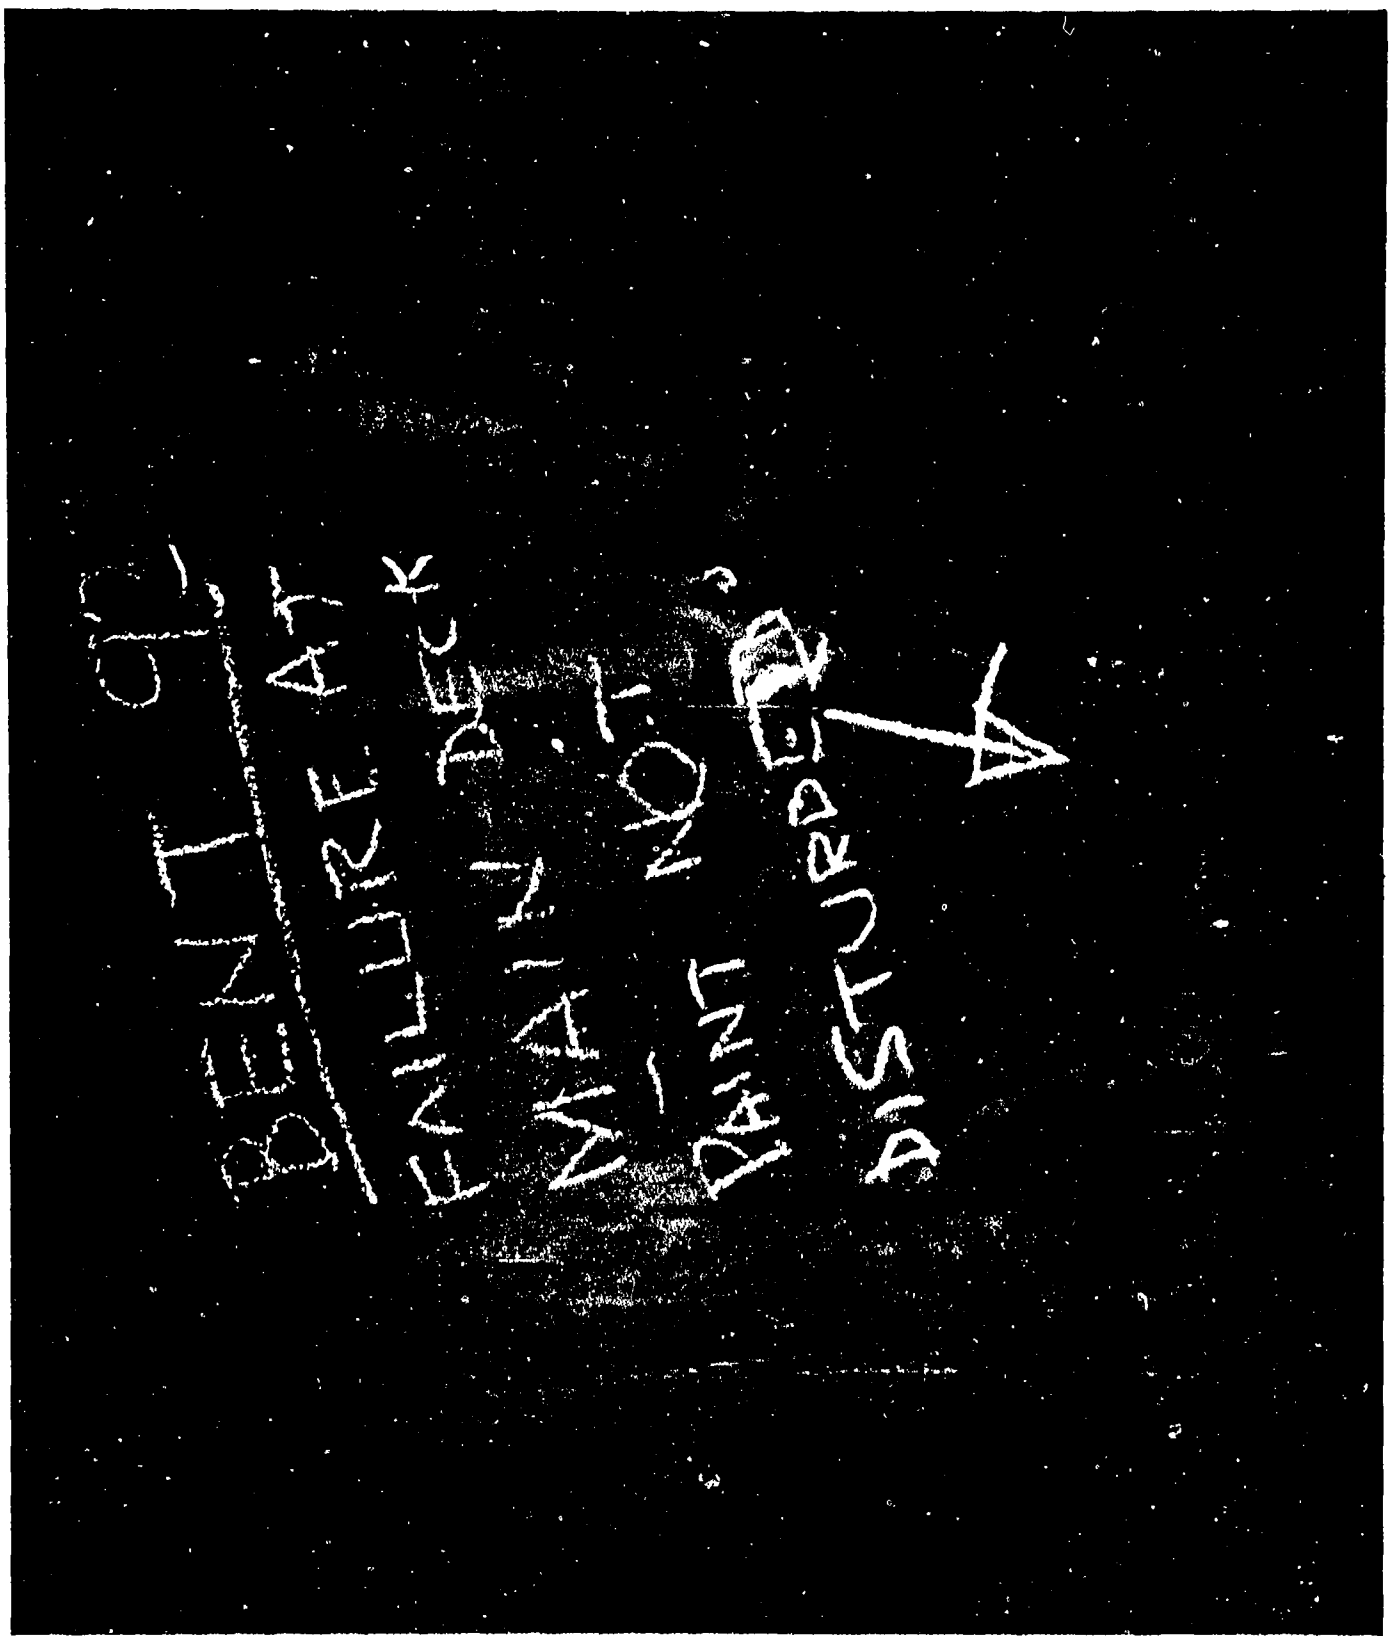
AA-CR-59-4161-1. Flight deck Bent 92. Weld failure at port side connection to S.T.S. shear strake, looking inboard to starboard.

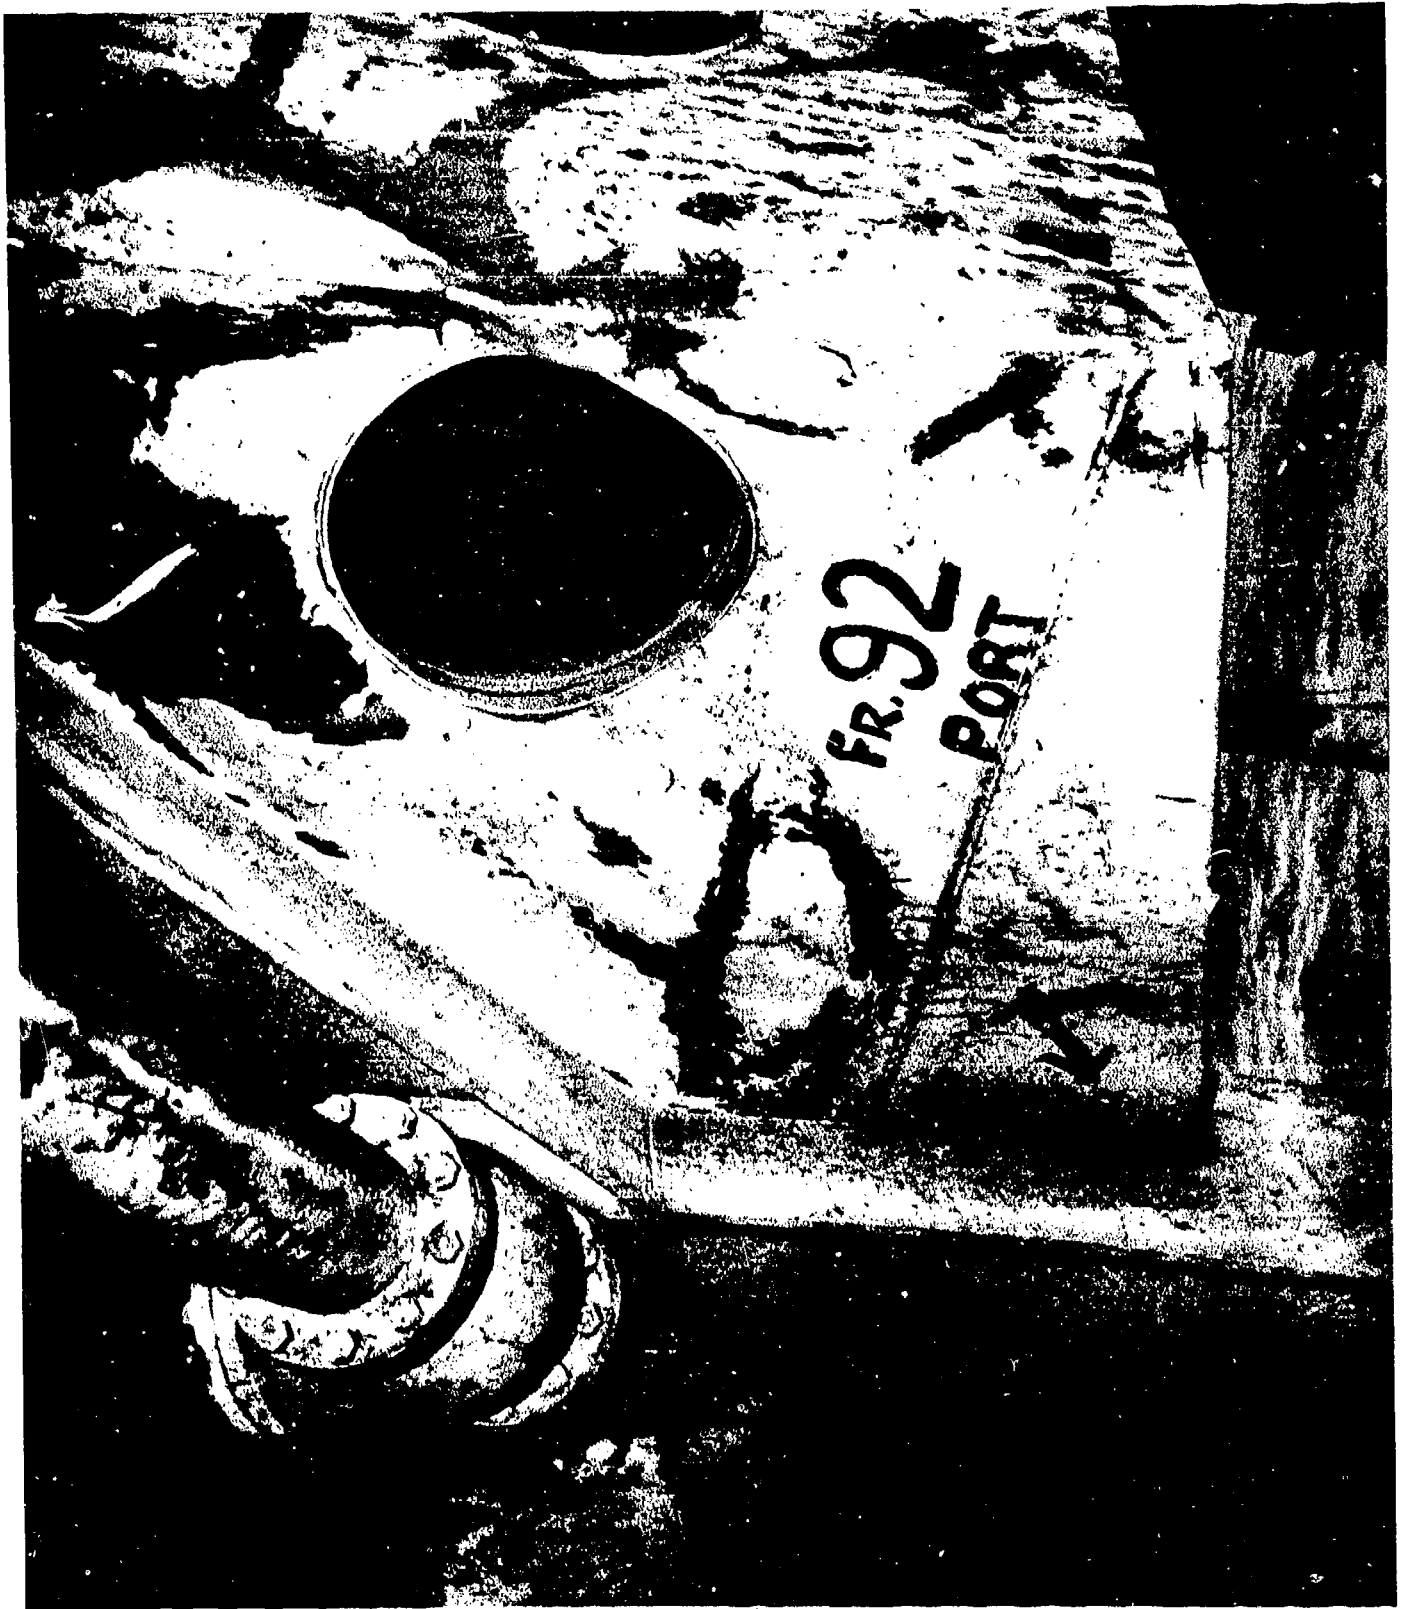
AA-CR-59-2223-11: Flight deck bent 92, port side, looking forward and to port. Note tear in light weight bracket and damage to conflagration station.
