U.S.S. INDEPENDENCE (CVL22)

TEST ABLE

OPERATION CROSSROADS

BUREAU OF SHIPS GROUP
TECHNICAL INSPECTION REPORT

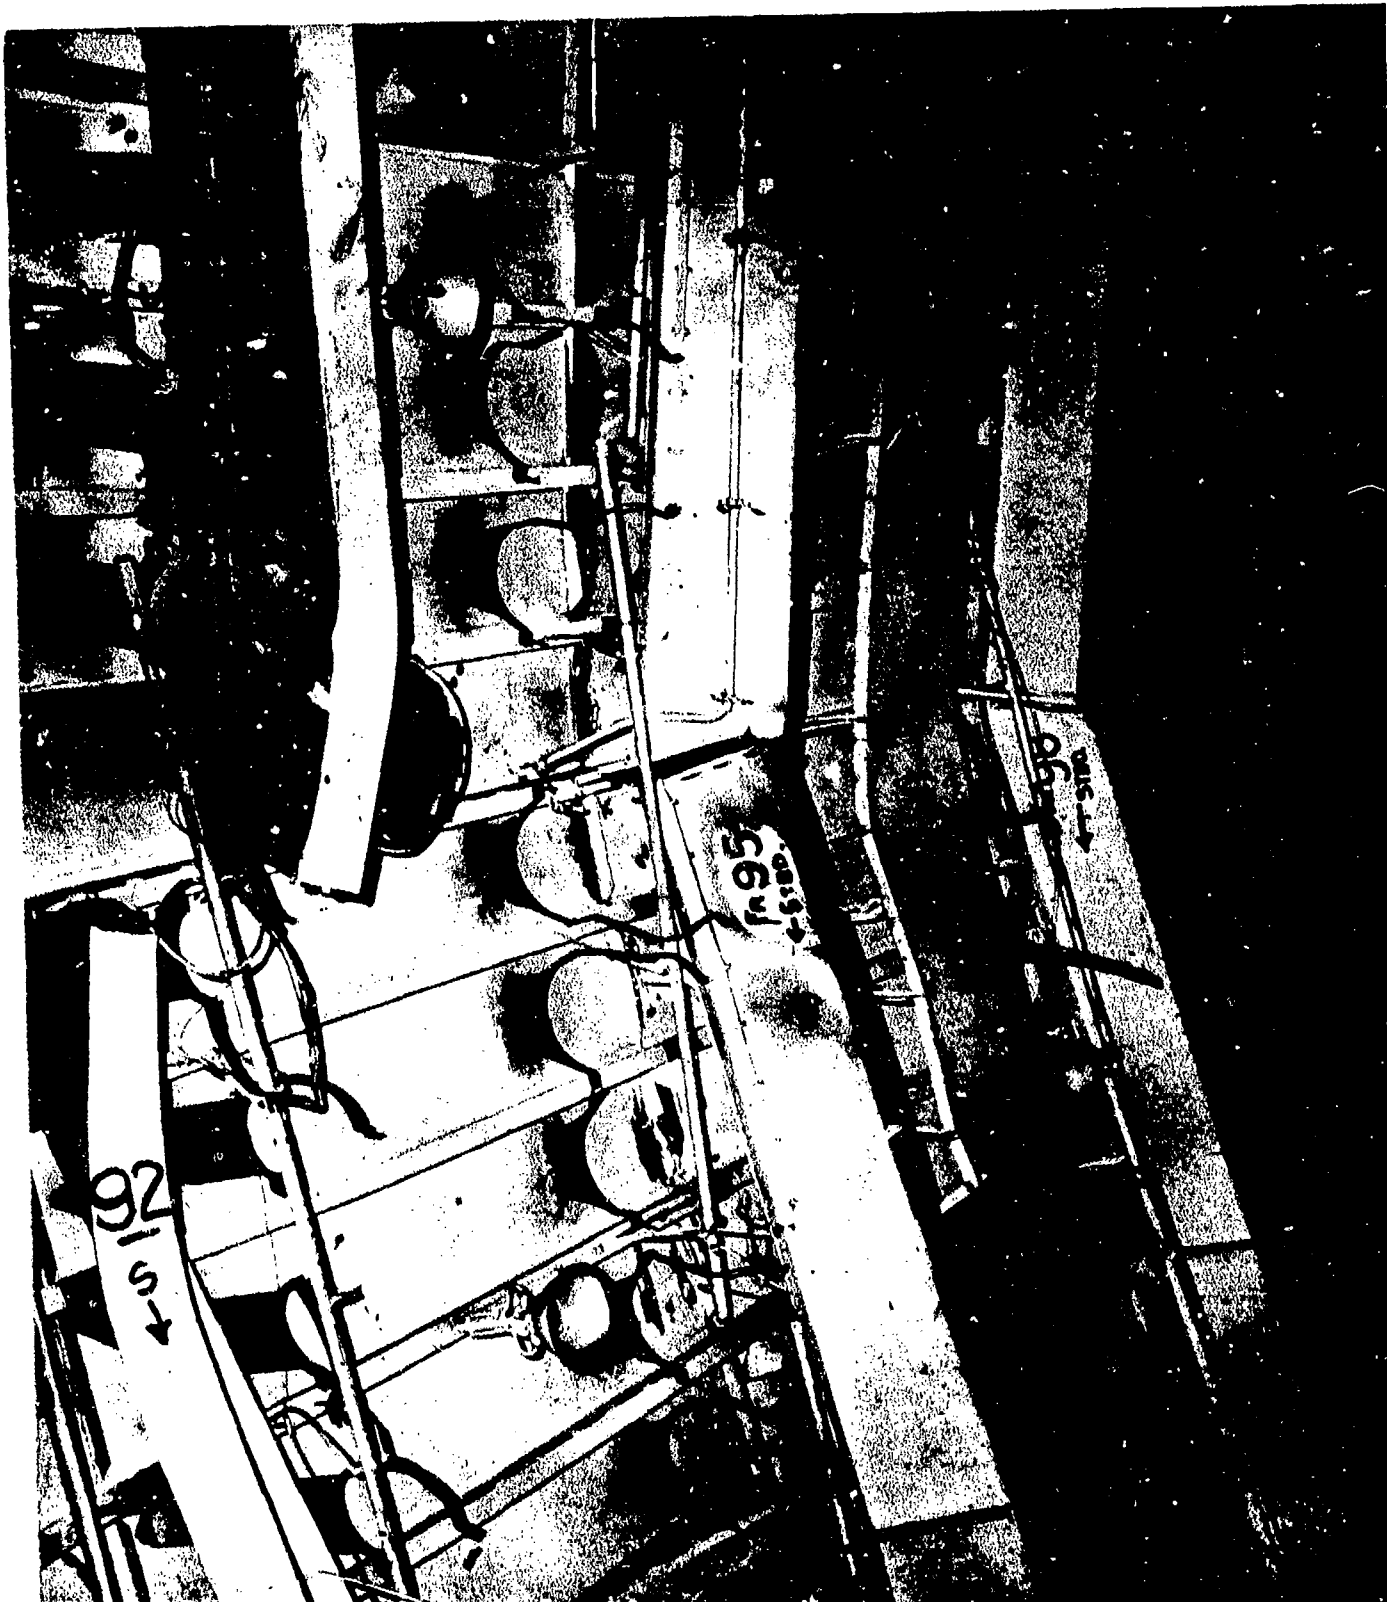
AA-CR-59-4152-11. Flight deck and flight deck bents 92, 95, 98, and 101, showing transverse tear in deck, deformation of transverse girders 95, 98, 101, and complete failure of welded centerline butt in girder 92, Looking aft and upward.

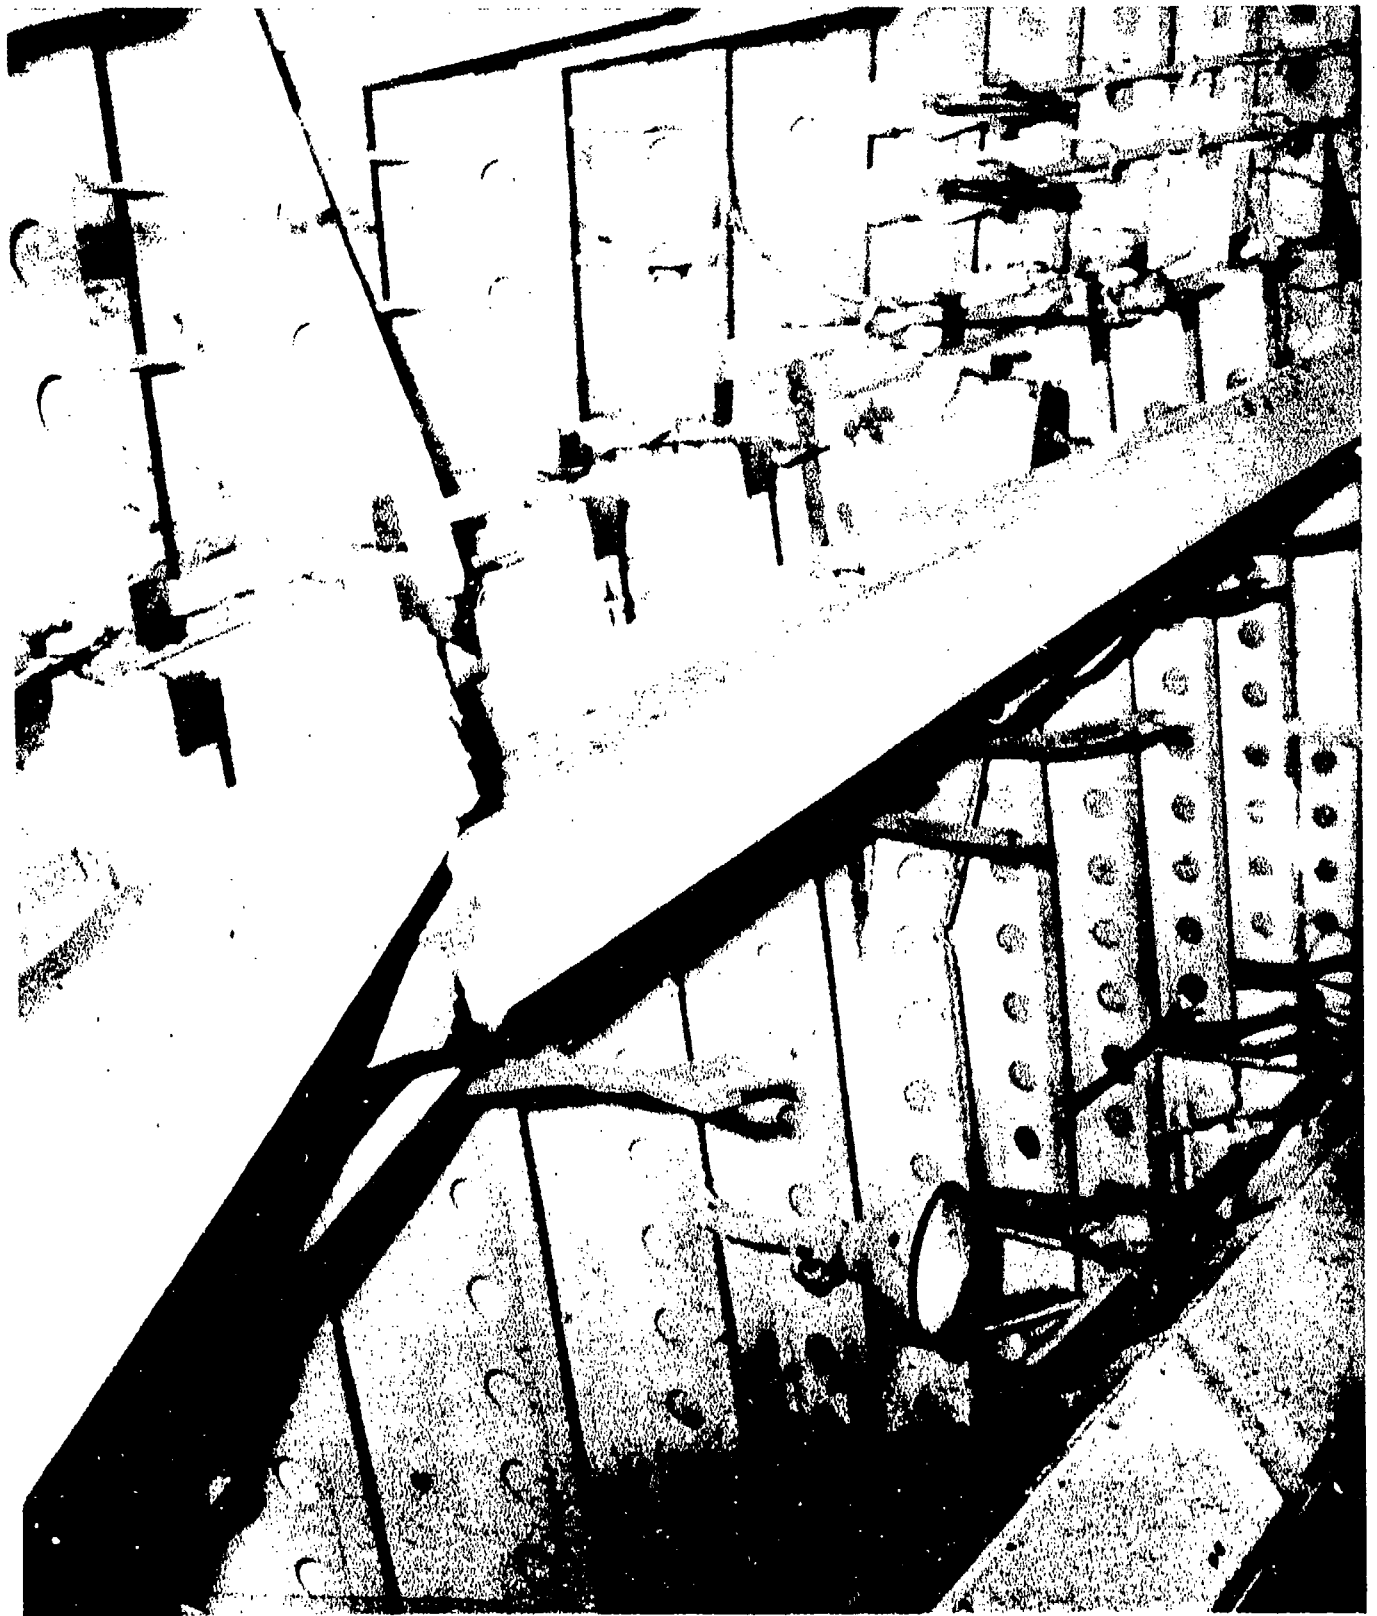
AA-CR-59-2225-1. Flight deck and Bent 95, showing tear in deck and failure of transverse girder at welded centerline butt. Looking to starboard.

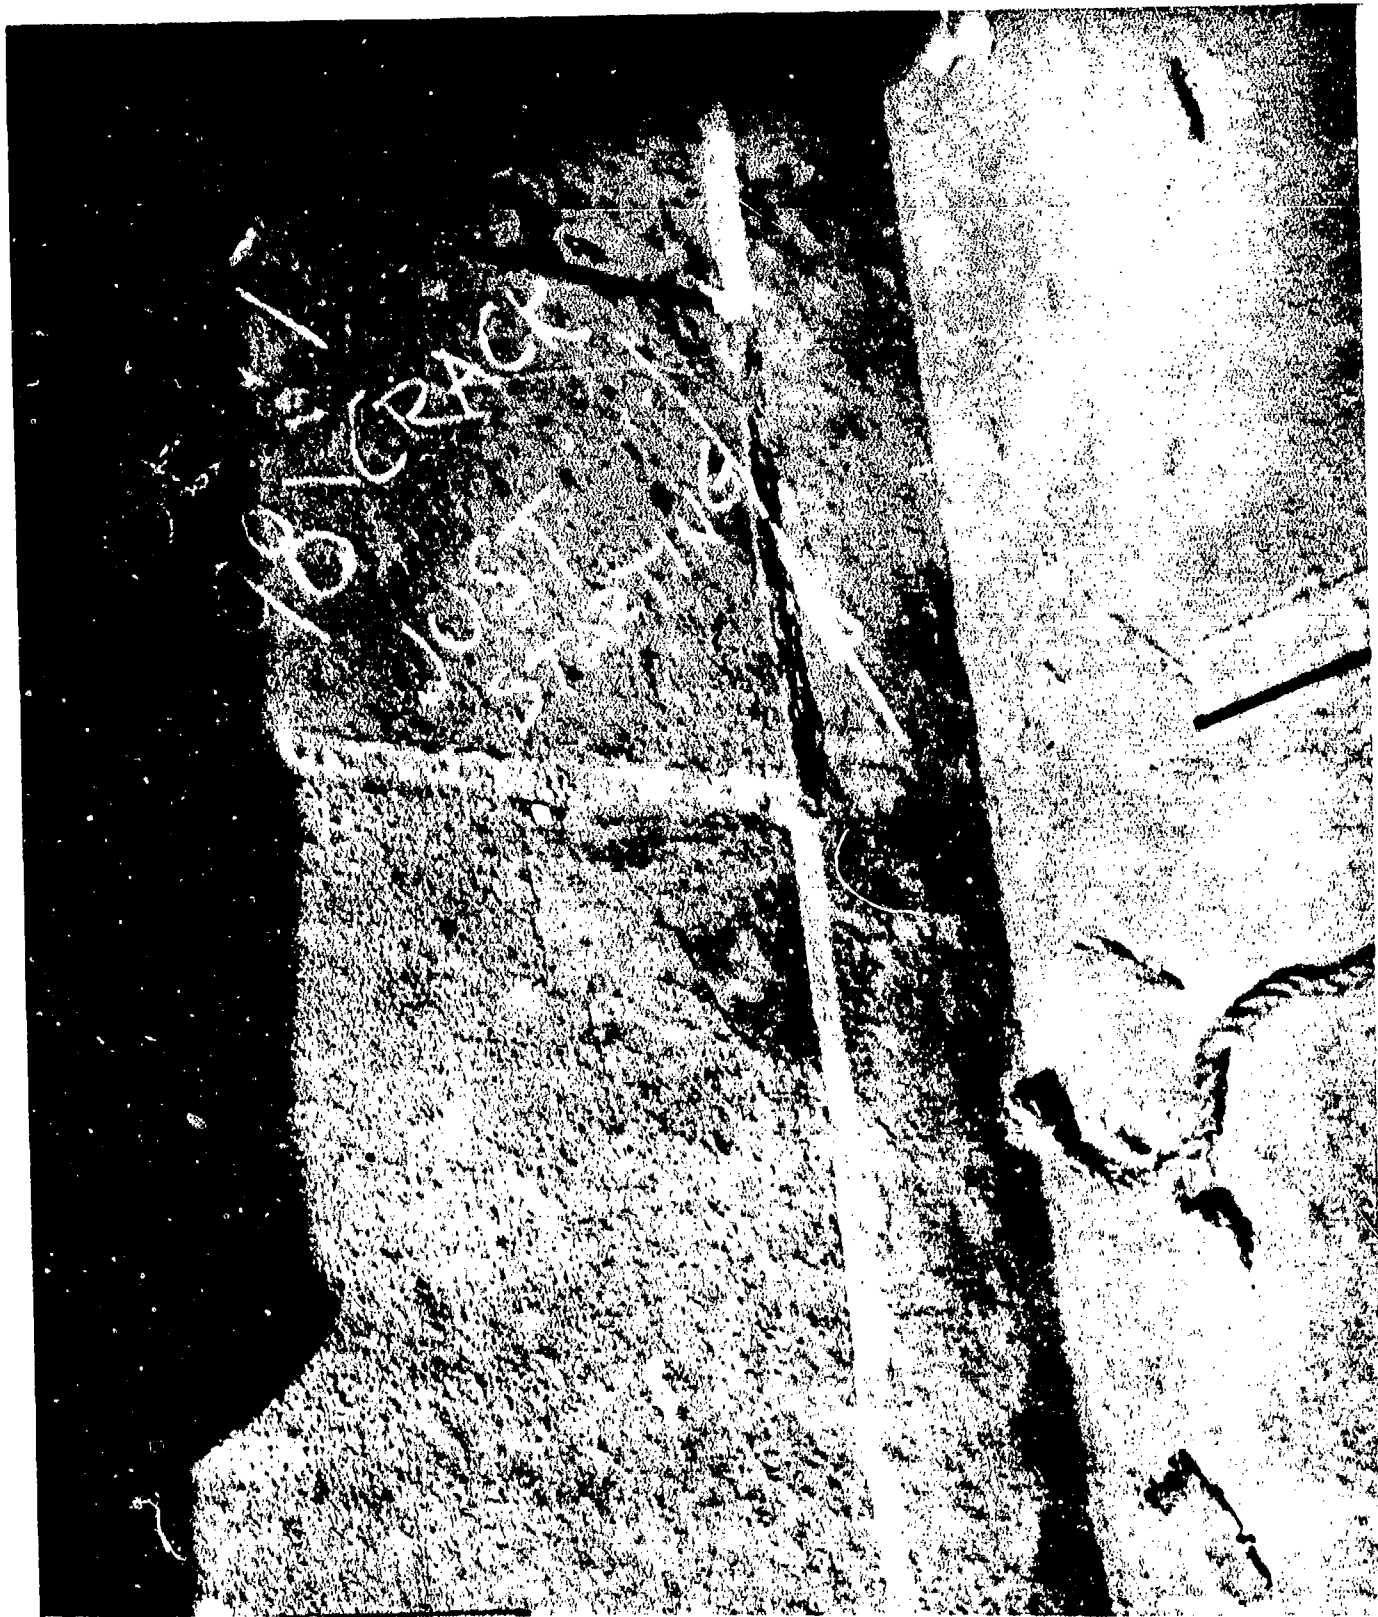
AA-CR-100-4161-2. Weld failure of port side connection of flight deck Bent 98 to S.T.S. shear strake. Looking inboard and to starboard.

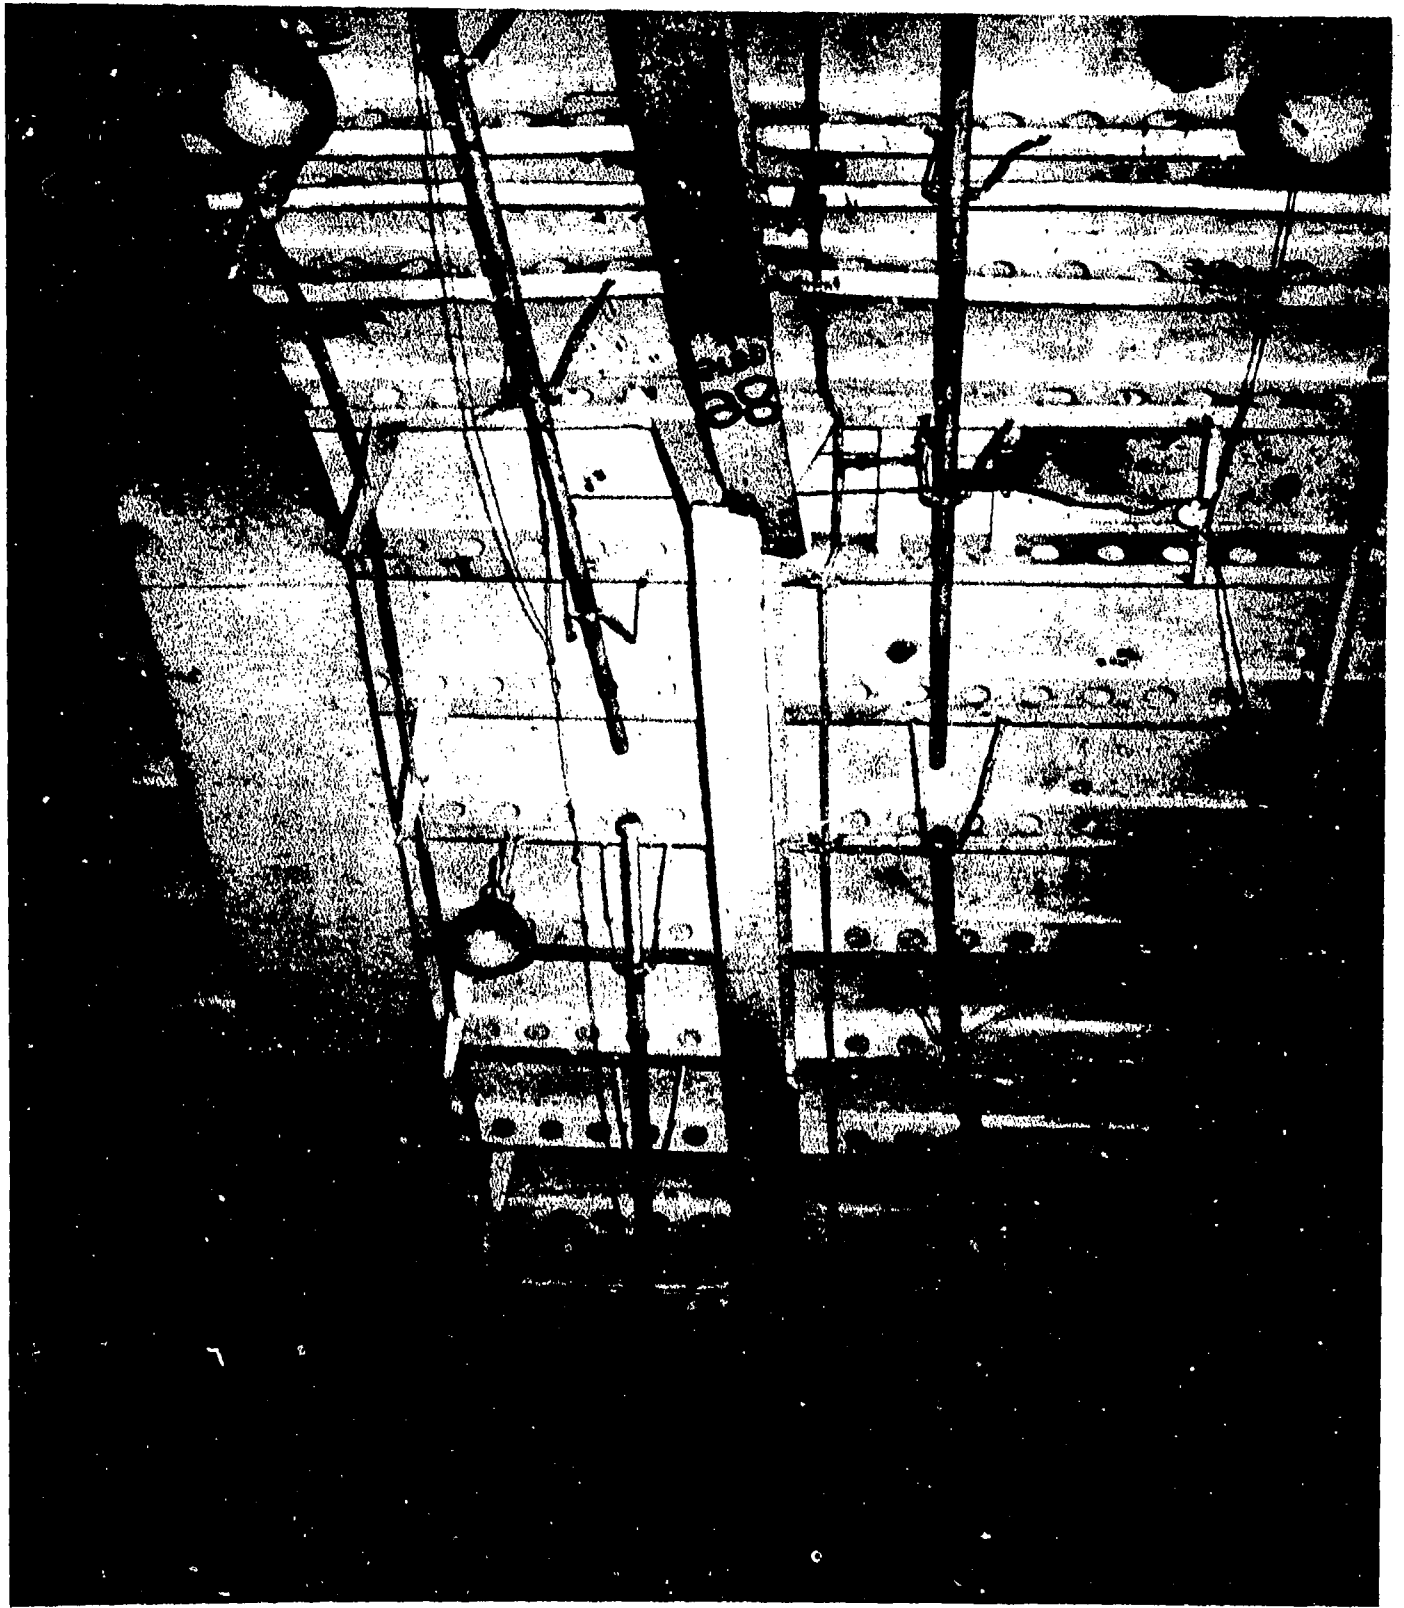
AA-CR-100-4161-8. Flight deck and Bent 98, showing tear in deck plating aft of frame 95, and failure of transverse girder at centerline butt weld. Looking to port.

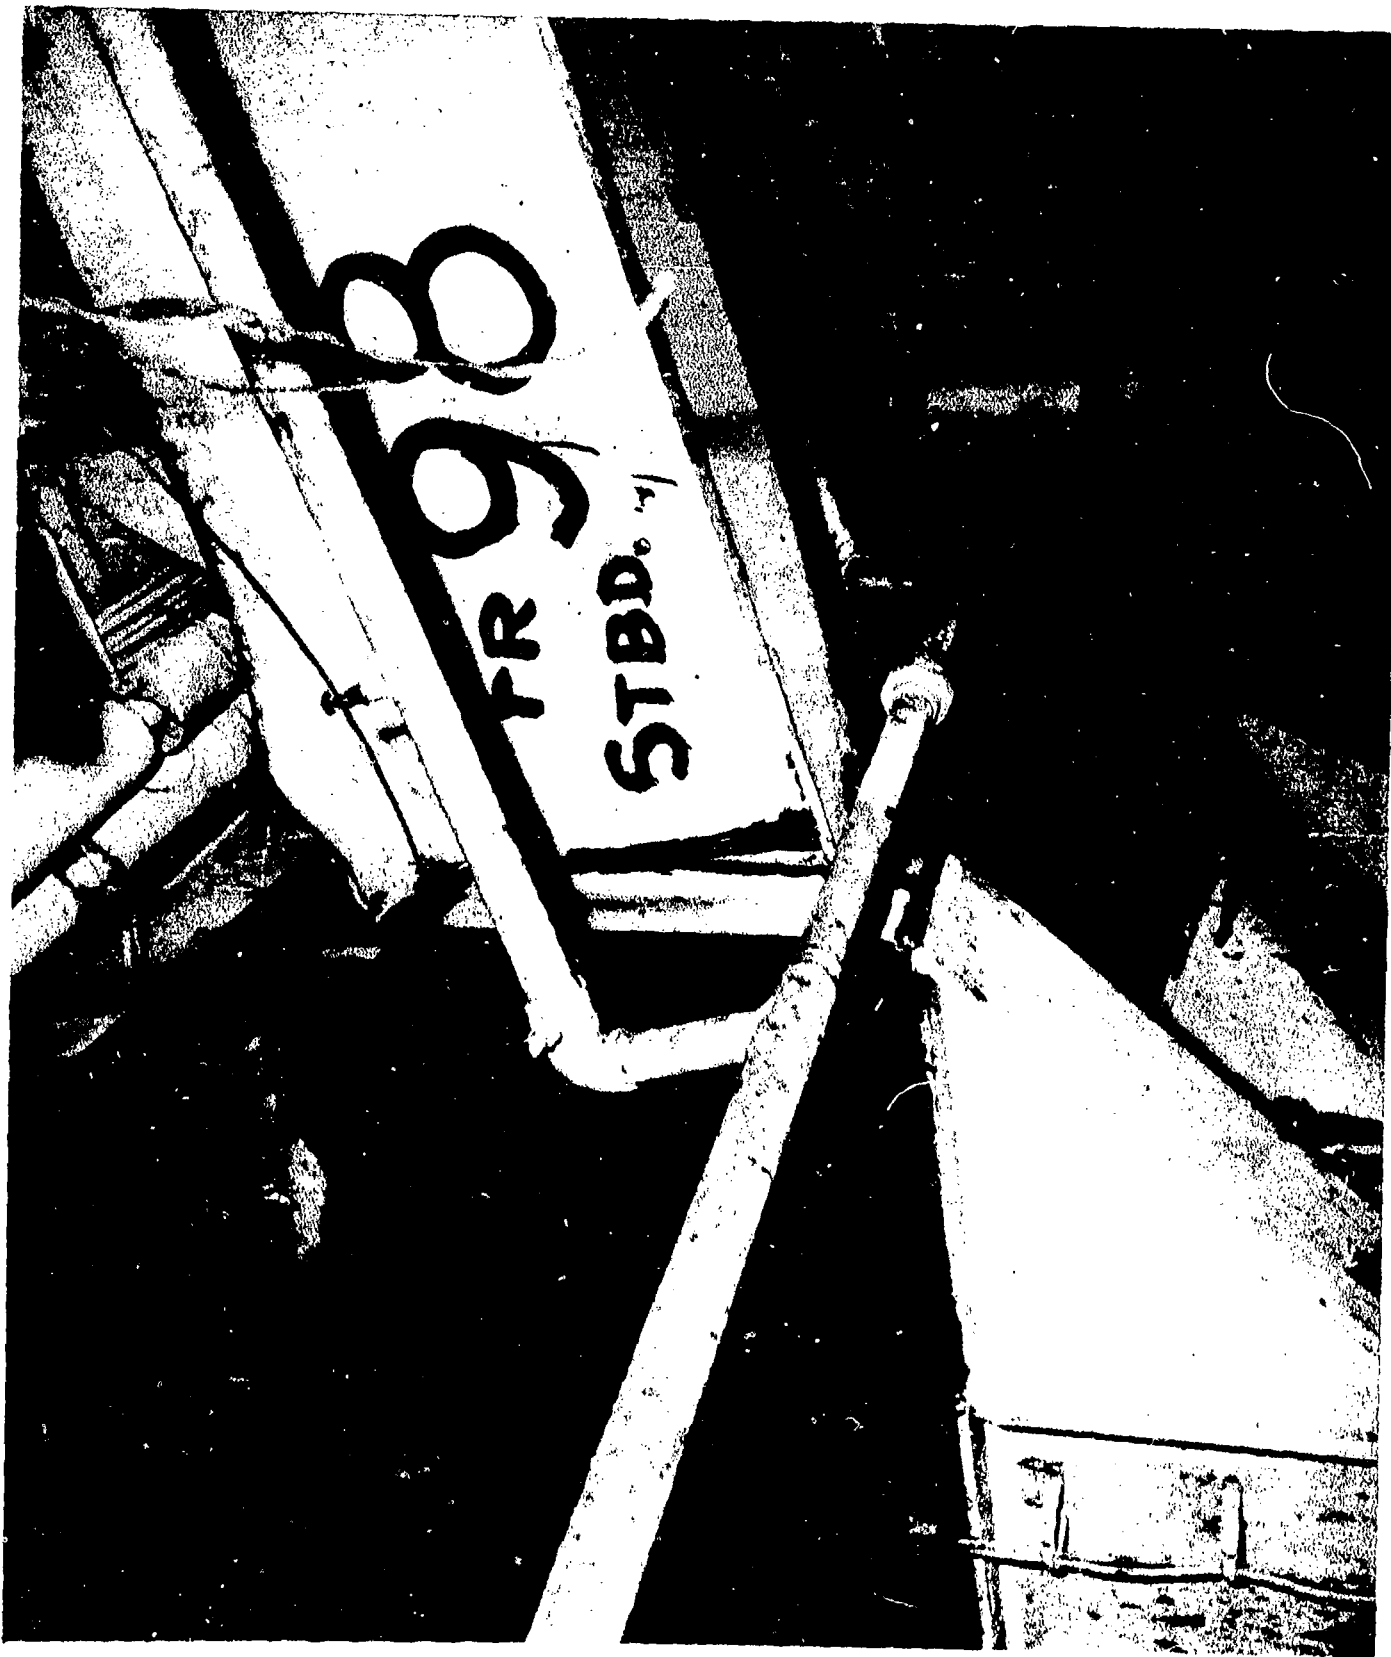
AA-CR-59-4149-9. Flight deck Bent 98, showing failure of overhead connection and origin of failure at edge of weld at top of bracket. Looking aft.

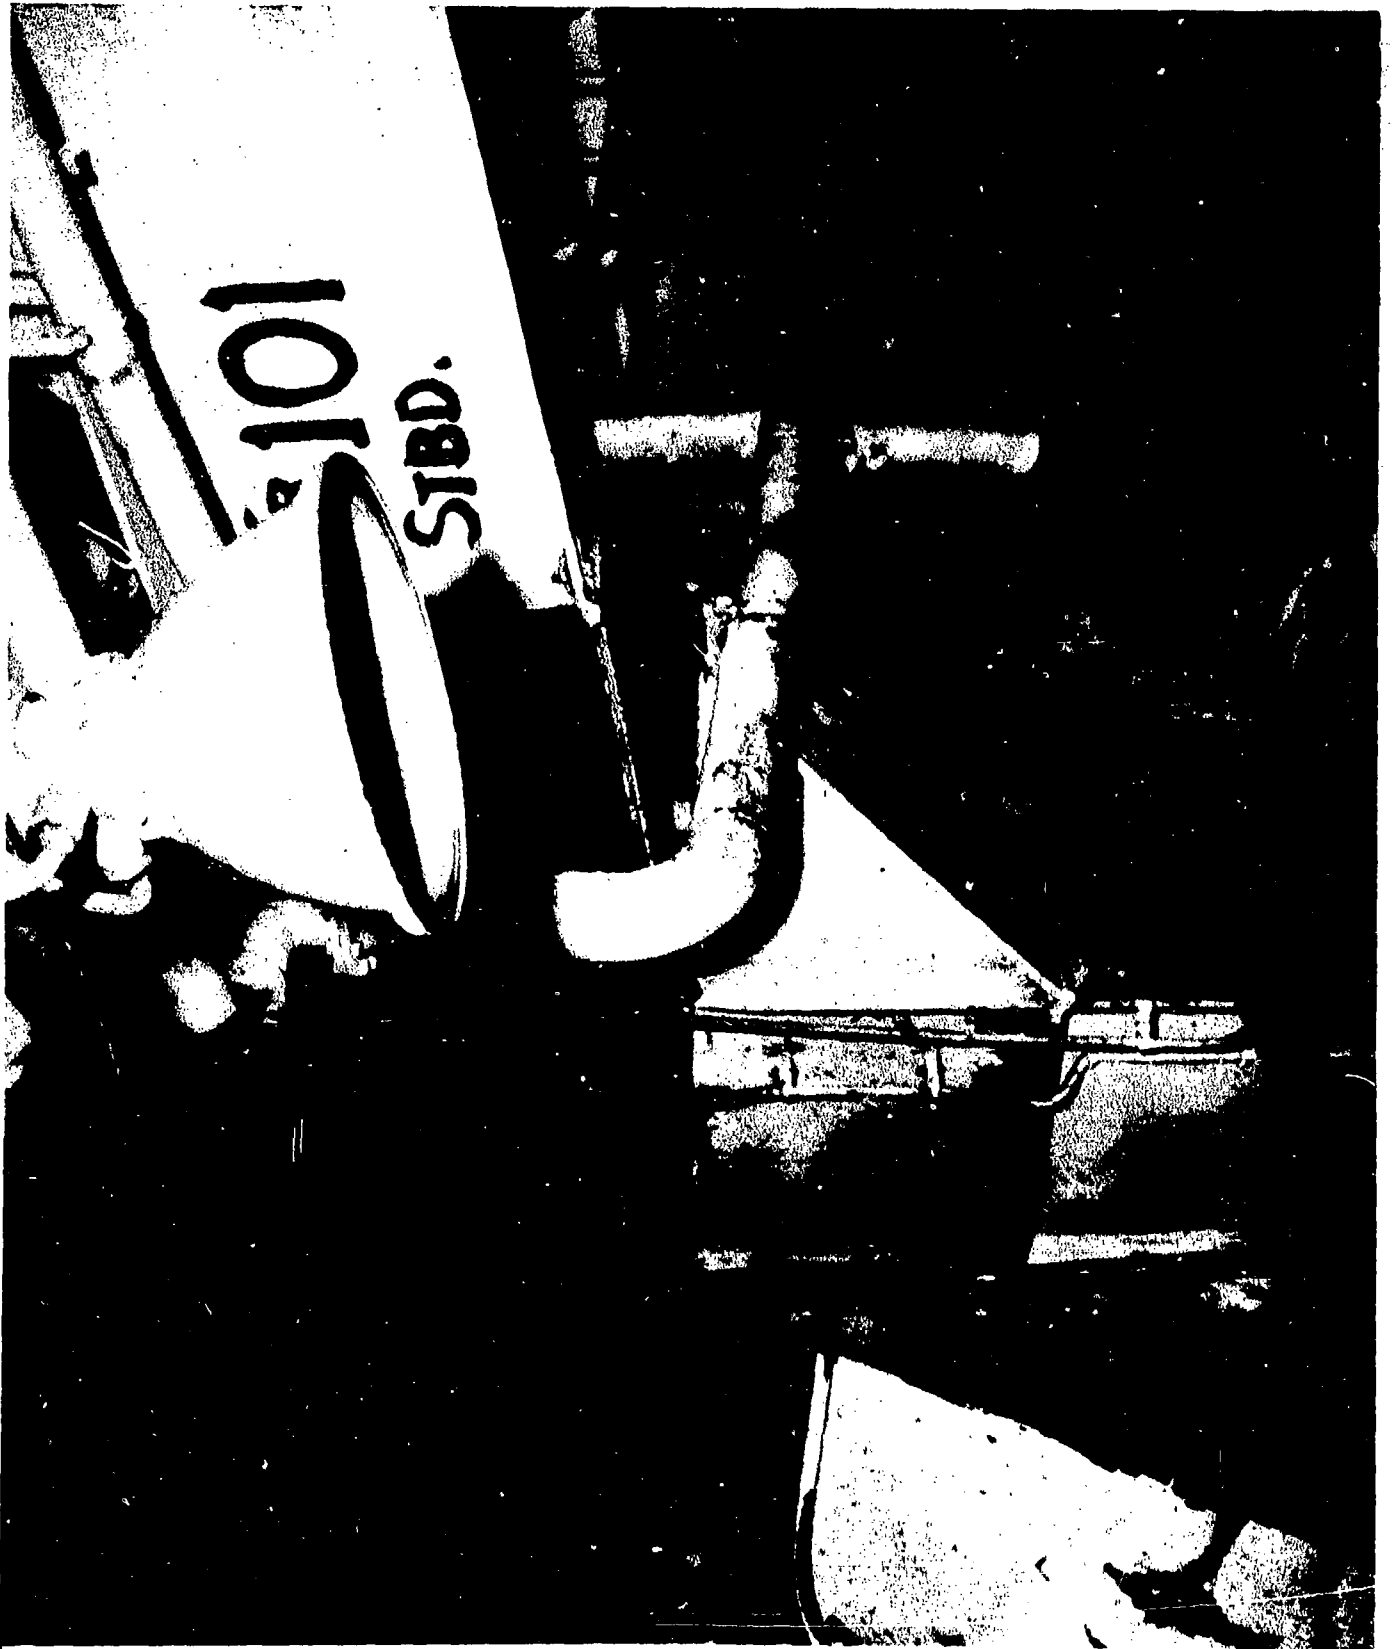
AA-CR-59-4149-10. Flight deck Bent 101, starboard side, showing failure of overhead connection in weld along upper edge of bracket. Looking aft.

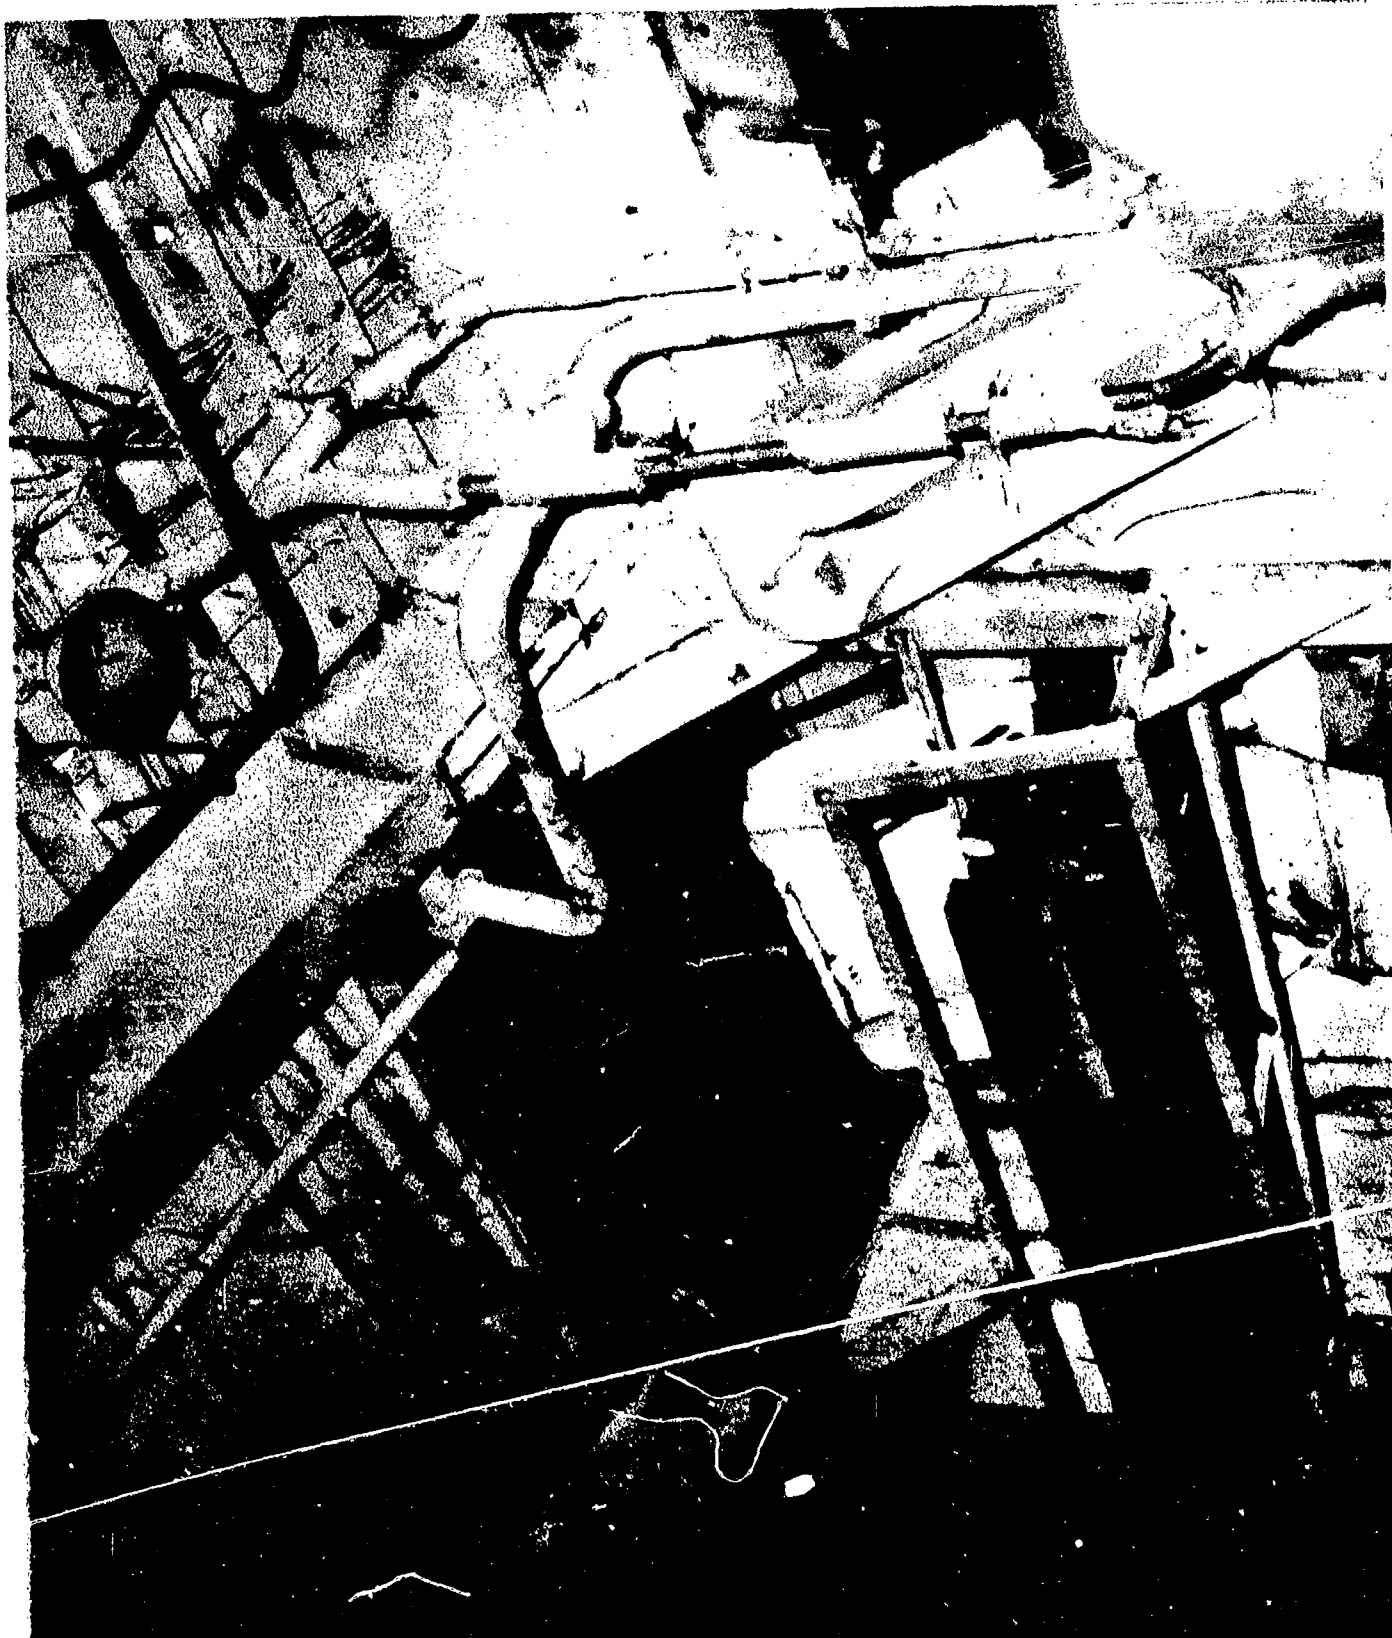
AA-CR-59-2113-4. Flight deck Bent 101, starboard side, showing failure of overhead connection along weld at upper edge of bracket. Looking forward.
