# BUREAU OF SHIPS GROUP TECHNICAL INSPECTION REPORT

## U.S.S. INDEPENDENCE (CVL22)

### TEST ABLE

### OPERATION CROSSROADS

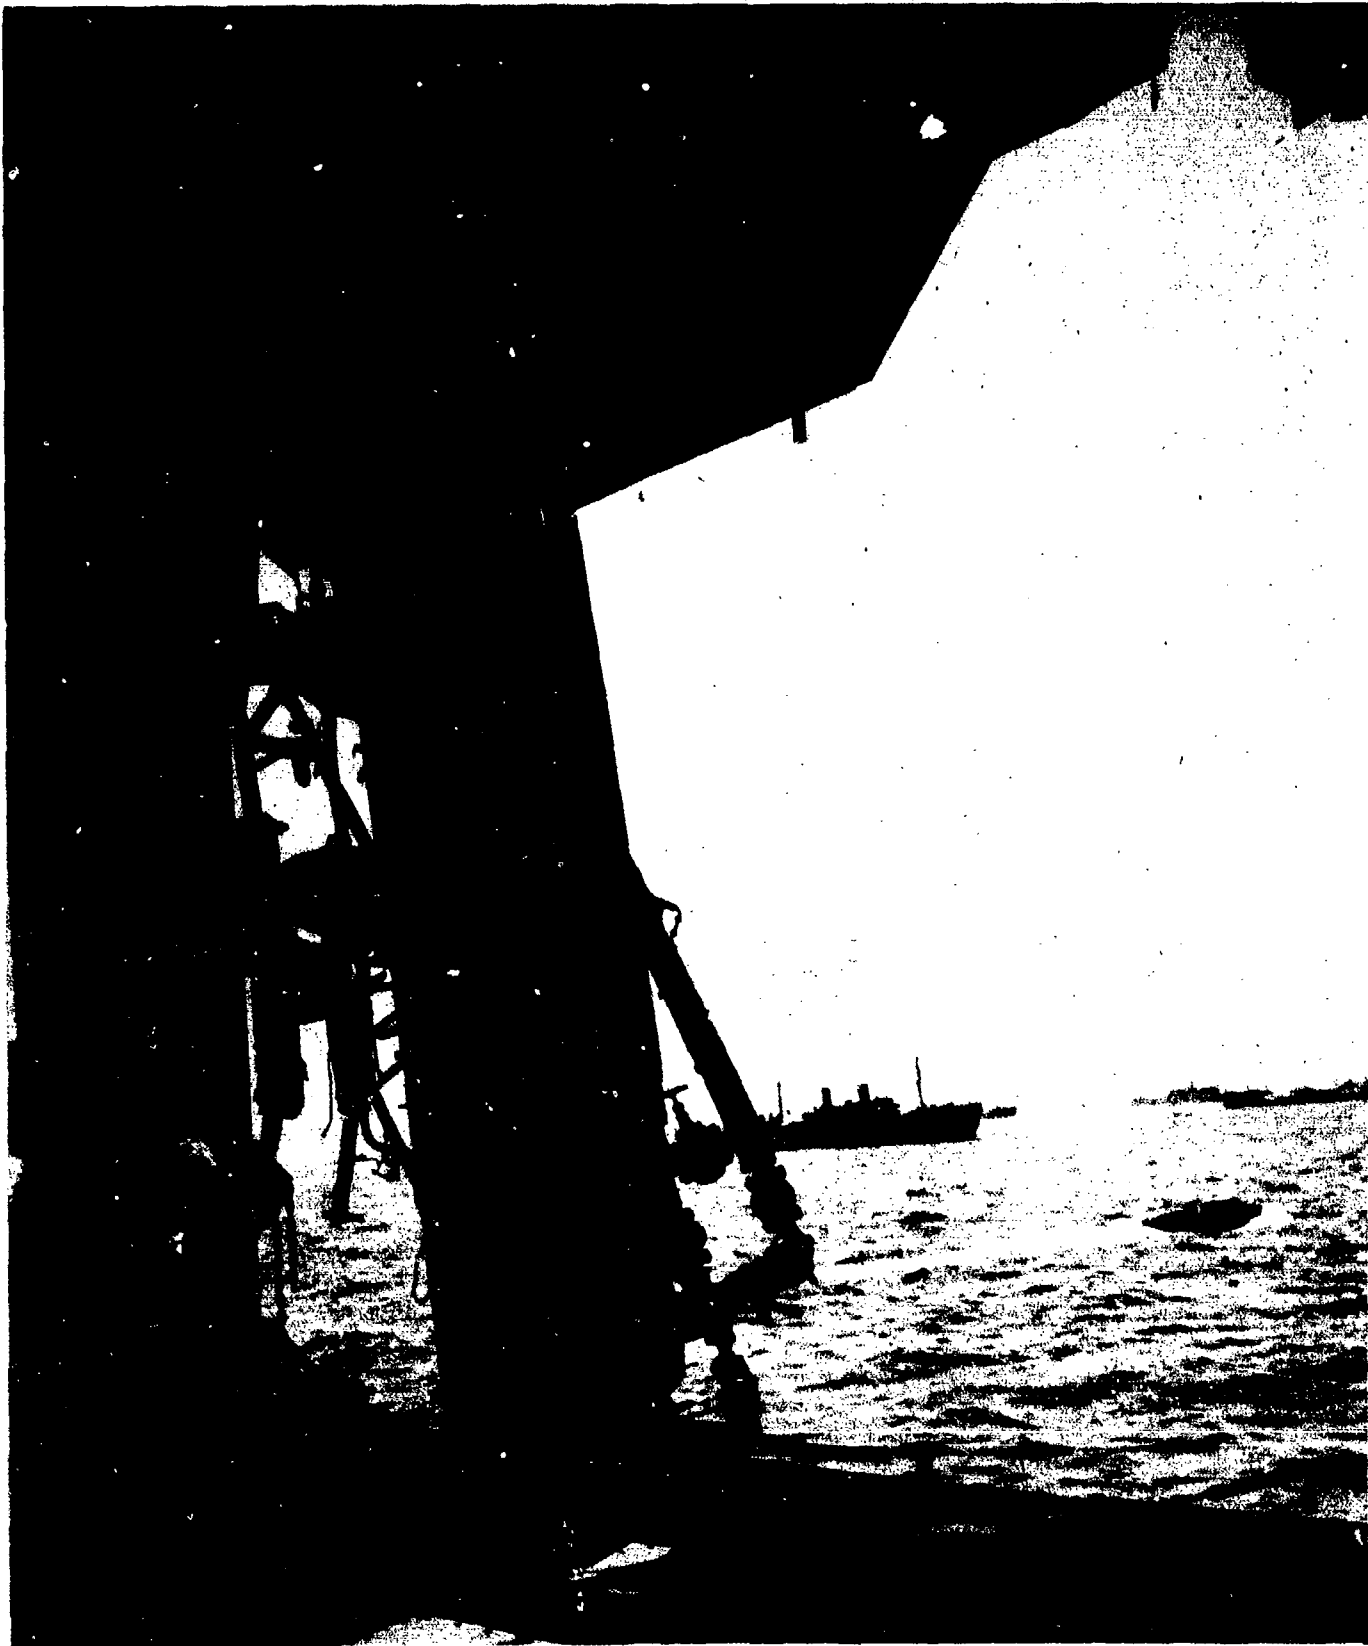
AA-CR-59-4153-1. Flight deck Wobble Bents 113 and 115, port side, looking aft and to port. Note failure of deck pad at 113.

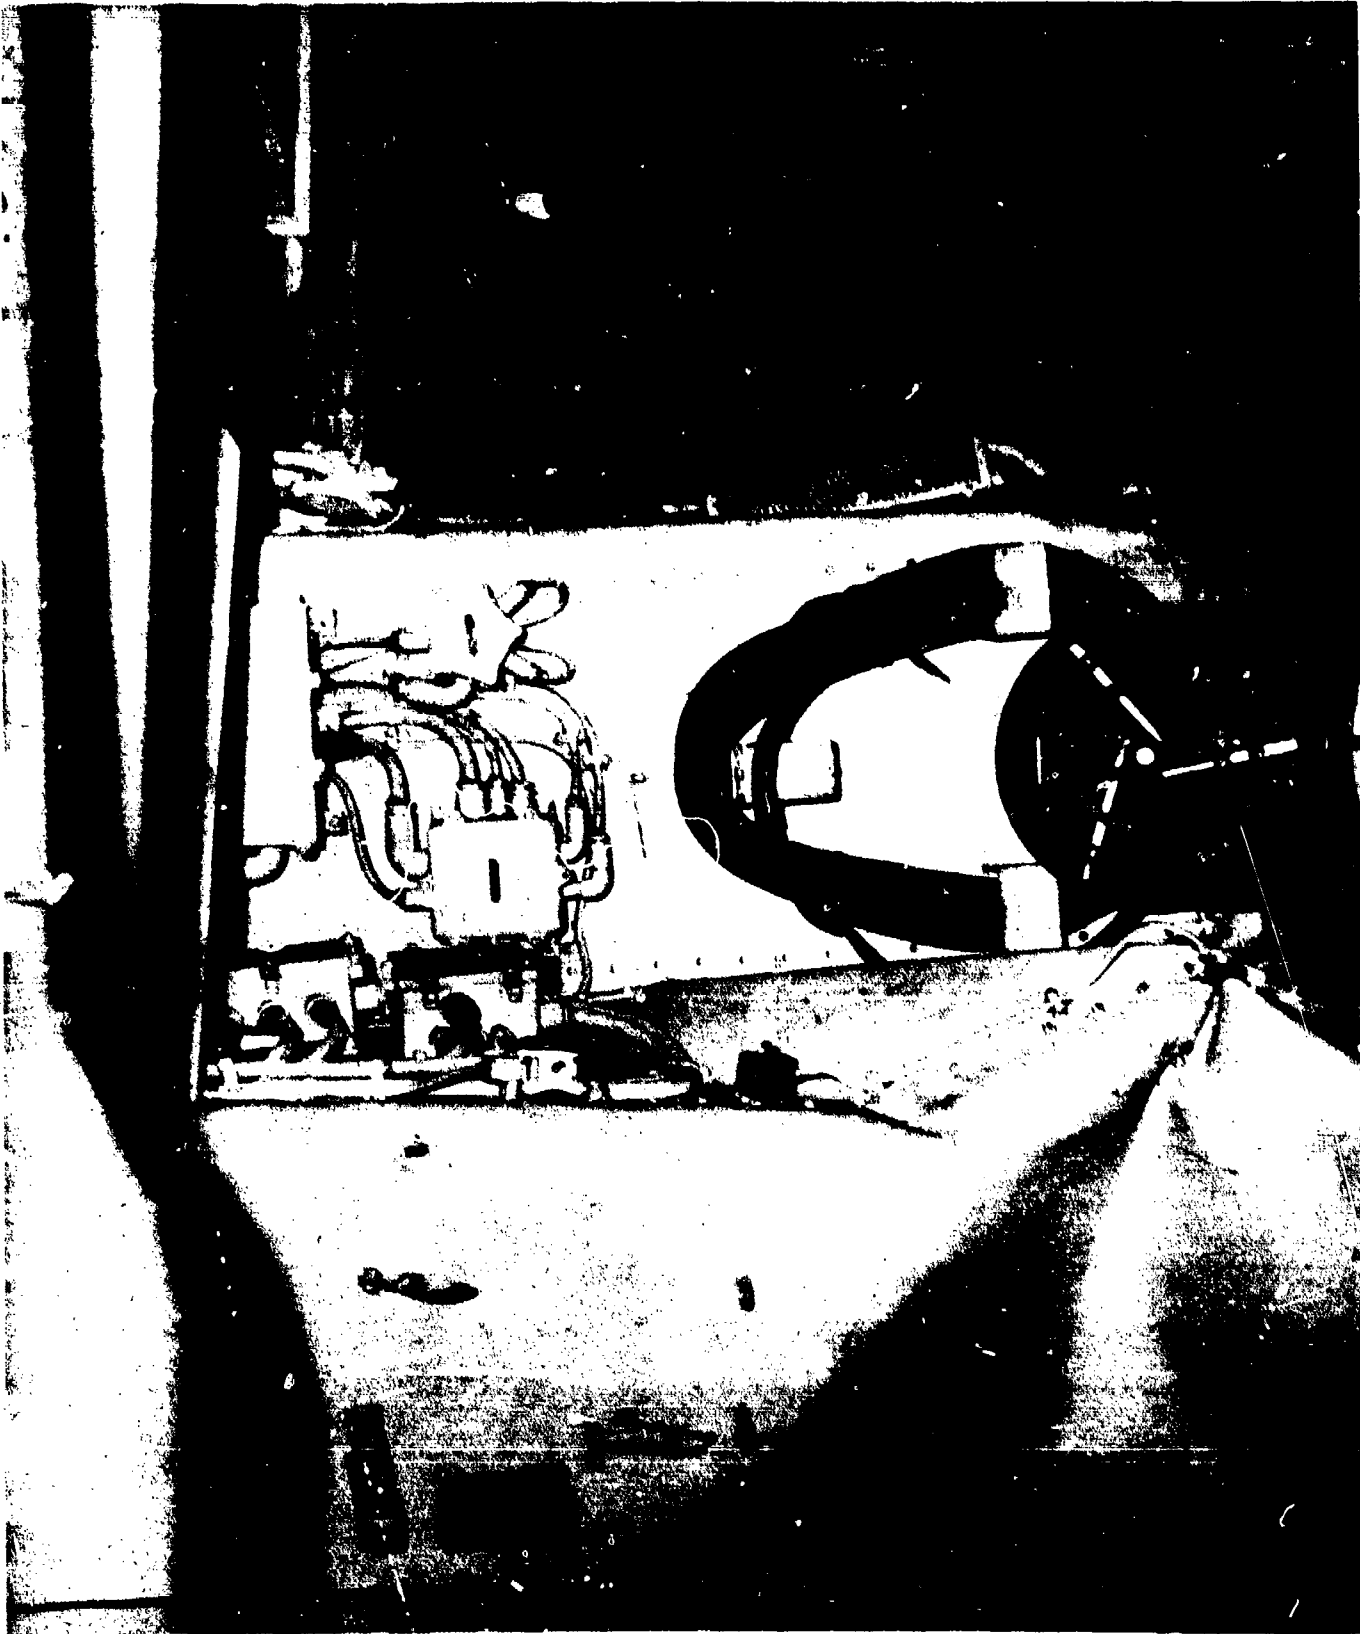
AA-CR-59-2087-10. Second deck, A-211-L. Failure of repair party locker and metal joiner bulkhead, frames 53 and 54, port side looking aft.

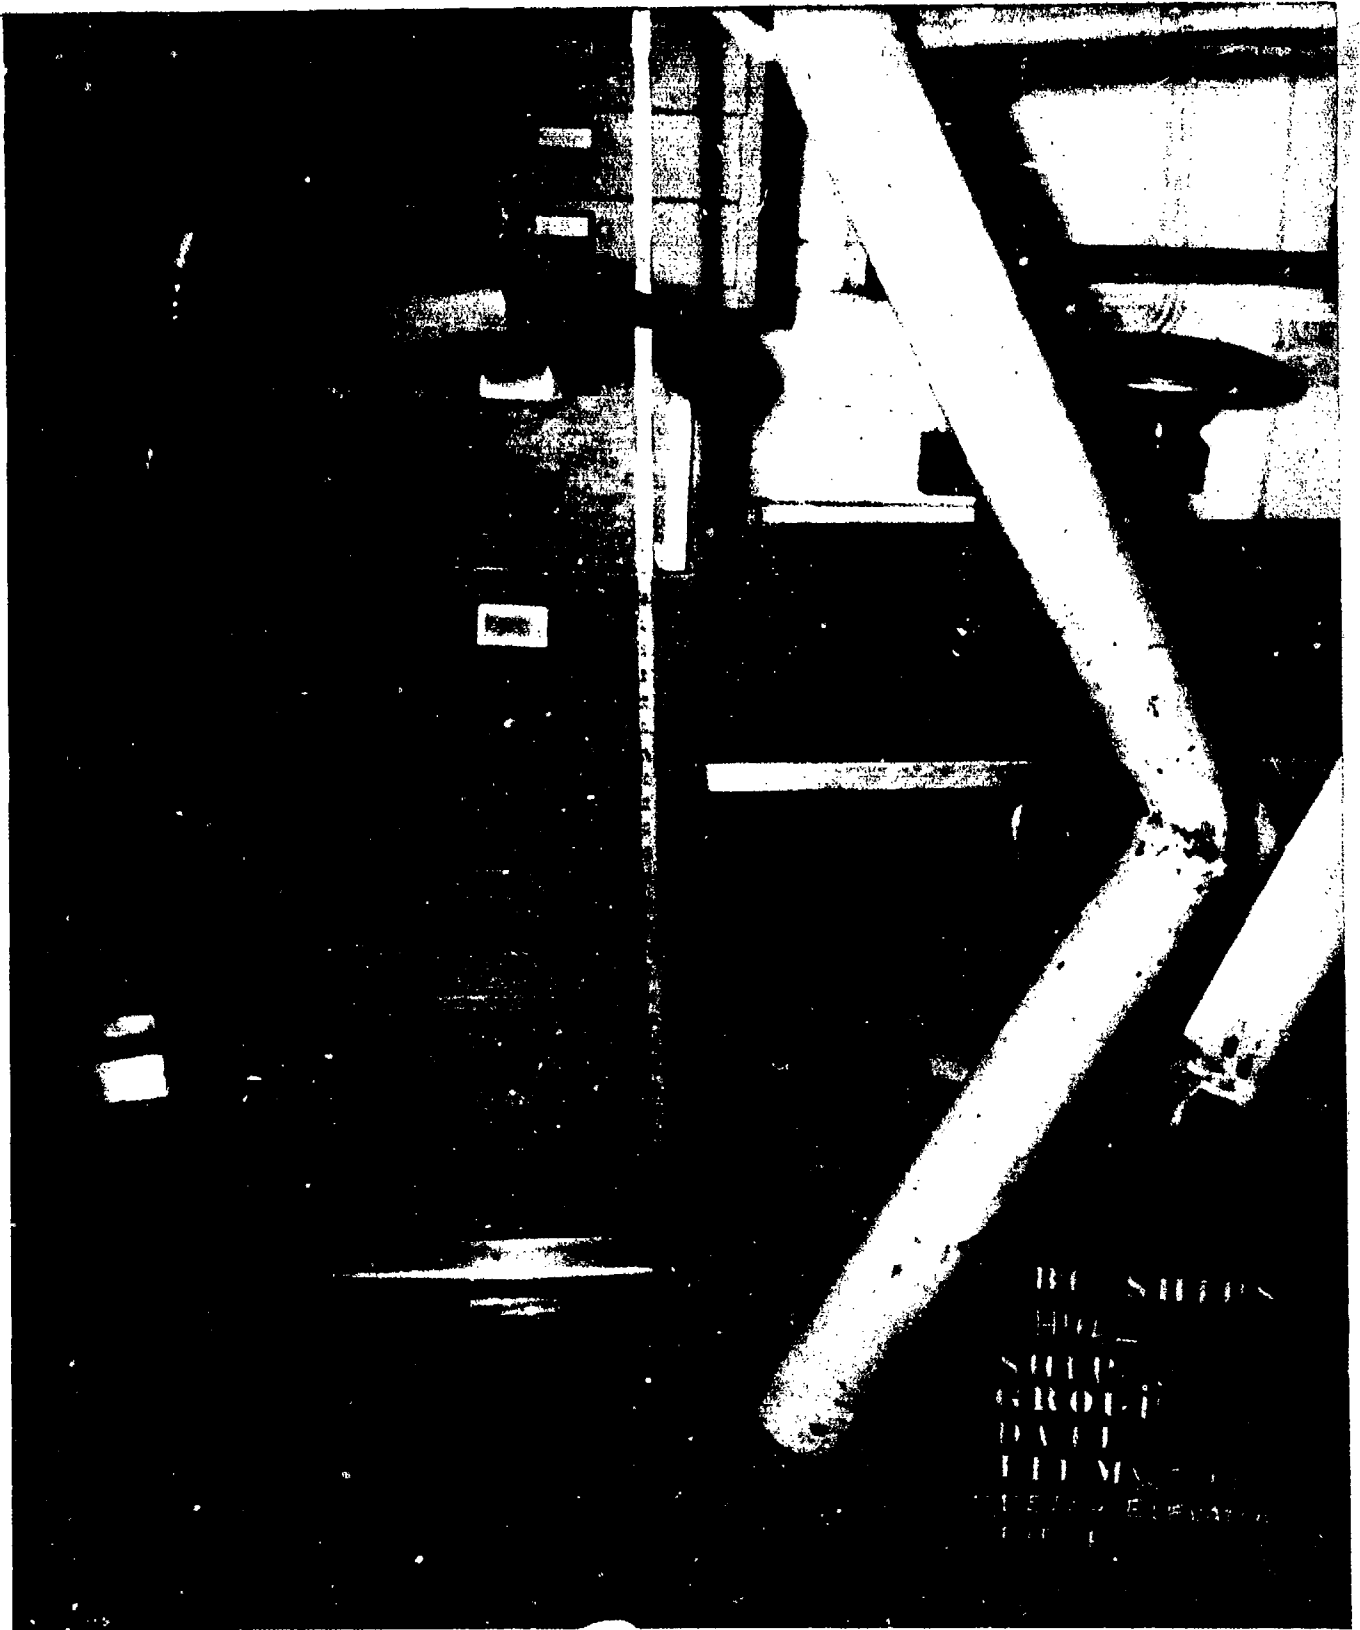
AA-CR-88-2100-9. Second deck, supply office, A-211-1, showing depression of overhead below forward elevator pit, buckled quarter span stanchion, frame 53, and weld failures between stanchion overhead and deck. Looking aft.

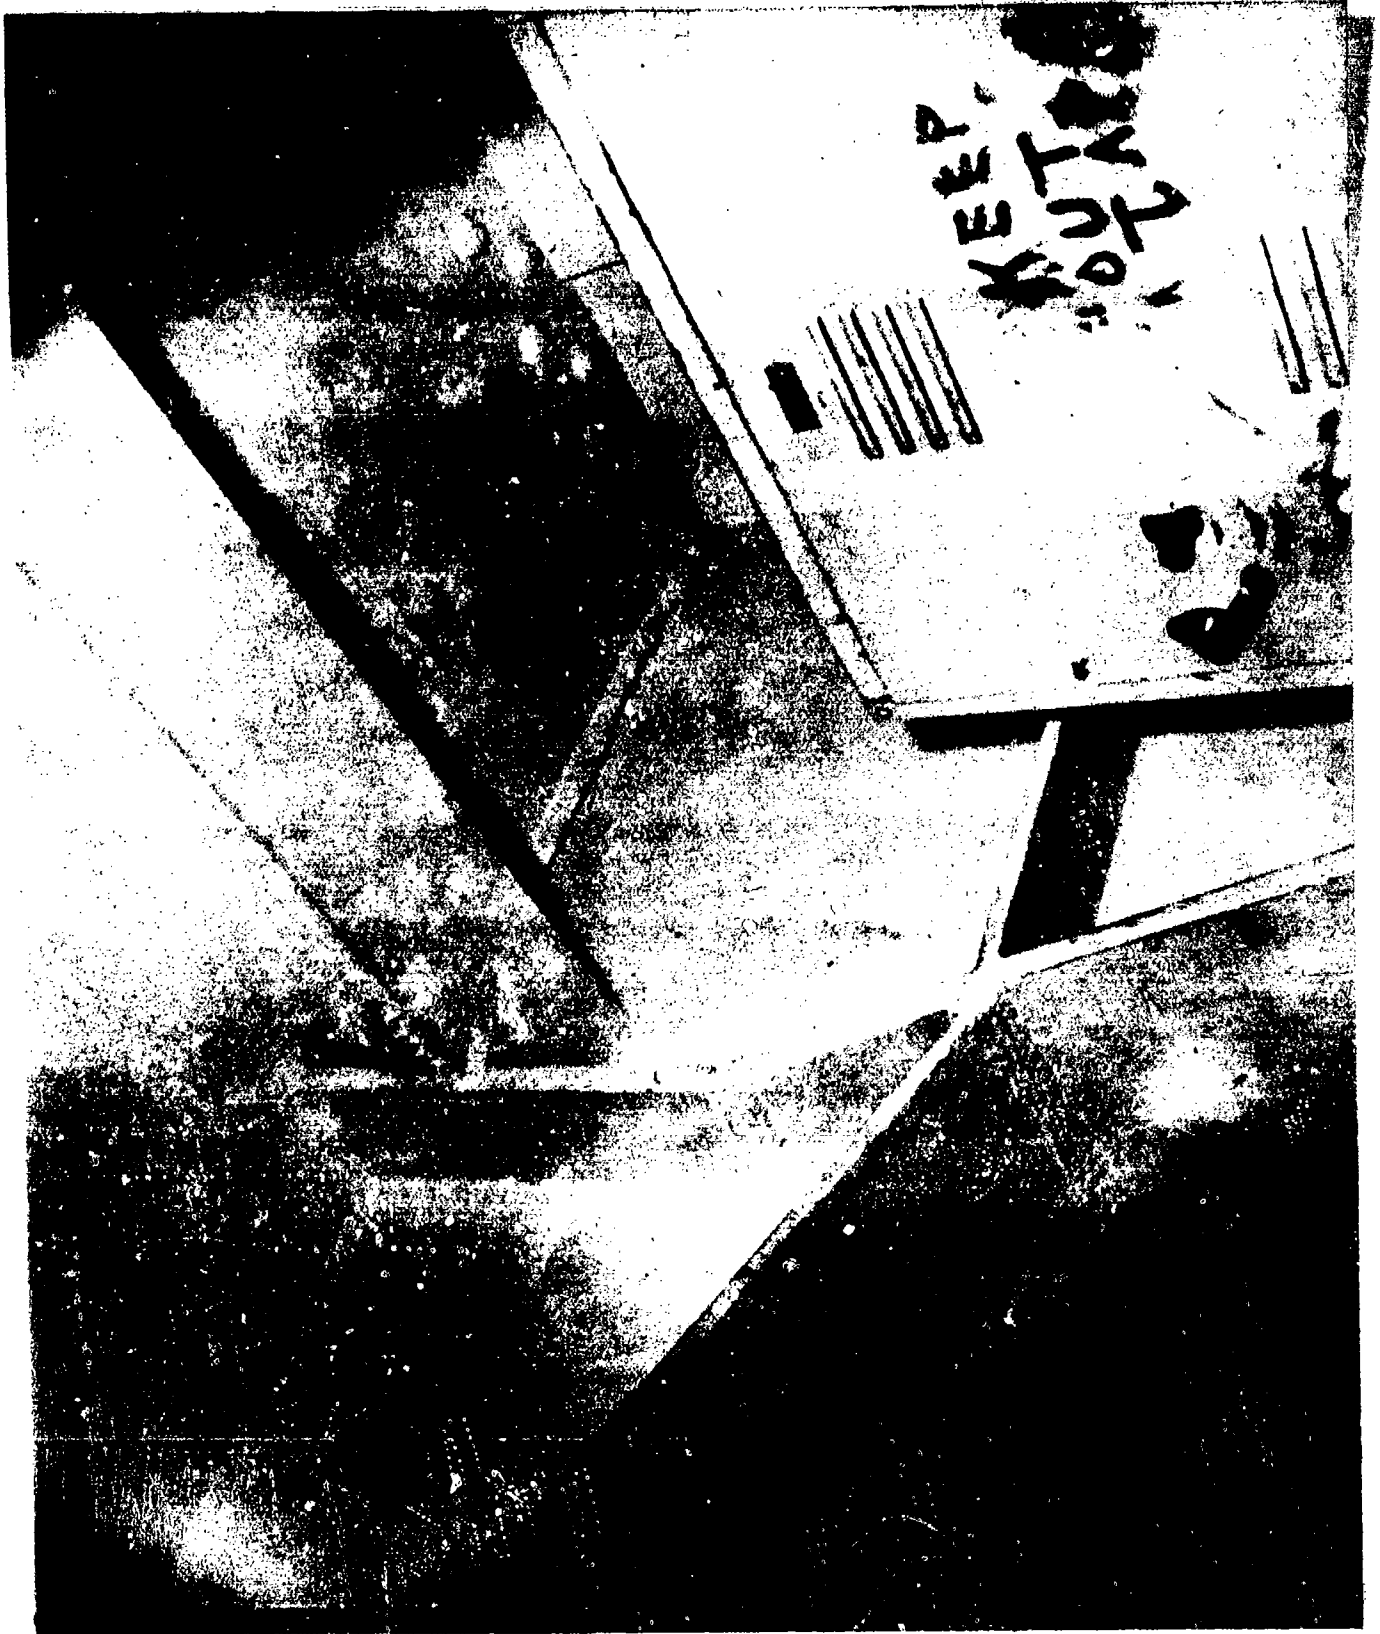
AA-CR-59-2088-7. Second deck, B-203-L. Failure of arc welded connection between port web frame 89, and S.T.S. stringer strake. Looking aft and outboard.

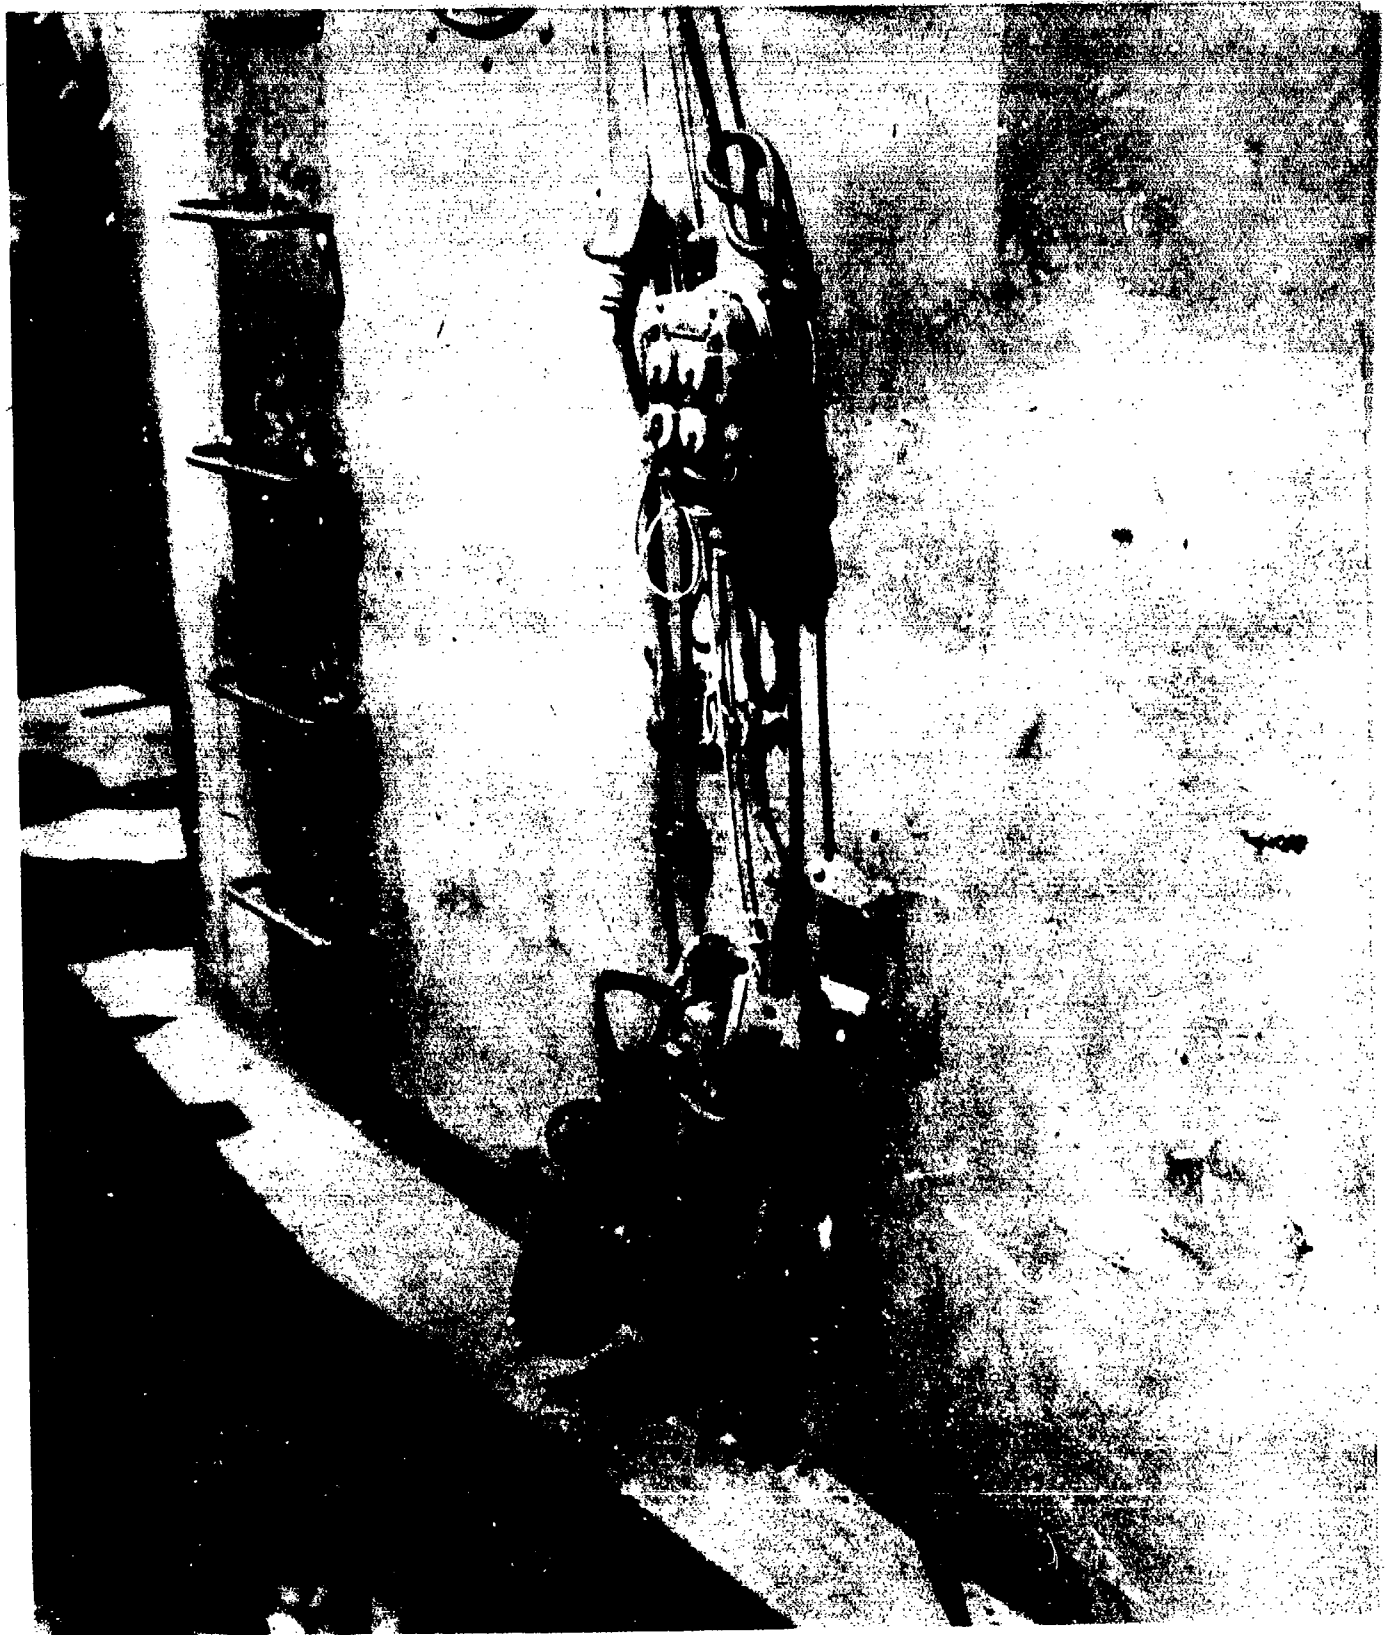
AA-CR-234-1990-4. Failure of mounts for telephone selector switch, jack-box and push button on bulkhead of island, air defense level.

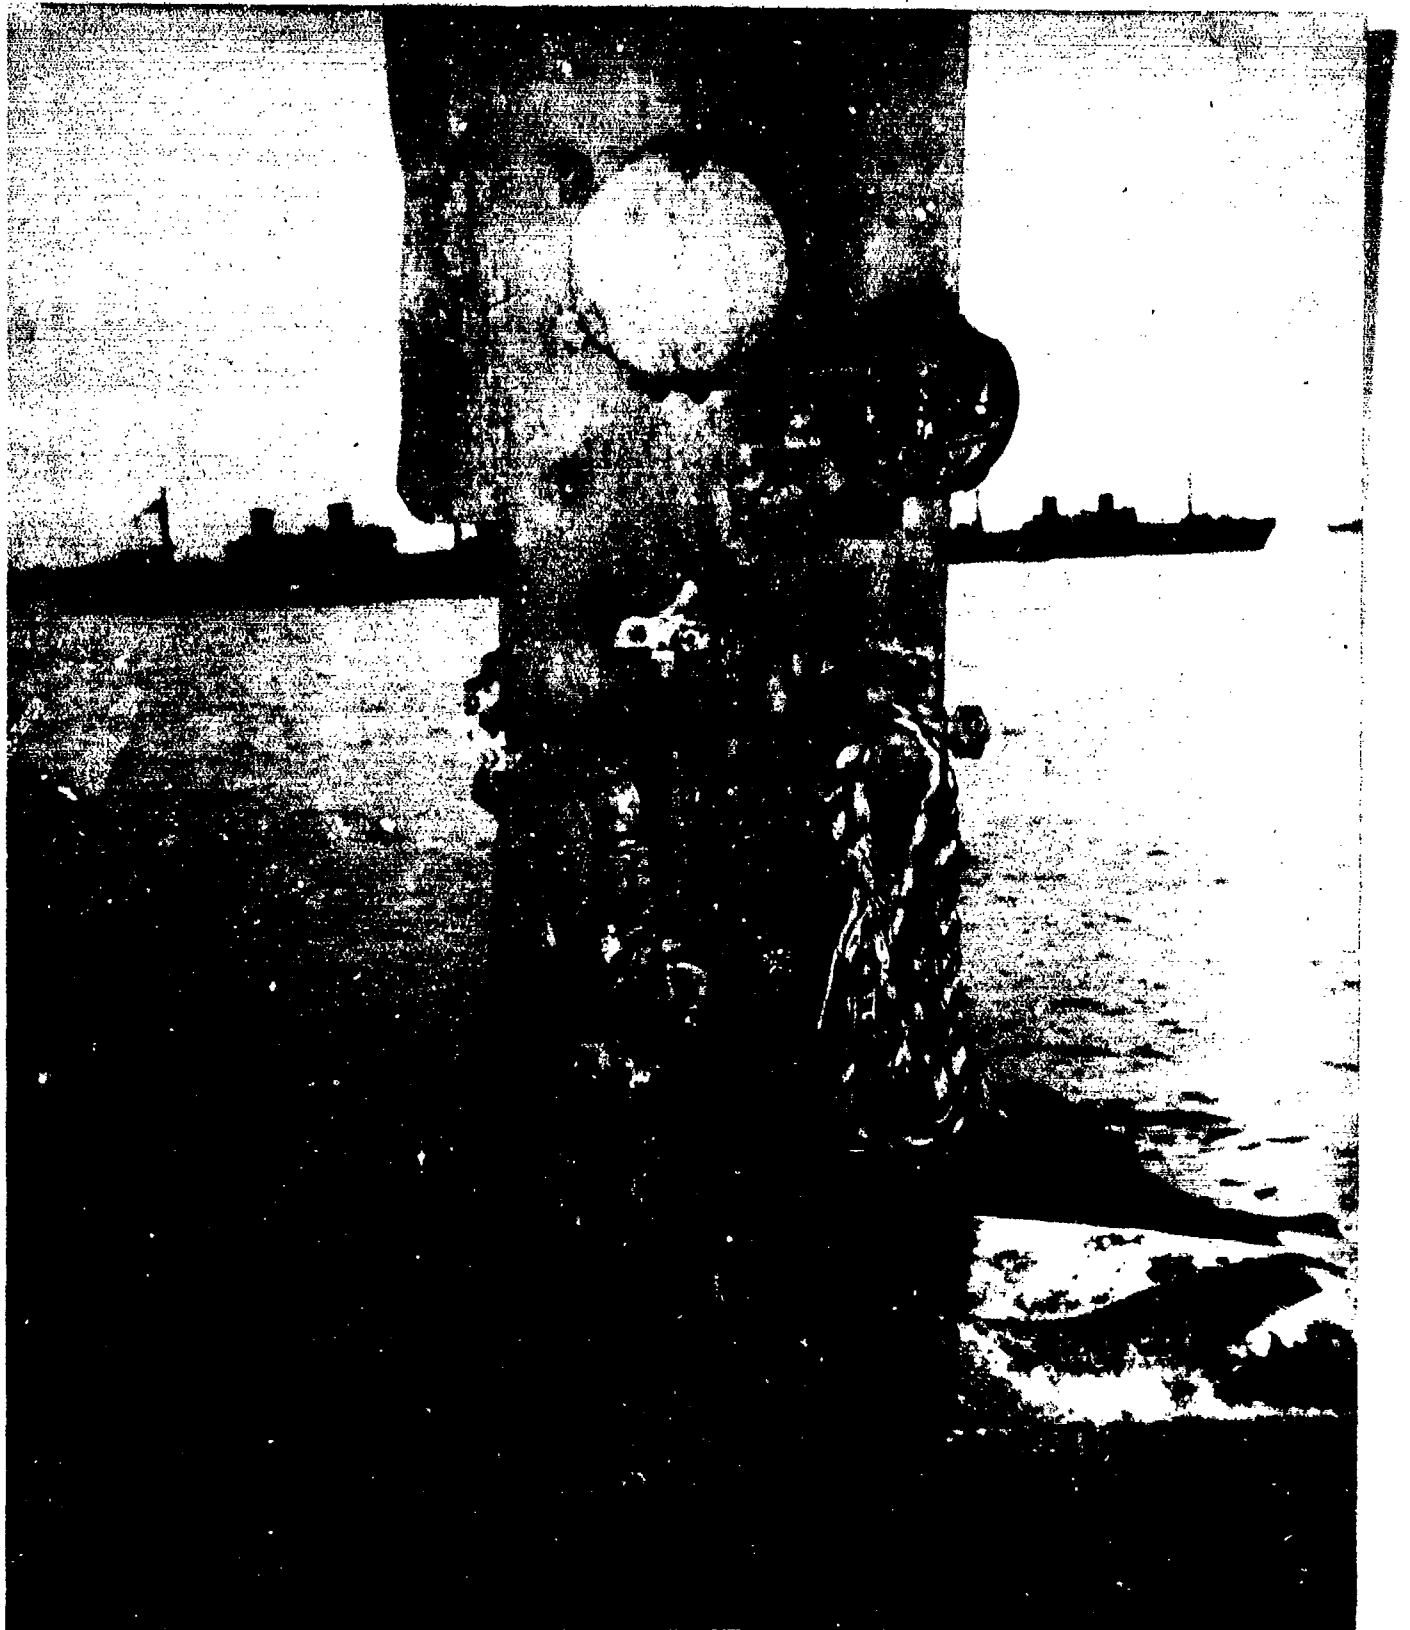
AA-CR-82-1918-7. Two power receptacles blown off foundation by blast pressure, located at frame 115 port side hangar space. View looking outboard.

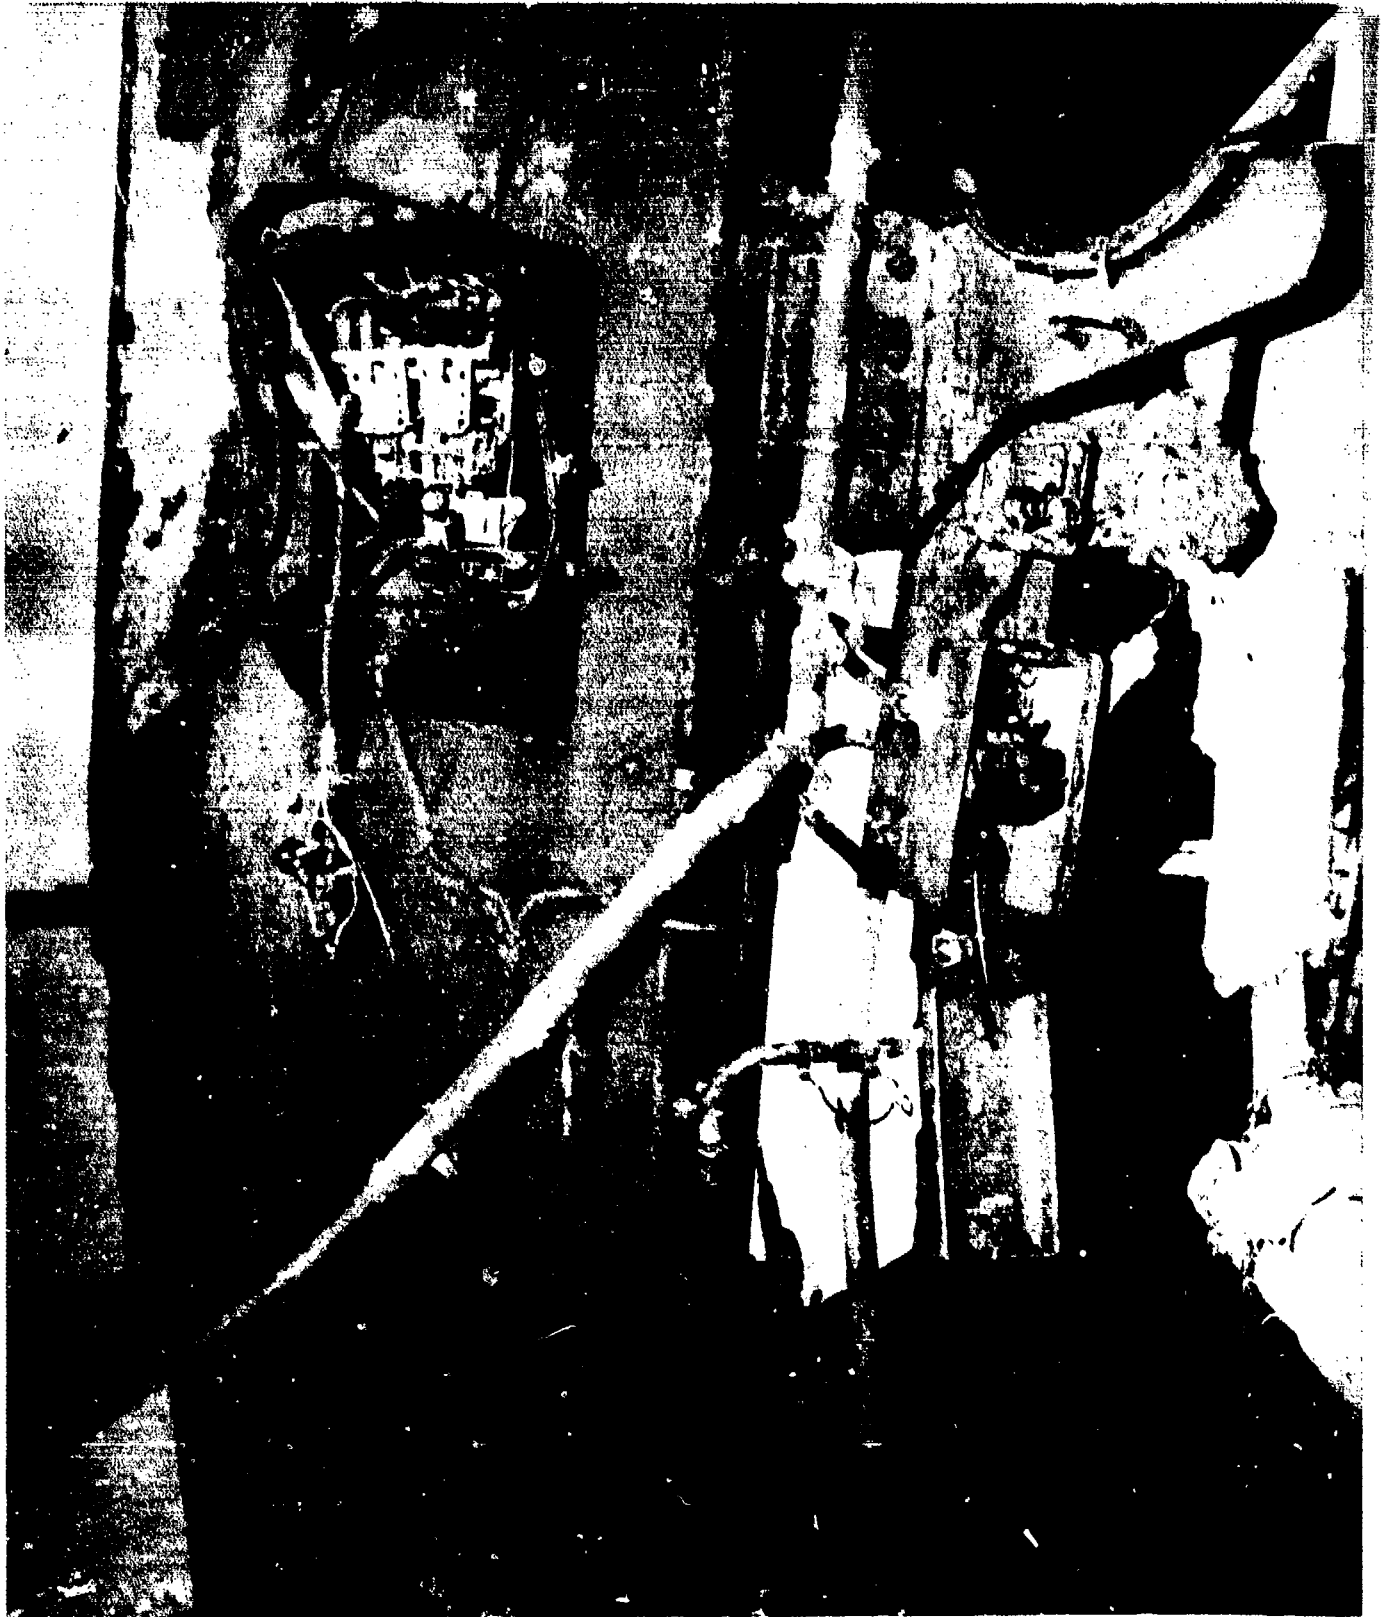
AA-CR-82-1918-6. Damage to ventilation controller and type "C" automatic telephone unit, located at frame 113 starboard side hangar space. View looking aft and outboard.

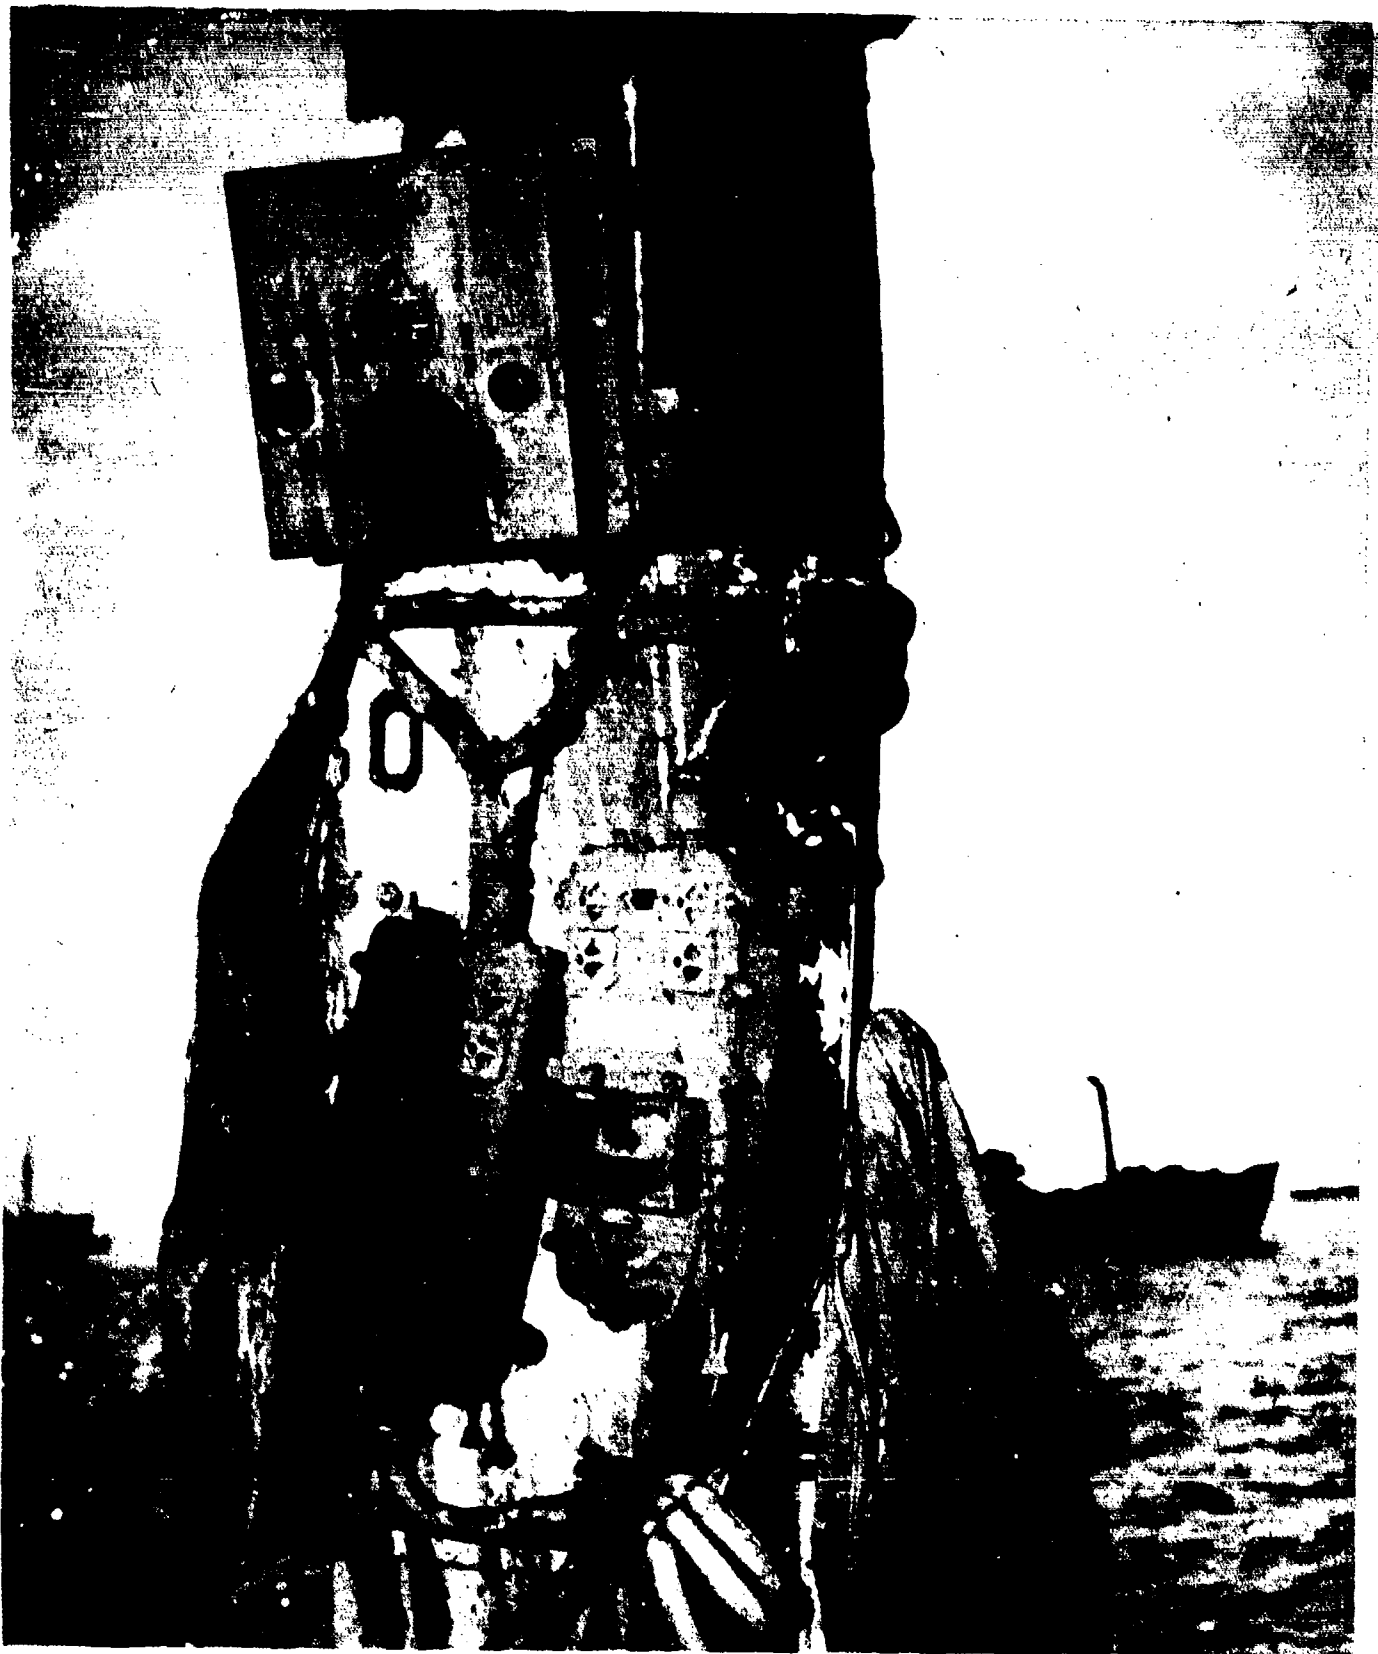
AA-CR-62-1882-2. Water curtain control switches and radio broadcast speaker, amplifier on bent frame 80 port side hangar space. One switch is missing. View looking outboard.

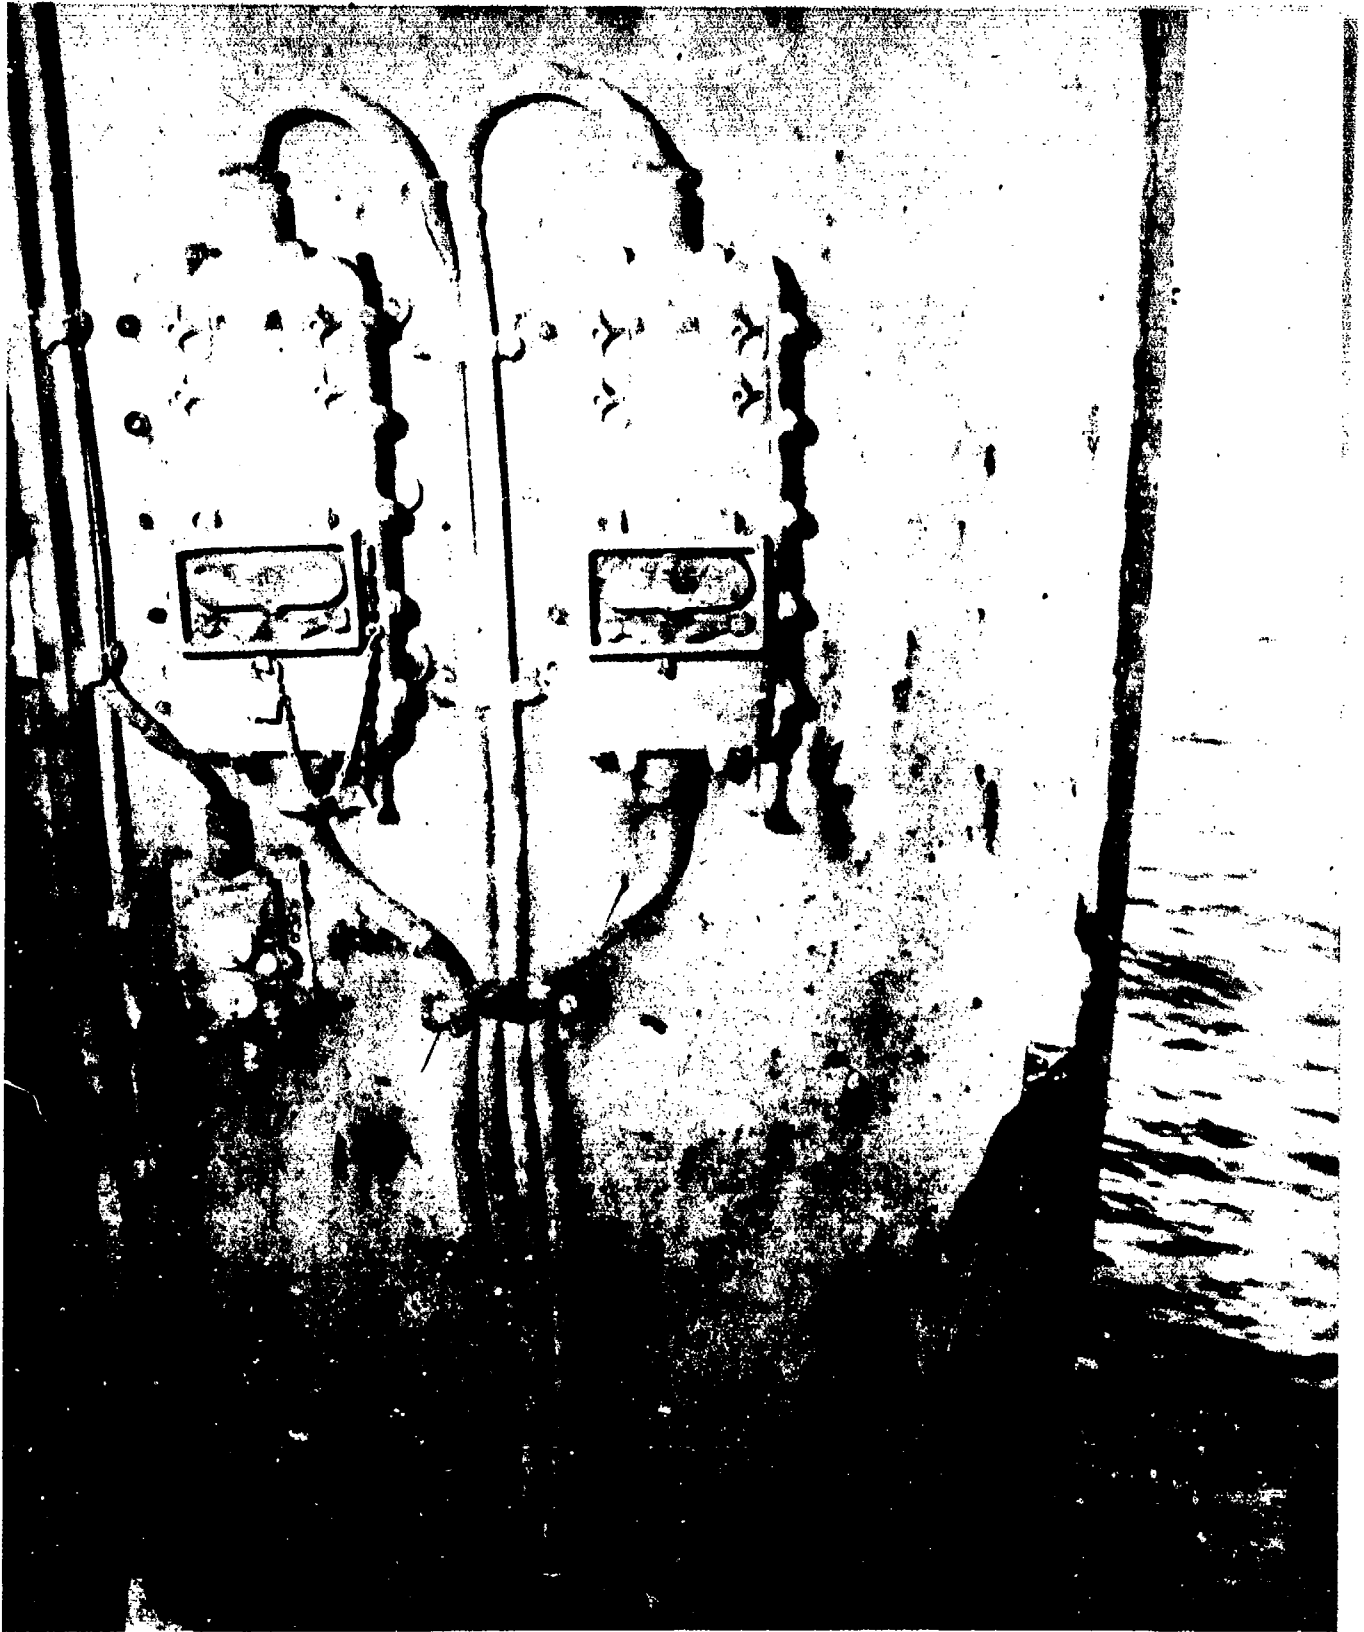
AA-CR-82-1918-8. Damage to cable at securing strap for water curtain control switches, frame 118 port side hangar space. View looking aft and outboard.

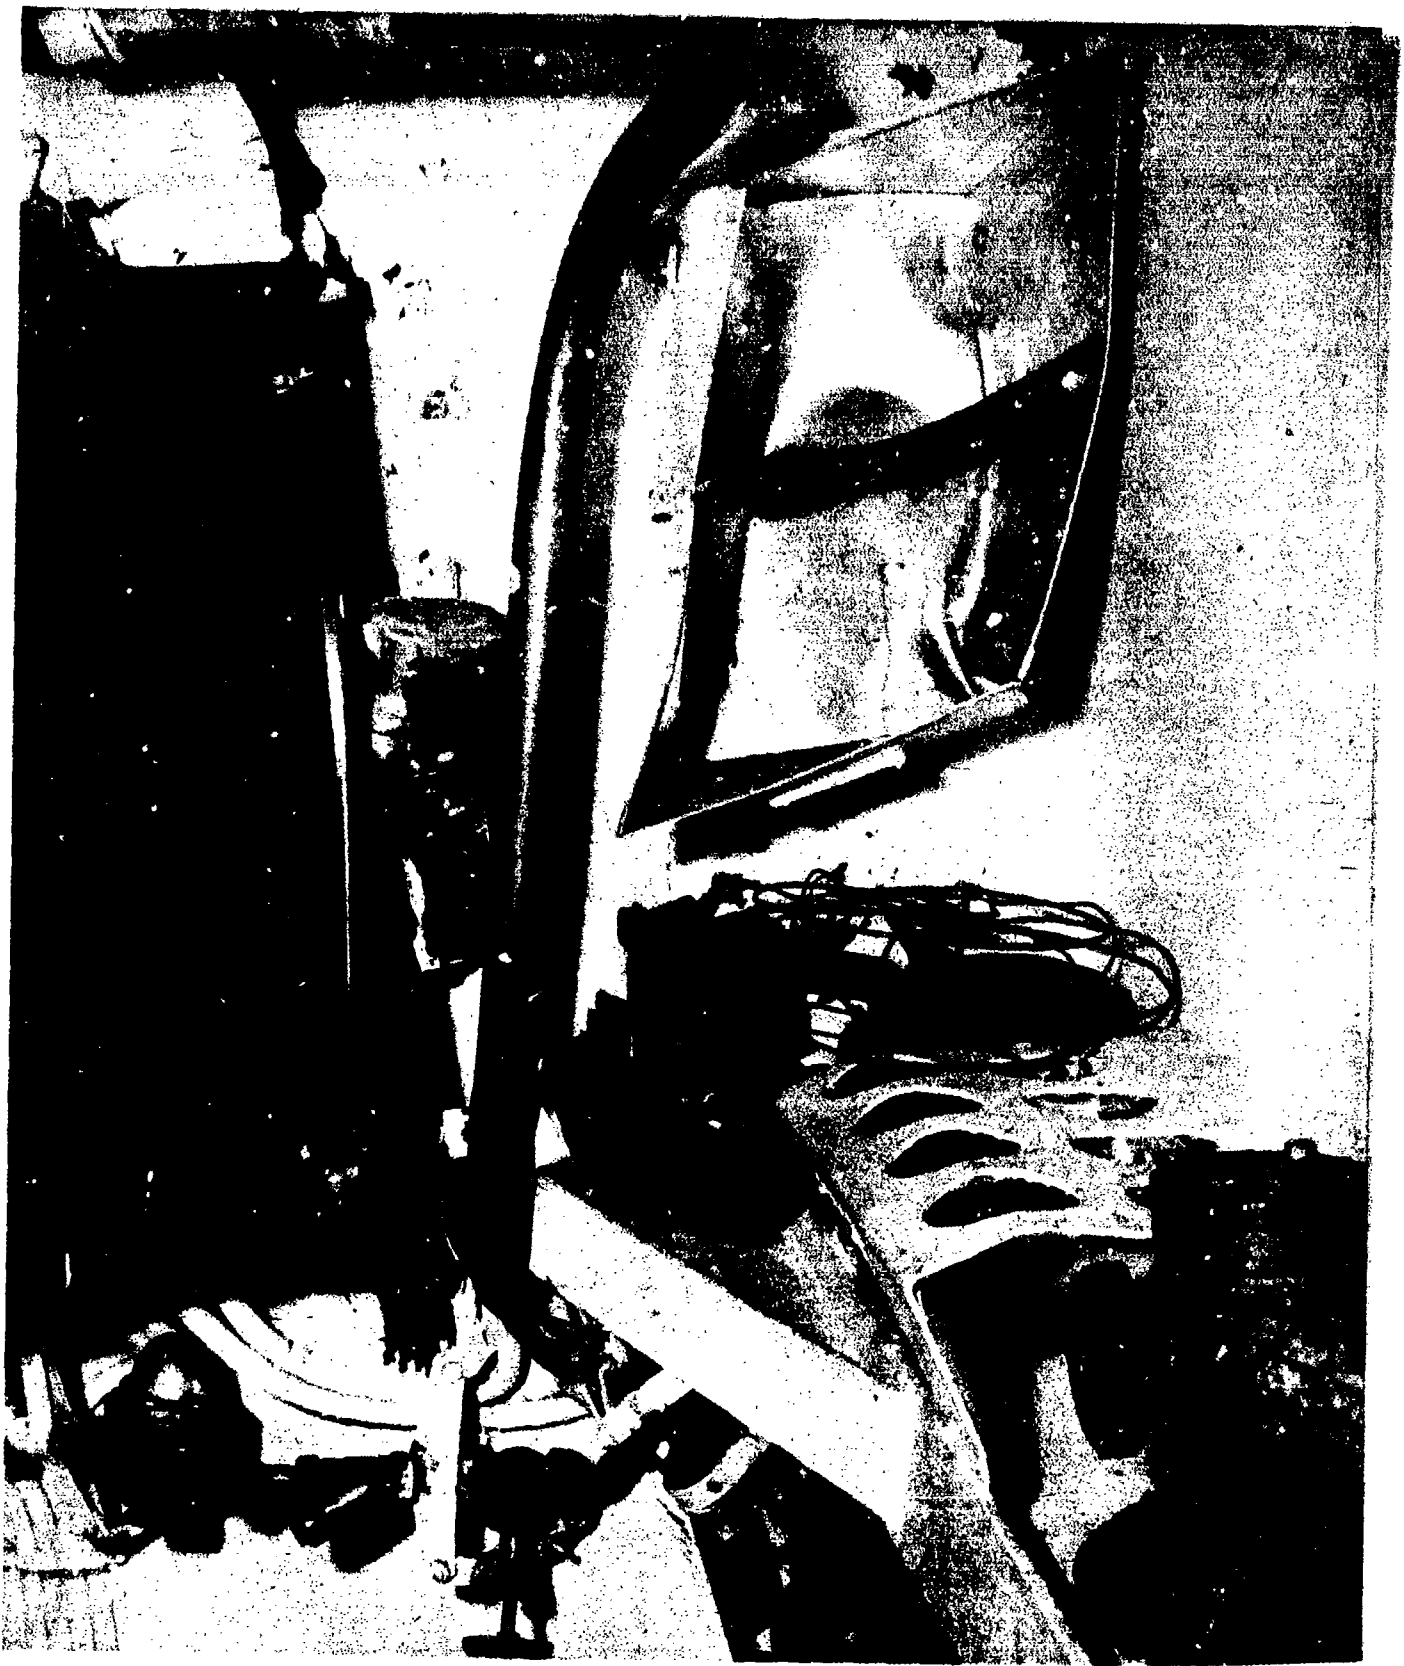
AA-CR-82-1917-1. Damage to control push button for refrigeration circulating pump motor No. 2 and electric fan on bulkhead 126 port side 3rd deck in ice machine room. View looking aft.
