# BUREAU OF SHIPS GROUP TECHNICAL INSPECTION REPORT

## U.S.S. INDEPENDENCE (CVL22)

### TEST ABLE

### OPERATION CROSSROADS

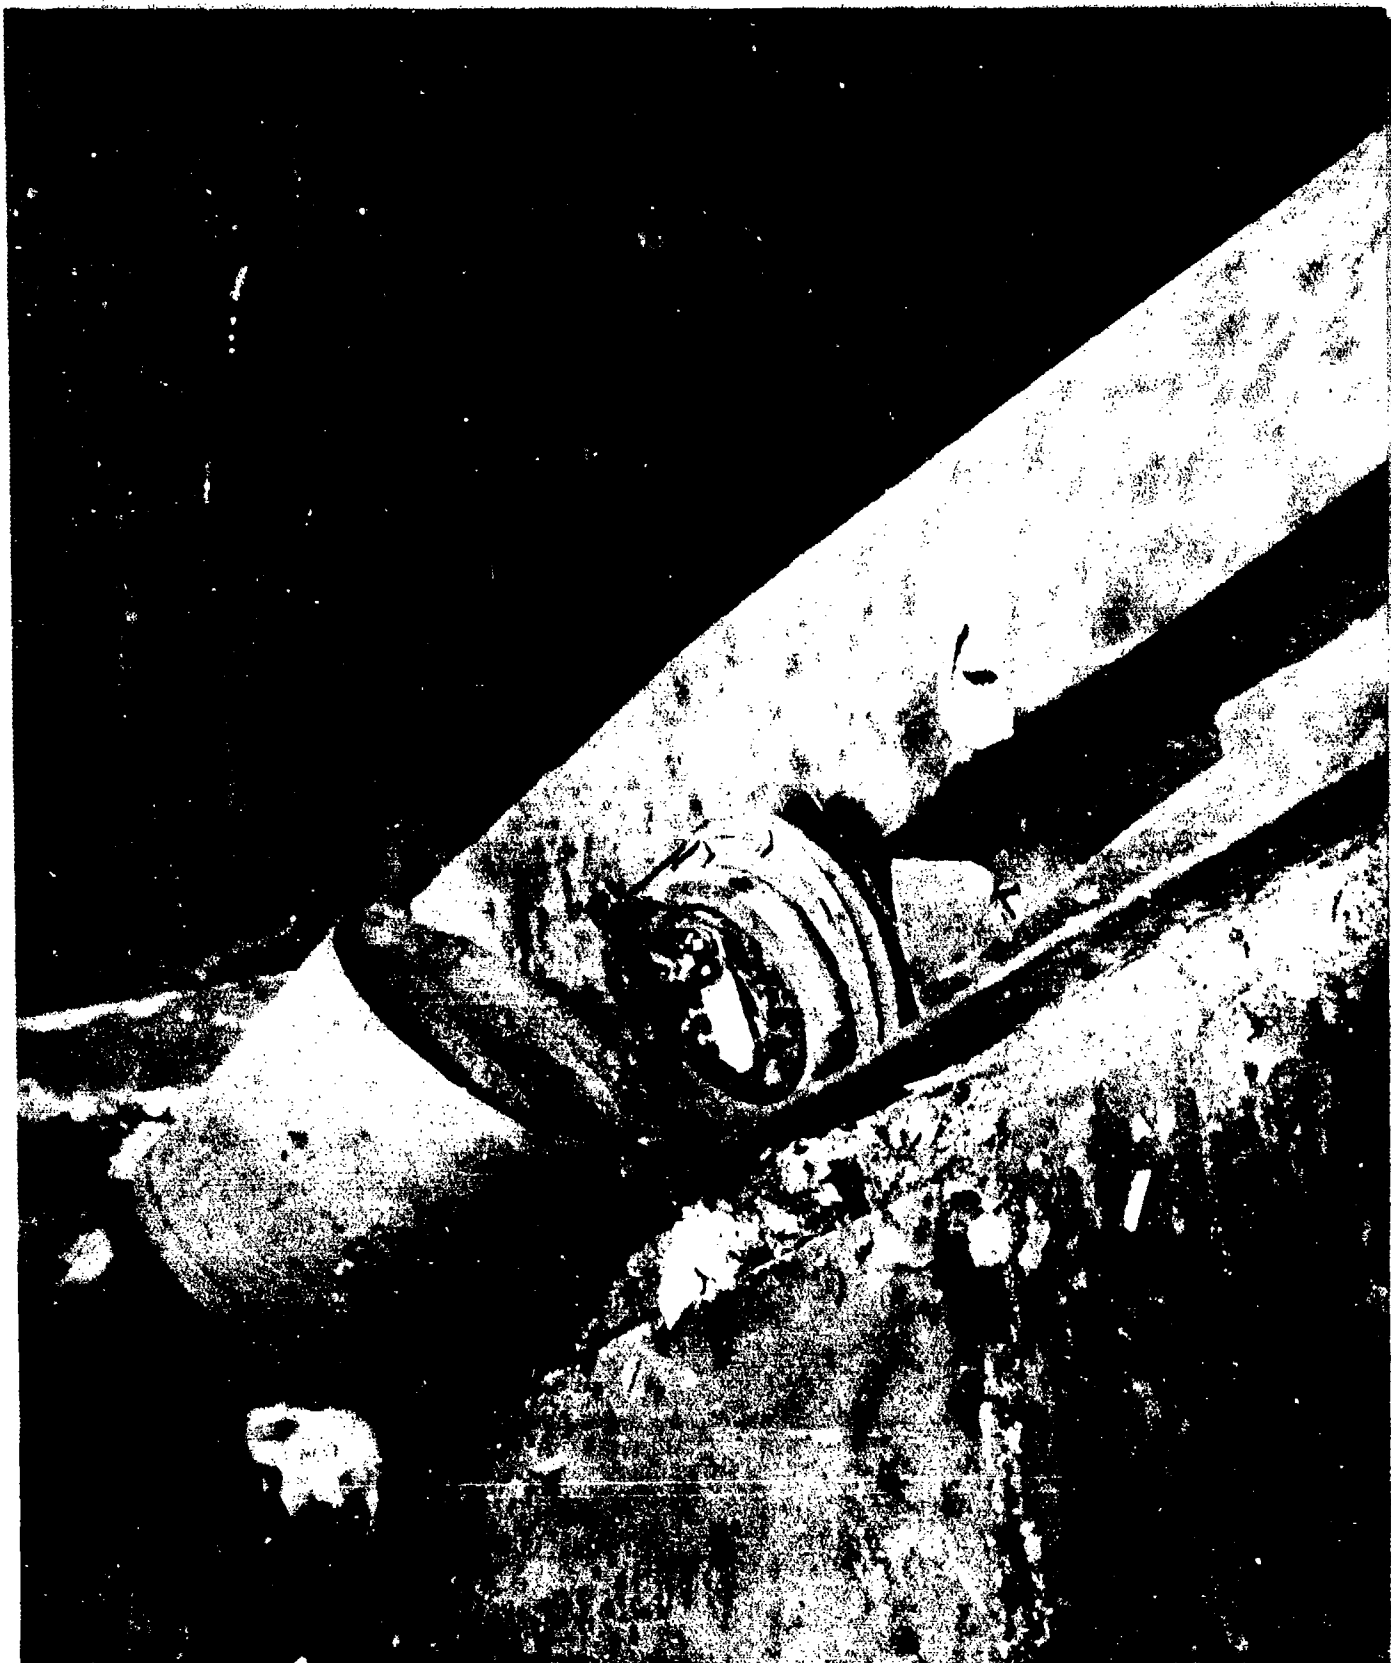
AA-CR-62-1881-4. Damage to deck edge landing light of frame 84 port side of flight deck, view looking aft and outboard.

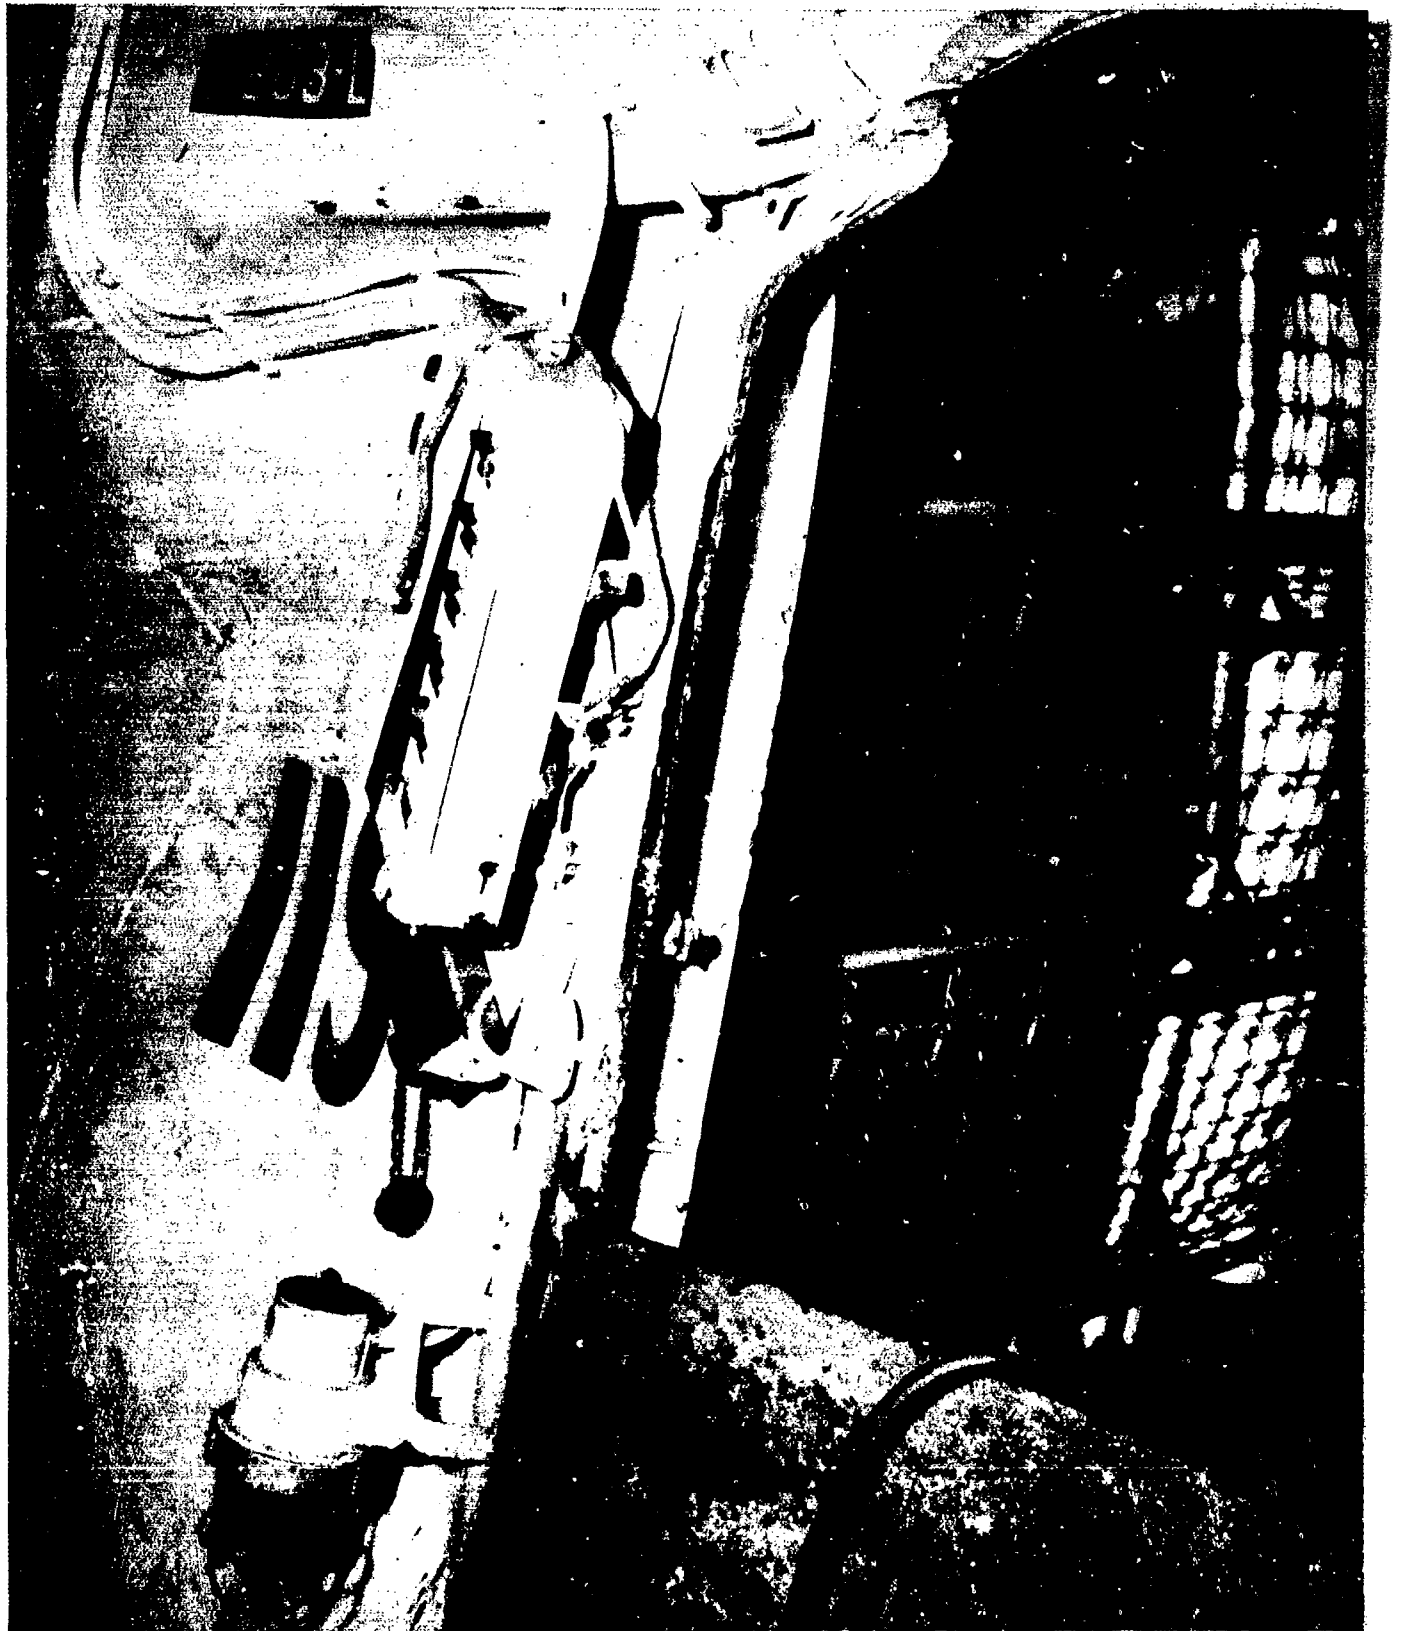
AA-CR-82-1916-8. "12T" lighting distribution box located on bulkhead frame 119 port side second deck mounting feet broken and cover distorted due to buckle in bulkhead. View looking forward and to port.

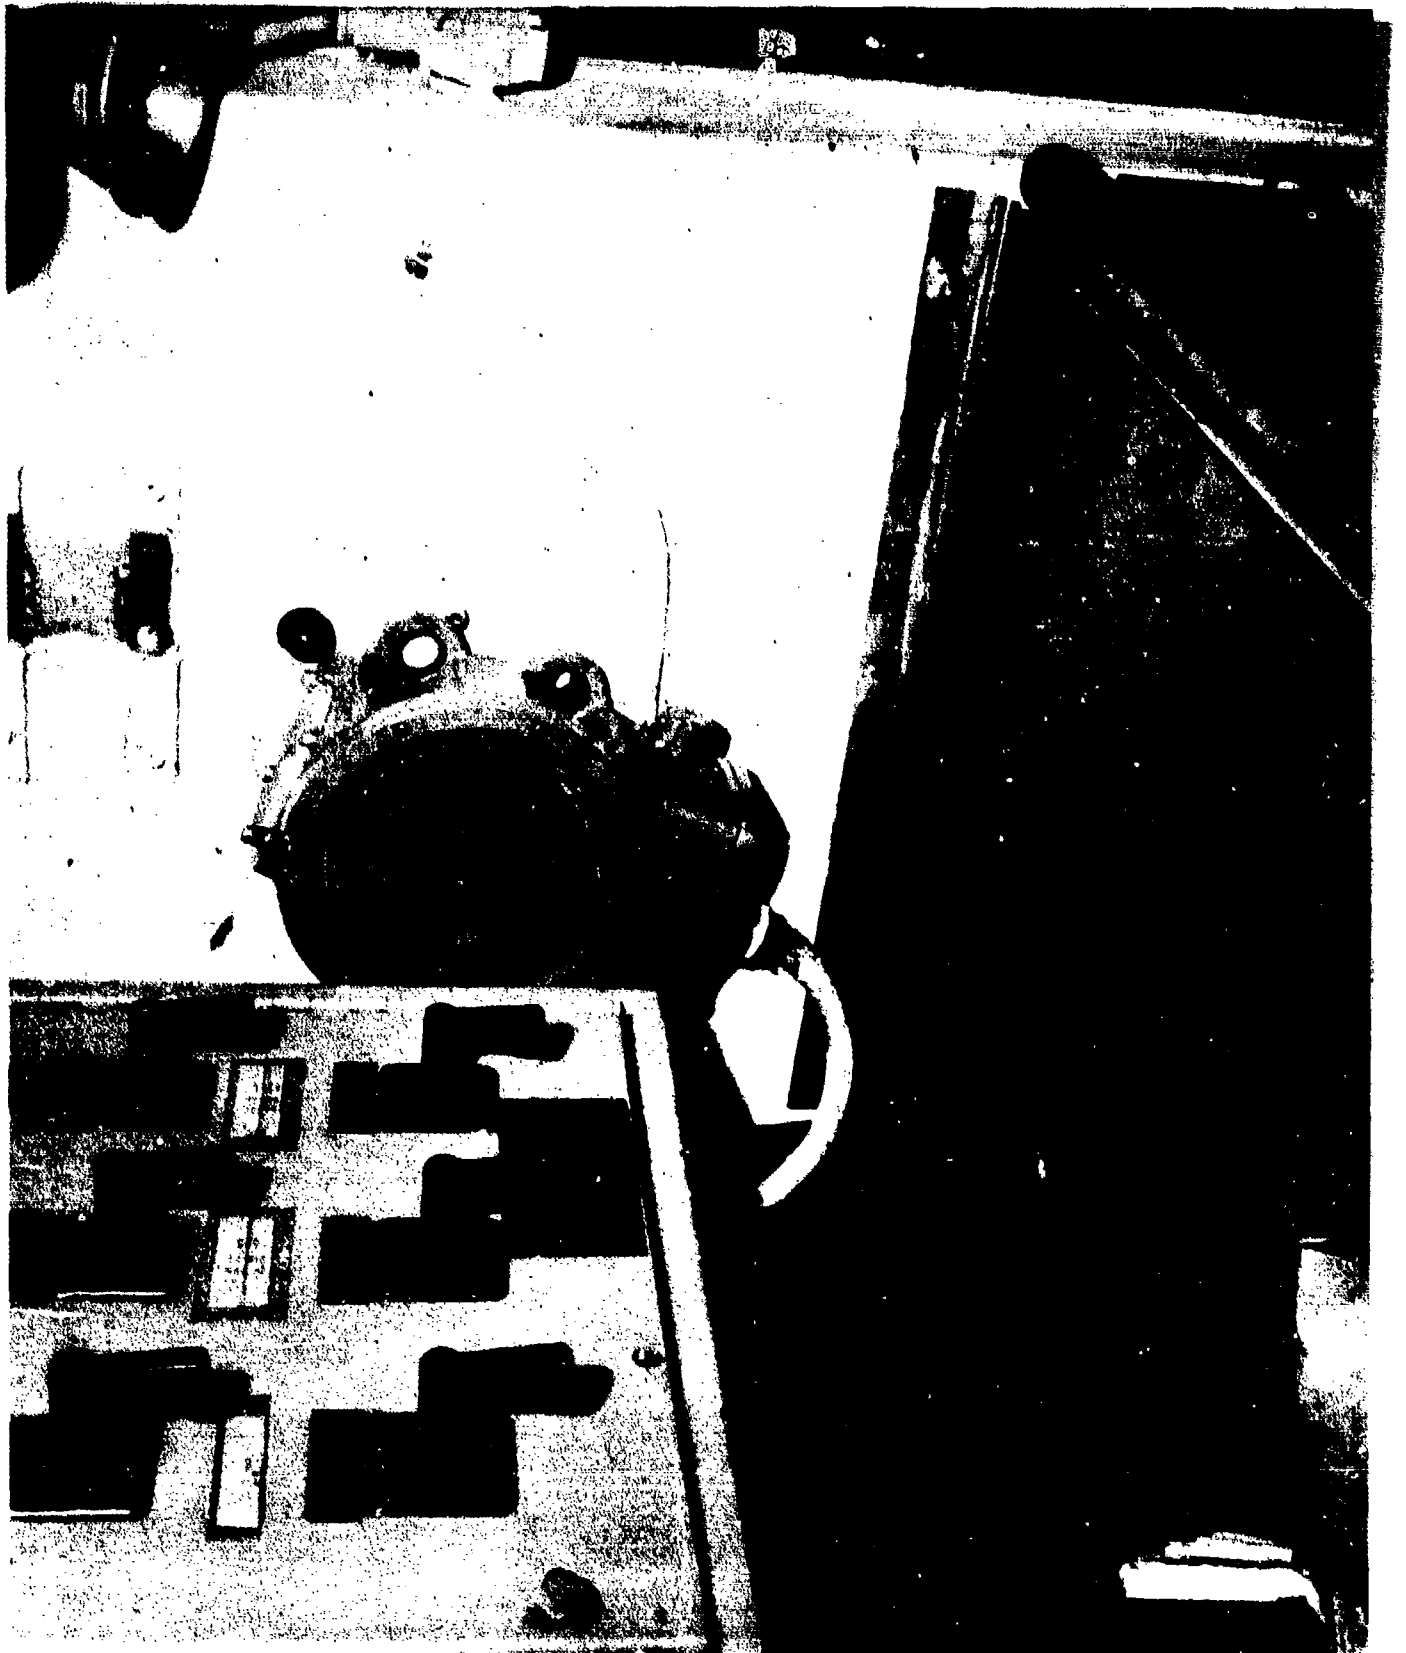
AA-CR-234-1989-10. Gyro compass repeater in chart house on forward bulkhead. Note failure of shock mounts. View looking forward and to port.

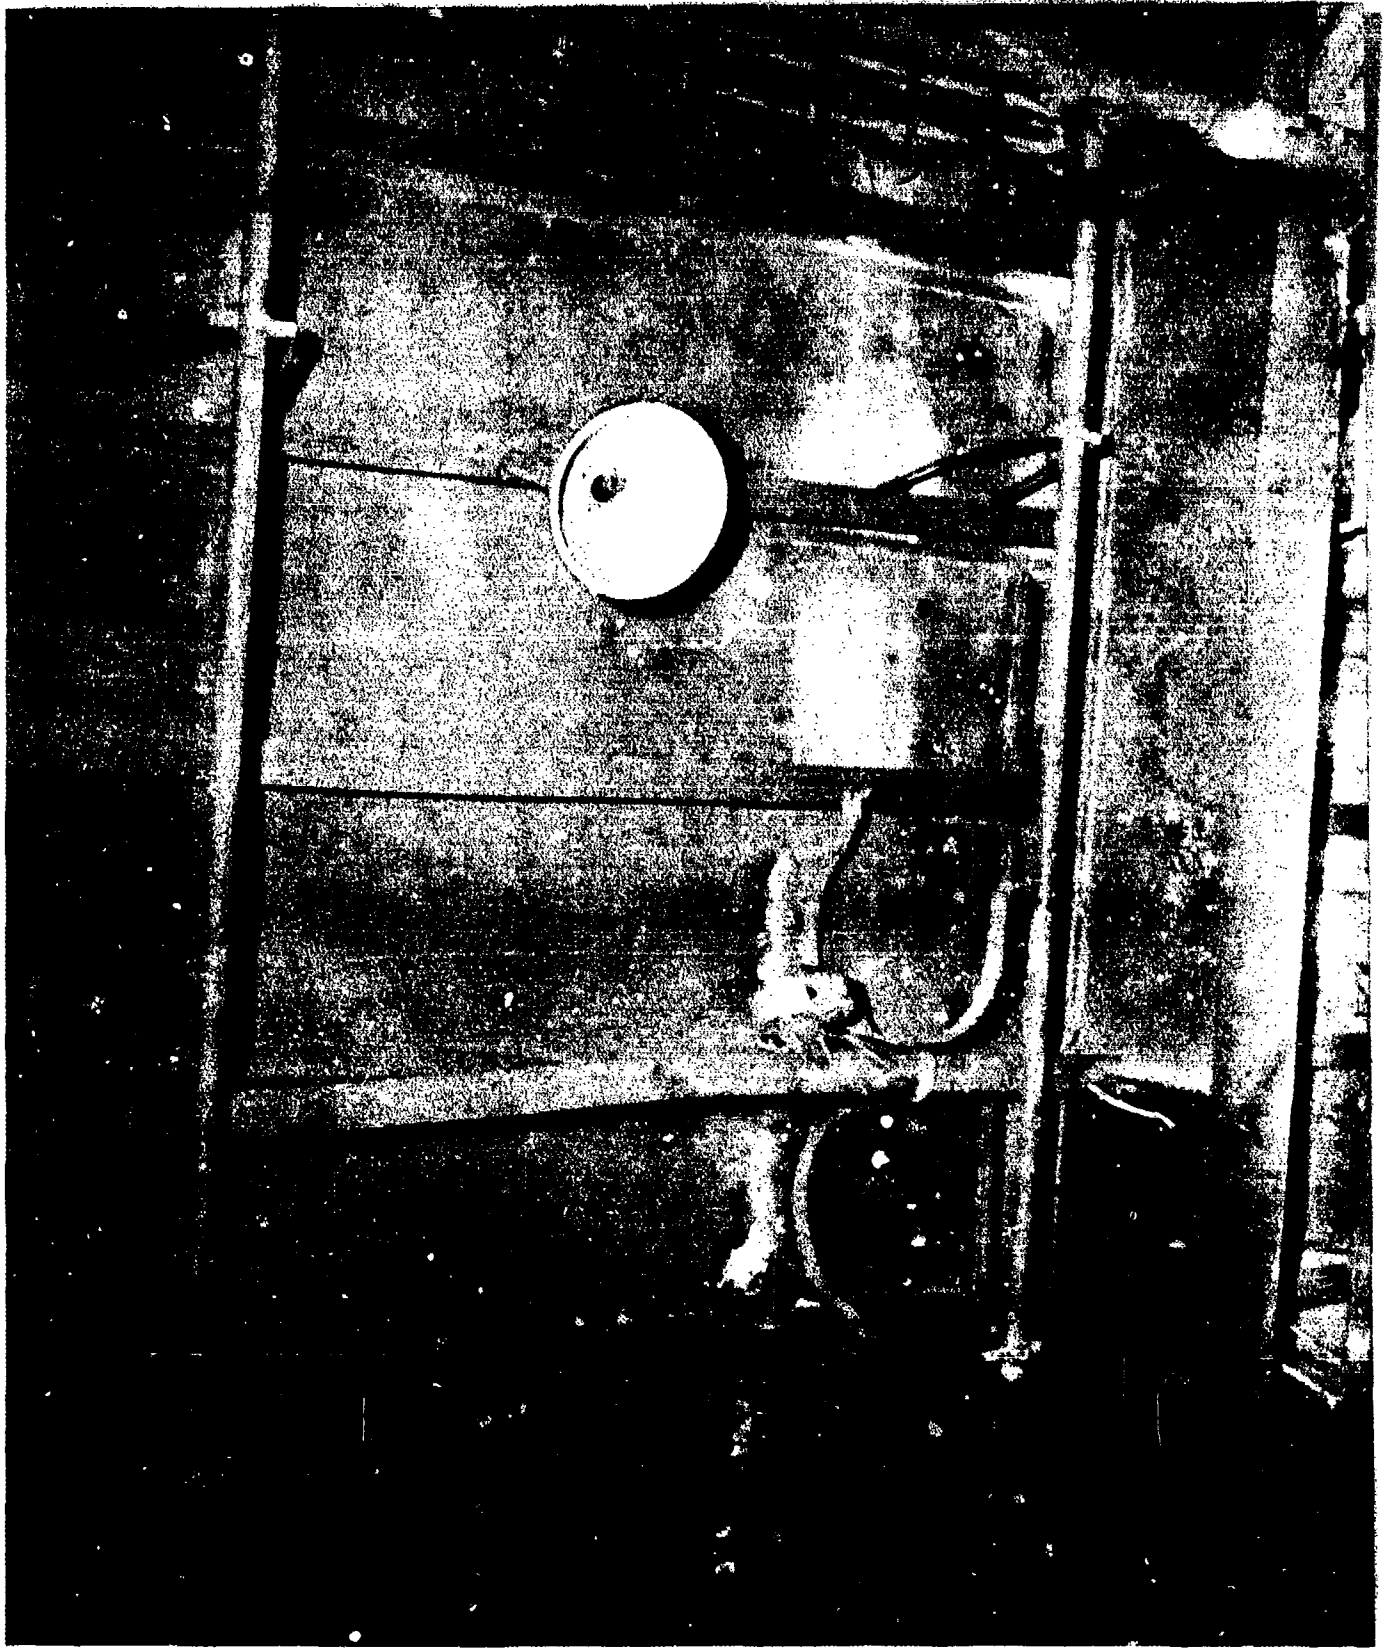
AA-CR-82-1919-5. Damage to lamp in lighting fixture located under flight deck in hangar space, frame 105. View looking up.

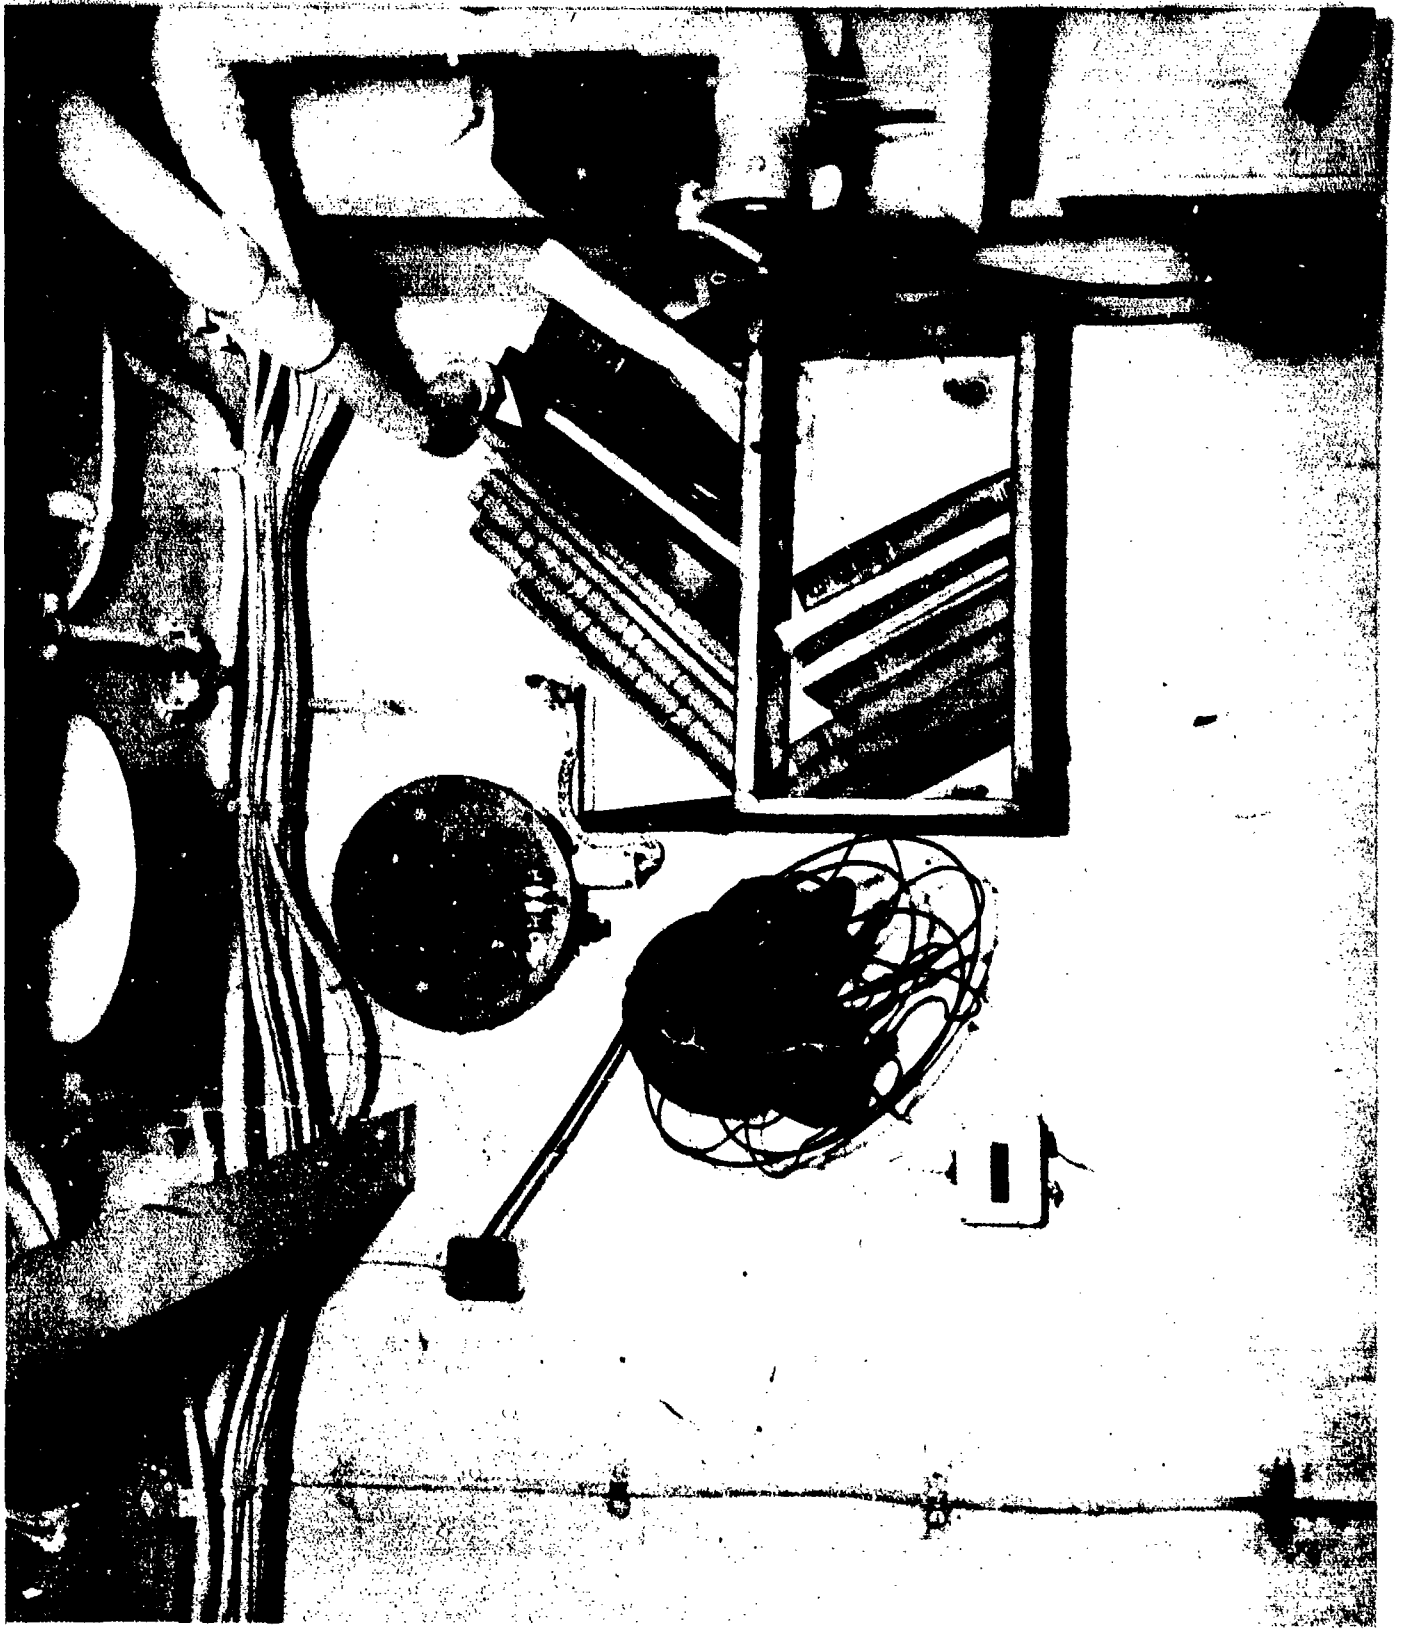
AA-CR-234-1989-6. Enclosure for "1MC" reproducer in and chart house, frame 57 starboard side gallery deck. Interior missing after test.

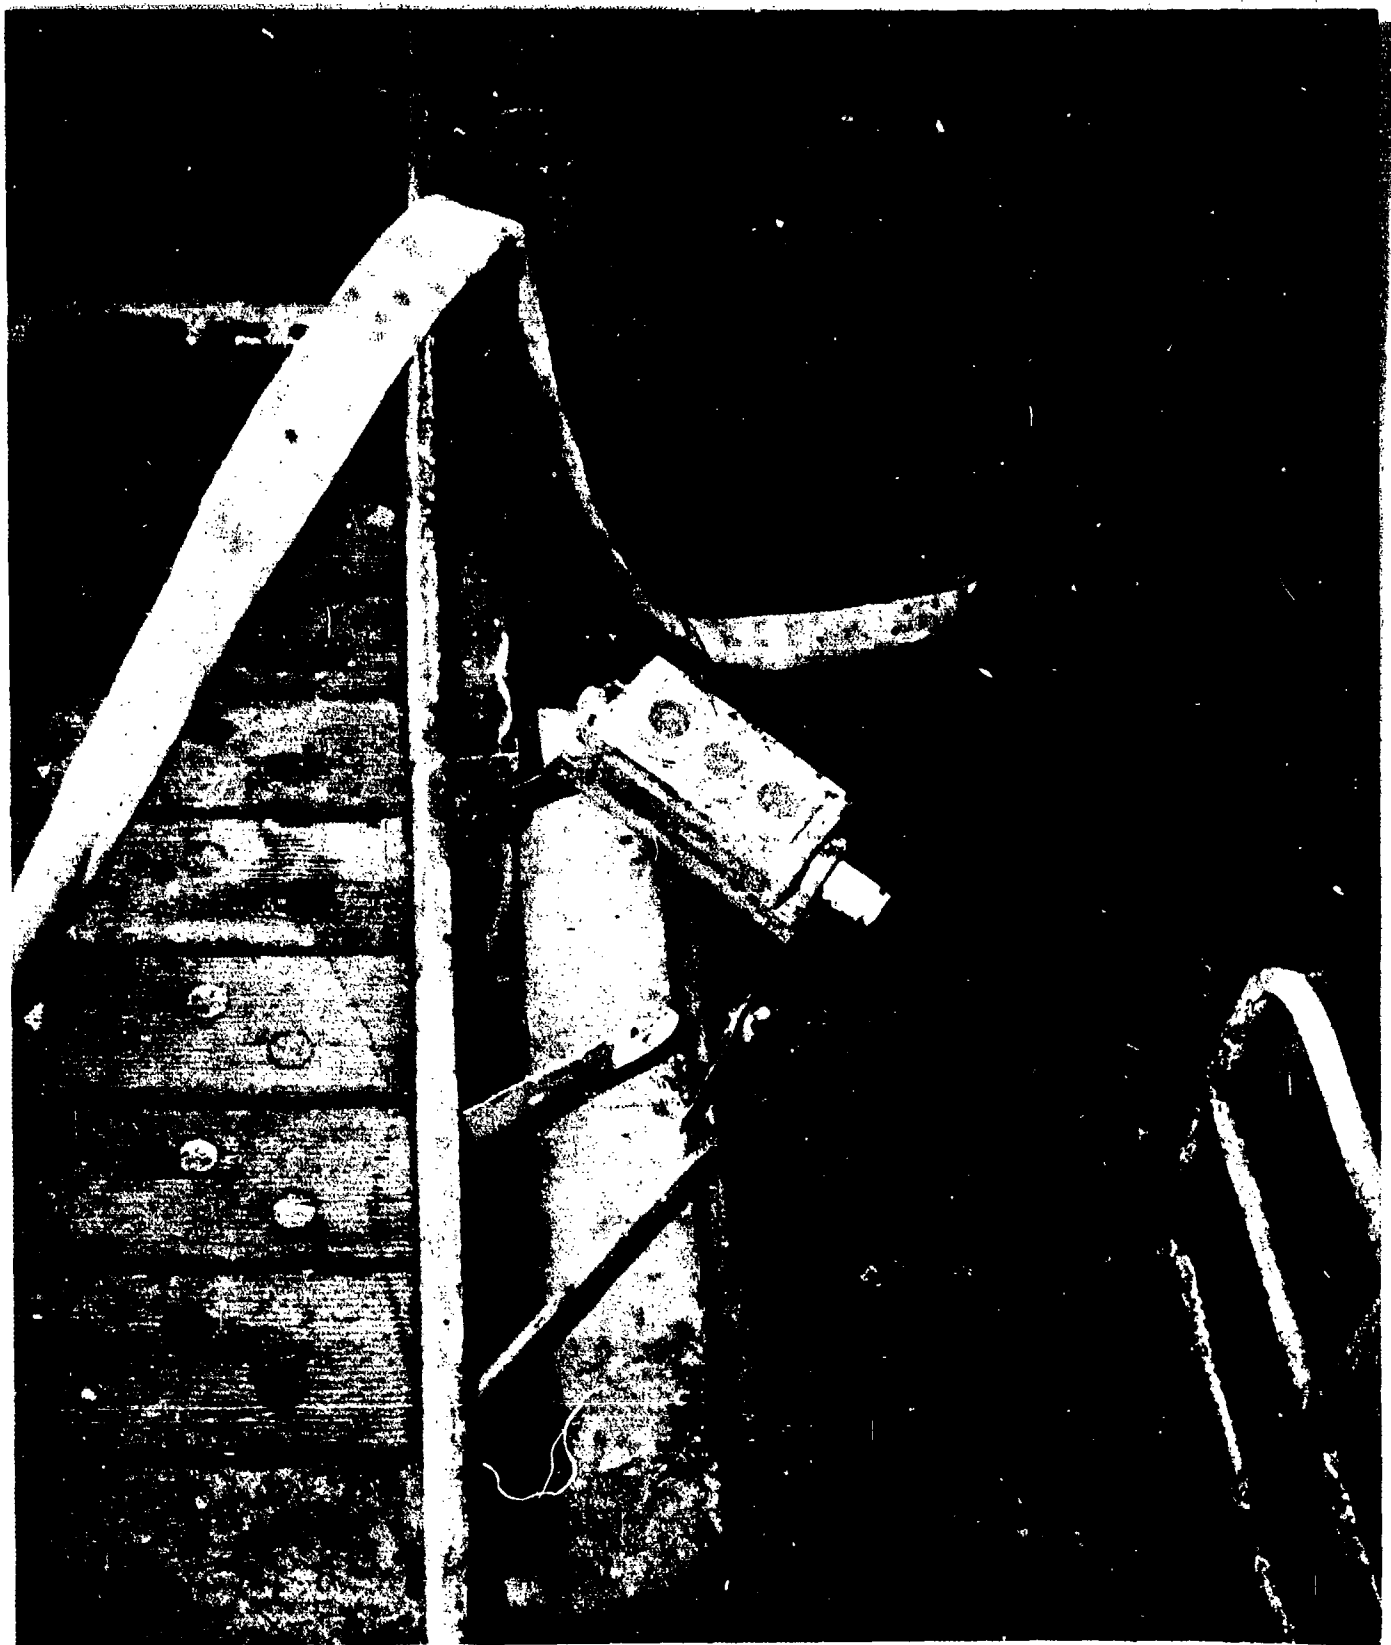
AA-CR-82-1920-9. Catapult ready light indicator frame 22 starboard side flight deck plastic lens damaged by radiant heat of bomb and foundation bracket broken.

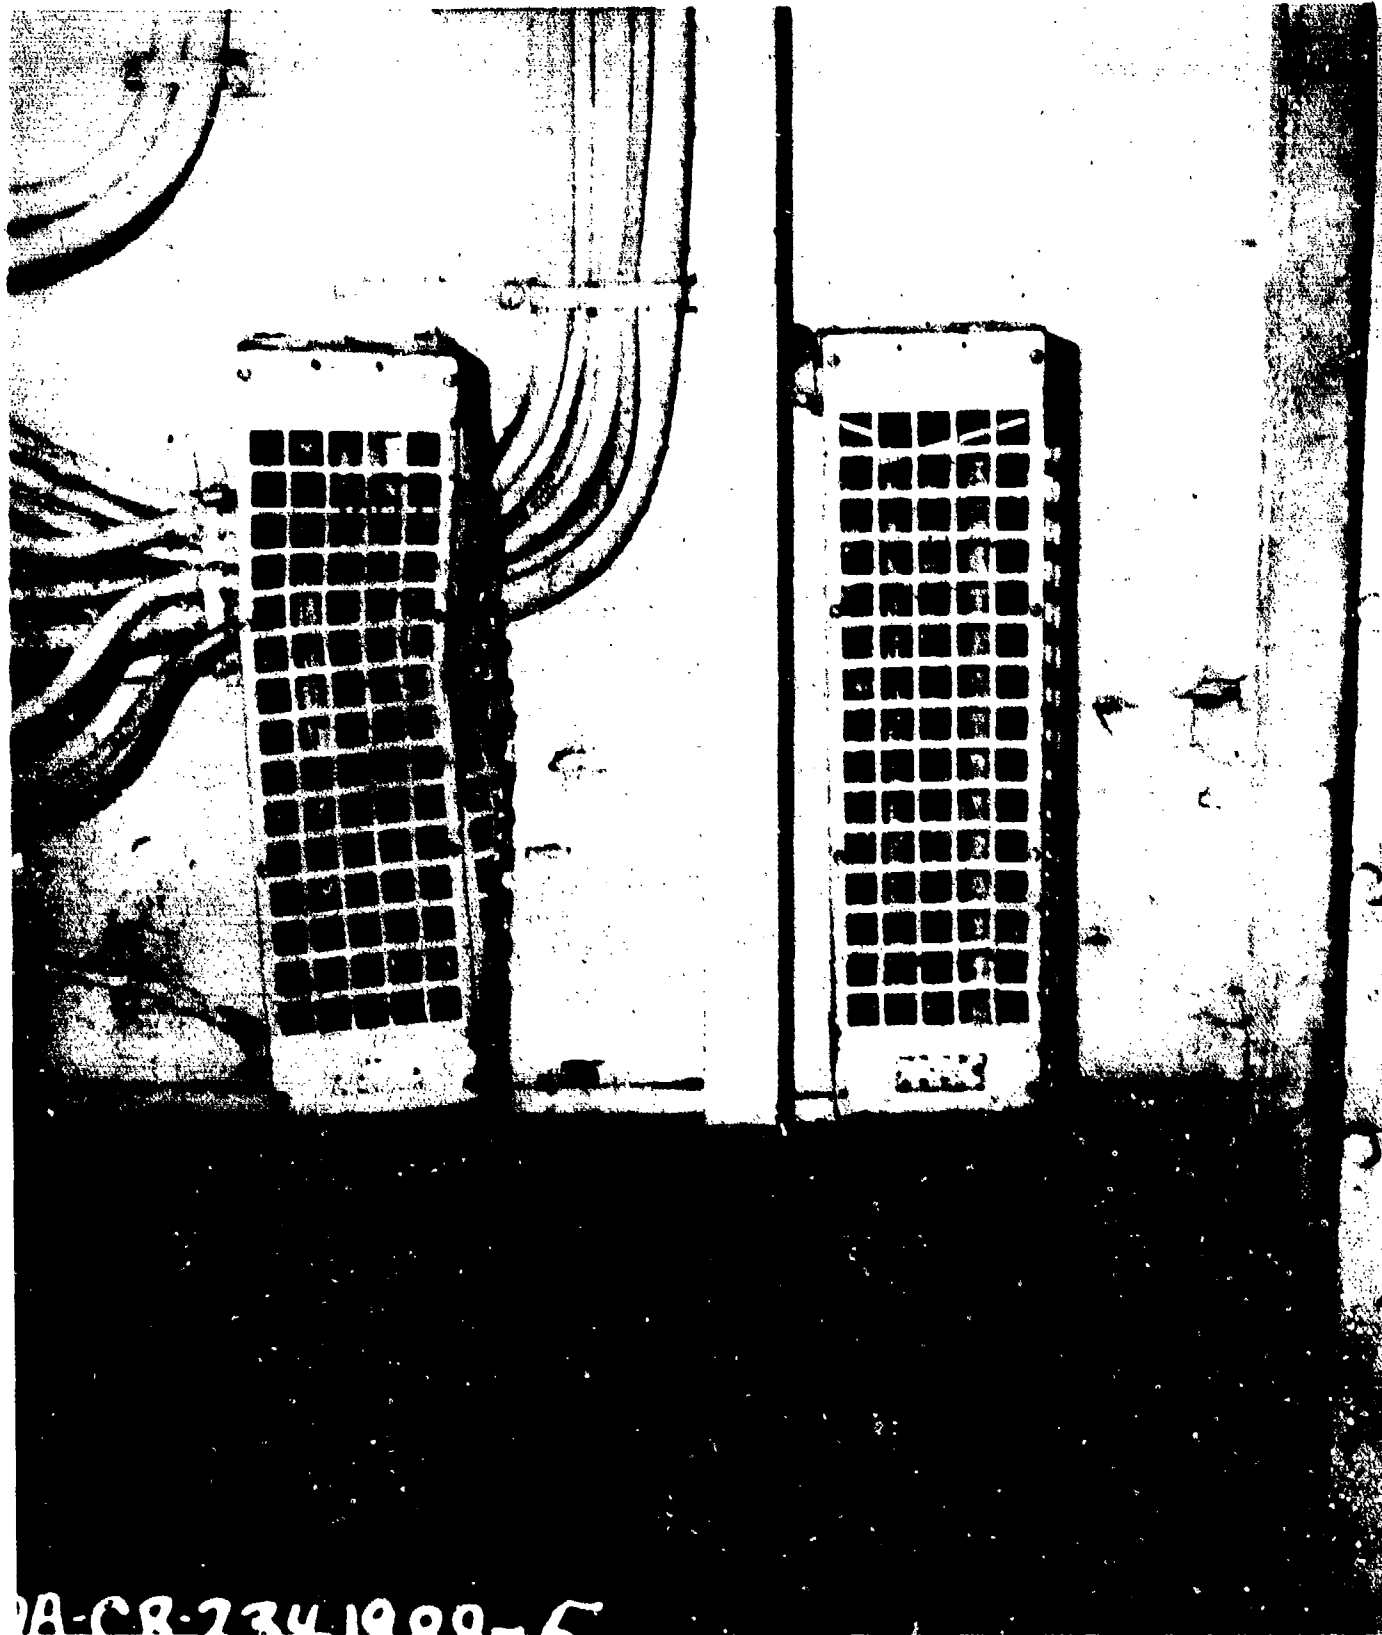
AA-CR-234-1989-5. Damage to non-radiant heater, by loose furniture falling against it. Grids were broken located in aix. Chart house from 51 starboard on gallery deck.
