BUREAU OF SHIPS GROUP TECHNICAL INSPECTION REPORT

OPERATION CROSSROADS. U.S.S. CONYNGHAM (DD371) TEST ABLE [U].

DIRECTOR OF SHIP MATERIAL
JOINT TASK FORCE ONE

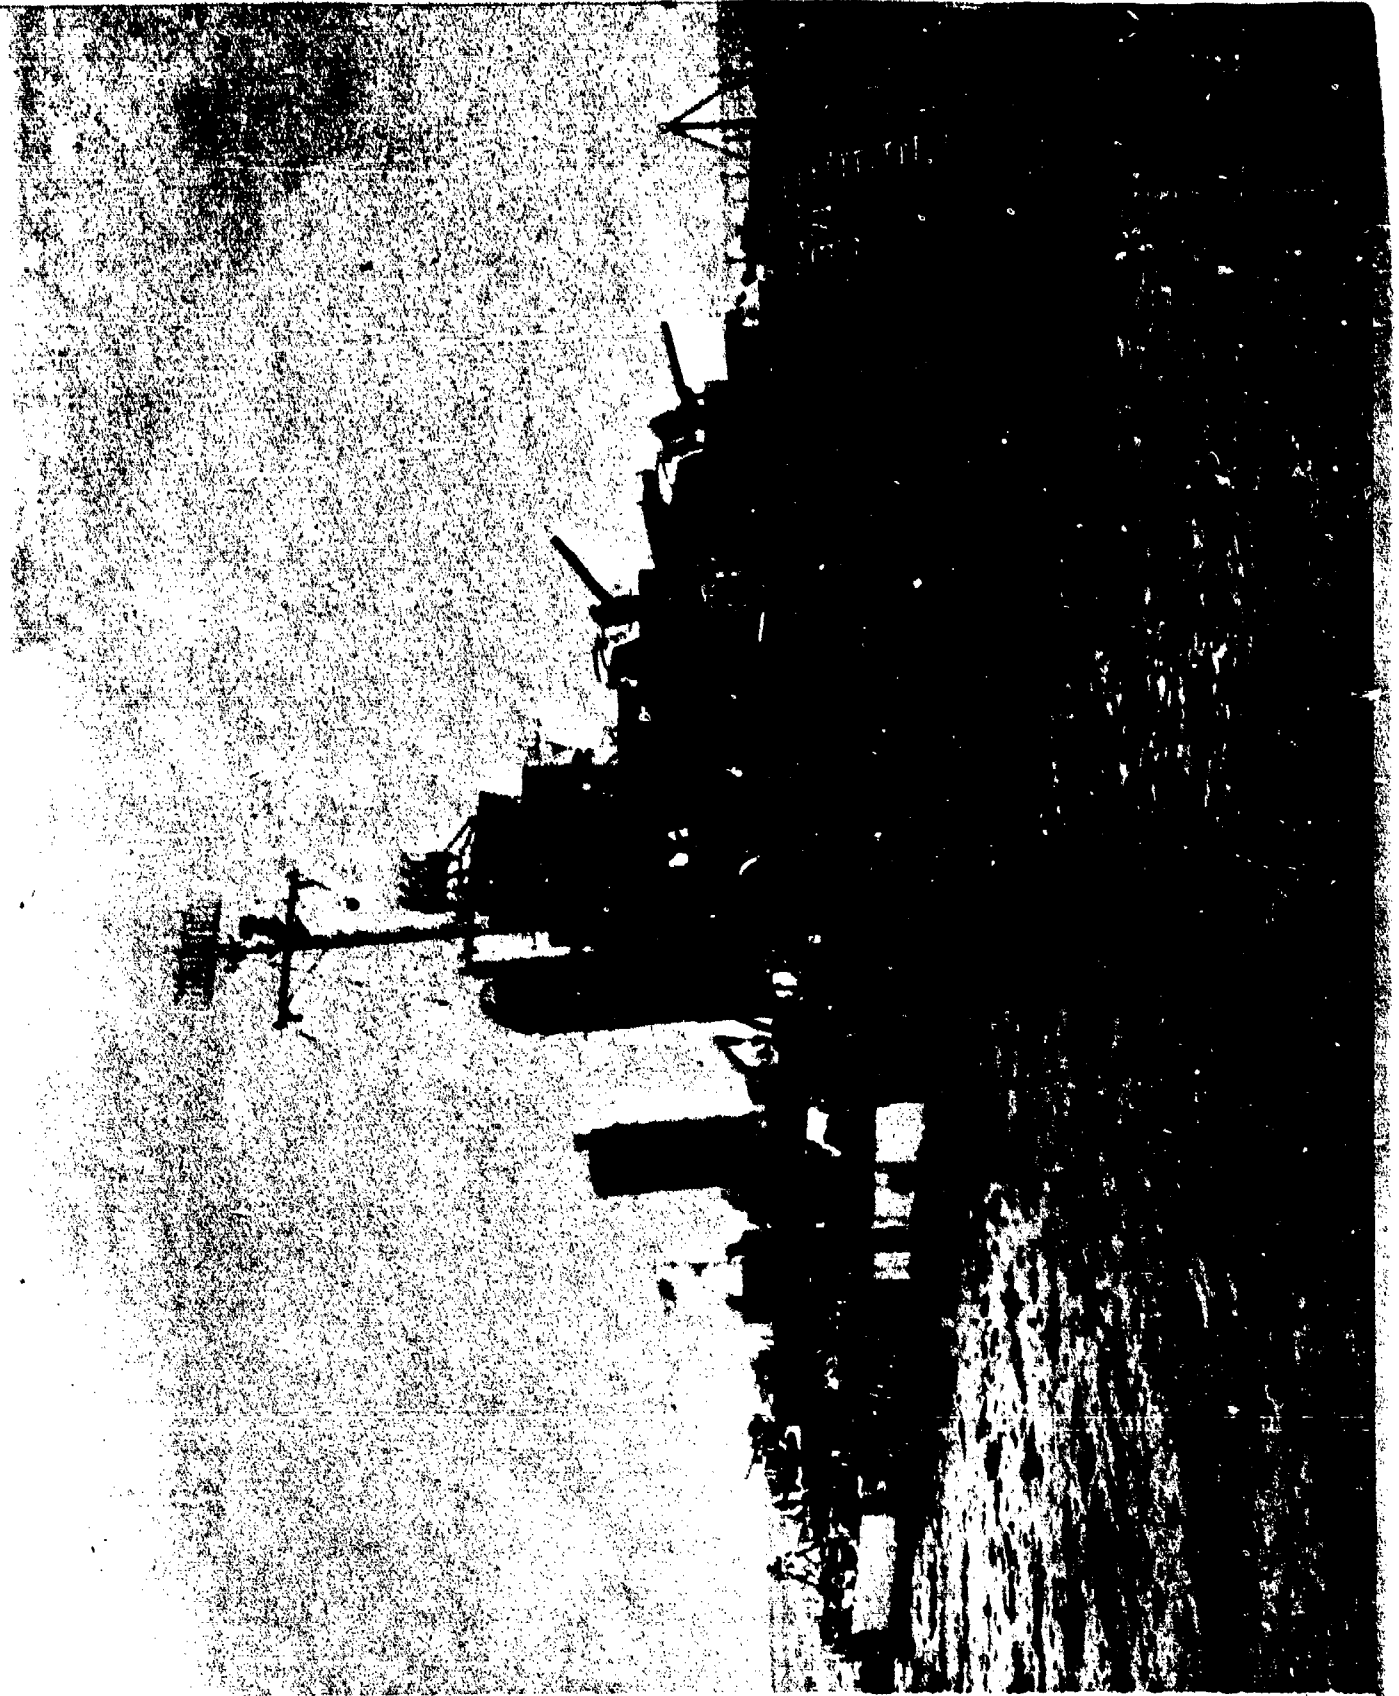
AA-CR-227-87-59. View from off starboard bow. (Spotting and re-painting of shell started.

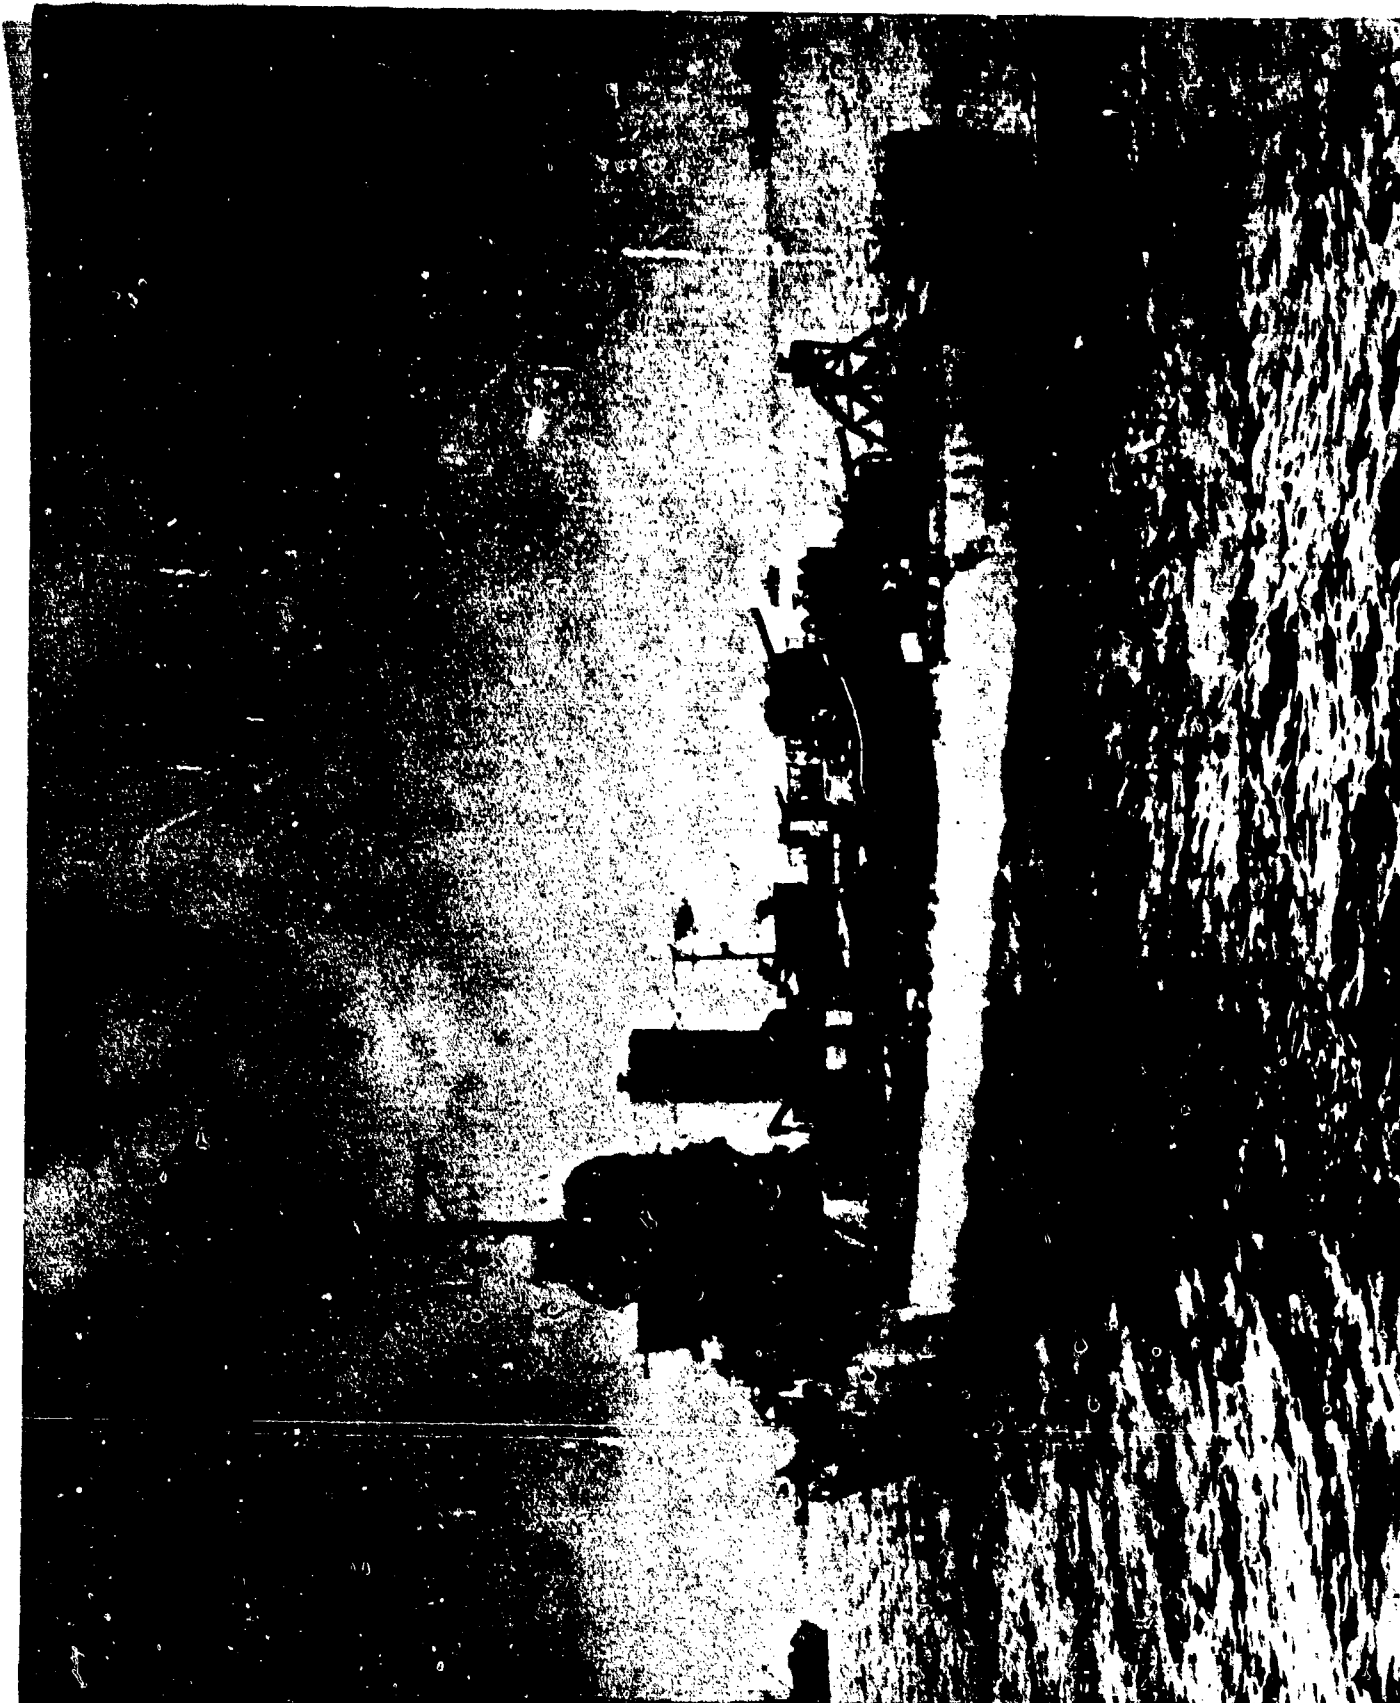
AA-CR-227-87-56. View from off port quarter. (Repainting of shell started.)
