# BUREAU OF SHIPS GROUP 1 TECHNICAL INSPECTION REPORT

TEST ABLE

OPERATION CROSSROADS

USS MUGFORD (DD389)

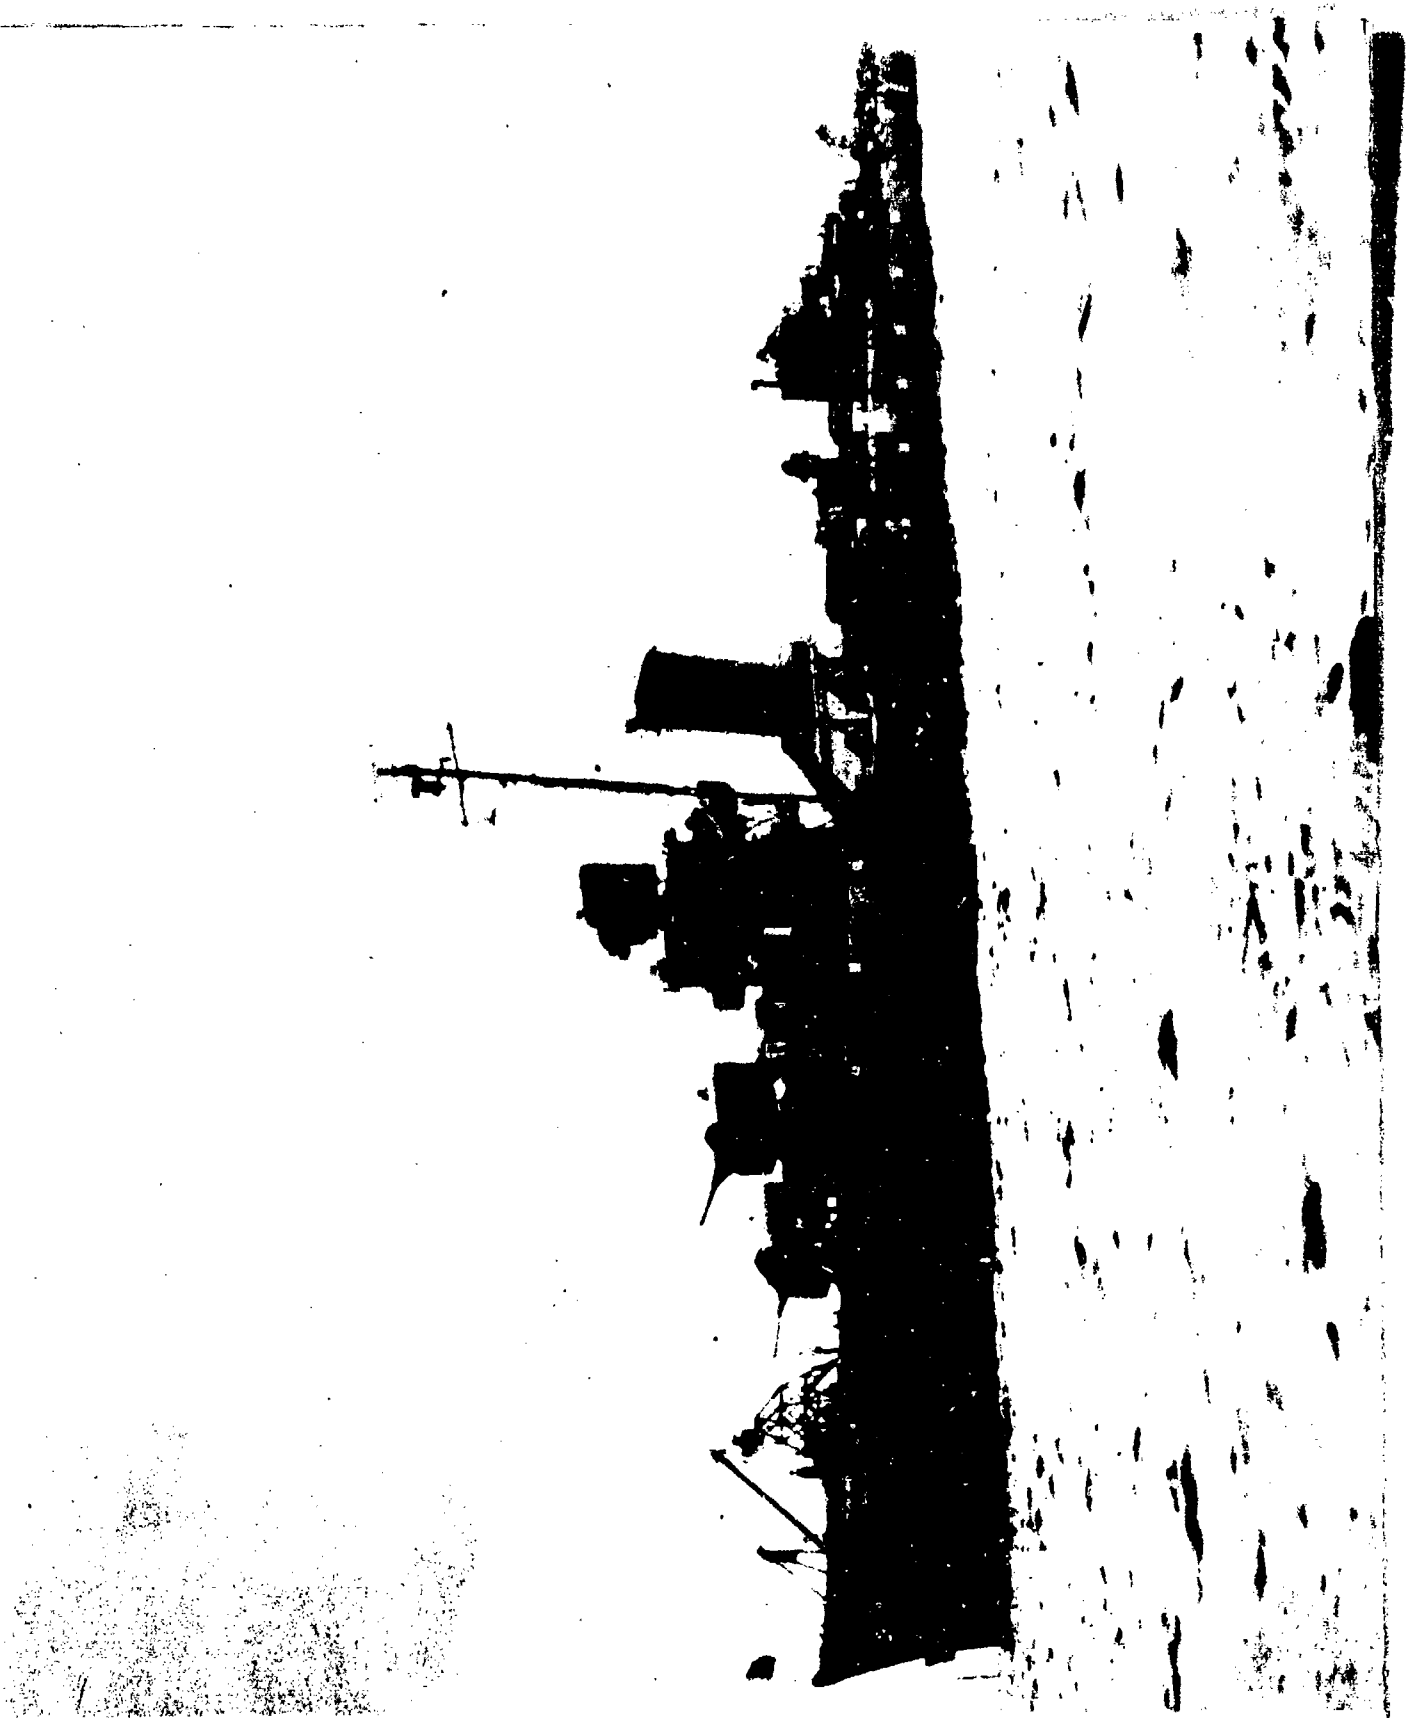
AA-CR-227-92-106. View from off port bow after Test A.

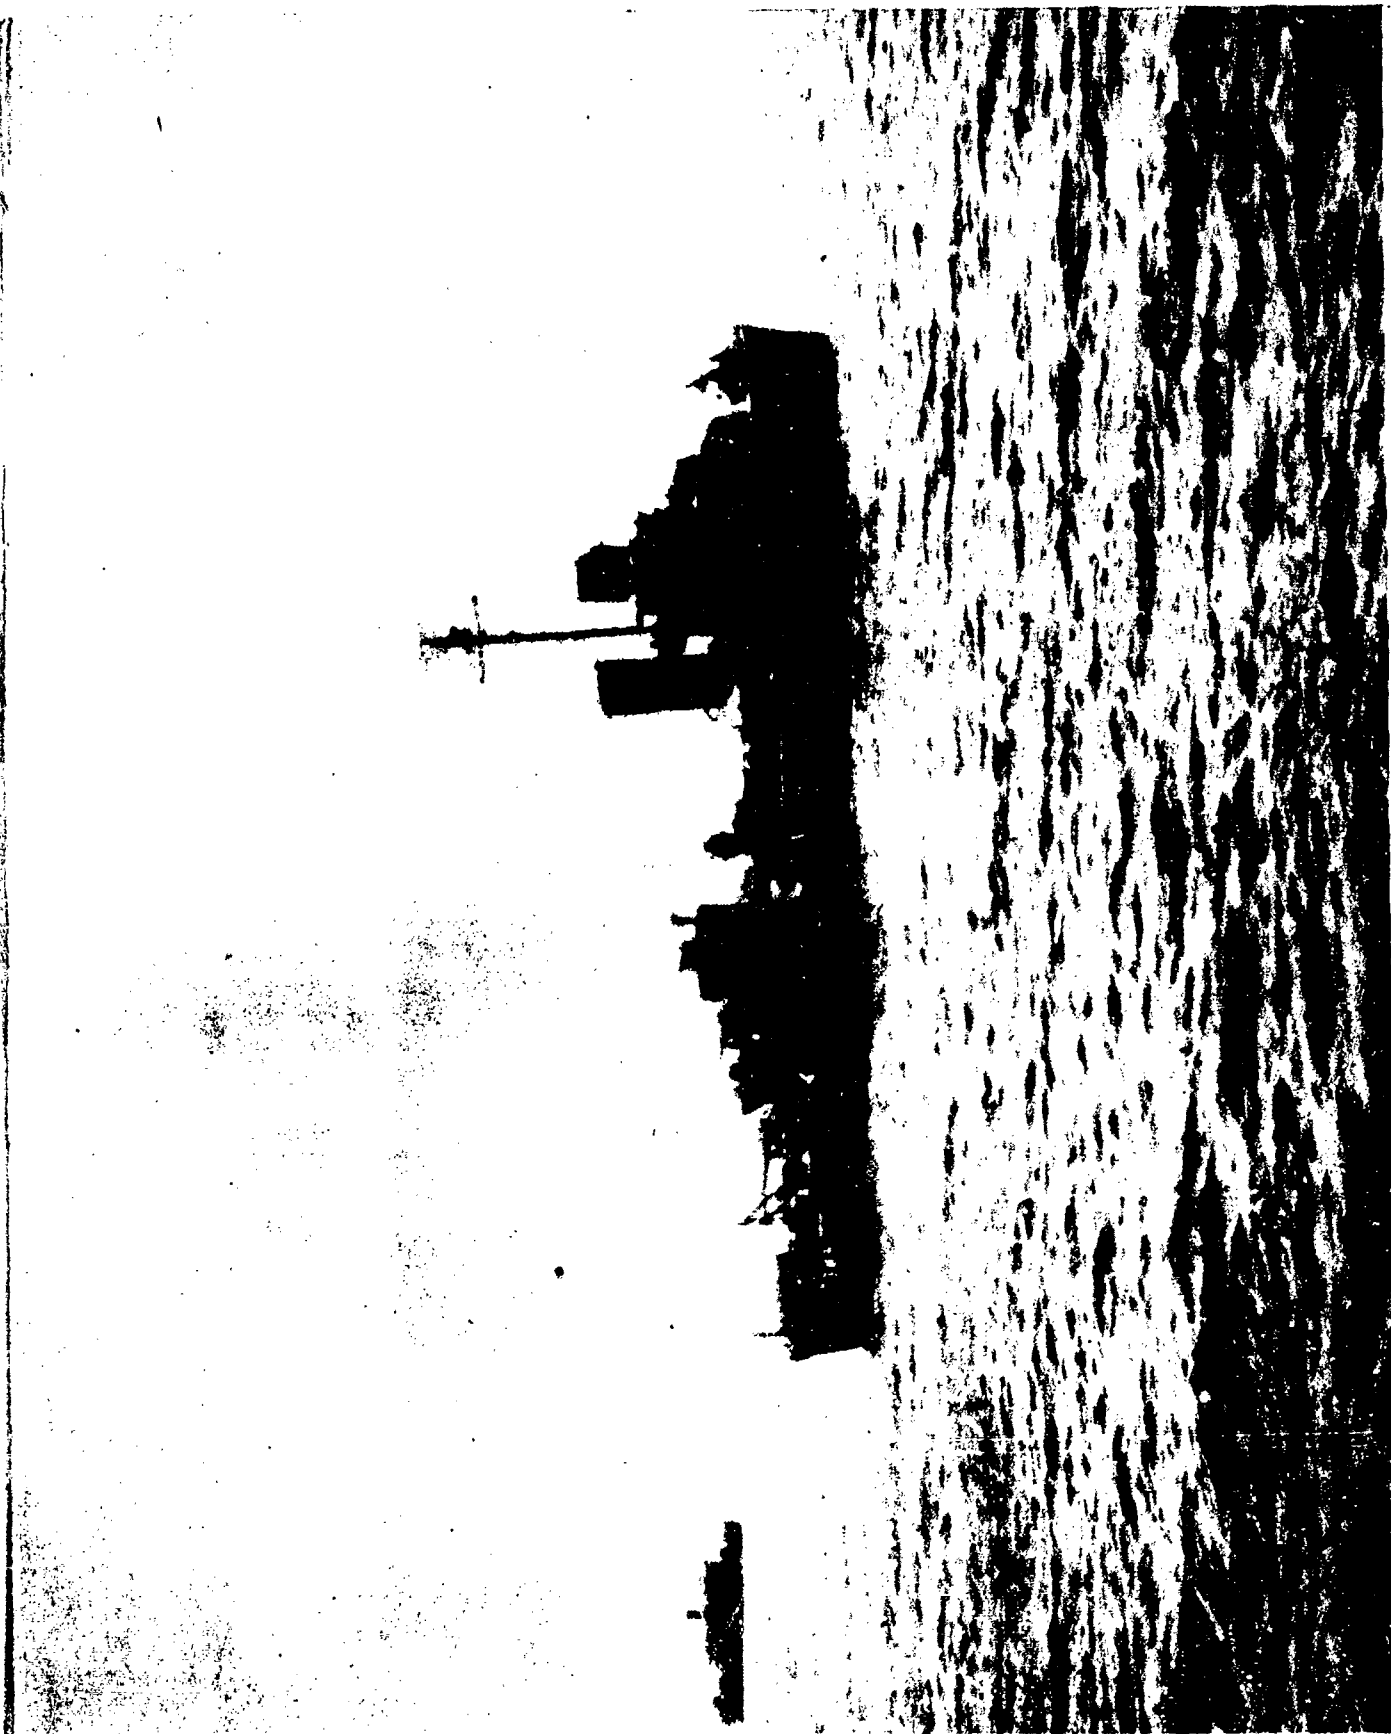
AA-CF-227-49-96. View from off starboard quarter after Test A.
