⑨ BUREAU OF SHIPS GROUP
TECHNICAL INSPECTION REPORT

⑥ OPERATION CROSSROADS
U.S.S. SARATOGA (CV3)

TEST ABLE

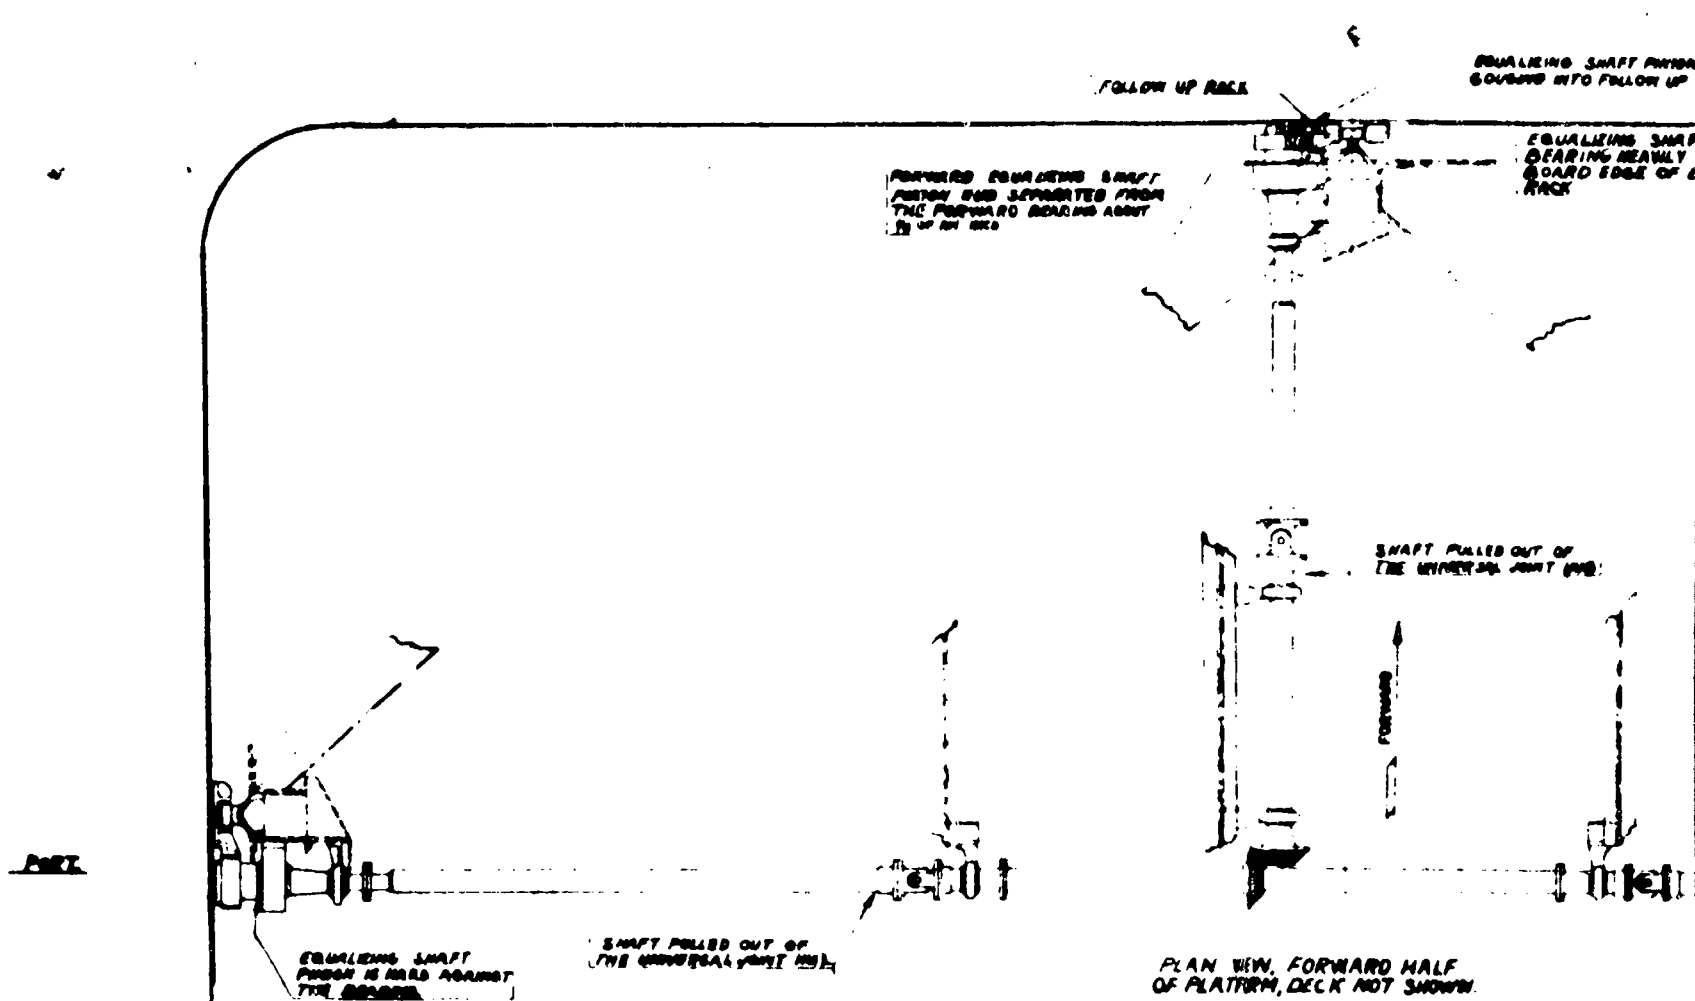
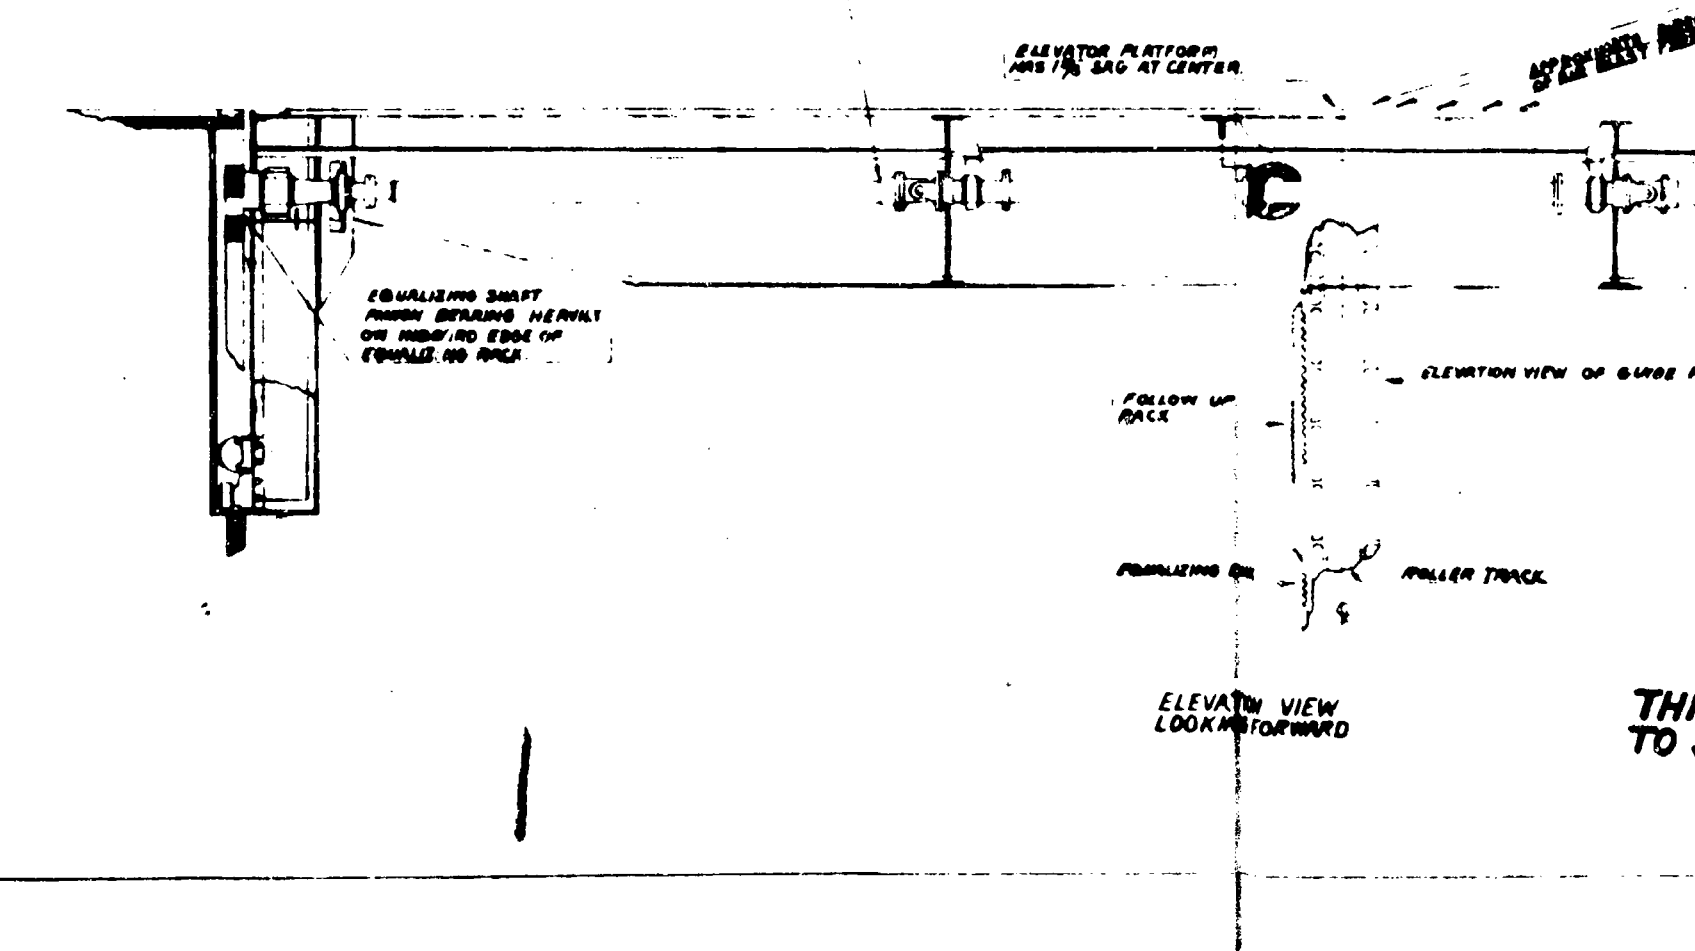
EQUALIZING SHAFT PINION
BOUNDS INTO FOLLOW UP RACK.

EQUALIZING SHAFT PINION
BEARING HEAVILY ON IN-
BOARD EDGE OF EQUALIZING
RACK

8. Repairs to the equalizing gear are beyond the capacity of the ship's force. It is estimated that complete repairs to the elevator could be made by a tender in about 6 days.

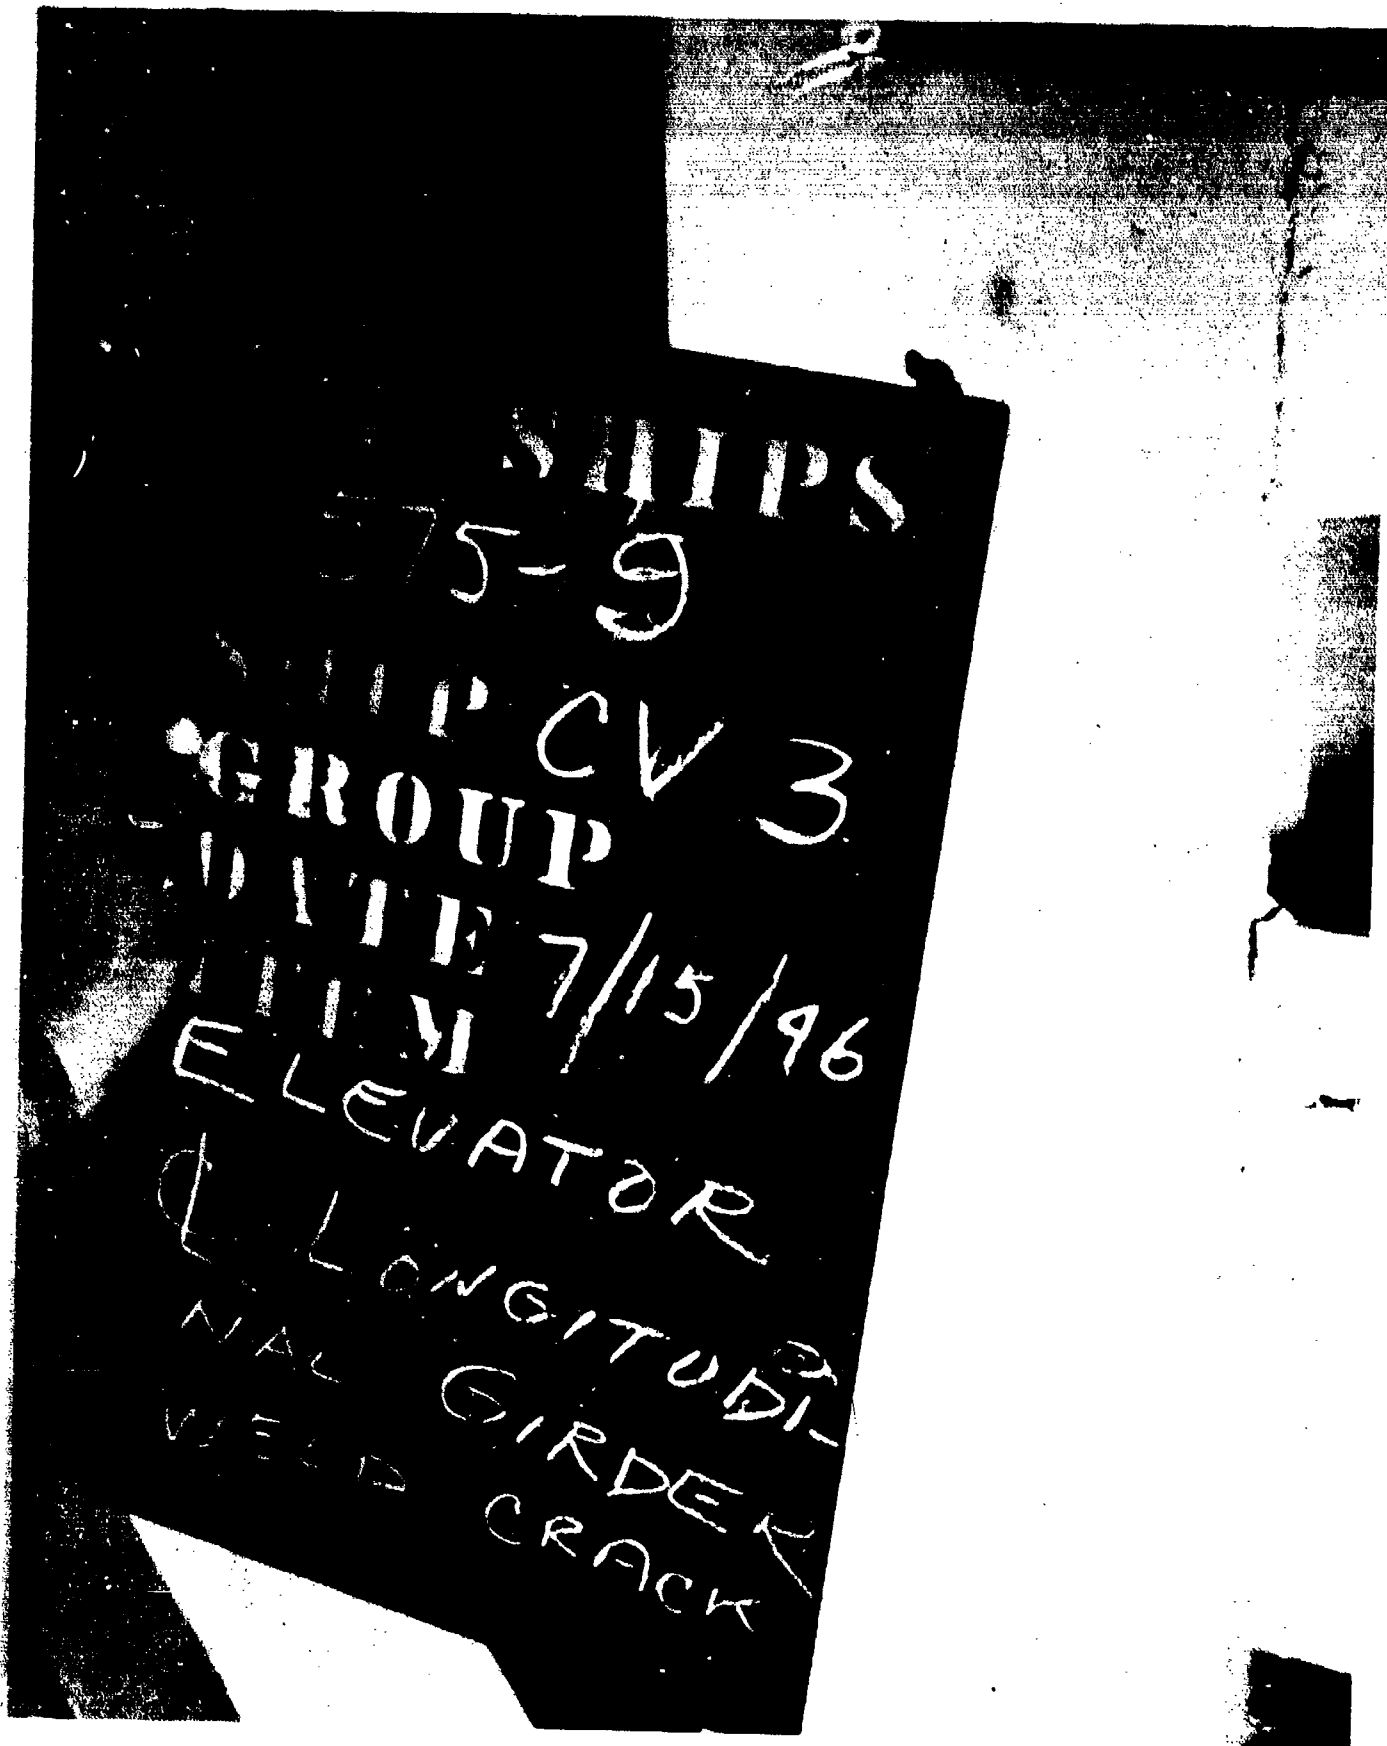
(c) The weld of the flange of transverse 2, port, to the centerline girder is cracked over half its length . Photograph 575-9, page 69 .

AA-CR-90-575-9. Centerline longitudinal girder of forward elevator showing cracked weld.
