**BUREAU OF SHIPS GROUP**  
**TECHNICAL INSPECTION REPORT**

**OPERATION CROSSROADS.**  
**U.S.S. RHIND (DD 404)**  
**TEST ABLE [U].**

**OPERATION CROSSROADS**

**JOINT TASK FORCE ONE**

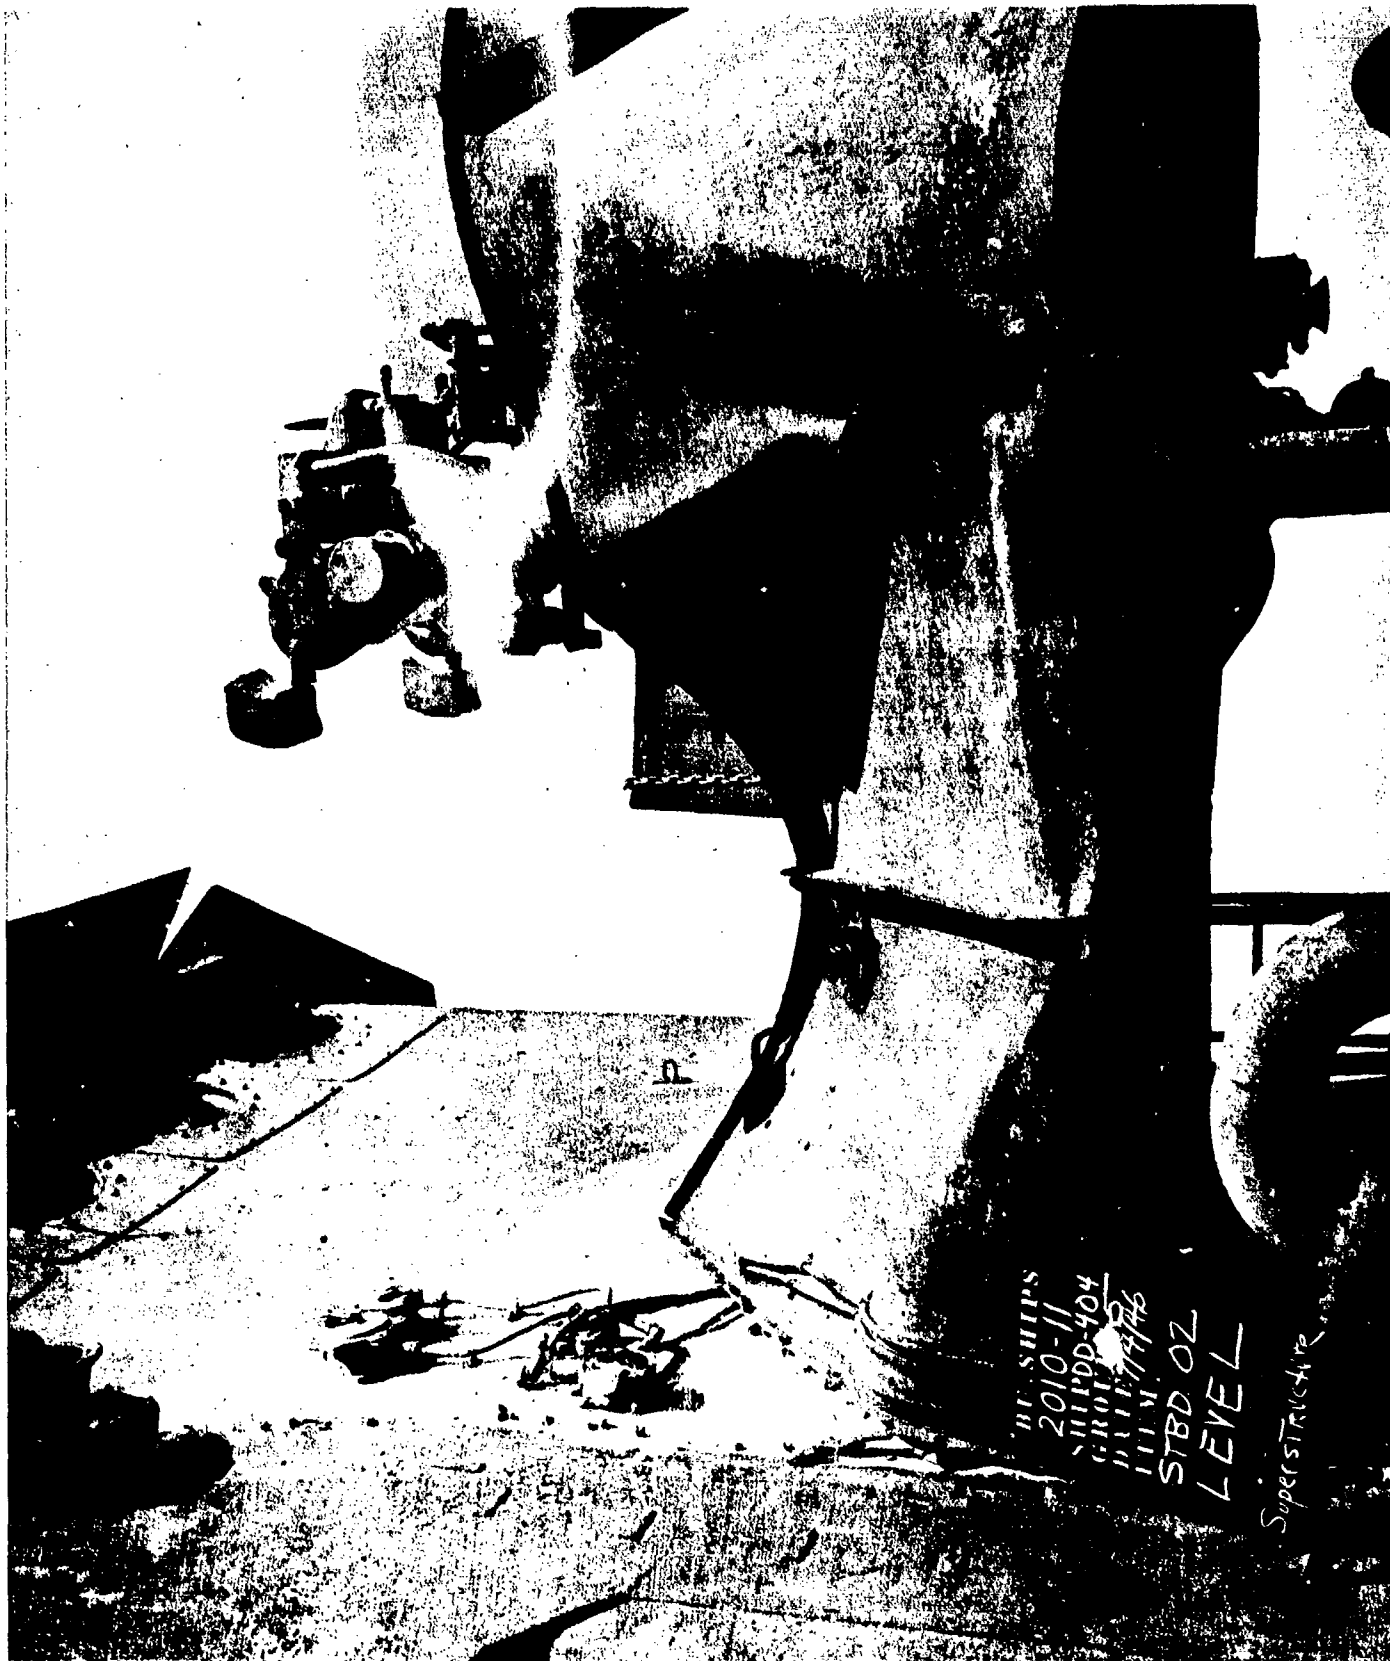
The forward bulkhead of the bridge is dished about two inches. Two brackets connecting the overhead girders and bulkhead stiffeners have failed. One panel of this bulkhead is opened slightly in way of a riveted seam where the rivets failed. (Photographs 2005-5, page 68, 2010-11, page 69, and 1721, page 70.)

AA-CR-58-2010-11. View looking athwartship in front of bridge, 02 level. Showing damage director shield and scorched paint on house.

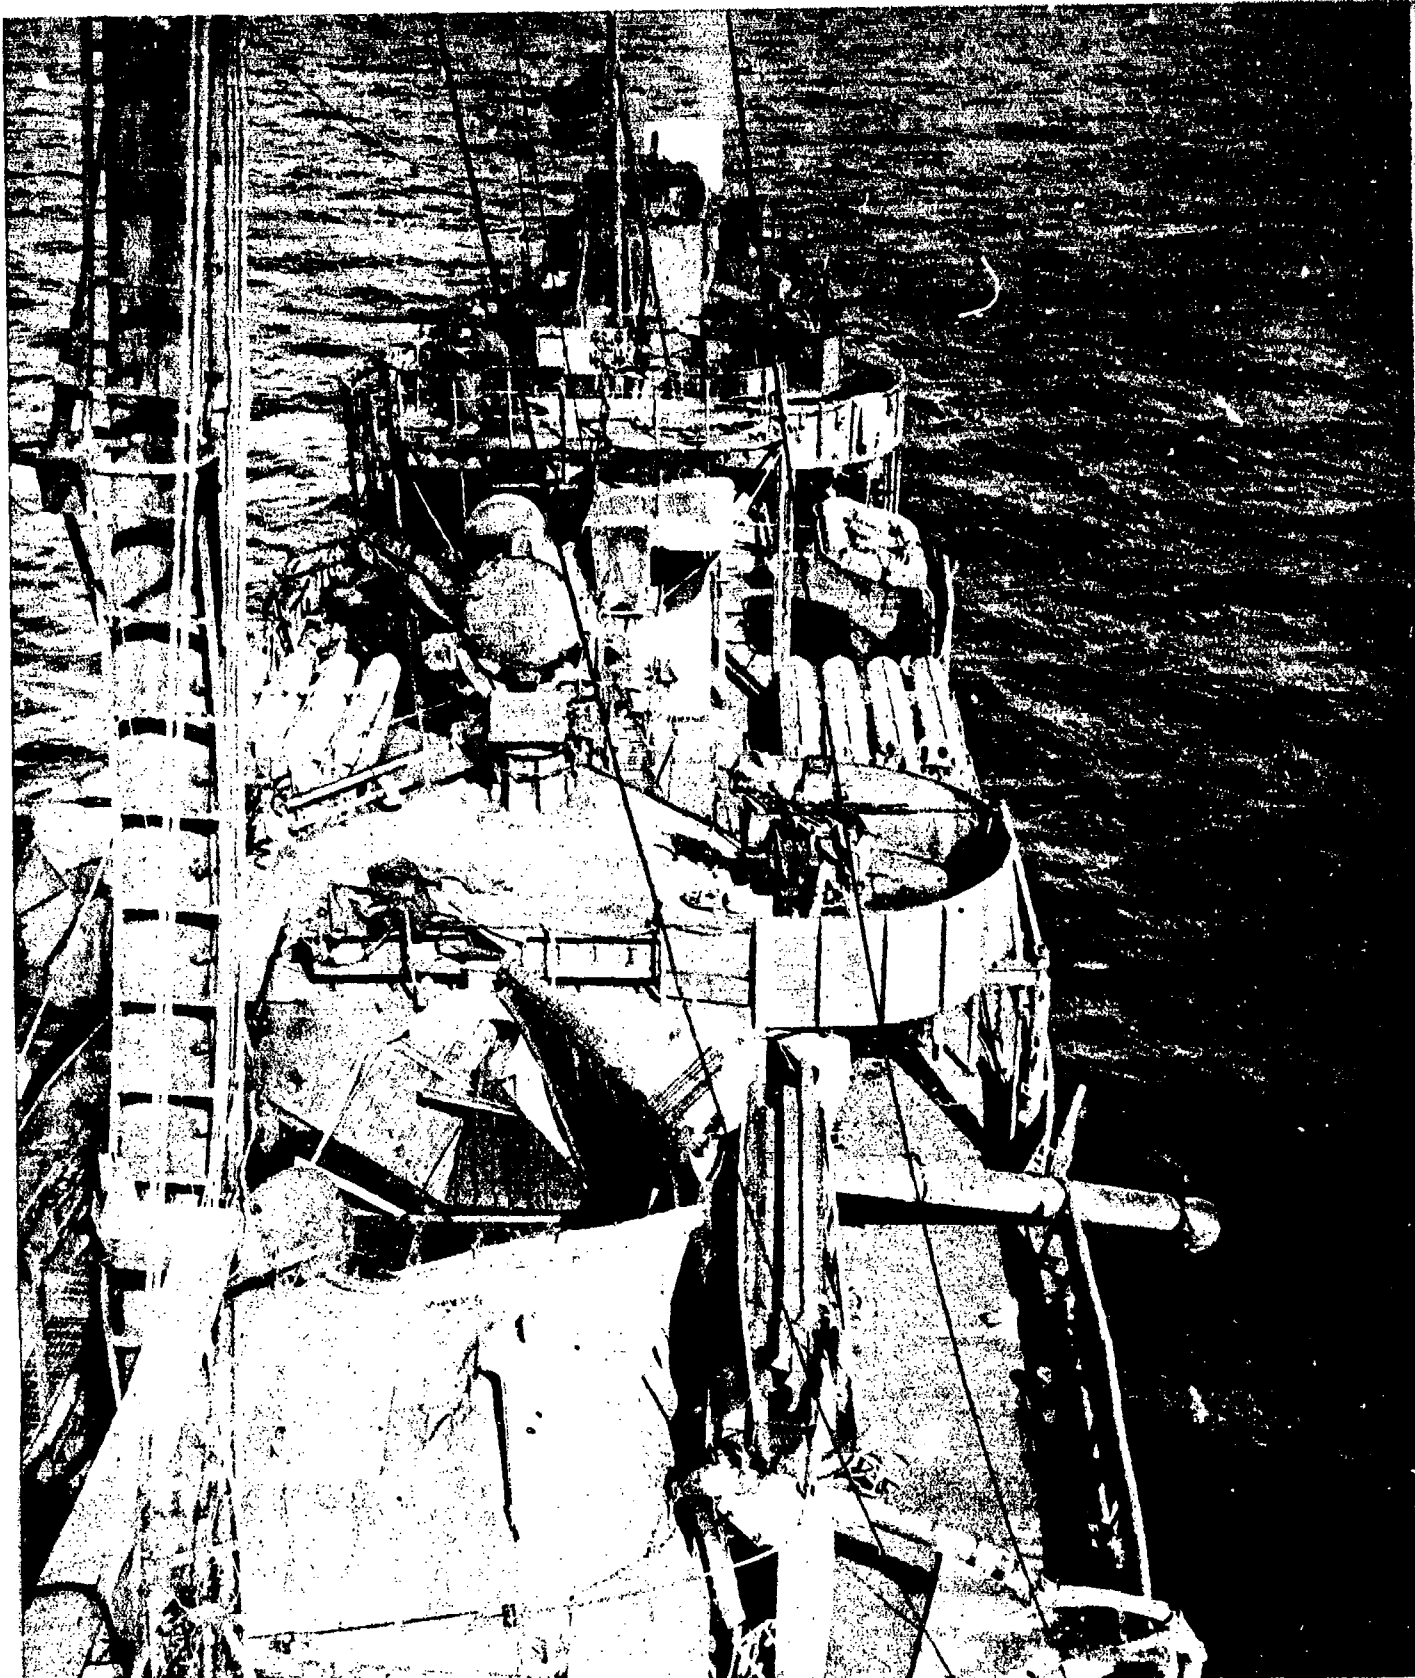
AA-CR-58-2010-9. General view of damage looking aft the length of the ship from the port side of the navigating bridge.

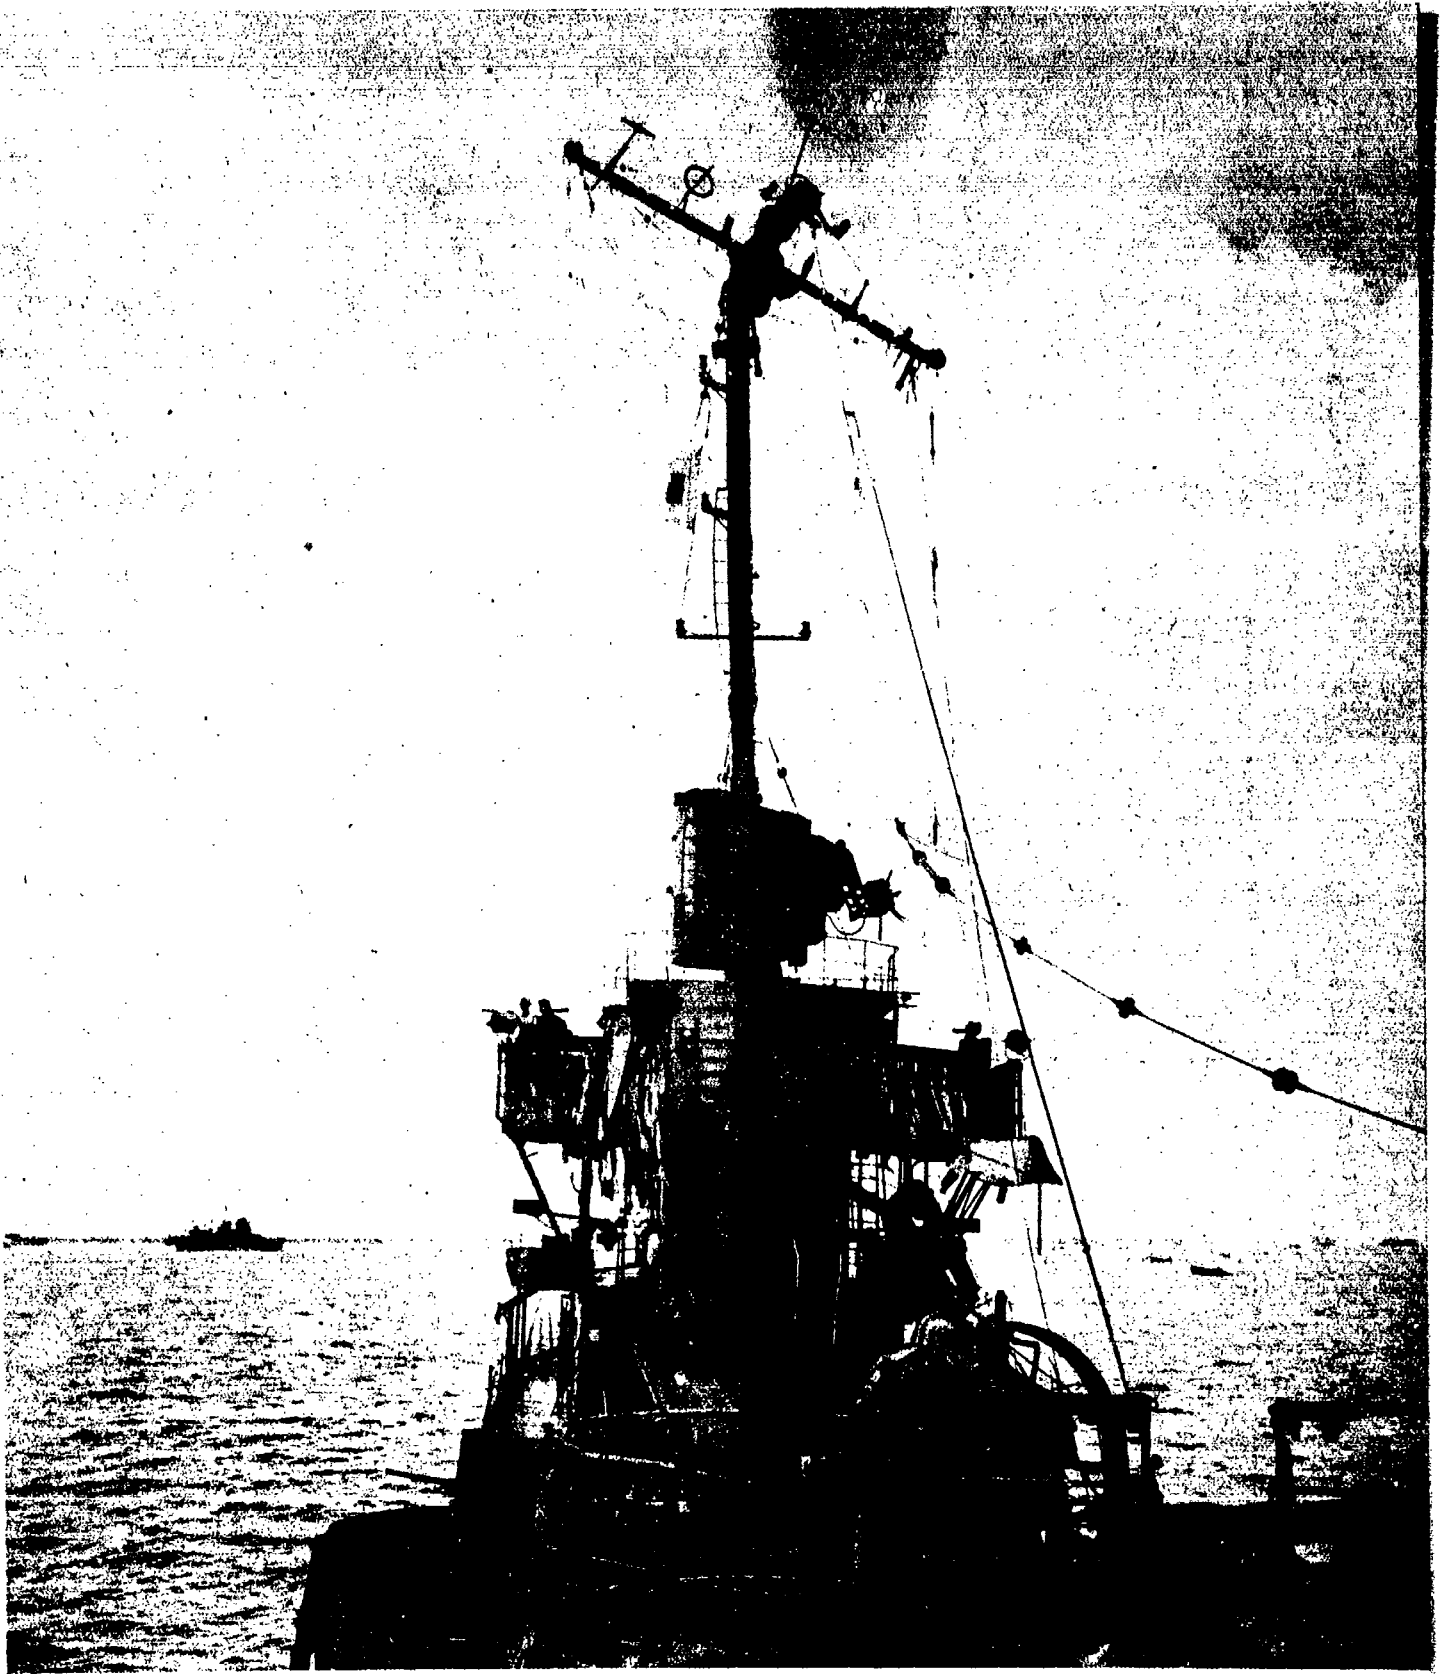
There is a general failure throughout of bulwarks, 20mm gun shields, life lines, stanchions, and other light metal work. Ladders are bent, twisted, and torn from their fastenings, but in no case are the ladders unusable. Catwalks, too, are distorted. Especially the catwalk from the forecastle deck, aft, which is almost impassable in places. All radar antennae are either down or broken. Whip antennae, although broken, bent, or twisted seem to stand up best and are still serviceable after the test. (Photographs 2005-5, page 68, 2010-11, page 69, 1772-1, page 70, 1771-11, page 73, 2005-3, page 74, 2010-10, page 75, 2010-8, page 76, 2010-9, page 77, 2003-11, page 78, 2003-10, page 79, 2003-2, page 80, 1817-3, page 81.)

AA-CR-58-2003-11. View looking forward from after deck house showing damage amidships.

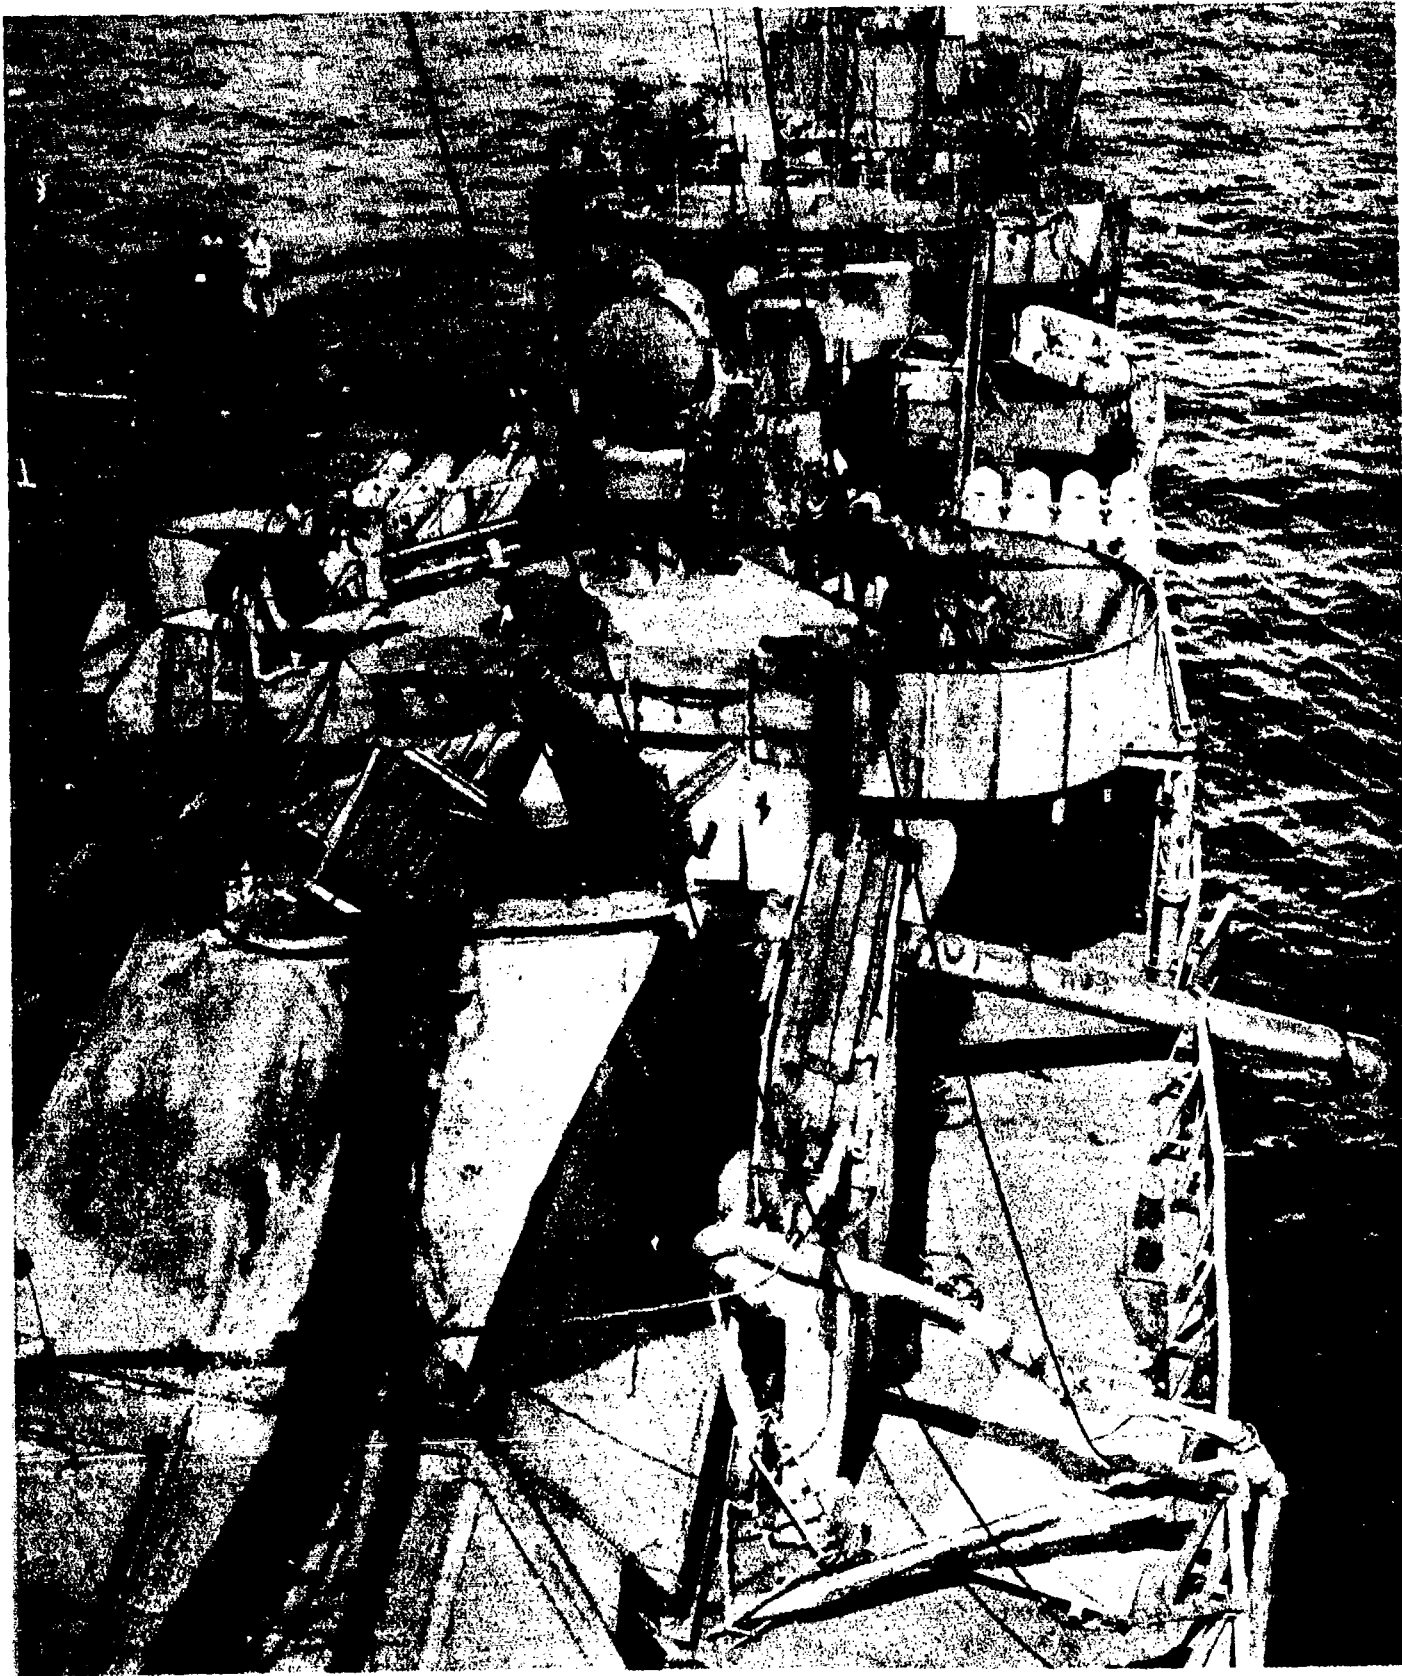
AA-CR-58-2003-10. View looking aft from port side of navigation bridge.

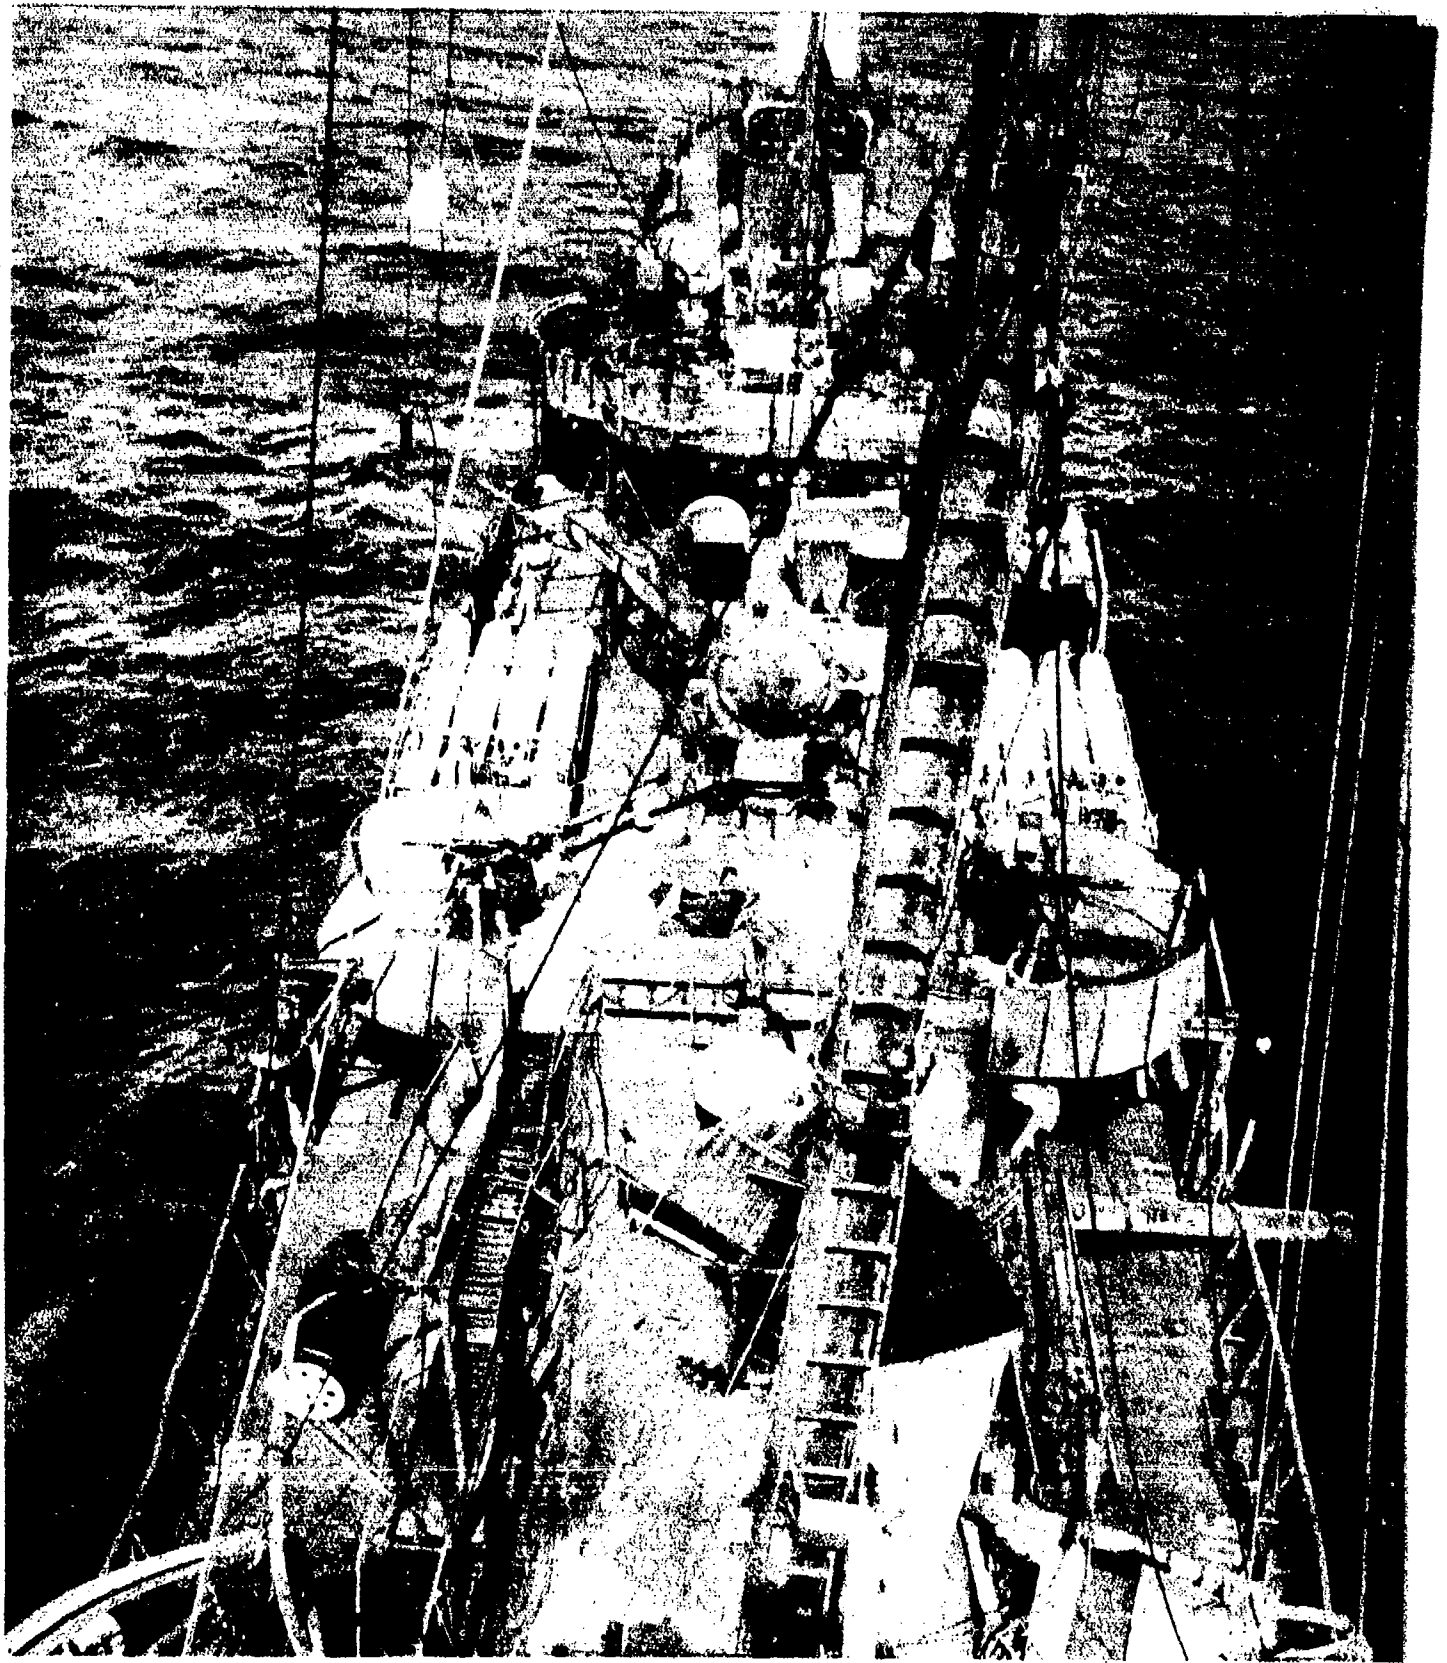
The foremast is severely damaged and twisted, rendering inoperable all radar antennae not torn off. The wave guide on the after side of the mast is broken and twisted. The foremast is bent aft and to port at the top of the main deck supporting brackets. About twelve feet above this point the mast is further bent in the same direction. A third kink occurs just above the padeyes to which the lower mast guys are secured. The forward guys are parted. The after guys have about 14 inches of slack. There is a further sharp bend just below the yardarm level. The yardarm is askew with respect to the rest of the mast. All signal halyards are either burned completely or torn off. (Photographs 2003-11, page 78 , 2003-2, page 80 , 2003-4, page 83 , 2200-2, page 84 , and 2200-9, page 85 ).

AA-CR-58-2003-2. View looking aft the length of the ship from sky lookout forward.

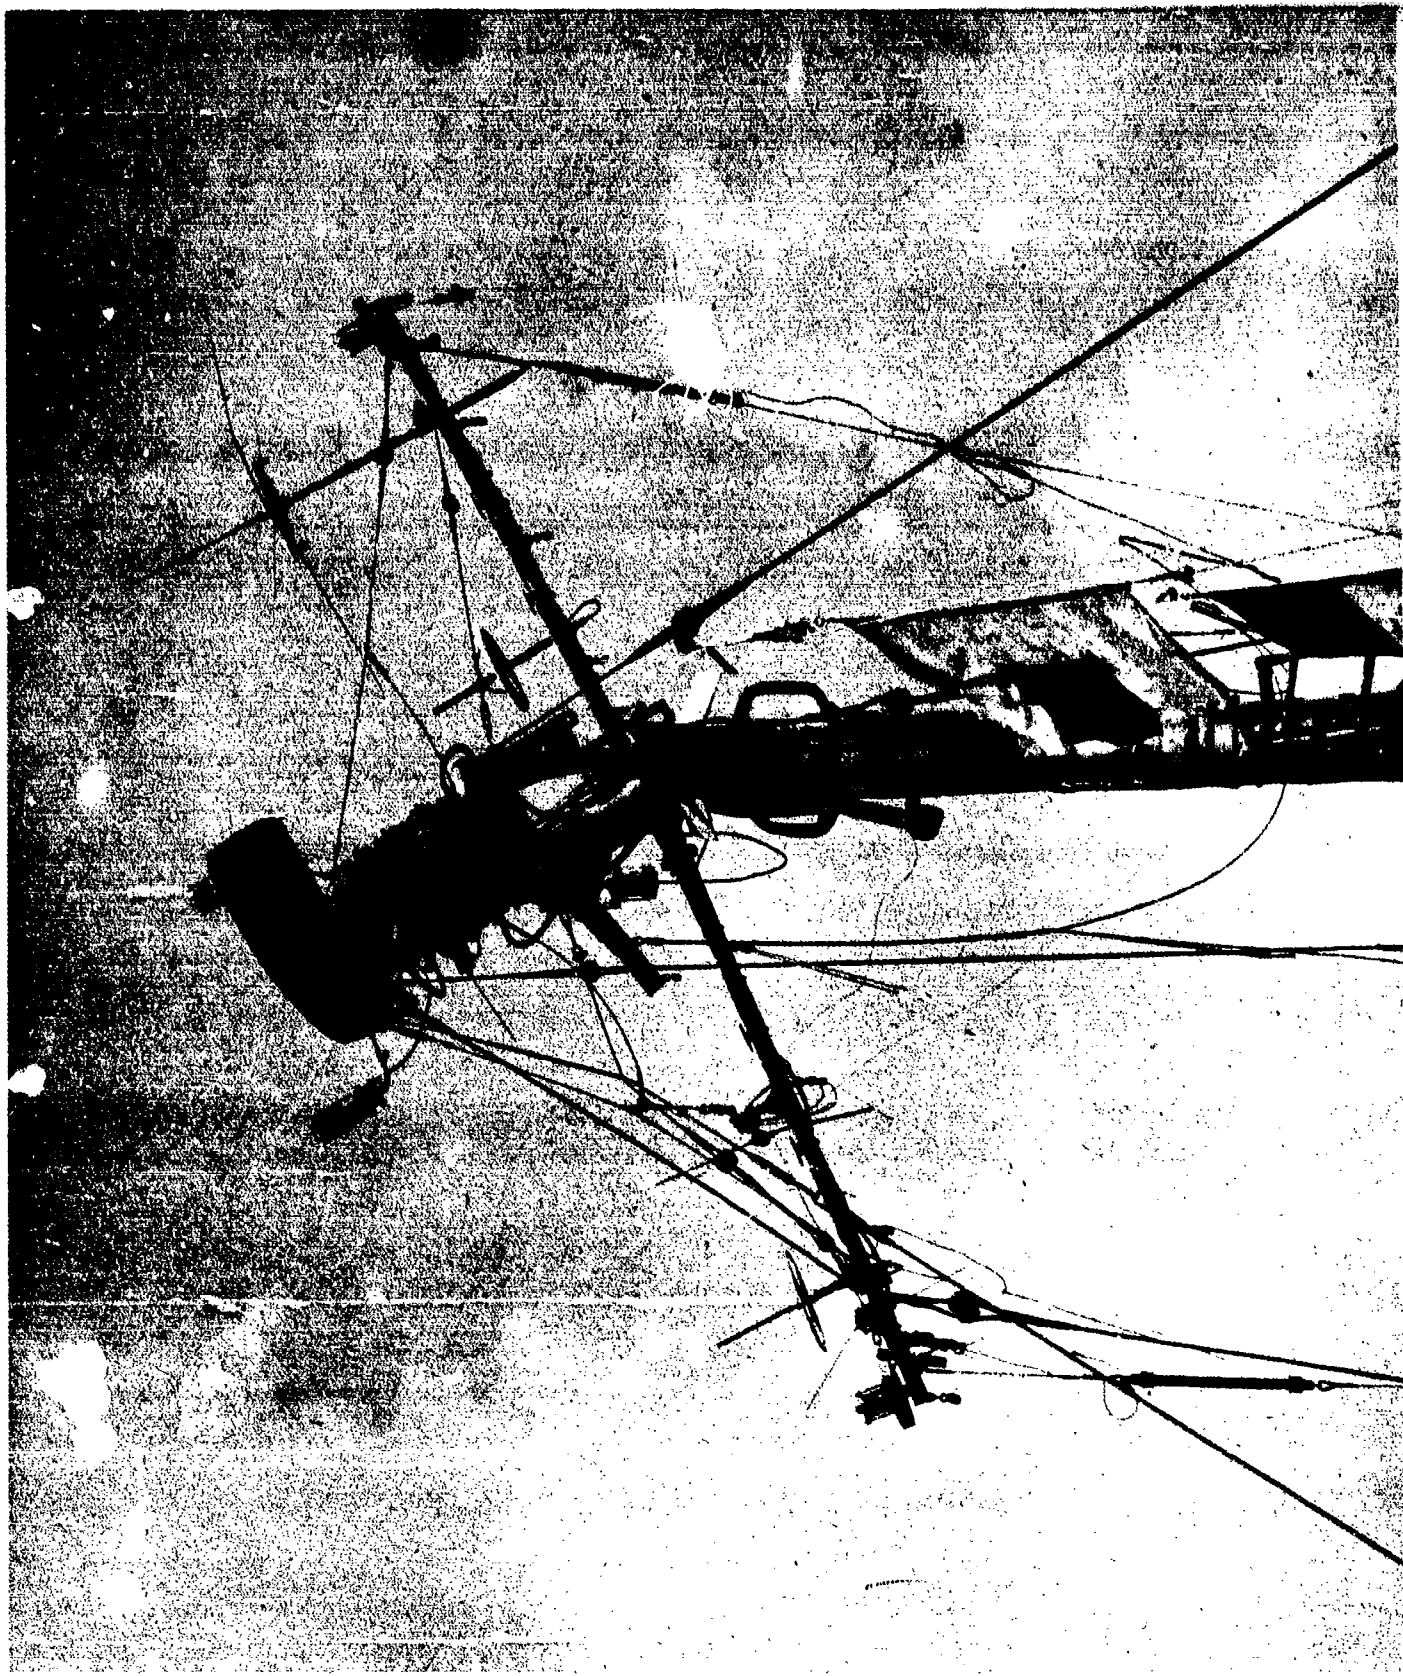
AA-CR-58-2003-4. View of foremast top from director platform.

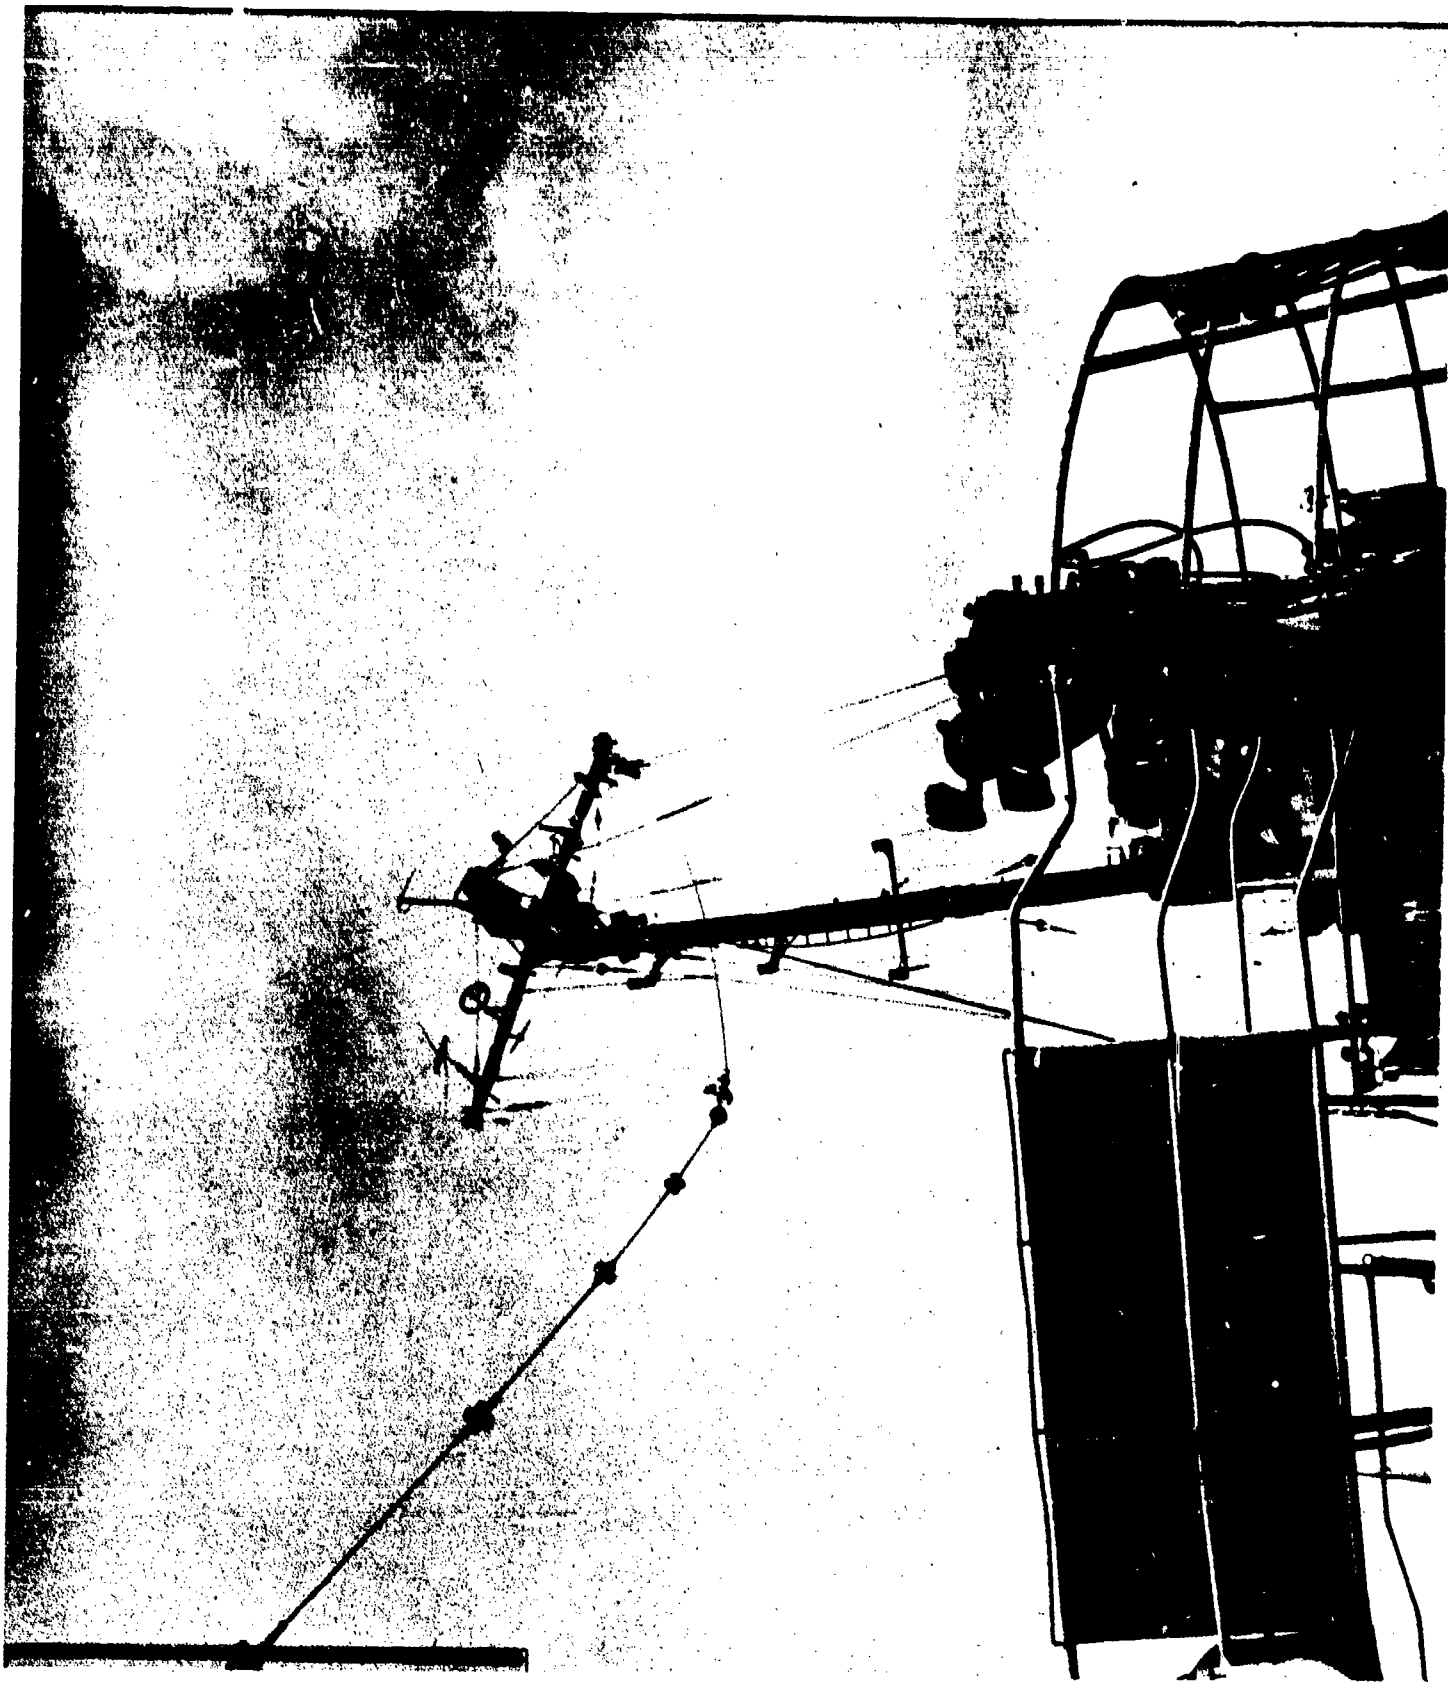
AA-CR-100-2200-9. View of foremast damage looking forward.

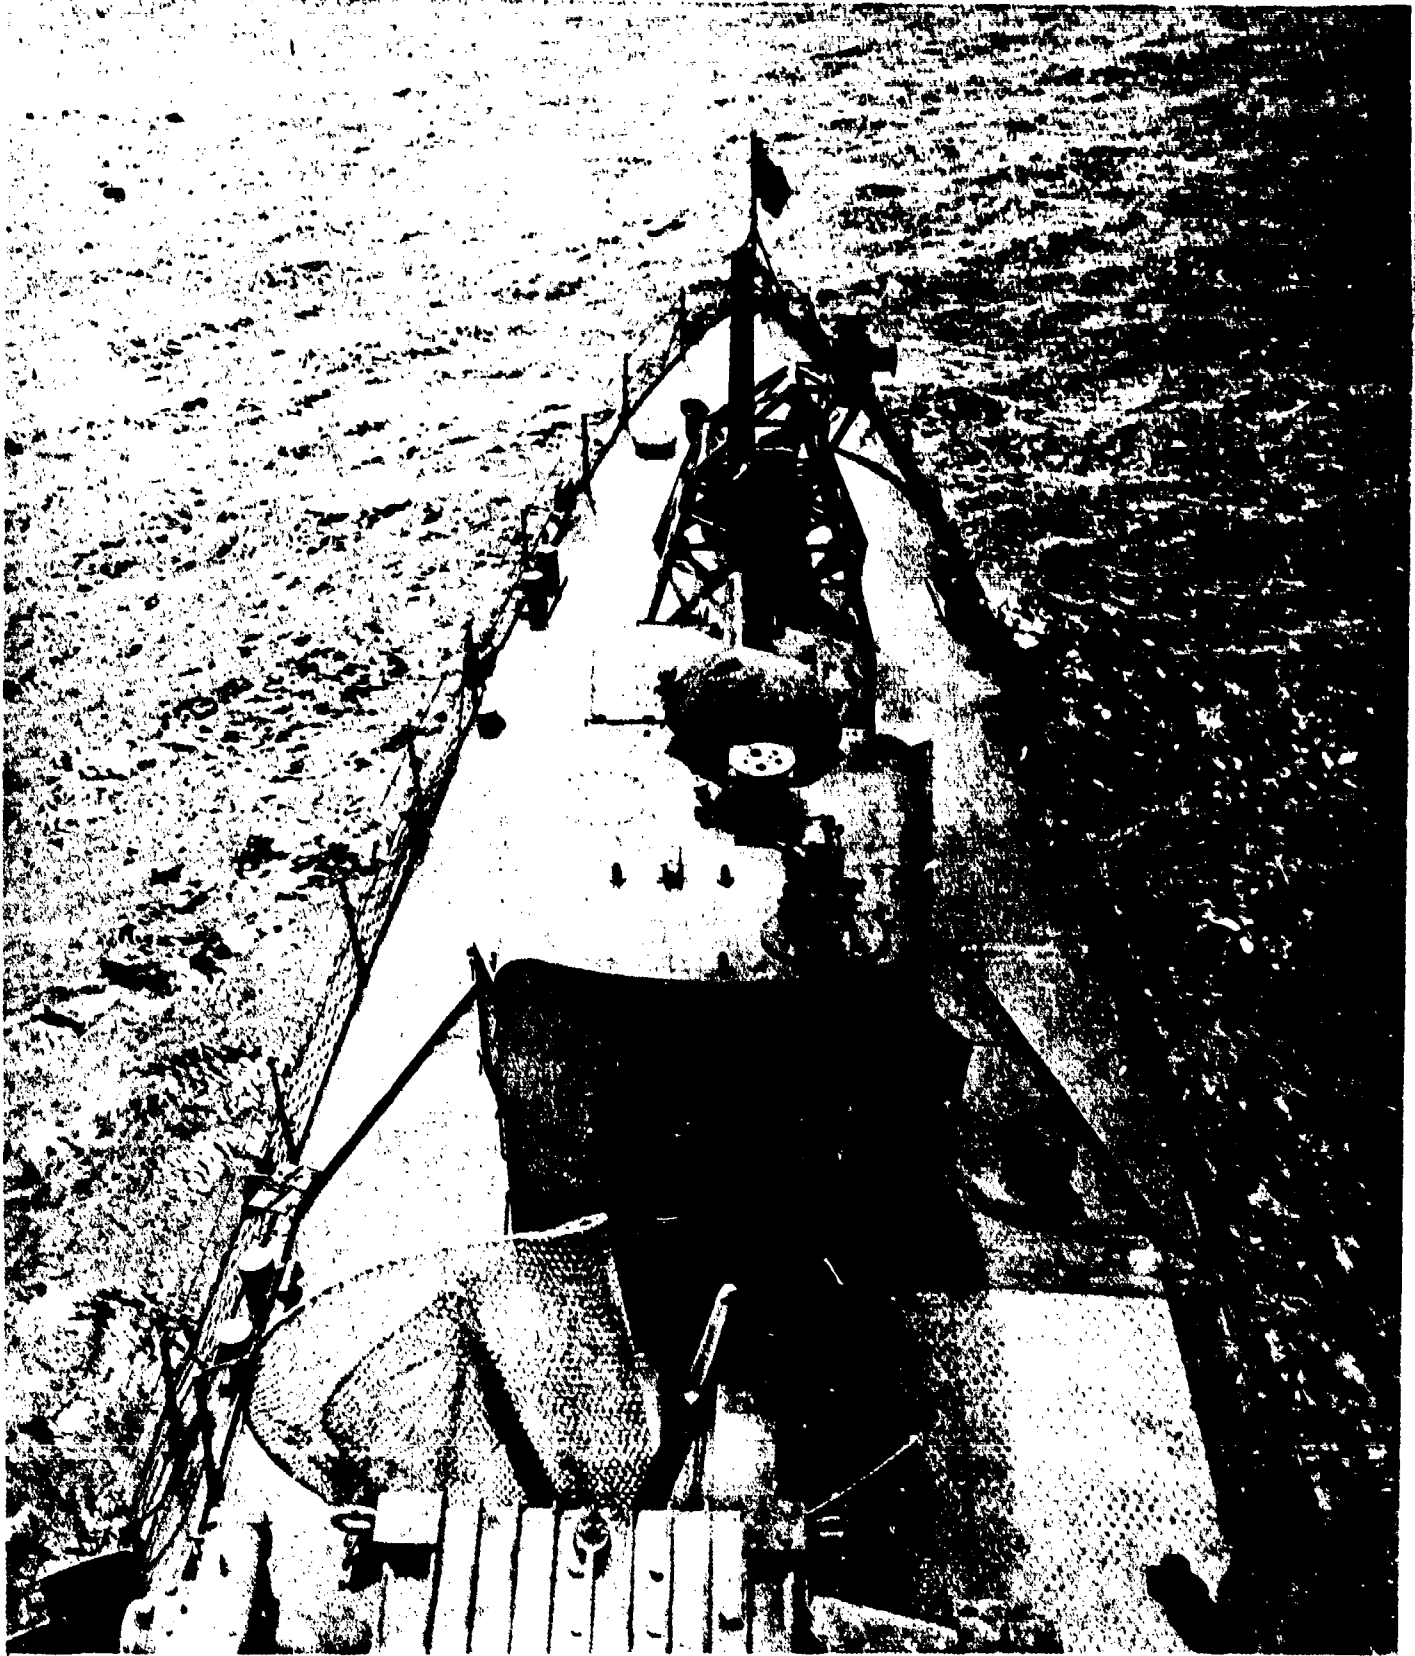
AA-CR-58-2003-3. View showing damage forward looking from sky look-out forward.

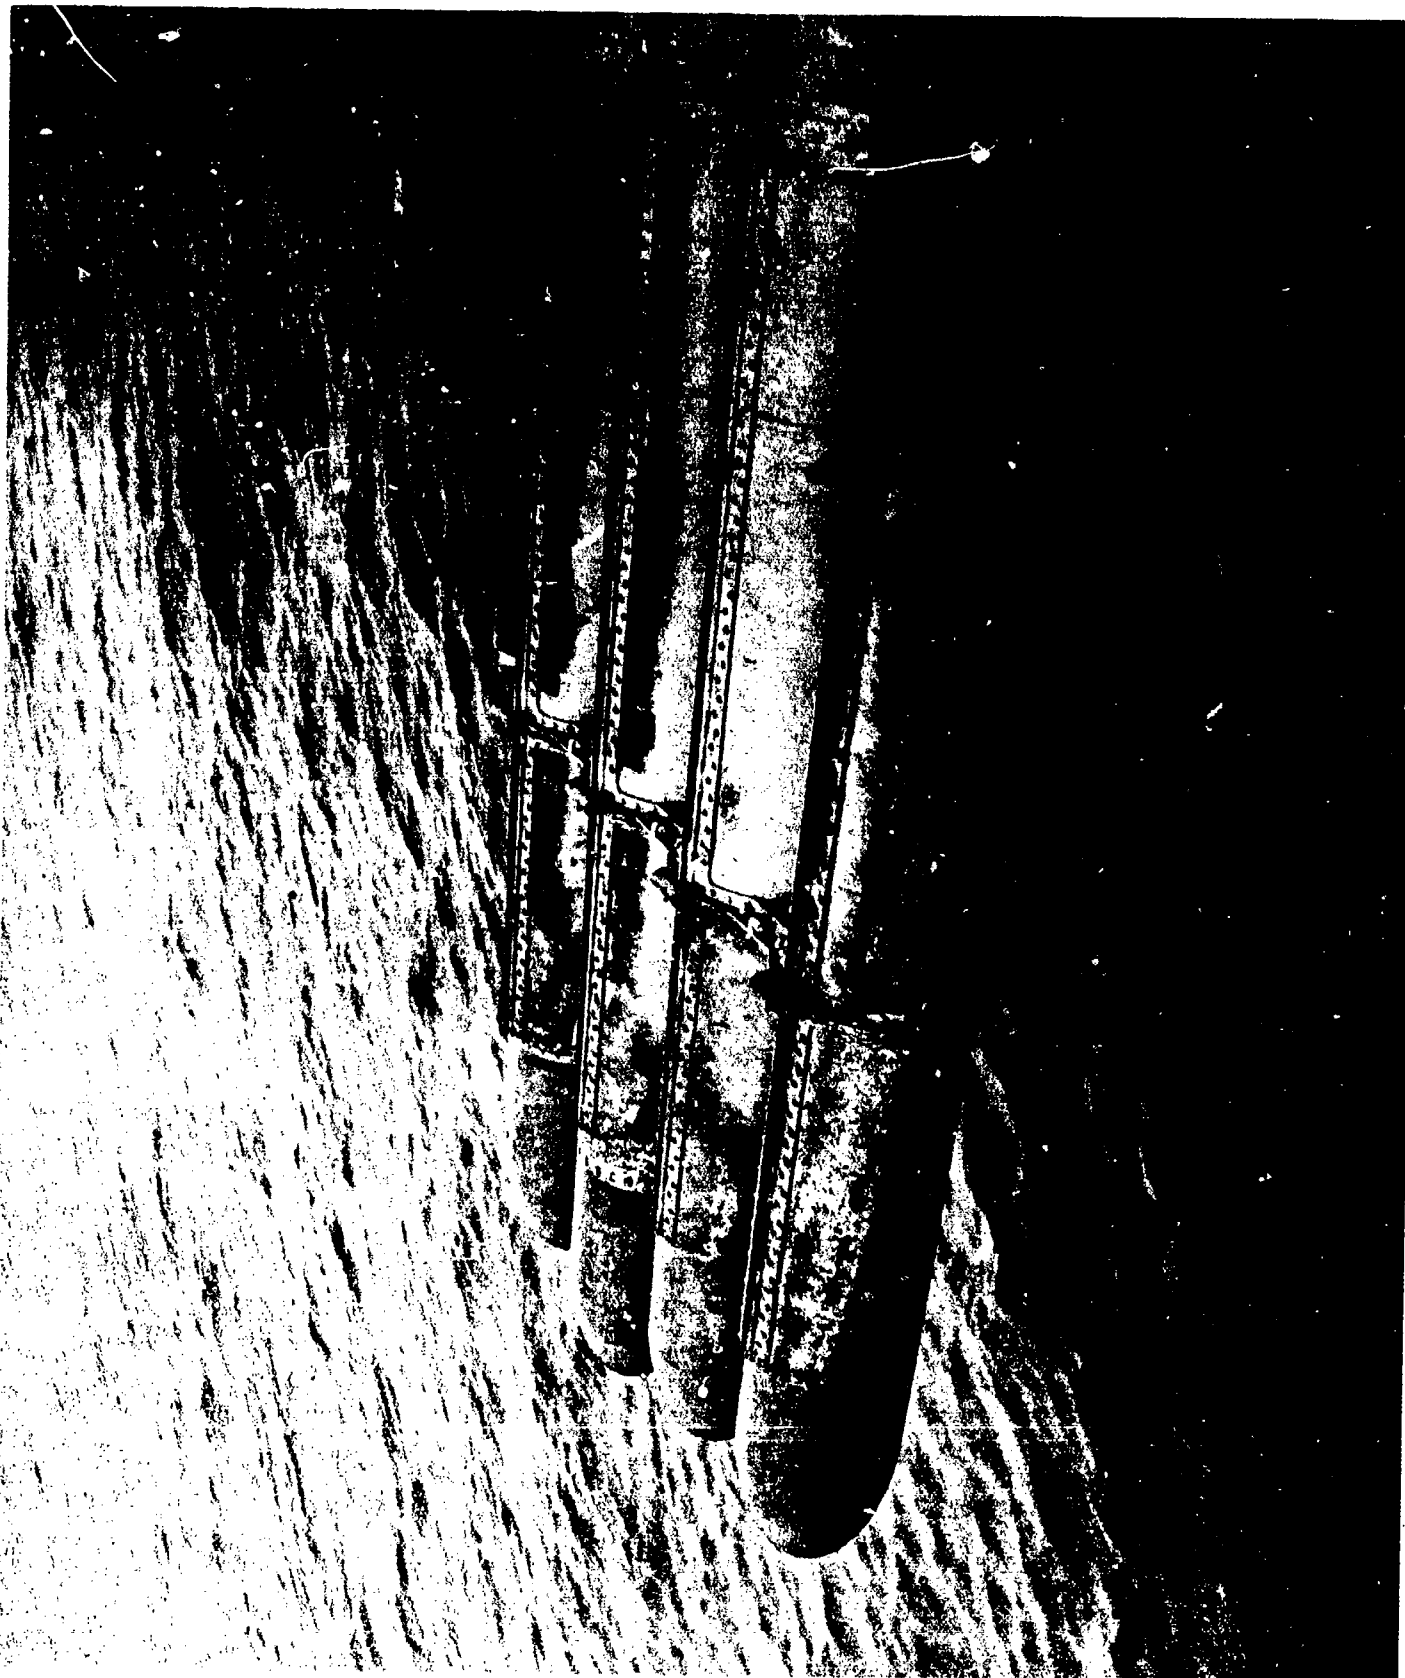
There is no material damage to the torpedo mounts. The torpedoes in the port mount, which was trained to 270 degrees, were knocked loose and now extend about three feet out from their normal position. This movement was caused by either the rapid roll and/or the high speed lateral displacement of the ship in the water caused by the blast pressure. The motion of the vessel and the inertia of the torpedoes produced a resultant force sufficient to break the tension lock holding the torpedoes in place. This force did not operate either the inertia starter or the starting lever. The torpedoes did not run and still have full air charges (photograph 1772-2, page 89 ).

AA-CR-92-1772-2. View looking aft along starboard side showing torpedoes extending from tubes as a result of Test A.
