**BUREAU OF SHIPS GROUP**  
**TECHNICAL INSPECTION REPORT**

**OPERATION CROSSROADS.**  
**U.S.S. RHIND (DD 404)**  
**TEST ABLE [U].**

**OPERATION CROSSROADS**

**JOINT TASK FORCE ONE**

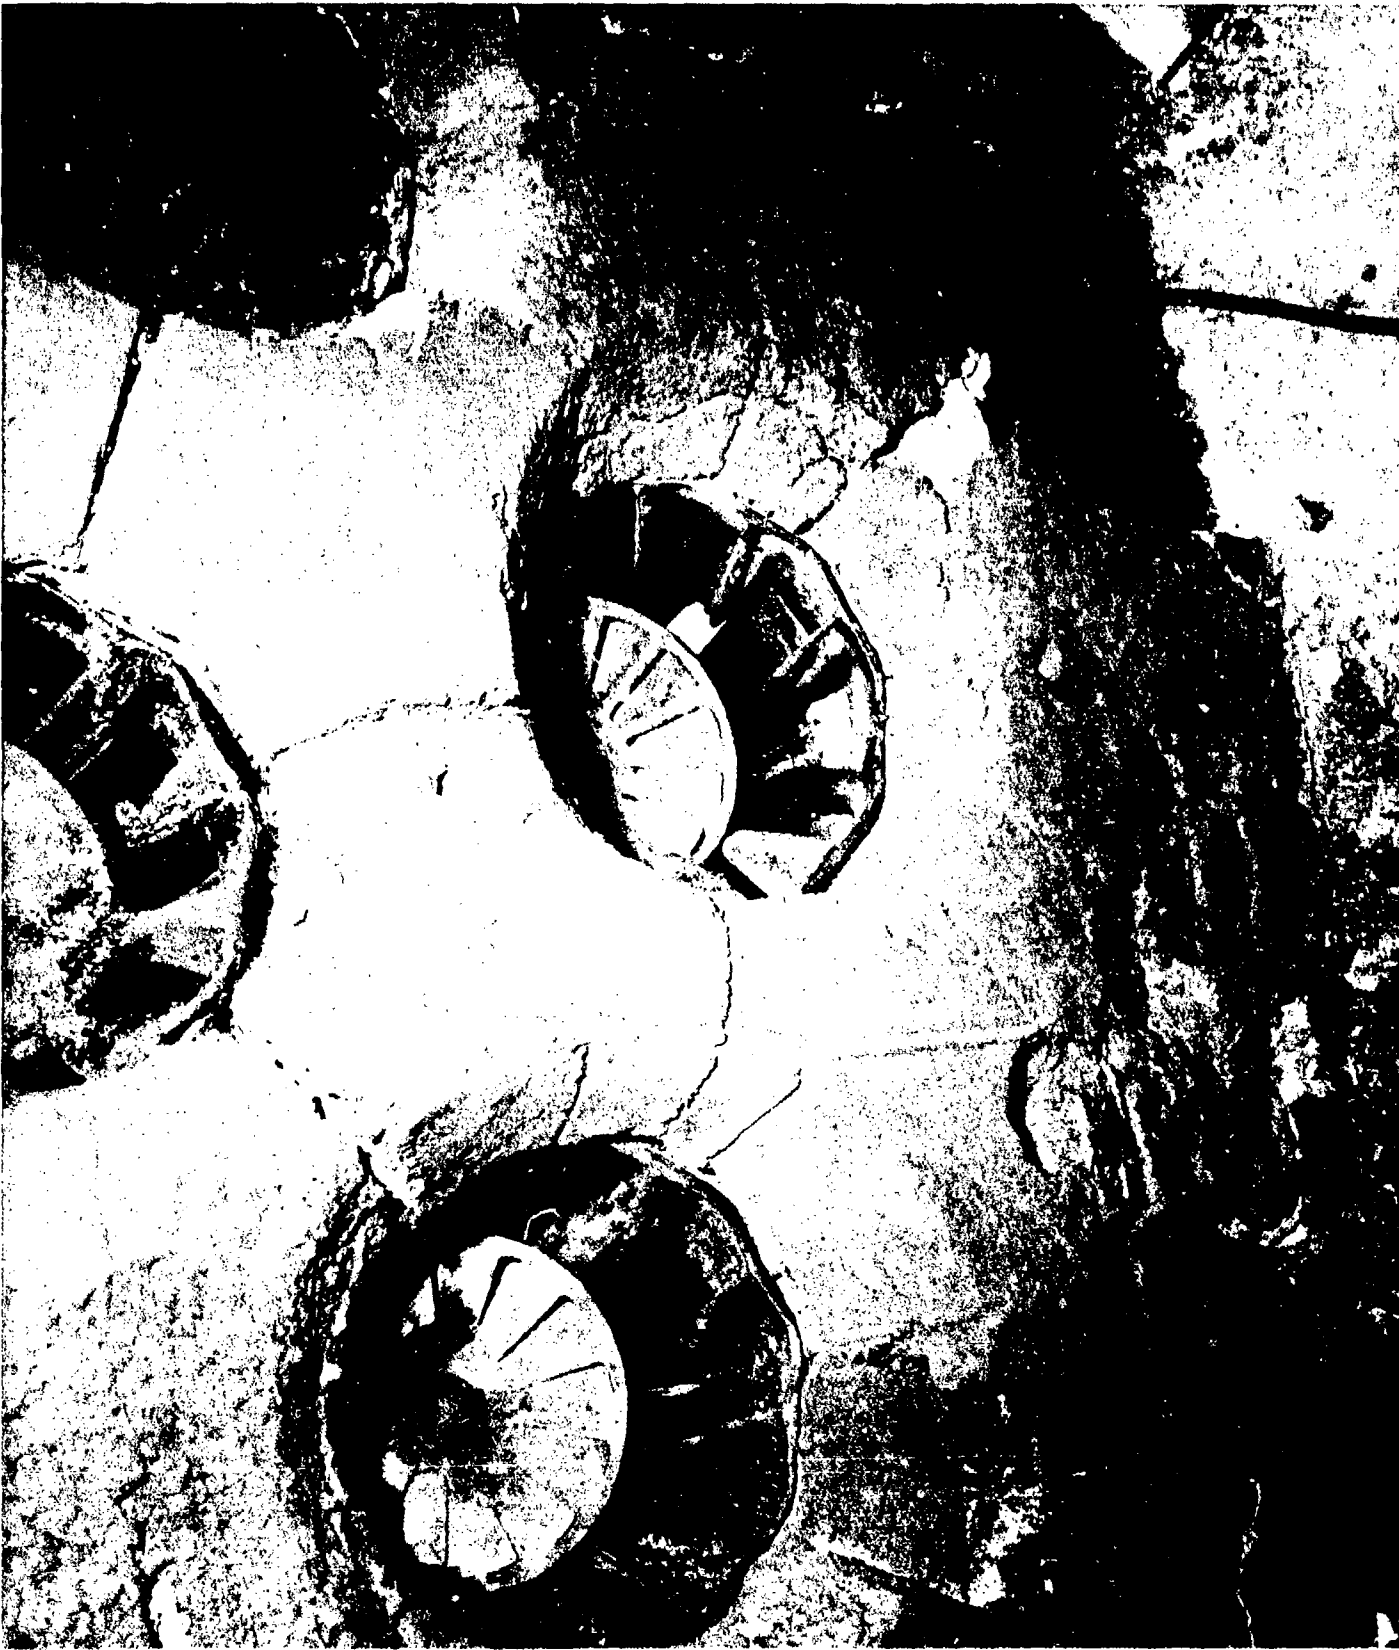
The brickwork of boiler #1 was severely damaged. Damage to stack and uptake breeching is described under (b) above. The steam line to whistle and siren, and the atmospheric exhaust pipe, which are attached to the stack, were bent into "U" shape and are hanging over the port side. The whistle and siren went overboard with their piping. The starboard motor whaleboat engine was badly damaged. Several nipples in small piping were broken.

Boiler #1 is inoperable. Repairs to brickwork could be made by the ship's force in about 3 days. All other damage to machinery is minor and would not affect operation. Damage to the stack would prevent operation except at low speed and under favorable wind conditions, because of stack gasses entering the engine rooms' ventilation. Emergency repairs to the uptakes breeching and the stub stack requiring about 1 day would improve this condition, but not sufficiently to permit normal operation. The atmospheric exhaust line, which was bent over and flattened, had to be punctured to allow steaming of any boiler.

AA-CR-58-2003-8. No. 1 boiler cracked front wall.

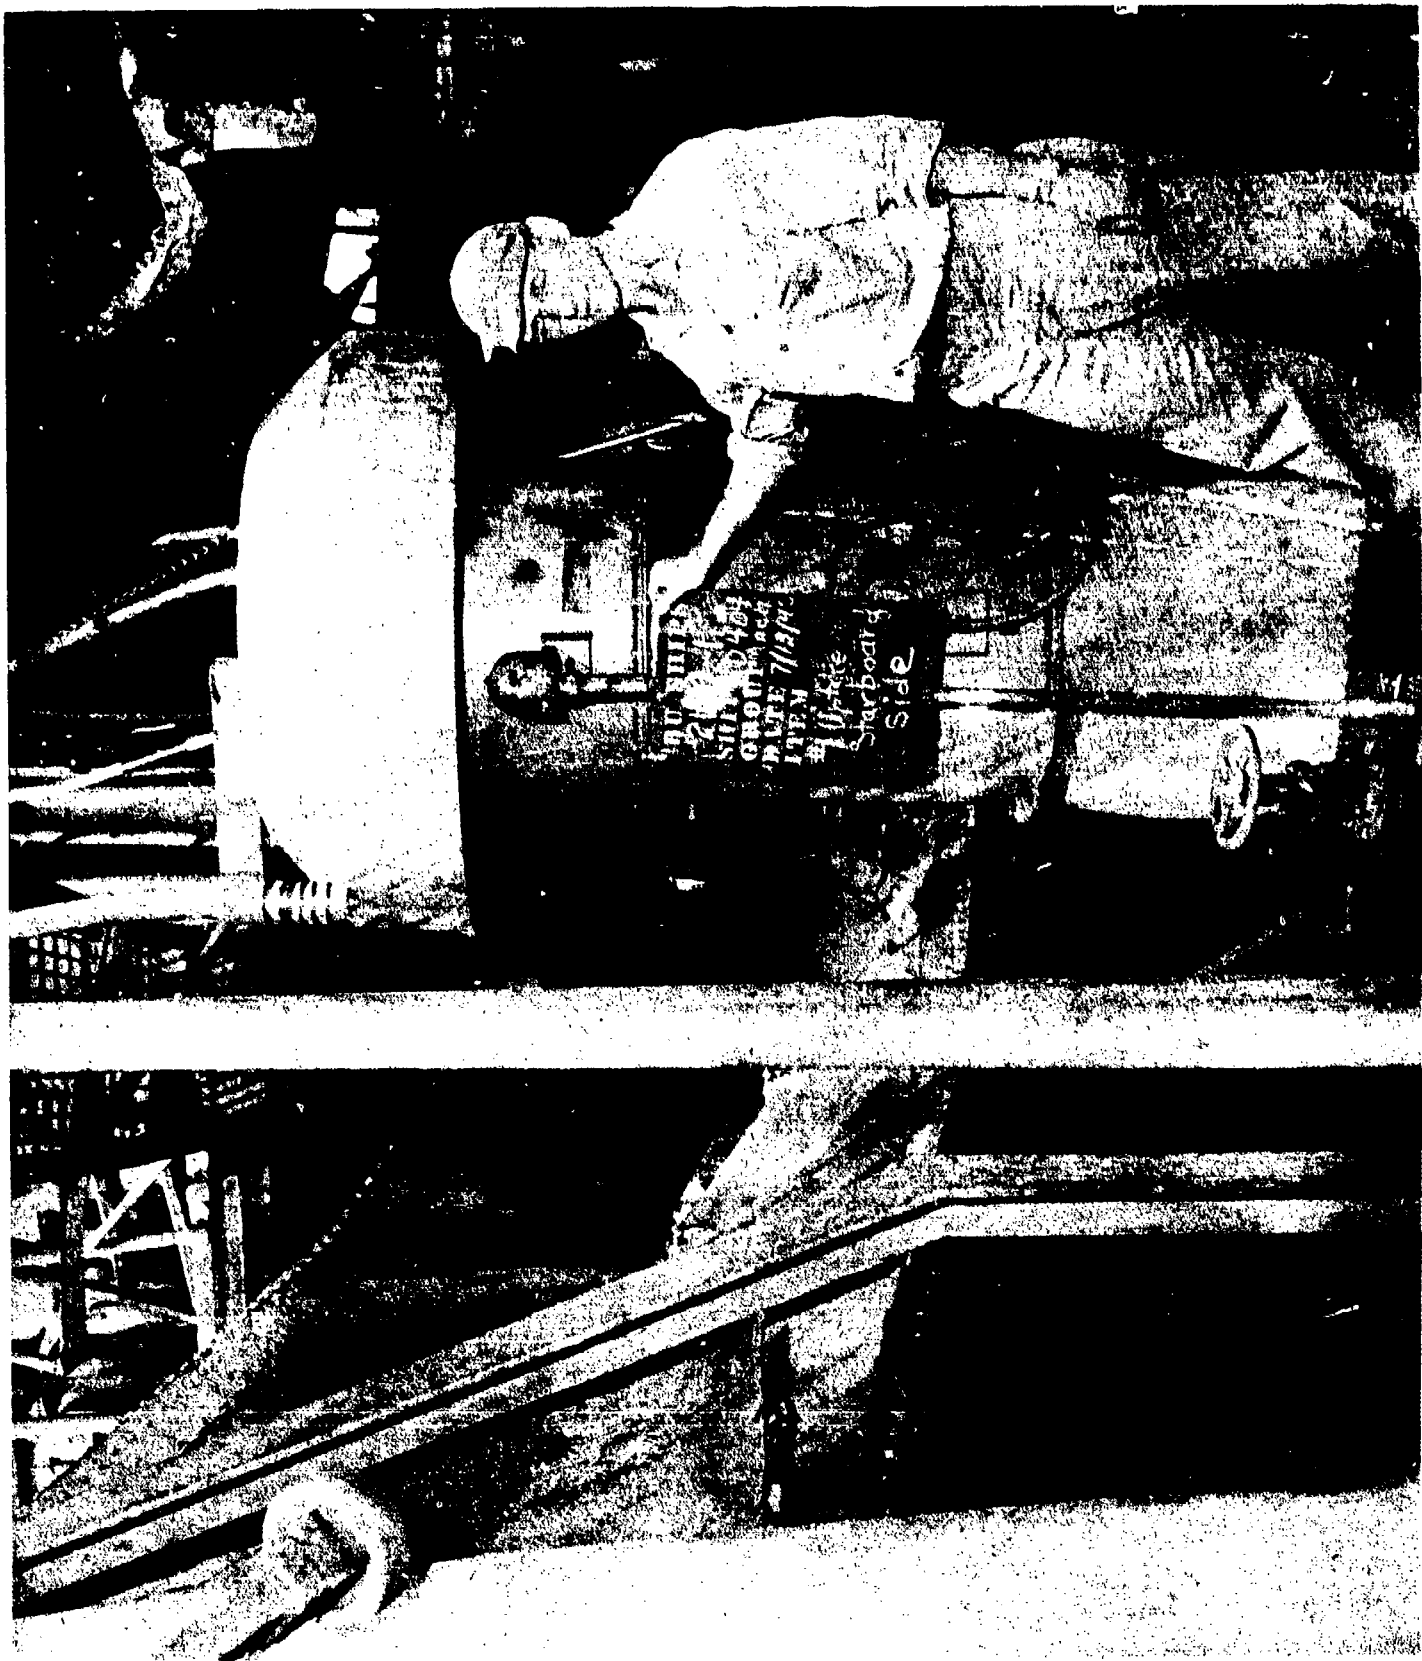
AA-CR-62-2170-1. No. 1 uptake, starboard side.

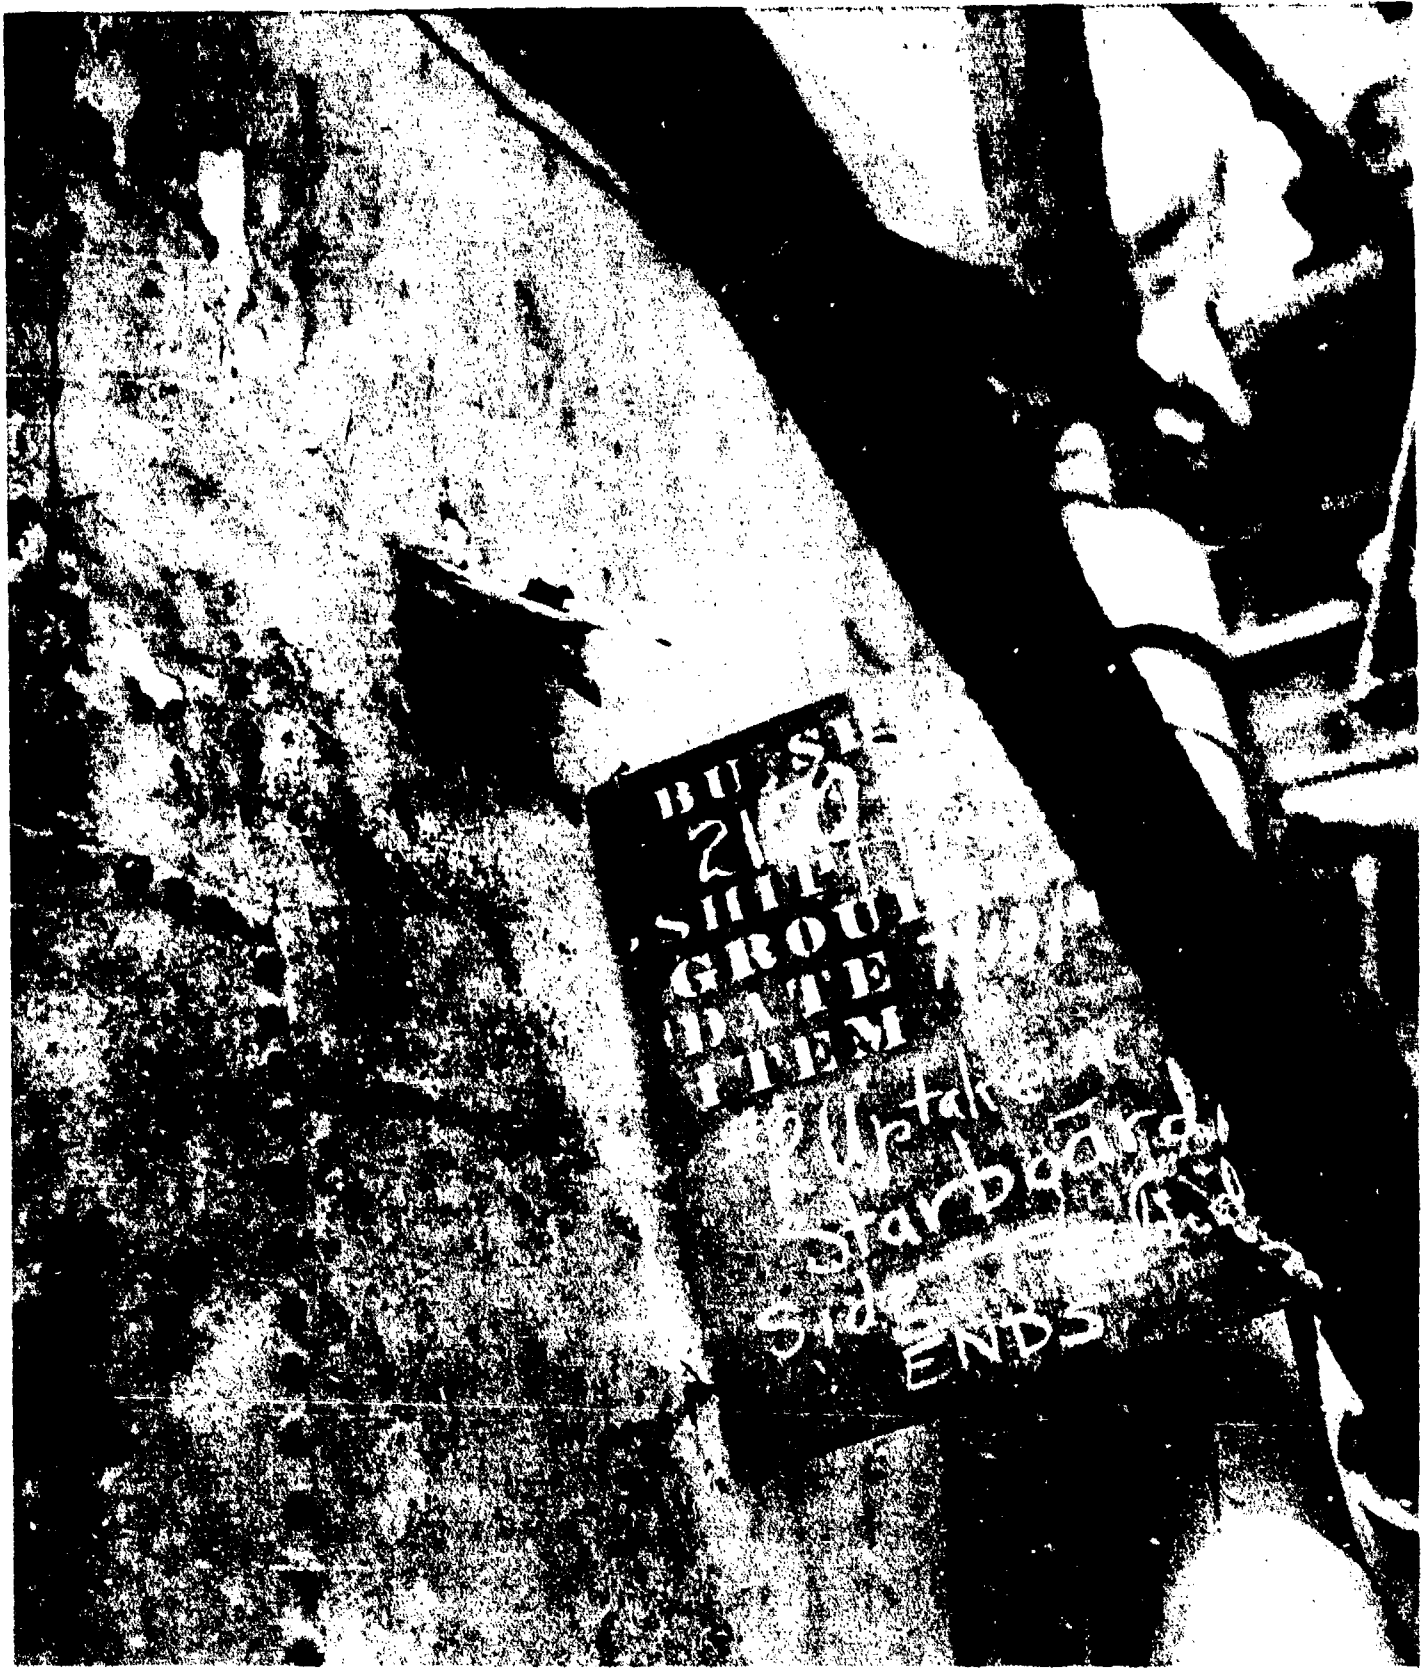
AA-CR-62-2170-4. No. 2 uptake, starboard side.
