BUREAU OF SHIPS GROUP TECHNICAL INSPECTION REPORT

U.S.S. STACK (DD 406)

TEST ABLE [U].

OPERATION CROSSROADS

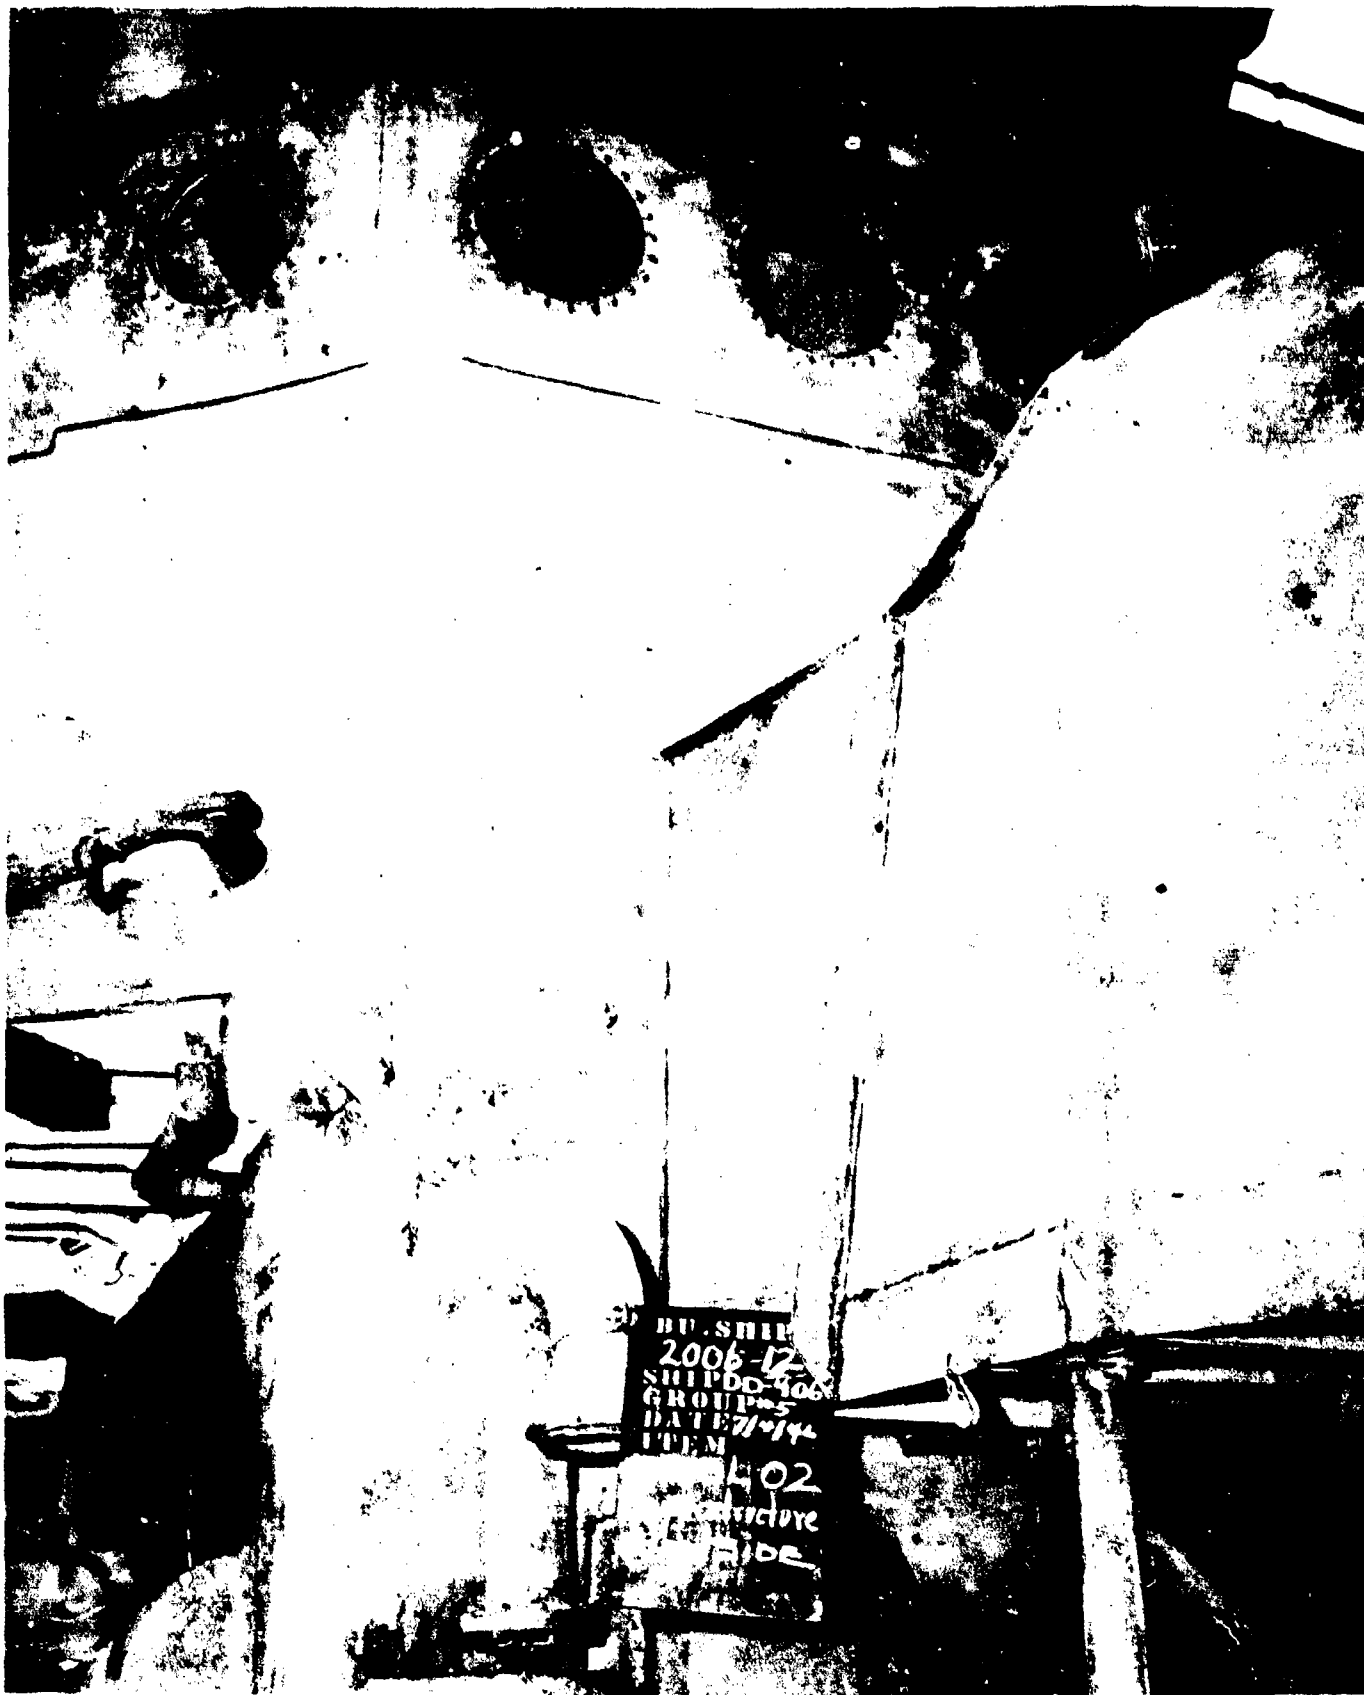
AA-CR-58-2006-12. Looking up and aft from superstructure deck showing forward face of pilot house and damage to Mark 51 director bulwark.

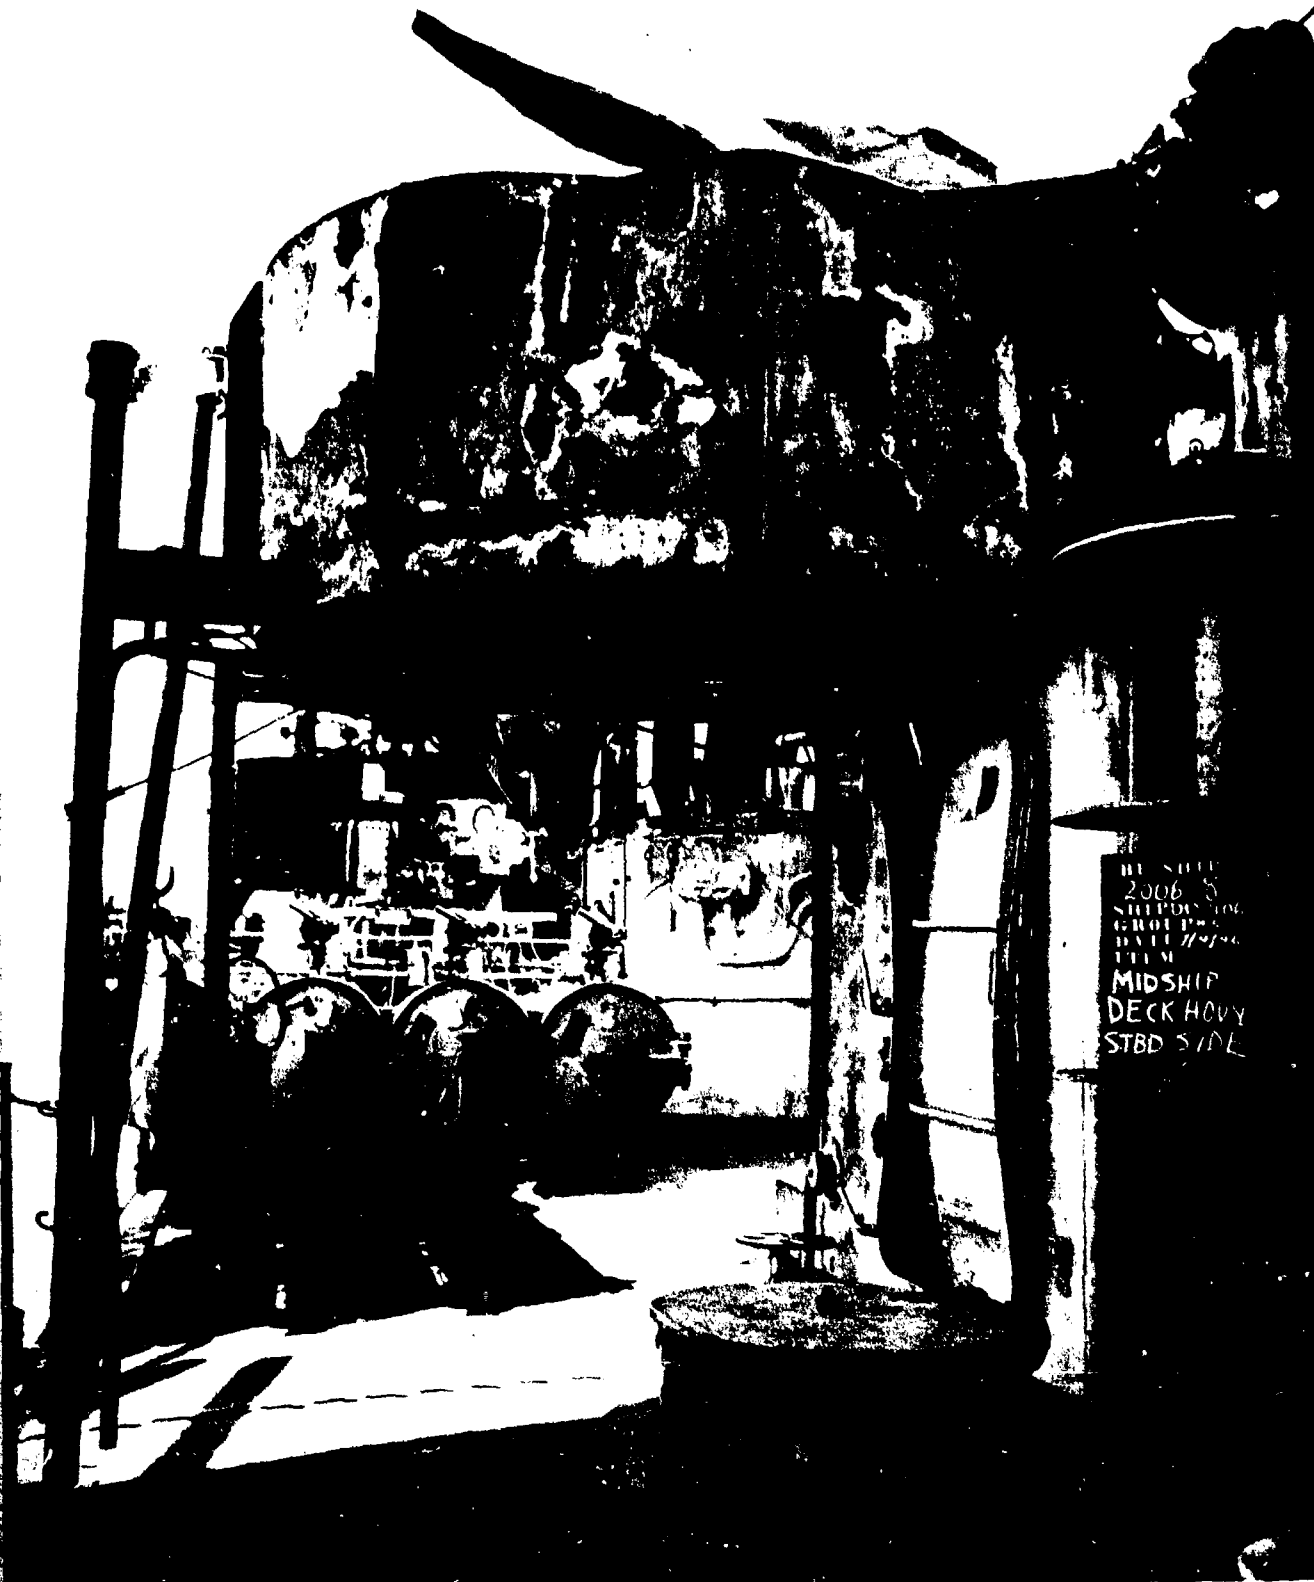
AA-CR-58-2006-8. Looking aft on main deck, starboard, showing distortion of 20 MM gun bulwark at frame 100 and dishing of bulkhead and door in way of Engineer's Log Room.

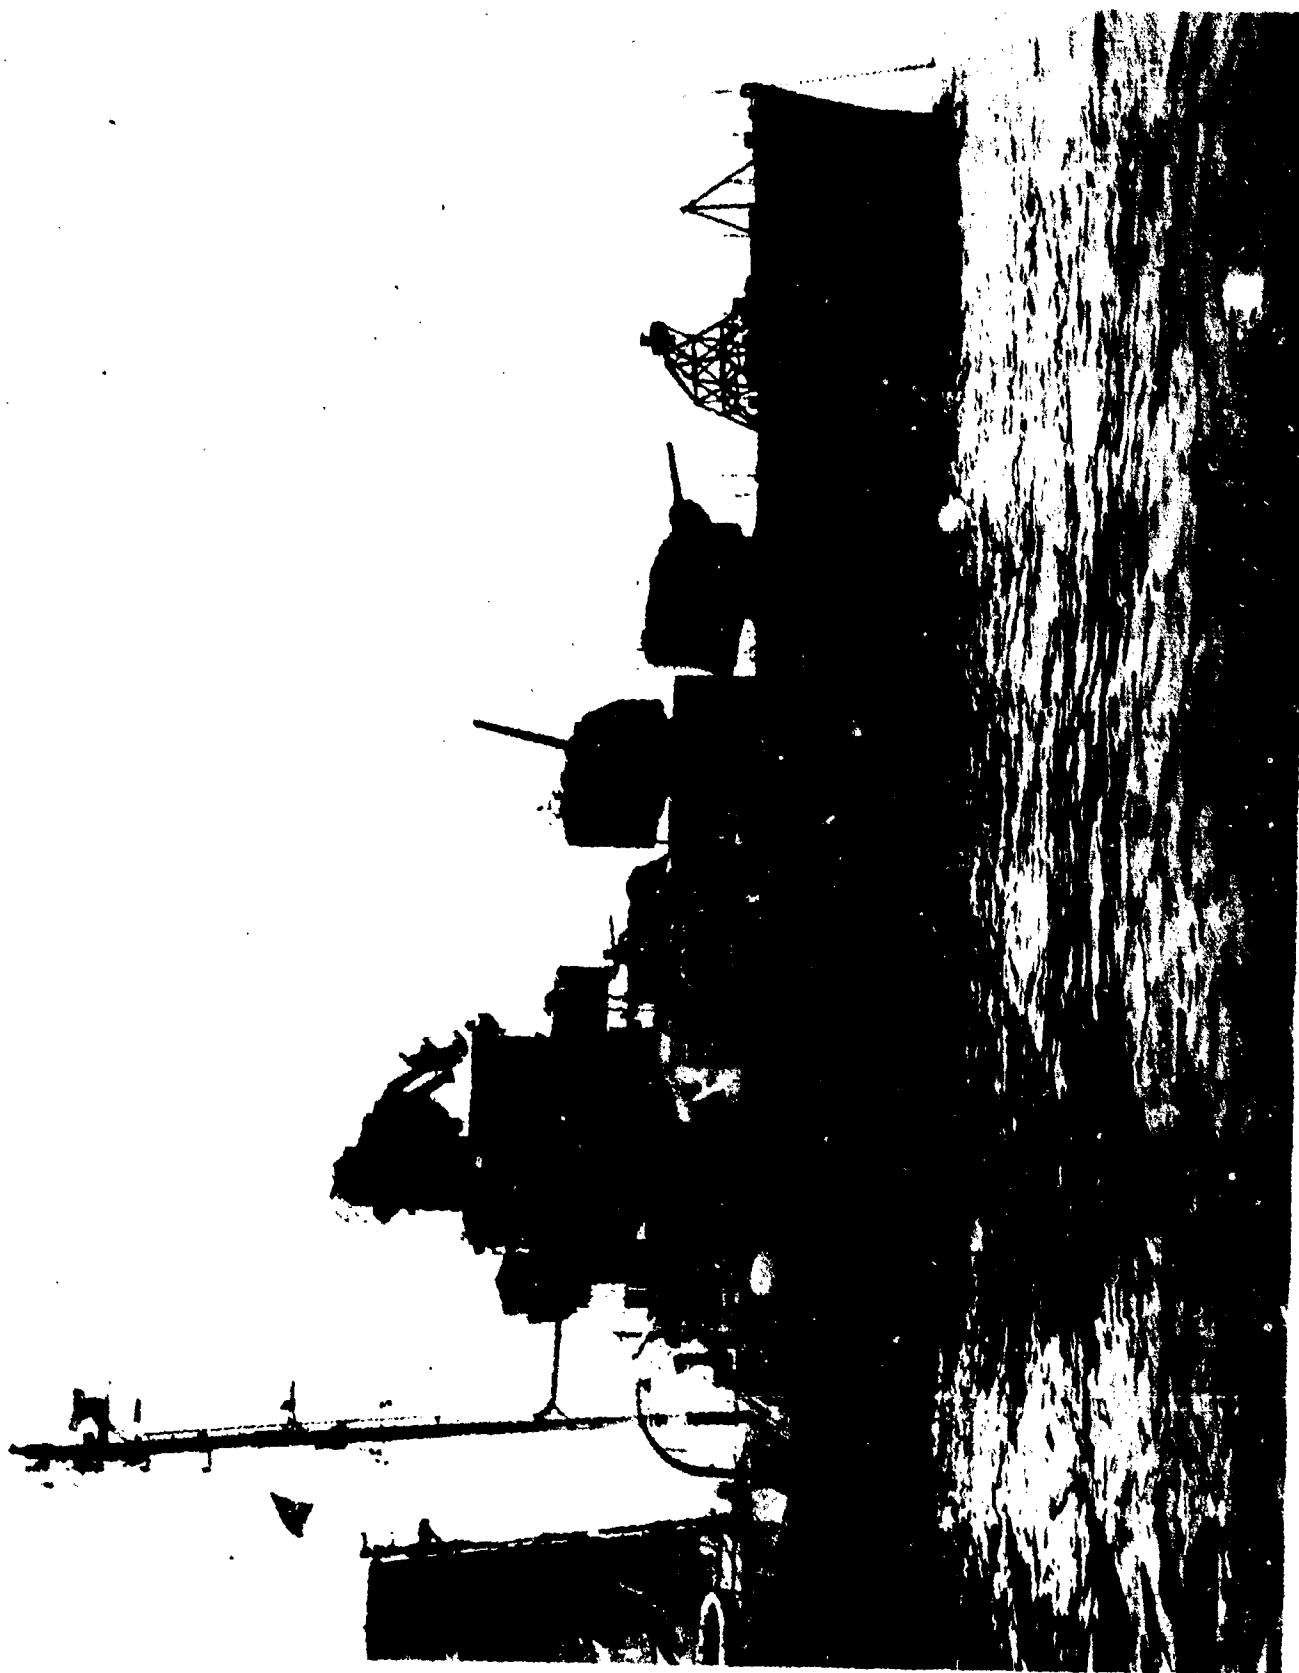
The stack is wrinkled on the starboard and forward sides, and lagging is stripped from the whistle and siren. (Photos. 1772-8, 2006-10, 1850-6; pages 54 , 55 , and 56). The stack starboard drain line is severed at an elbow. The top and starboard side of the uptake breeching are damaged. The most severe damage occurred to the forward breeching, which is severely dished and torn. (Photos. 2006-7, 2170-5,7,8,9,10; pages 57 , 58 , 59 , 60 , 61 , and 62).

AA-CR-92-1772-8. View from off starboard bow, stem to stack.
Note damage to stack.

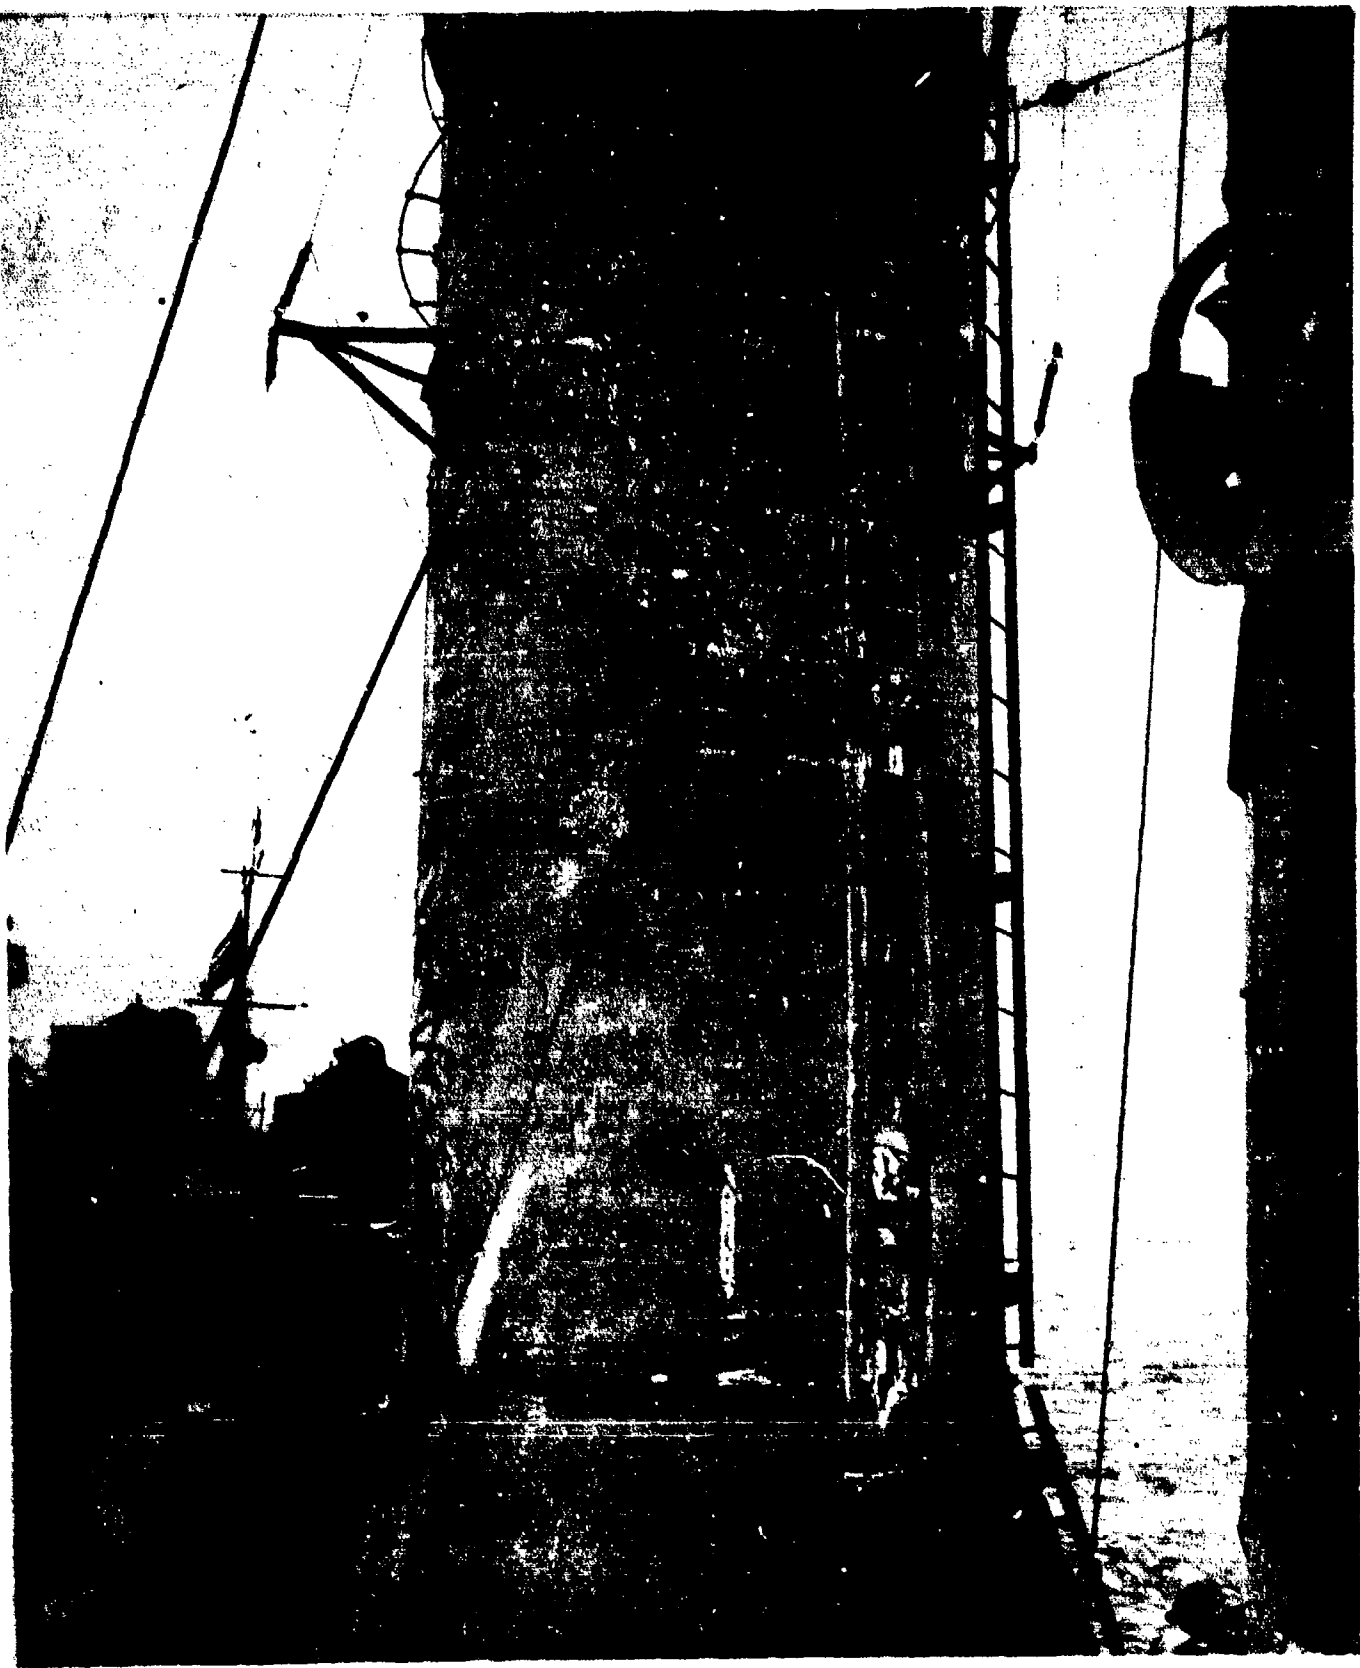
AA-CR-58-2006-10. Looking aft from superstructure showing paint damage on stack and lagging stripped from whistle drain line.

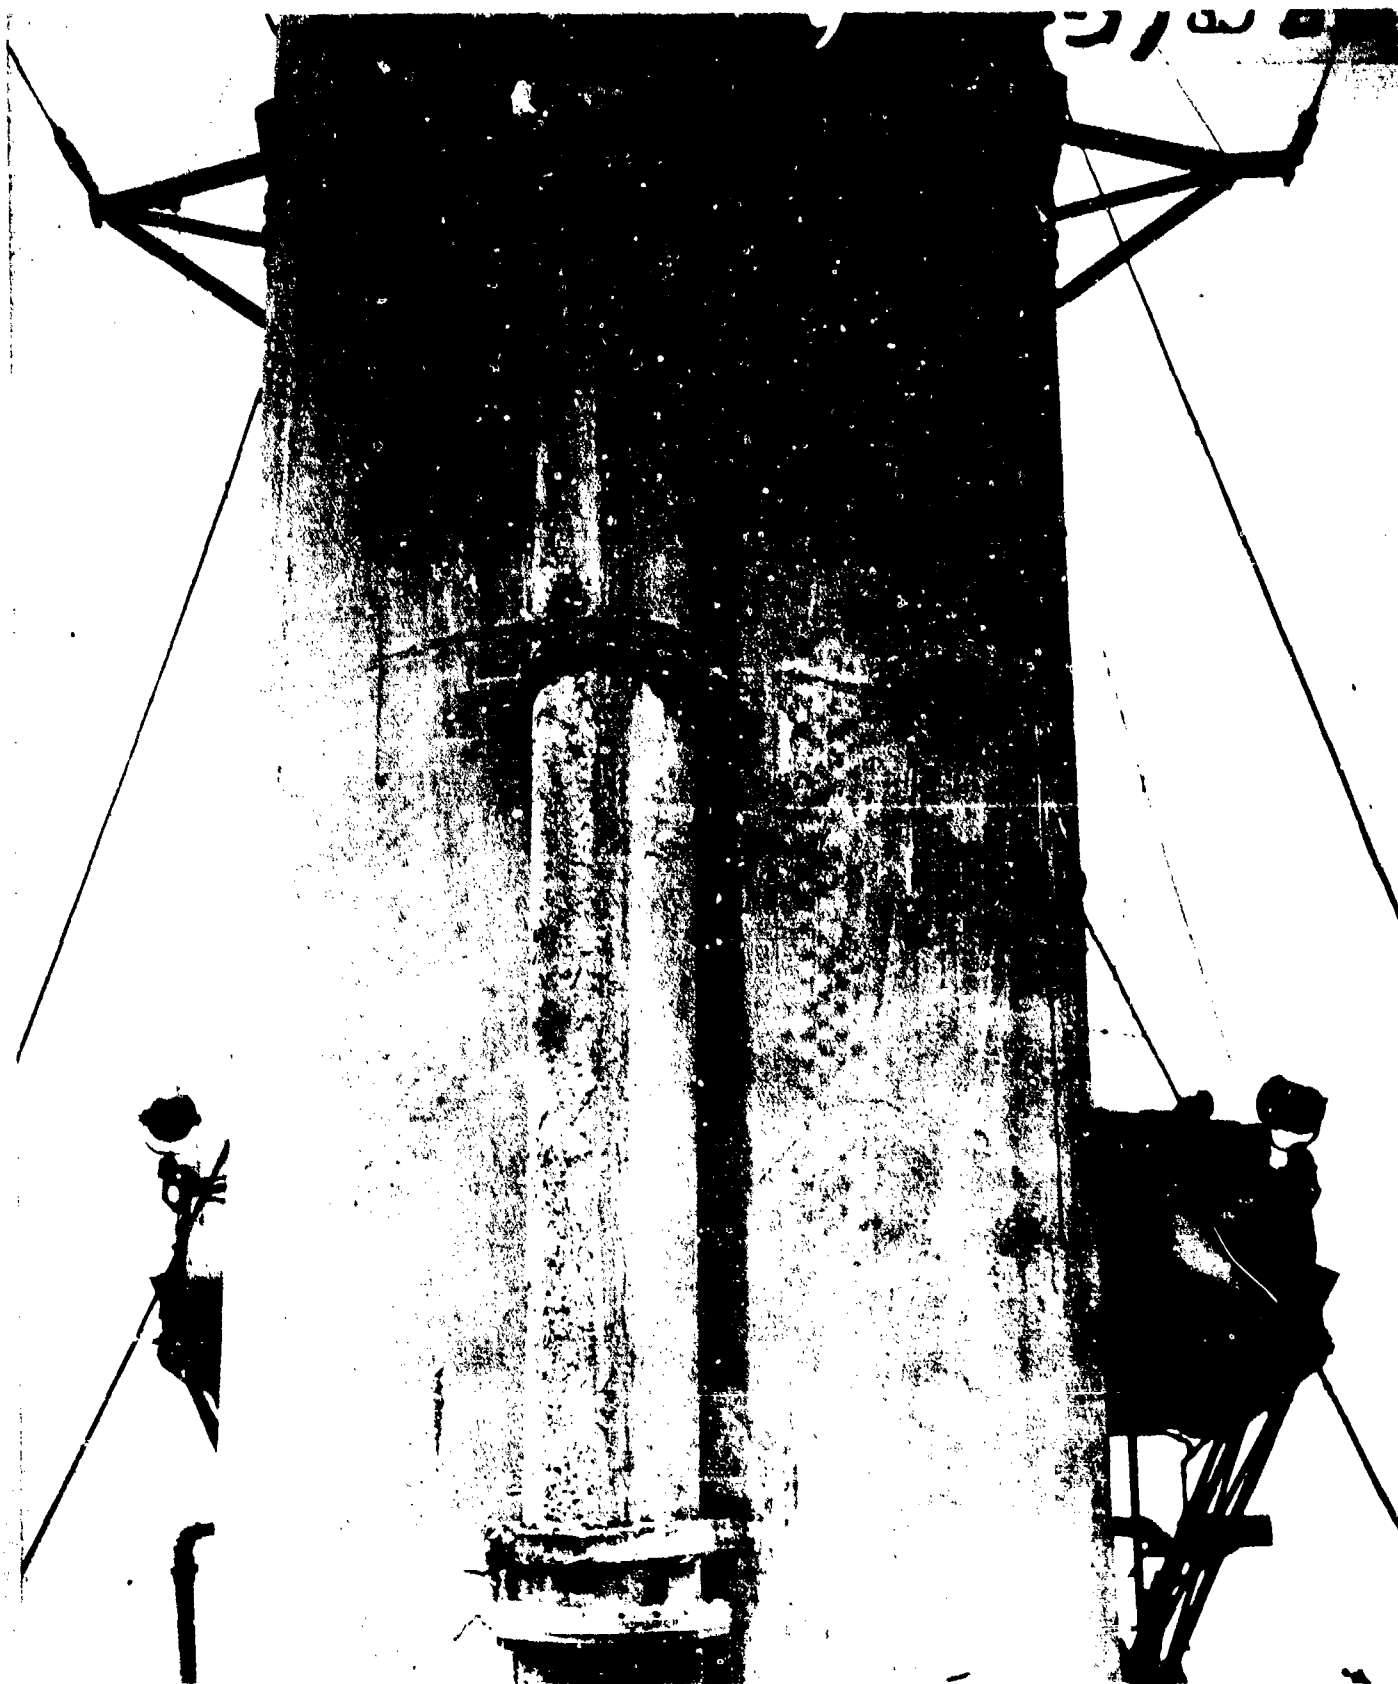
AA-CR-65-1850-6. Looking forward towards stack showing paint damage. Note distorted starboard flag bag.

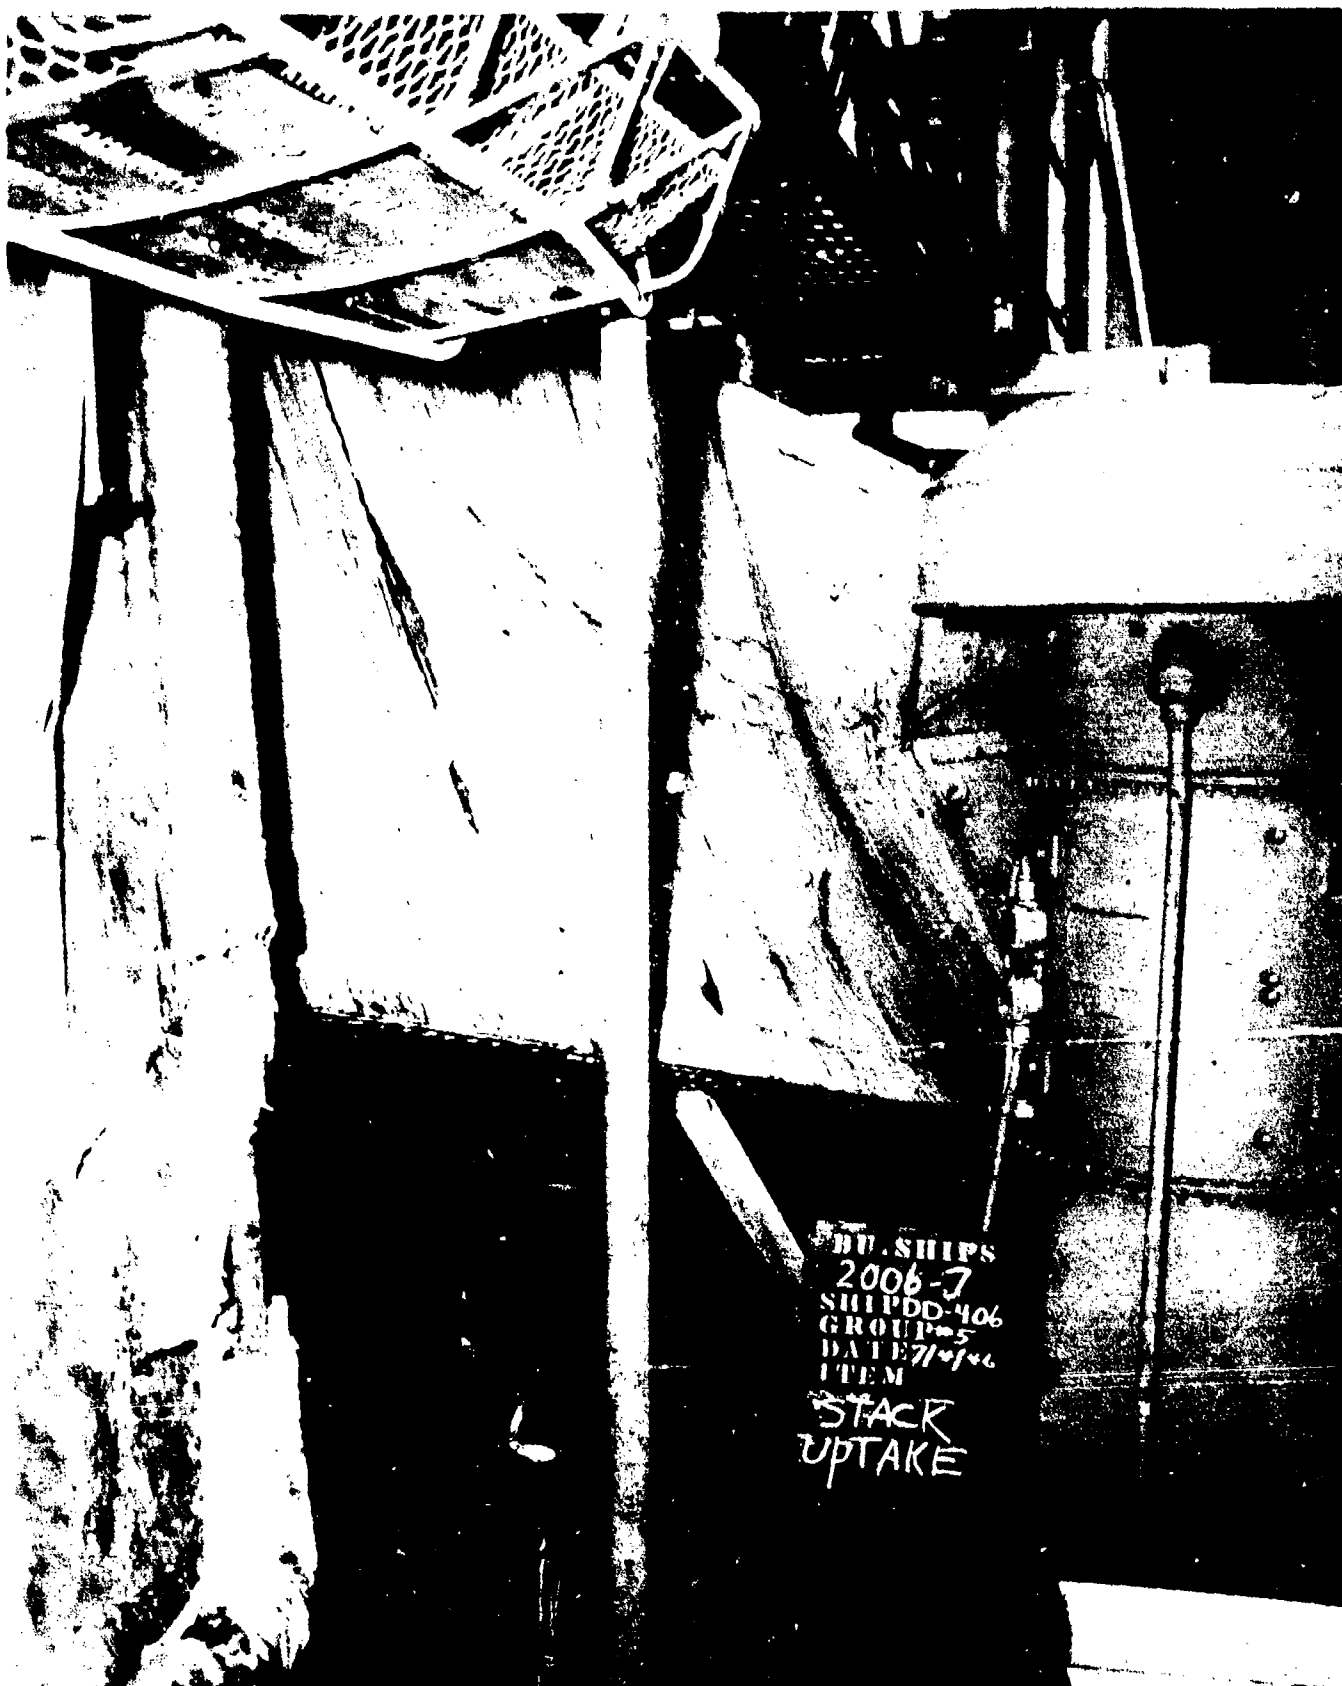
AA-CR-58-2006-7. Looking forward and to port on main deck showing damage to starboard side of No. 1 uptake breeching. Note damage to pipe lagging.

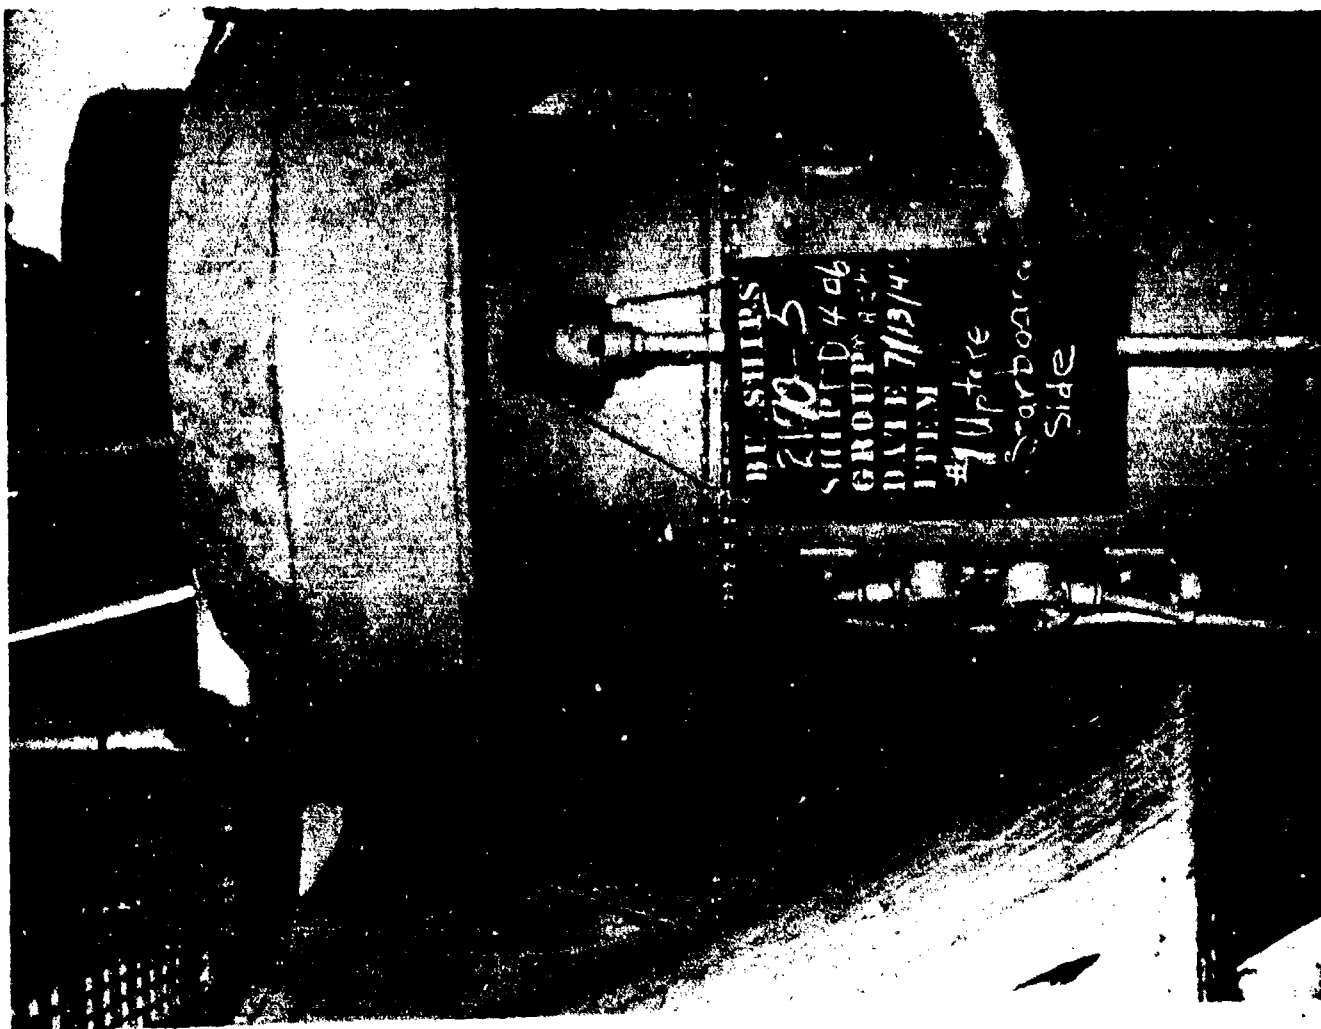
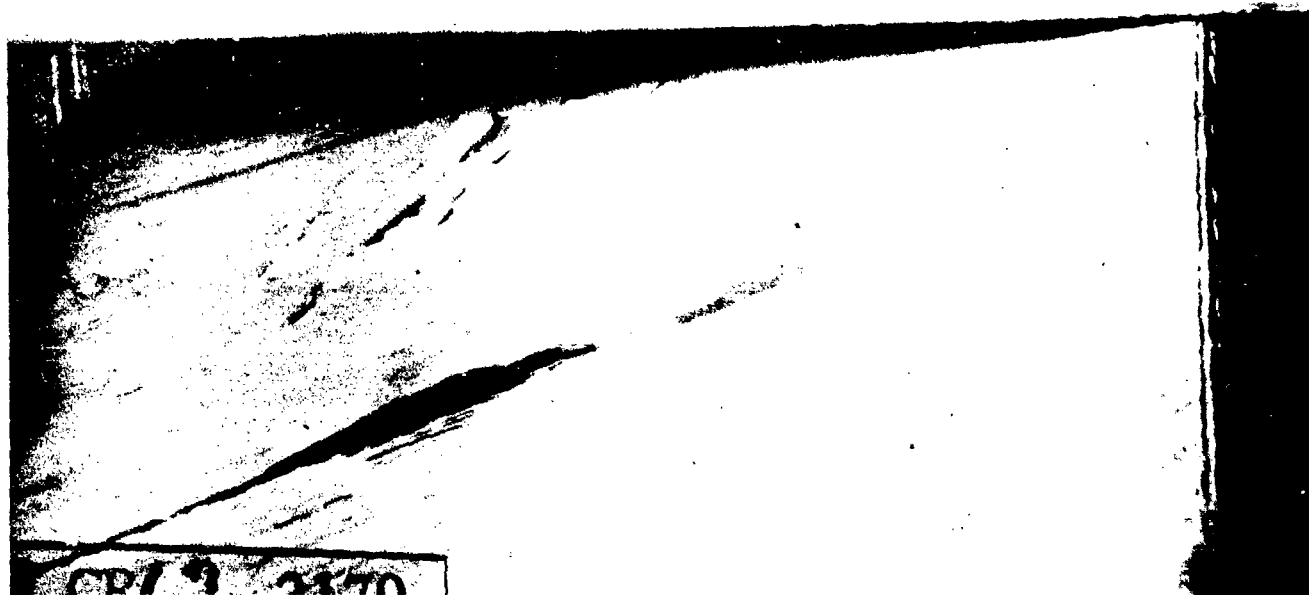
The boilers are undamaged. They have been steamed since Test A, and function normally. Hydrostatic tests indicate no change in their tightness. The uptake breeching from #1 fireroom between the stack and top of uptakes was crushed in slightly on the starboard side, opening a few seams which can be easily repaired by the ship's force and which will not impair normal operation of the boilers. (See photos 2170-5, 7, 10; pages 58, 59, and 62.)

AA-CR-62-2170-5. Looking forward and to port on main deck showing damage to starboard side of No. 1 uptake breeching.

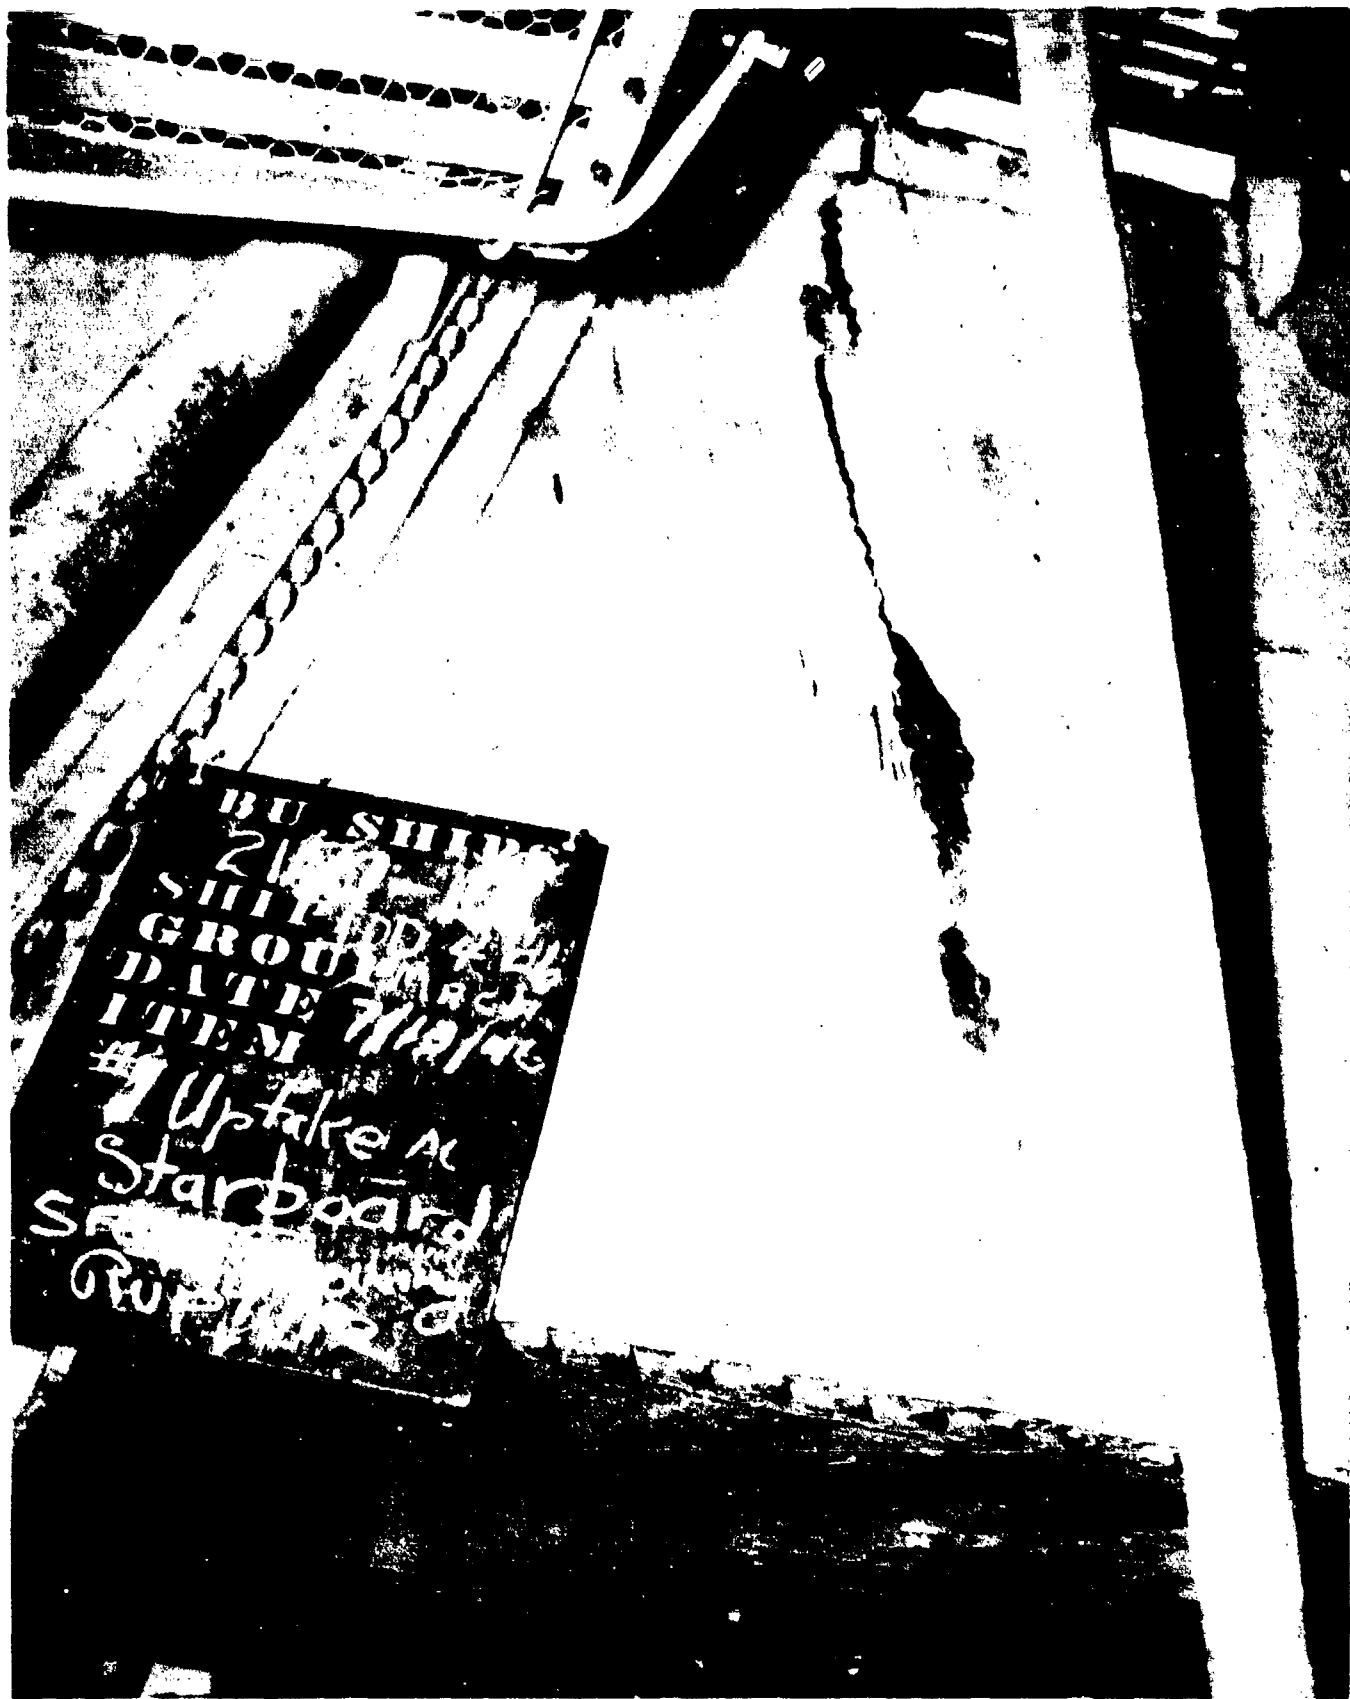
AA-CR-62-2170-7. Looking inboard at starboard side of No. 1 uptake showing torn plating.

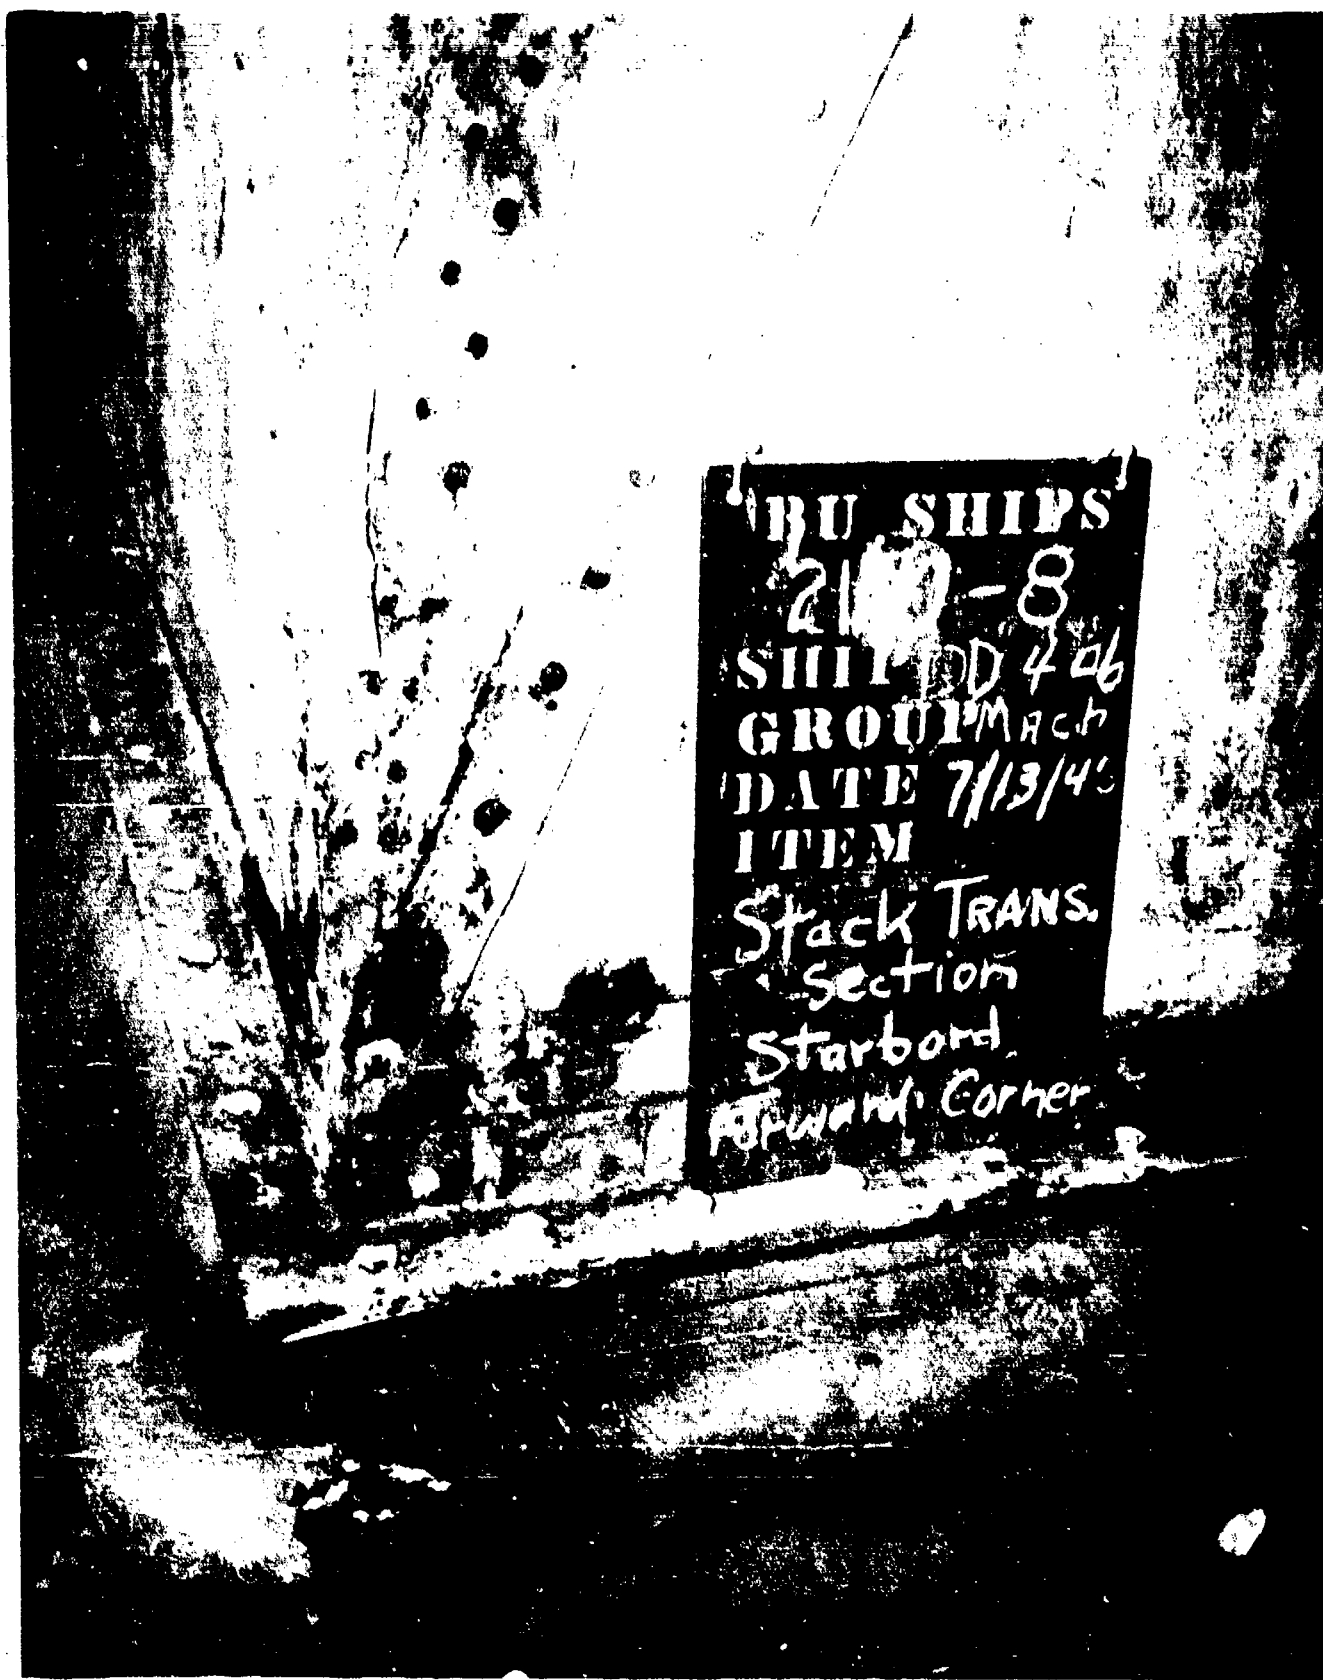
AA-CR-62-2170-8. Cracks near starboard forward corner of transtion section between uptakes and stack.

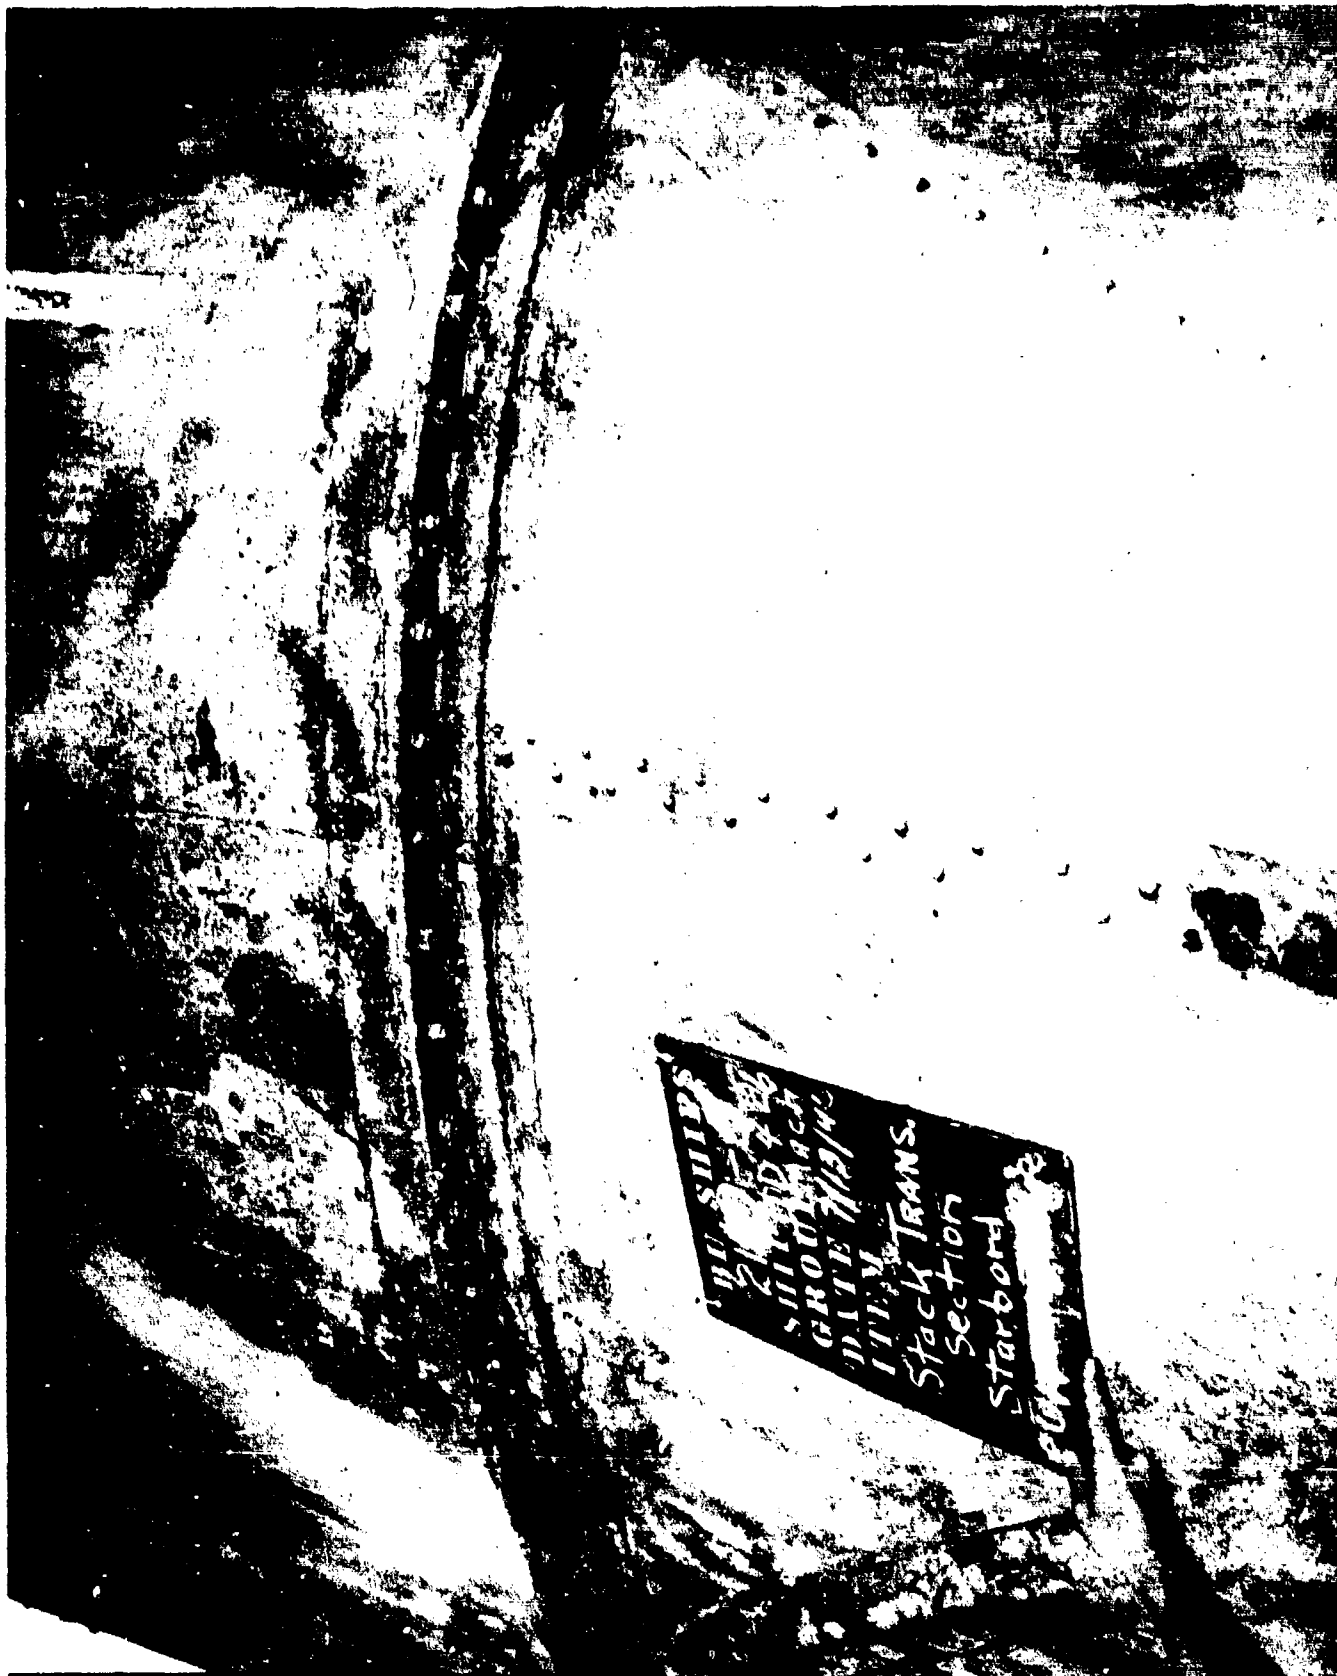
AA-CR-62-2170-9. Paint damage on starboard side of stack in way of transition section between stack and uptake.
