BUREAU OF SHIPS GROUP TECHNICAL INSPECTION REPORT

U.S.S. STACK (DD 406)

TEST ABLE [U].

OPERATION CROSSROADS

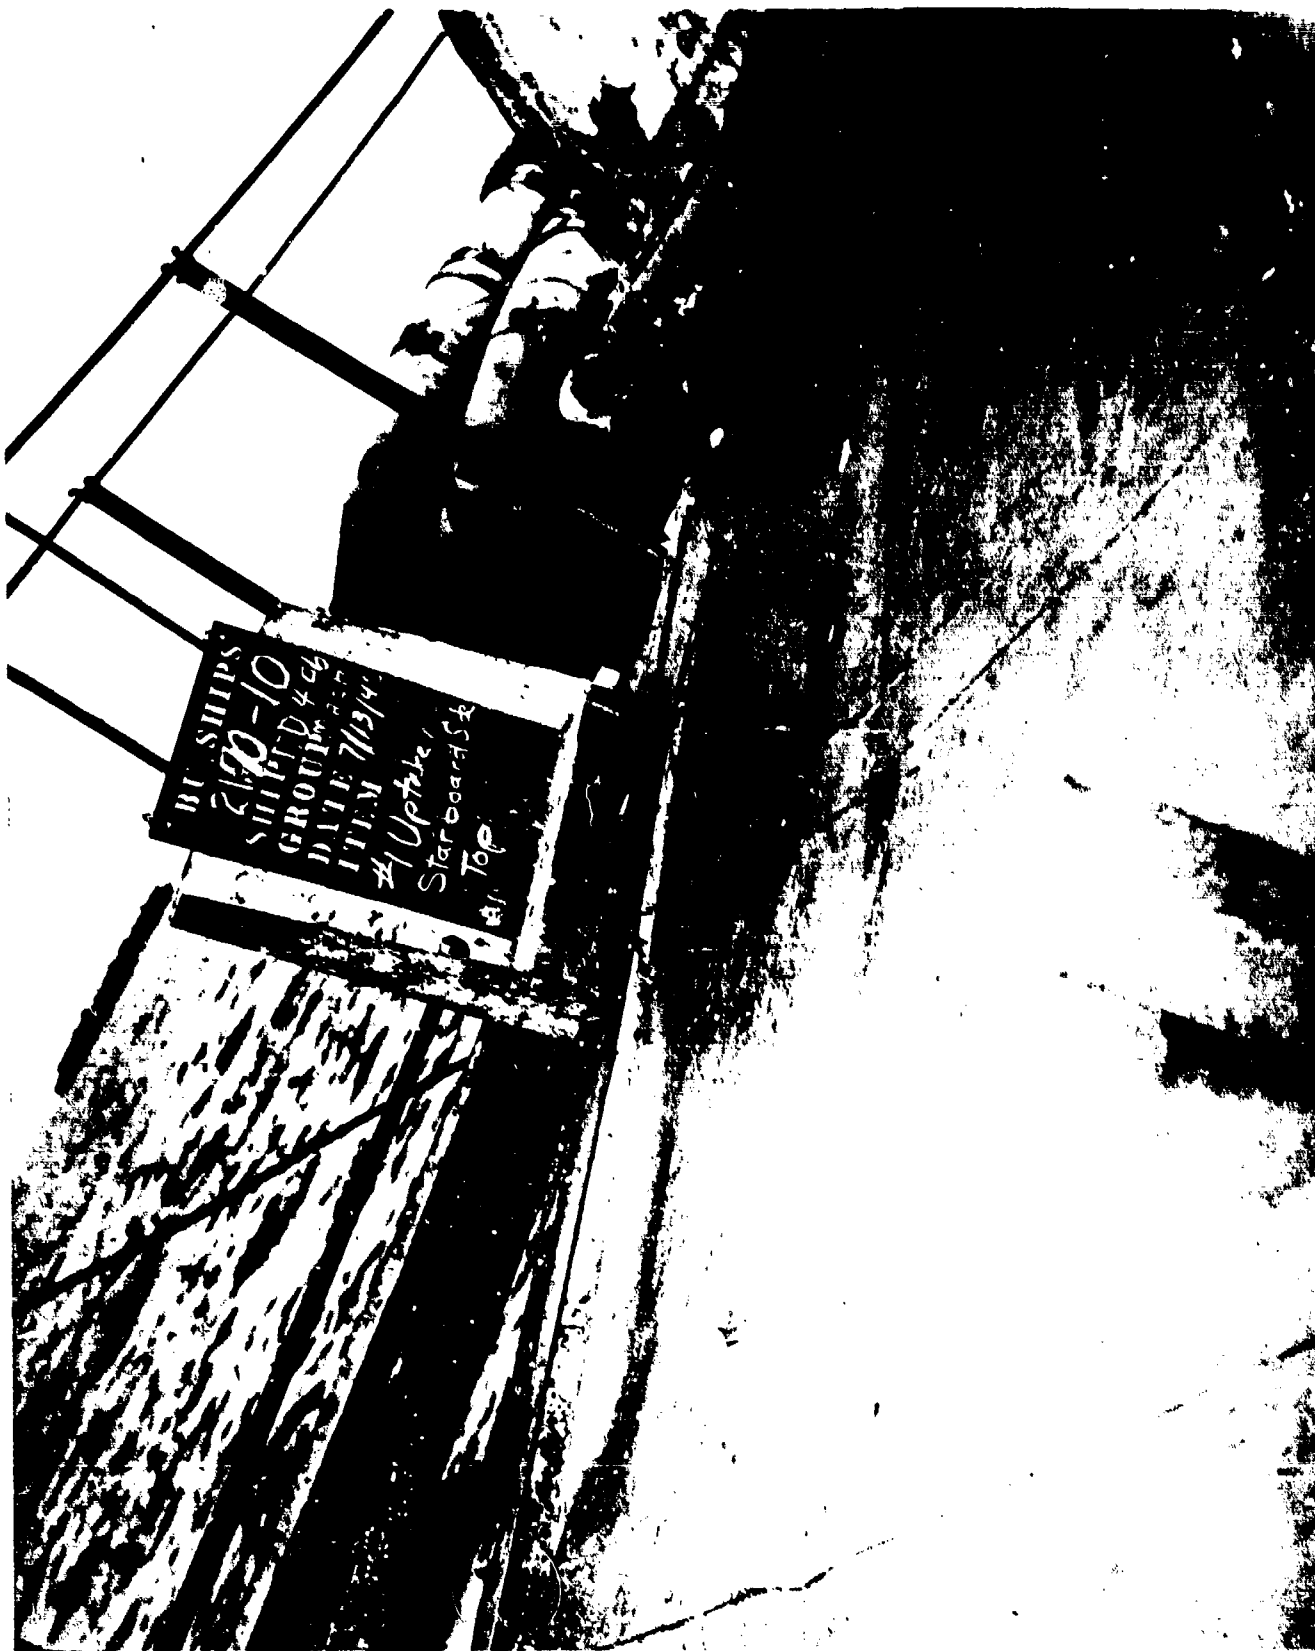
The boilers are undamaged. They have been steamed since Test A, and function normally. Hydrostatic tests indicate no change in their tightness. The uptake breeching from #1 fireroom between the stack and top of uptakes was crushed in slightly on the starboard side, opening a few seams which can be easily repaired by the ship's force and which will not impair normal operation of the boilers. (See photos 2170-5, 7, 10; pages 58, 59, and 62.)

AA-CR-62-2170-10. Looking aft and to starboard showing tear at starboard edge of top of No. 1 uptake.

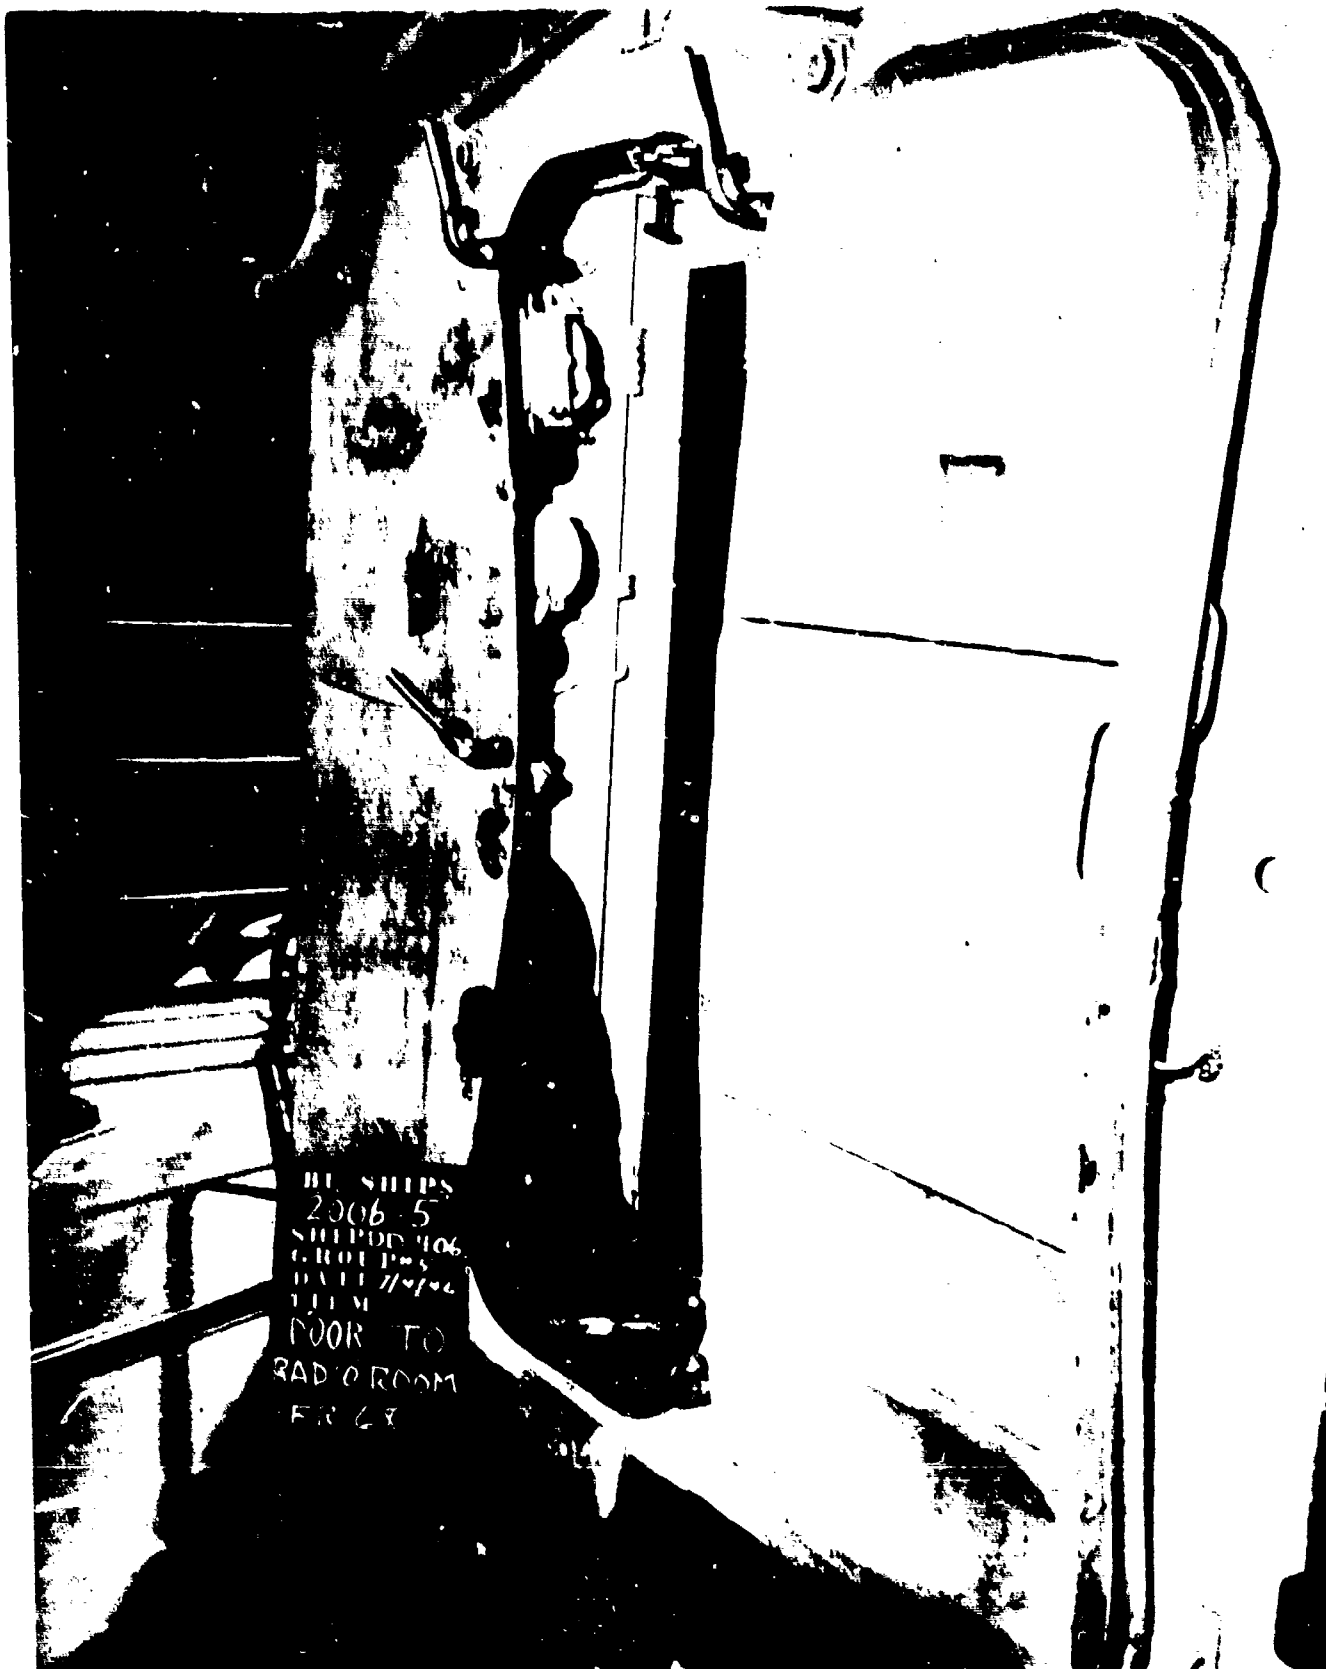
7. Radio room, frames 64-1/2 - 72-1/2, forecastle deck: starboard bulkhead, door, and door frame dished approximately three inches. (Photo. 2006-5; page 4). Damage to a locker inside the radio room, struck by a dog handle, indicates a three inch retraction of the bulkhead from a maximum deflection of six inches.

AA-CR-58-2006-5. Looking aft on forecastle deck, starboard, showing dishing of bulkhead and door to radio room.

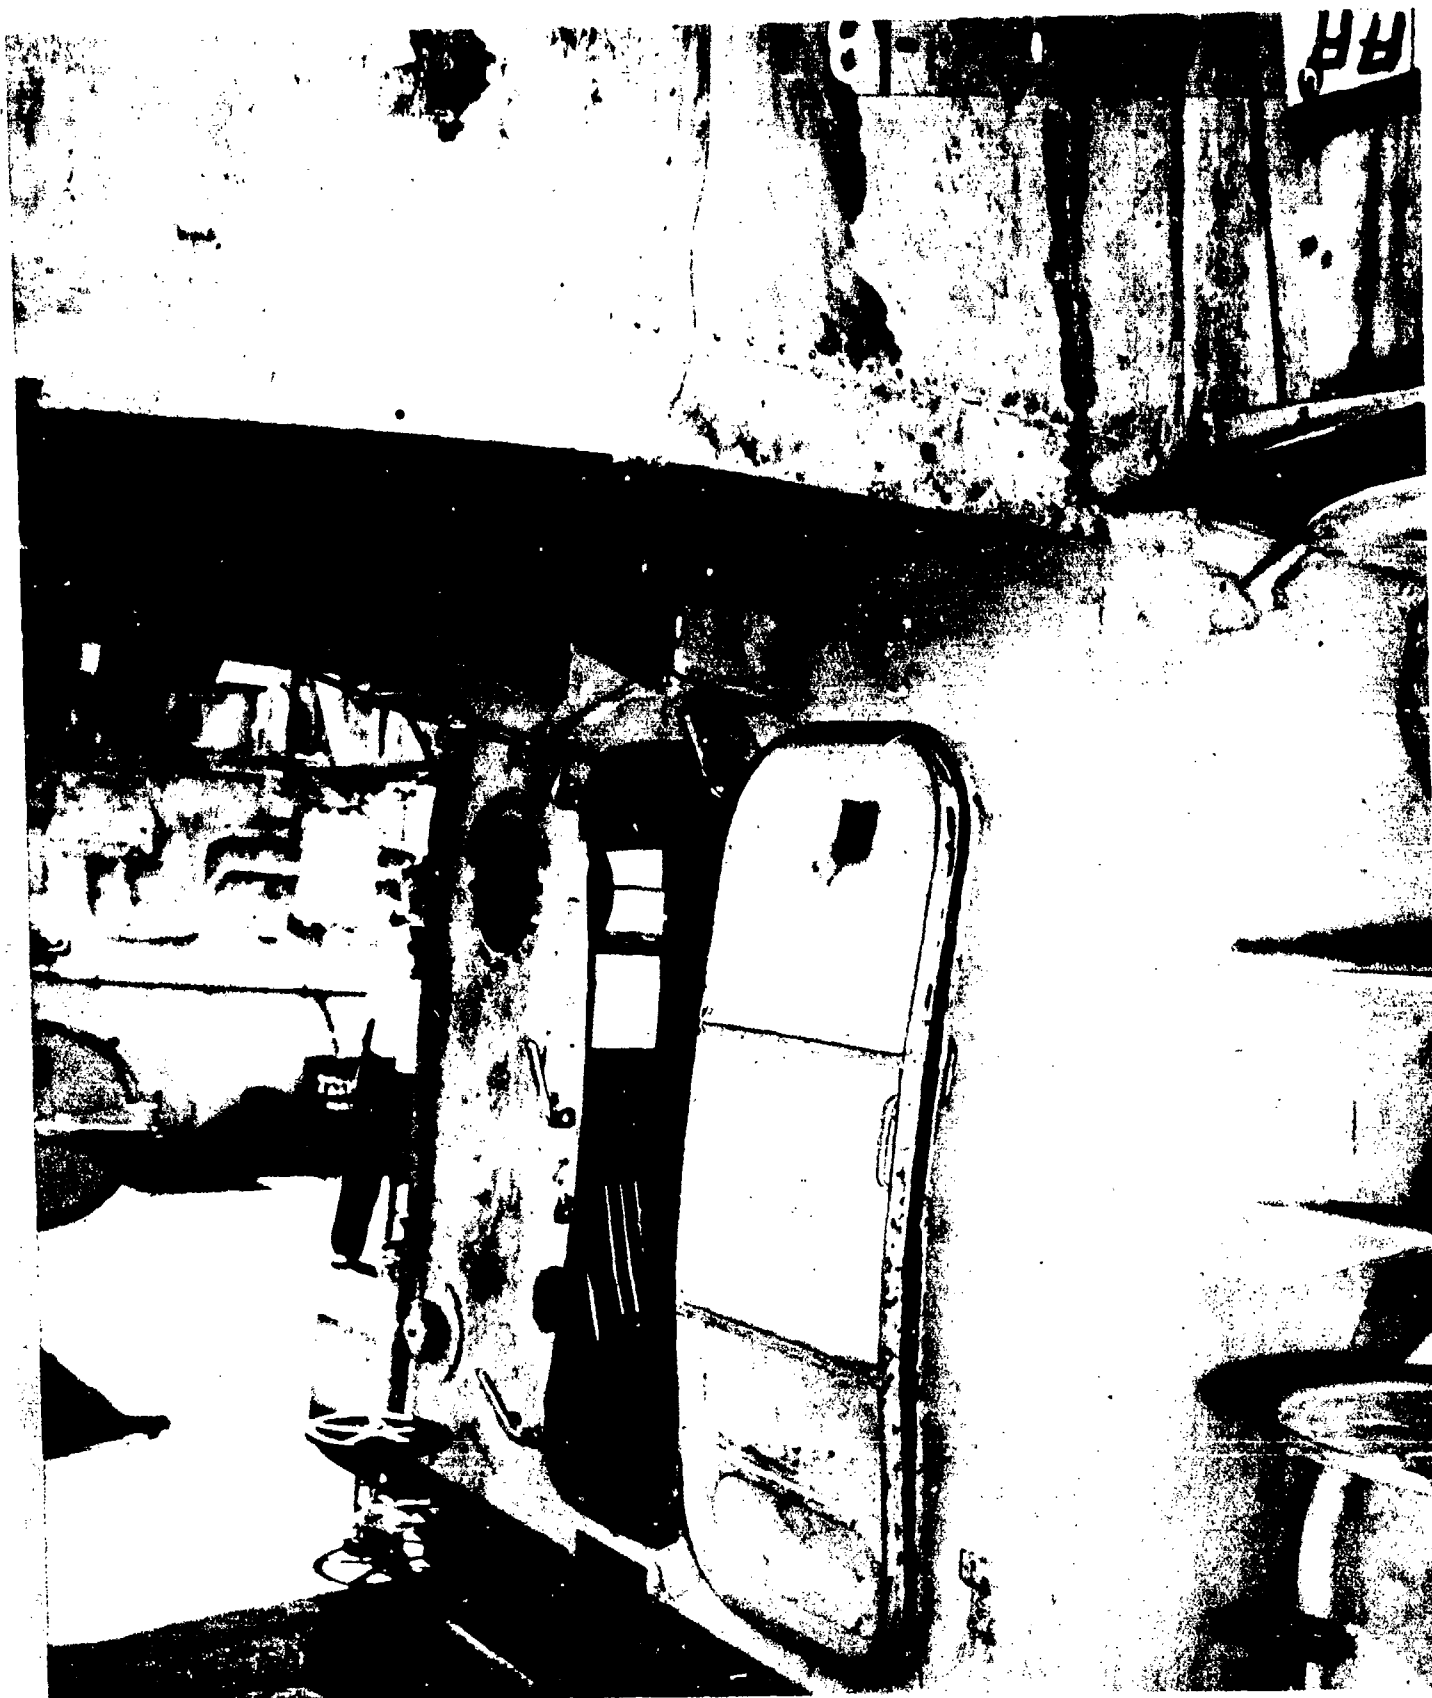
AA-CR-65-1850-8. Close-up of damage to bulkhead and door to Engineer's Log Room, main deck, starboard, looking aft.

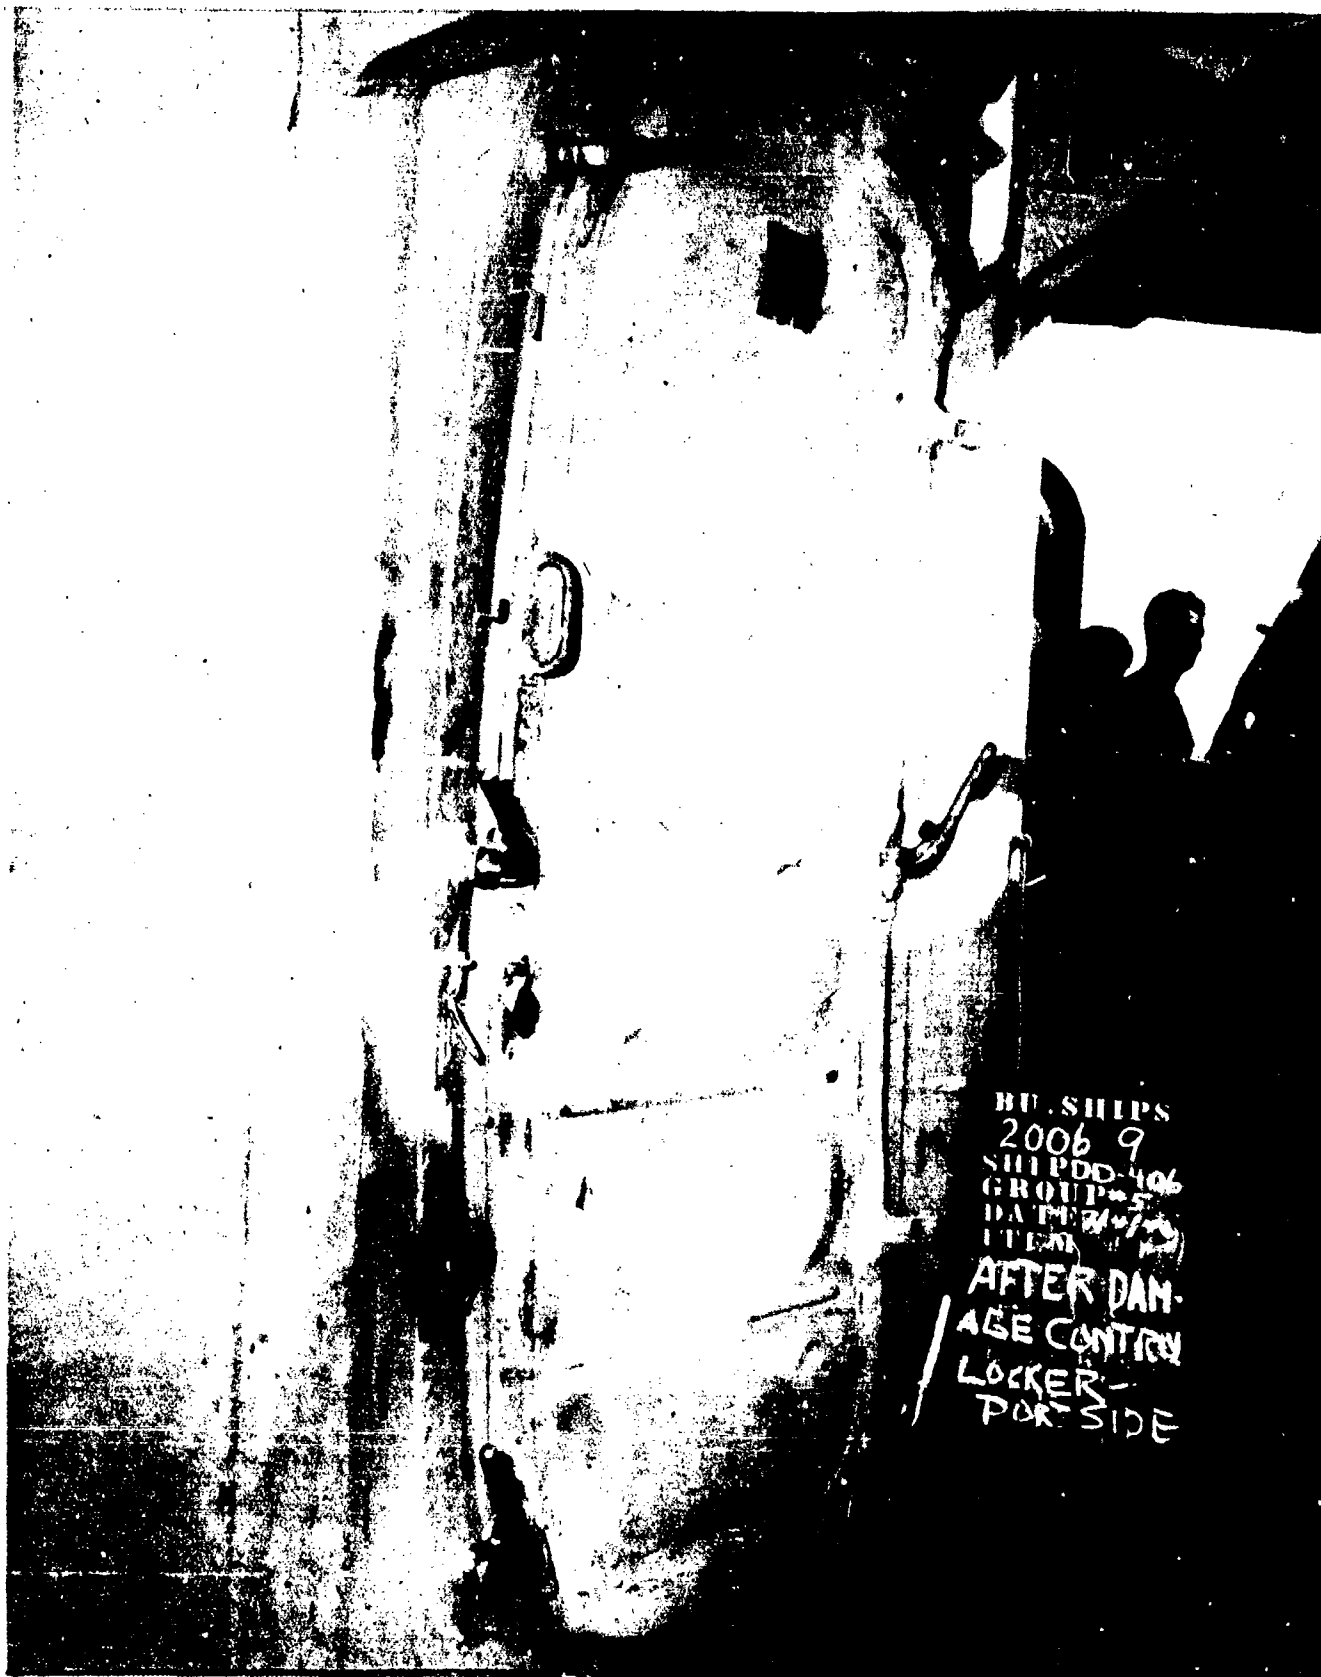
12. Repair party locker, B-108 A, frames 121-124, main deck: port quartering bulkhead, door, and door frame dished. (Photo. 2006-9; page 67).

AA-CR-58-2006-9. Looking forward and to starboard on main deck showing dishing of door to damage control locker, frame 123, port.

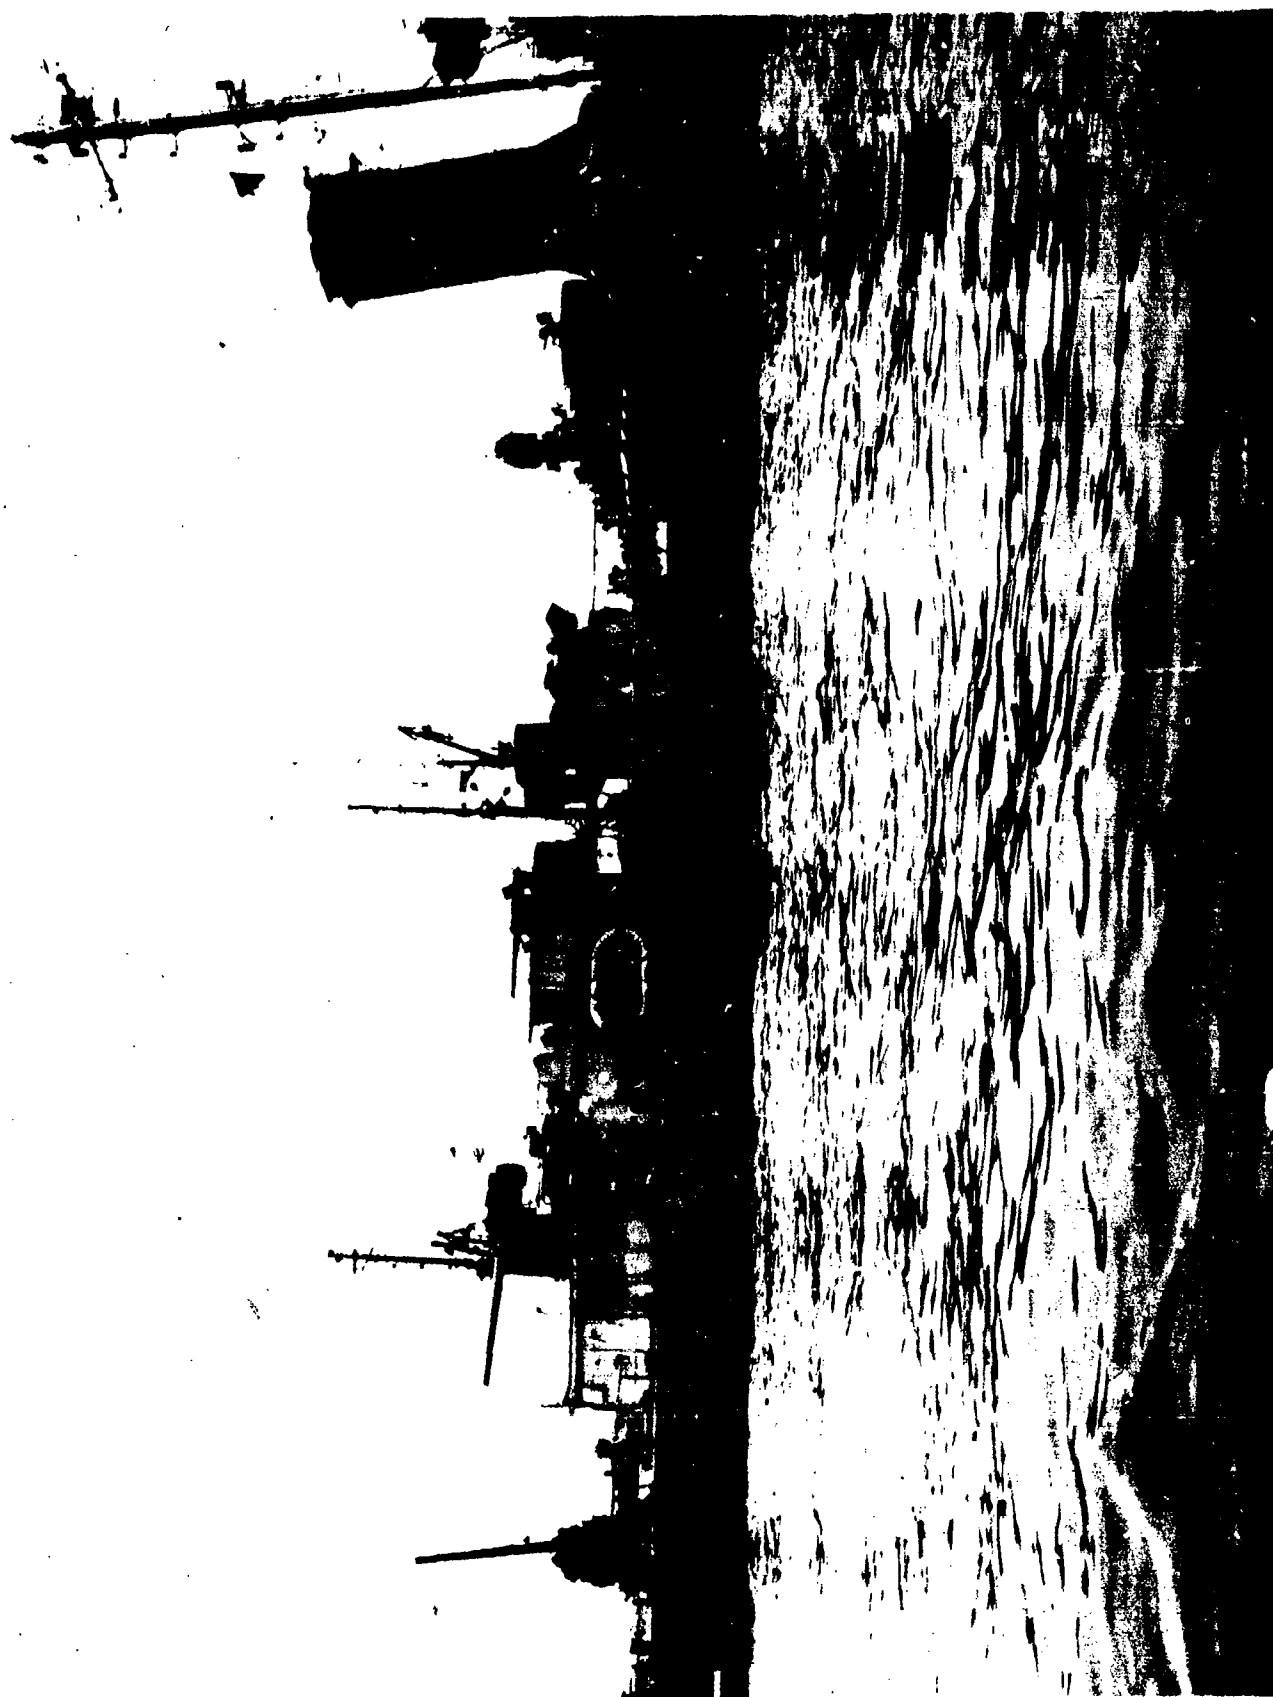
1. SC radar antennae are missing.
2. Foremast starboard headstay tang at truck sheared off and yard arm is rotated, 10 degrees; blinker lights are tilted aft. (Photo. 1772-7: page 35).

AA-CR-92-1772-7. View from off starboard beam, stack to stern.
Note twisted yardarm on foremast.
