TECHNICAL INSPECTION REPORT

U.S.S. WILSON (DD408)

8  
TEST ABLE [U.S.]

6 OPERATION CROSSROADS.

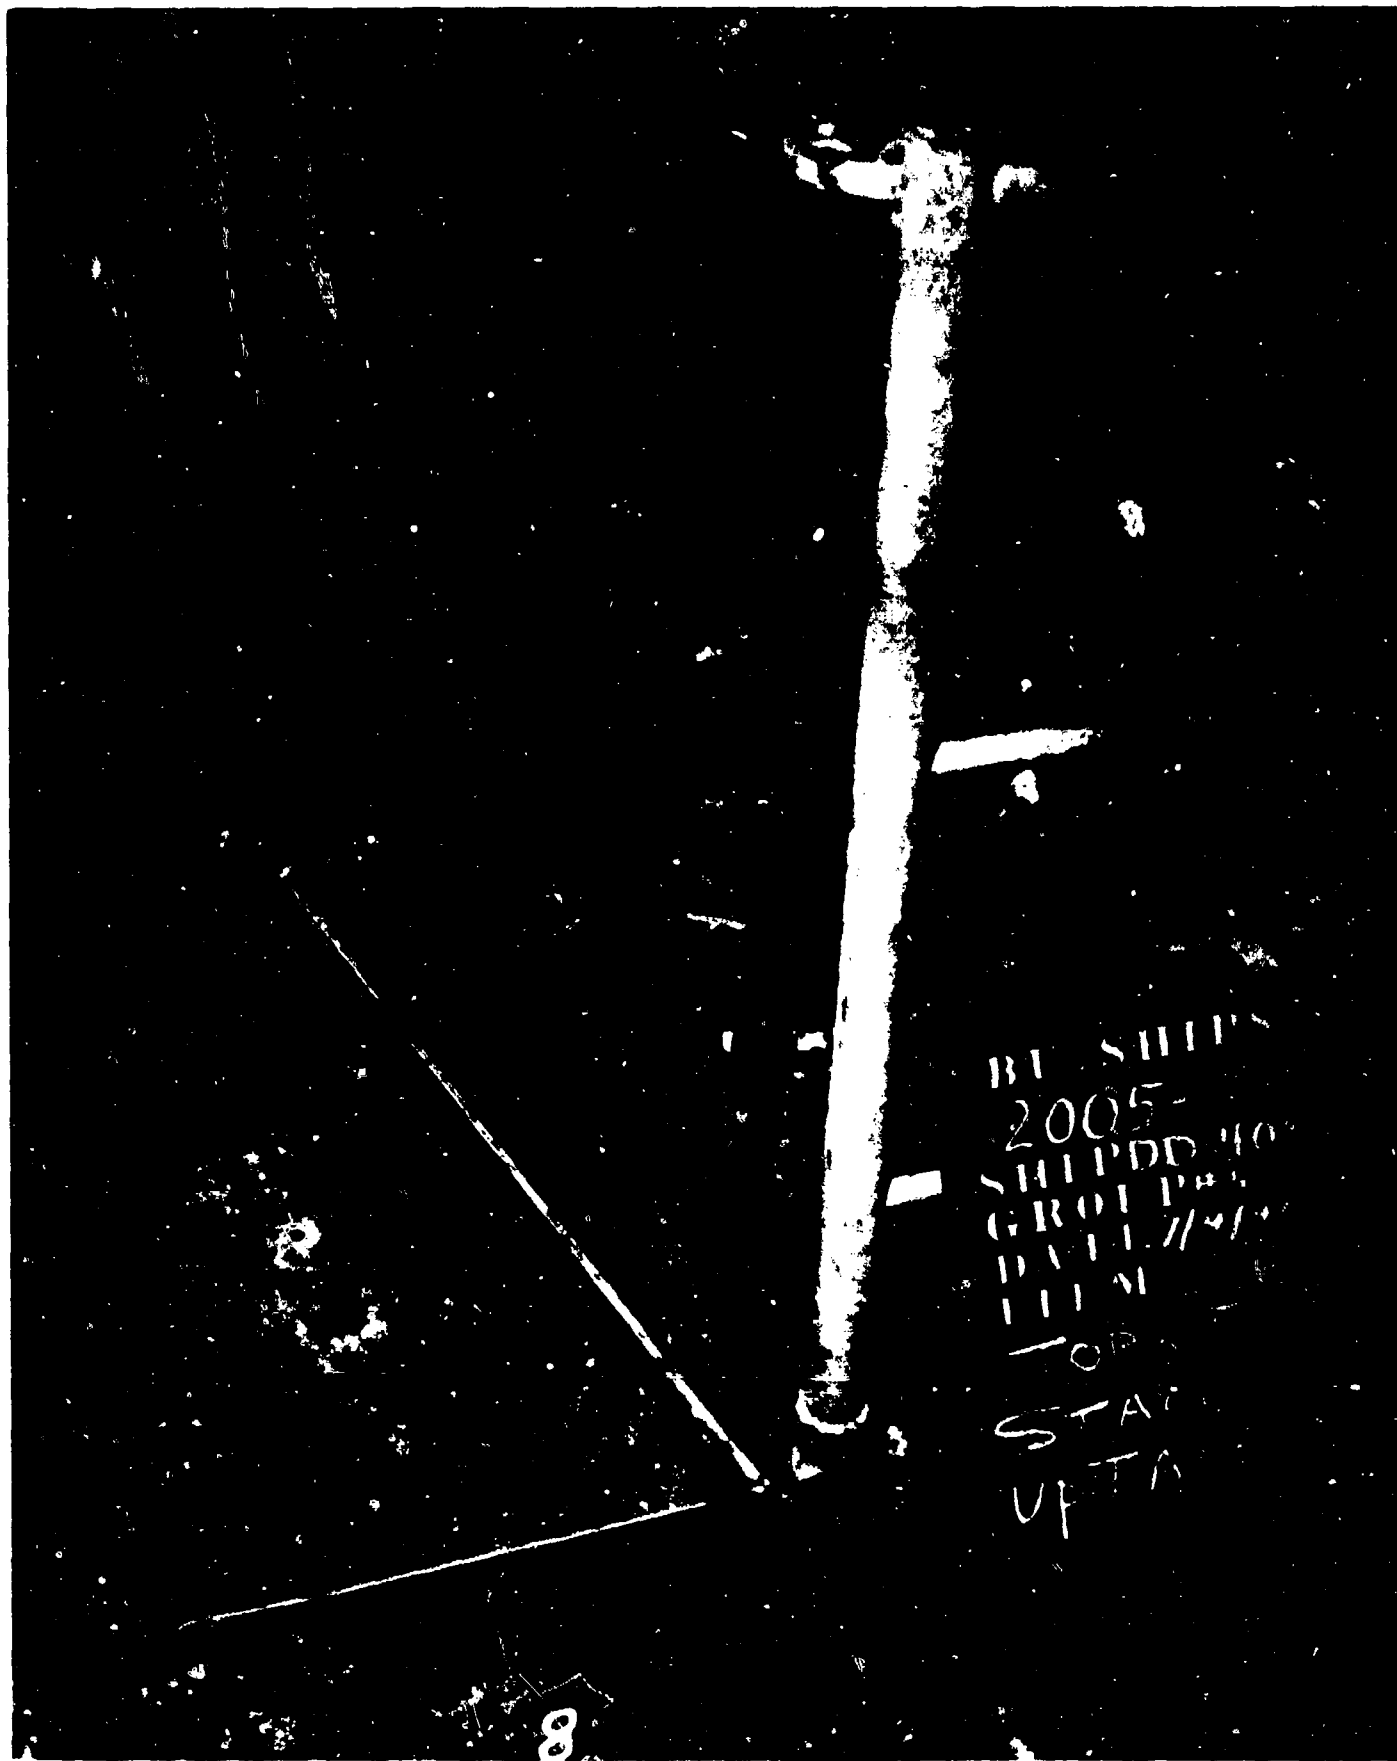
AA-CR-58-2005-8. Damage to top of stack breaching looking aft.

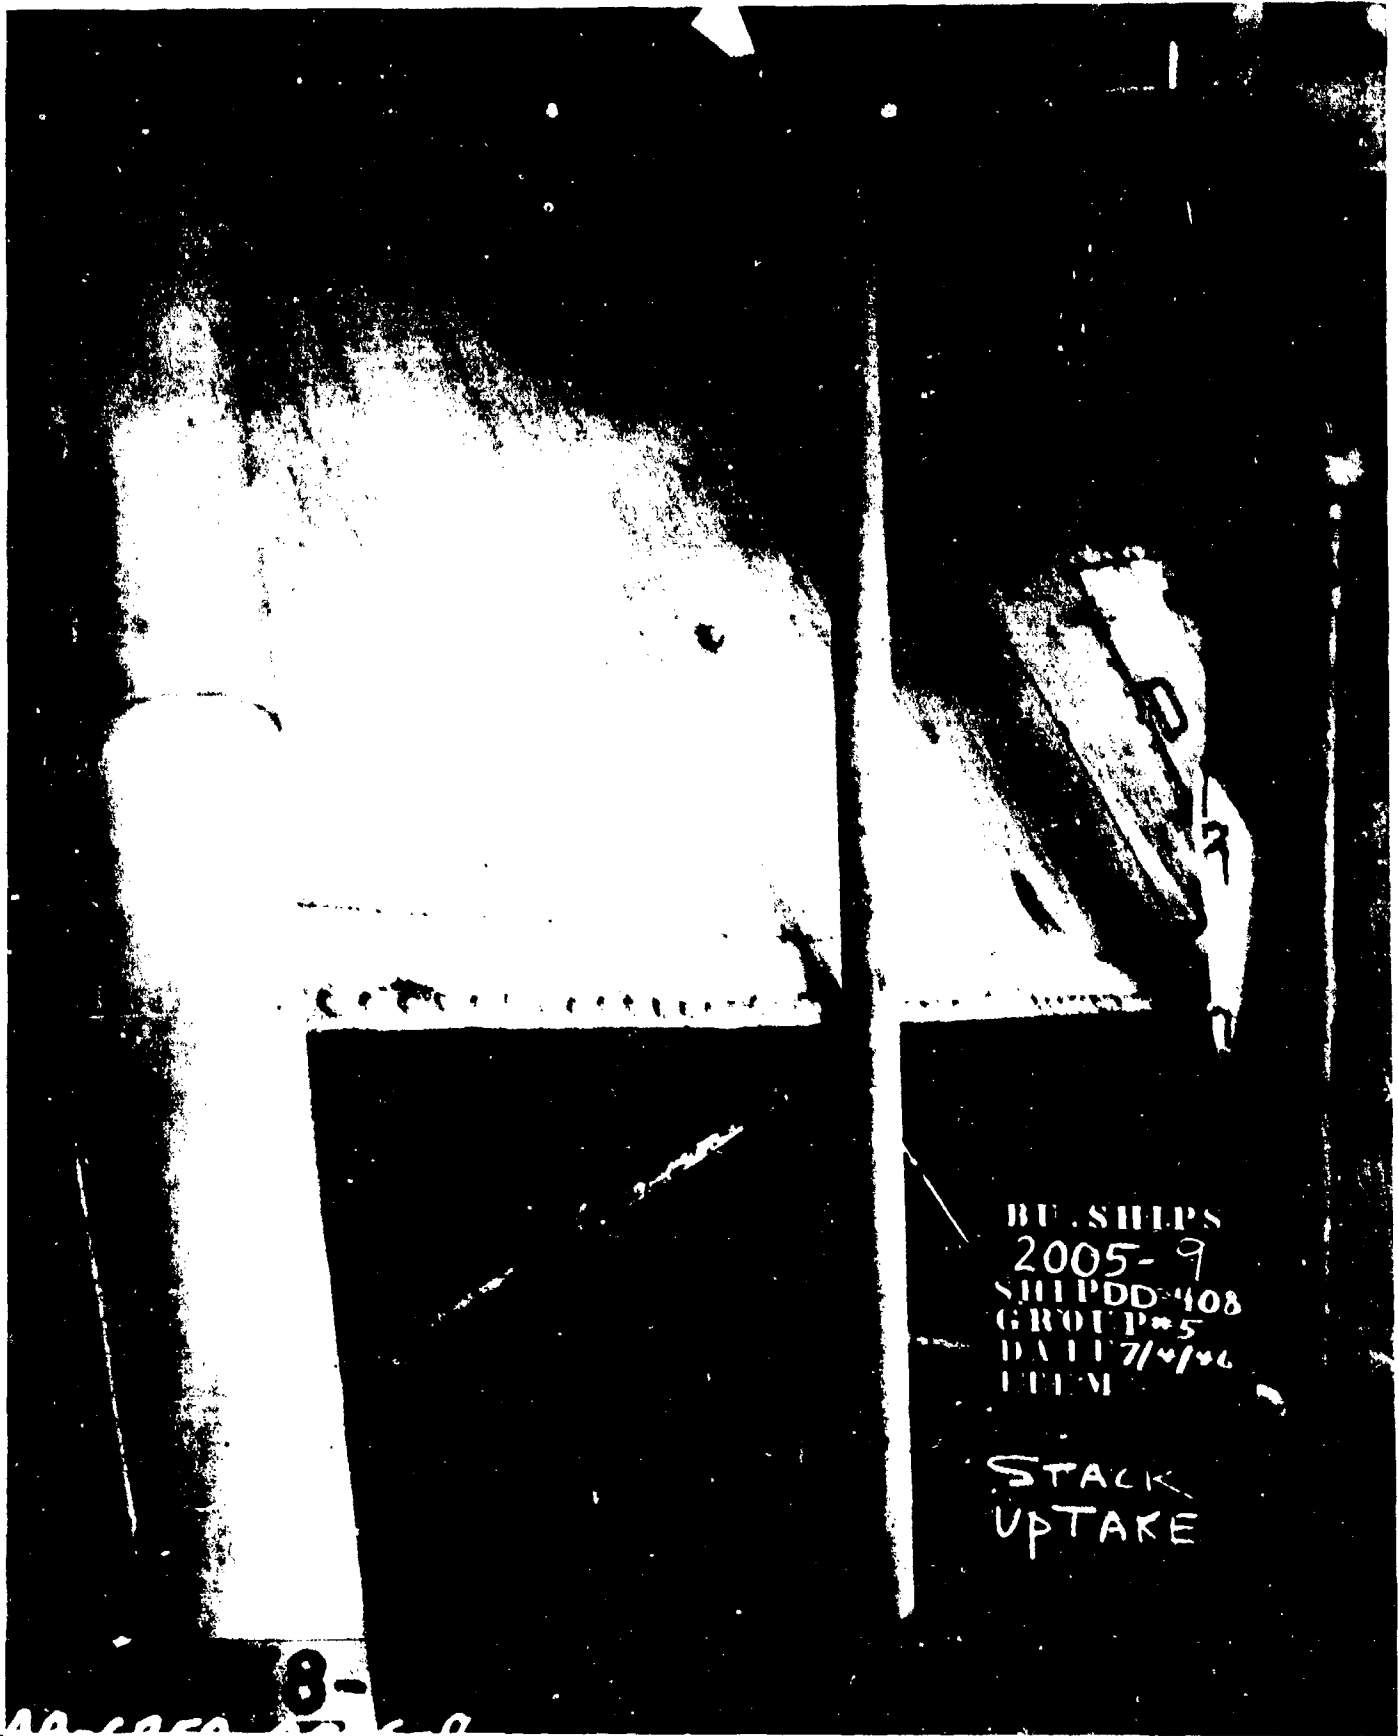
AA-CR-58-2005-9. Damage to starboard side of stack breeching, looking forward.

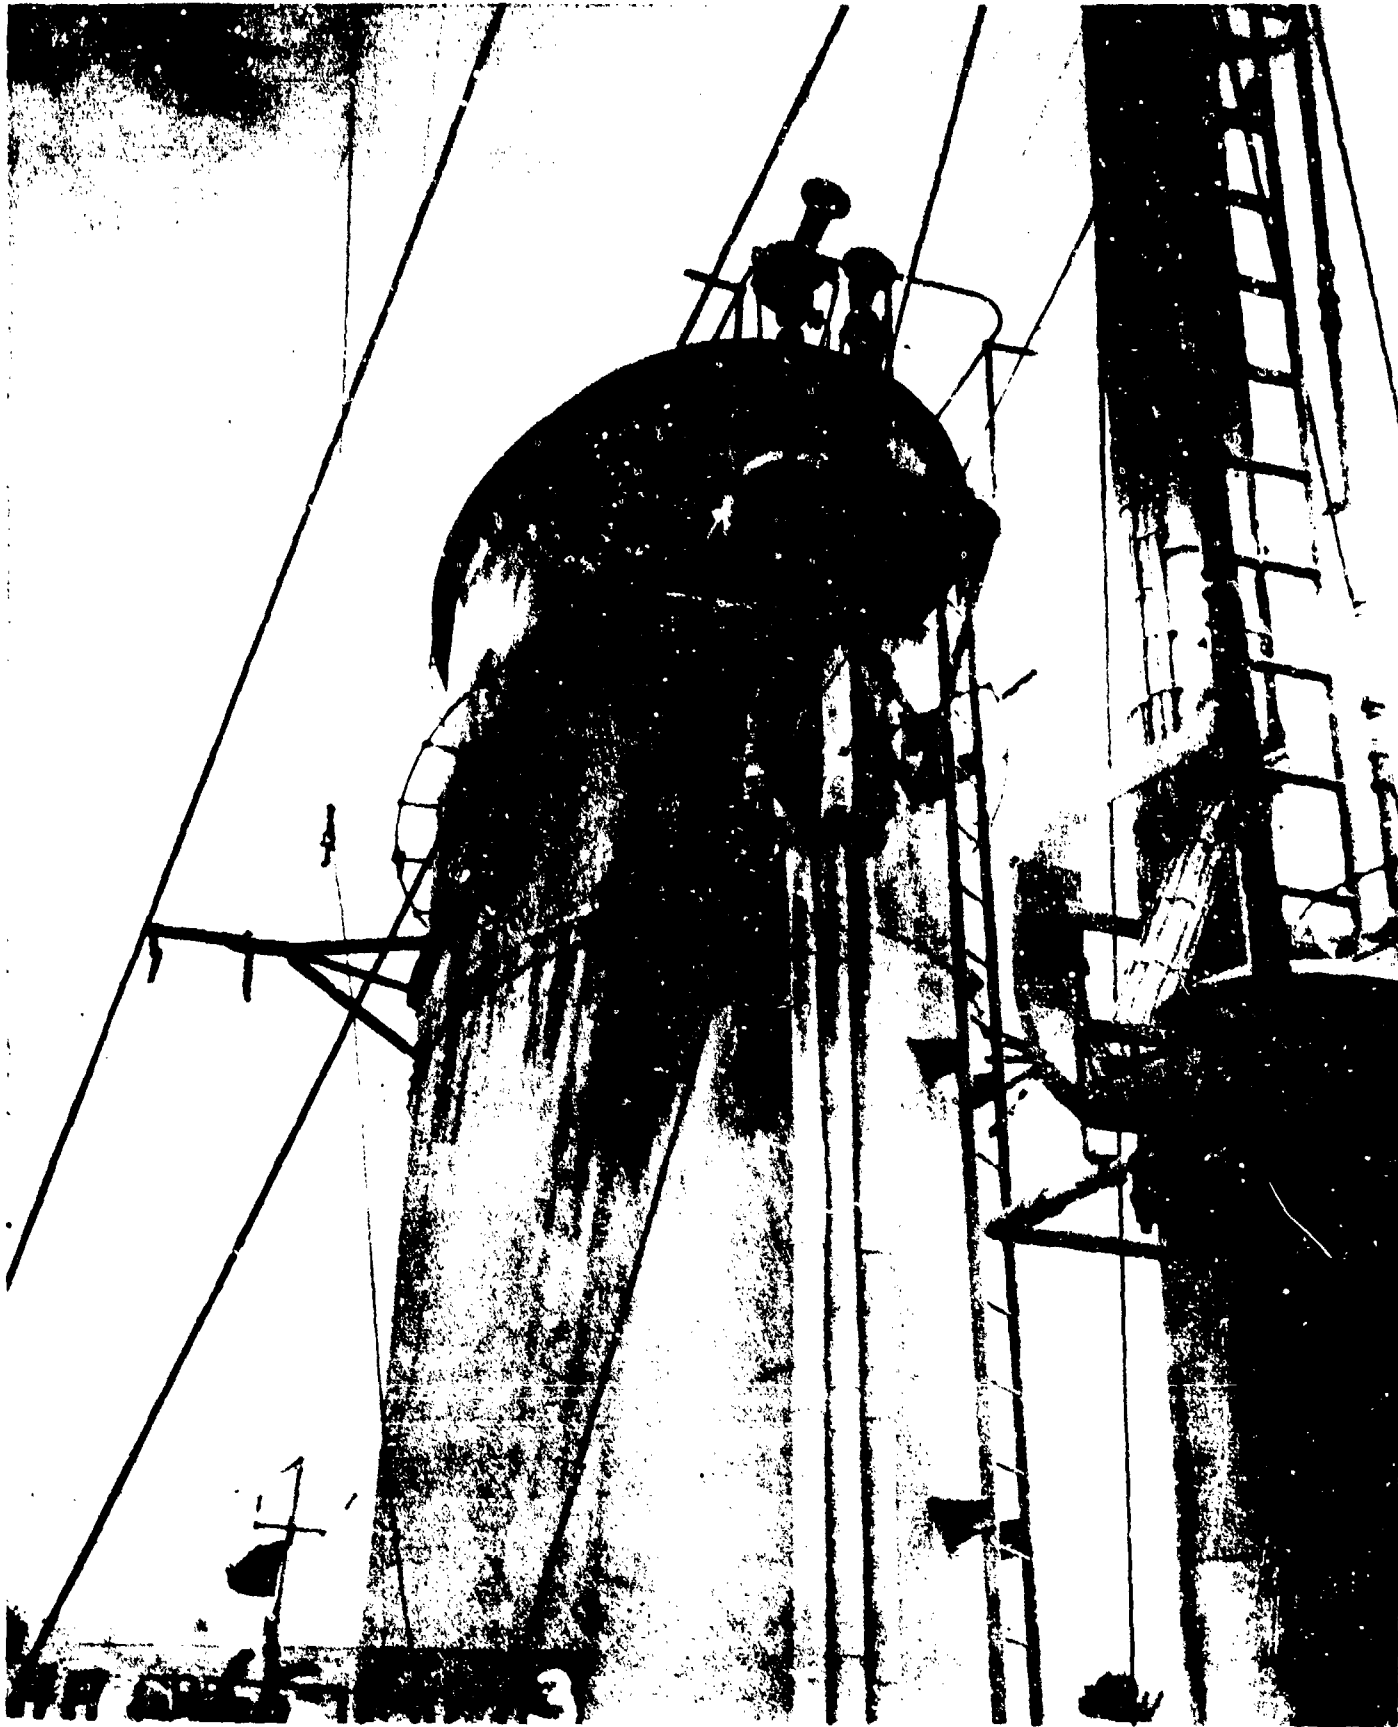
AA-CR-65-1850-3. Looking aft and to port, showing paint damage on stack.
