**BUREAU OF SHIPS GROUP**  
**TECHNICAL INSPECTION REPORT**

**6 OPERATION CROSSROADS.**  
**U.S.S. HUGHES (DD410)**  
**TEST ABLE [U].**

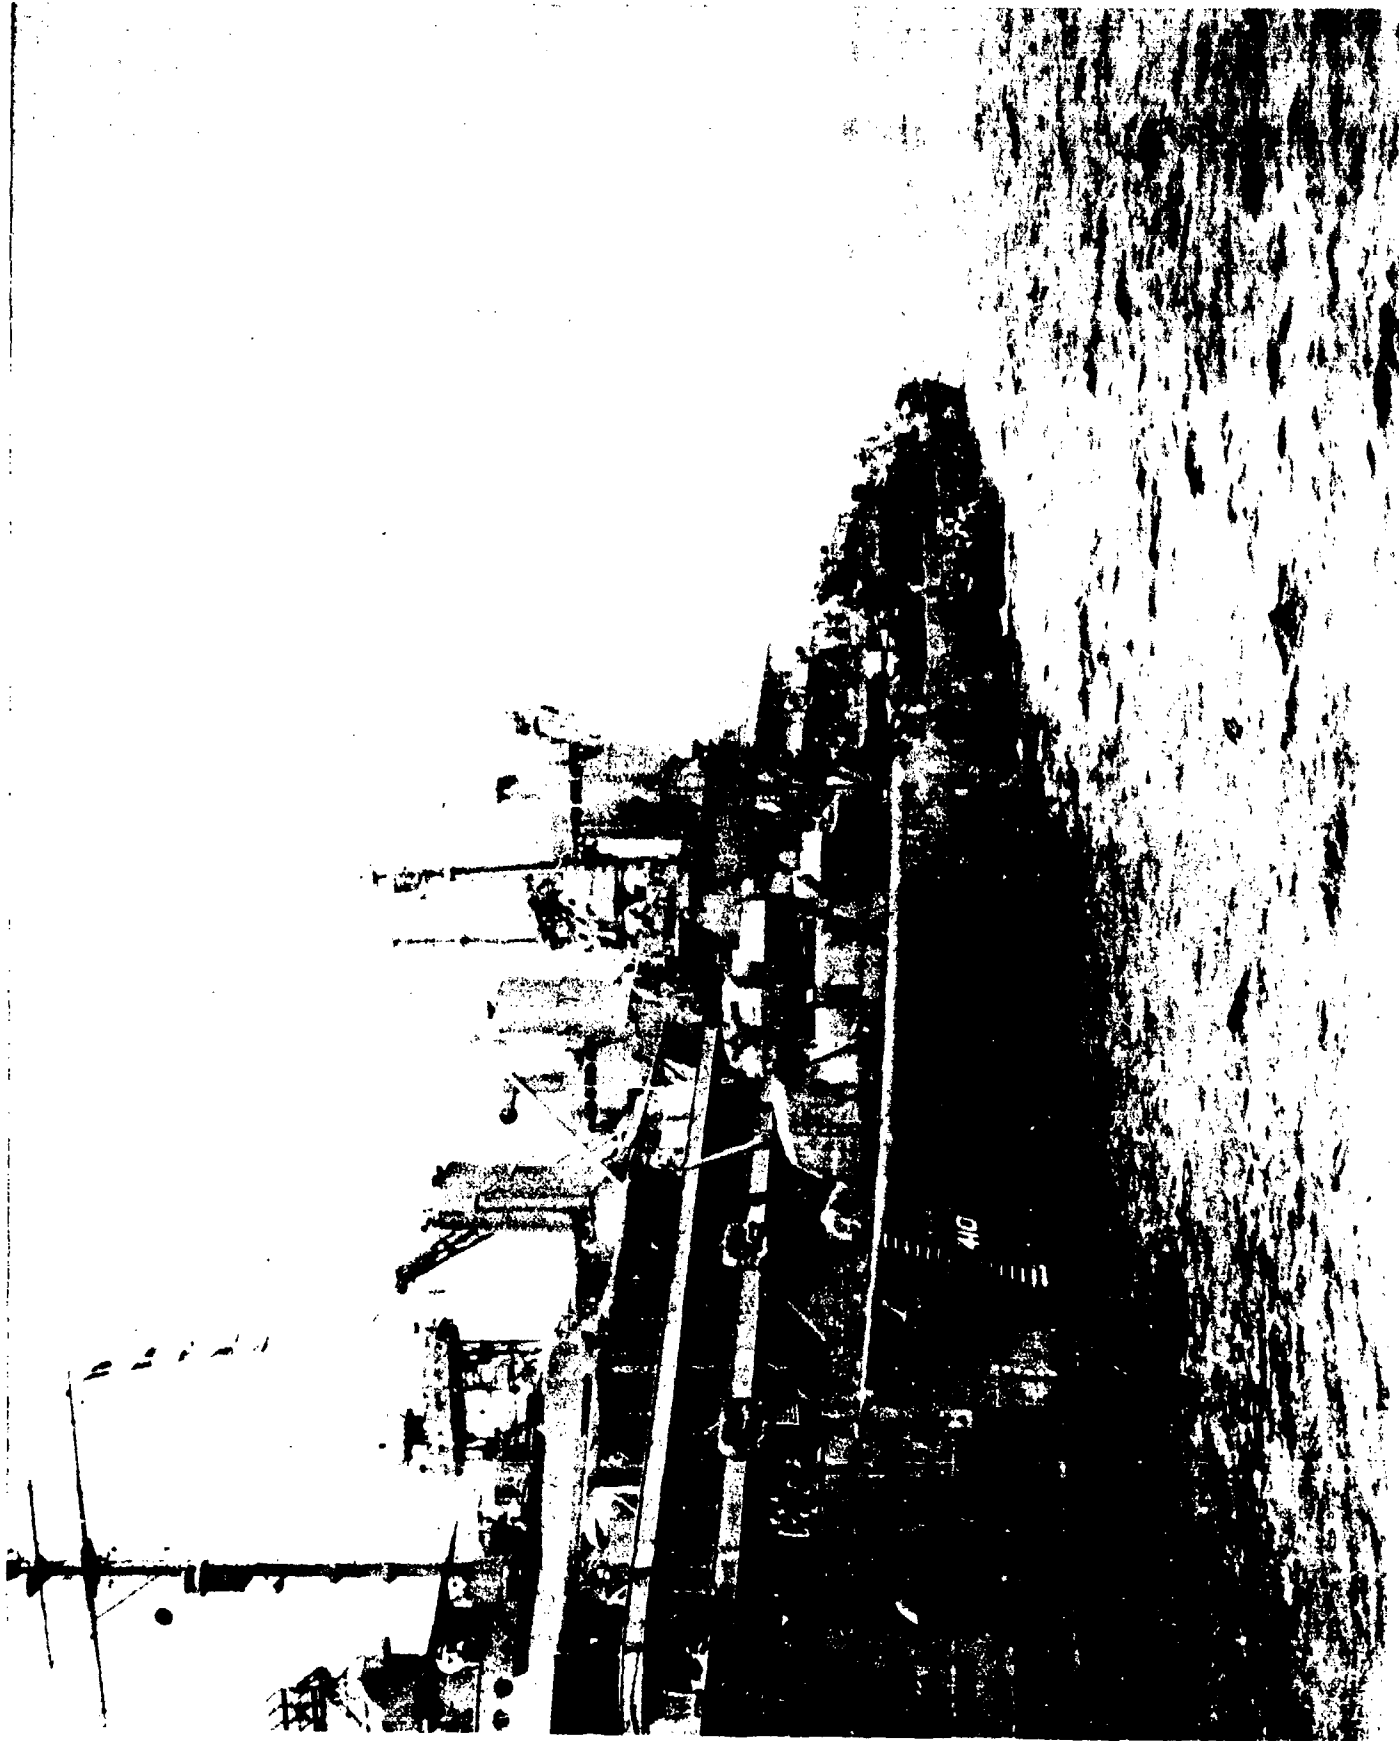
AA-CR-227-49-84. Port bow after Test A.

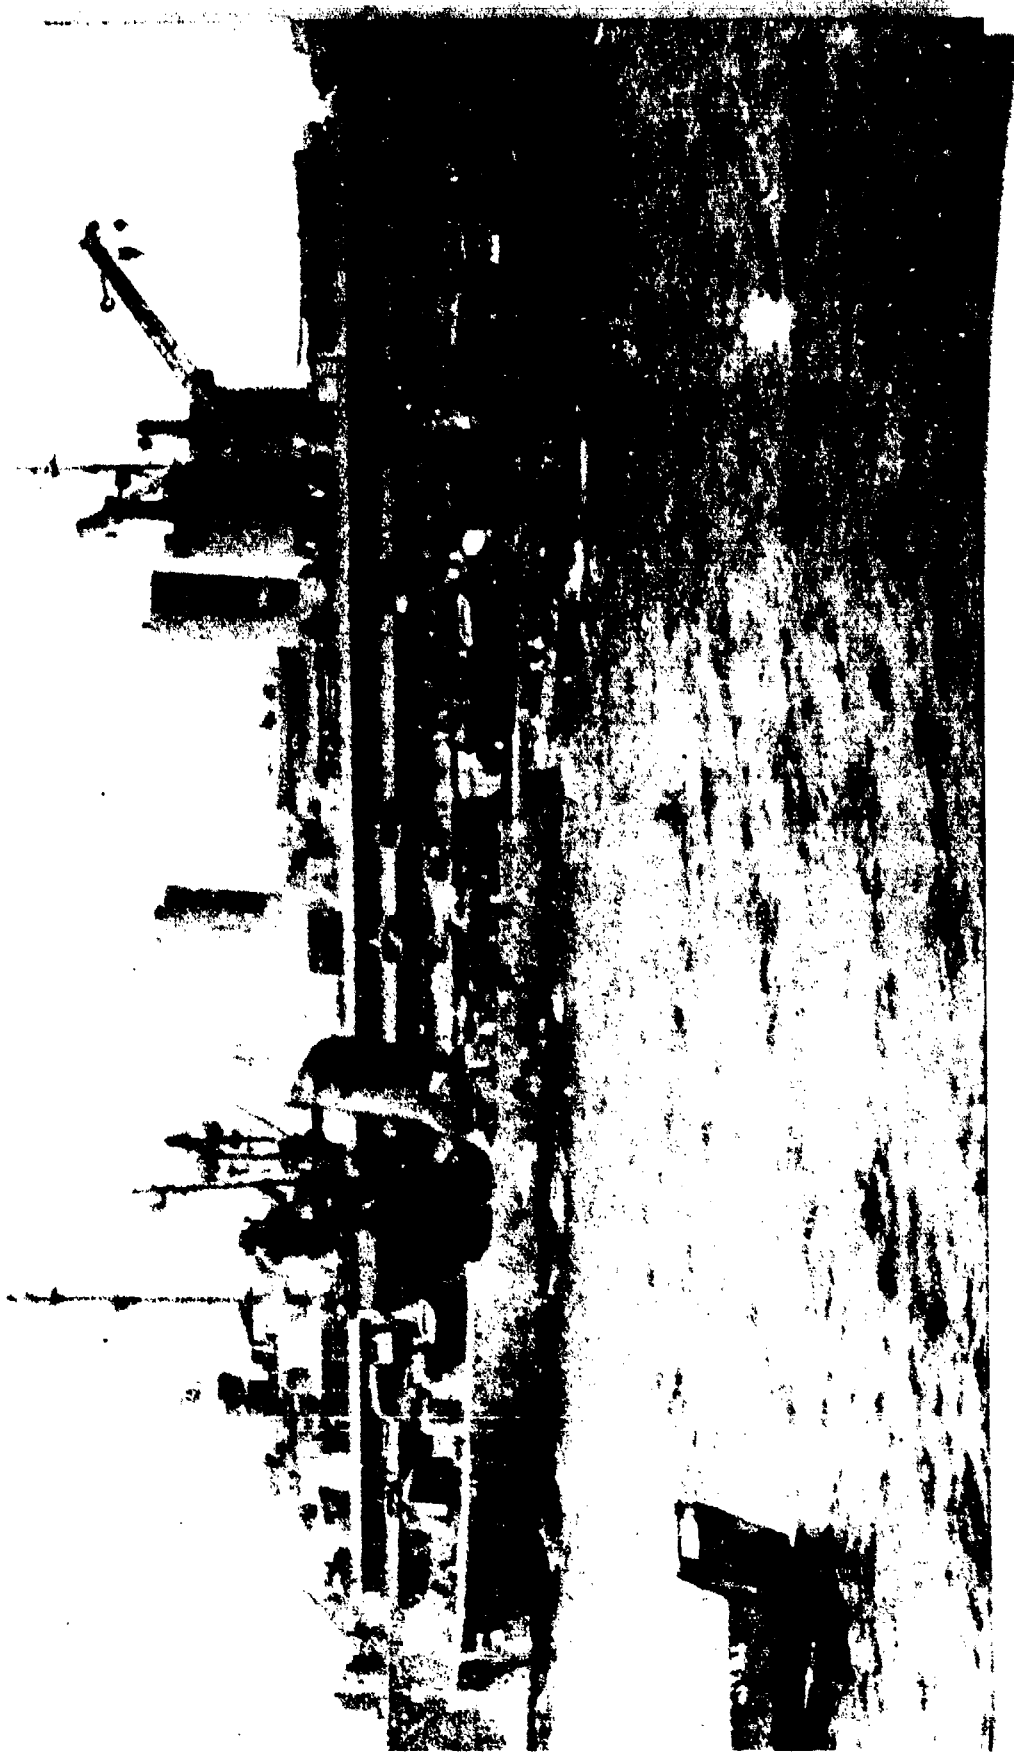
AA-CR-227-49-82. Port beam after Test A.

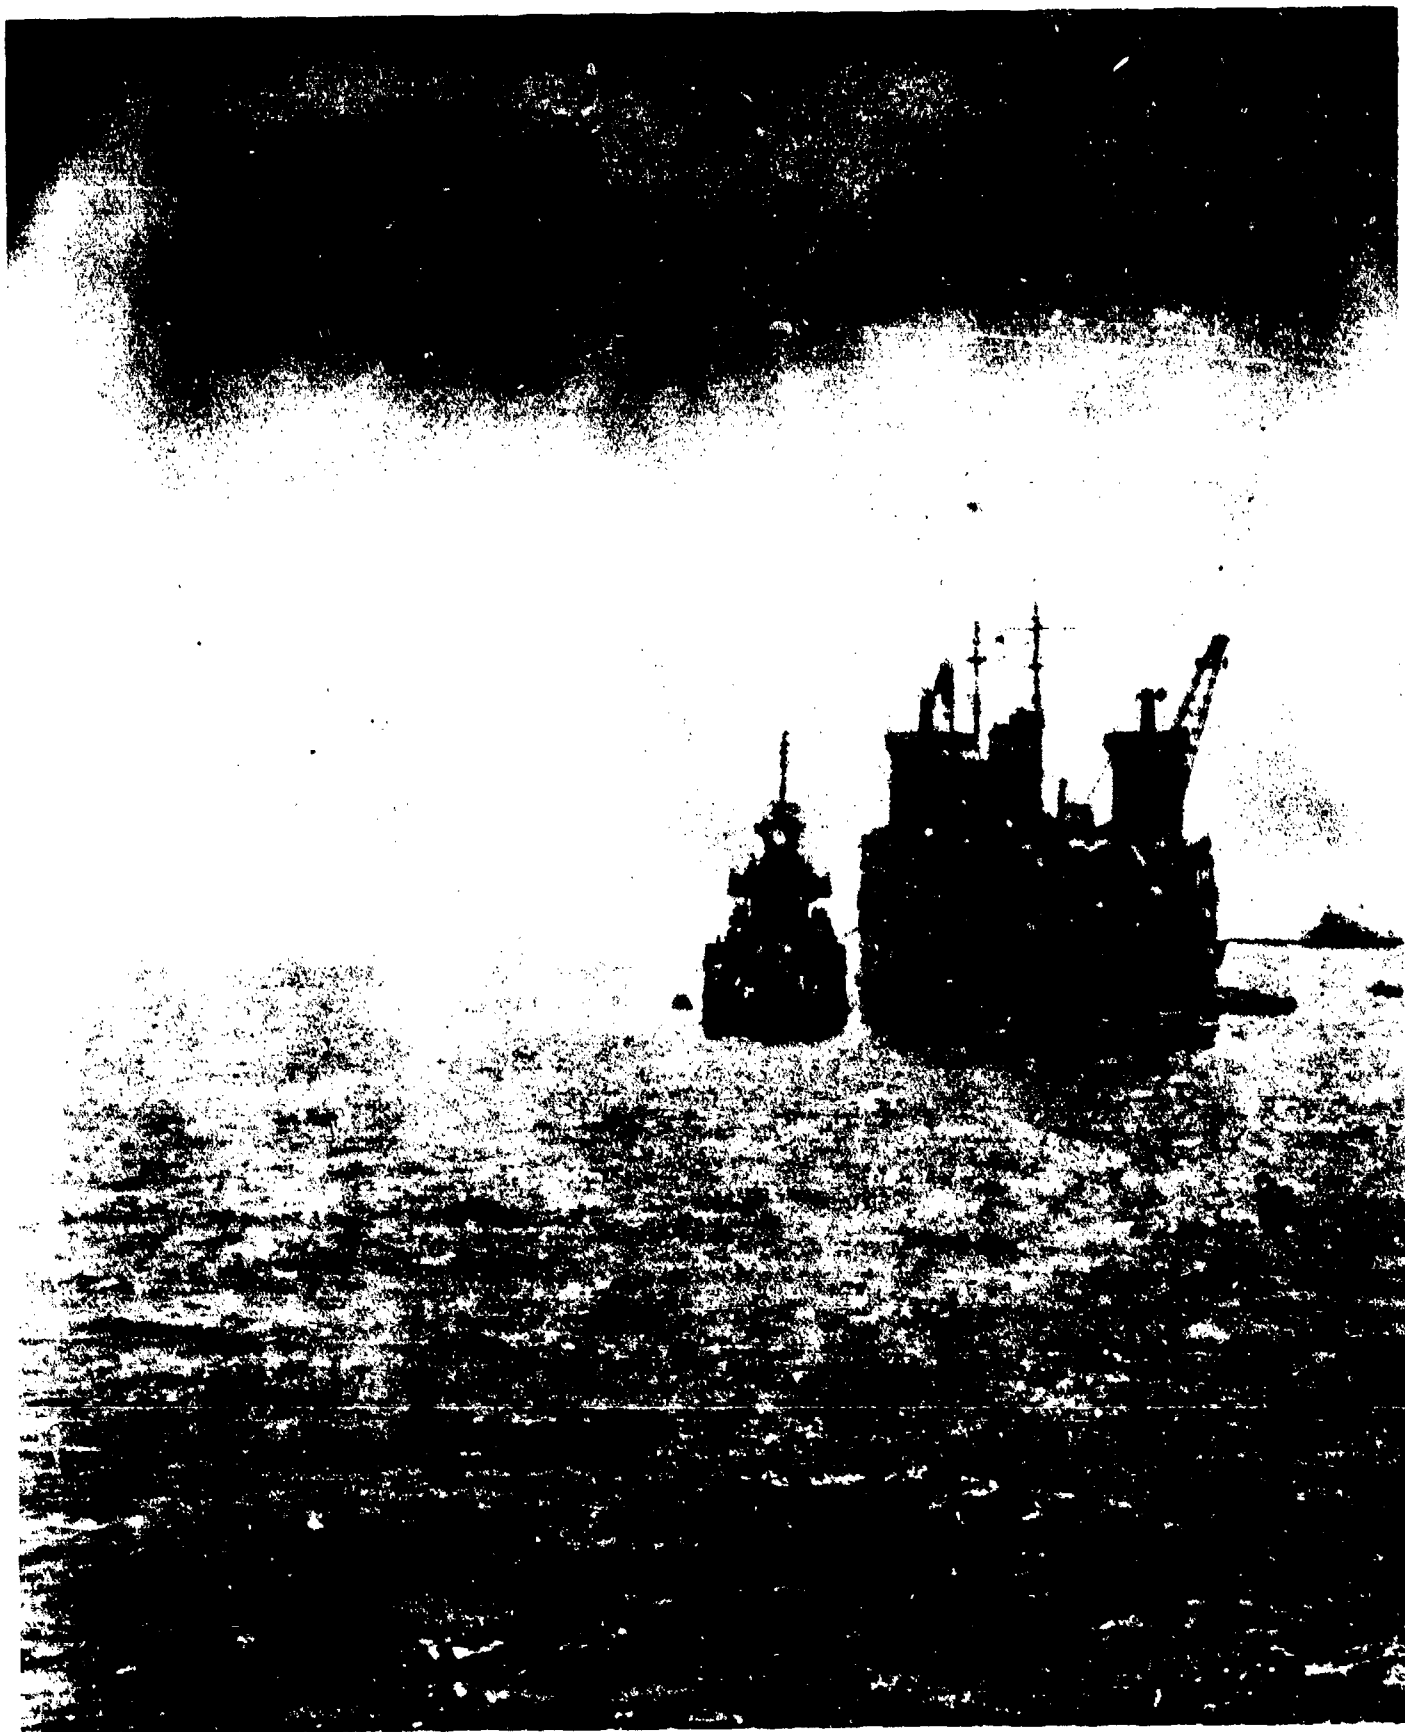
AA-CR-227-49-86. Stern after Test A.

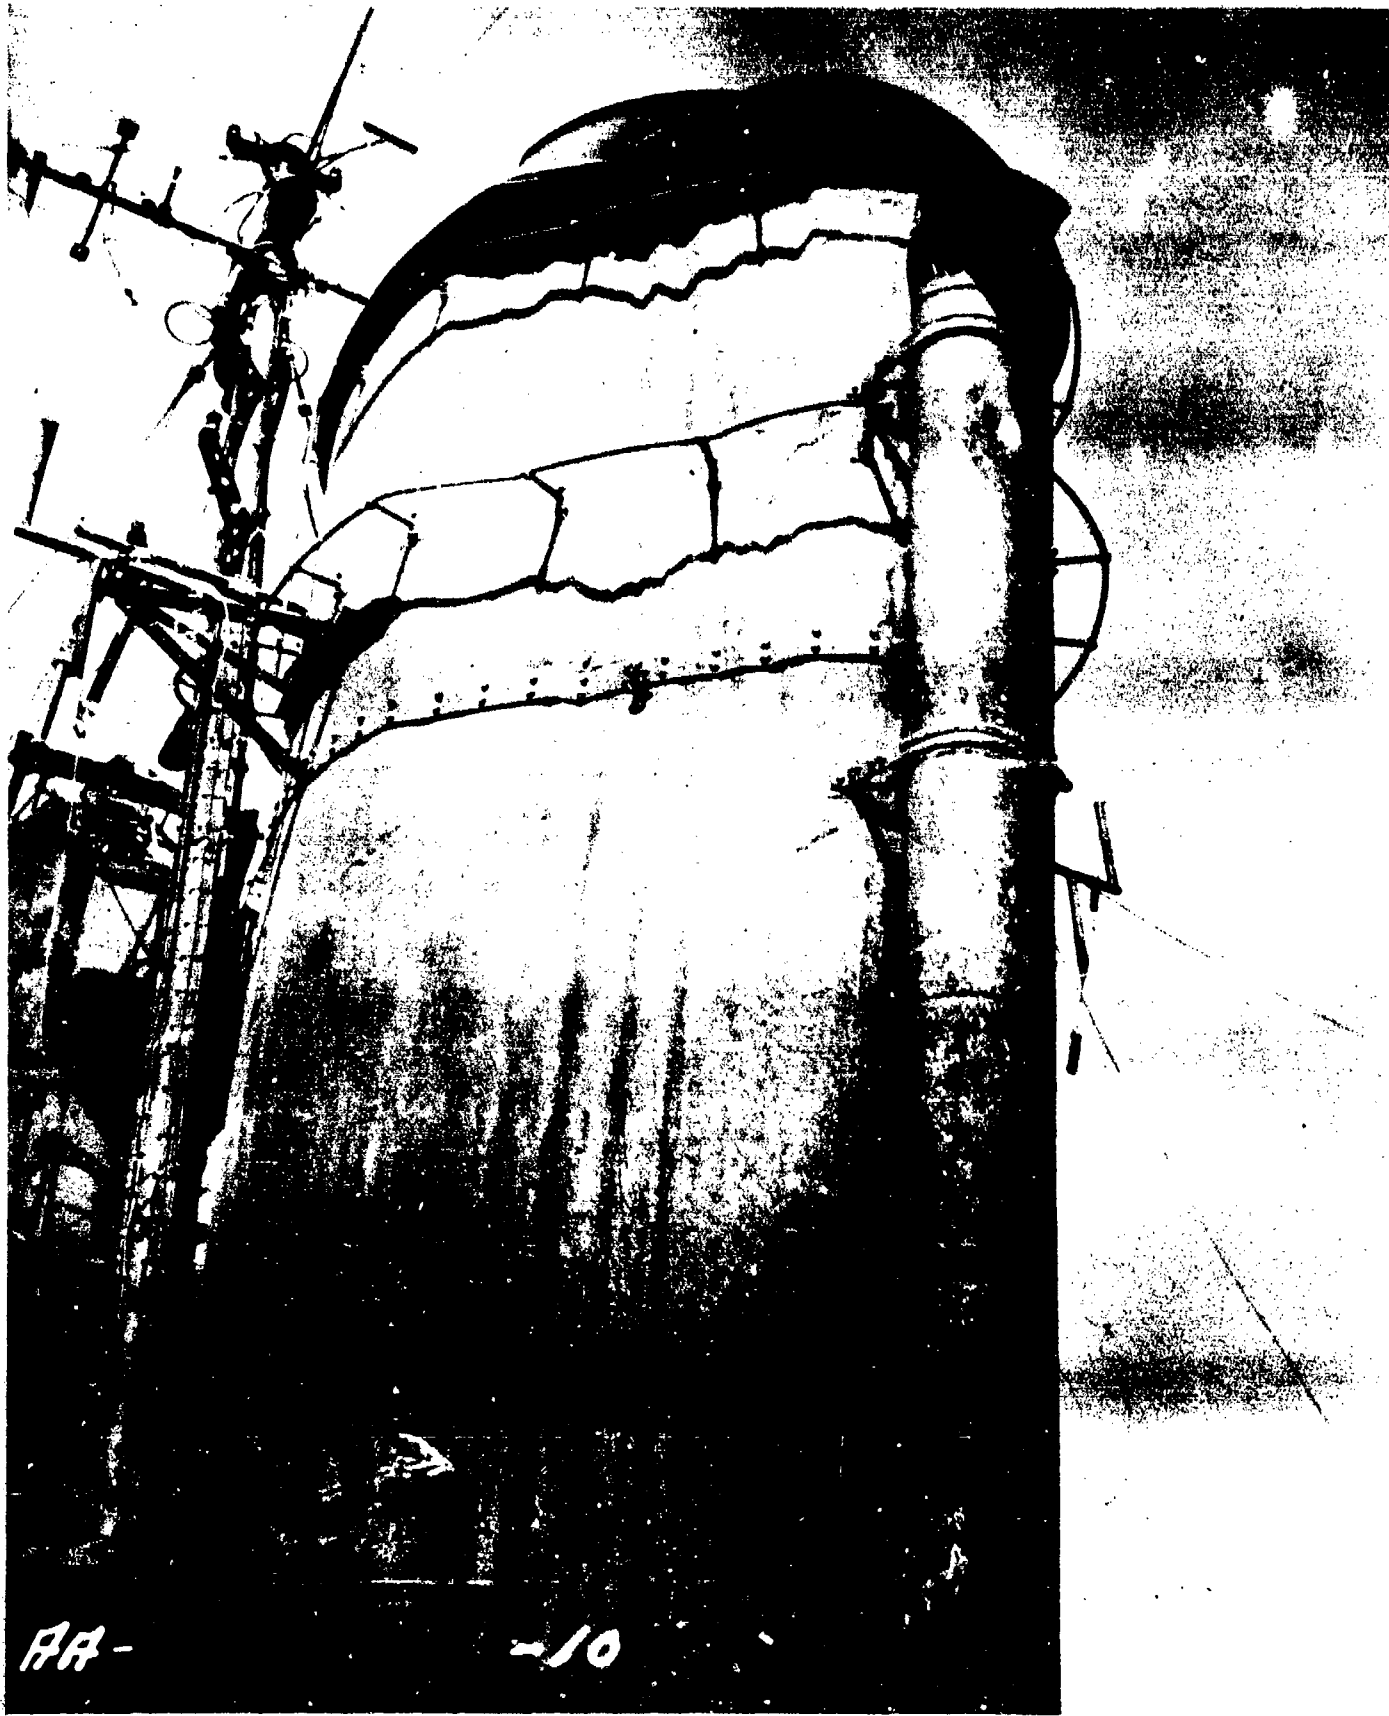
The stack is dished for about the top ten feet on the after port corner, (photo 1747 10; Page 67 ). The funnel cap is distorted in way of this damage and the top edge is pushed in. Compression wrinkles appear in the forward face of the stack (photo 1849-10; Page 66 ).

AA-CR-68-1747-10. Port after sector, of stack, looking forward and to starboard.

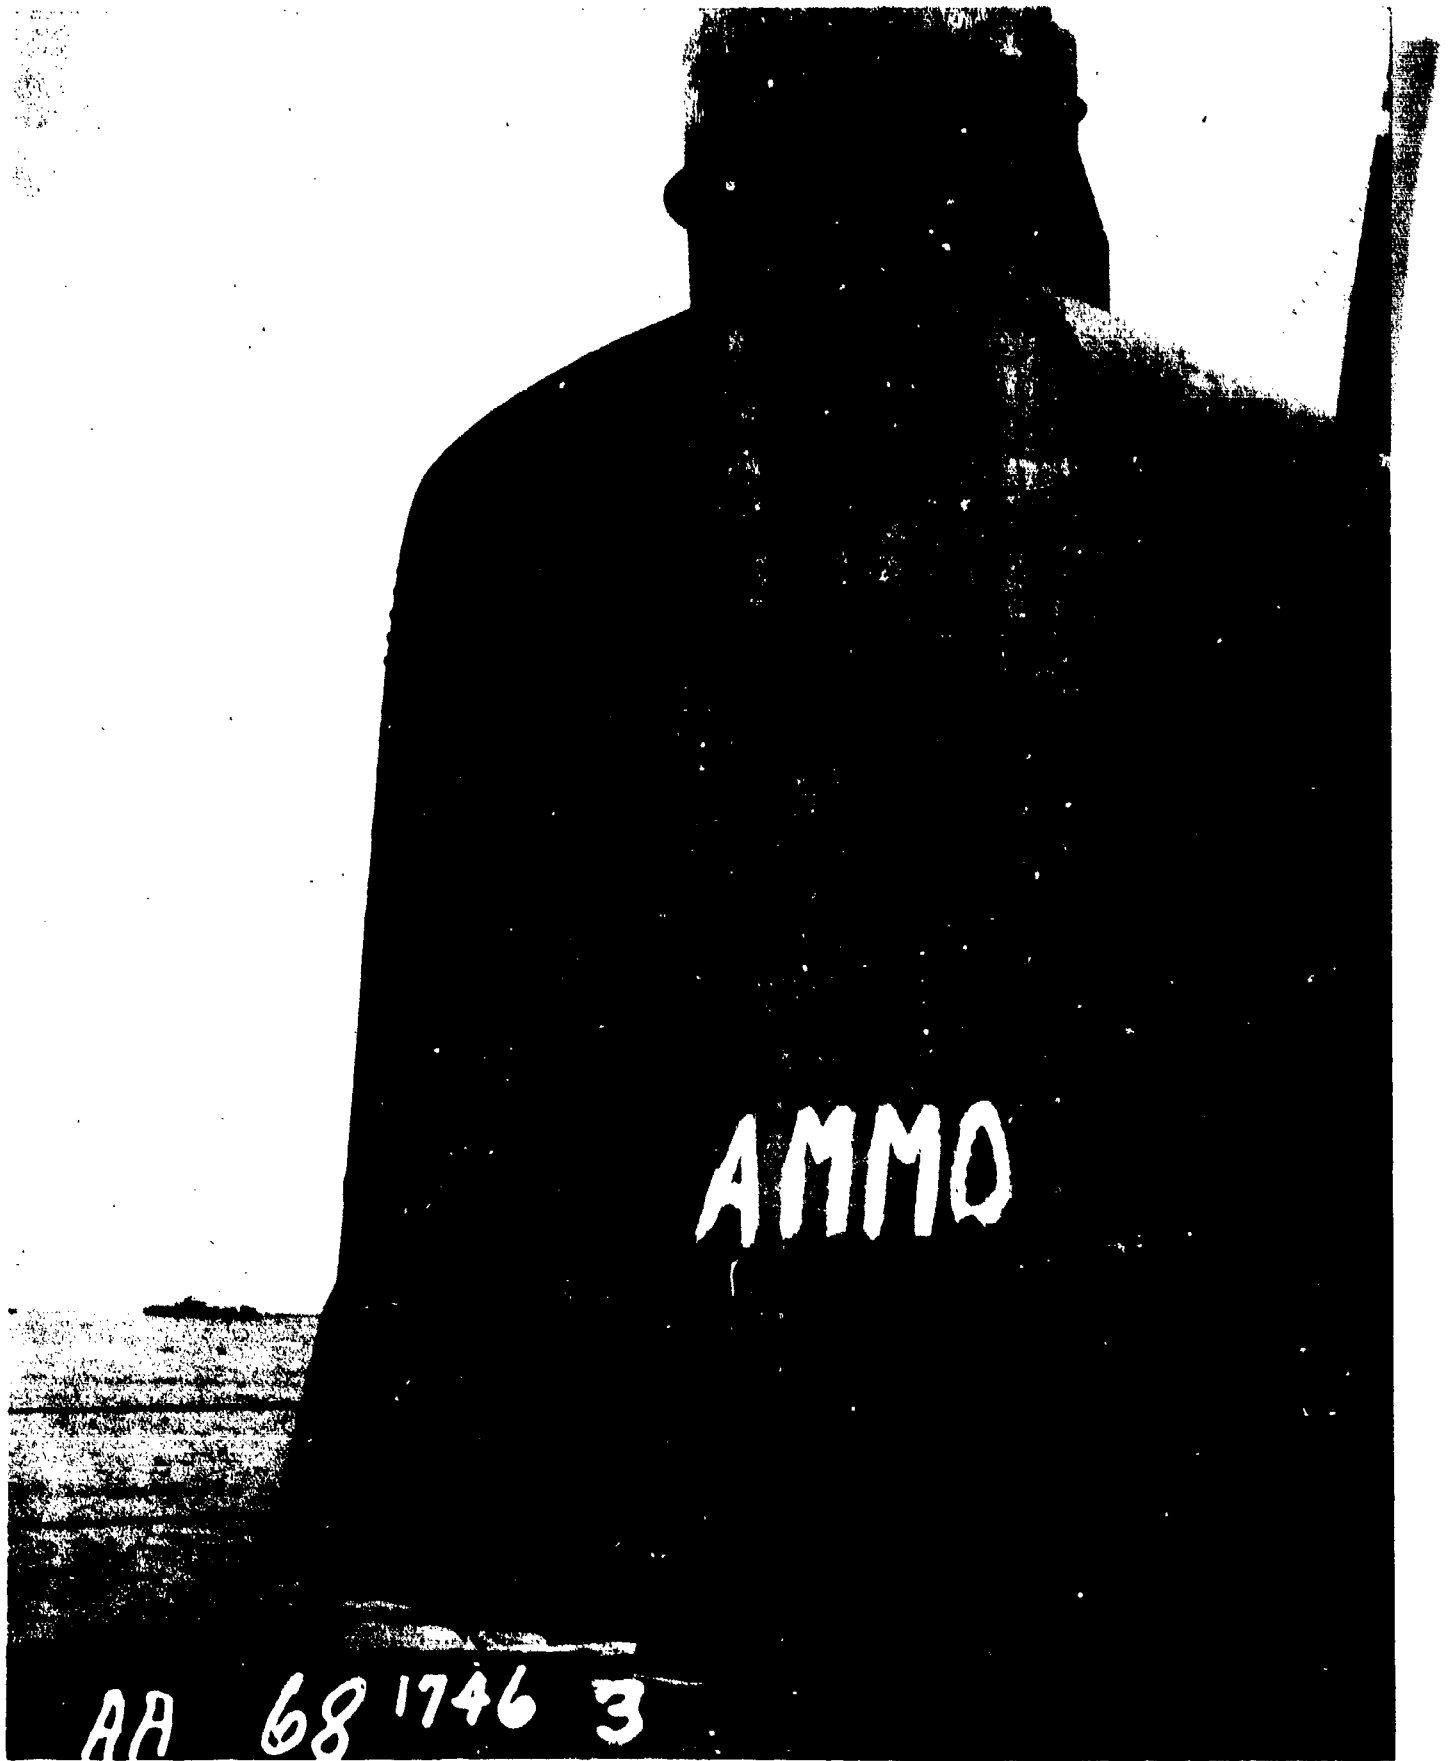
AA-CR-68-1746-3. No. 1 mount, dishing of rear plating.

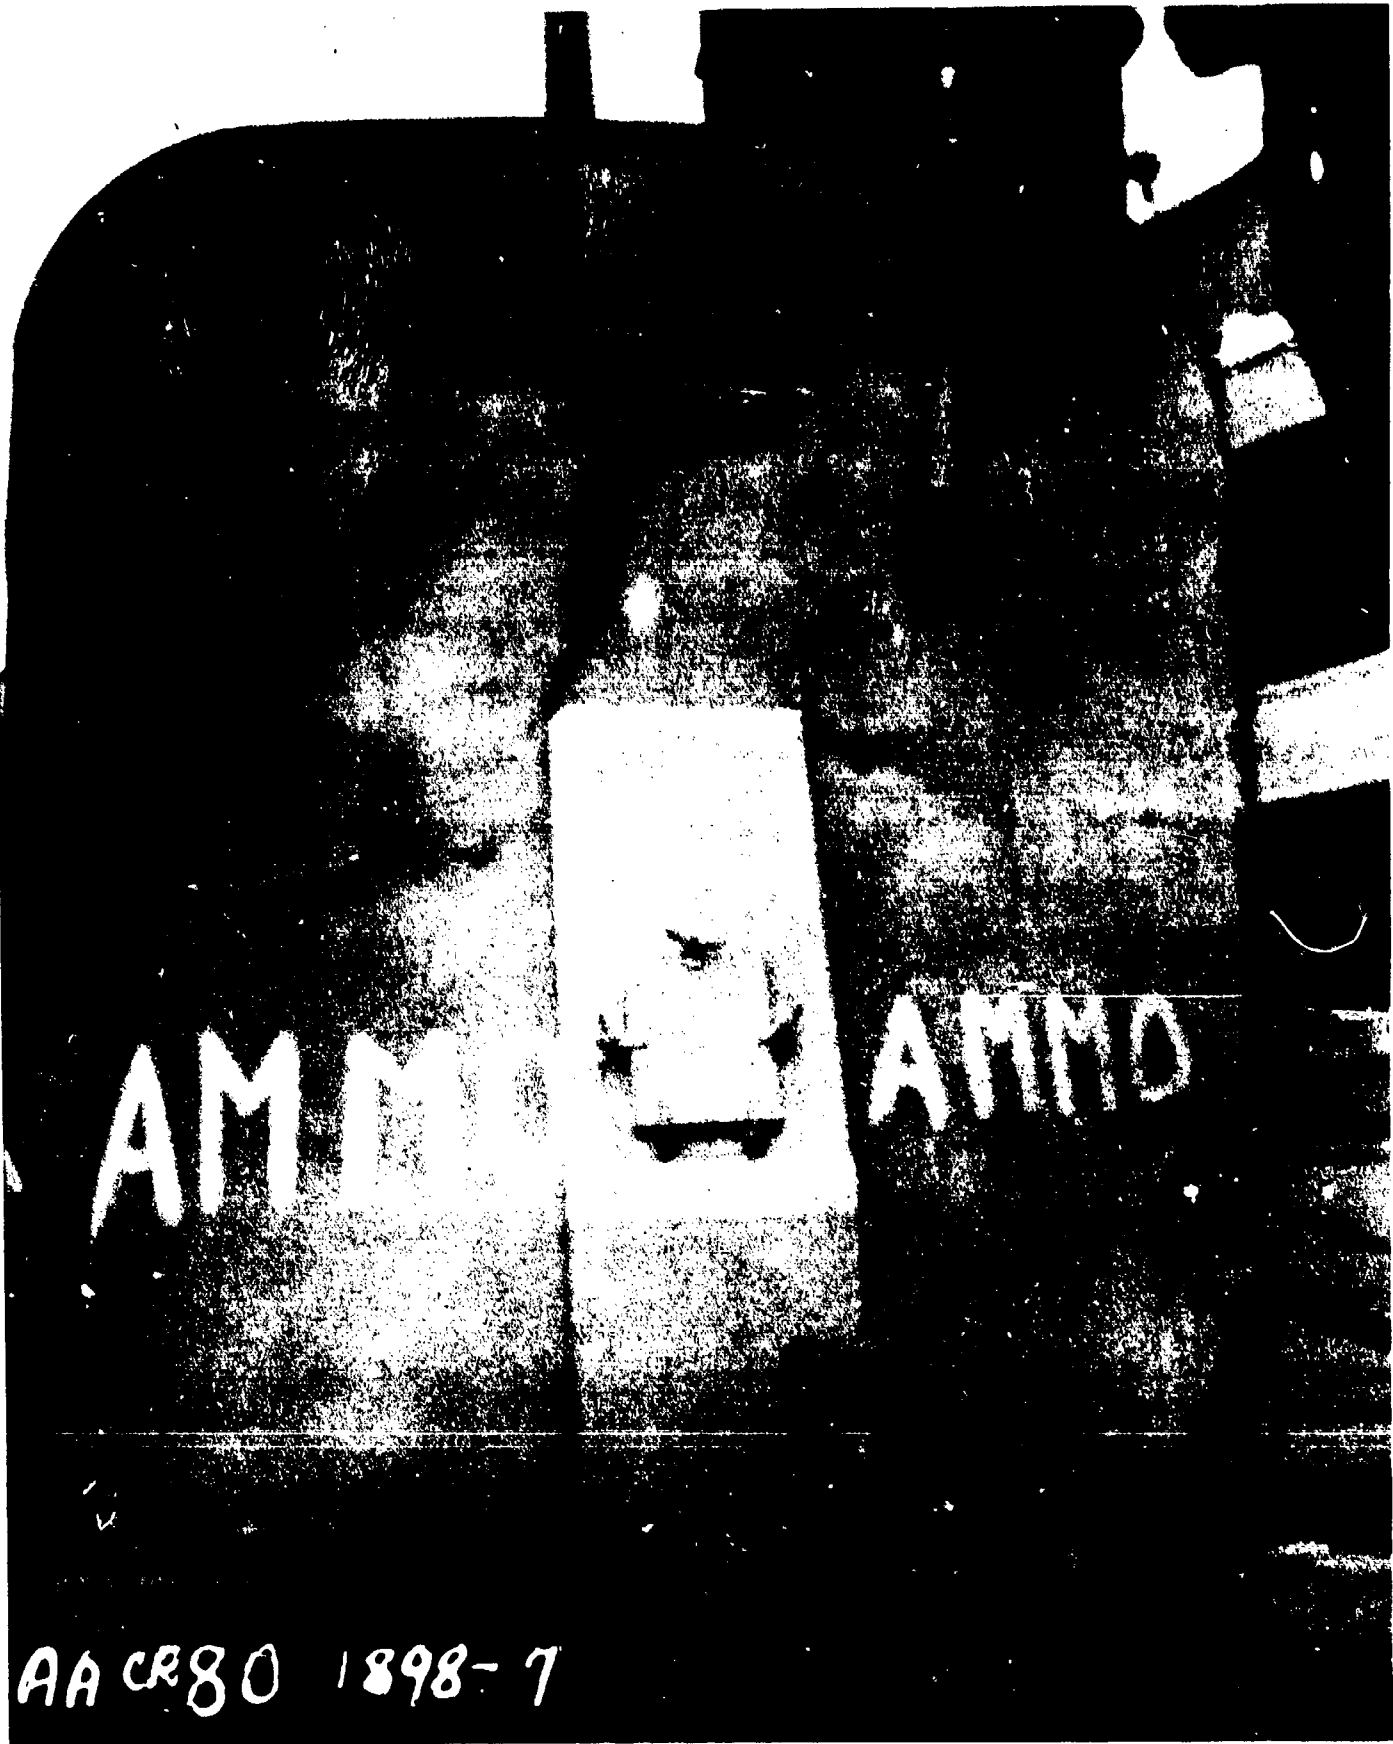
AA-CR-80-1898-7. Damage to back plating of No. 1 gun mount.
