## TECHNICAL INSPECTION REPORT

### 6 OPERATION CROSSROADS. U.S.S. MUSTIN (DD413)

TEST ABLE [U].

USS MUSTIN (DD413)

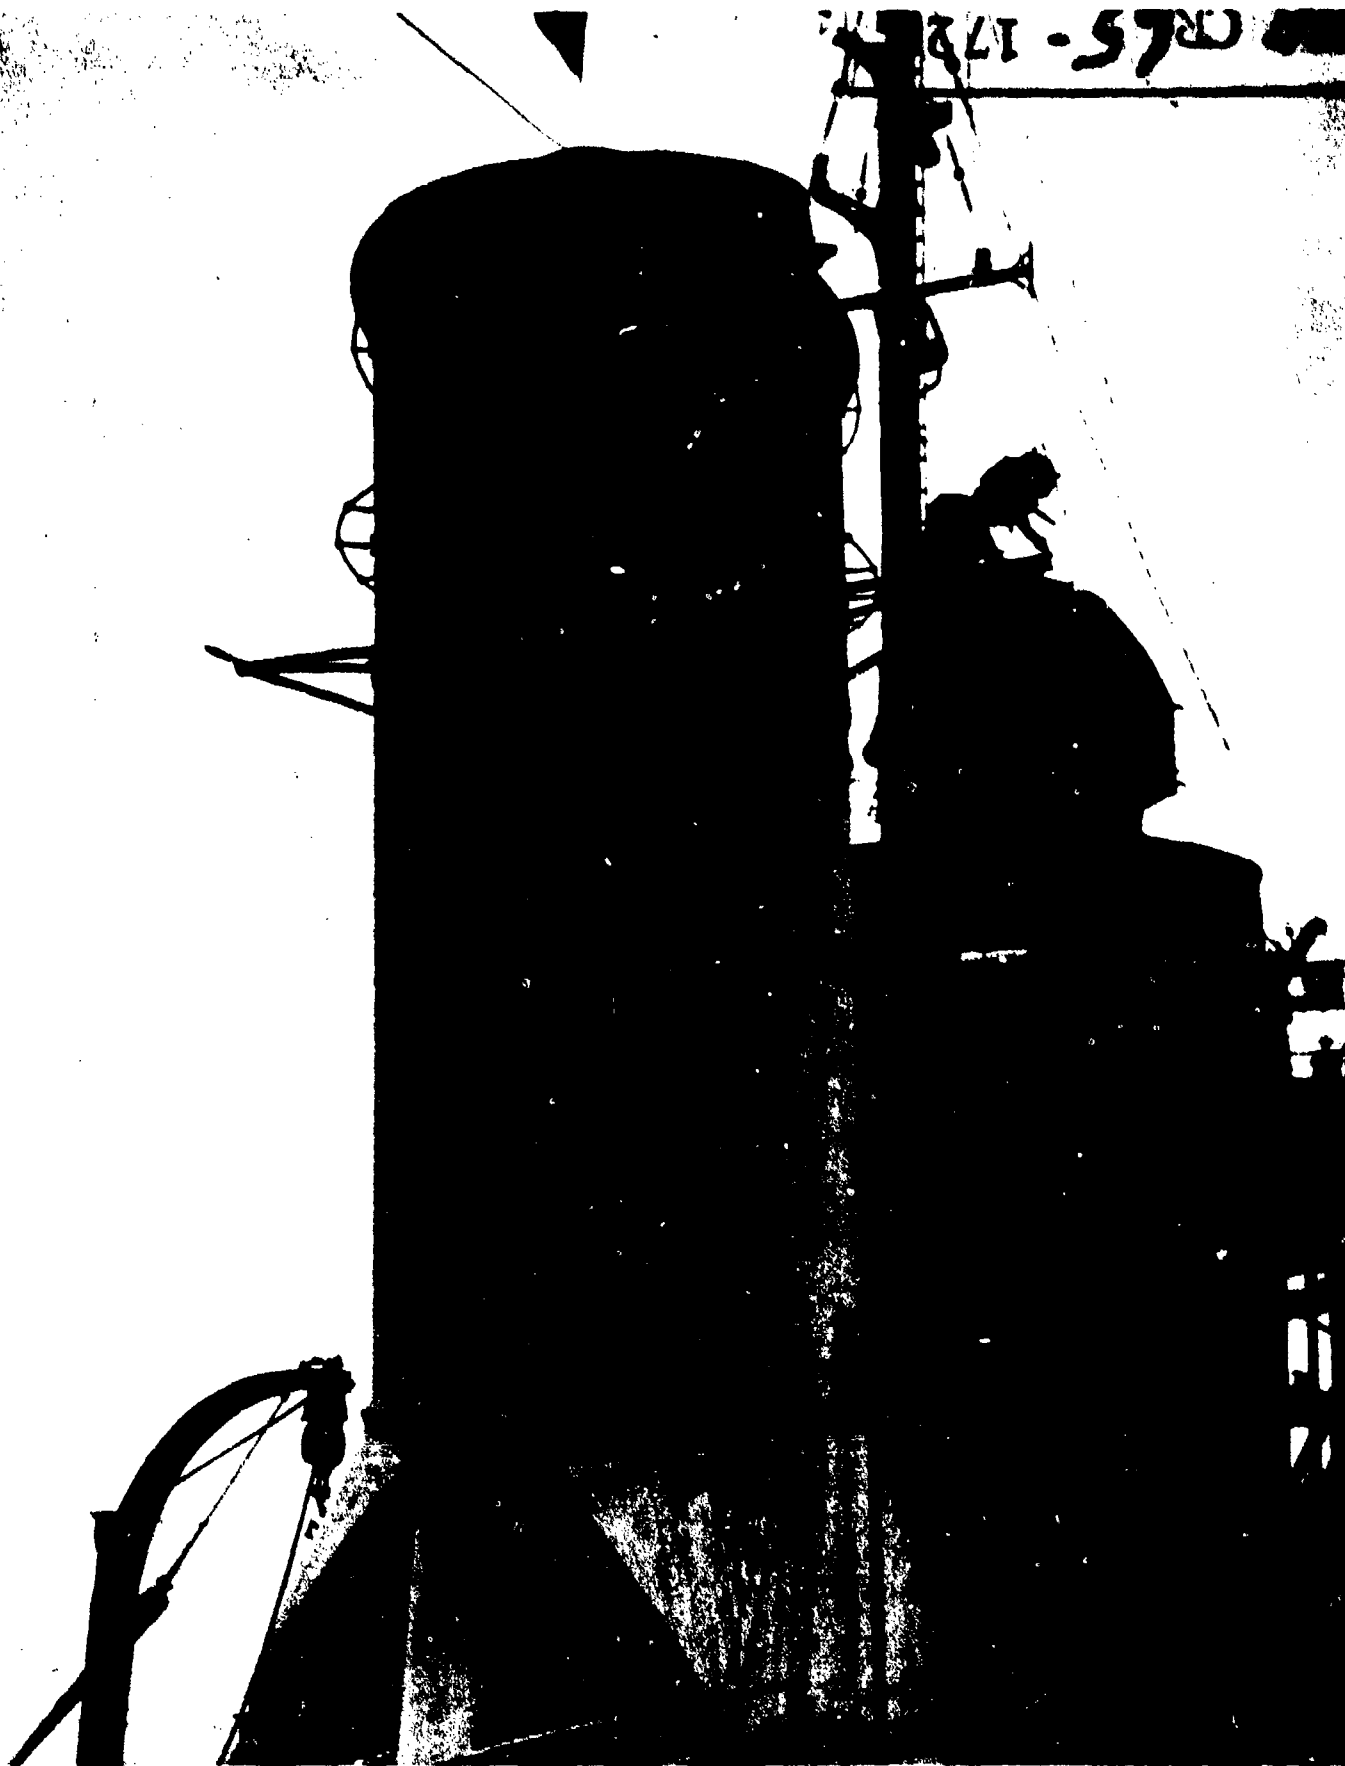
The after side of both port and starboard flag bags is dished to a depth of one inch. (Photo 1728-6, page 31).

AA-CR-65-1728-6. Looking forward to superstructure showing damaged paint on stack.

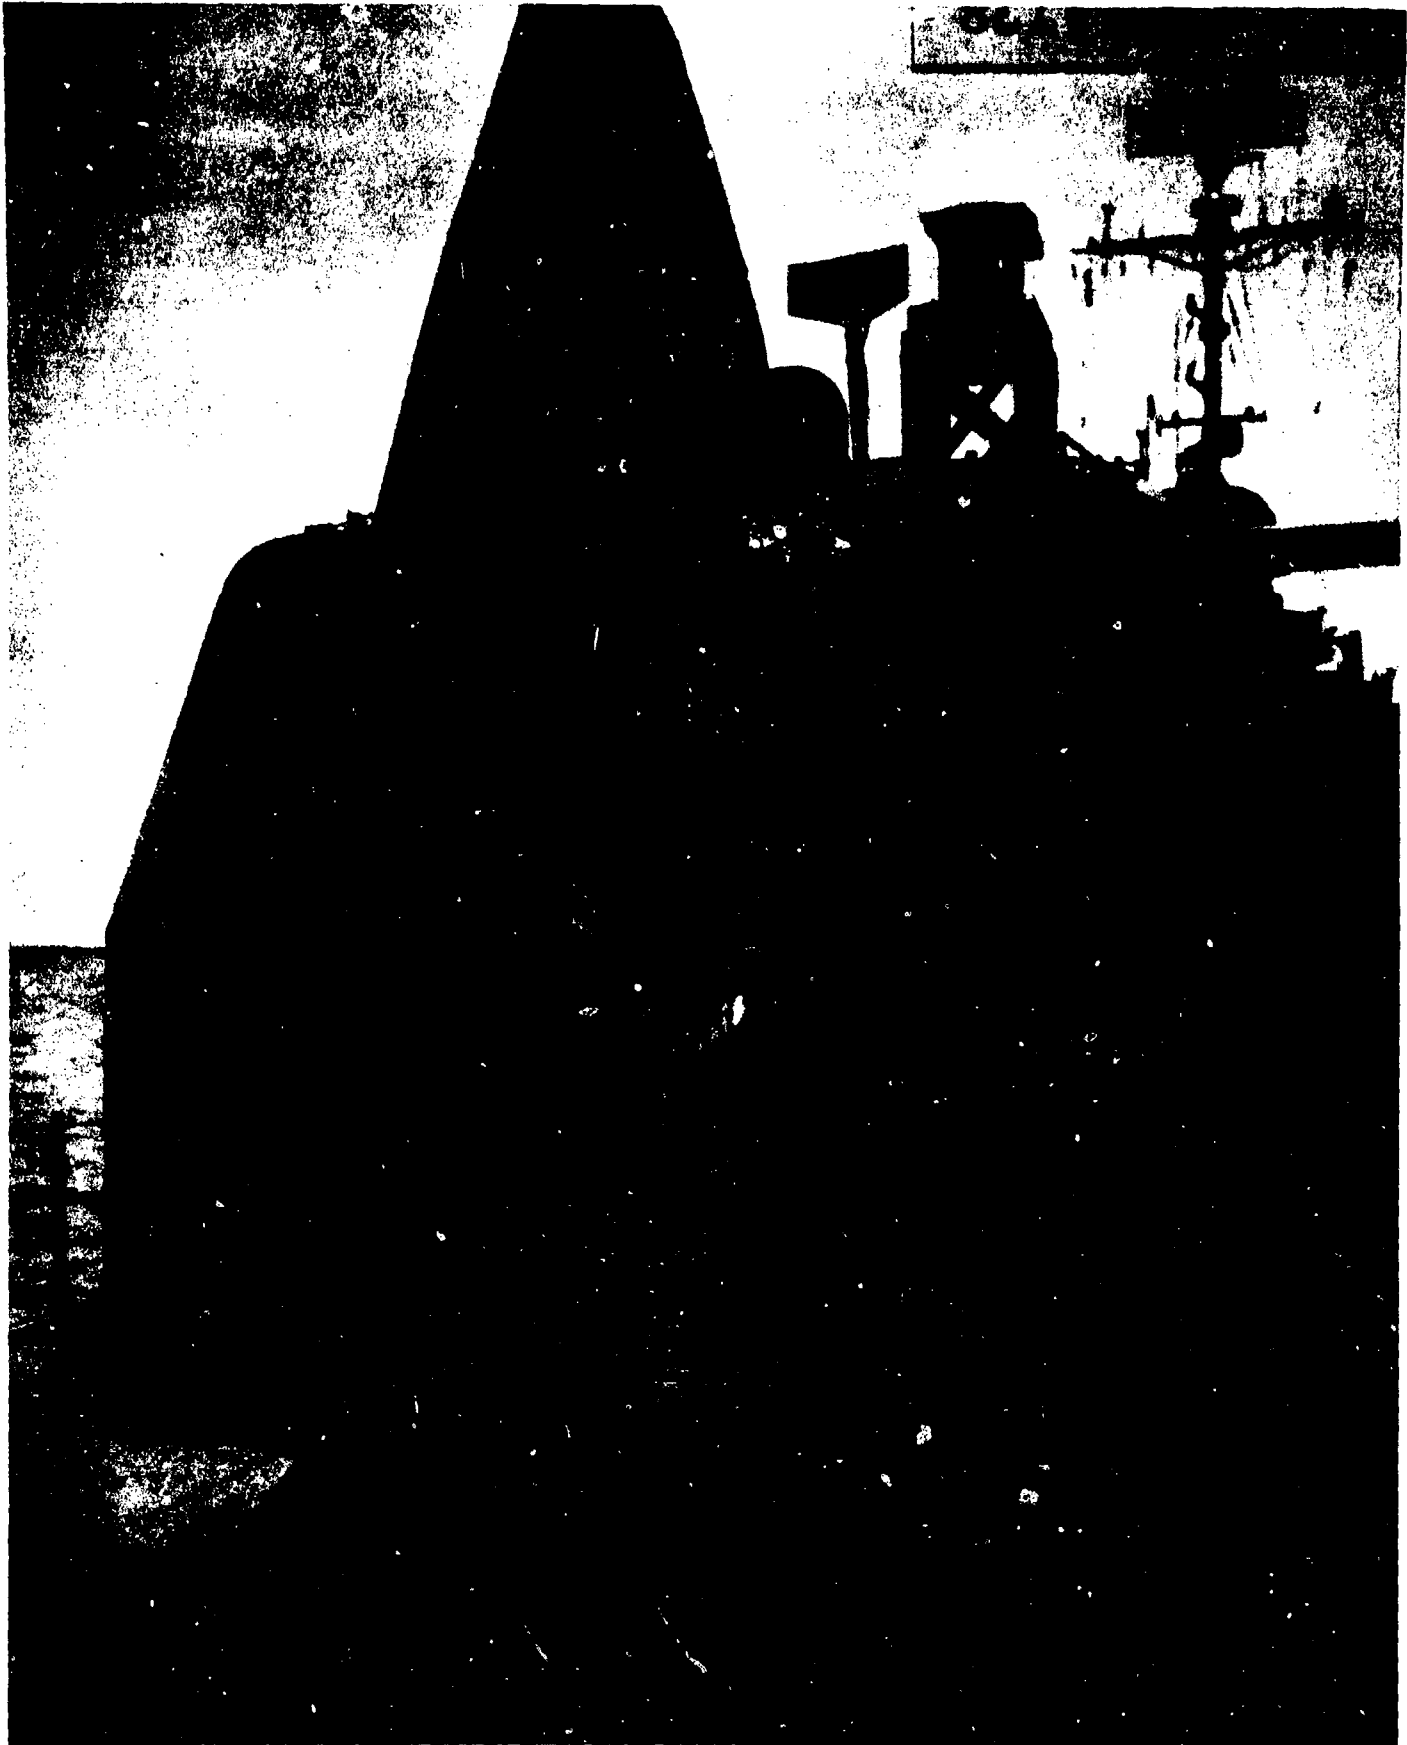
AA-CR-65-1728-7. Paint damage on after face of #4 mount.
