TECHNICAL INSPECTION REPORT

OPERATION CROSSROADS. U.S.S. WAINWRIGHT (DD 419)

TEST ABLE [U]

BUREAU OF SHIPS GROUP
TECHNICAL INSPECTION REPORT

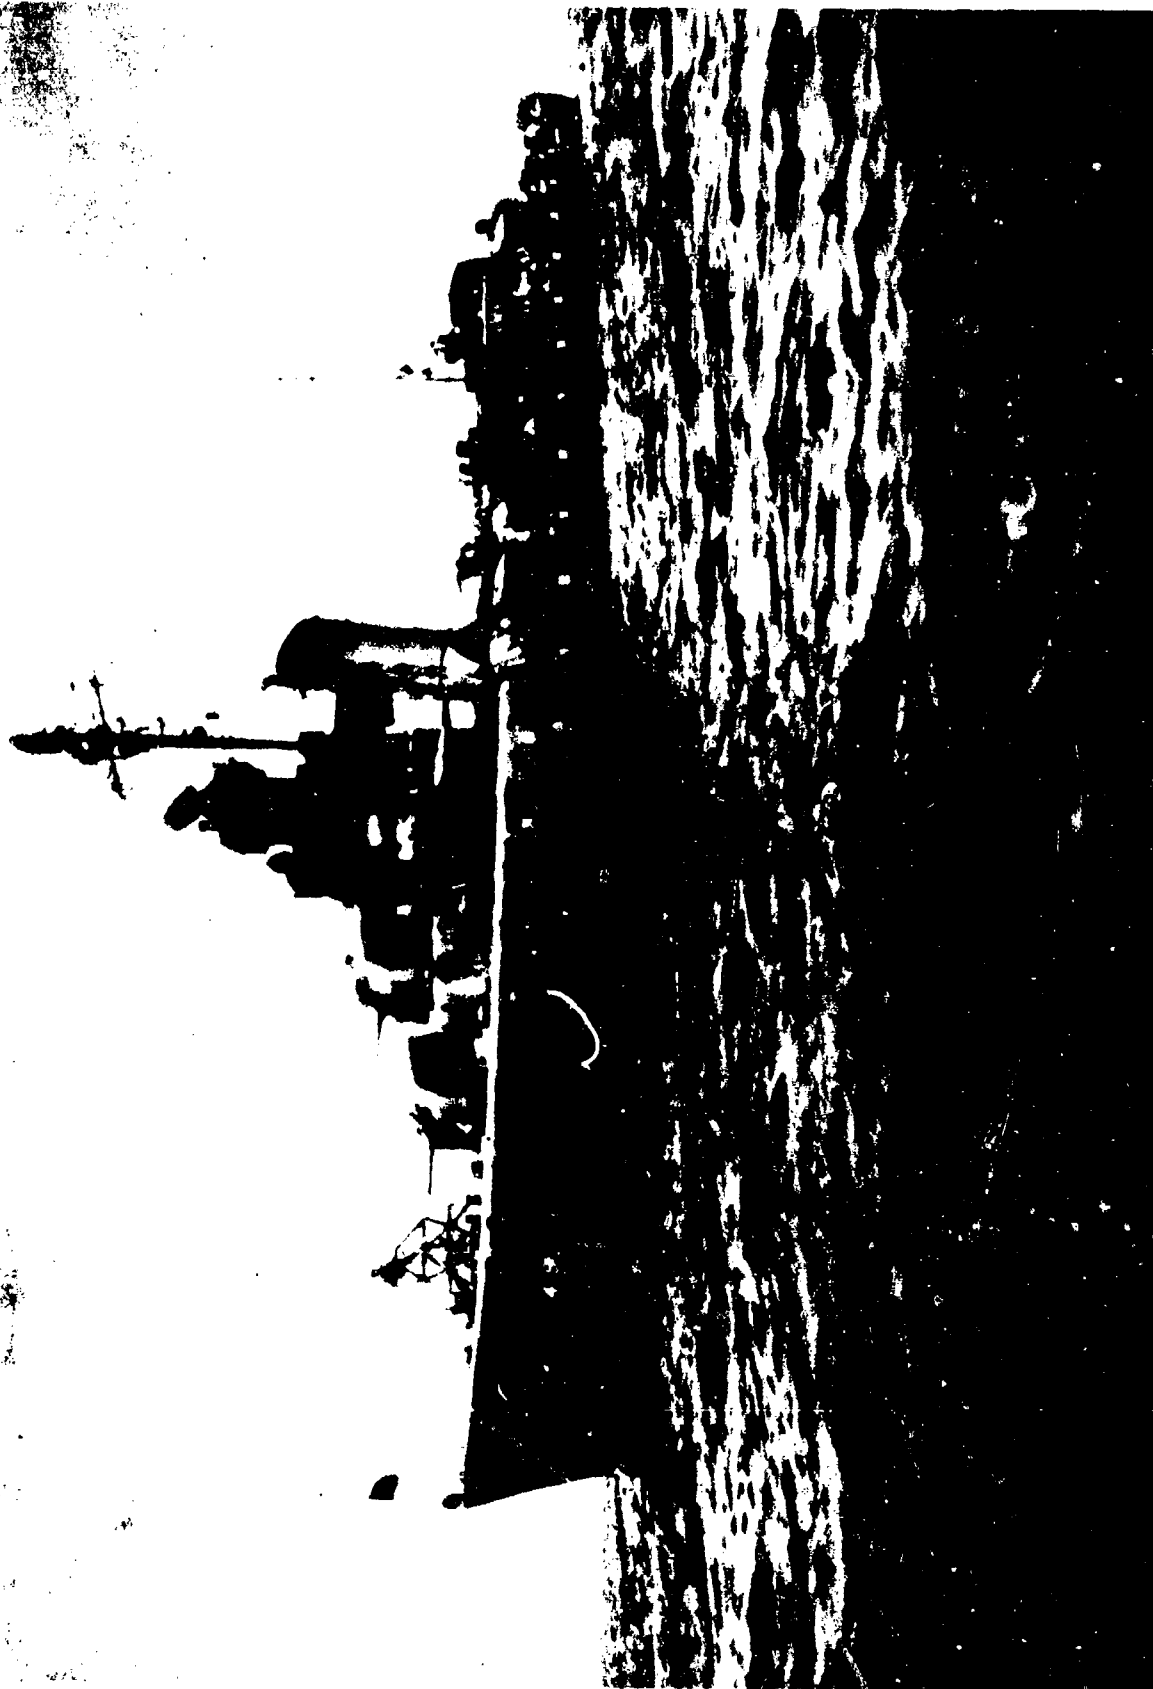
AA-CR-227-49-98. View from off port bow after Test A.

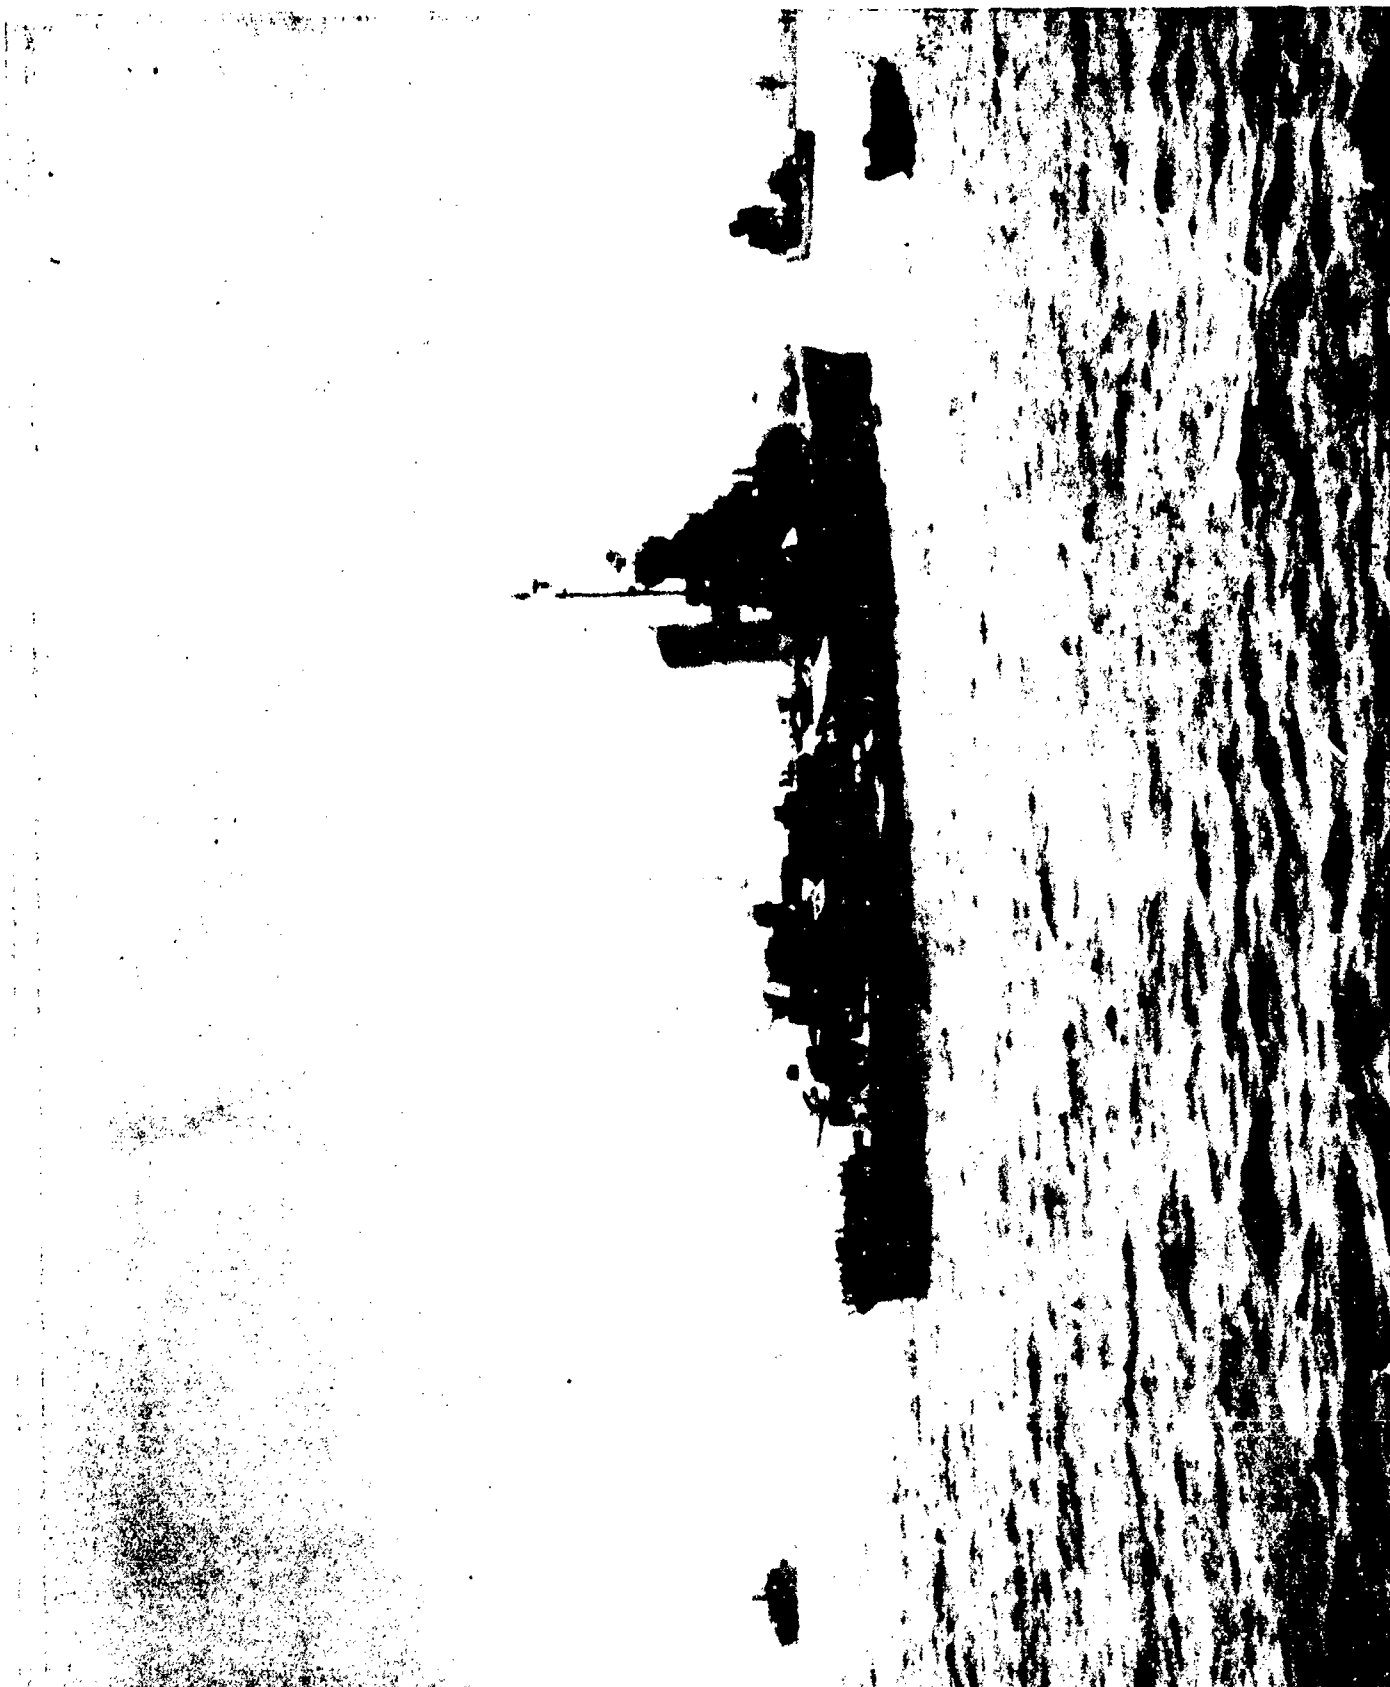
AA-CR-227-49-101. Starboard quarter after Test A.

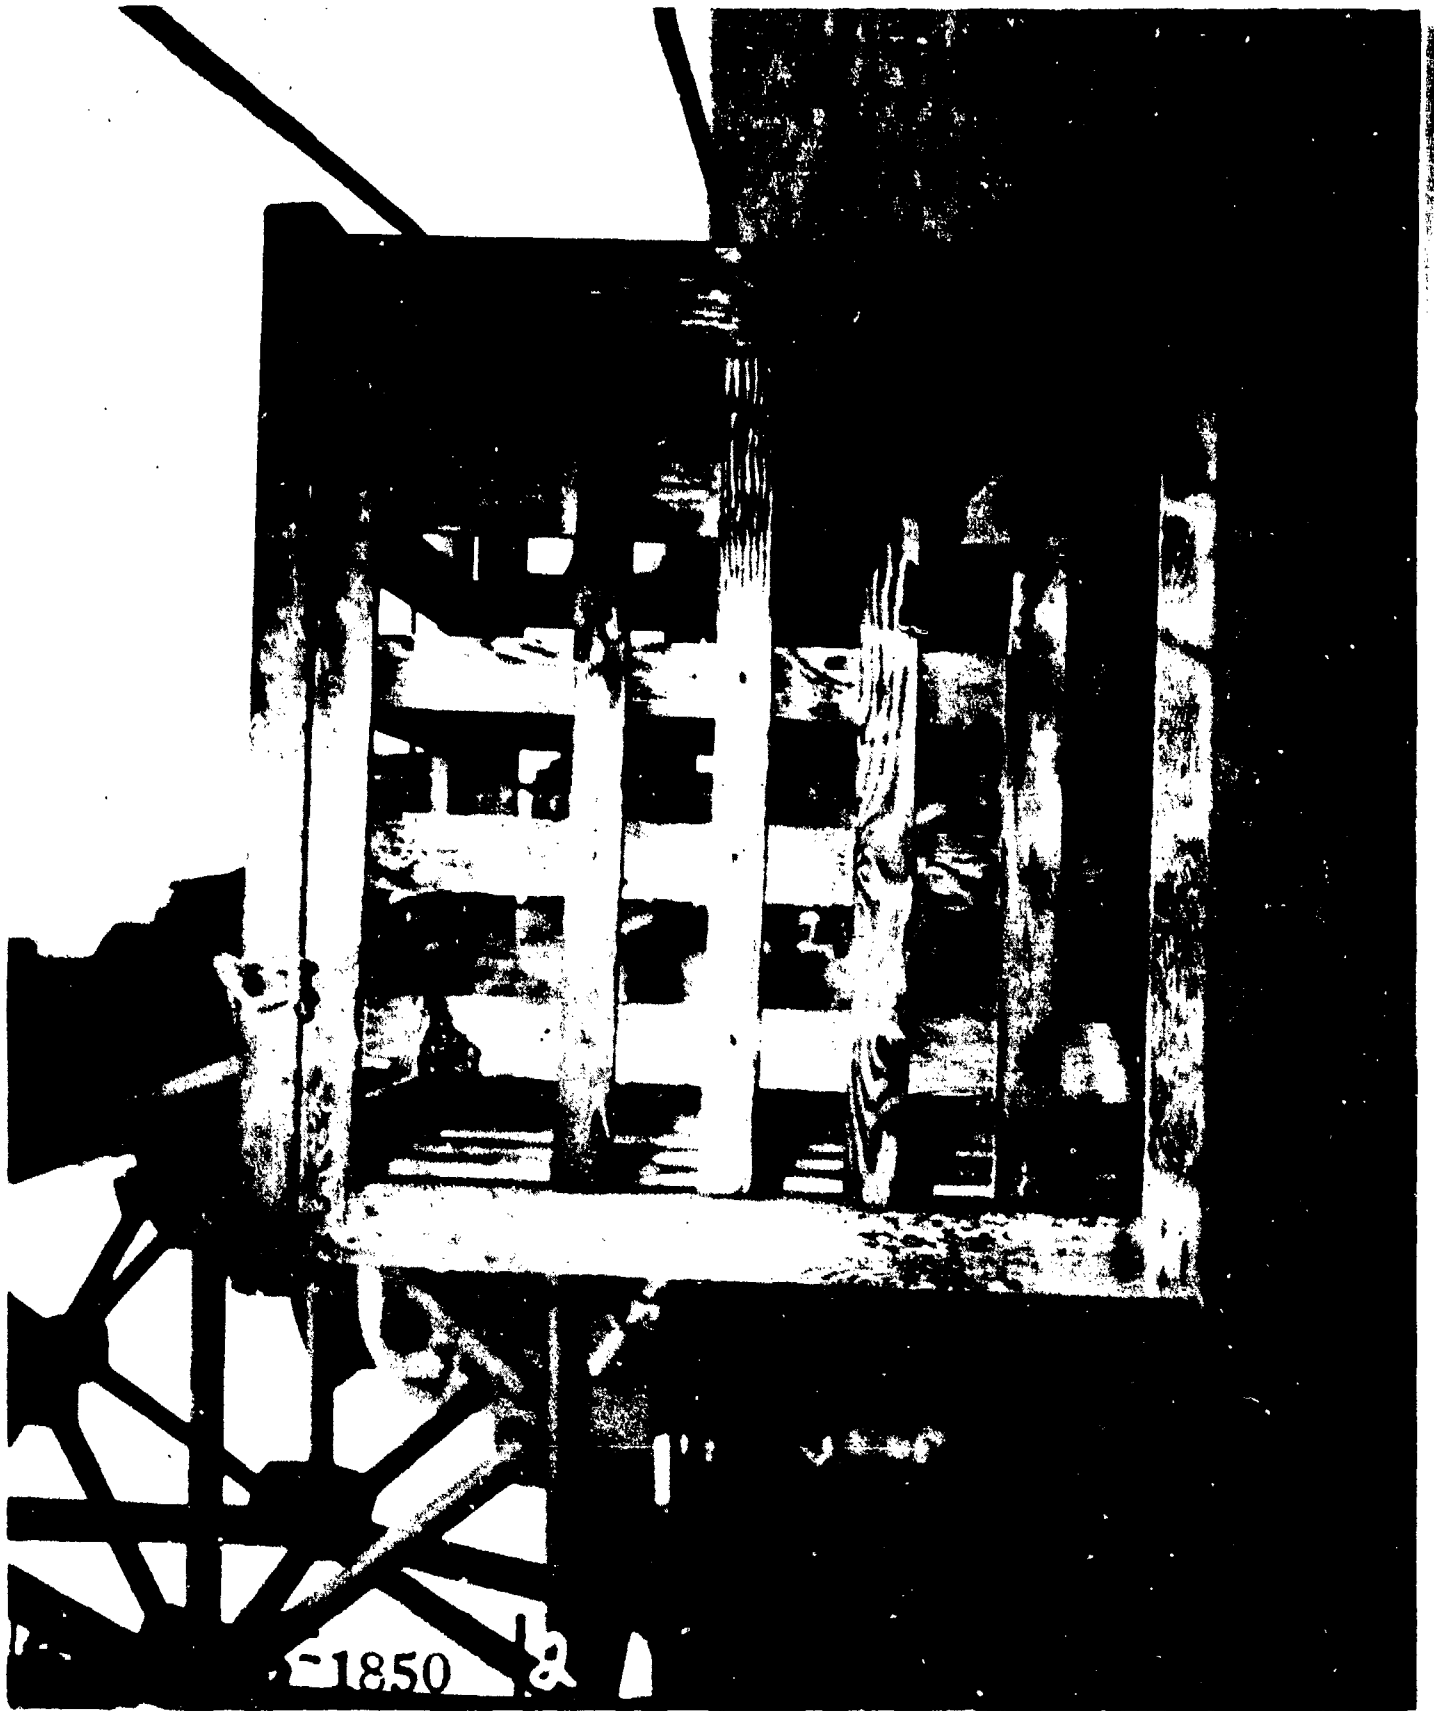
The weather decks and equipment and fittings thereon are undamaged. At frame 10 on the forecastle, two wooden crates containing goats were secured, one port and the other starboard. The crates had a new, unpainted piece of canvas on top, presumably to protect the animals from the sun. The port crate was scorched and the canvas burned. (Photo 1850-2, page 41). No movement was recorded by any of the six deflection scratch gages located under the weather deck.

AA-CR-65-1850-2. Paint scorching on animal cage located at frame 10, looking aft on forecastle deck, port.
