TECHNICAL INSPECTION REPORT

U.S.S. SKATE (SS305)

TEST ABLE

(6) OPERATION CROSSROADS
Place of
Atomic Support Agency
Washington, D. C. -20301

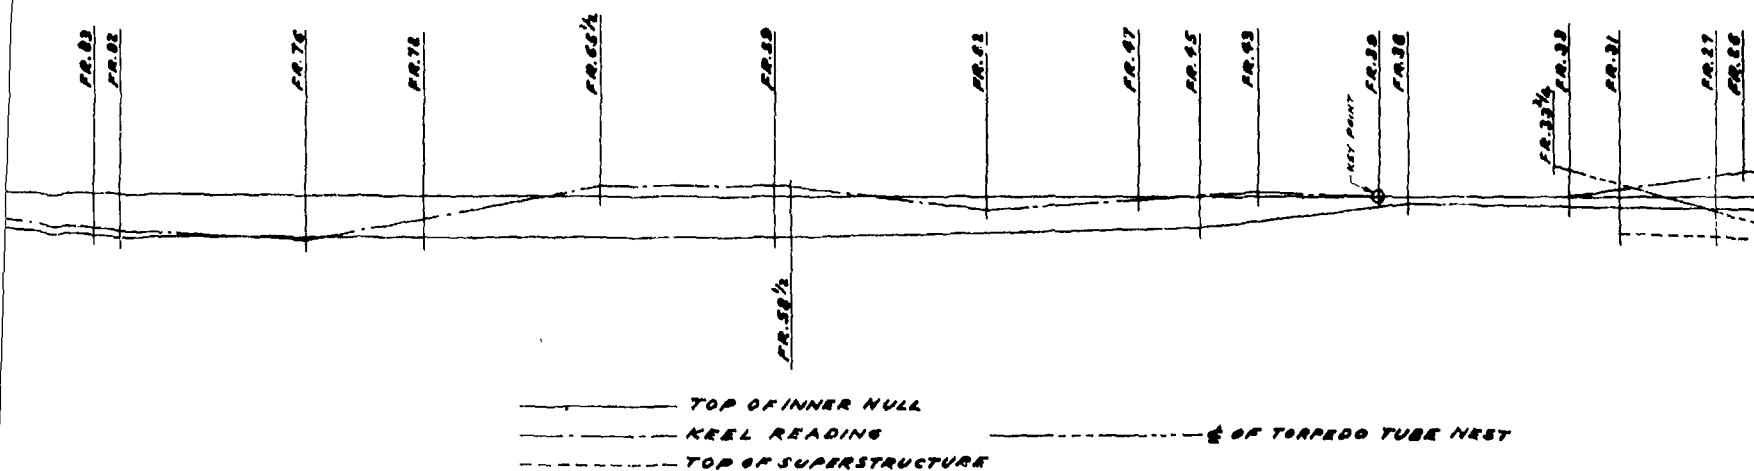
respectively, as a result of failures at the connection to their foundations. A survey of the keel and builders centerline punches in the opt of the frames was made in drydock at the Naval Shipyard Mare Island. The results are plotted in Plate I, page 96. The off-sets of the structural hull between the forward perpendicular and frame 103 are not greater than the variations to be expected in building or in making such a survey.

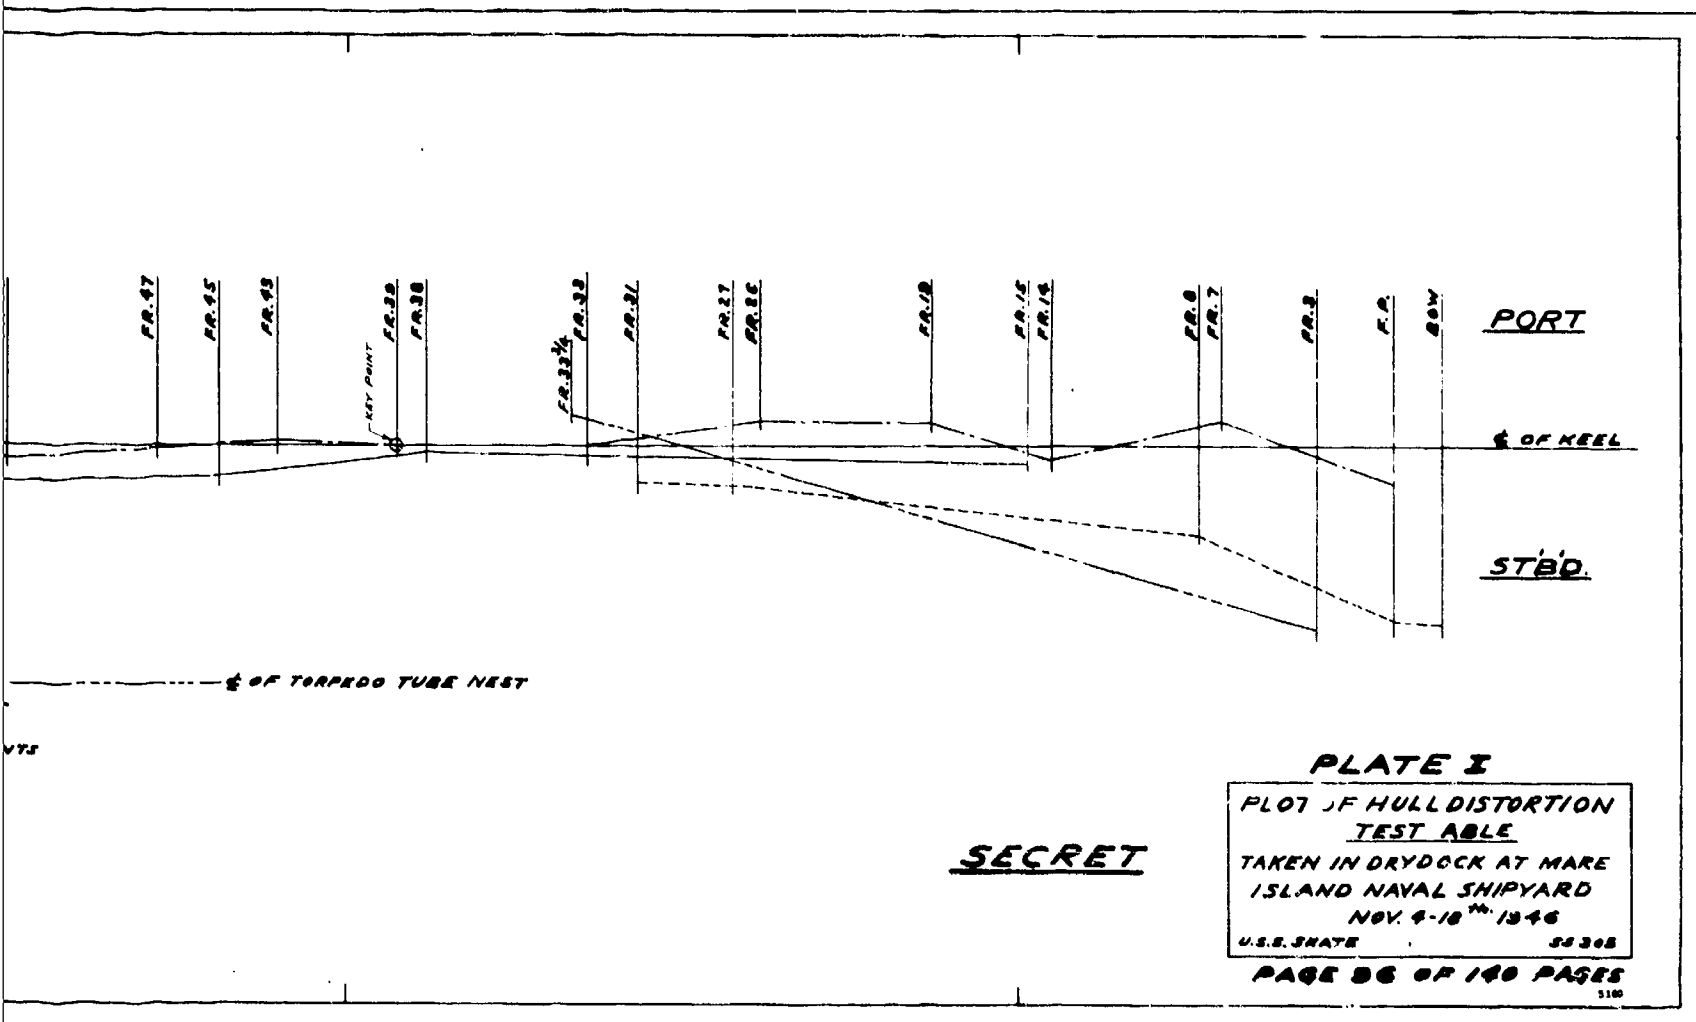
A check of all tracks in drydock showed that the average discrepancy from the plan dimension is less than $1/8''$ which is within the usual builders tolerance. The maximum difference was $3/16''$ low on the forward track of number one tube. No difficulty in unloading torpedoes was encountered except in starting the torpedoes out of No. 3 tube. This was probably due to a rusty torpedo and possible high spots in the tube barrel.
