BUREAU OF SHIPS GROUP TECHNICAL INSPECTION REPORT.

**6 OPERATION CROSSROADS.
U.S.S. PILOTFISH (SS386).**

TEST ABLE [U]

USS PILOTFISH (SS386)

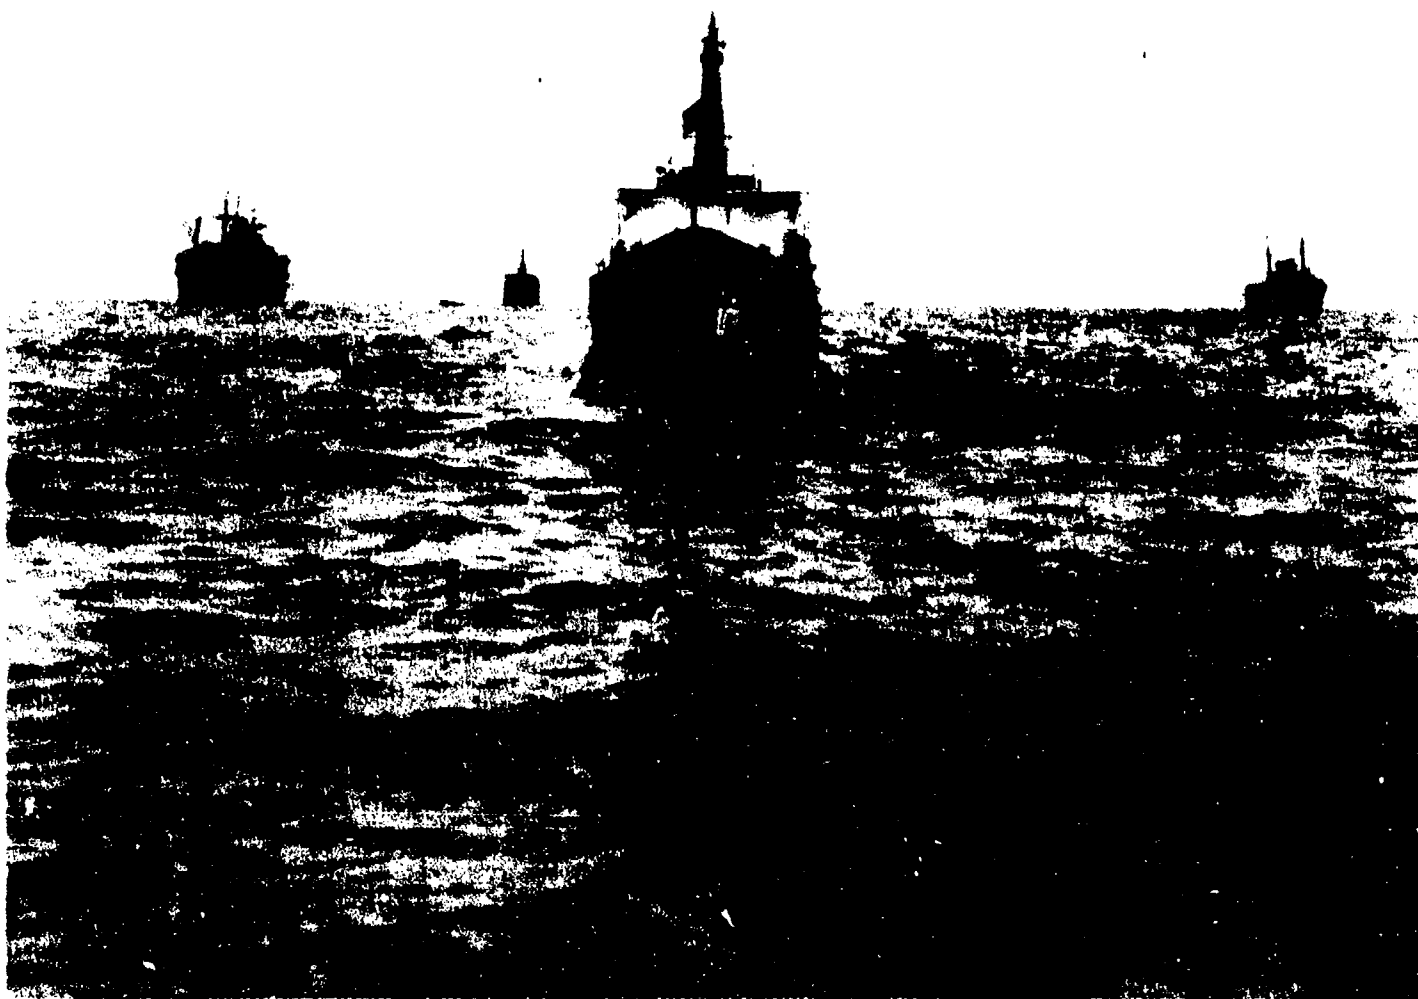
AACR-227-92-37. General view from ahead.

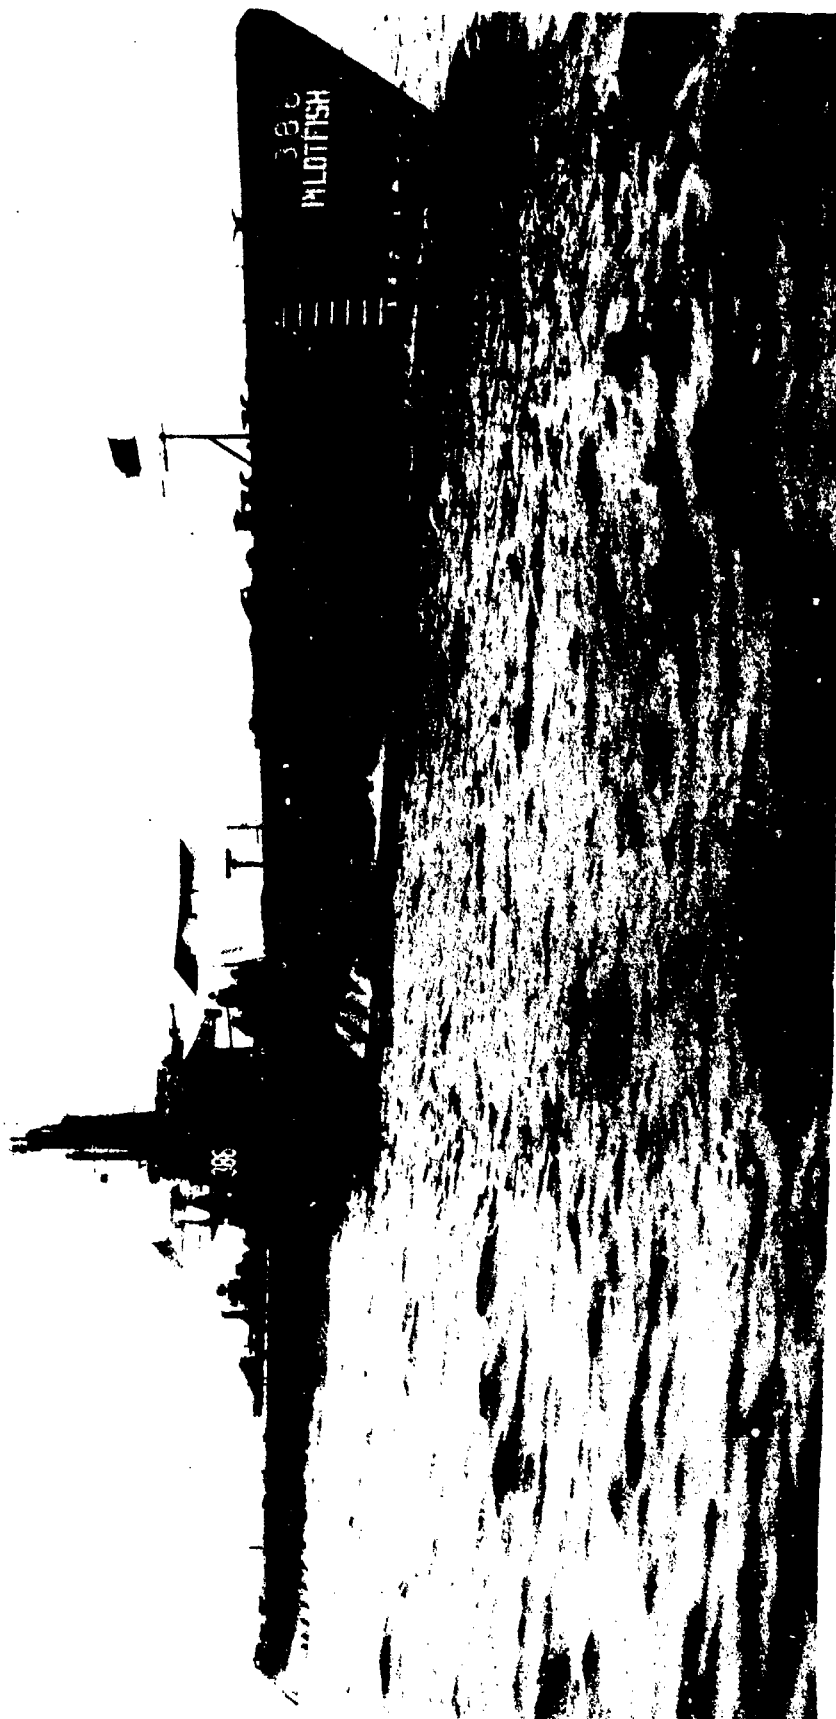
AACR-227-92-38. General view fro starboard bow.

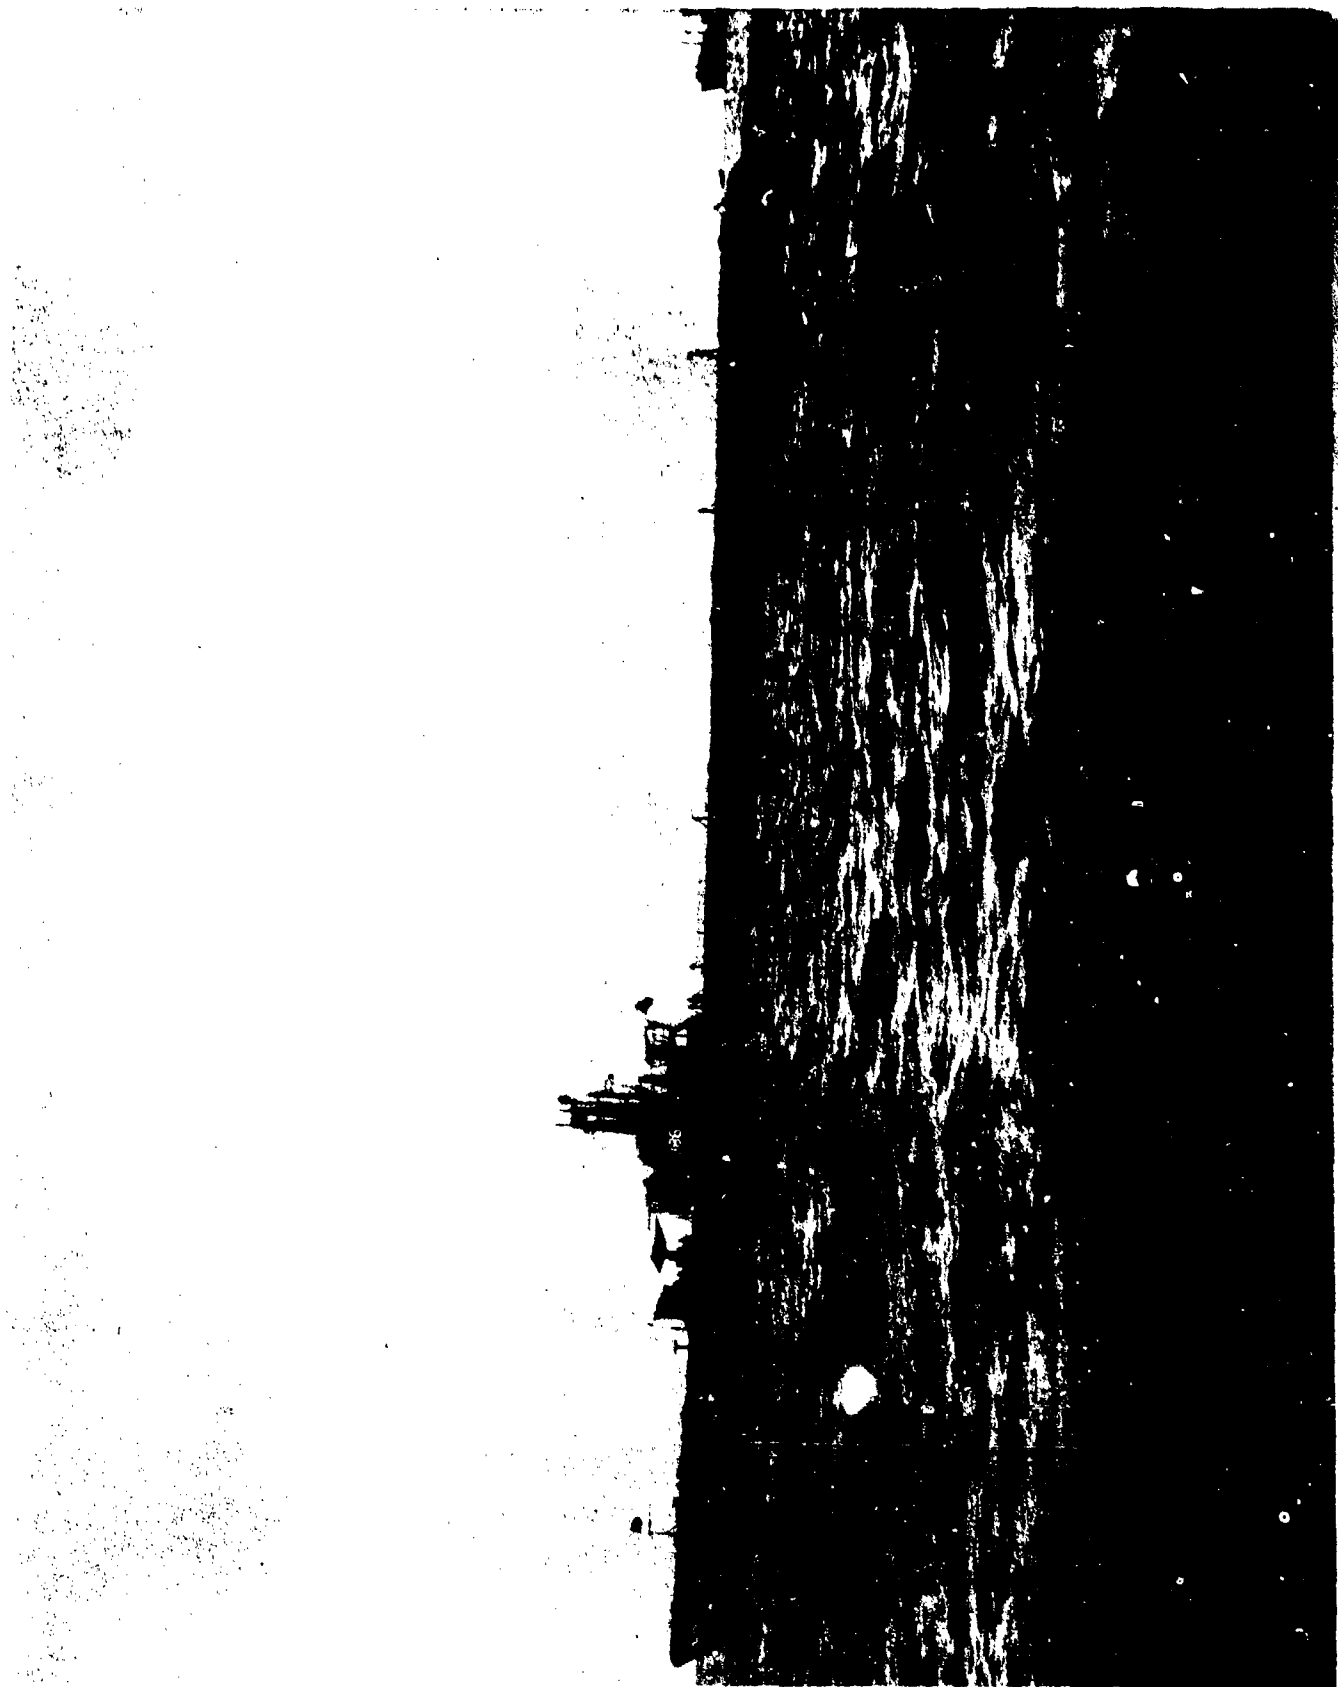
AACR-227-92-39. General view from starboard beam.

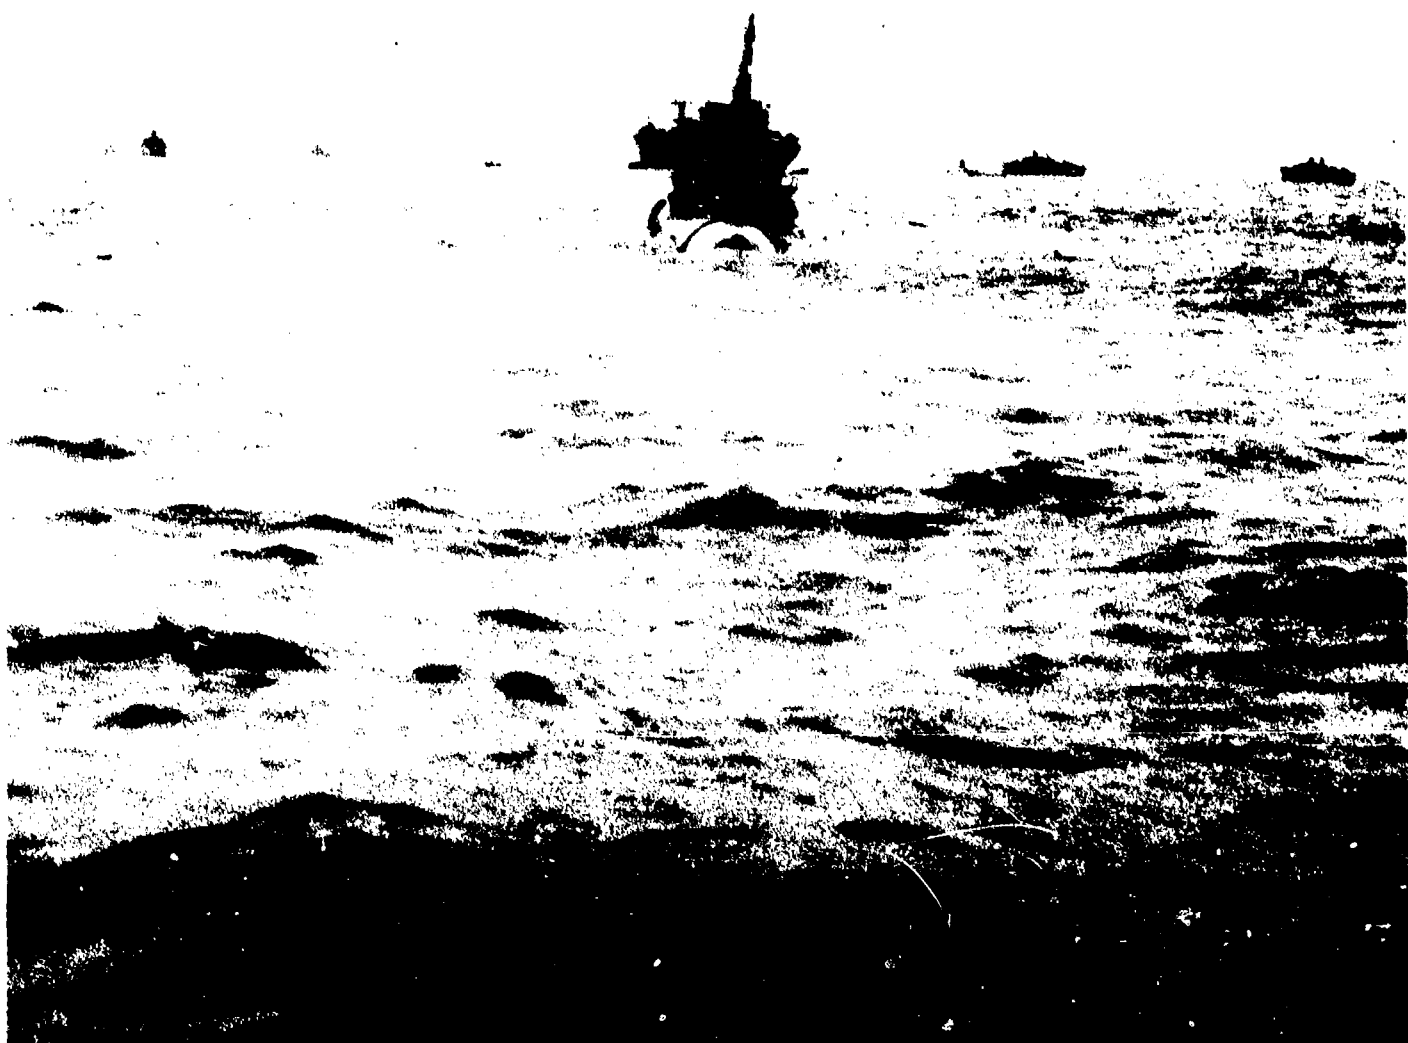
AACR-227-92-41. General view from astern.

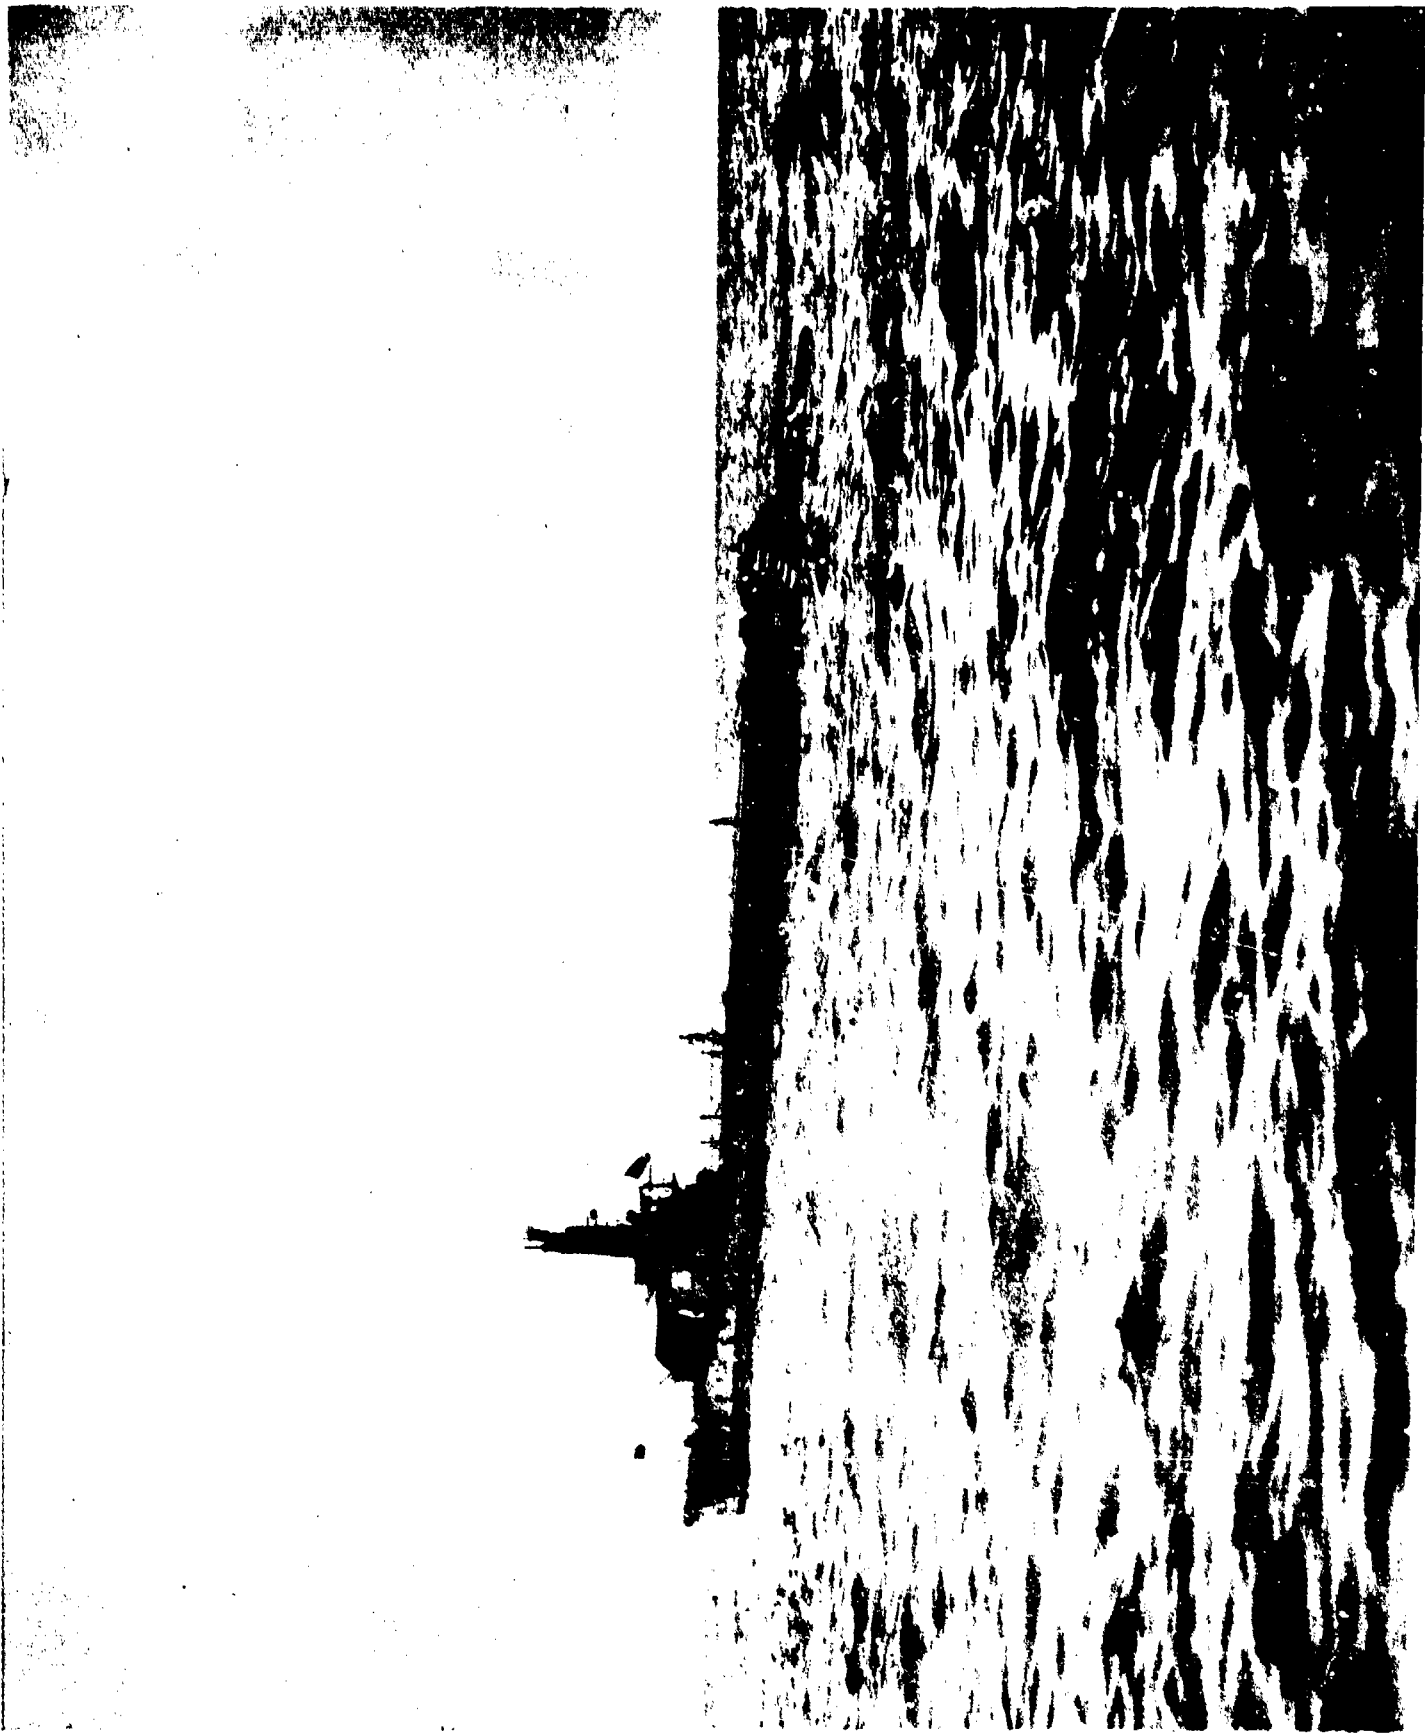
AACR-227-92-42. General view from port quarter.

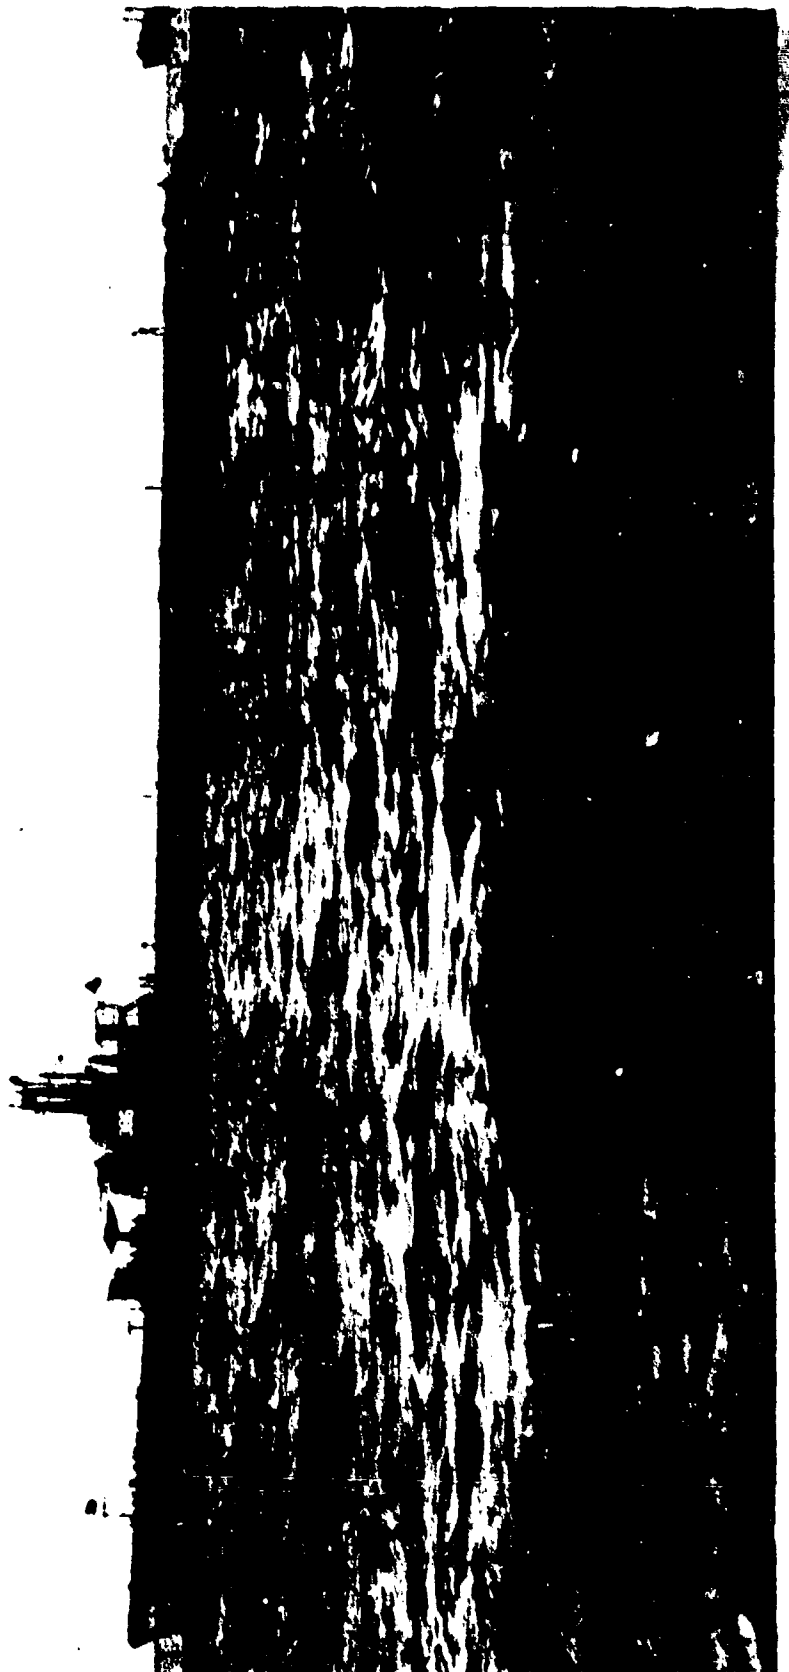
AACR-227-92-43. General view from port beam.

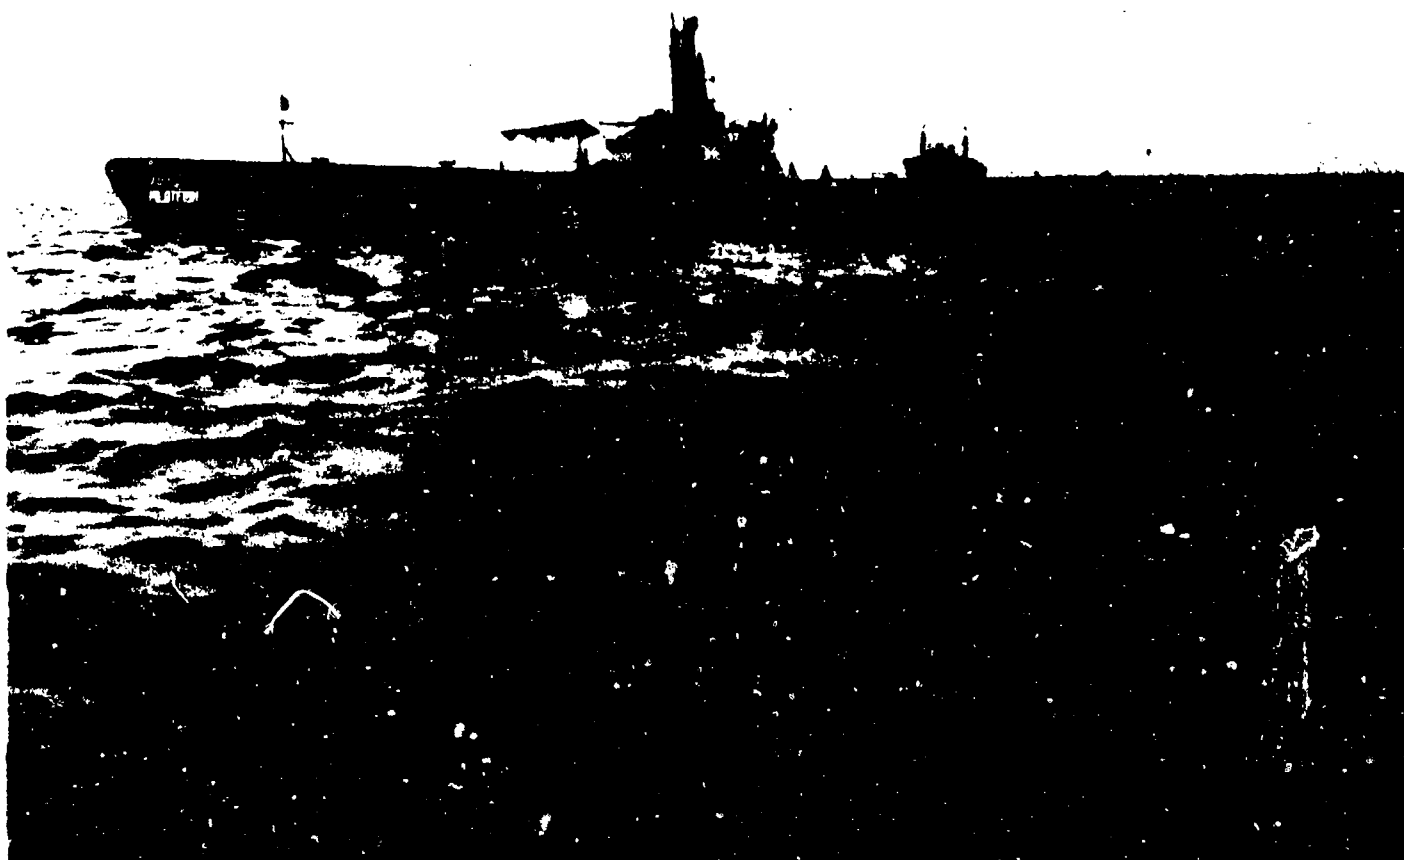
AACR-227-92-36. General view from port bow.
