~~CONFIDENTIAL~~
9 BUREAU OF SHIPS GROUP
TECHNICAL INSPECTION REPORT

6 OPERATION CROSSROADS.
U.S.S. BRULE (APA 66).

TEST ABLE [U].

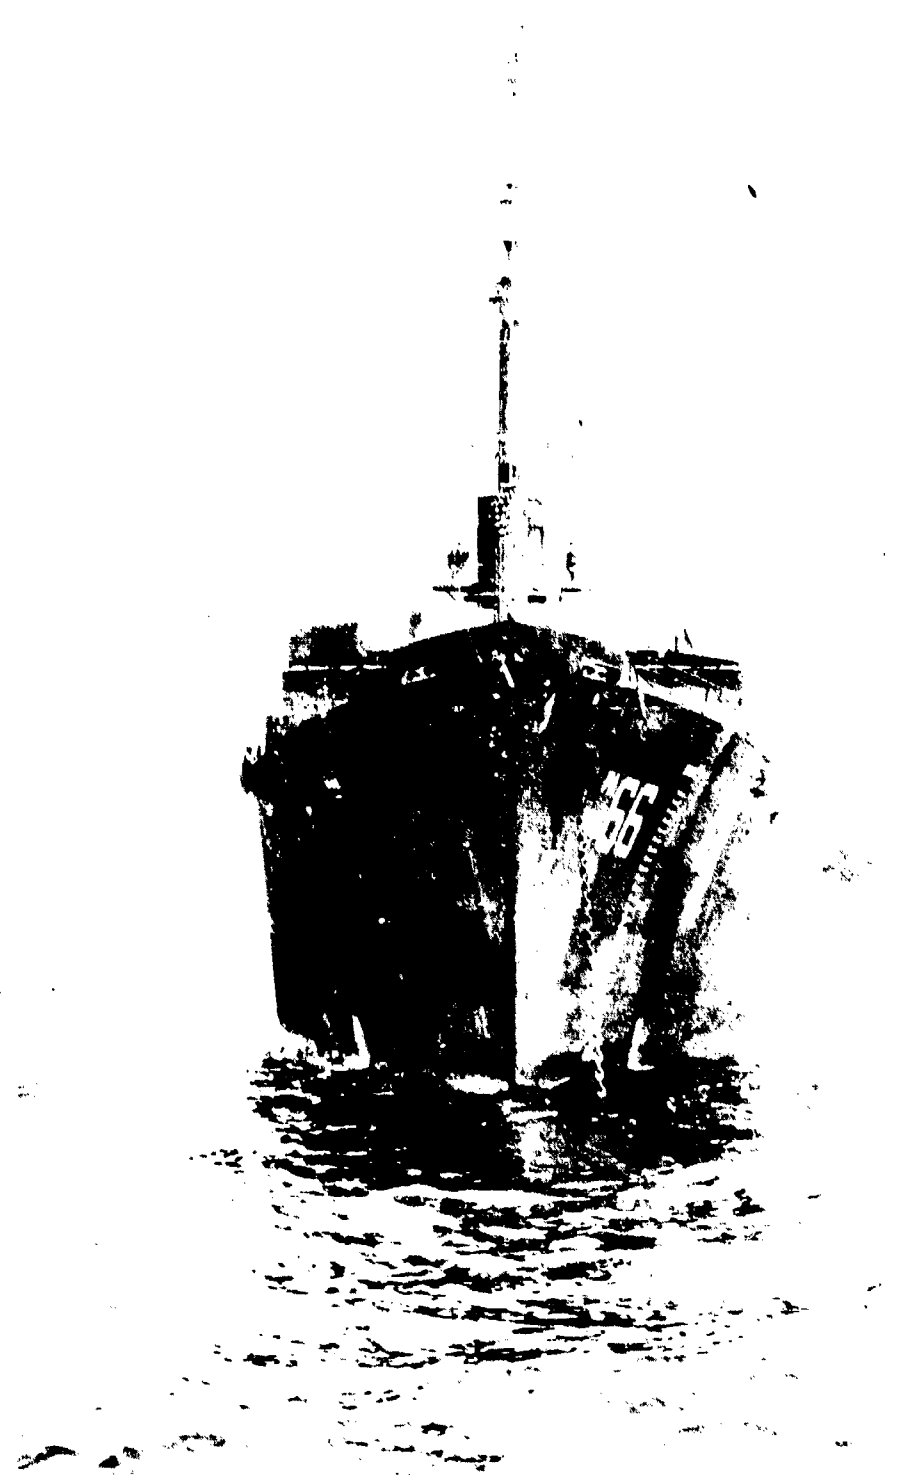
AA-CR-227-49-110. Bow after Test A.

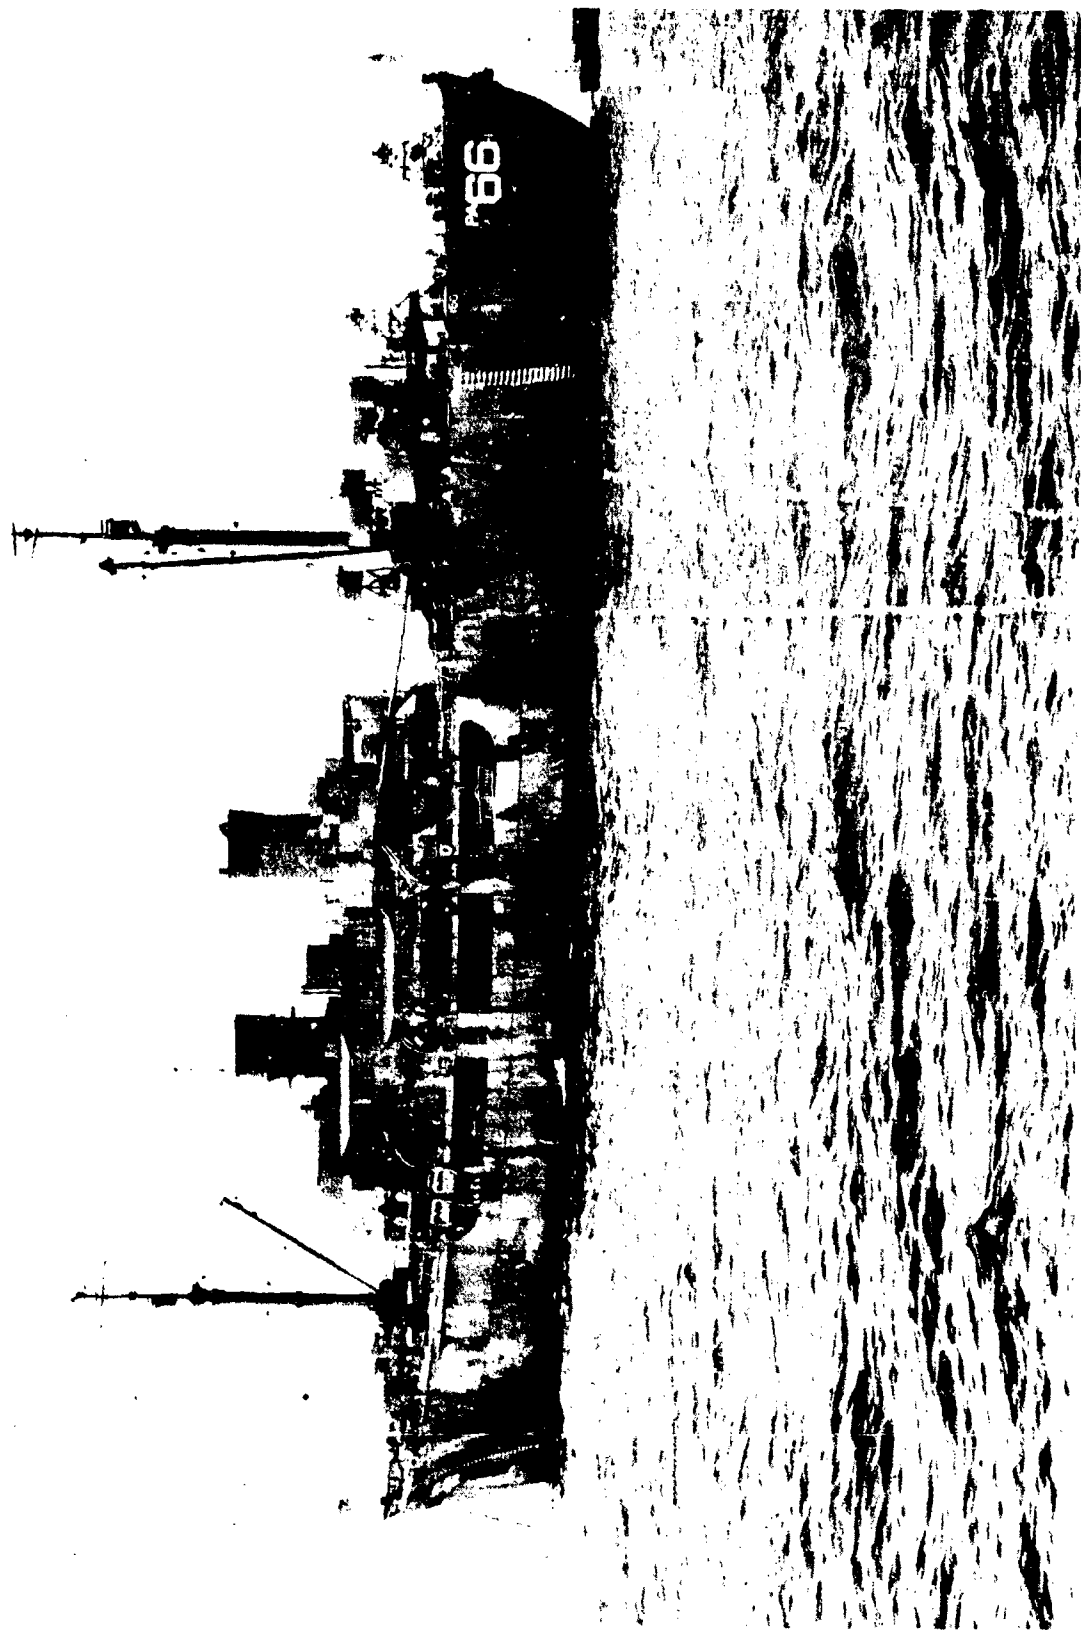
AA-CR-227-49-105. Port quarter after Test A.

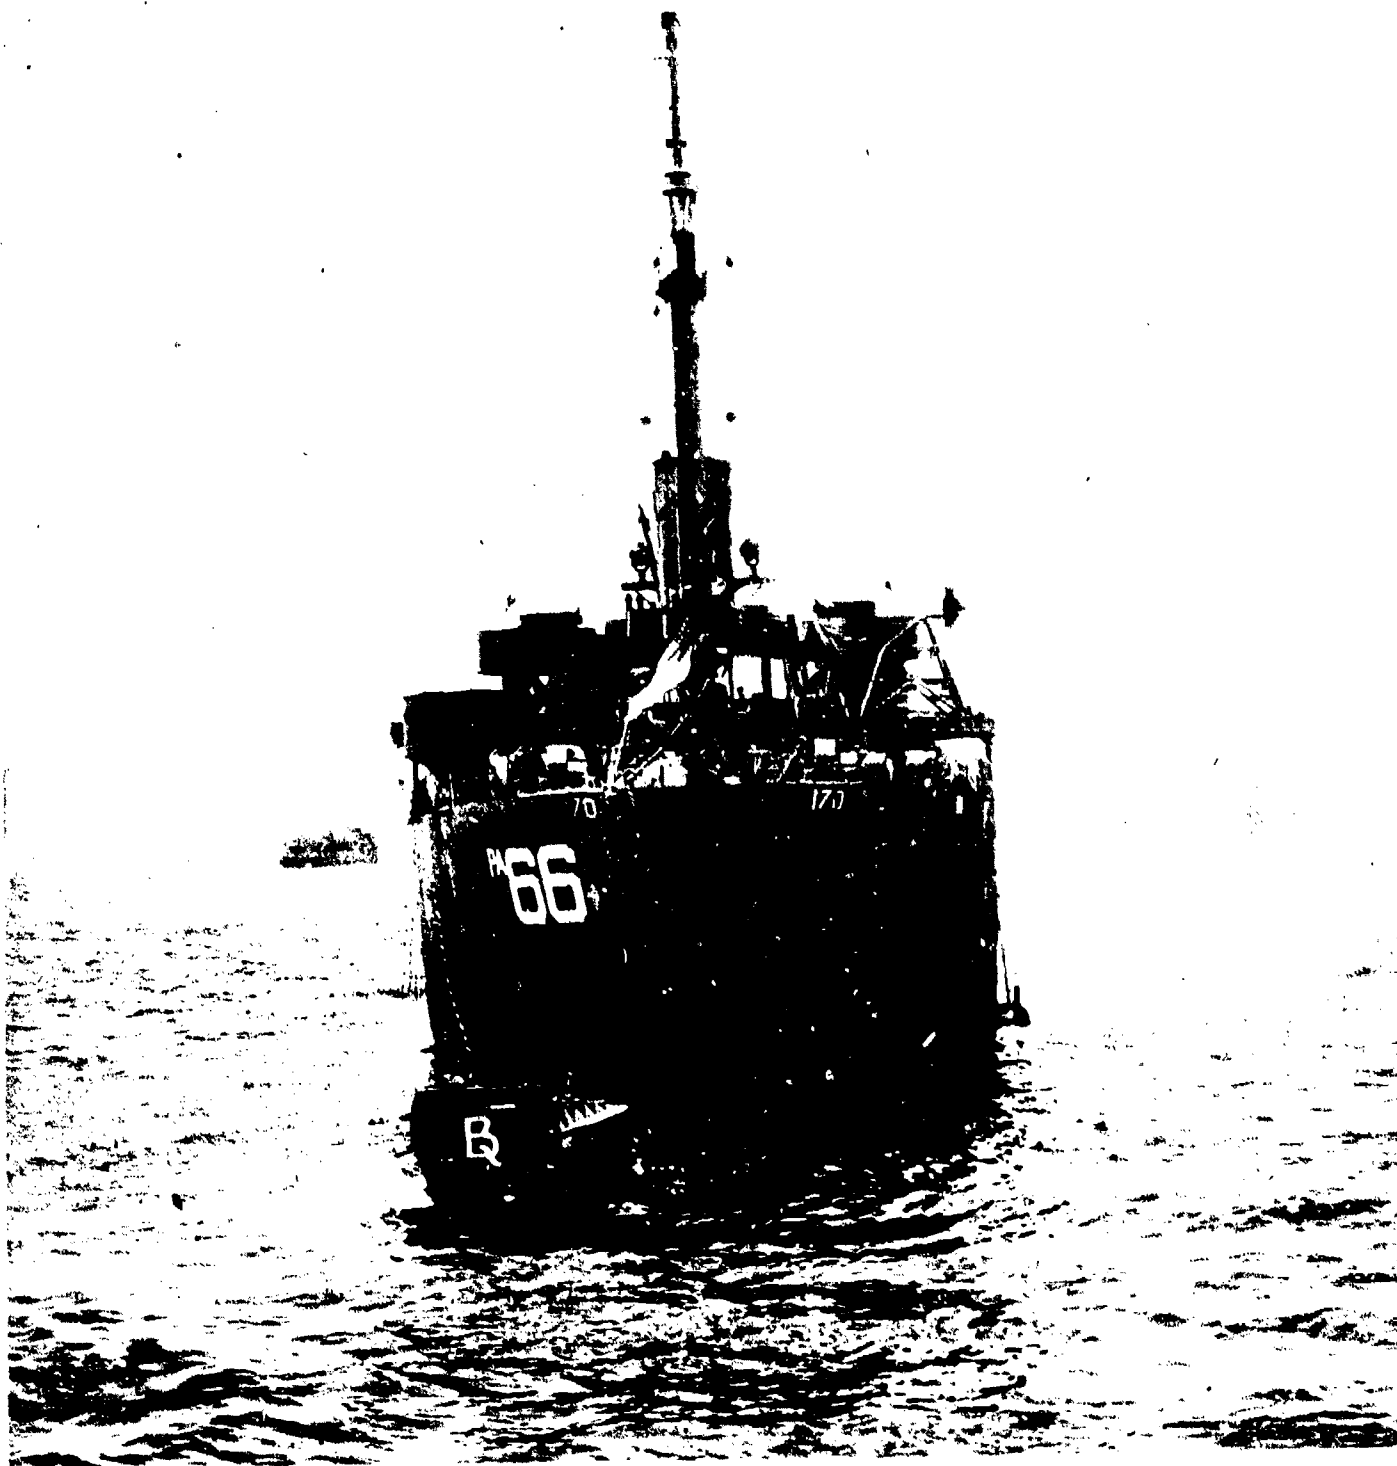
AA-CR-227-49-106. Stern after Test A.

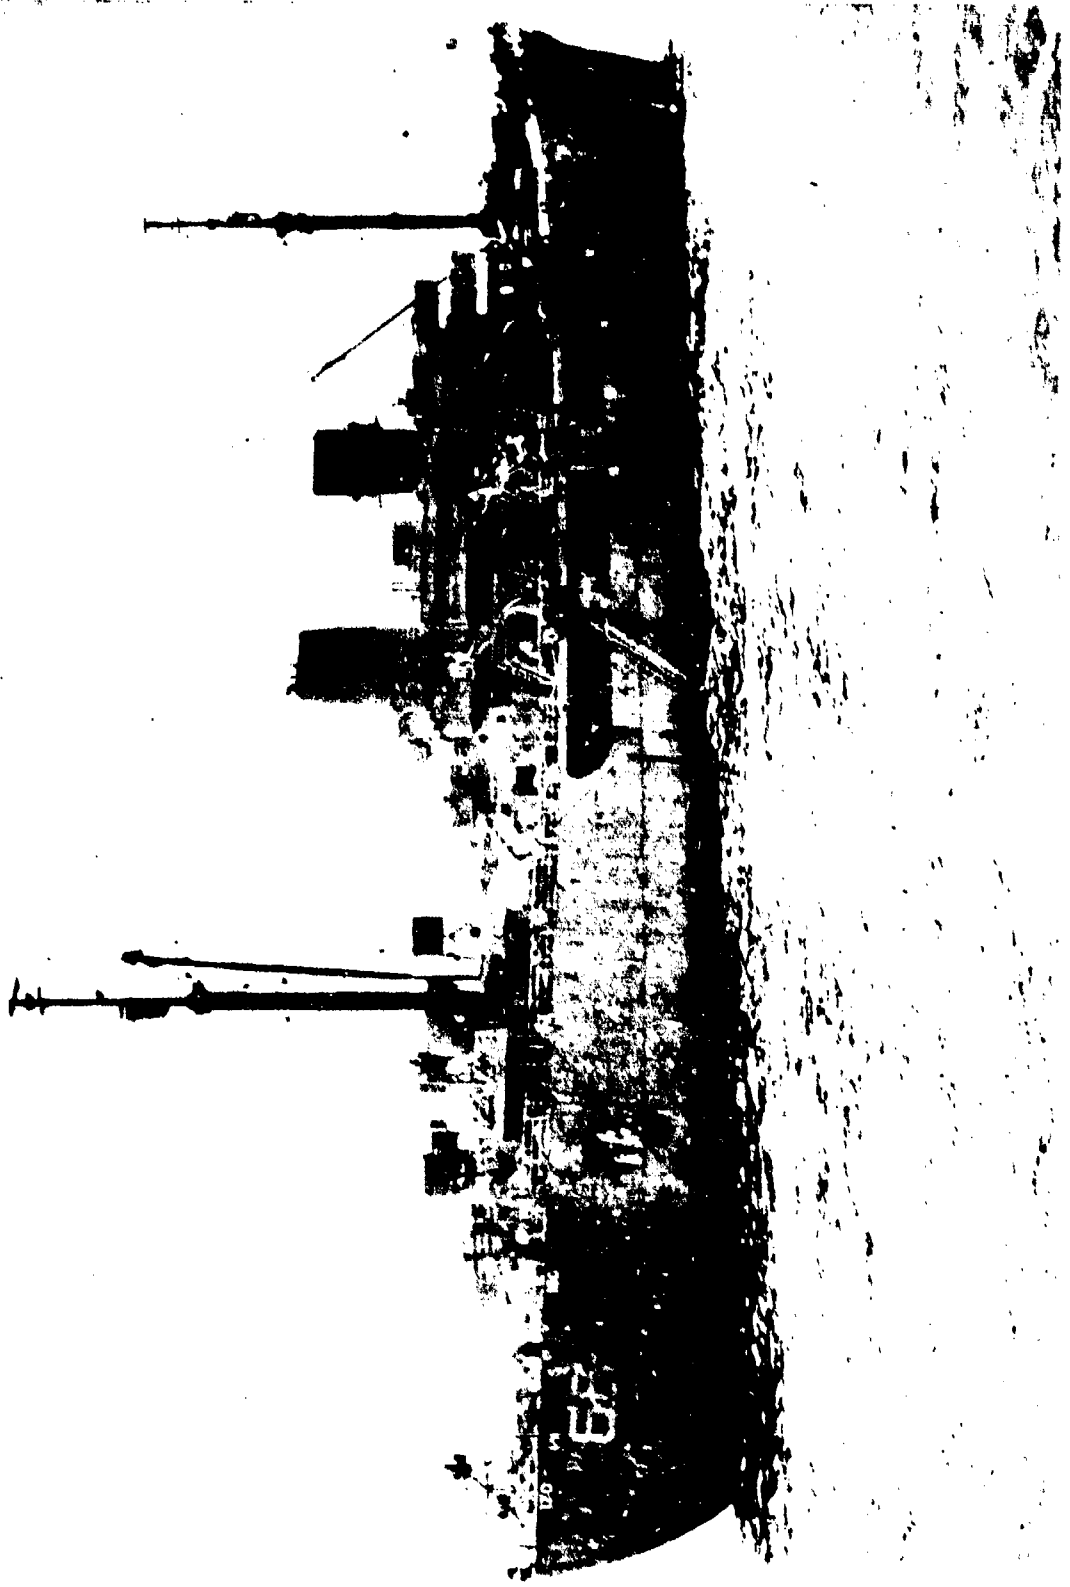
AA-CR-227-49-107. Starboard quarter after Test A.

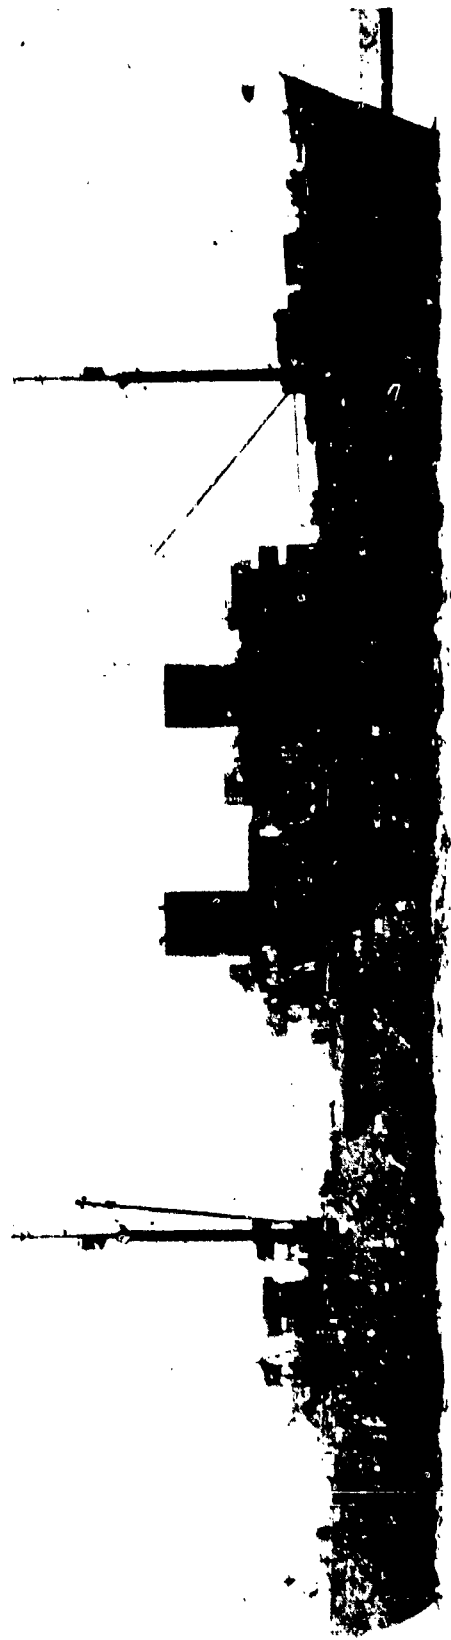
AA-CR-27-49-108. Starboard beam after Test A.

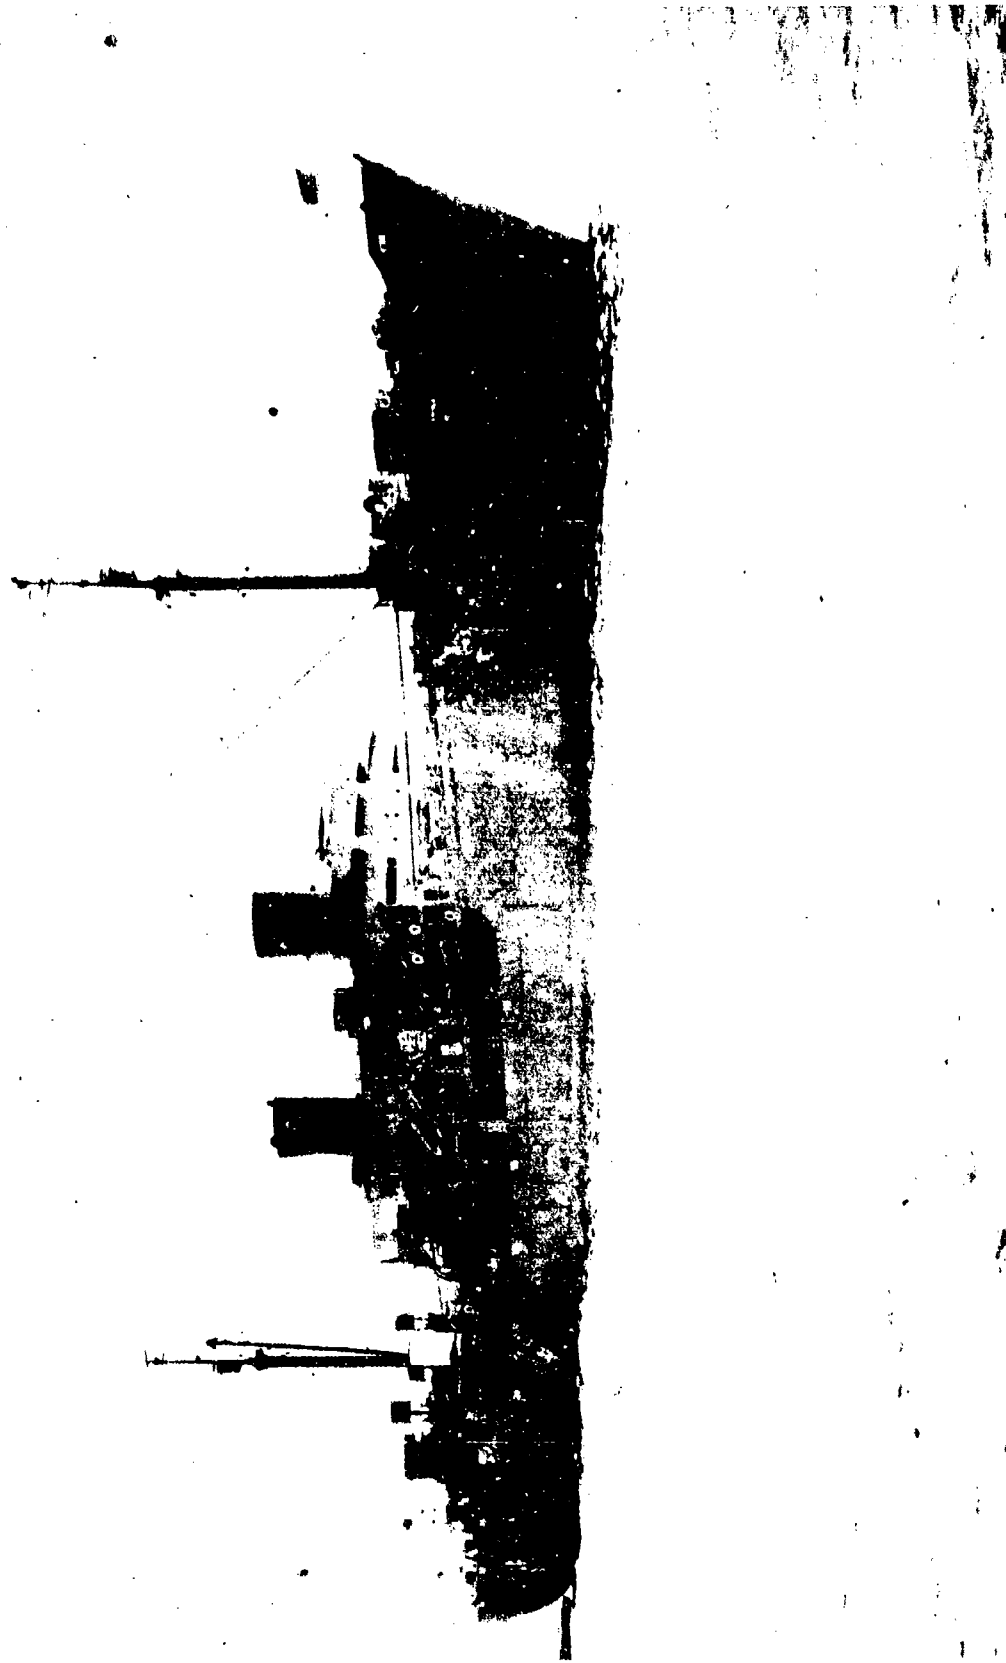
AA-CR-227-49-109. Starboard bow after Test A.

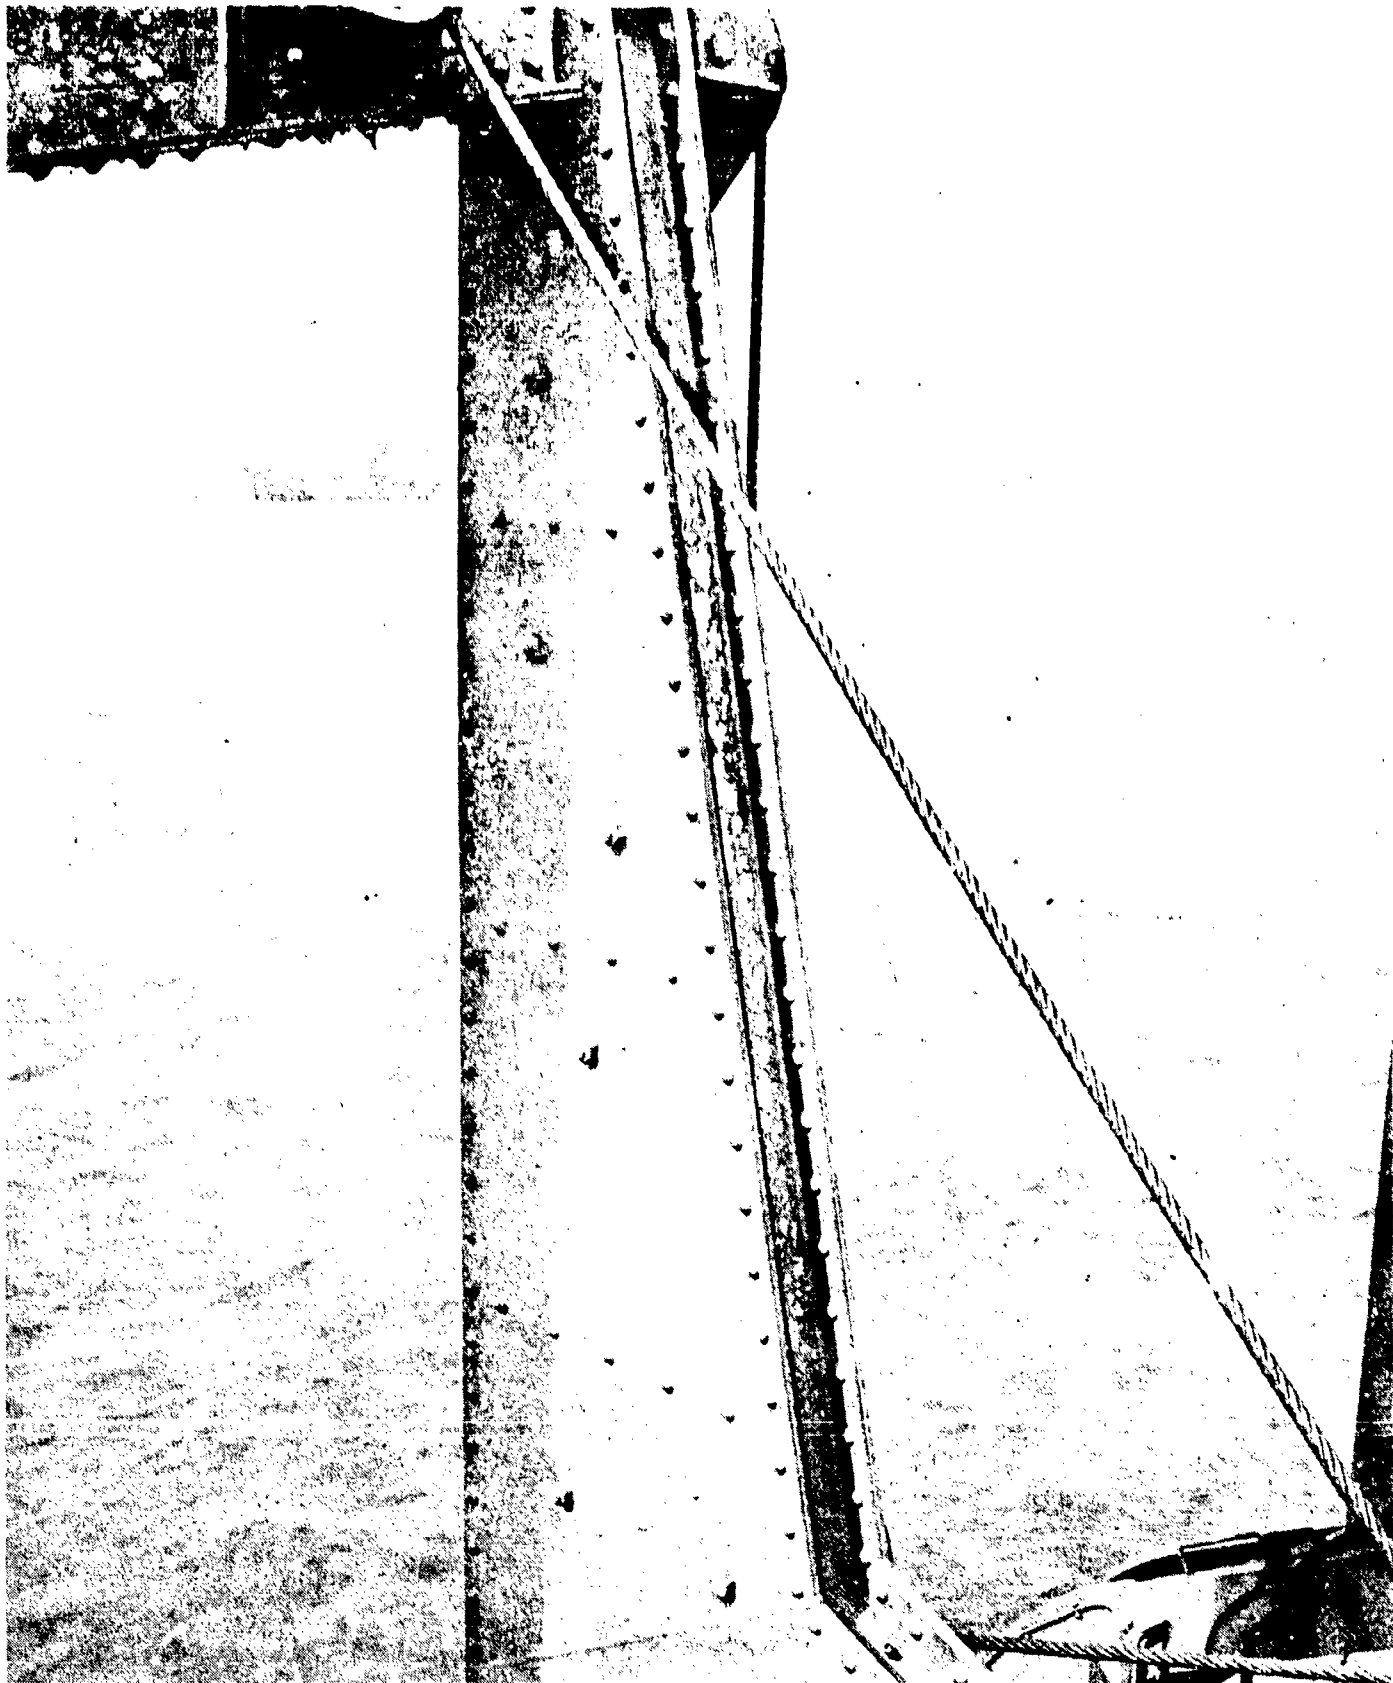
The source of radiation bore about 120 degrees relative. All surfaces facing aft or to starboard, unless shielded by structure, are blistered. Evidence of vortexing of the heat wave was seen on the starboard boat davits where blistering and scorching of paint occurred on the lee sides. Zinc chromate, formula 84, seems to be affected more than ordinary top coats similarly exposed. Wood surfaces received greater blistering than corresponding steel surfaces. Grease was not burned on cables or hoist drums. No glass was broken by heat. Scorching of all exposed fire hoses and cordage was noted. Insulation was scorched on a few electric cables on the starboard side aft.

AA-CR-65-1819-9. Scorched paint on forward side of after leg of Welin davit on starboard side.

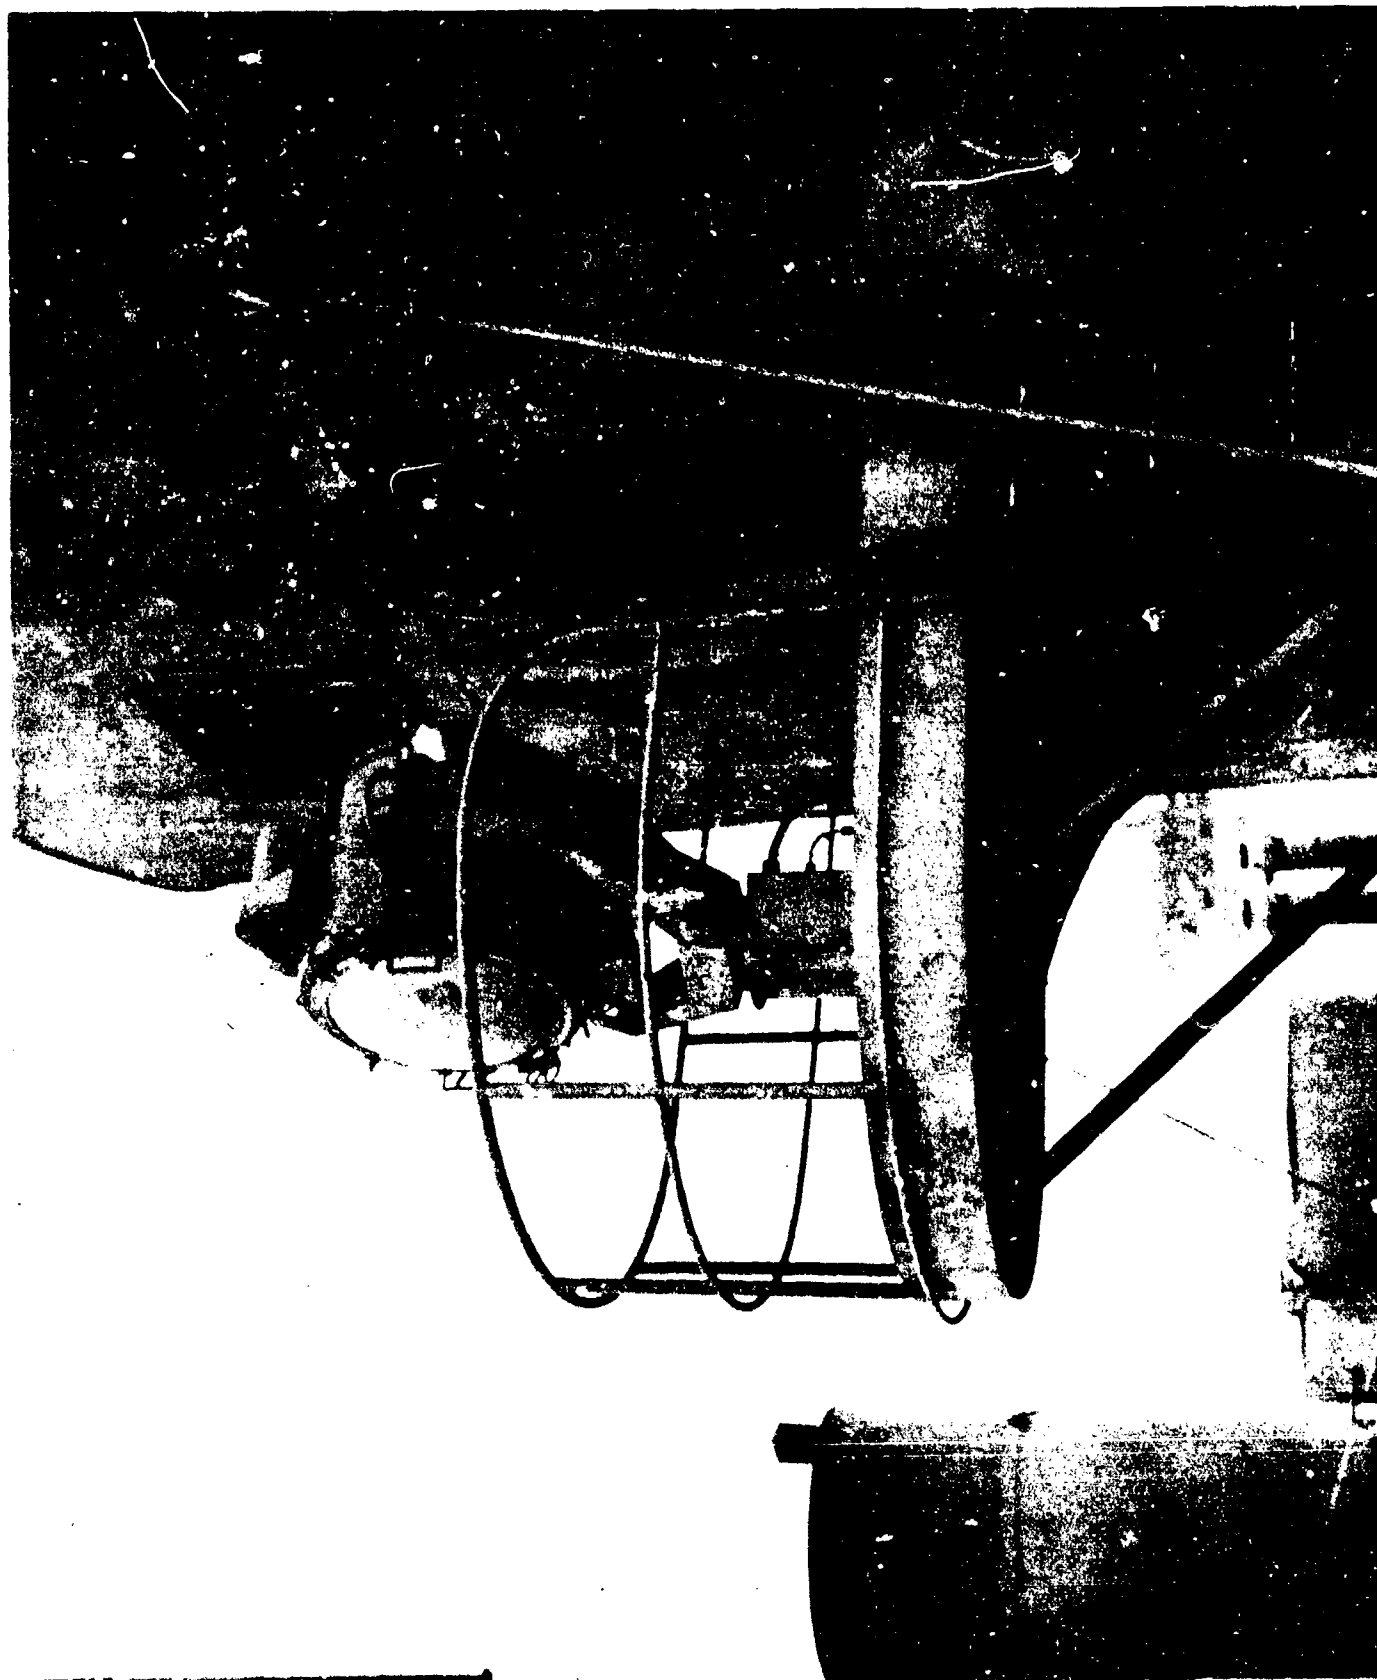
AA-CR-175-2157-2. Bent king-pin of 24 inch searchlight on starboard side of forward stack.

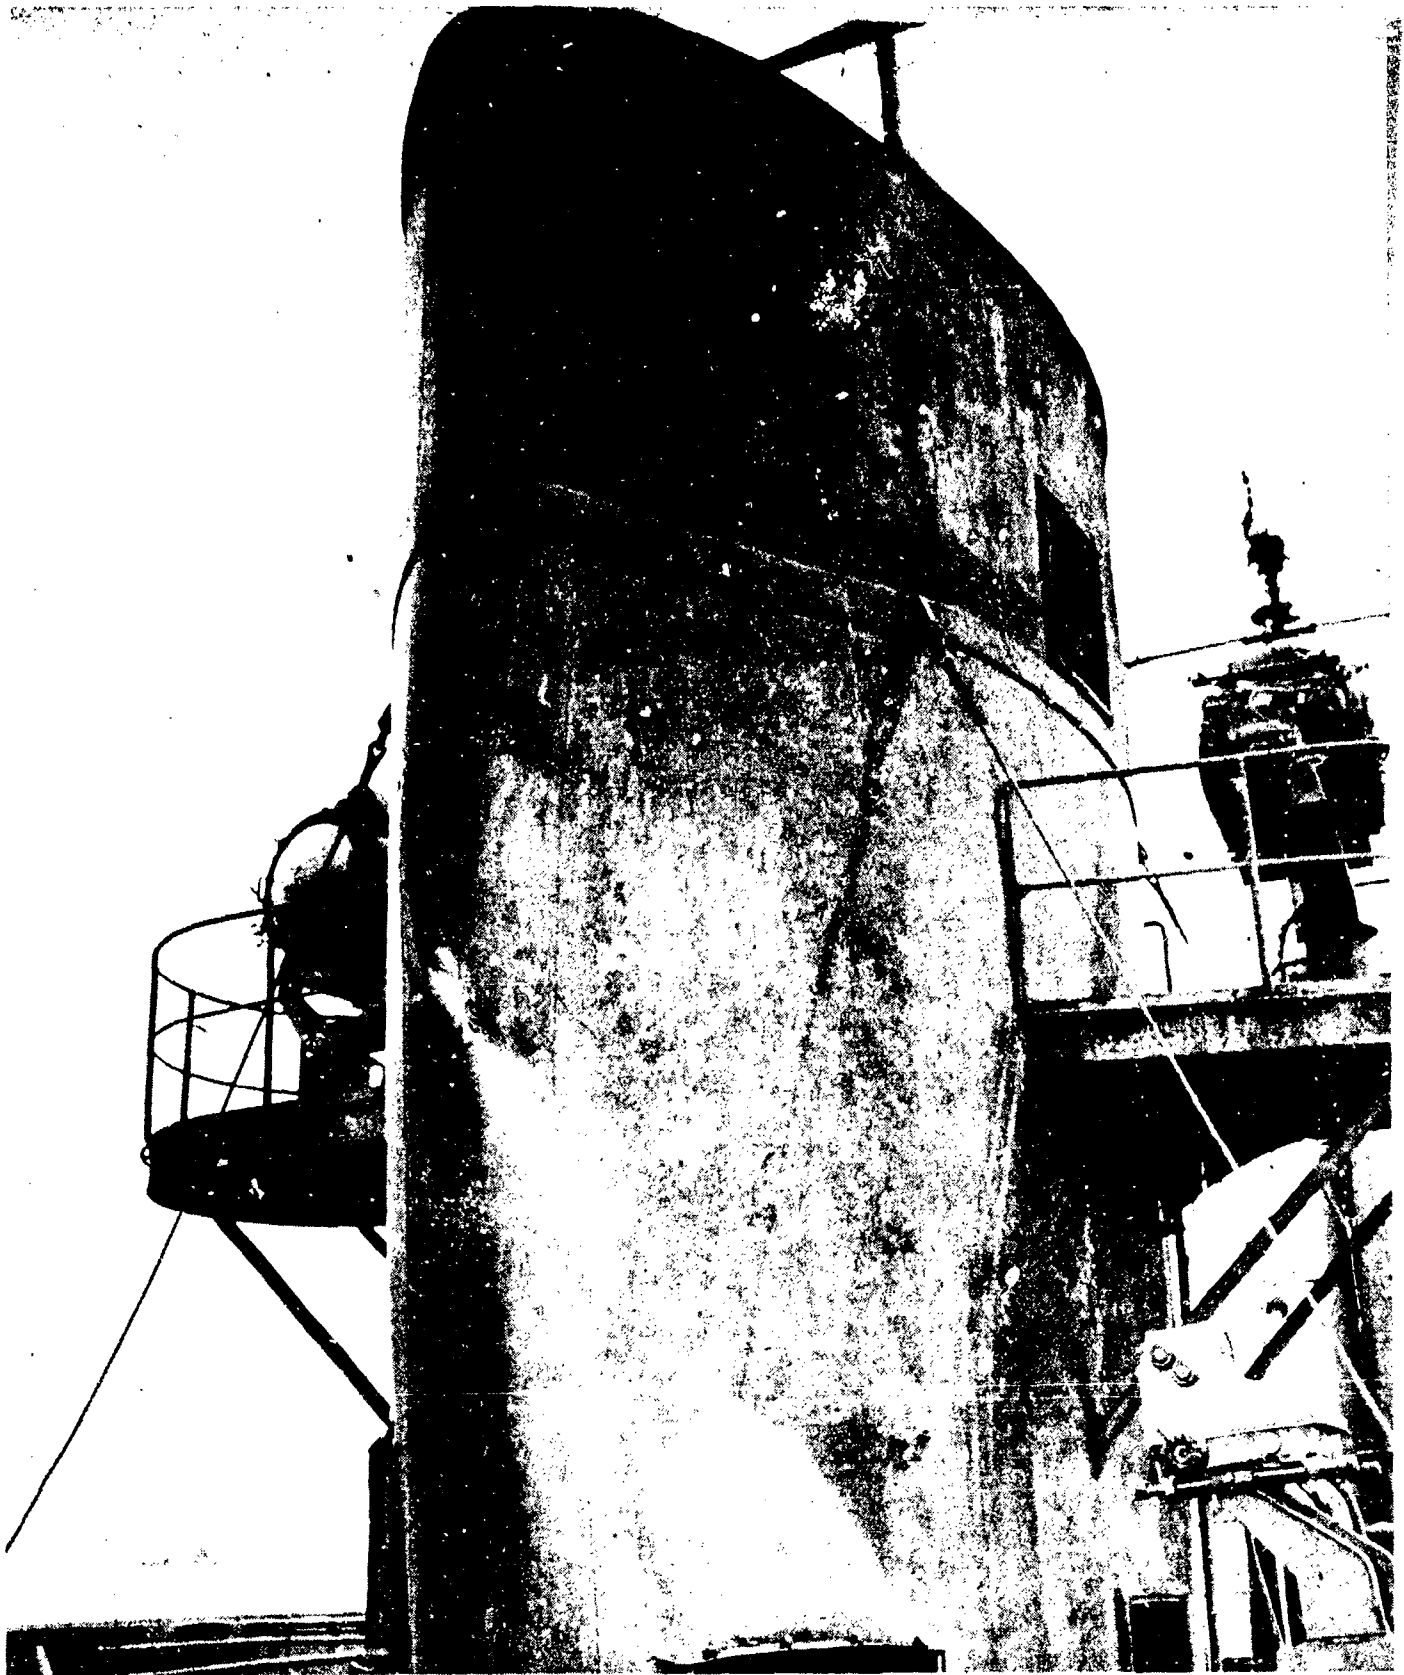
AA-CR-62-2172-12. Looking forward and to port at starboard side of forward stack. Note damaged yoke of starboard 24 inch searchlight.

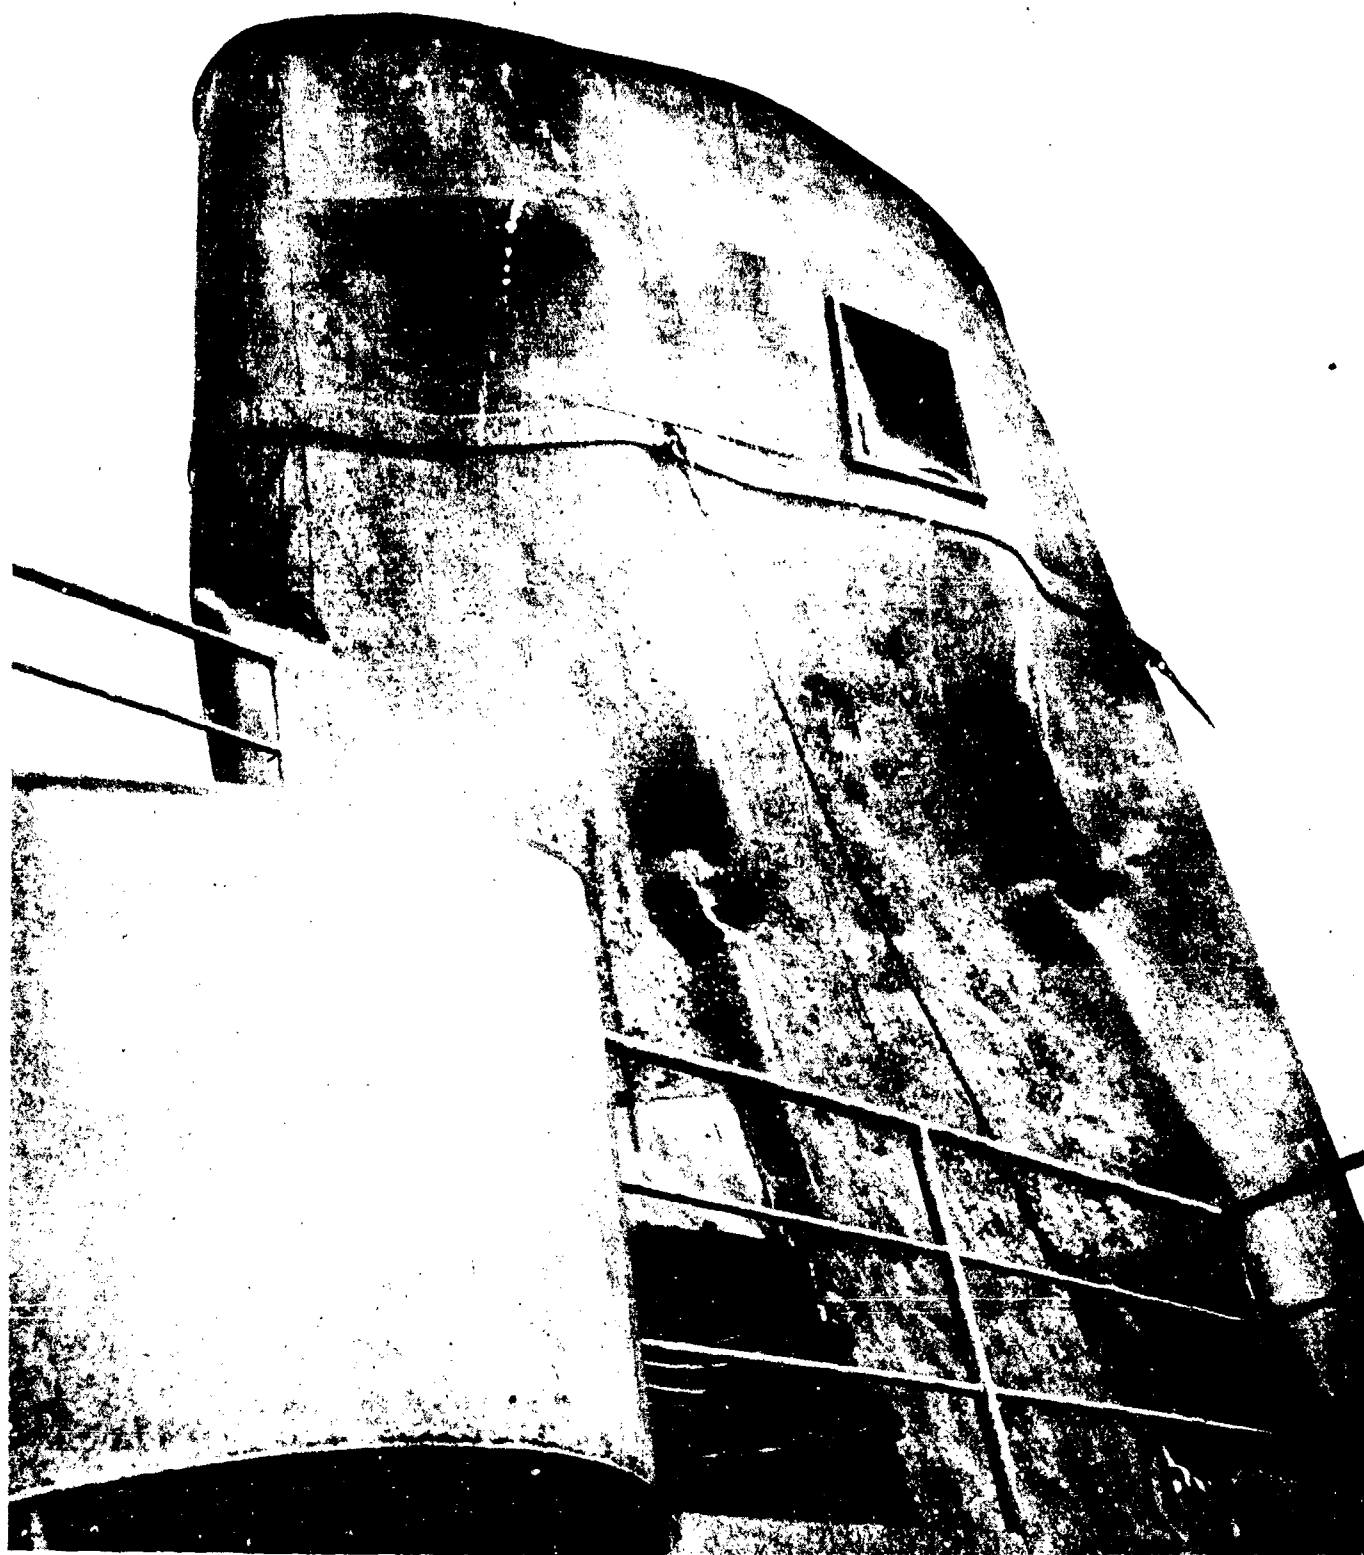
AA-CR-62-2172-11. Starboard side of after stack from navigating deck.

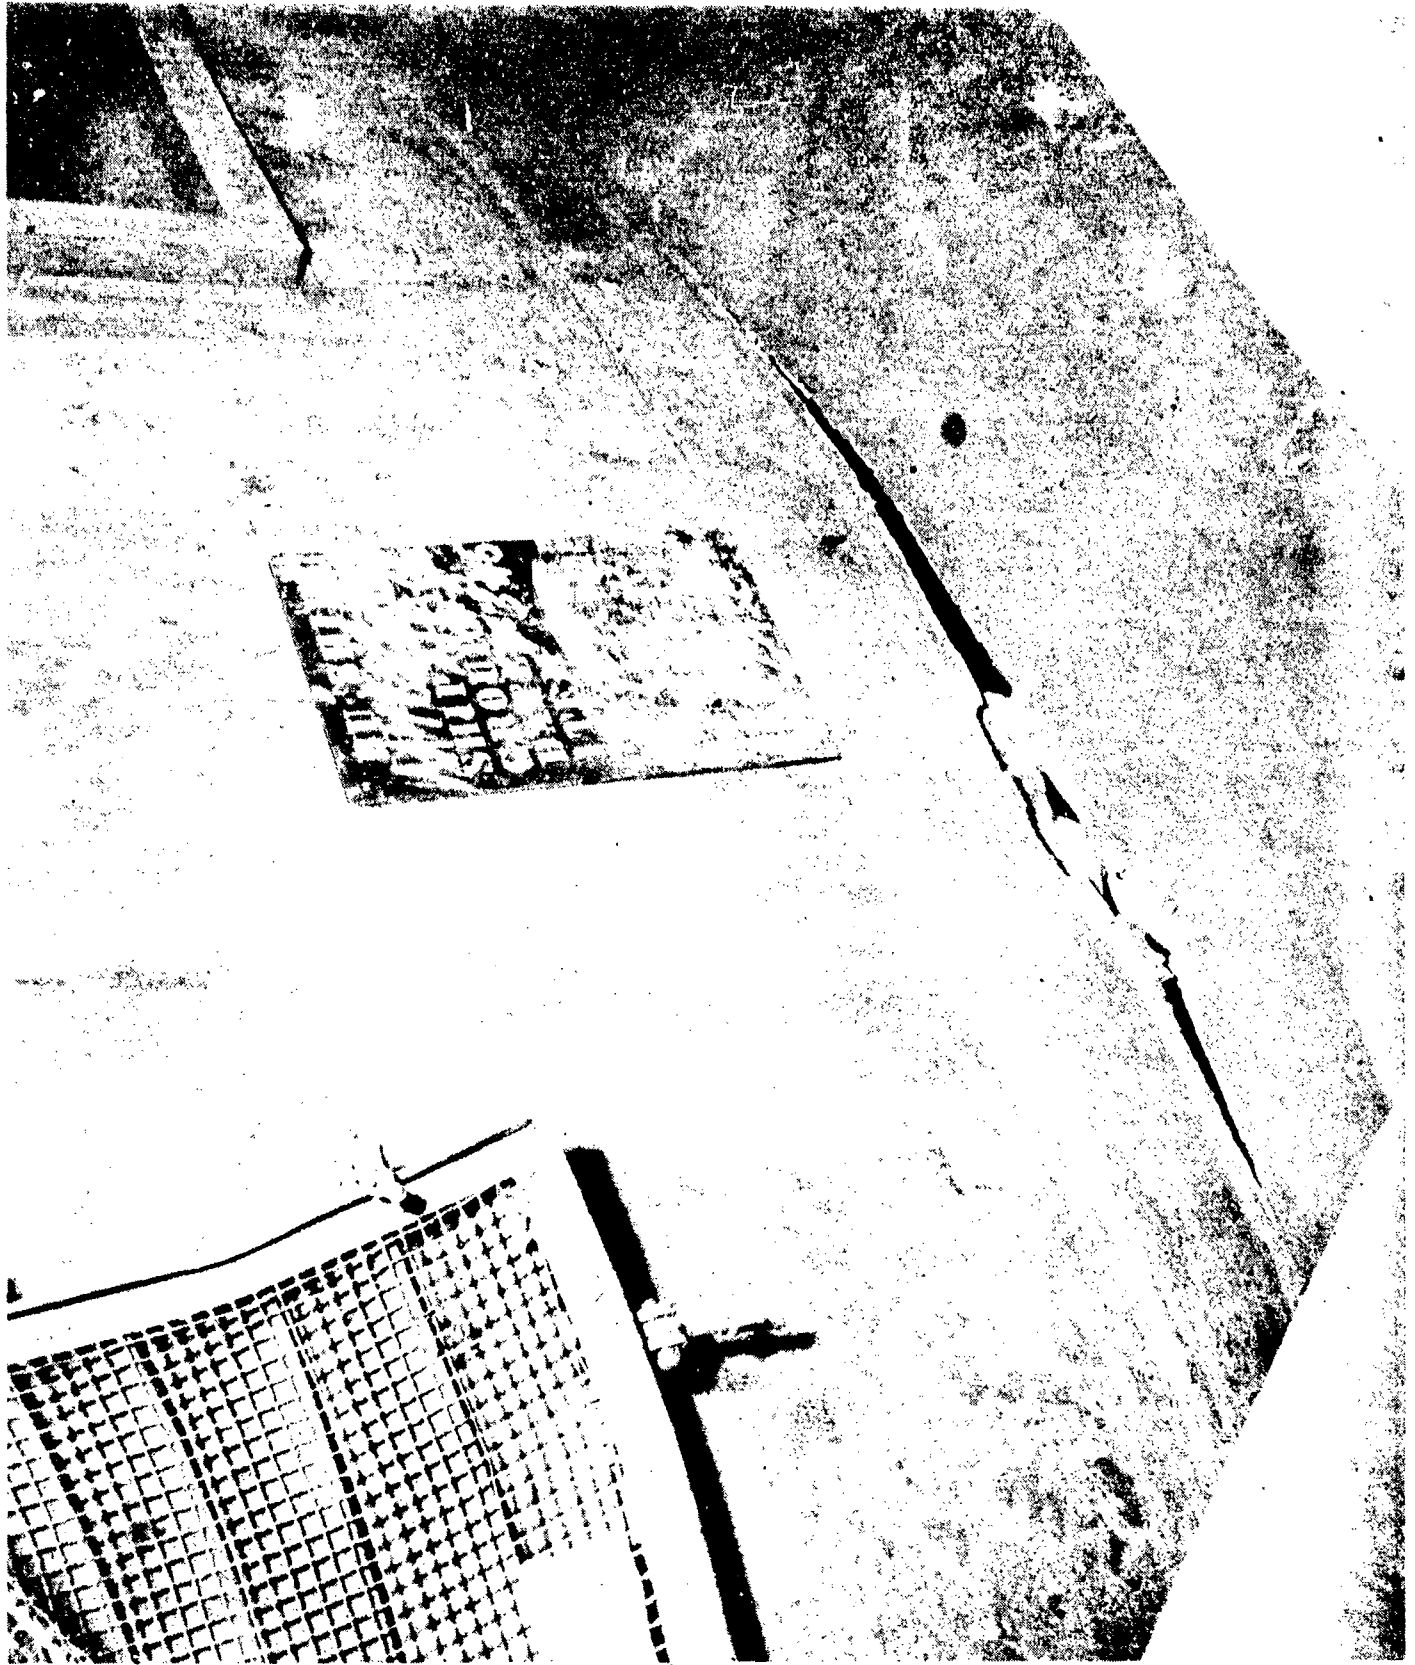
AA-CR-82-1828-4. Tear at connection of starboard side of base of after stack to top of house.
