~~CONFIDENTIAL~~
9 BUREAU OF SHIPS GROUP
TECHNICAL INSPECTION REPORT

6 OPERATION CROSSROADS.
U.S.S. BRULE (APA 66).

TEST ABLE [U].

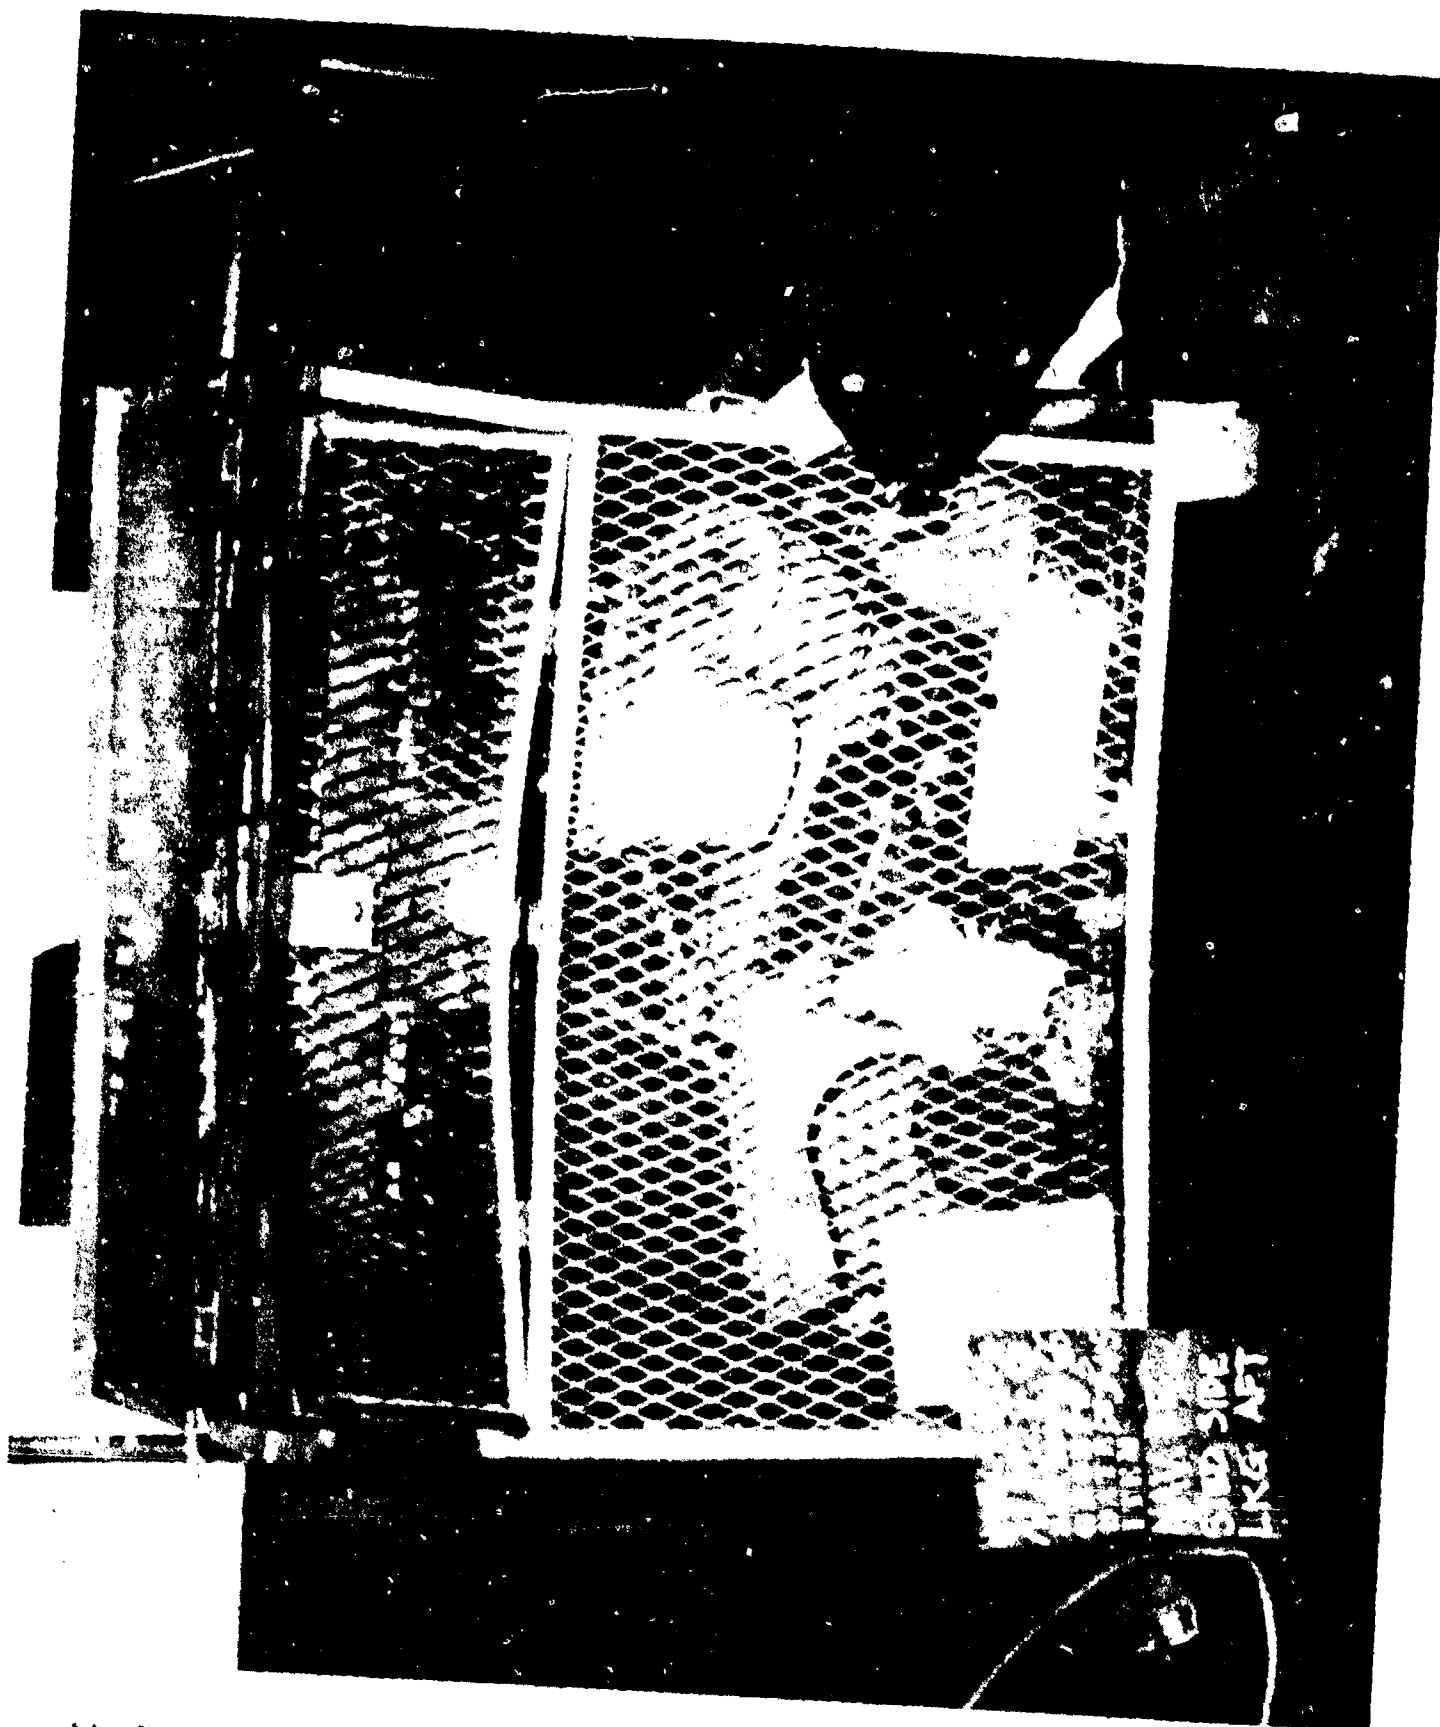
AA-CR-82-1828-6. Looking aft at blast damage to gear locker on starboard wing of navigation deck, frame 66.

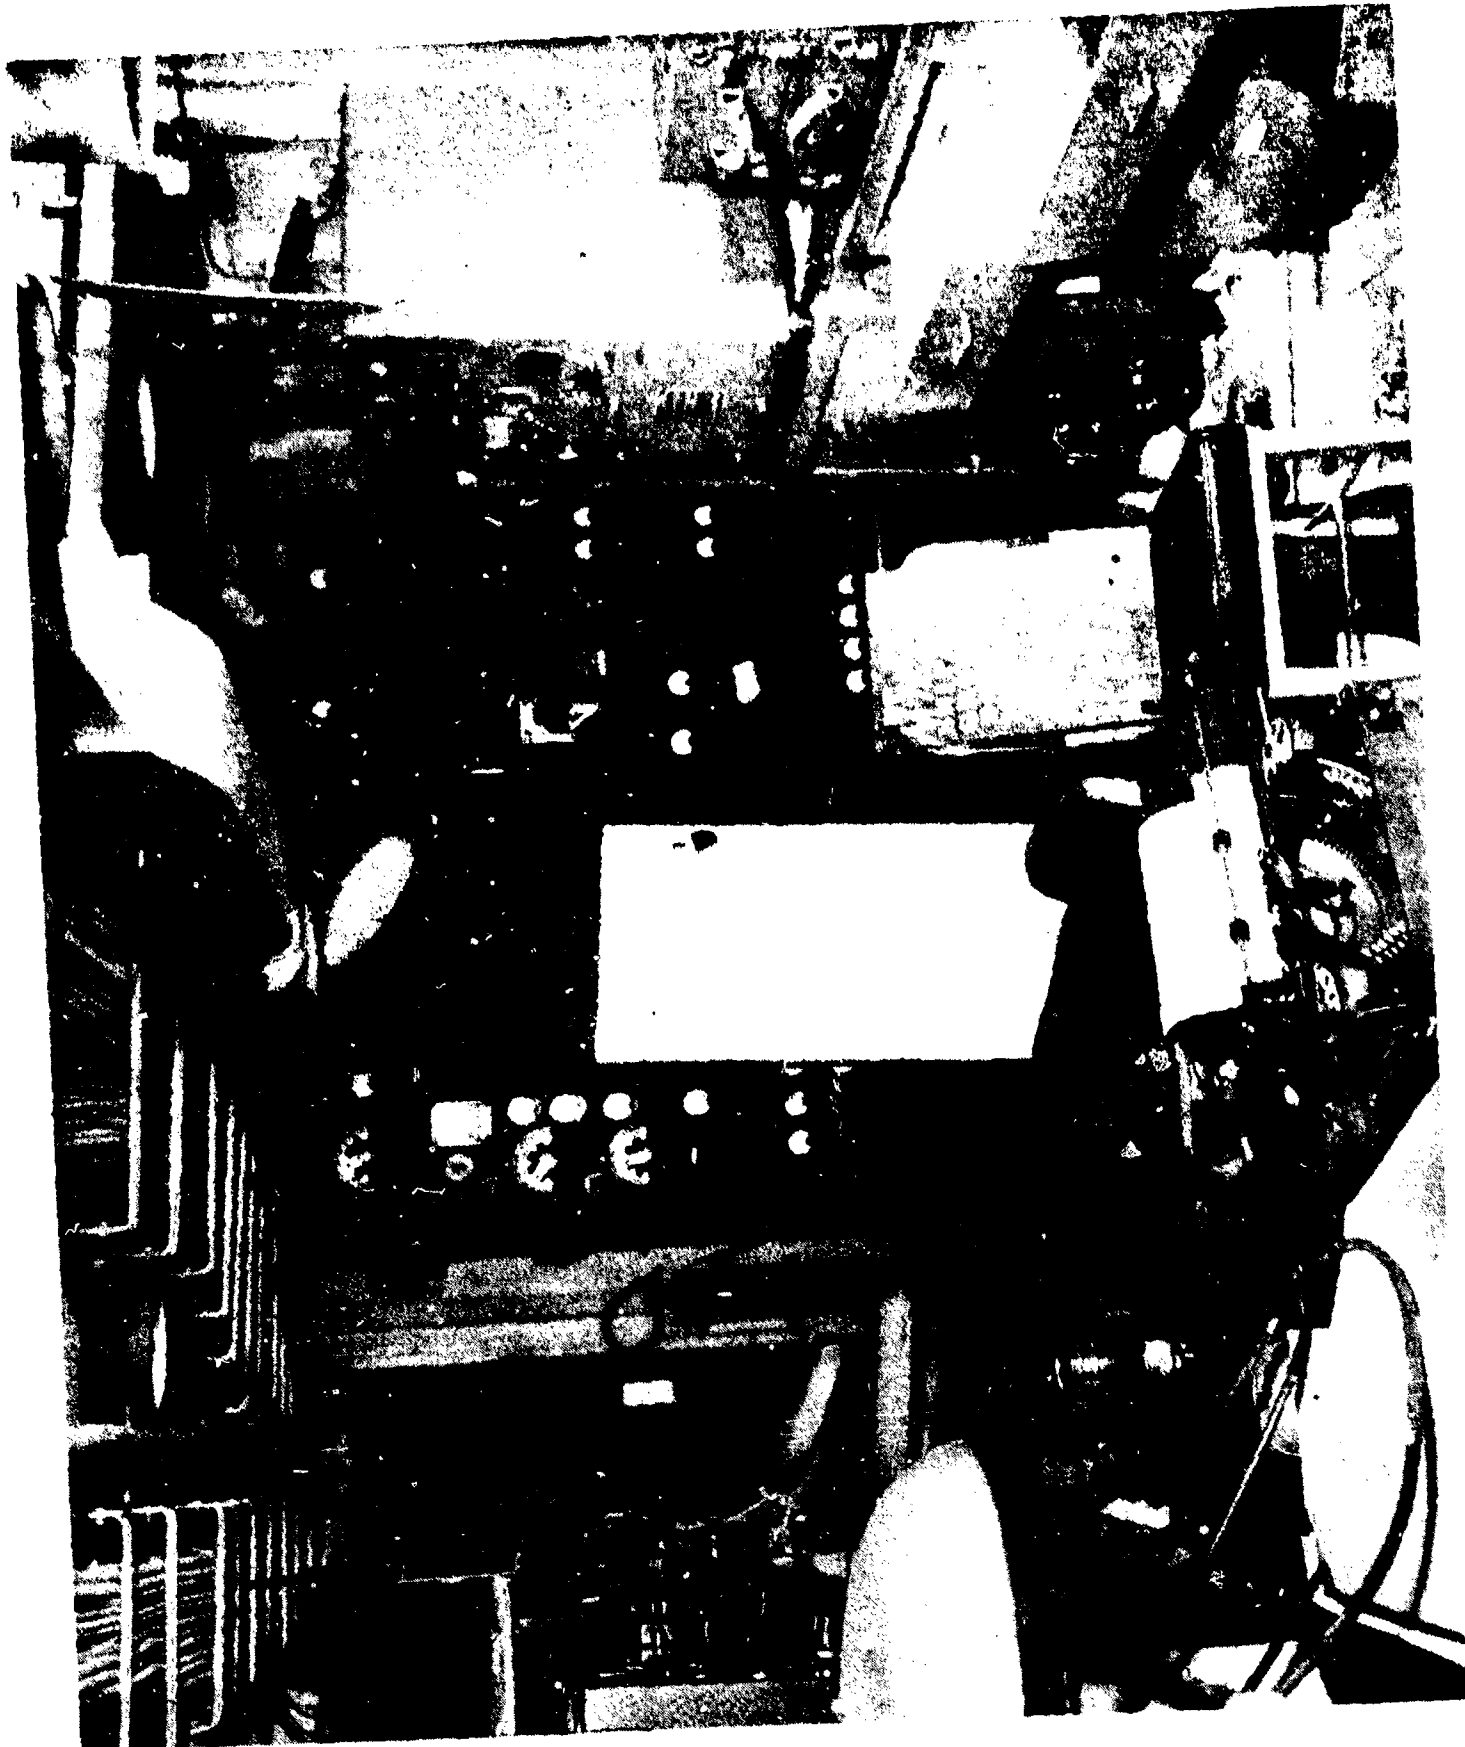
AA-CR-82-1828-2. Looking aft at disarrangement of equipment in radio 1.

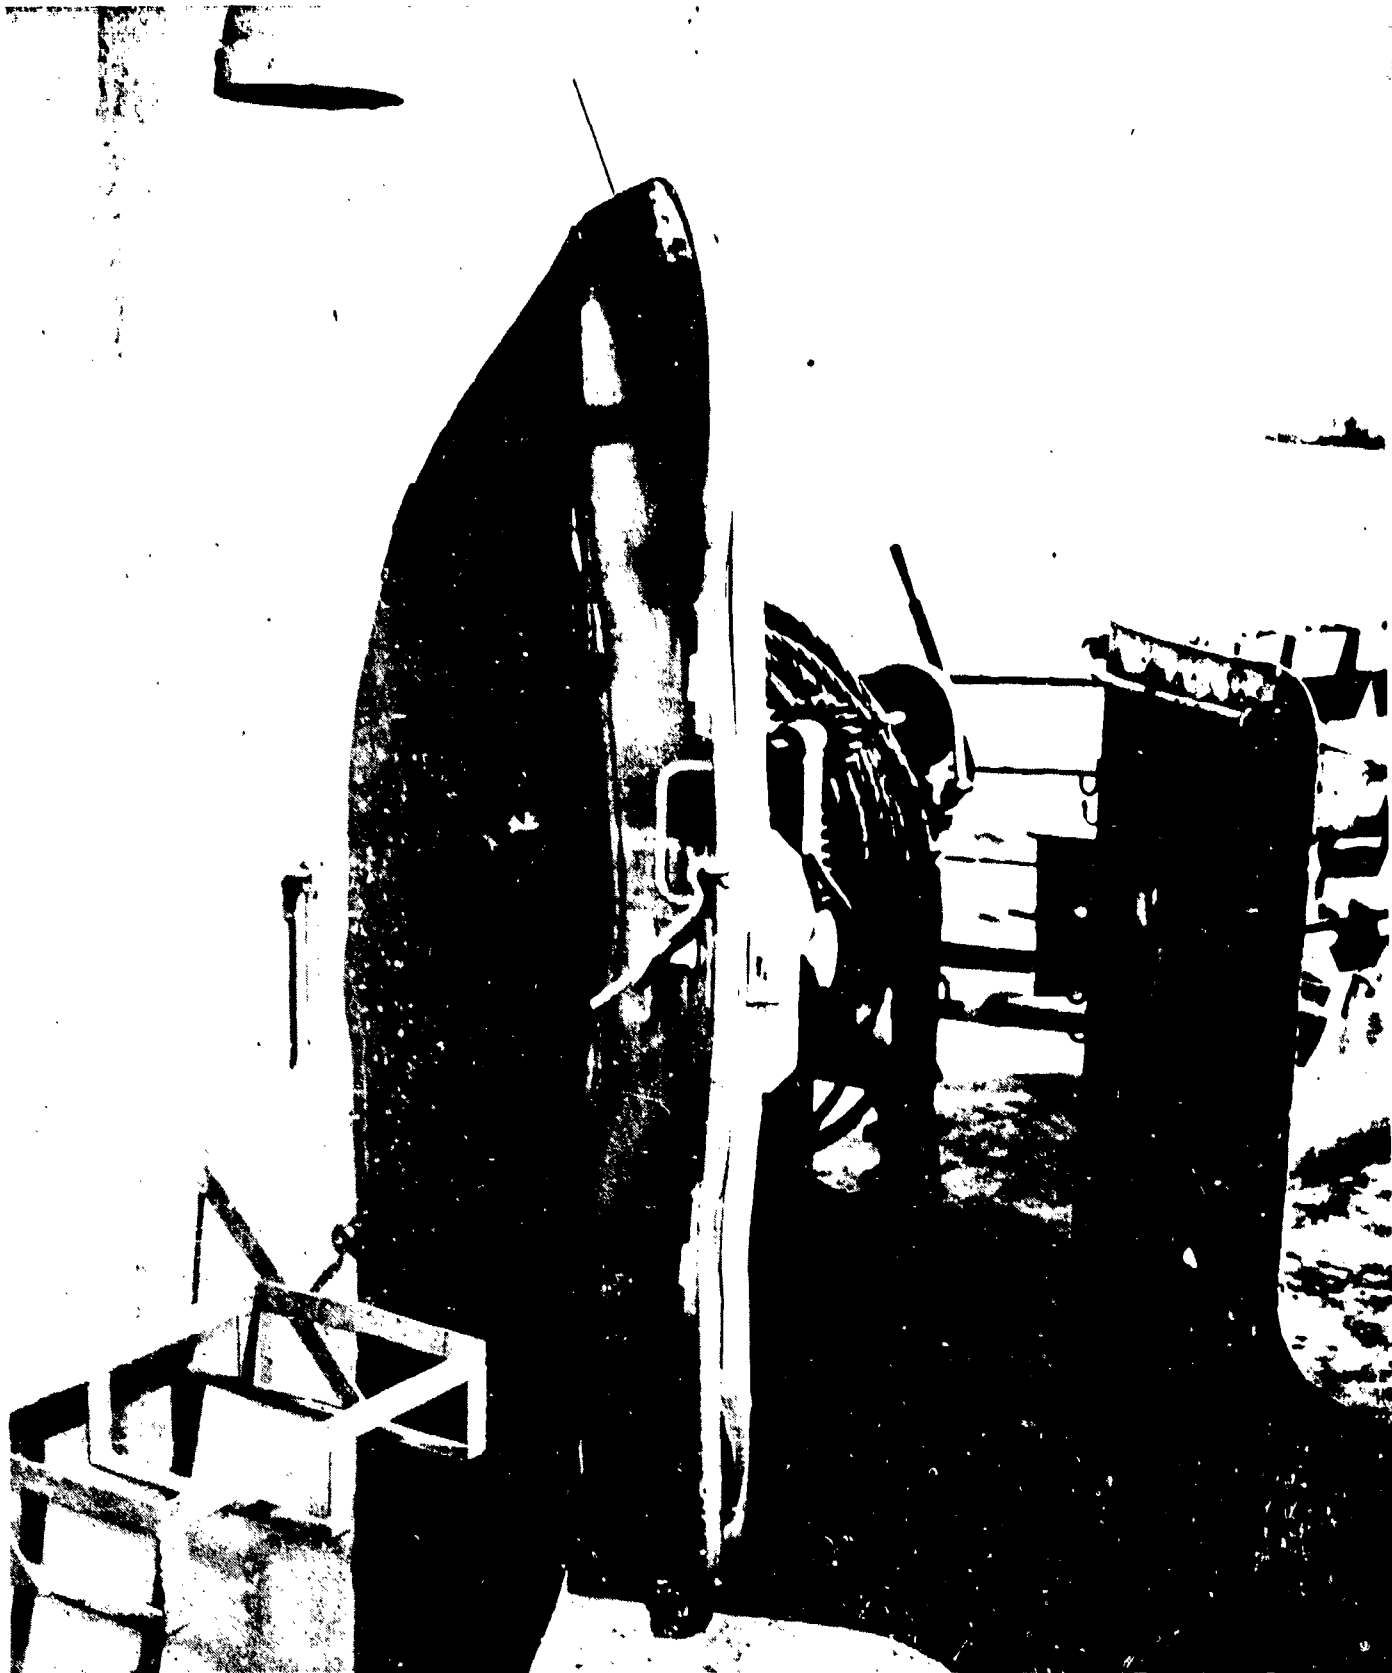
AA-CR-65-1819-10. Damaged door and broken door hook, upper deck, frame 27, port.

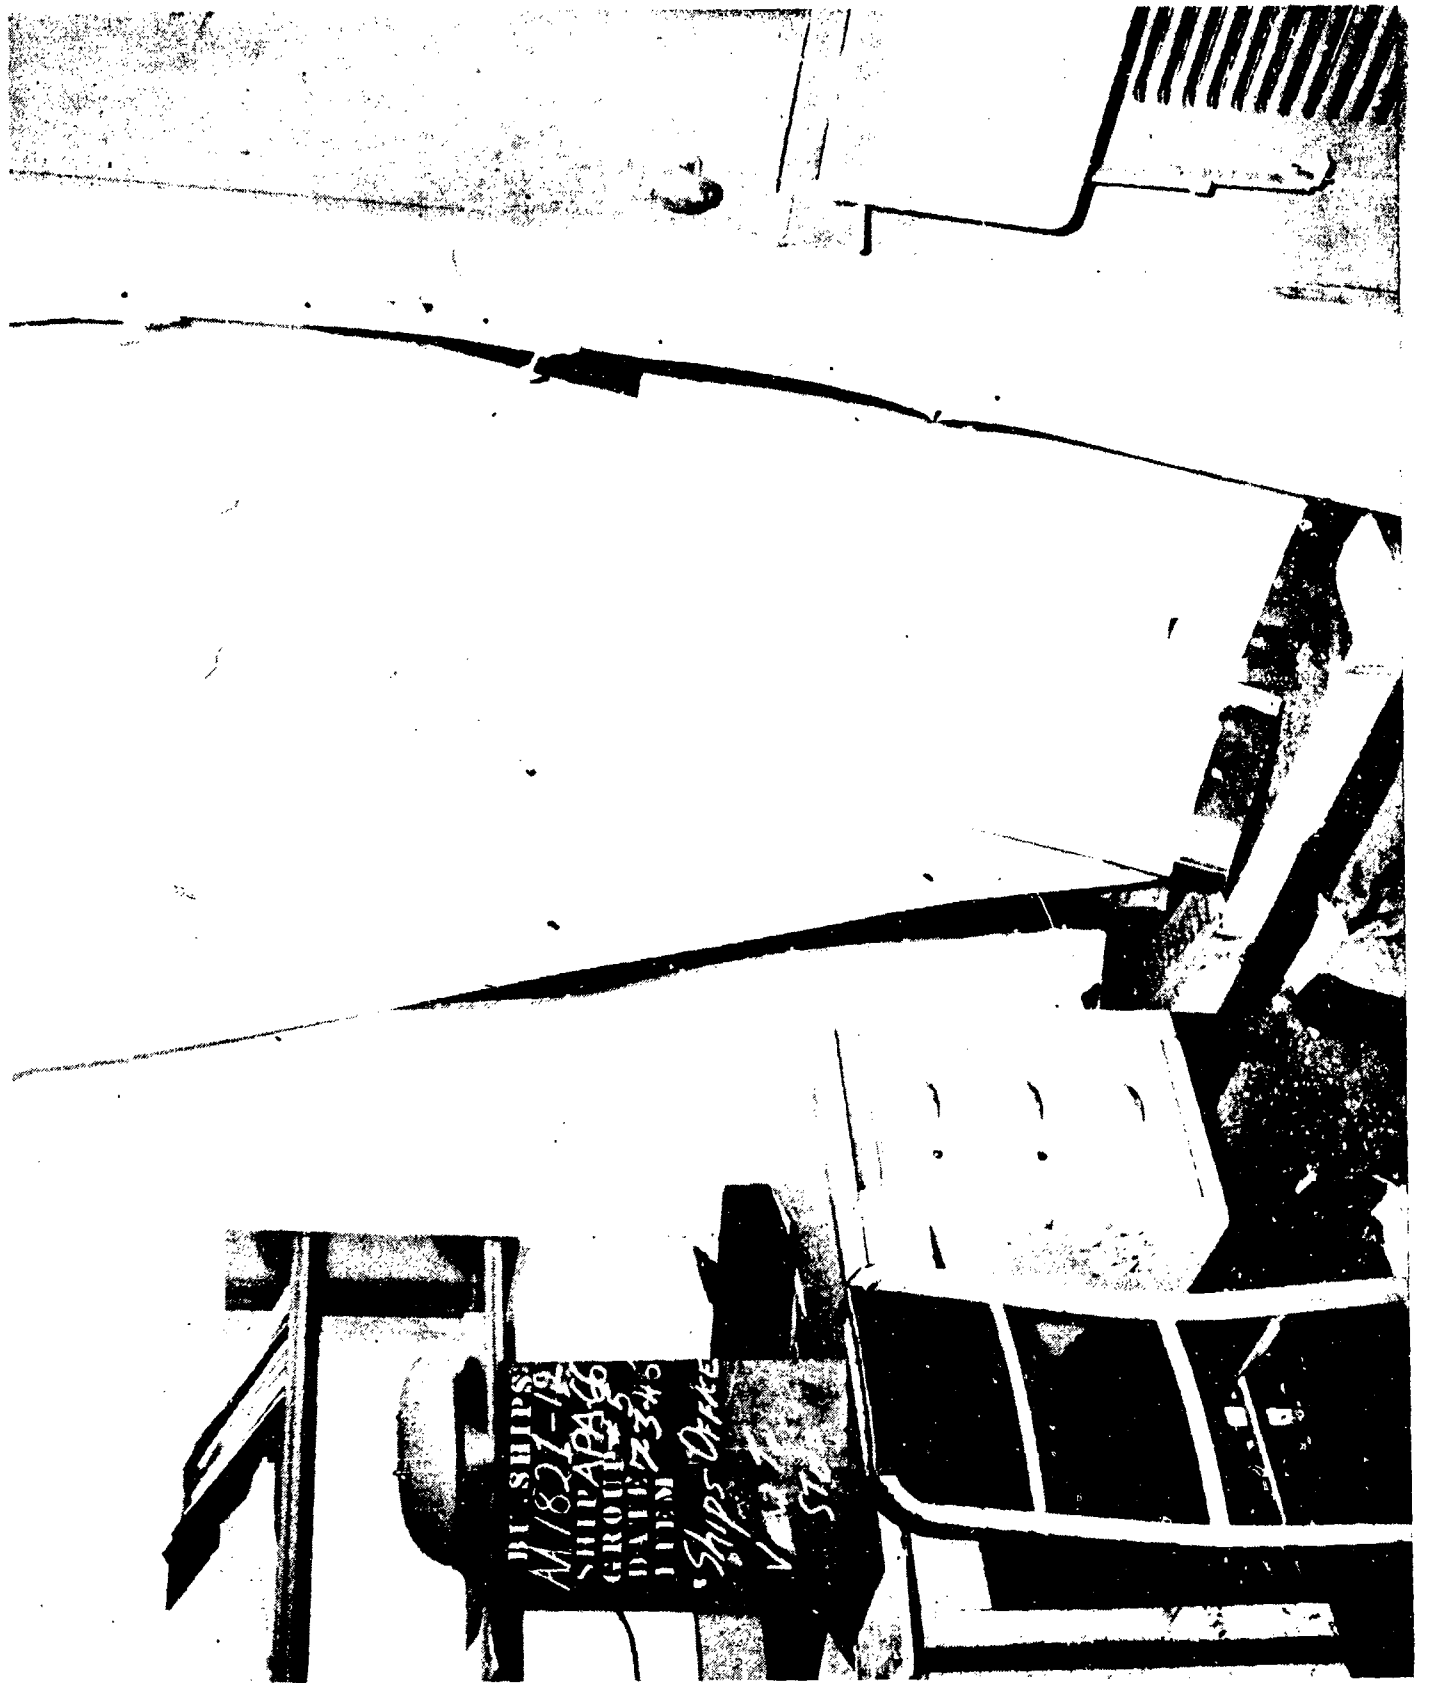
AA-CR-82-1827-12. Ship's office, main deck, frame 98, port, looking forward and to starboard. Blast damage to metal joiner bulkhead.

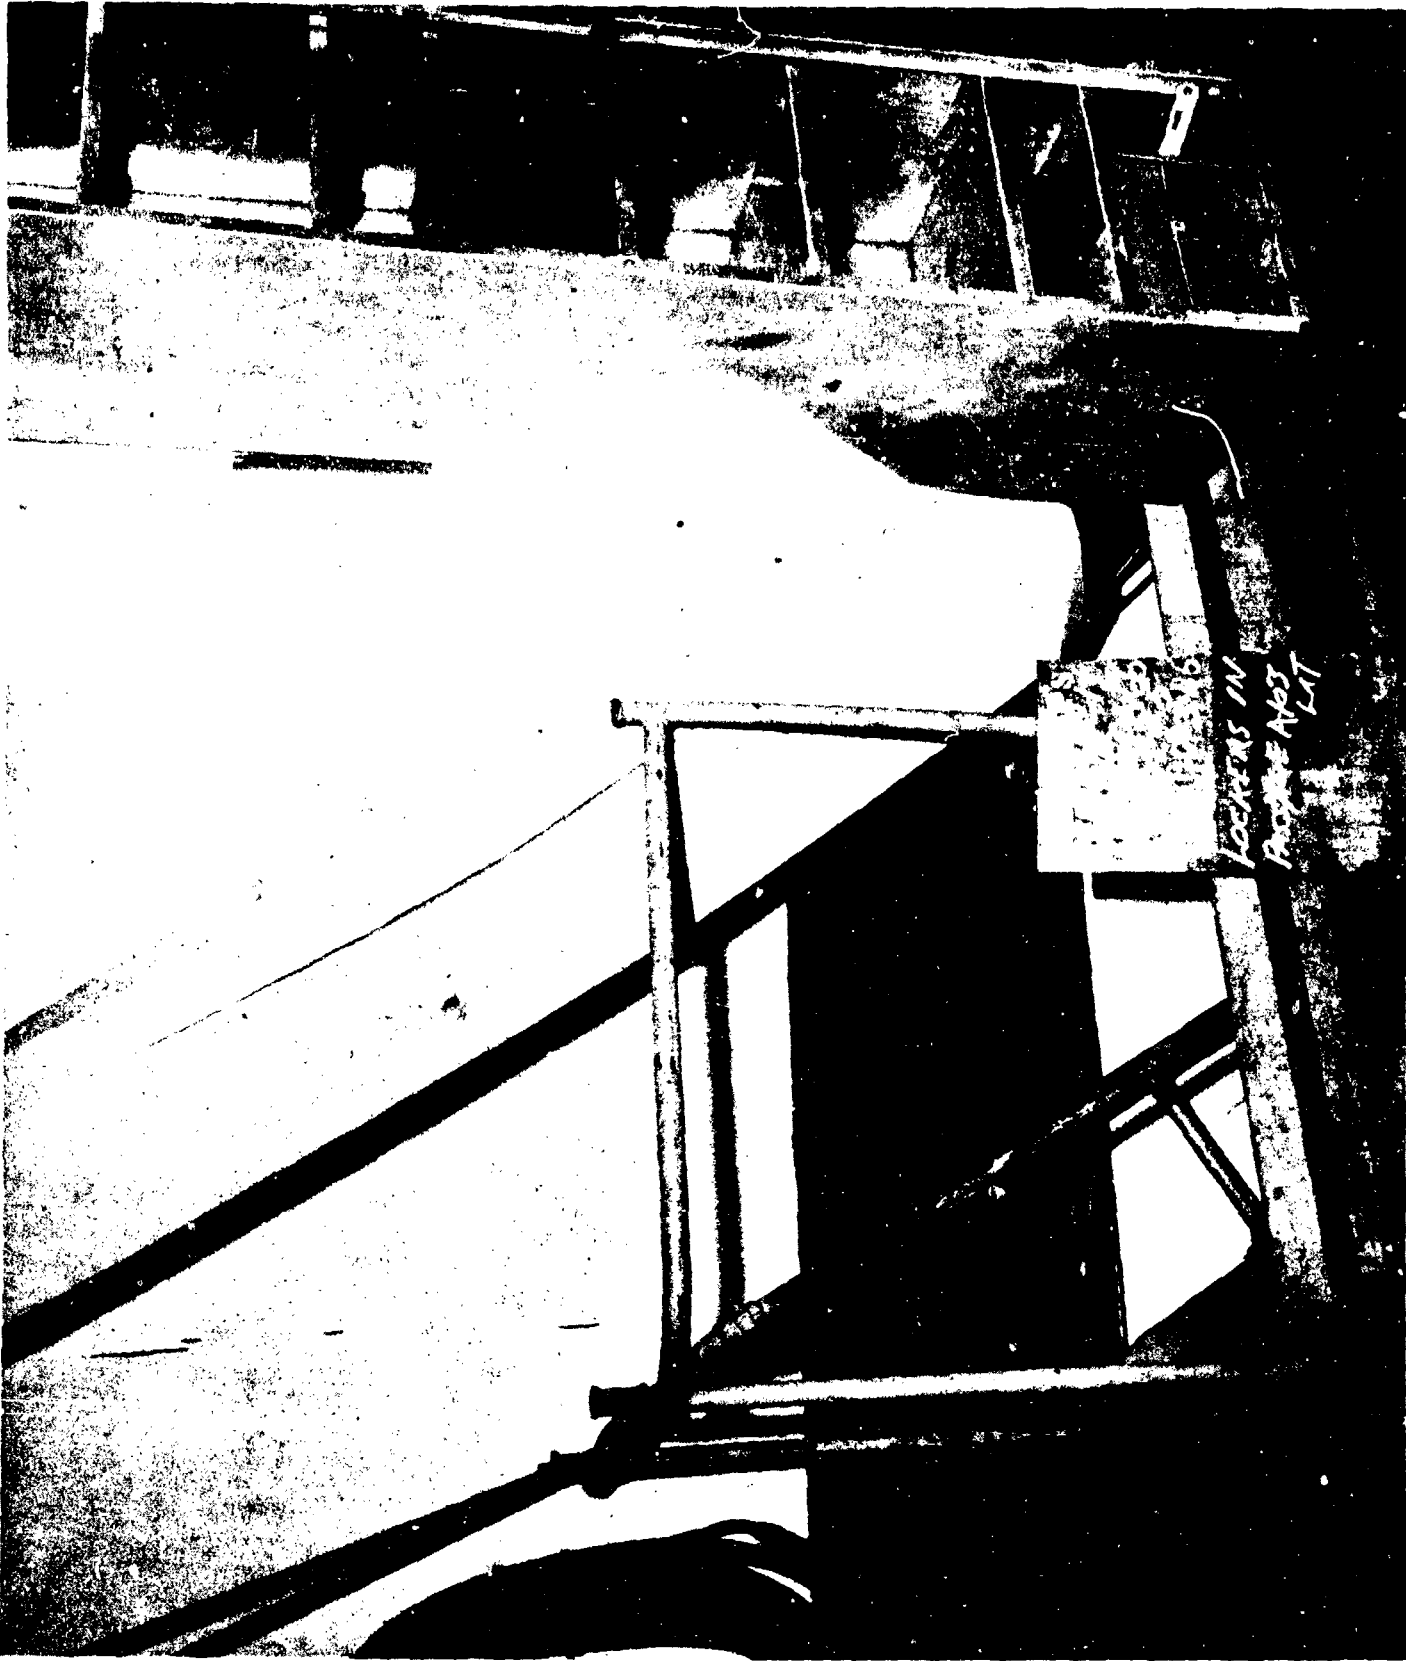
AA-CR-82-1827-11. Passage A-102LAT. Blast damage to lockers and apron under ladder. Lockers were displaced from foundation.

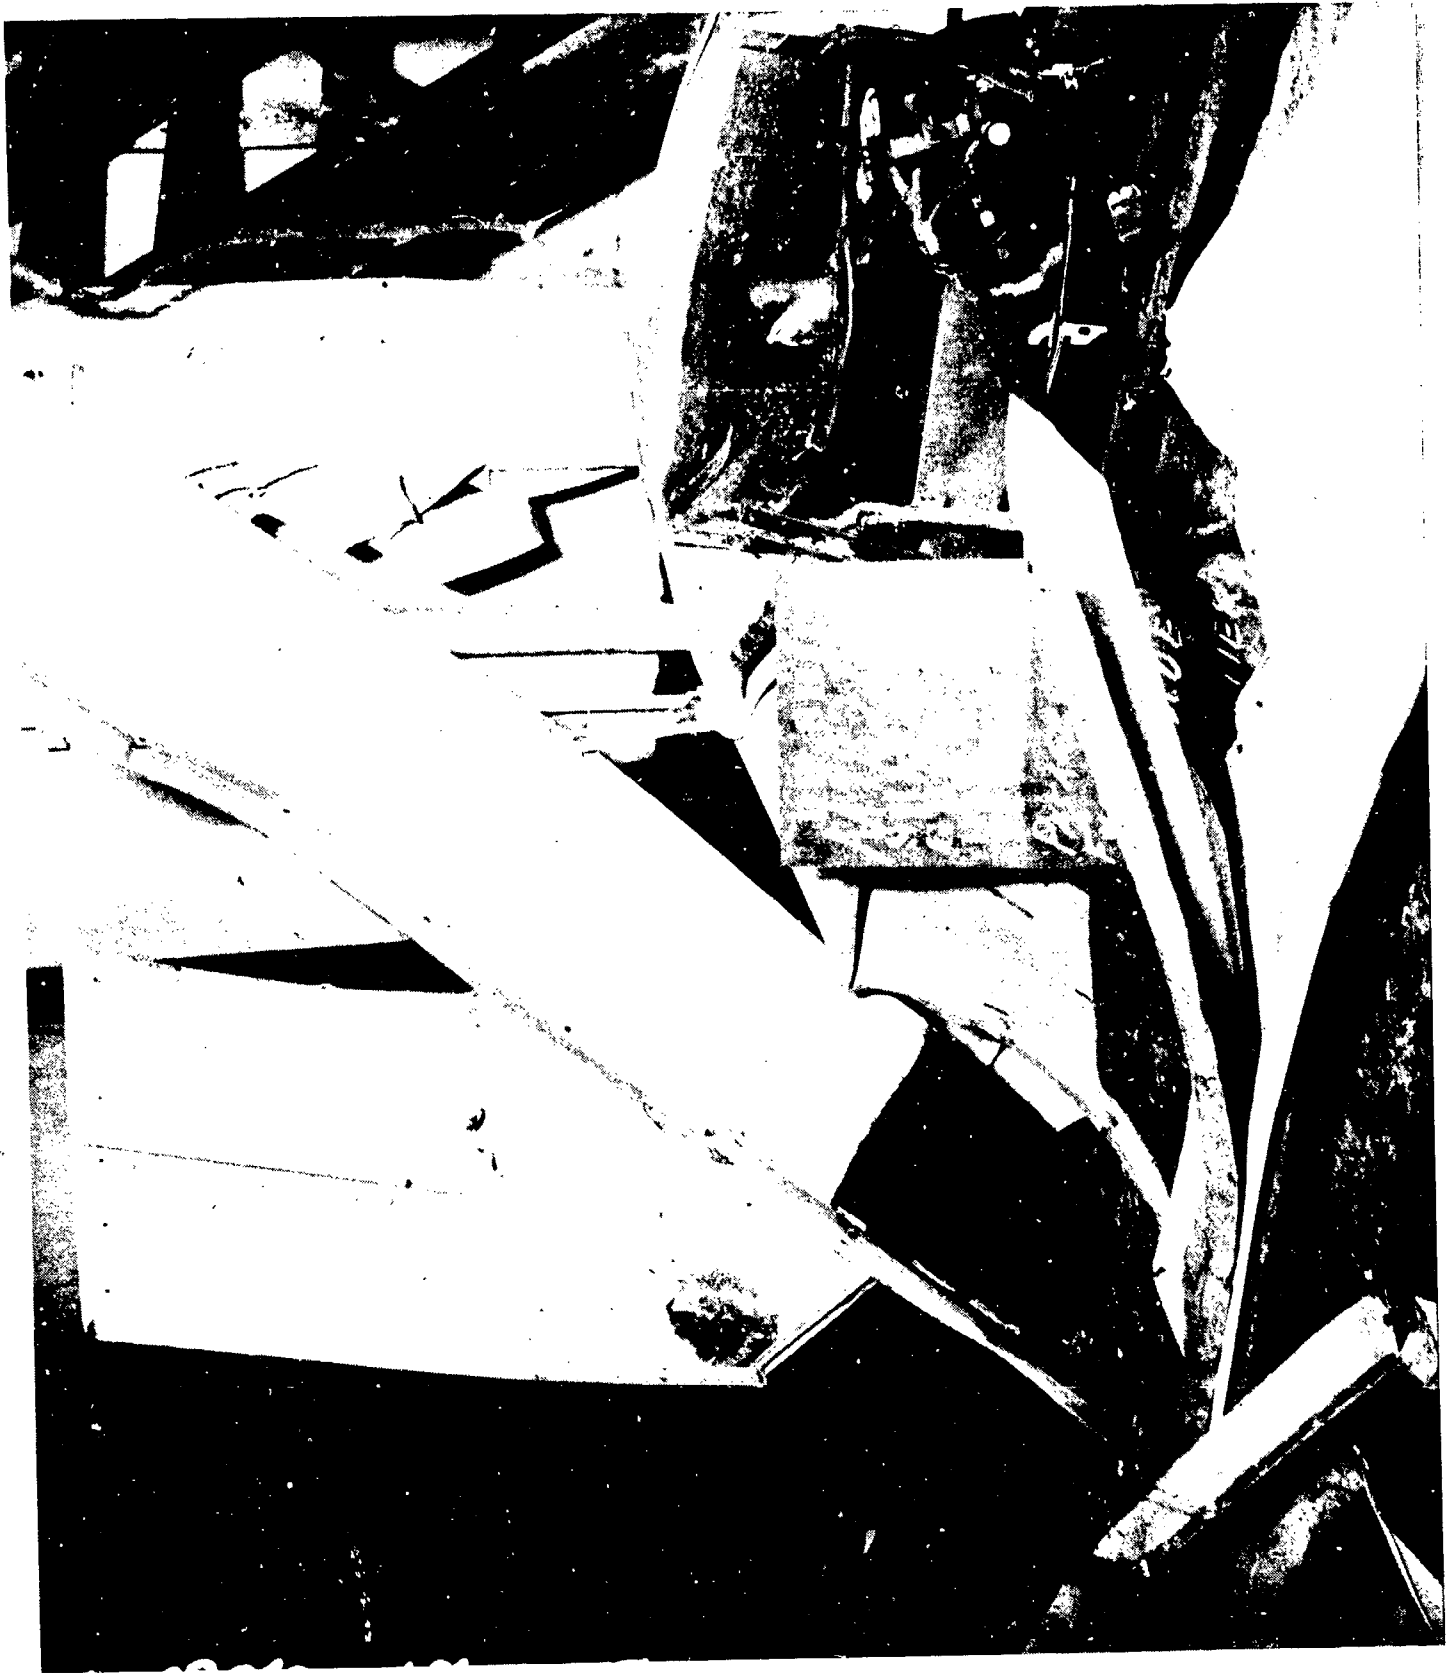
The two starboard boat davit controllers and a dishwasher controller were inoperable due to broken insulating panels.

AA-CR-82-1827-5. Main deck, frame 68, starboard. Damage to metal joiner bulkhead around ladder 1-68-1. Note damage to electric controller for dish washer secured to bulkhead.

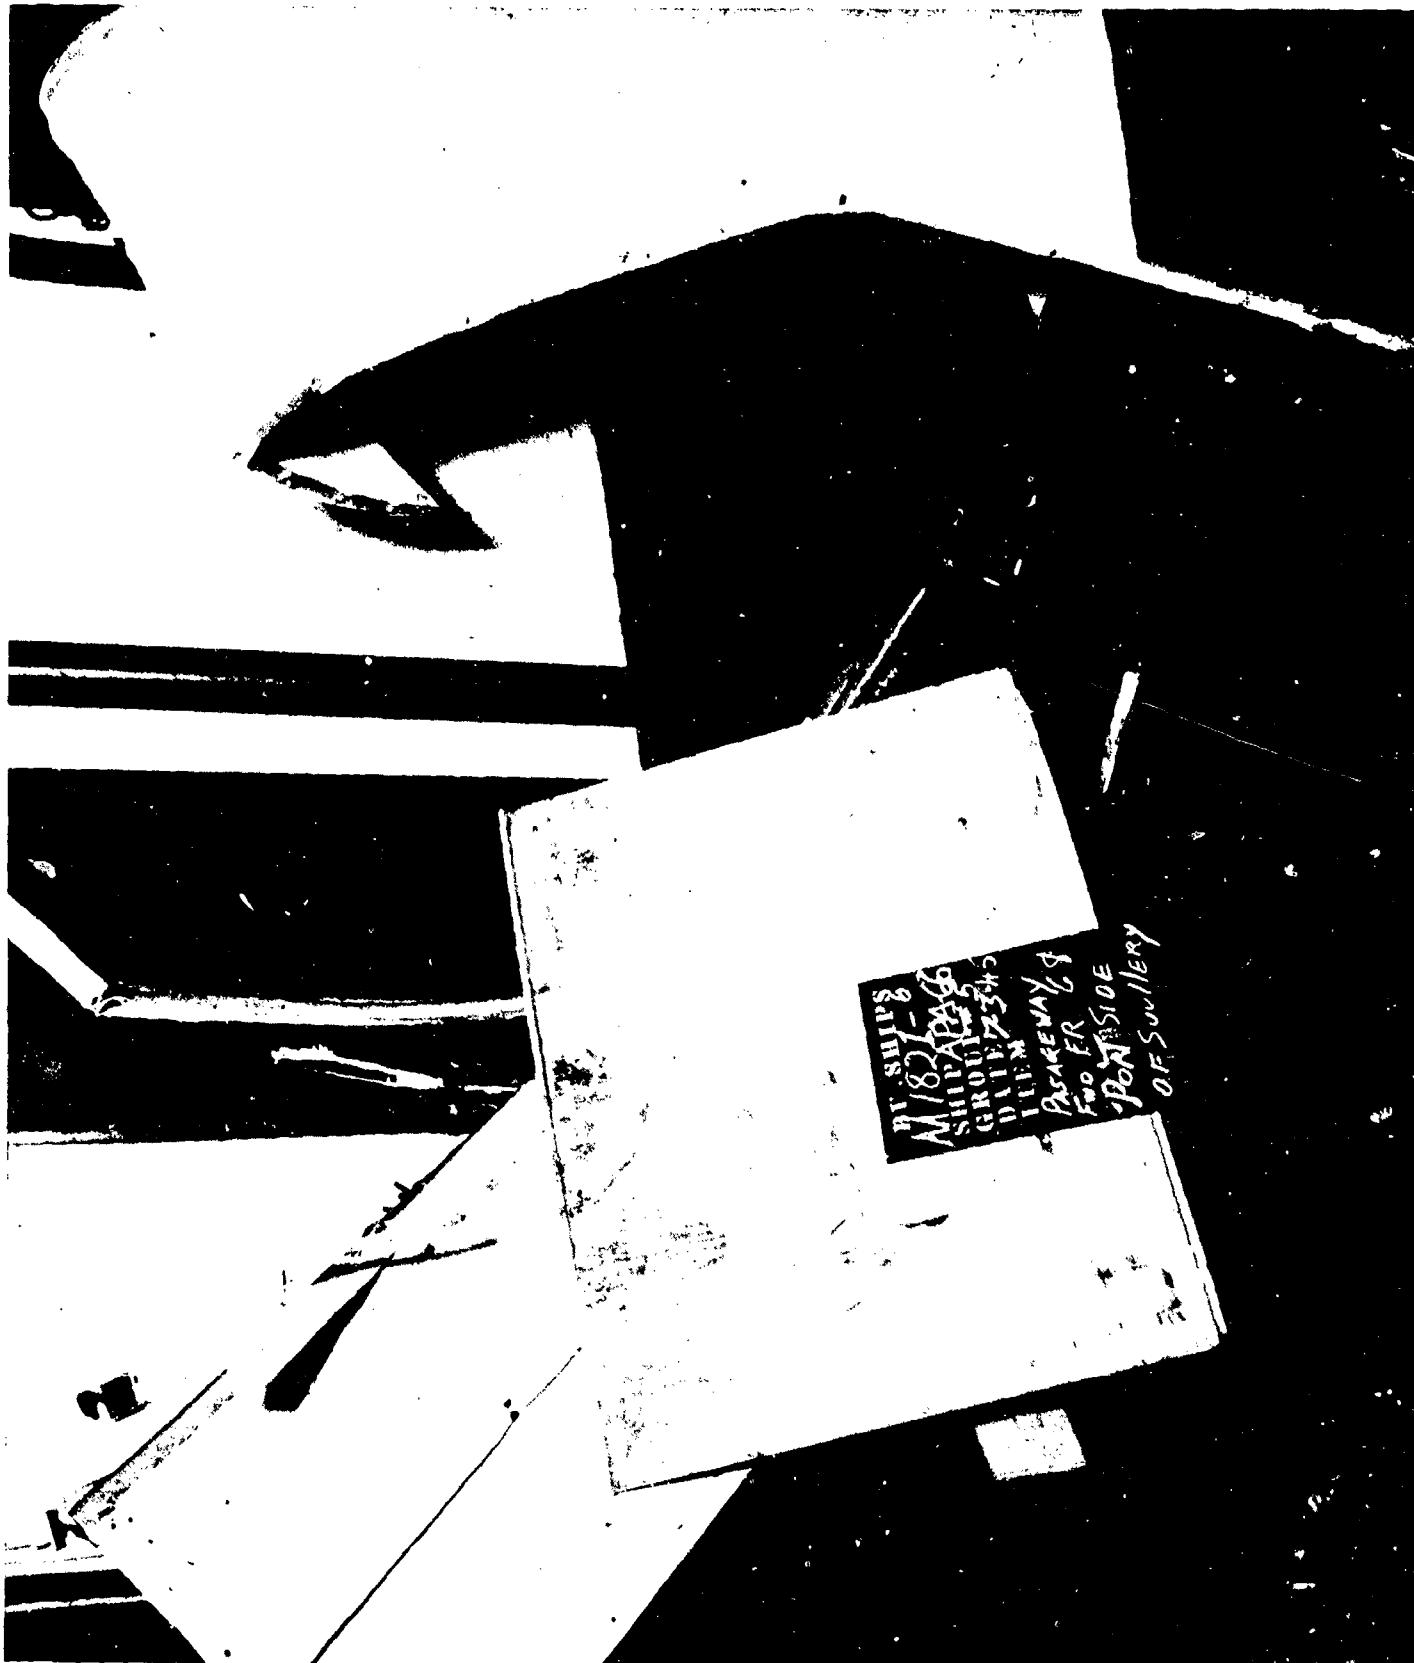
AA-CR-82-1827-6. Main deck, frame 68, port. Damage to metal joiner bulkhead around ladder 1-68-2.

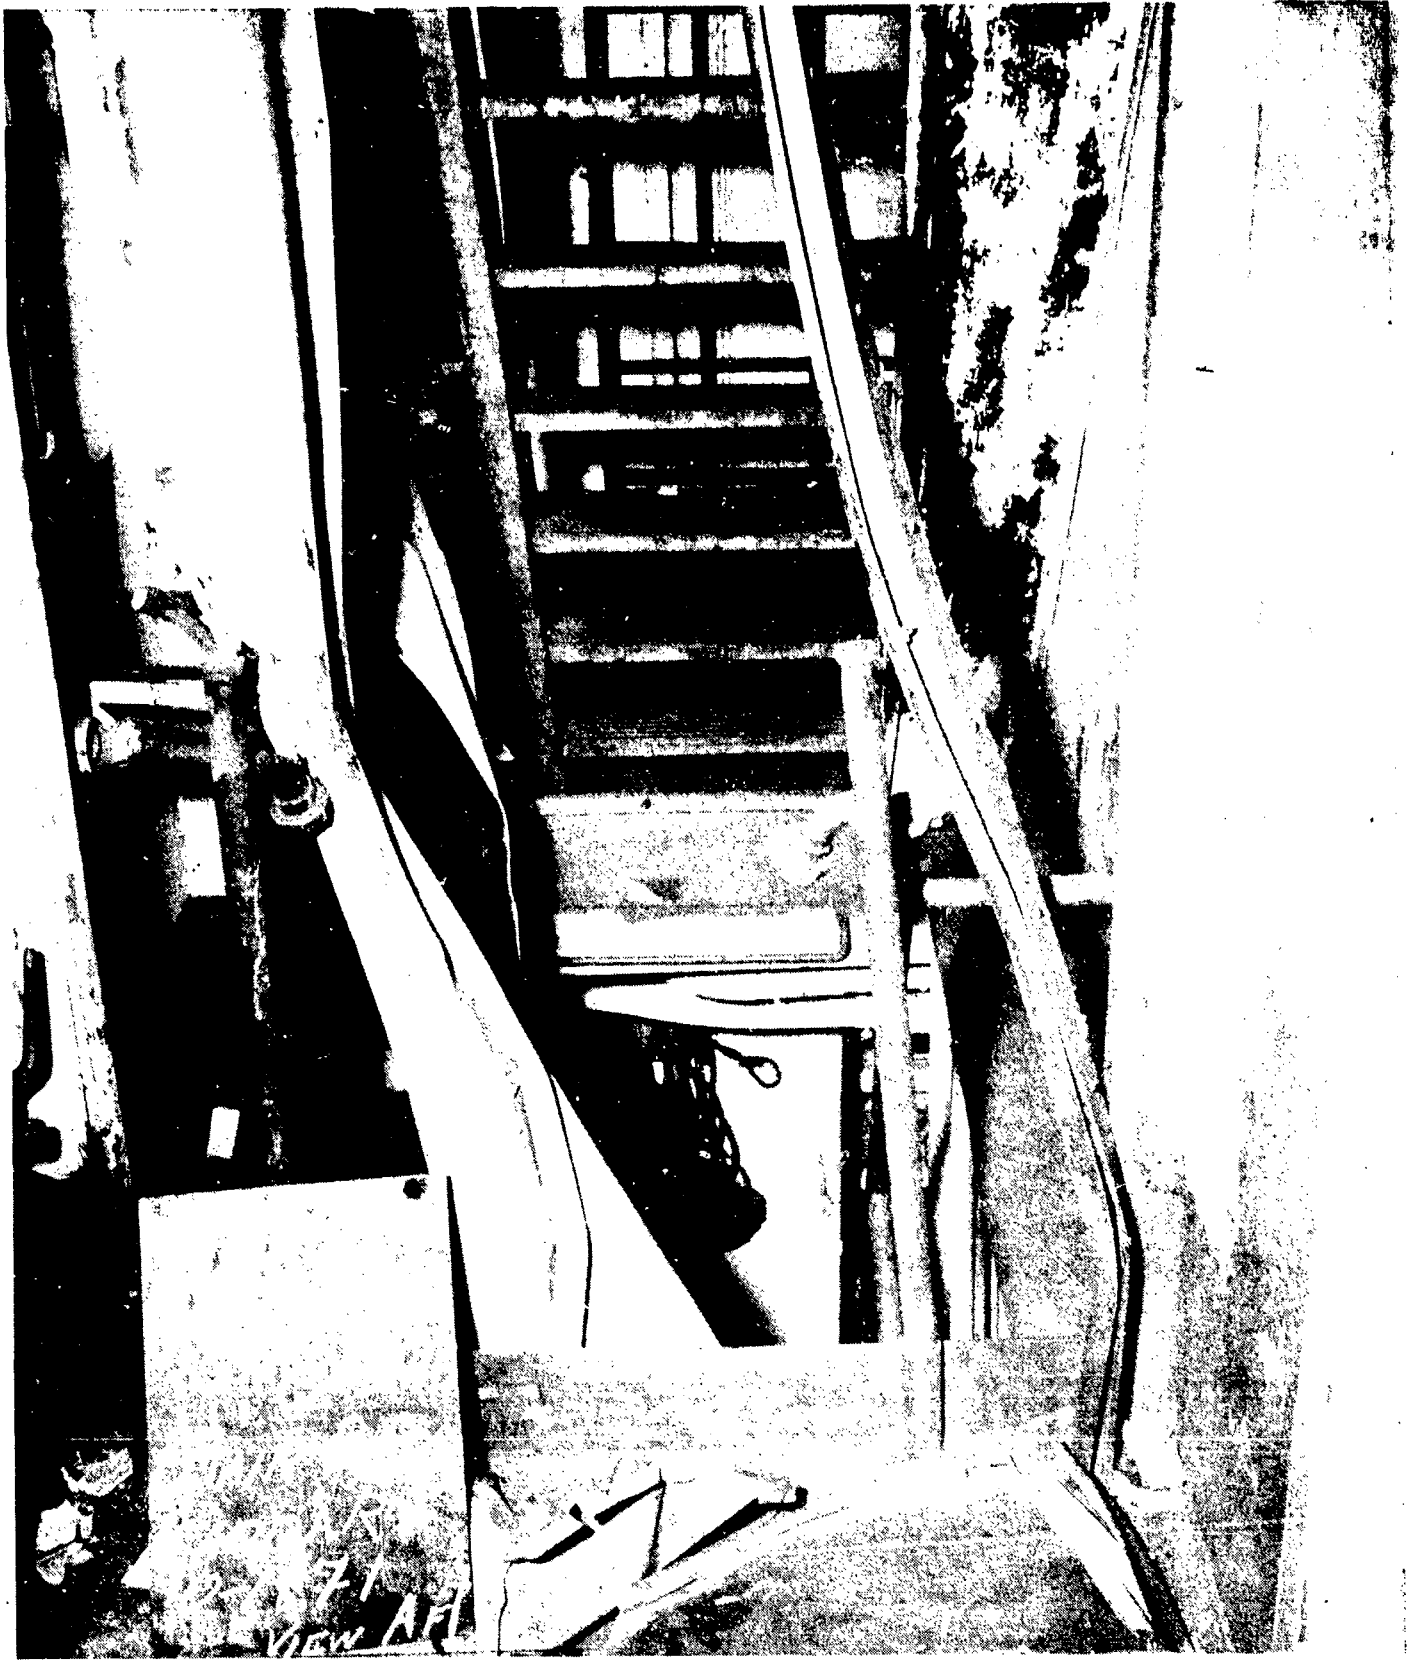
AA-CR-82-1828-12. Main deck, frame 87, starboard. Damage to metal joiner, light lock around ladder 1-87-1.

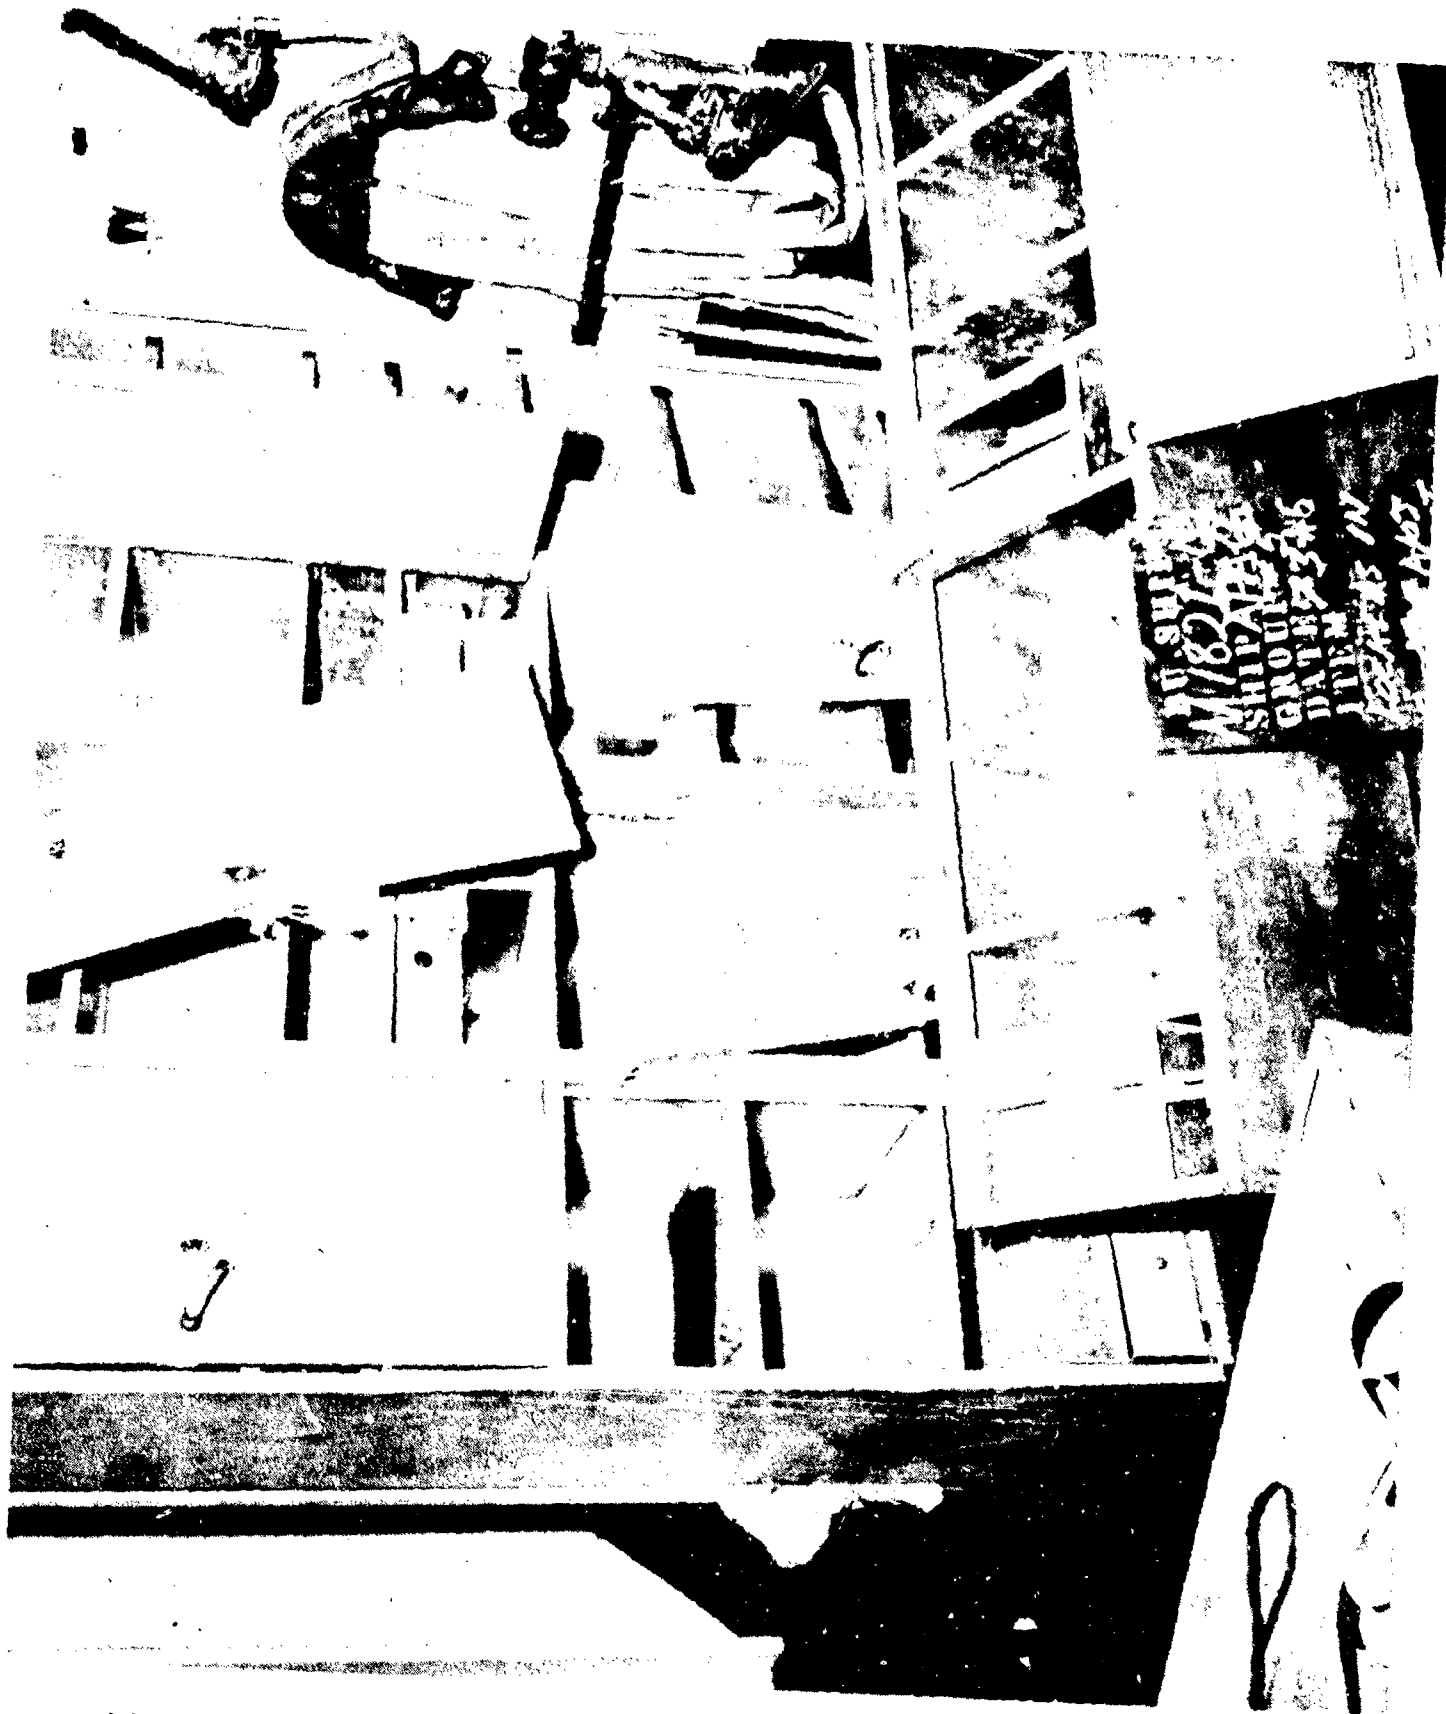
AA-CR-82-1827-10. Passage A-102LAT. Blast damage to lockers.
