~~CONFIDENTIAL~~
9 BUREAU OF SHIPS GROUP
TECHNICAL INSPECTION REPORT

6 OPERATION CROSSROADS.
U.S.S. BRULE (APA 66).

TEST ABLE [U].

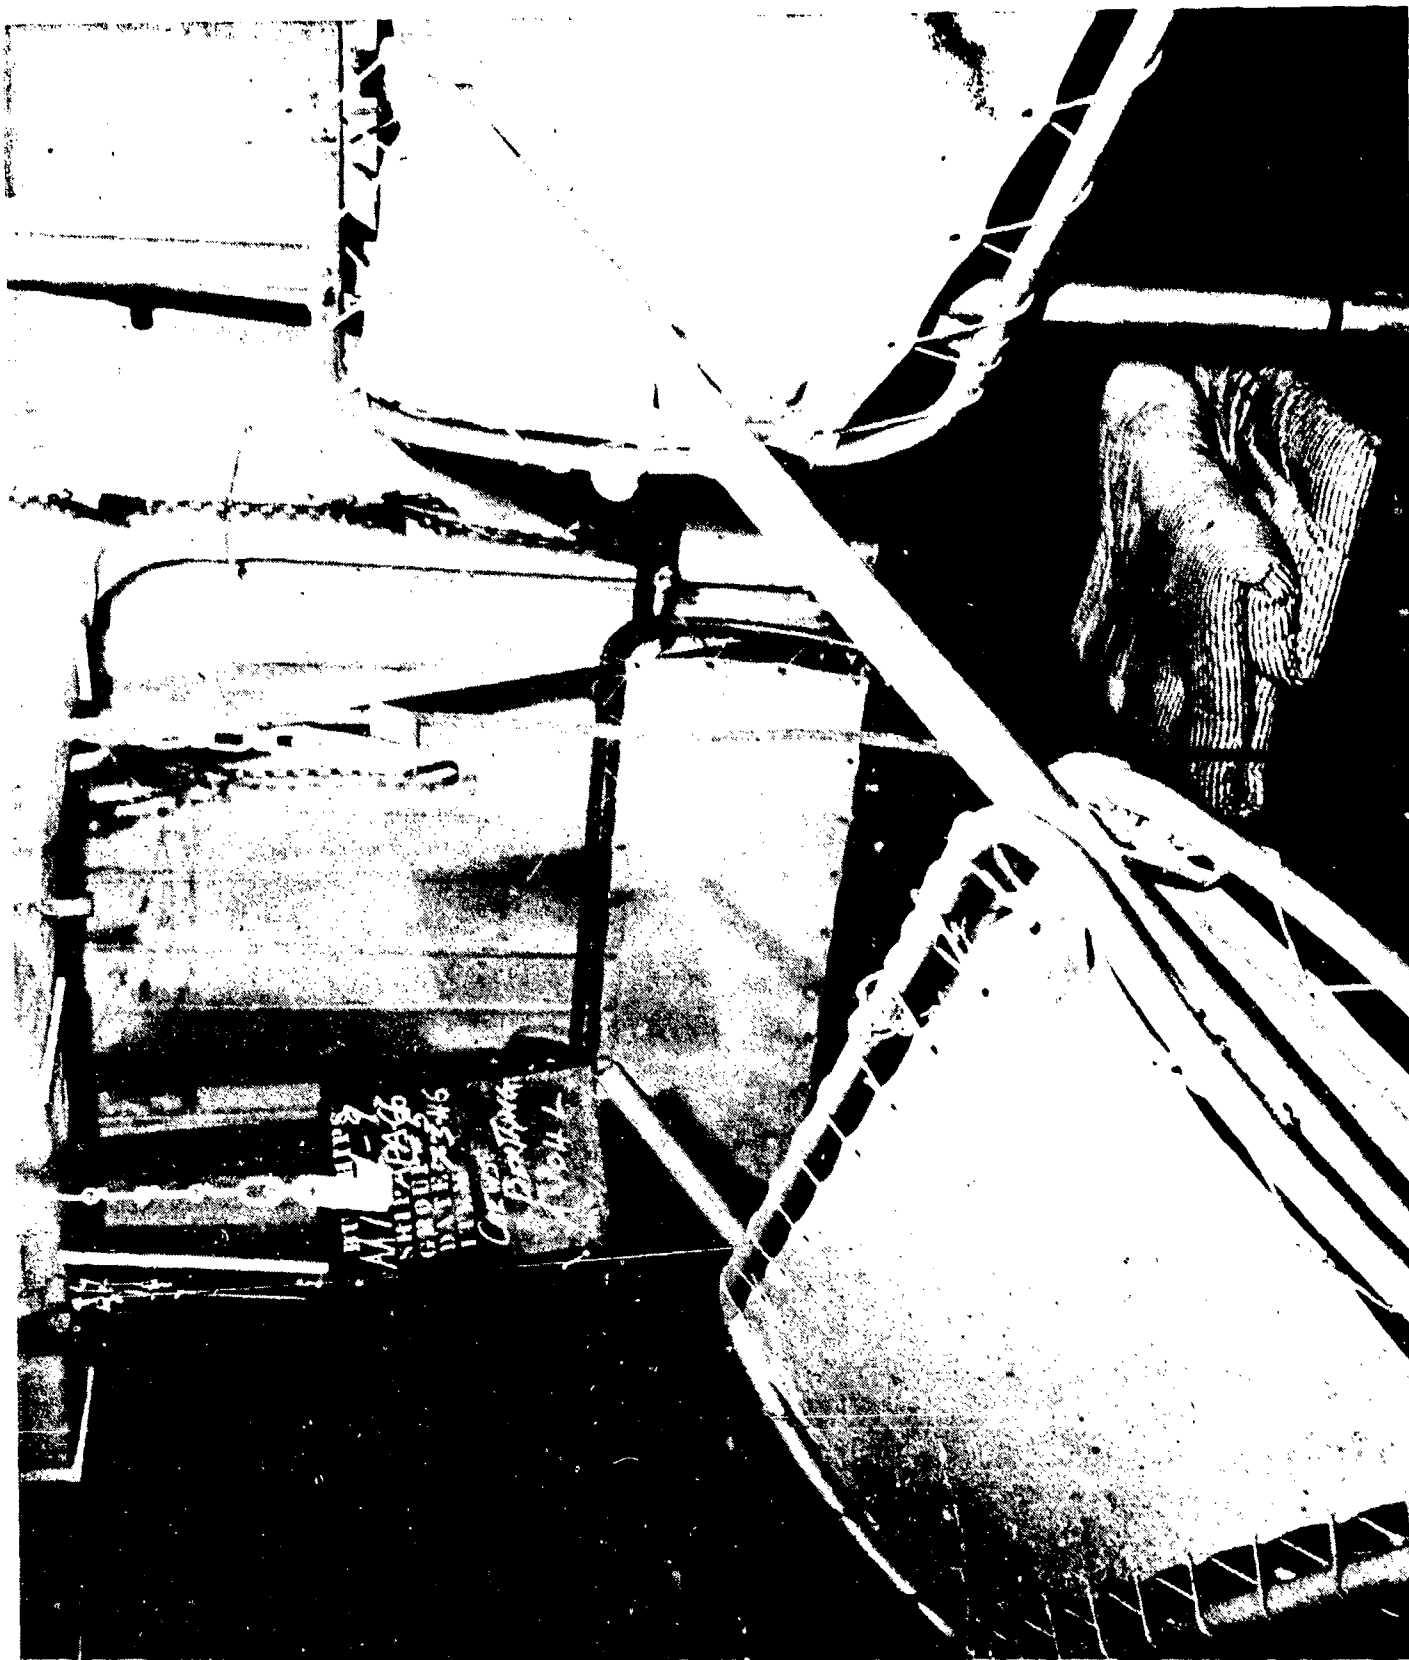
AA-CR-82-1827-9. A-104L. Disarrangement of bunk stanchions and bunks.

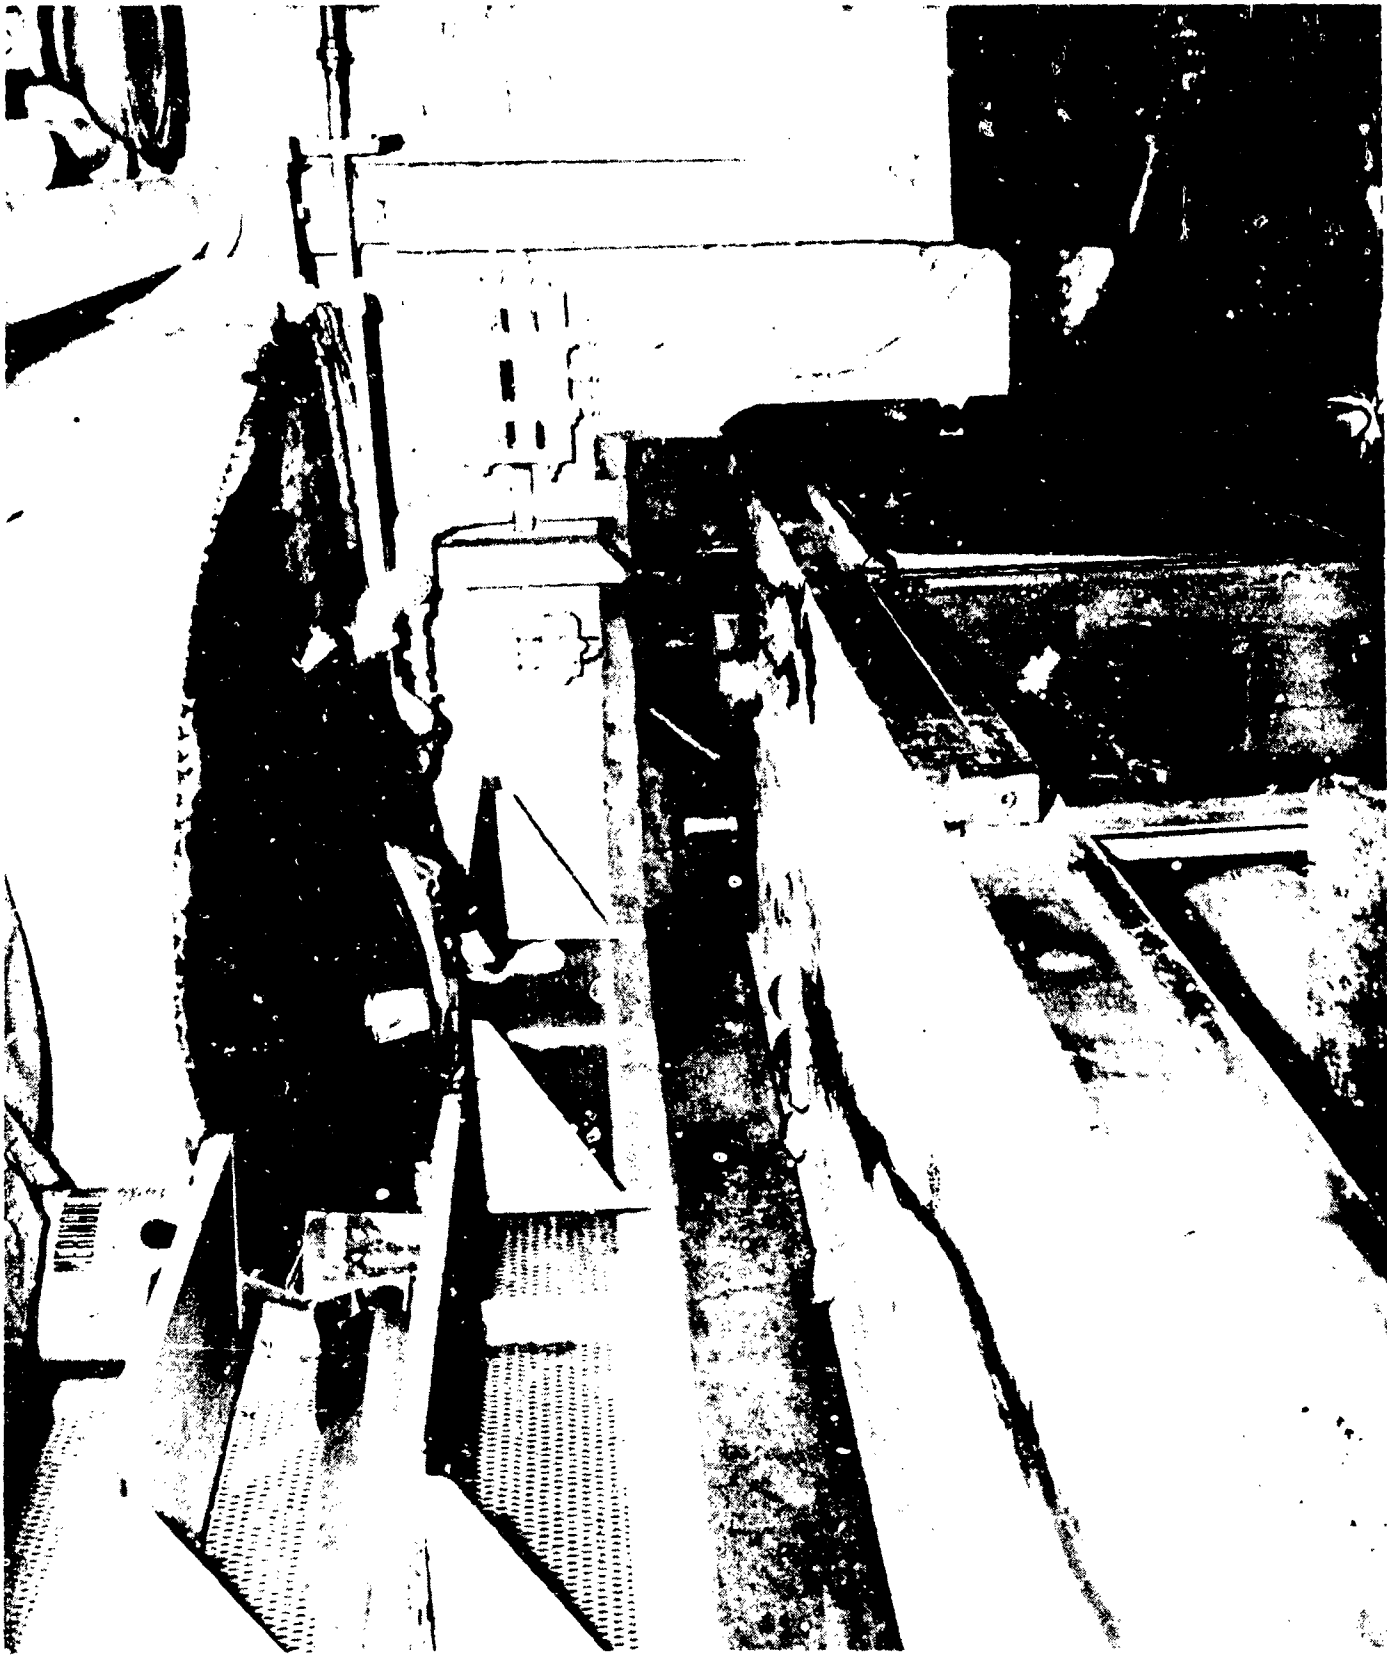
AB-CR-100-2992-6. Test A damage to vent duct in bakery.

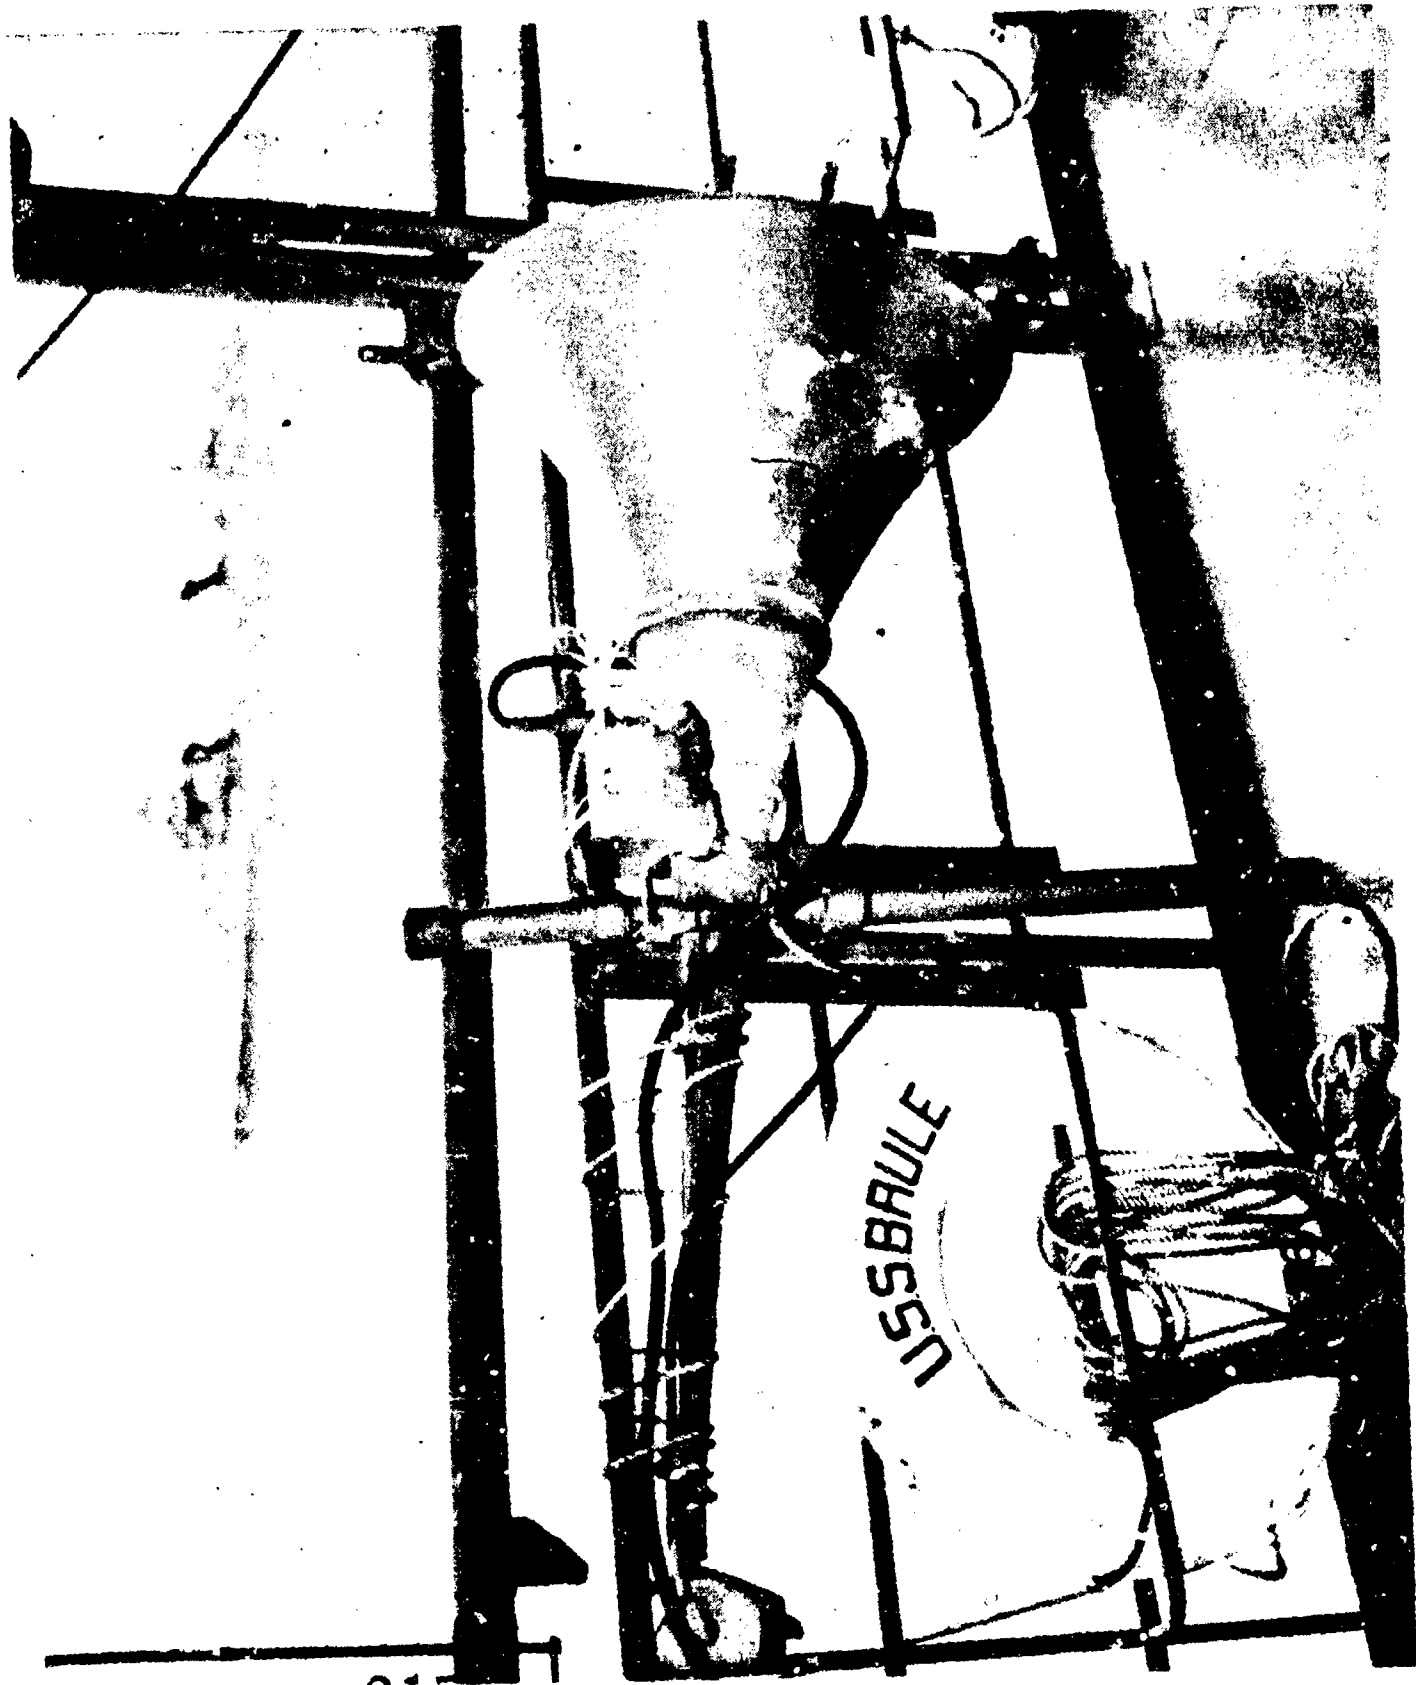
AA-CR-175-2157-5. Air blast bull horn Photo shows horn broken.
from pedestal.

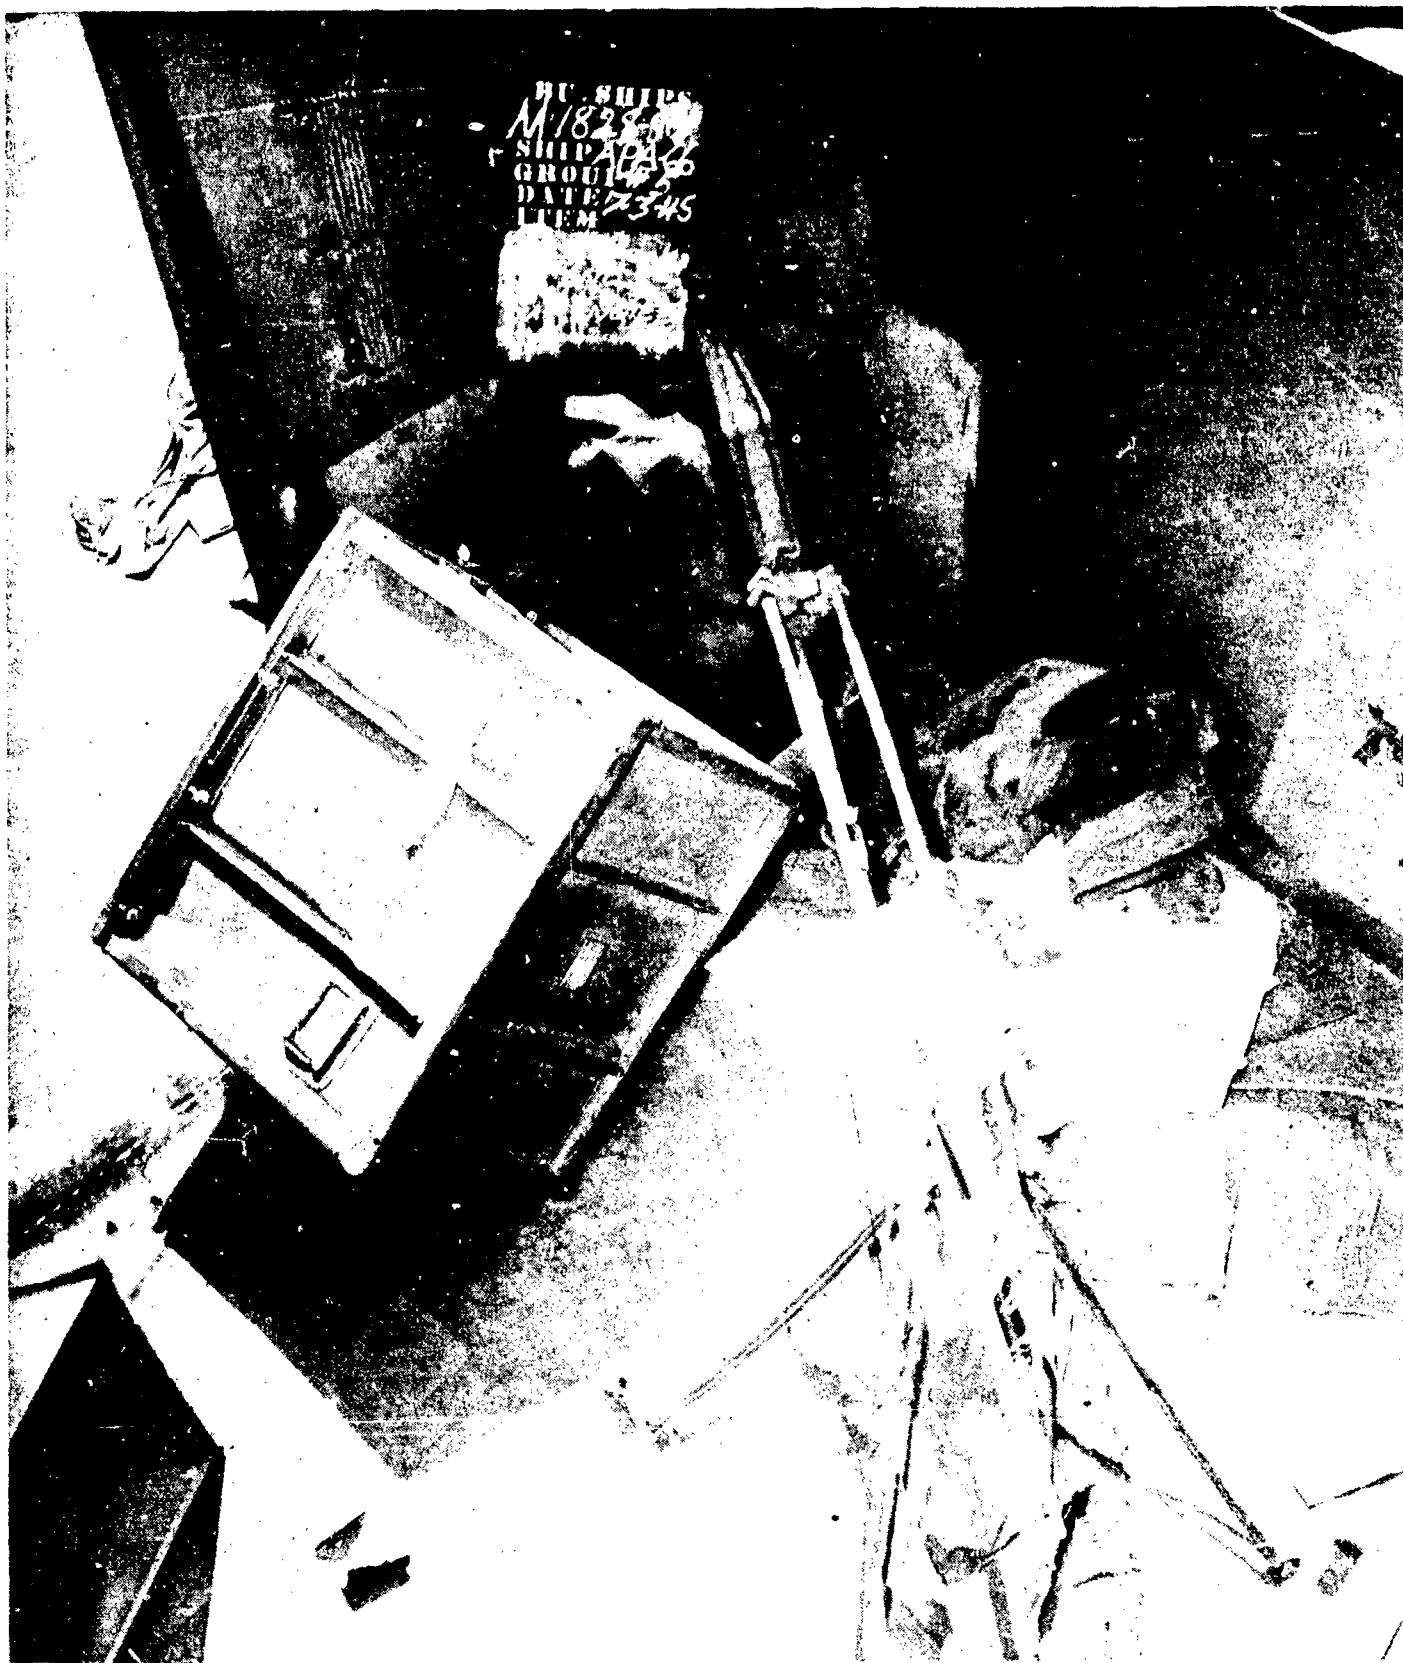
AA-CR-82-1828-10. Support for P.A.B. speaker Photo shows support damaged due to blast.

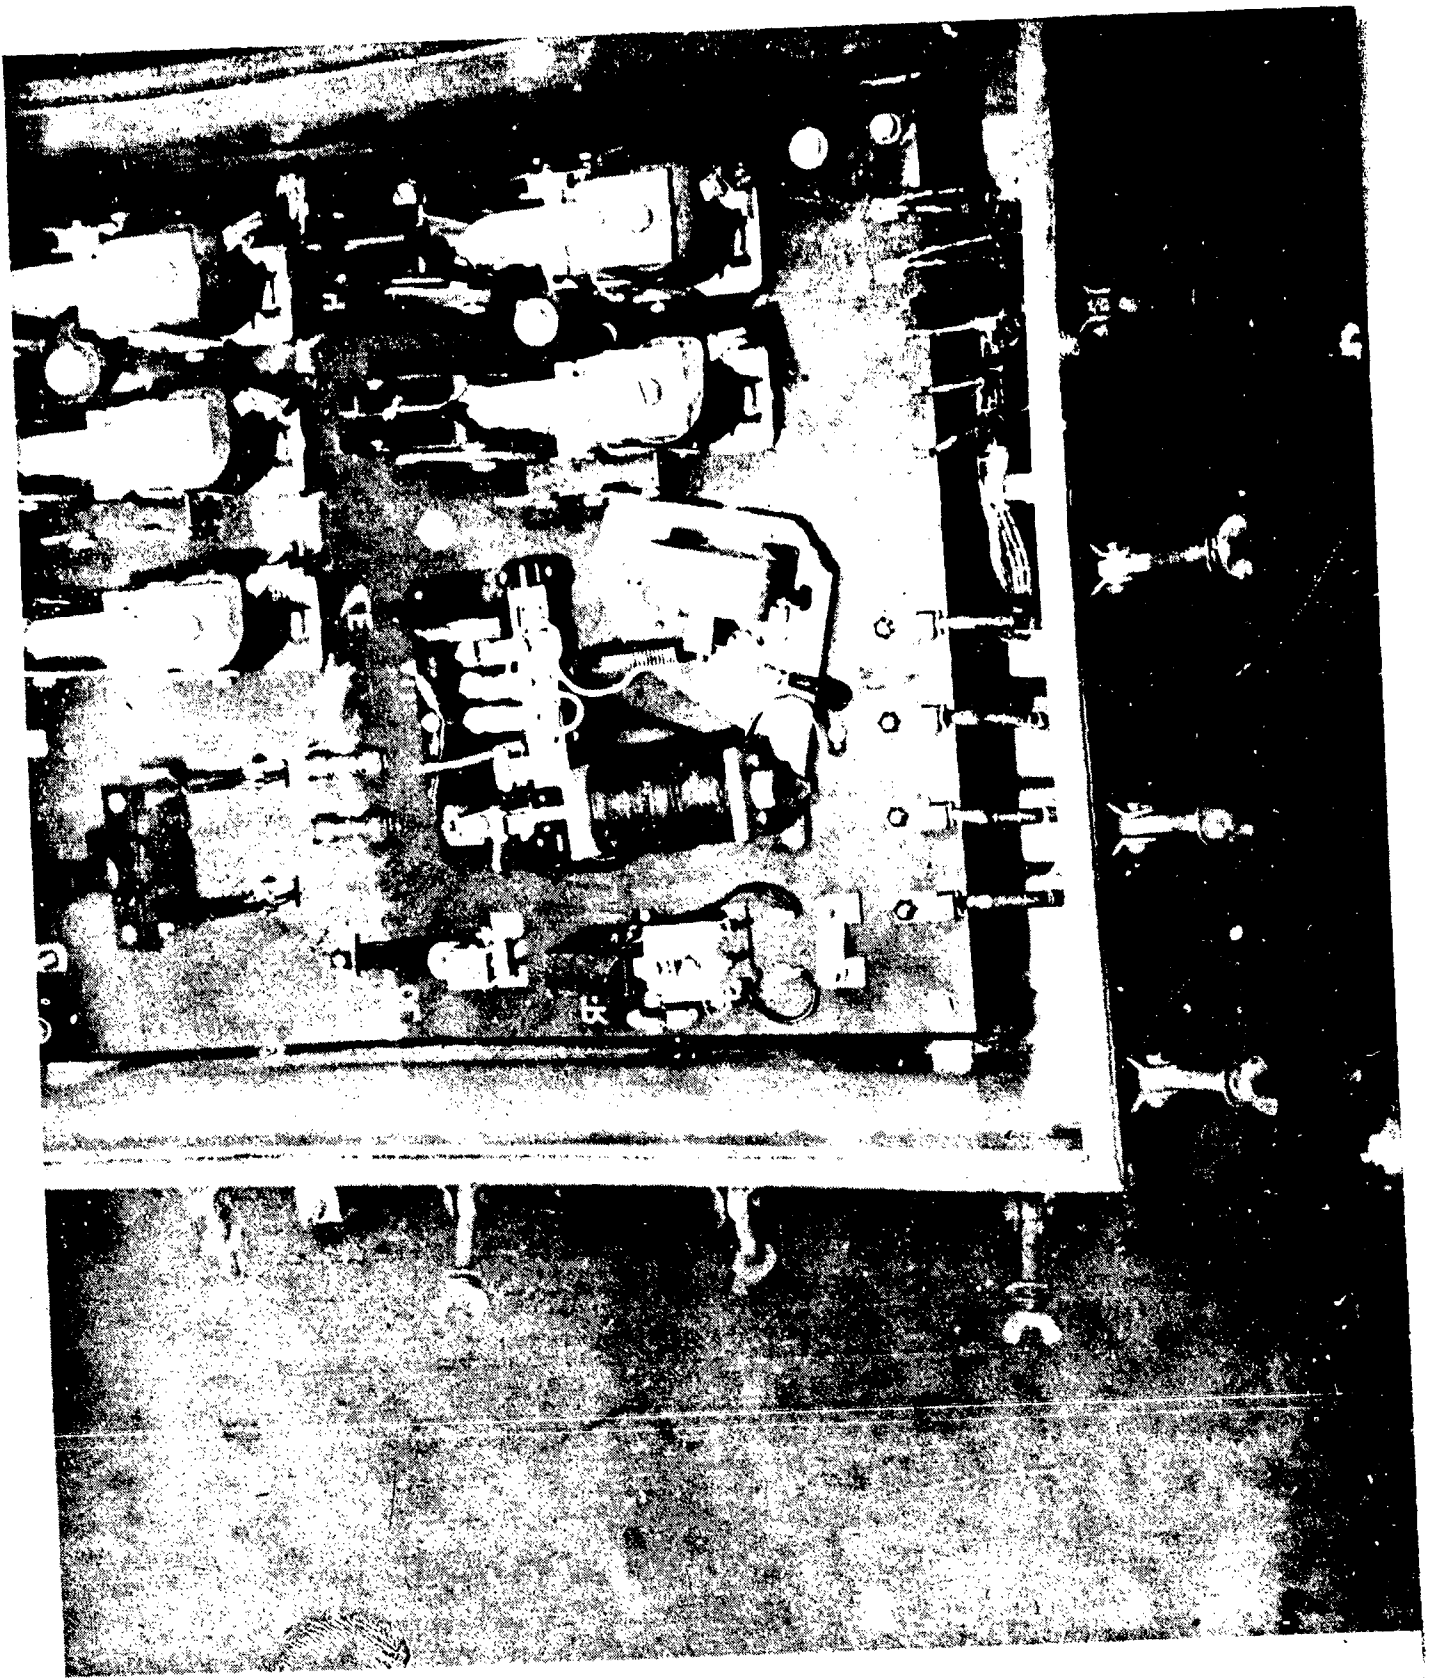
1. Dishing and whipping of starboard outboard bulkhead on main deck cracked insulating panels of boat davit controllers.

The only electrical damage having an appreciable effect on the operation of the vessel was that to the two starboard boat davit controllers. Damage to these units materially affected the ship's ability to disembark troops.

AA-CR-175-2156-12. Controller for forward starboard boat davits. Photo shows cracked main panel of ebony asbestos and broken and sub panel of molded phenolic. Damage was due to whipping of bulkhead due to blast.

AA-CR-175-2157-1. Controller for forward starboard boat davit.
Photo shows method of mounting on bulkhead. See photo 2156-12
for internal damage.

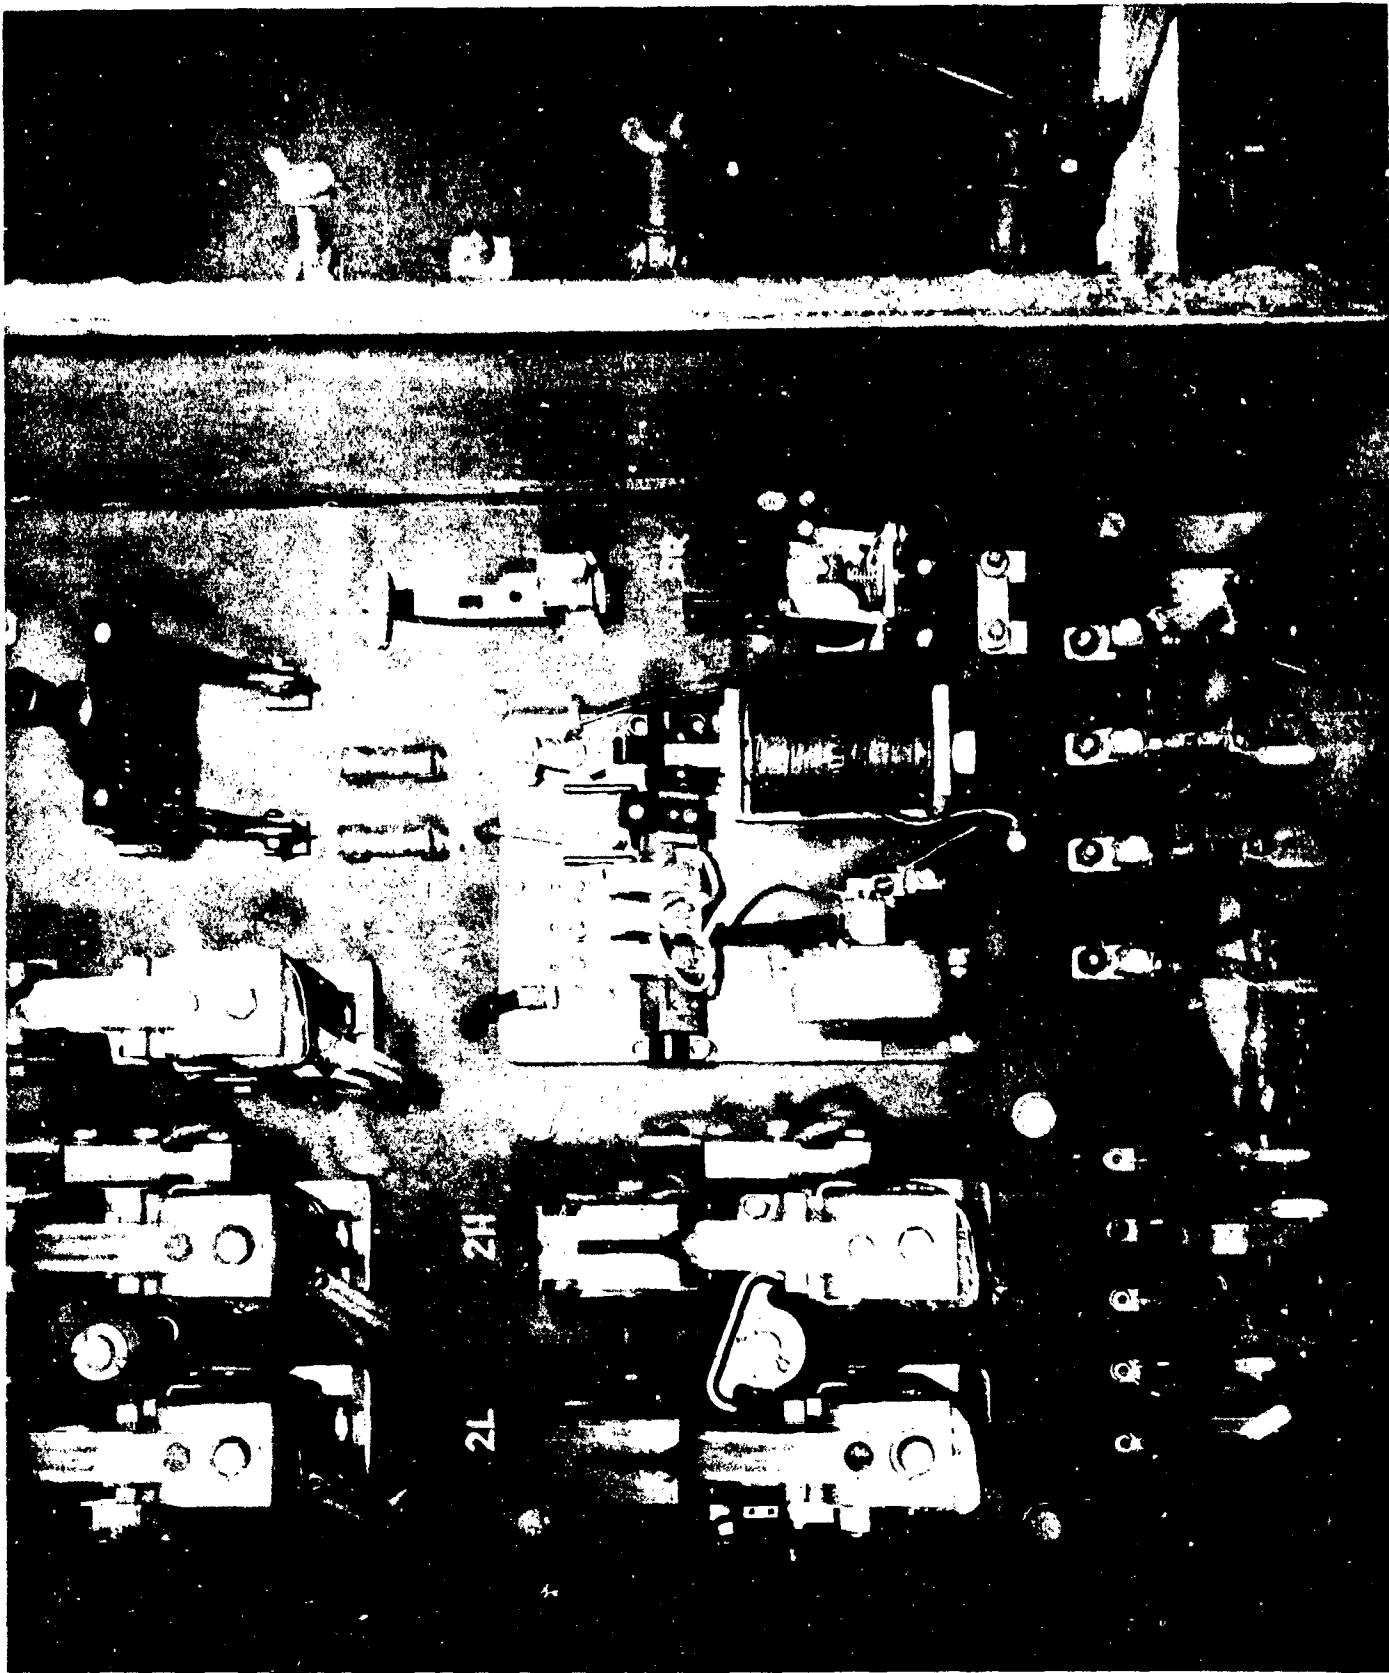
AA-CR-175-2156-11. Controller for after starboard boat davit. Photo shows cracked main panel of ebony asbestos and sub panel of molded pheuolic. Damage was due to whipping of bulkhead due to blast.
