TECHNICAL INSPECTION REPORT

U.S.S. CORTLAND (APA 75)

TEST ABLE [U]. 8

6 OPERATION CROSSROADS

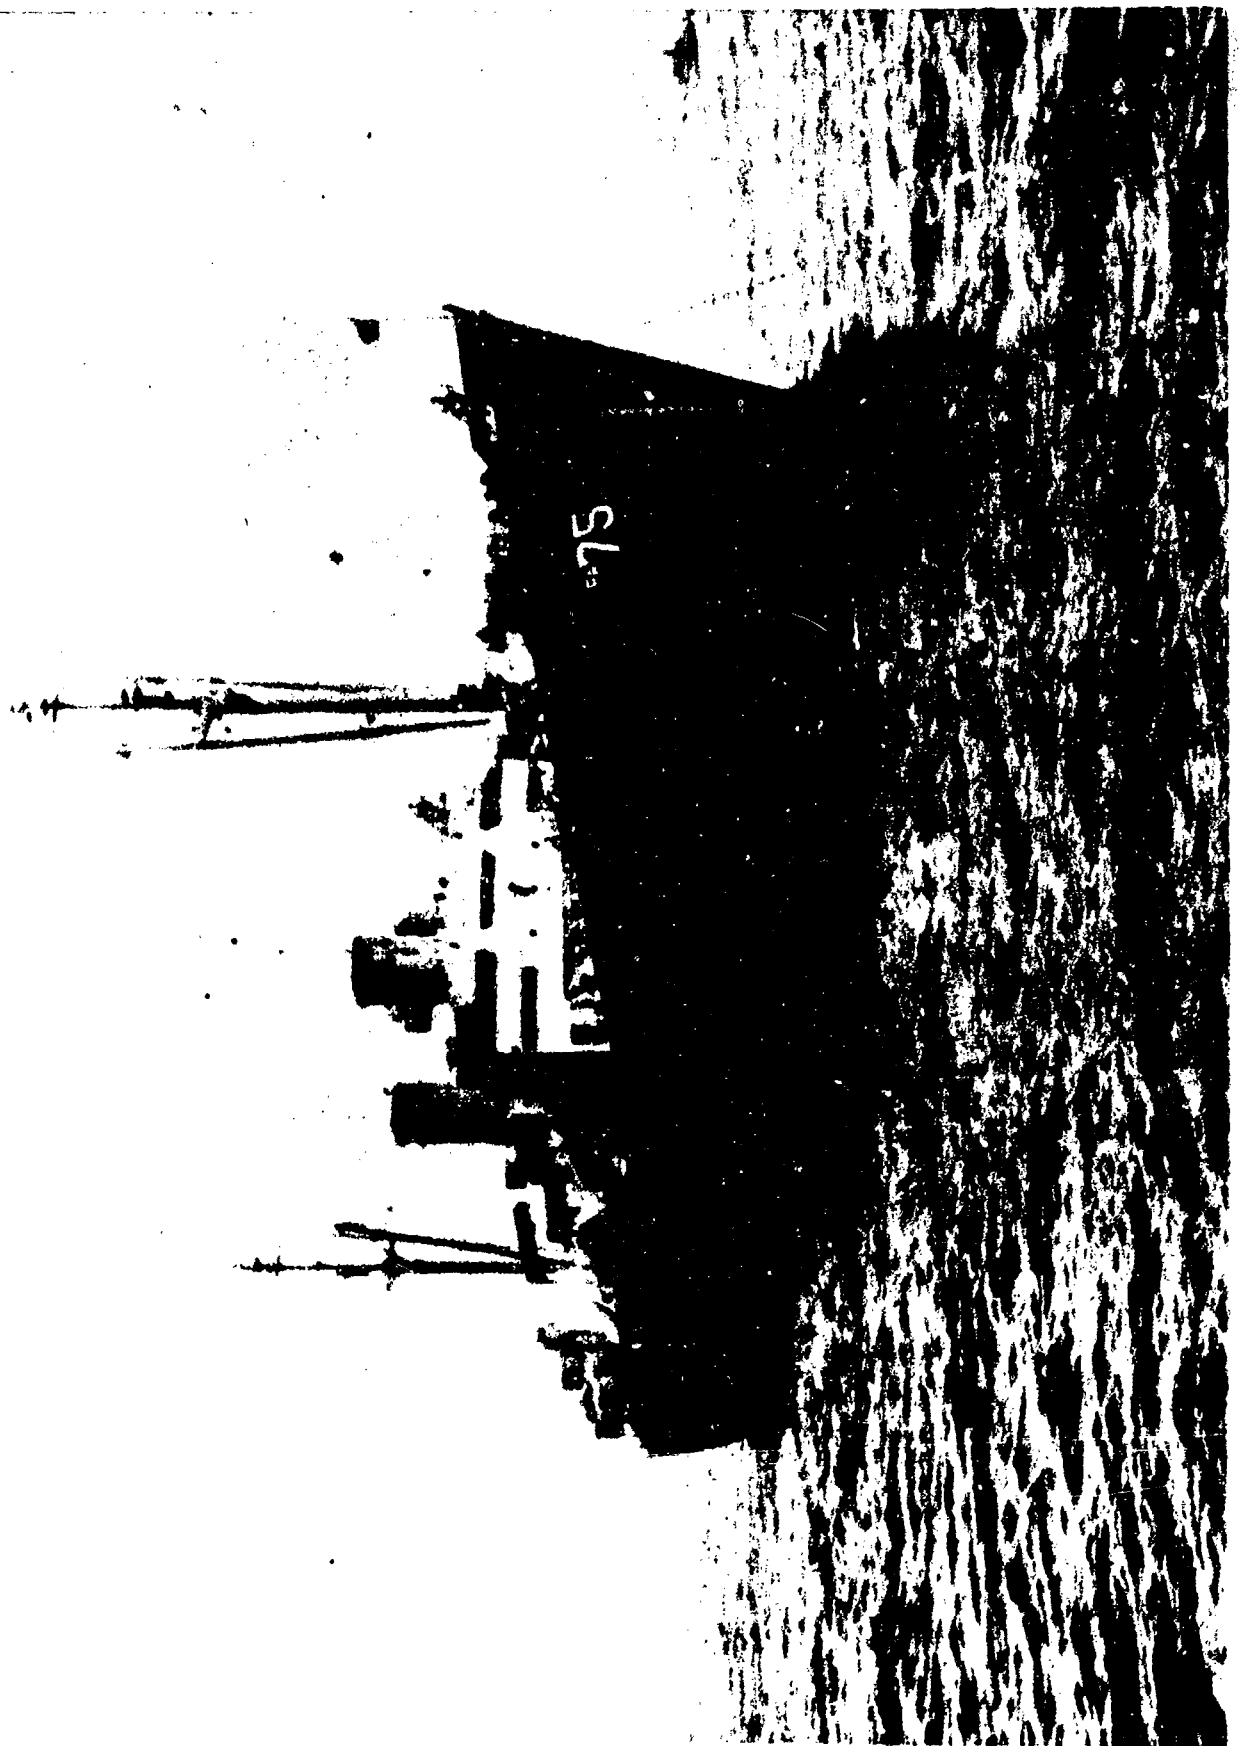
AA-CR-227-87-20. Starboard bow after Test A.

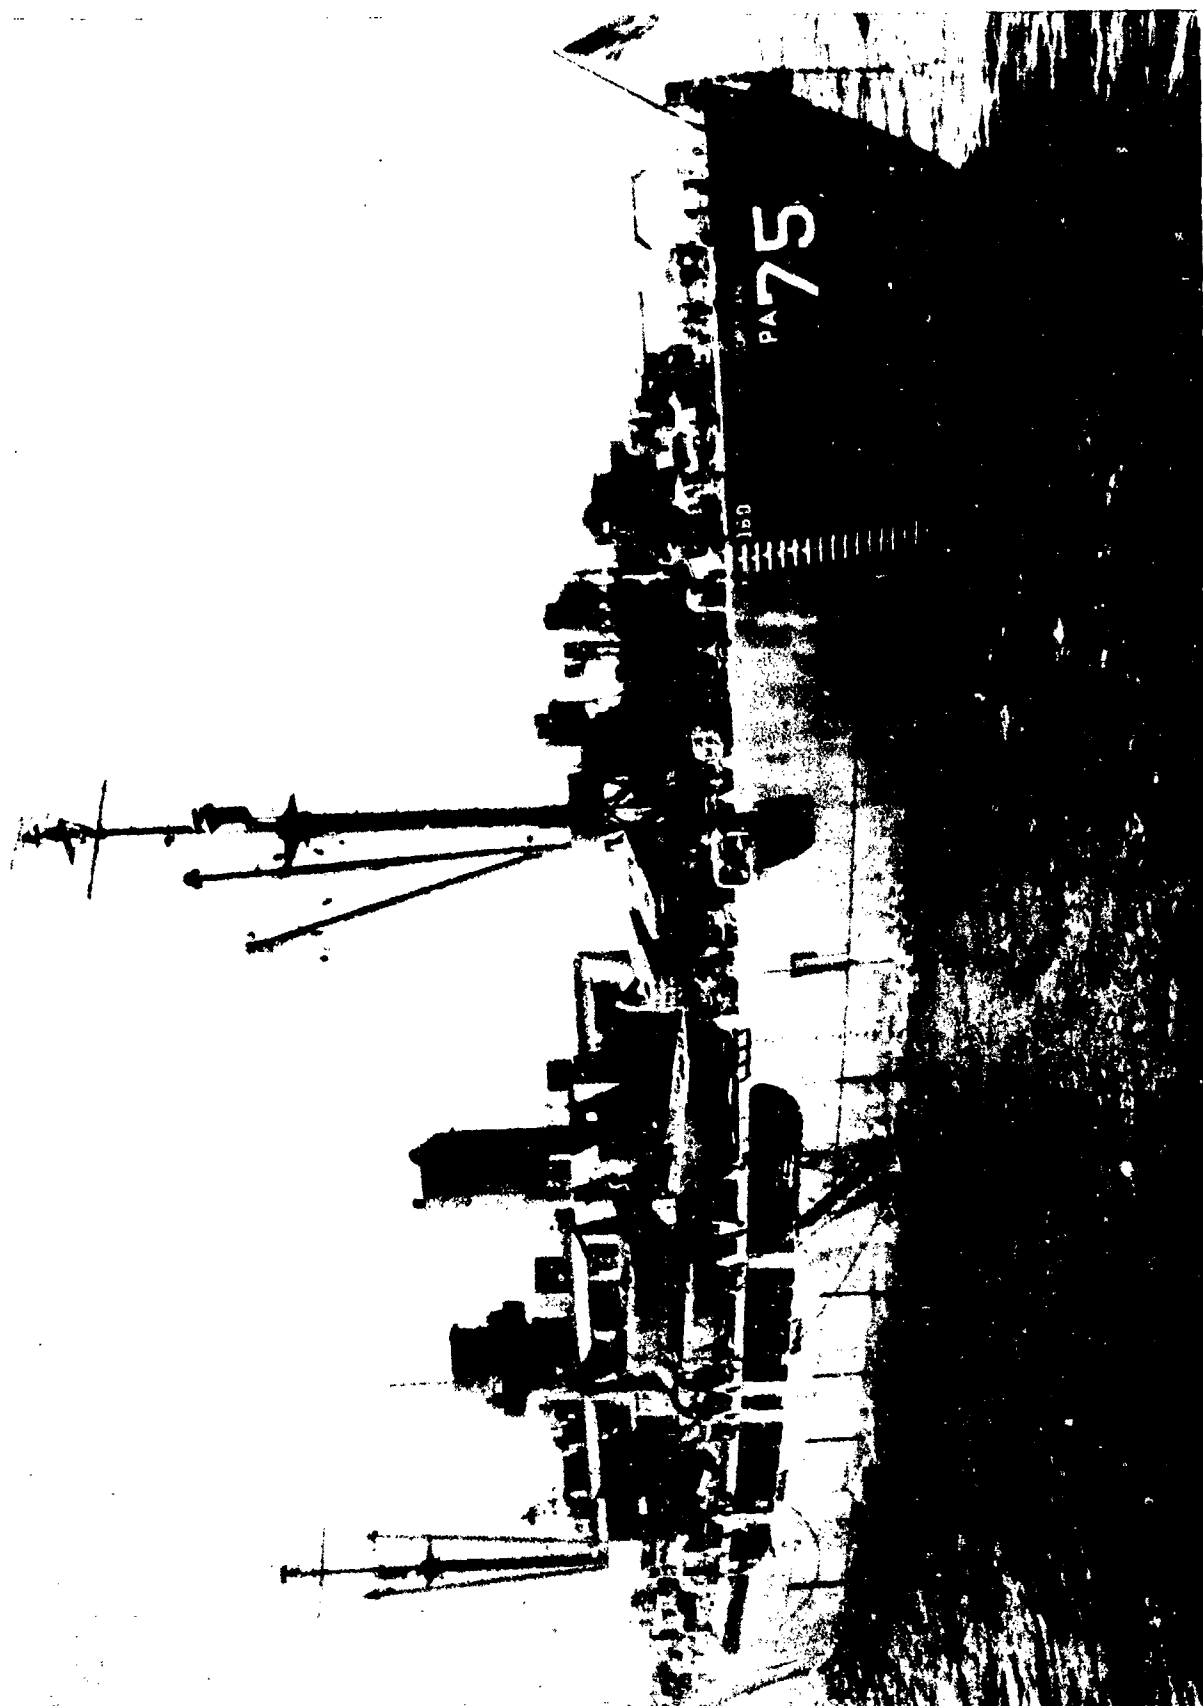
AA-CR-227-87-16. Port quarter after Test A.

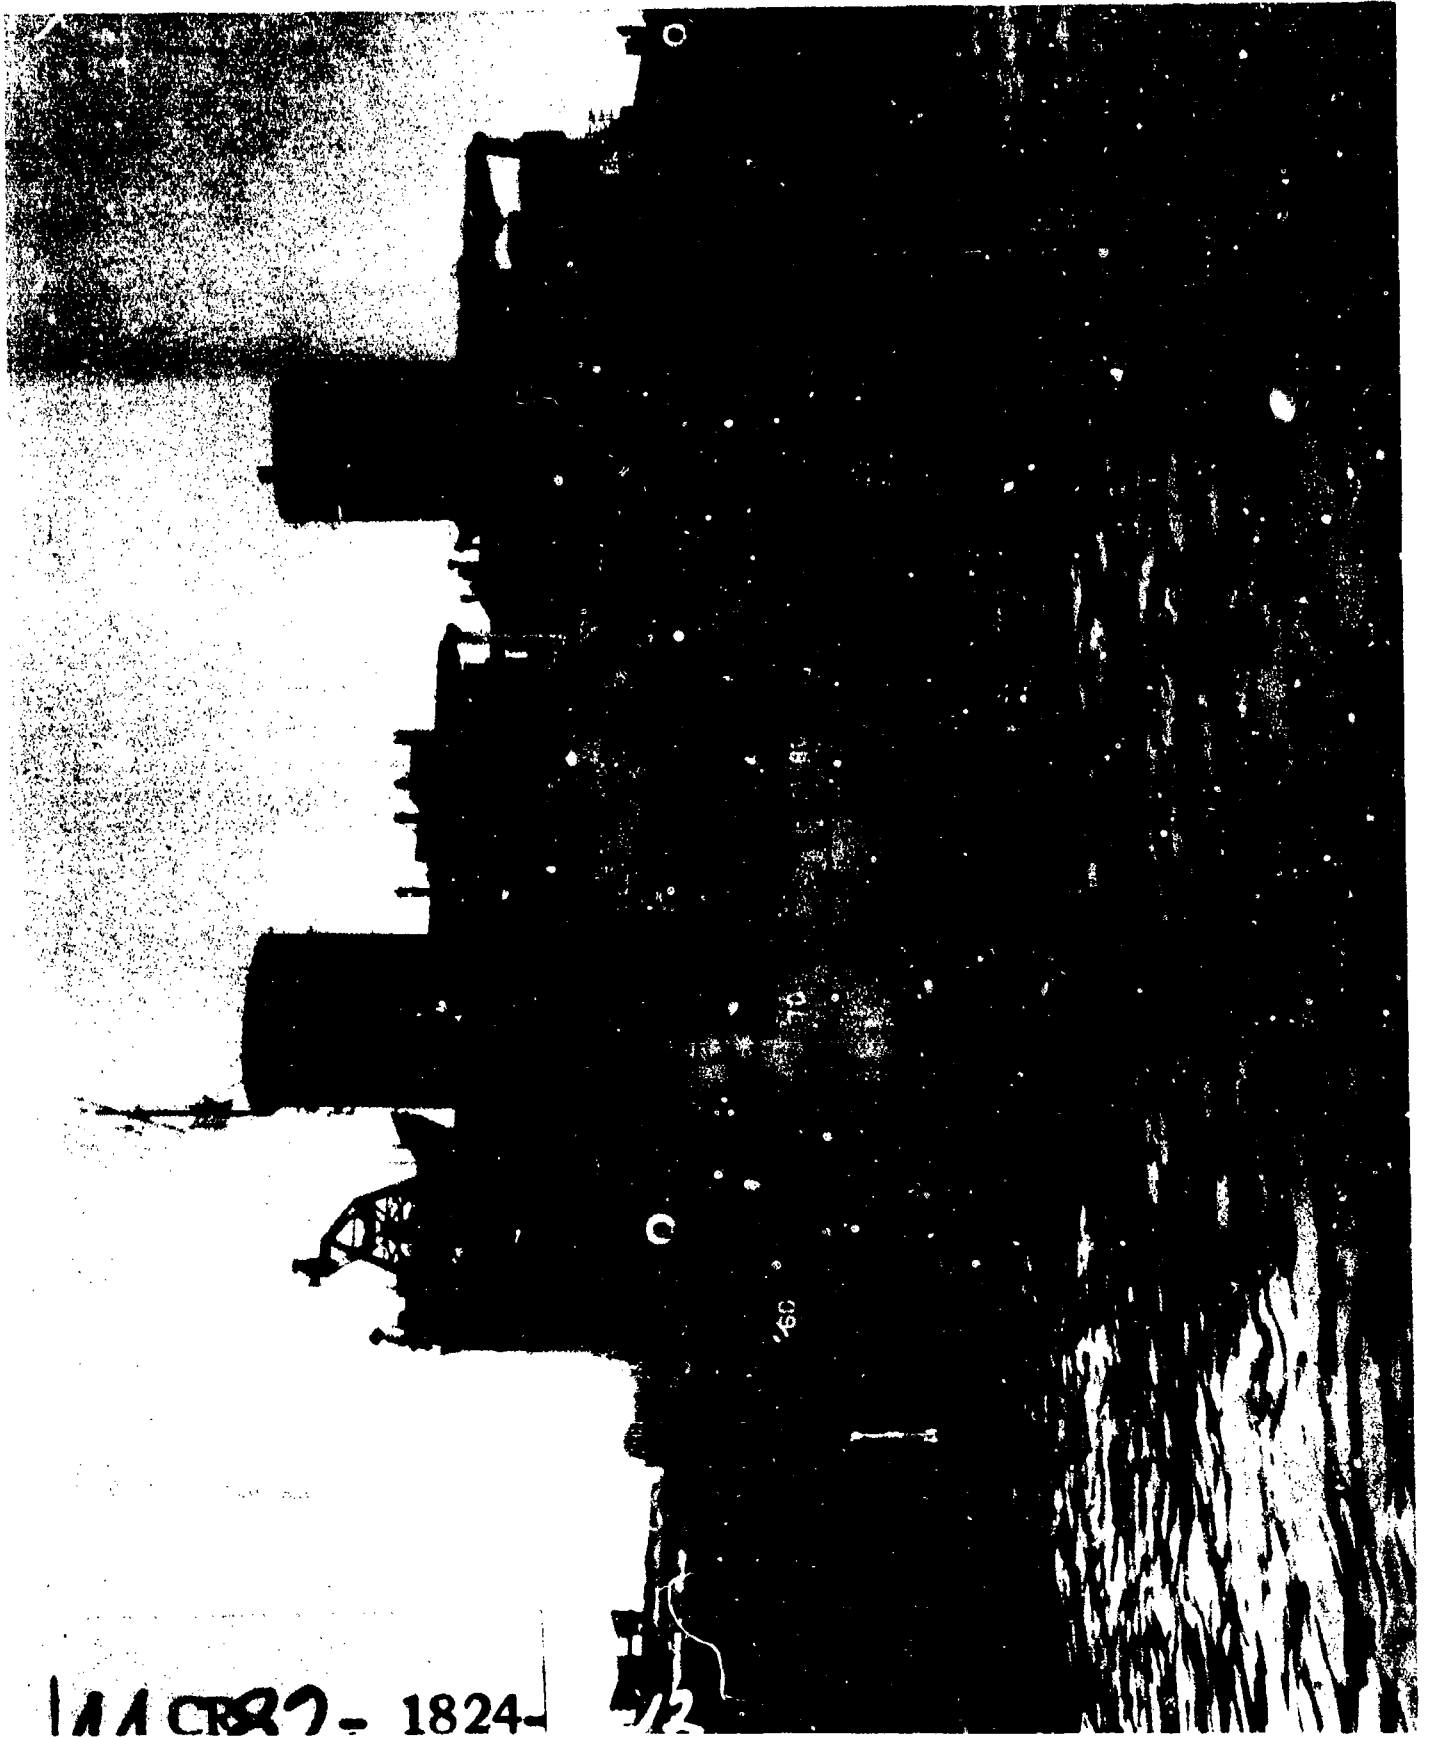
Structural damage resulting from fire, was sustained by the port side of the superstructure between frames 70 and 90. Side plating and outboard deck plating at the superstructure deck level were buckled at many points to a depth of about 2 or 3 inches. A wooden cabinet leaning against bulkhead 83 port, in the wardroom burned, causing the bulkhead plating to dish aft about 2-1/2 inches over an area of about ten square feet. Exposed sheet metal items were slightly dished by pressure.

AA-CR-82-1824-12. Port side, frames 50 to 110.

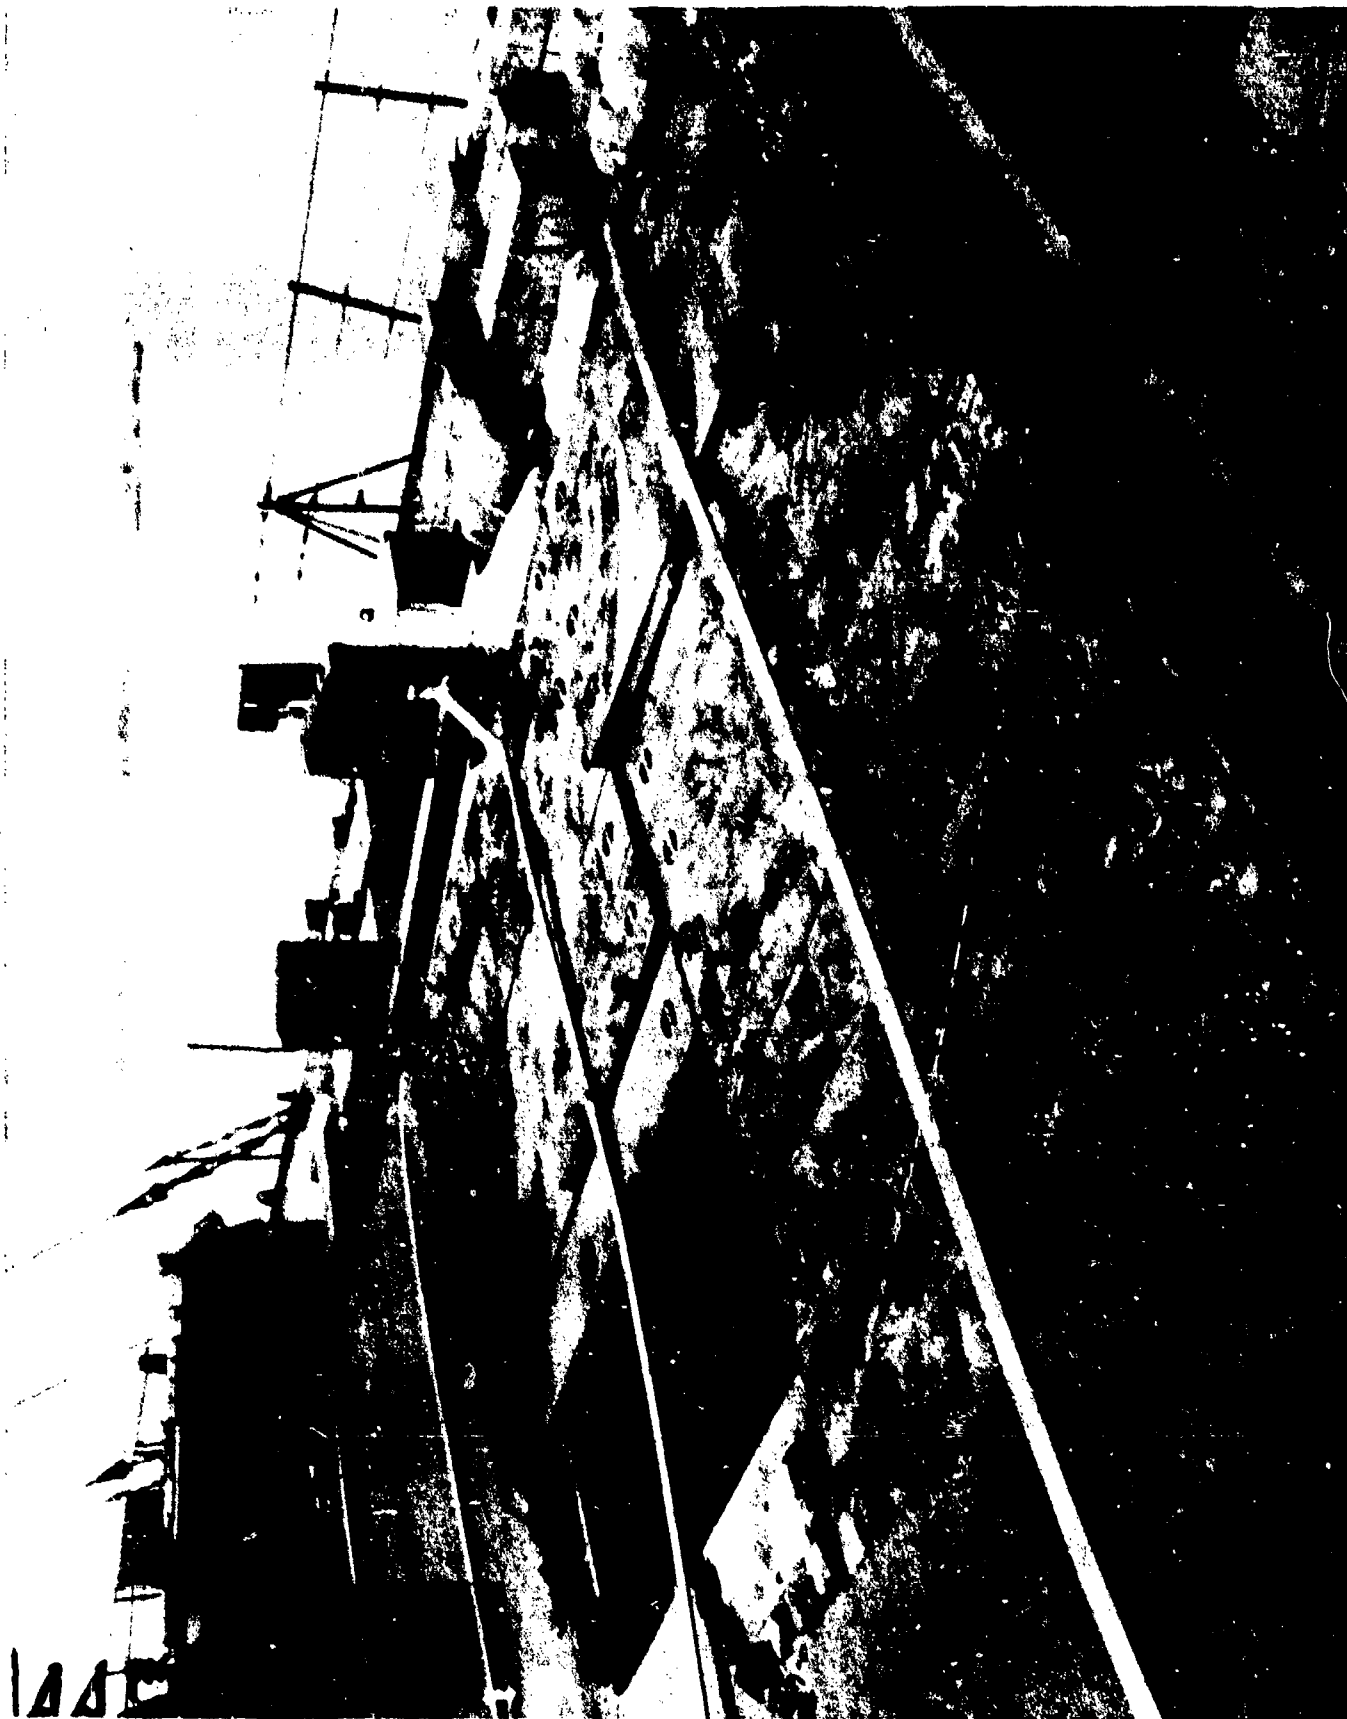
The canvas tarpaulin on both cargo hatches were partially burned (photo 1824-9, page 42 ). Several hatch boards on both hatches were lifted and dropped to the level below but were not damaged. There was some elastic deflection of the upper deck outboard of the forward cargo hatch. A tabulation of scratch gage location and readings is included as an Appendix.

AA-CR-82-1824-9. Forward cargo hatch cover, showing burned tarpaulin and displaced cover panels.
